**REQUEST FOR INFORMATION**      **DATE:** December 27, 2016      **NO.:** RFI-395

Project Name: 15051-Webster University Interdisciplinary Science Building      Project No.: 15051

Subject: Structural Steel Field Corrections

# Field connection revision #1

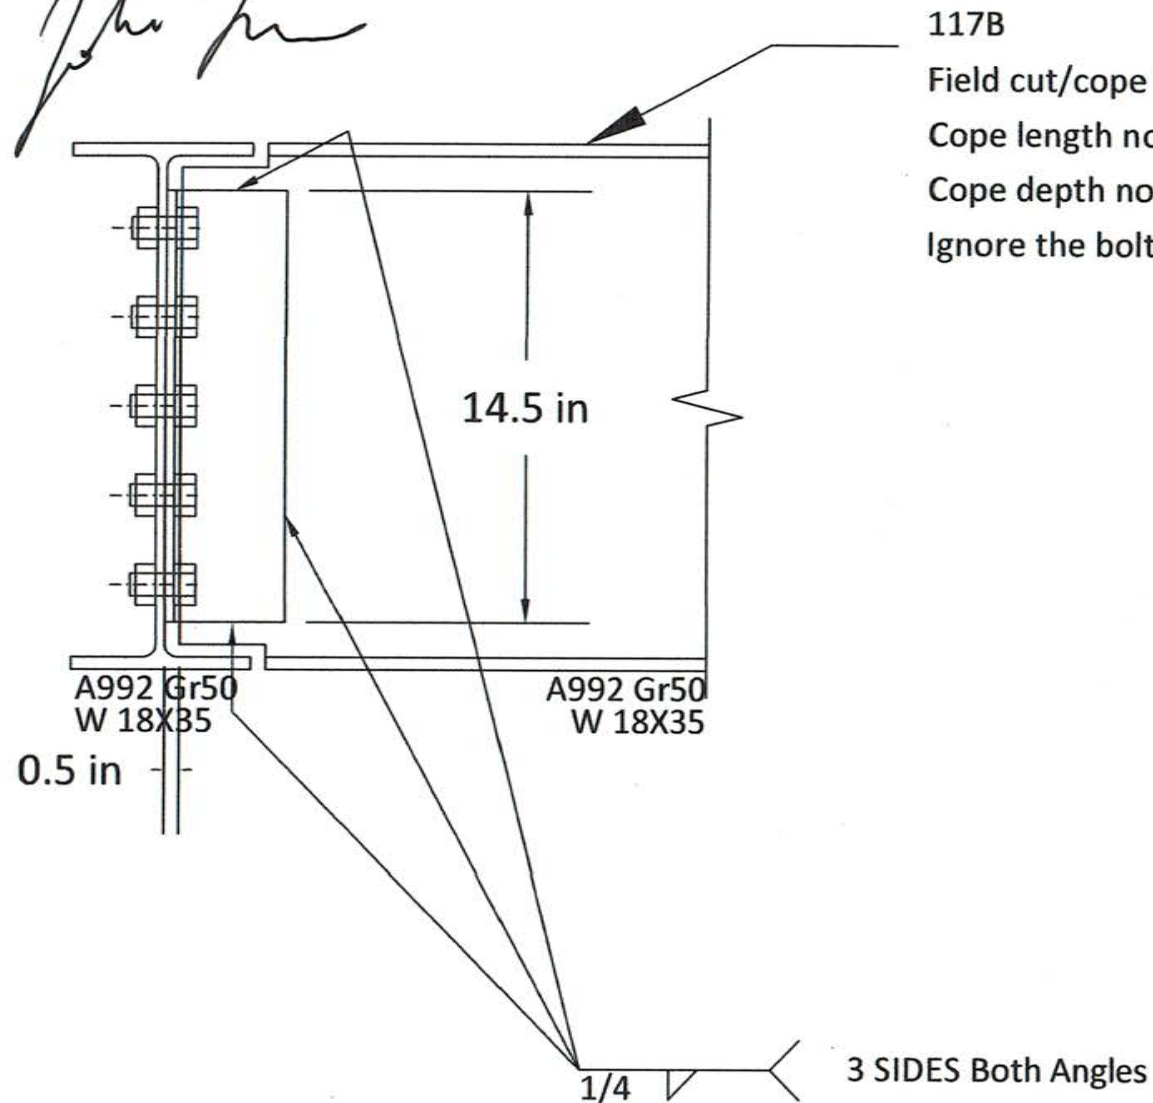
117B bolting to field welding  
JH 8/26/2016

Field cut/cope T&B Flange to fit

Cope length no more than 3 inch

Cope depth no more than 1 inch

Ignore the bolt hole on angle outstanding leg and beam web

3 SIDES Both Angles

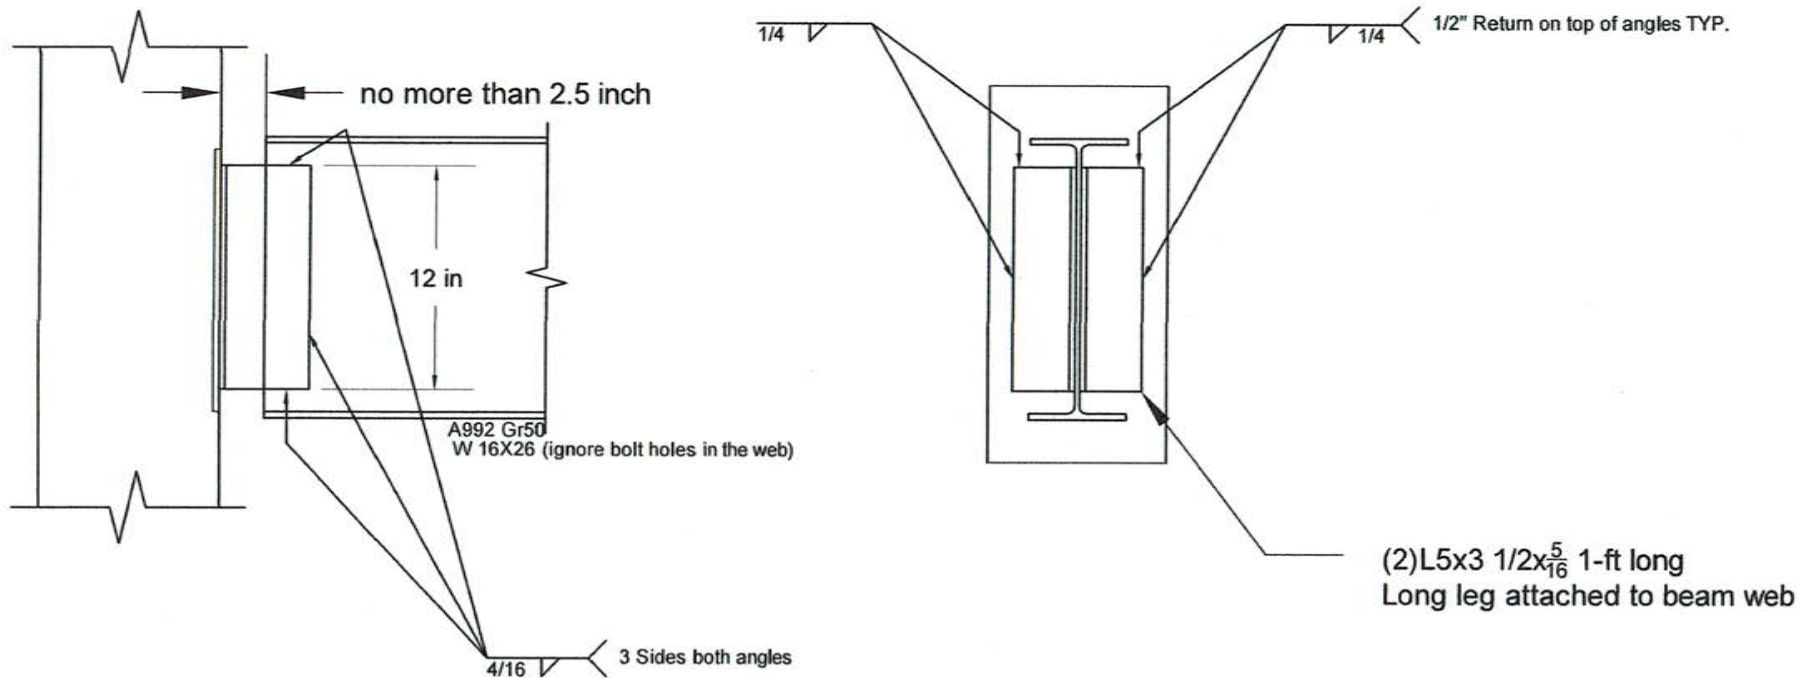
## FOR PARIC RFI-320 ONLY, (3) W16x26s Framed into Wall Embeds

Beam framing into wall/foundation issues. Bolting changed to Welding in field  
JH 10/11/2016

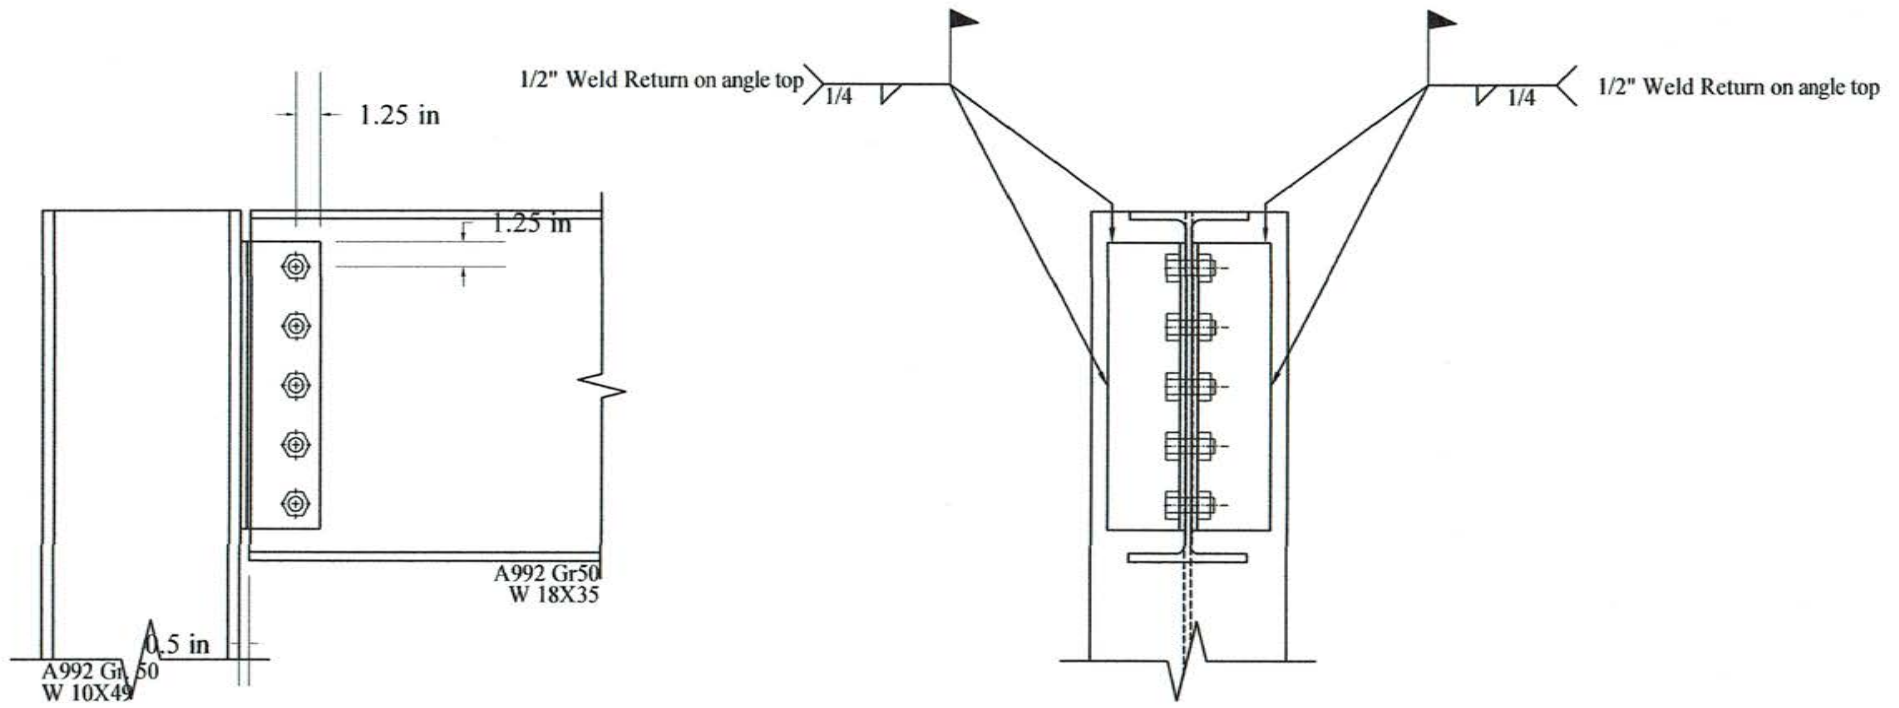
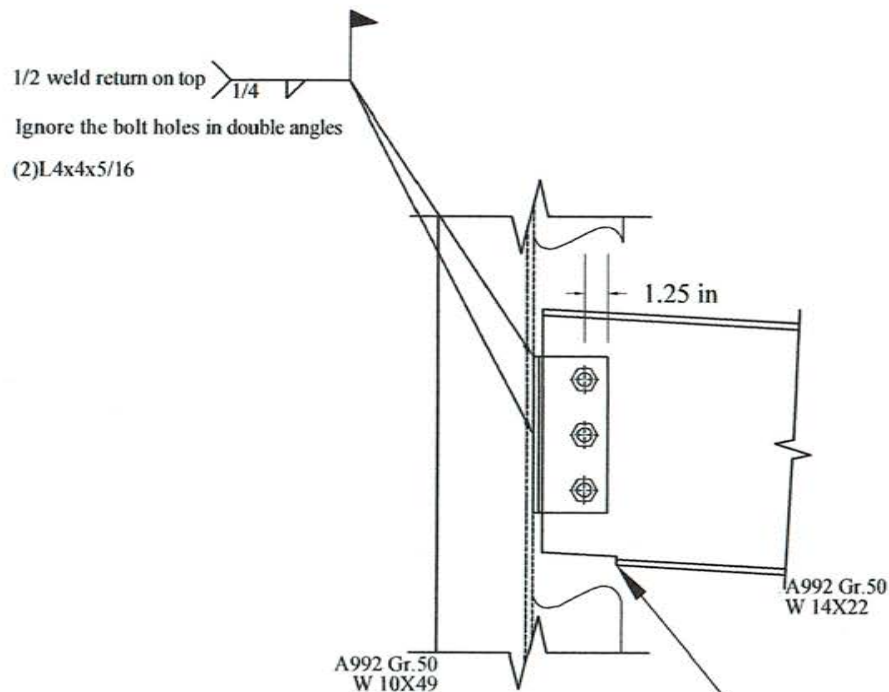
Column 305A missing hole punches at top  
JH 10/18/2016

OPTION 1  
Keep the angles  
Weld angles to support  
column in field

Cut/Grind the bottom flange as needed if the double angles are welded to column web first.
