**PROJECT:** Webster University ISB  
**Cx PROGRESS REPORT:** #001  
**R&B PROJECT NO:** 1136-16  
**TOPIC:** Coordinated Model Review – Equipment Accessibility  
**DATE:** 2016-10-14  
**Cx TEAM:** Kevin McCormick (R&B)

**PROJECT:** Webster University ISB  
**Cx PROGRESS REPORT:** #002  
**R&B PROJECT NO:** 1136-16  
**TOPIC:** Field Observations – 1<sup>st</sup> Floor  
**DATE:** 2017-01-27  
**Cx TEAM:** Kevin McCormick (R&B)

**PROJECT:** Webster University ISB  
**Cx PROGRESS REPORT:** #003  
**R&B PROJECT NO:** 1136-16  
**TOPIC:** Field Observations – 2<sup>nd</sup> Floor  
**DATE:** 2017-02-03  
**Cx TEAM:** Kevin McCormick (R&B)

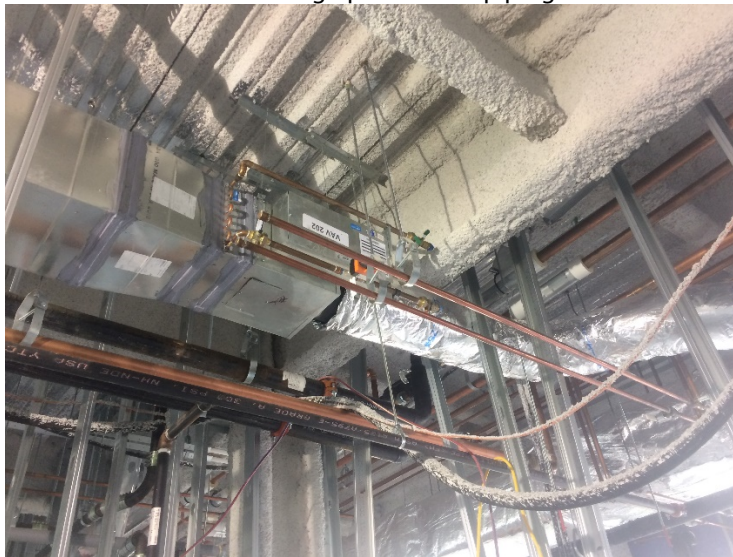
- 1) The majority of the mechanical equipment was installed in Area A and Area B.
- 2) Ductwork not yet installed was observed to have its openings covered.
- 3) Access panels appeared small for the following units: SAV-208, VAV-209, VAV-212.
- 4) GEV-207 control panel cover was off and the controller was not protected.
- 5) VAV-201 did not appear to be fully protected from fire protection spray.
- 6) VAV-202 and its piping components appear to have been rotated. The bleed valve is now on the lower piping and needs to be relocated to the high point of the piping.

- 1) Confirm that the access panels used for 12" and 14" terminal units' heating coils provide ample space to access for service.
- 2) Cover the exposed control panel for GEV-207.
- 3) Clean up structural fire protection spray from VAV-201.
- 4) Re-pipe VAV-202 to match the piping detail on M0501 in construction drawings.
