## Site Visit Notes – Water Testing observations

**Date/Time:** July 28, 2017  
**Prepared by:** Scott Klingsick, KWA  
**Project Title:** Webster University – Interdisciplinary Science Building  
**KWA Project No.:** 2014-0119  
**Cannon Project No.:** 004561.00  
**Project Location:** 470 East Lockwood Avenue  
 Webster Groves, MO 63119

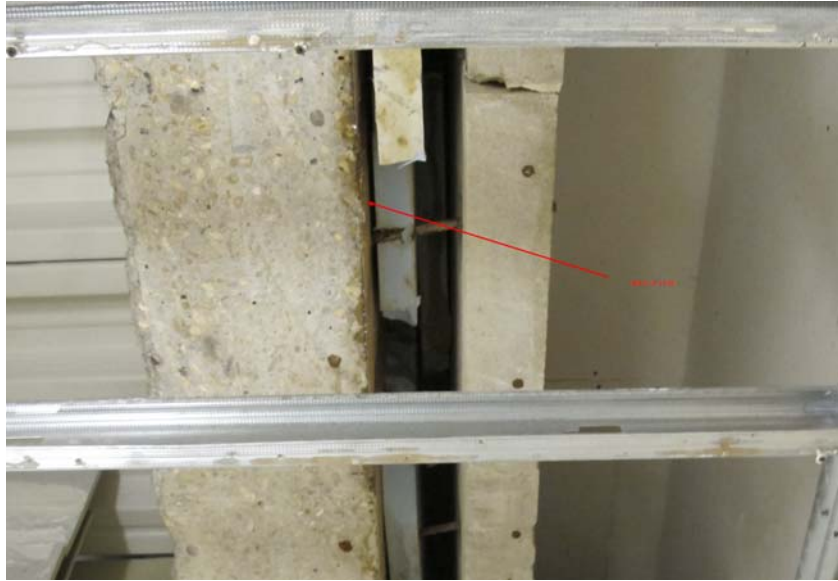
- KWA arrived on site and checked in at Paric's job trailer. Jason Szachnieski discussed an issue with leaking between the ISB and the EAB. Jason informed KWA that they have been investigating a leak in this area for some time. Jason stated that they have reviewed the movement joints (roof and walls) between the two buildings and made some modifications but the leak was still present. Leaking was noted at the head on door C170 between the ISB and EAB. Demolition had been performed to locate the source of the water infiltration at the door head. When on site water was noted coming from on top of the waterproofing that covered the EAB Vestibule metal deck and running down the outside of the beam on the waterproofing between the beam and the remaining existing limestone. Paric removed the cap from the abandoned drain line in the vestibule floor and informed KWA that they filled 2 five gallon buckets with water. When reviewing the second level no water was noted in the space between the two buildings at the movement joints. On the west door (XC270A.1) of the EAB Connector the pavers were not installed and the existing concrete was exposed at the door. No water proofing was noted in this area and existing concrete appeared to slope back to the EAB Connector and a cold joint was present between two pours. KWA requested that Paric preform a water test in this location. Water testing was preformed while KWA was on site. Water ponded against the entrance to the EAB Connector. Water was noted flowing into the cold joint in the concrete below and into the joint at the building. An increase in dripping was first noted at the drain pipe and then at the door head.

Door head C170

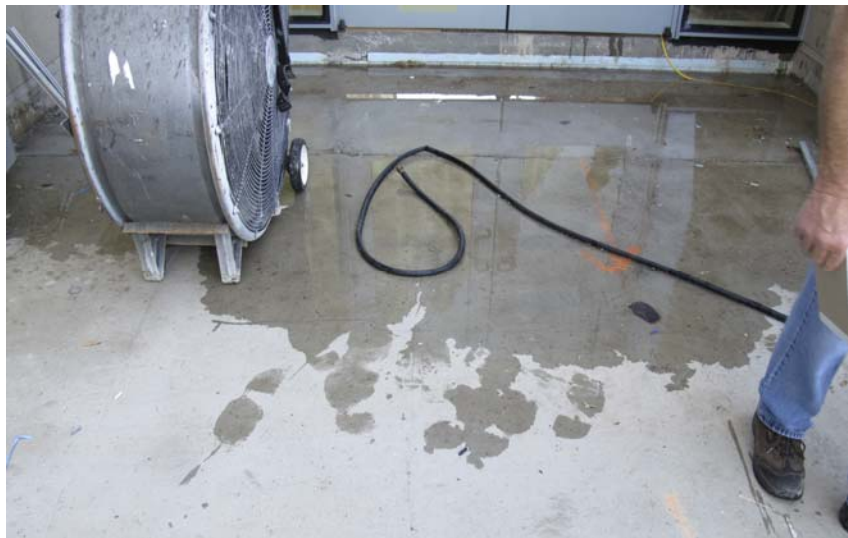
Area of water testing

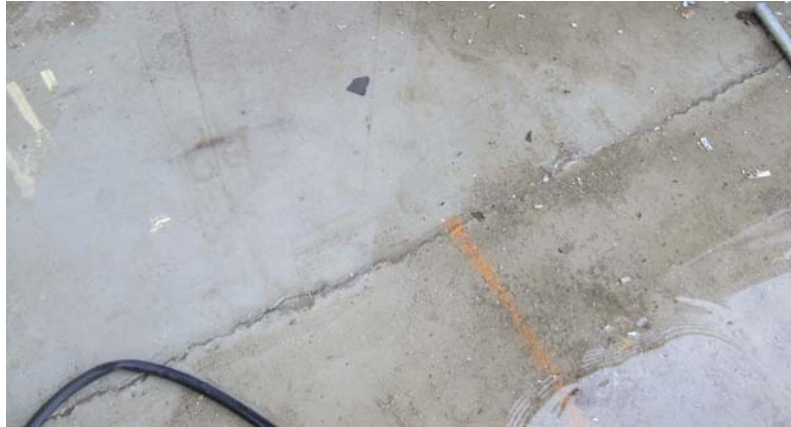
Cold joint

Craig Miller, George Crow, Jason Szachnieski and Scott Klingsick discussed the issue. KWA recommended that the cold joint be waterproofed. Then a 12 foot area at the Vestibule doors be sloped away from the building with waterproofing be added below the vestibule doors and extended to join the water proofing at the new paver area. Jason contacted Western water proofing to see if there was something that could be used to slope the deck that would not have a long cure time. Western said that they would look into options and get back to Jason. George Crow recommended using the same waterproofing material used on the deck at the pavers. See picture below.

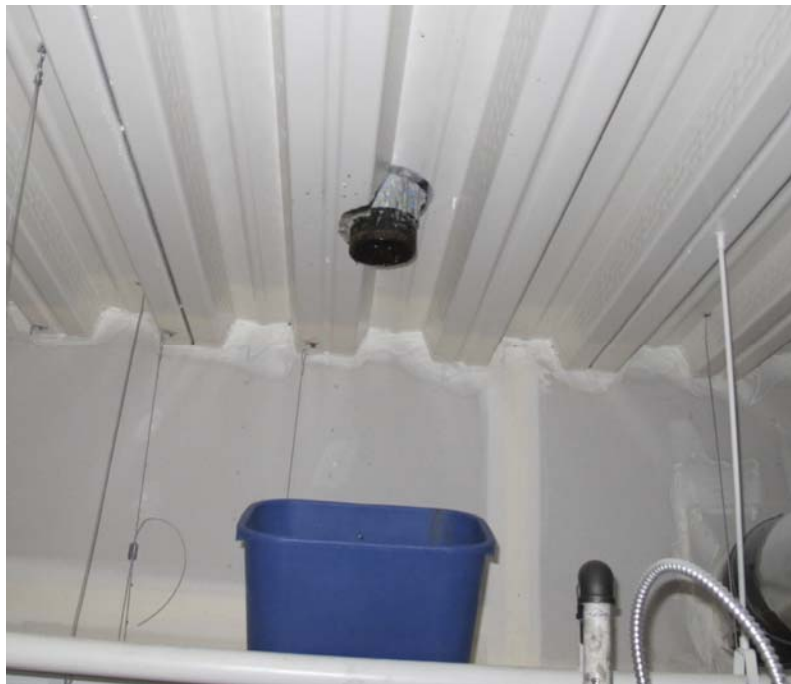
Existing drain pipe that was capped.
