### **CONSTRUCTION OBSERERVATION REPORT**

Project: Webster University - ISB  
Location: Webster Groves, Missouri  
WES No.: 607  
Visit Date: May 10, 2017  
Report Date: May 11, 2017  
Report No.: 3  
Report By: Mike Whitworth and Rannae Lowery  
Copies To: Patrick Garner, P.E., CPD, Wm. Tao & Associates  
WES file

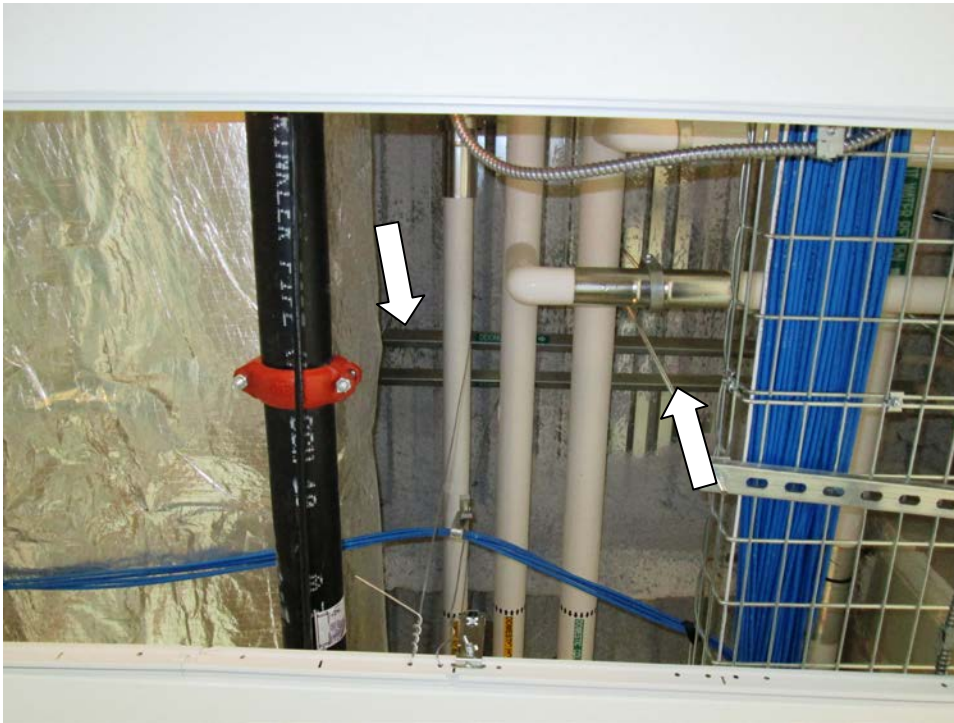
Photo 2-1  
Corridor C280 – Di / RO piping not wrapped where crossing in corridor.

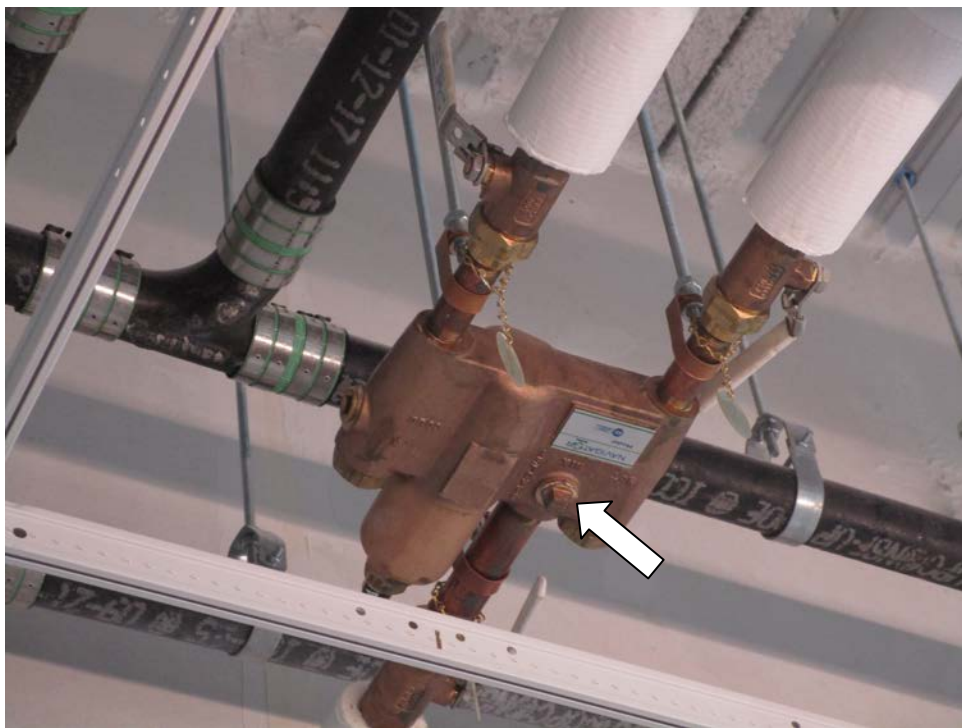
1. Plumbing:
  1. Physiology Lab 391:
    - a. Missing thermometer gauge on TMV. Refer to Photo 3-1.
  2. Biology Prep Room West 389::
    - a. Missing thermometer gauge on TMV. Refer to Photo 3-2.

Photo 3-1  
Physiology Lab 391 – Missing thermometer gauge on TMV

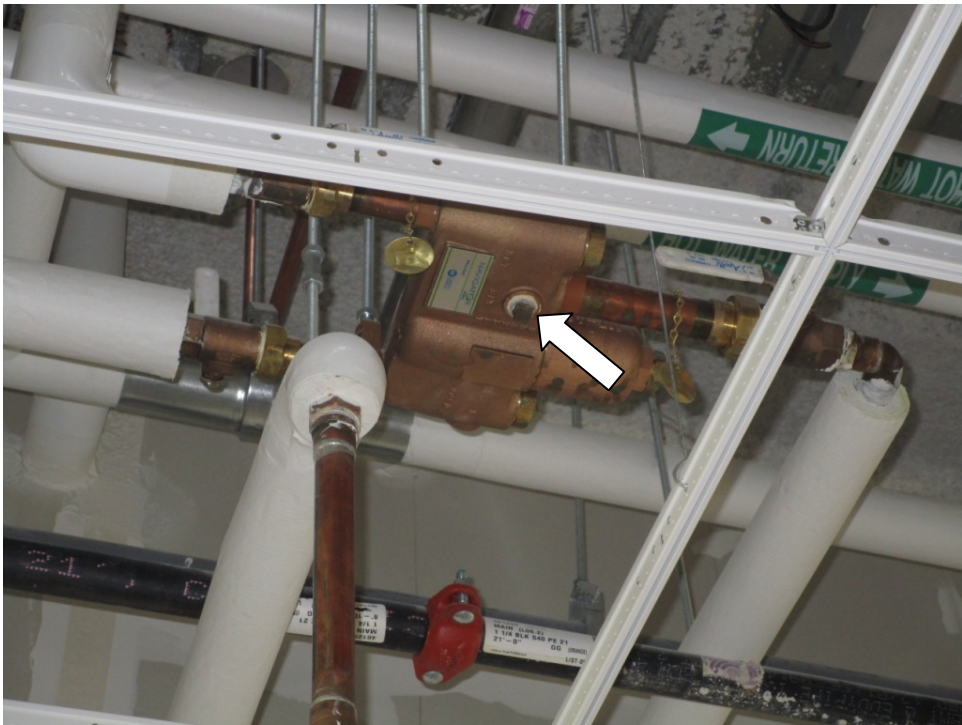
Photo 3-2  
Biology Prep Room West 389 – Missing thermometer gauge on TMV.

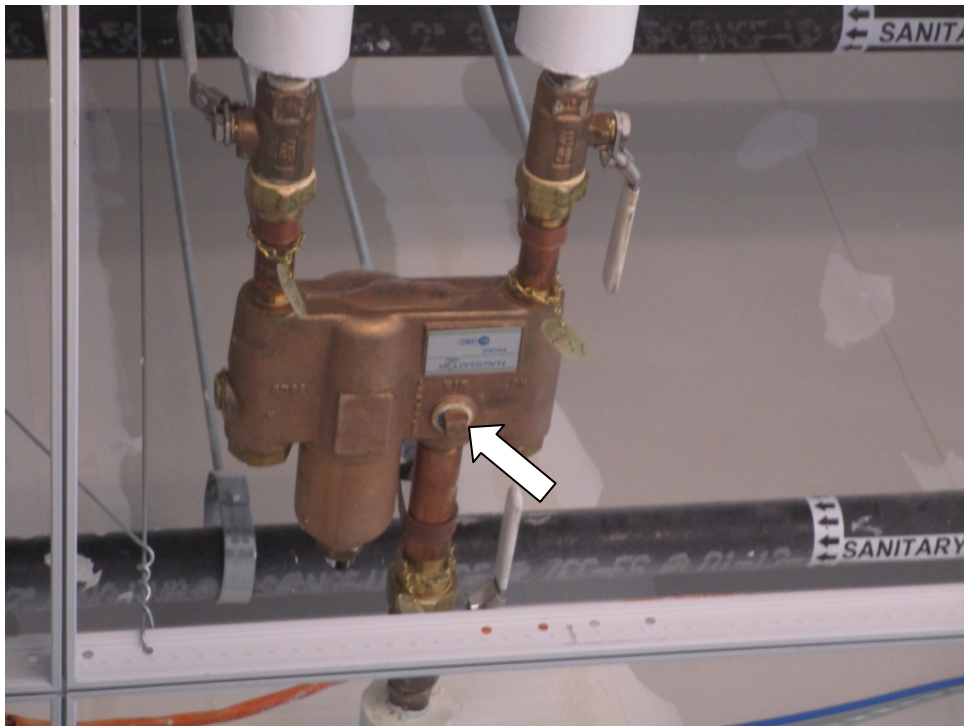
3. Cell Biology and Biochemistry Lab 383:
    - a. Missing thermometer gauge on TMV. Refer to Photo 3-3.
  4. Biology Autoclave Room 372B:
    - a. Missing thermometer gauge on TMV. Refer to Photo 3-4.

Photo 3.3  
Cell Biology and Biochemistry Lab 383 – Missing thermometer gauge on TMV.

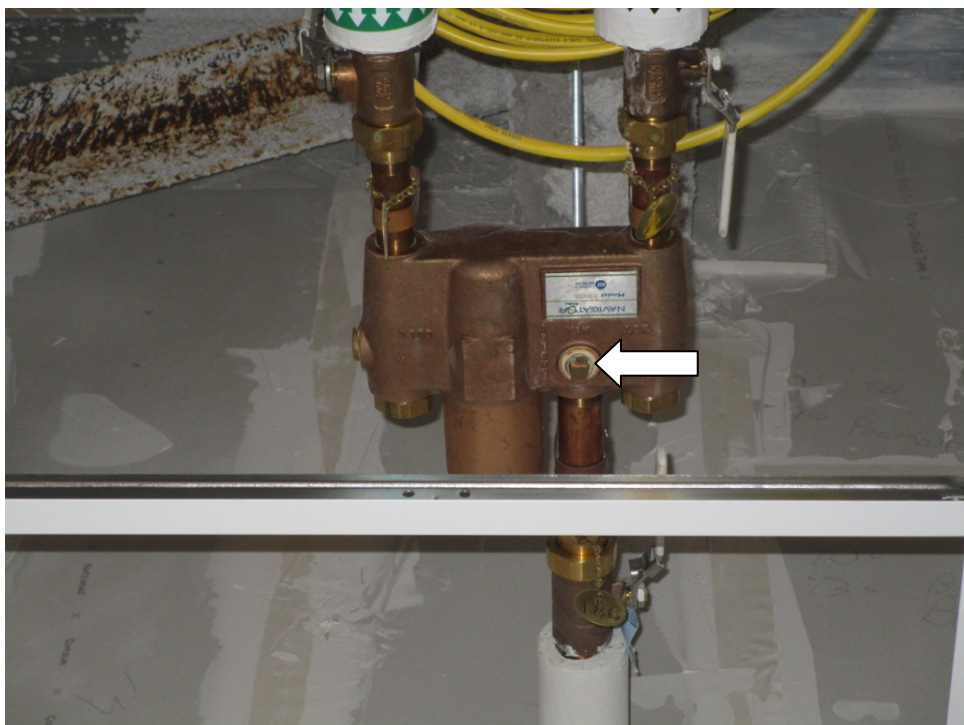
Photo 3-4  
Biology Autoclave Room 372B – Missing thermometer gauge on TMV

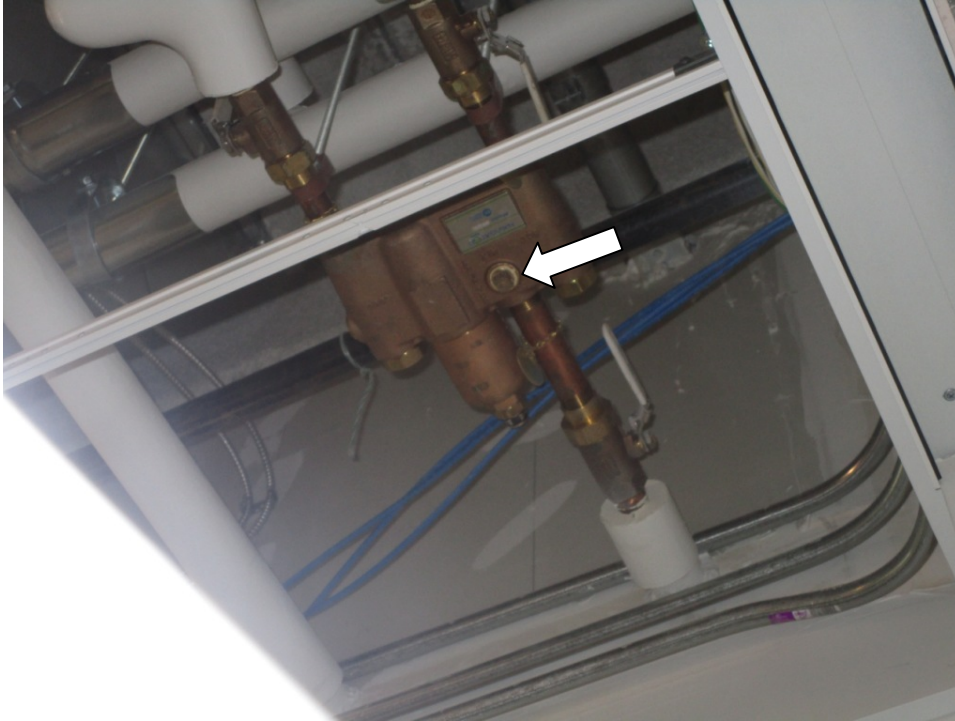
5. Ginny Harrison Organismal Biology Lab 378:
    - a. Missing thermometer gauge on TMV. Refer to Photo 3-5.
    - b. Domestic hot water pipe elbow serving Level 4 lab sinks not insulated. Refer to Photo 3-6

Photo 3-5  
Ginny Harrison Organismal Biology Lab 378 – Missing thermometer gauge on TMV.

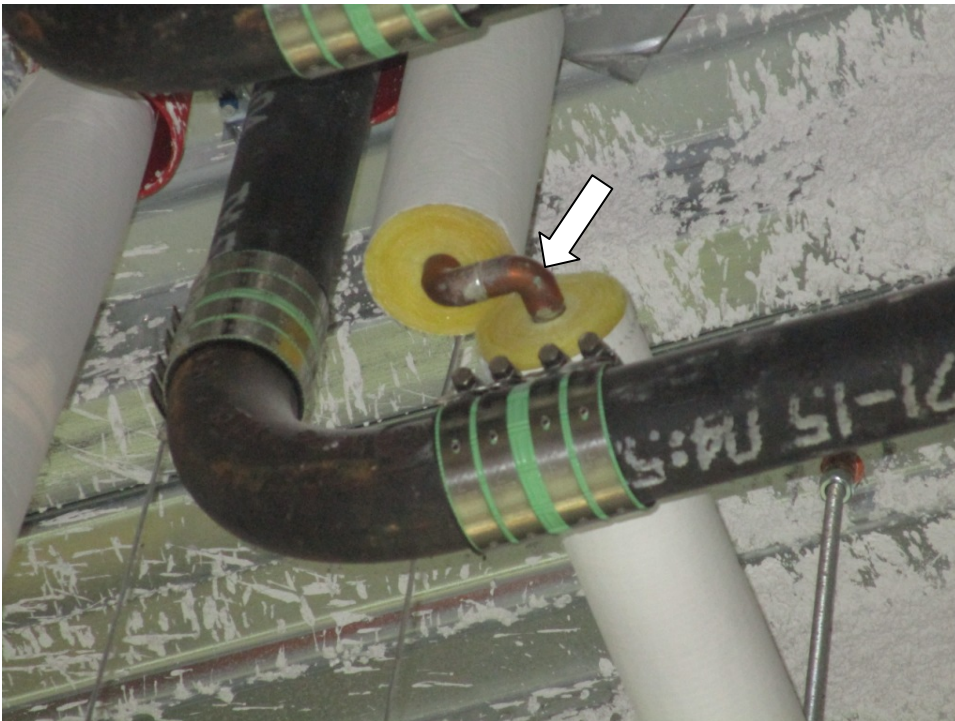
Photo 3-6  
Ginny Harrison Organismal Biology Lab 378 – Missing pipe insulation.

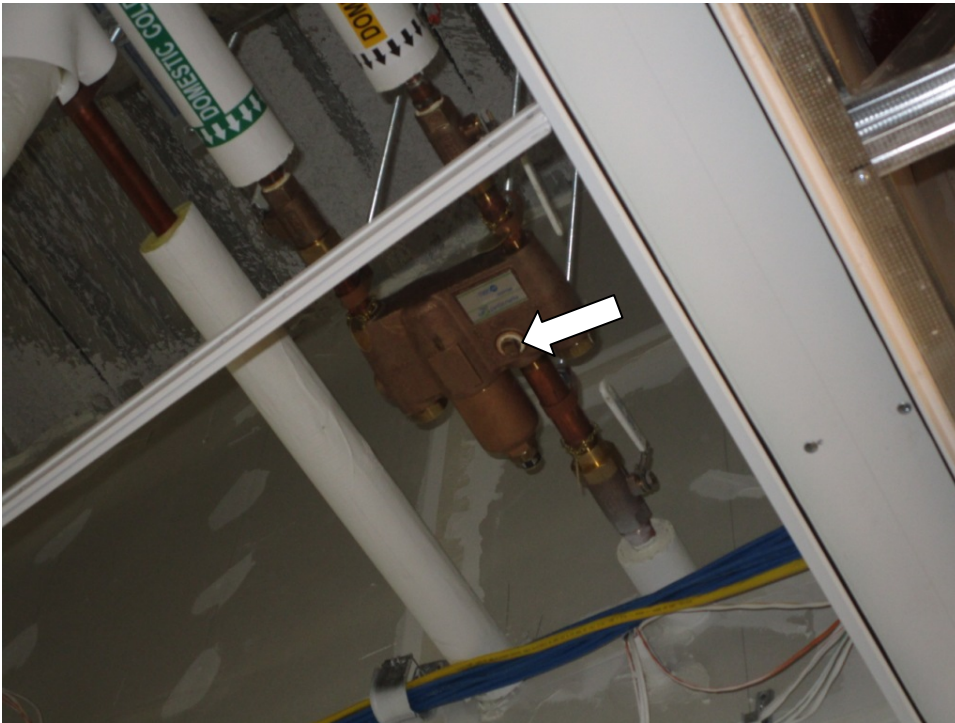
6. Biology Research Lab (Neurobiology) 374A:
    - a. Missing thermometer gauge on TMV. Refer to Photo 3-7.
    - b. Piping not insulated. Refer to Photo 3-8 and Photo 3-9.

Photo 3-7  
Biology Research Lab (Neurobiology) 374A – Missing thermometer gauge on TMV

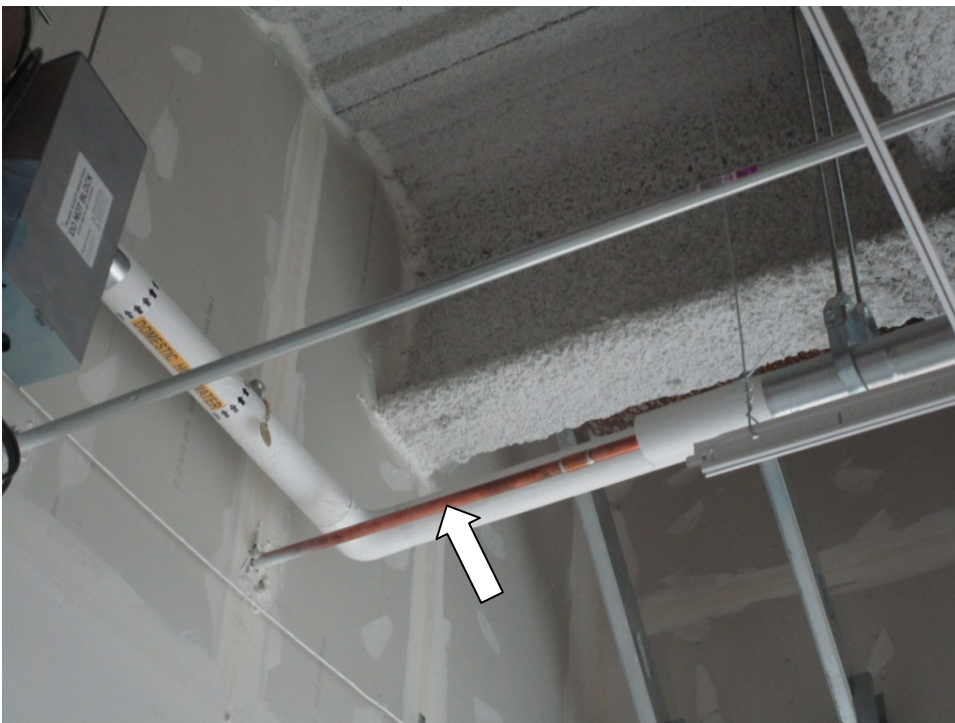
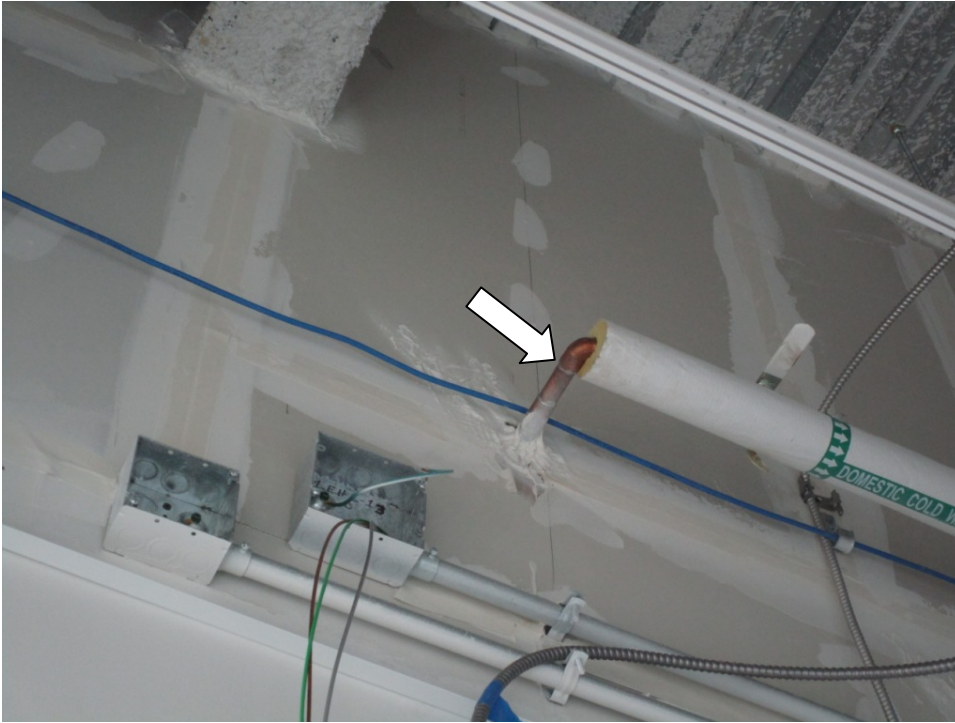
Photo 3-8  
Biology Research Lab (Neurobiology) 374A – Missing pipe insulation

Photo 3-9  
Biology Research Lab (Neurobiology) 374A – Missing pipe insulation

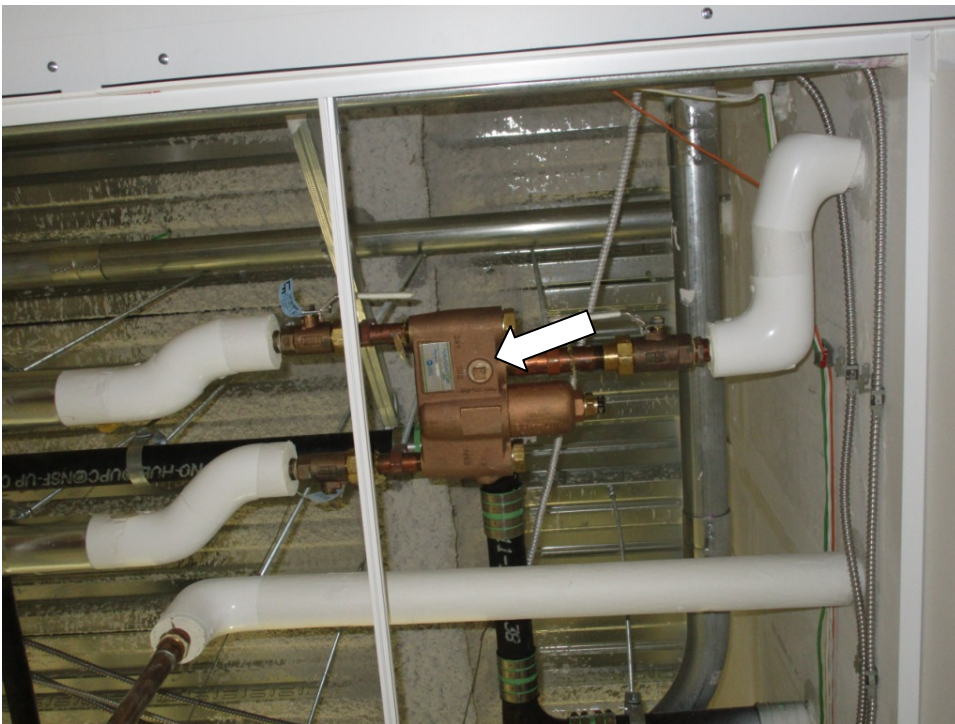
7. Biology Prep Room East 386:
    - a. Missing thermometer gauge on TMV. Refer to Photo 3-10
  8. Microbiology and Genetics Lab 388:
    - a. Missing thermometer gauge on TMV. Refer to Photo 3-11.

Photo 3-10  
Biology Prep Room East 386 – Missing thermometer gauge on TMV

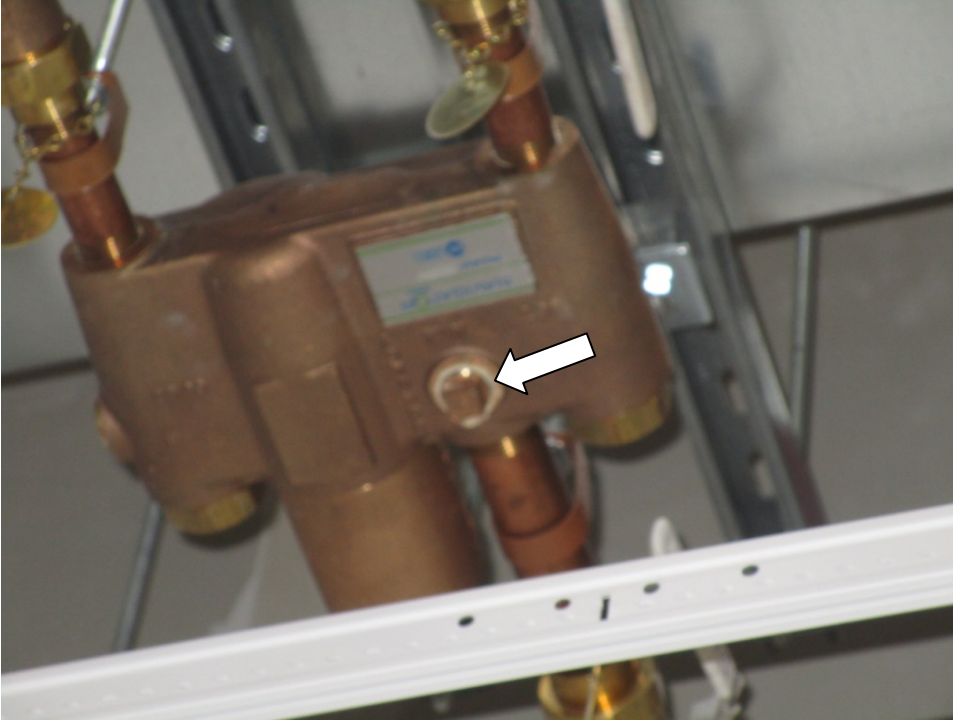
Photo 3-11  
Microbiology and Genetics Lab 388 – Missing thermometer gauge on TMV.

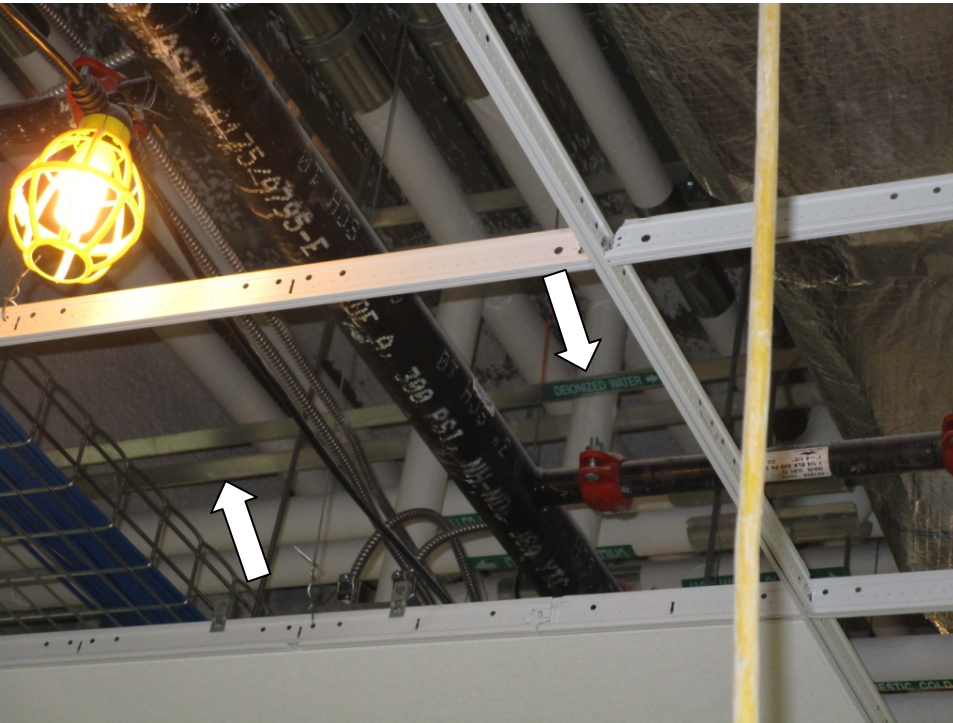
3. DI / RO Process Water:
  1. Corridor C380 (outside Bio. Lab Prep. B-386):
    - a. Piping crossing corridor between Lab 383 and Lab 386 is not fire wrapped. Refer to Photo 12.

Photo 3-12  
Corridor C380 – Di / RO piping not wrapped where crossing in corridor.

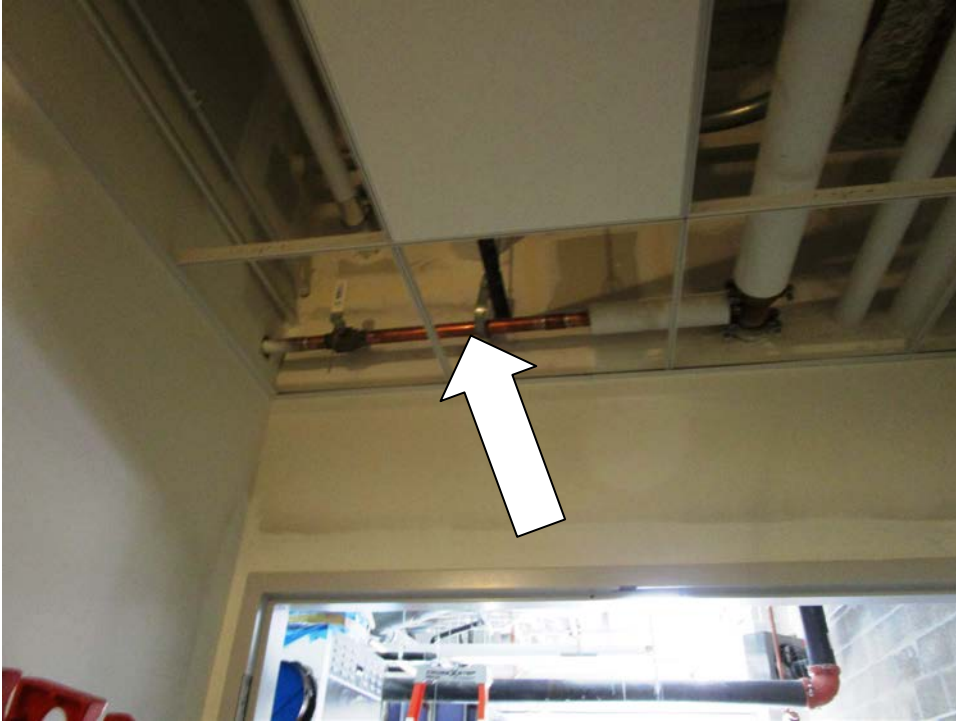
1. Plumbing:
  1. Corridor C180 (outside Mechanical Room 178):
    - a. Domestic cold water piping serving single Toilet Room 180/182 is not insulated. Refer to Photo 1-1.
  2. Cadaver Lab 191:
    - a. Floor sink serving Level 2 is supported by single underfloor brace, others are supported by two braces. Refer to Photo 1-2.
    - b. Emergency shower piping is not insulated, on other floors piping is insulated. Refer to Photo 1-3.
  3. Teaching Kitchen 174:
    - a. Trap primer piping is not insulated. Refer to Photo 1-4.
  4. Loading Dock 172:
    - a. Unable to locate trap primer serving floor drain for this area. Refer to Photo 1-5.
2. Laboratory Air and Vacuum Systems:
  1. No comments.
3. DI / RO Process Water:
  1. No Comments.

Photo 1-1  
Corridor C180 (outside Mechanical Room 178) – Piping not insulated.

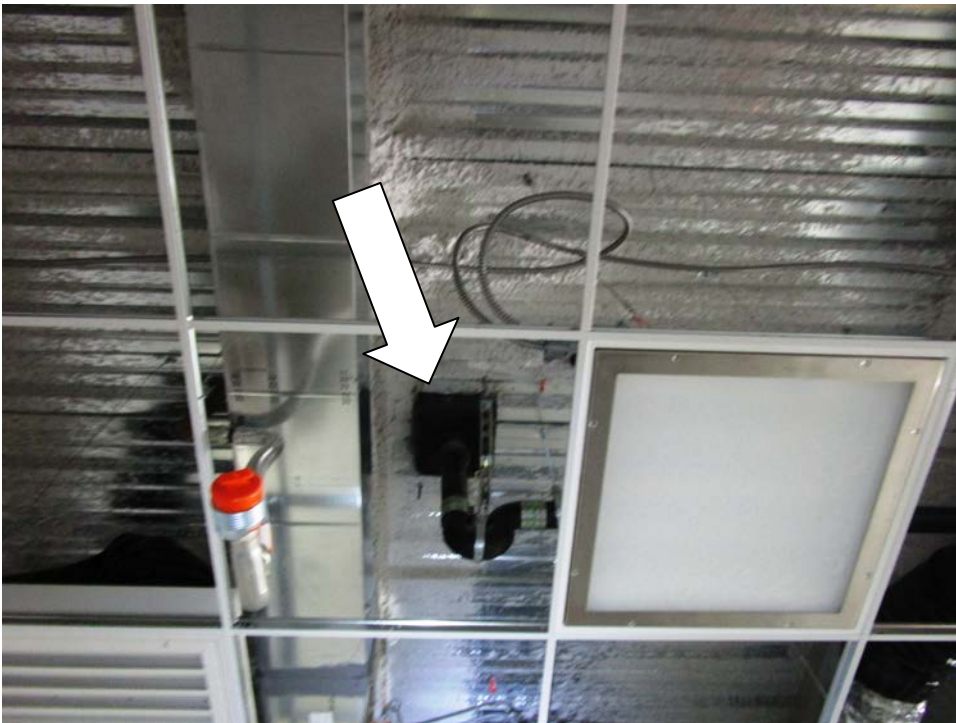
Photo 1-2  
Cadaver Lab 191 – Floor sink supported by single underfloor brace.

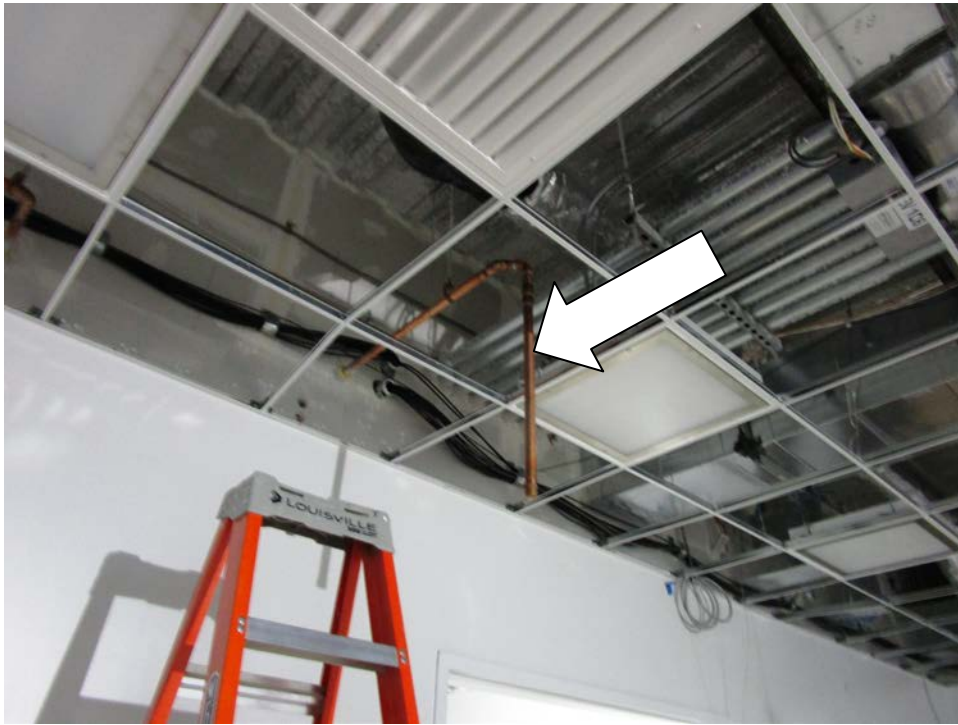
Photo 1-3  
Cadaver Lab 191 – Emergency shower discharge piping not insulated.

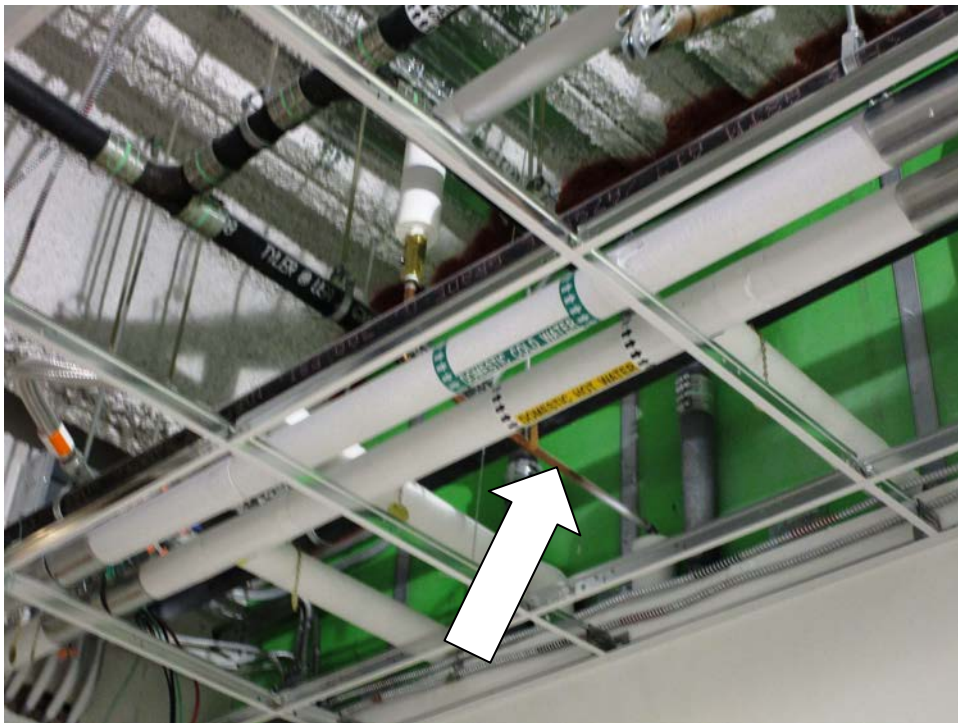
Photo 1-4  
Teaching Kitchen 174 – Trap primer piping not insulated.

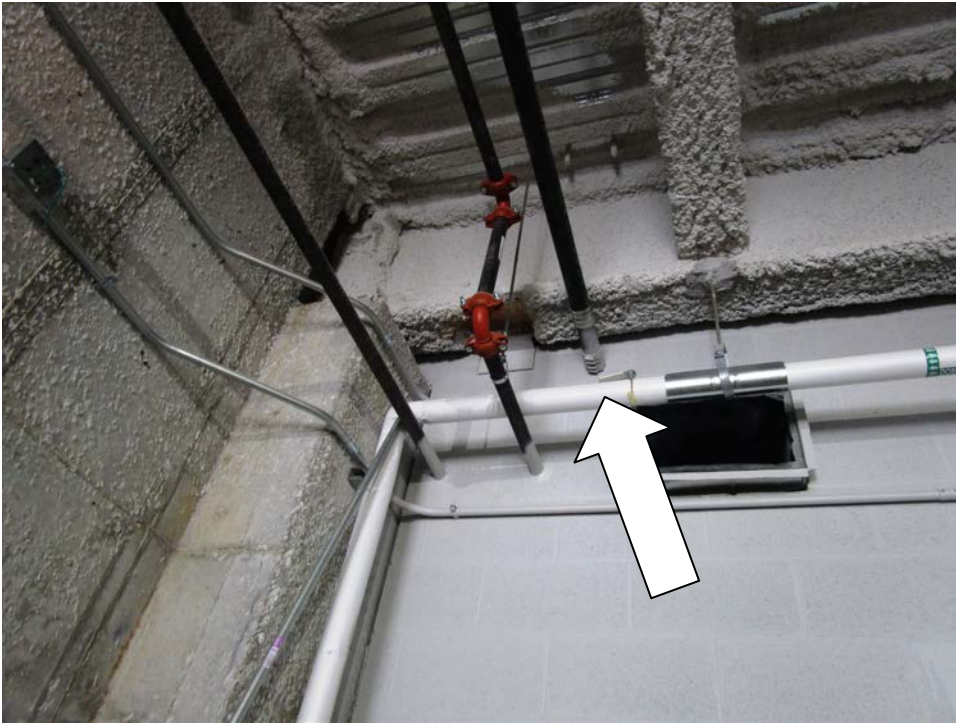
Photo 1-5  
Loading Dock 172 – Unable to locate trap primer.

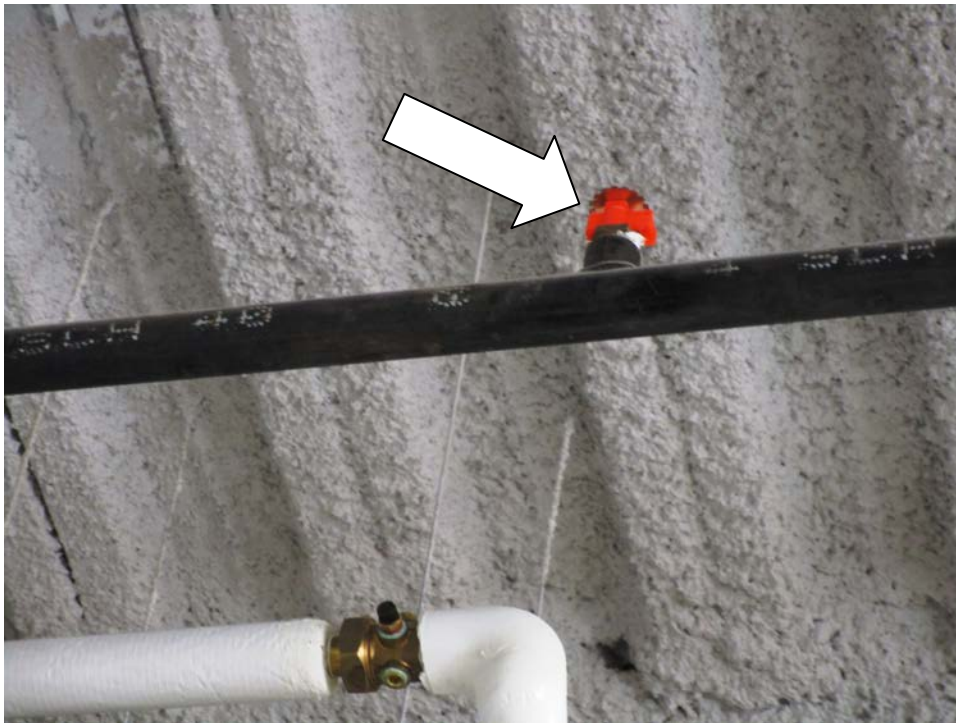
4. Fire Suppression:
  1. Cylinder Room 187:
    - a. Room locked, no entry.
  2. Elevator Machine Room 176:
    - a. Room located, no entry.
  3. Loading Dock 172:
    - a. Sprinkler head covered with protective cap. Refer to Photo 1-6.
  4. EAB Connector 150:
    - a. Work not complete. Refer to Photo 1-7.

Photo 1-6  
Loading Dock 172 – Sprinkler head covered.

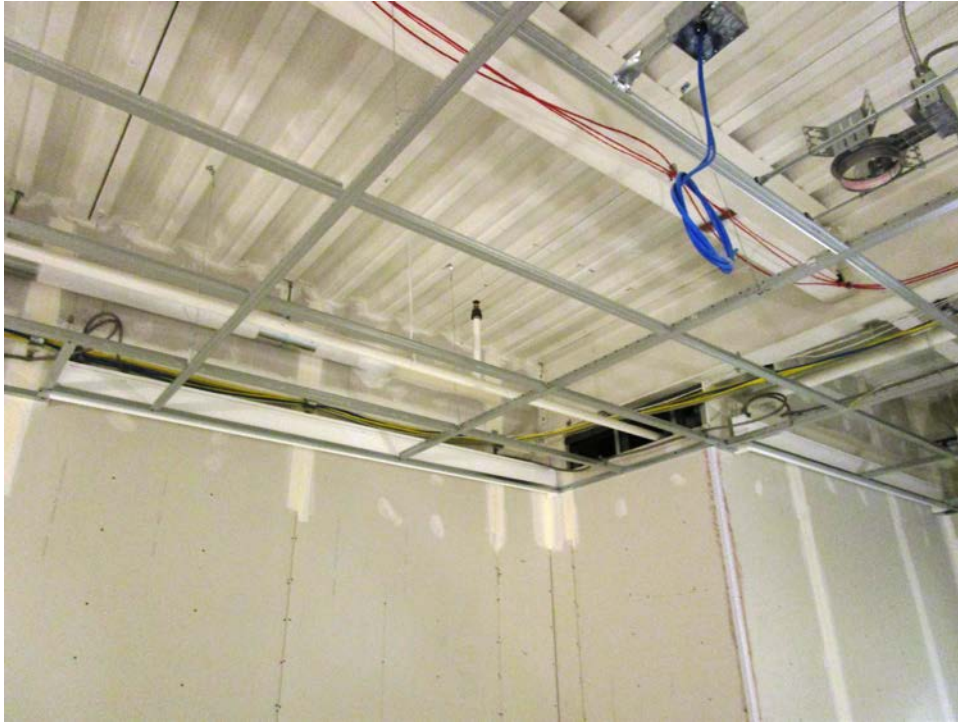
Photo 1-7  
EAB Connector – New sprinkler work not completed.

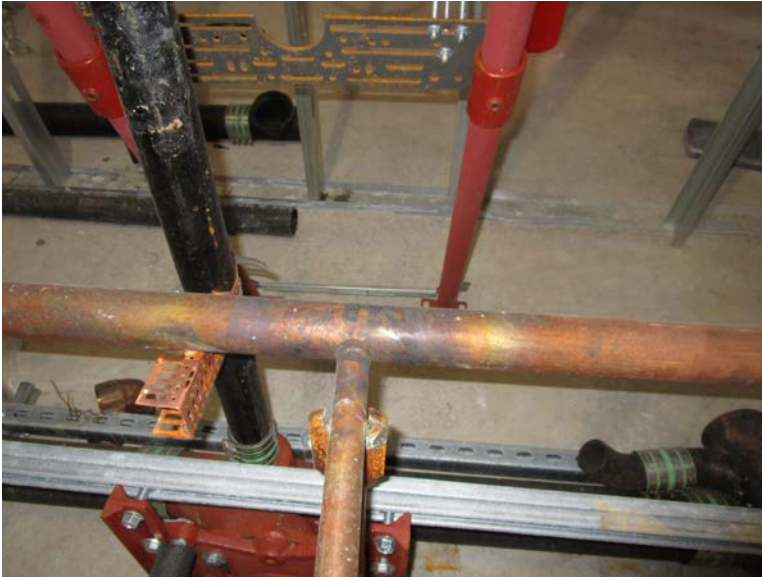
1. Domestic water service has not been extended into building.
2. Unable to locate wall sleeve for domestic water service.
3. Domestic water piping, main and branch, has not been installed.
4. Domestic hot water heaters have not been installed.
5. Toilet room(s) wet wall piping has been assembled, not yet set in place.
6. Roof drain and overflow drain piping has been routed / installed.
7. Piping stub-ups are in place.
8. Floor Drains are covered.
9. Piping stub-ups are capped.
10. Branch water piping in wet wall of Toilet Rooms 180 / 182 appears to be made with a 'brazed tap', rather than a standard pipe fitting. All changes in direction and branch connections are to be made with fittings. Refer to specification section 22 11 16, Part 3, paragraph 3.2, line 'O'. This method appears to be similar elsewhere. Refer to Photo 1.

Photo 1  
Brazed pipe tap

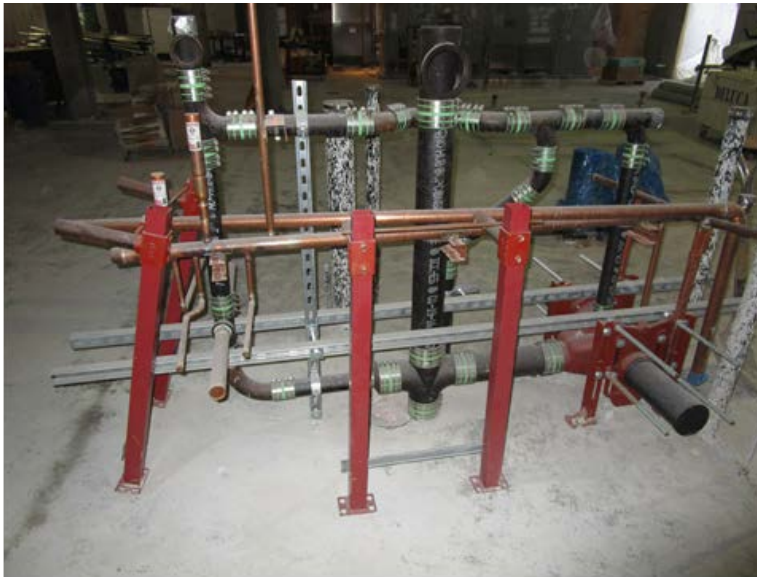
11. Water hammer arresters (piston style) being installed were rejected in the shop drawing review process for not complying with the specifications, 22 11 19, part 2, paragraph 2.12 and plumbing drawing P0601. Refer to shop drawing review report dated 11 June 2016. CP's indicate Wade model 4480 is being provided. Refer to Photo 2.

Photo 2  
Piston type water hammer arrester

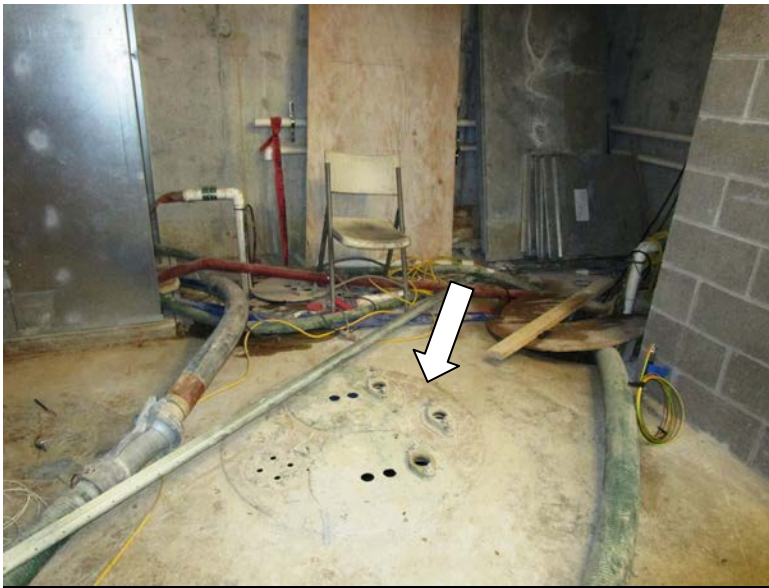
Photo 01  
Level 0 – Sump pumps not yet installed.

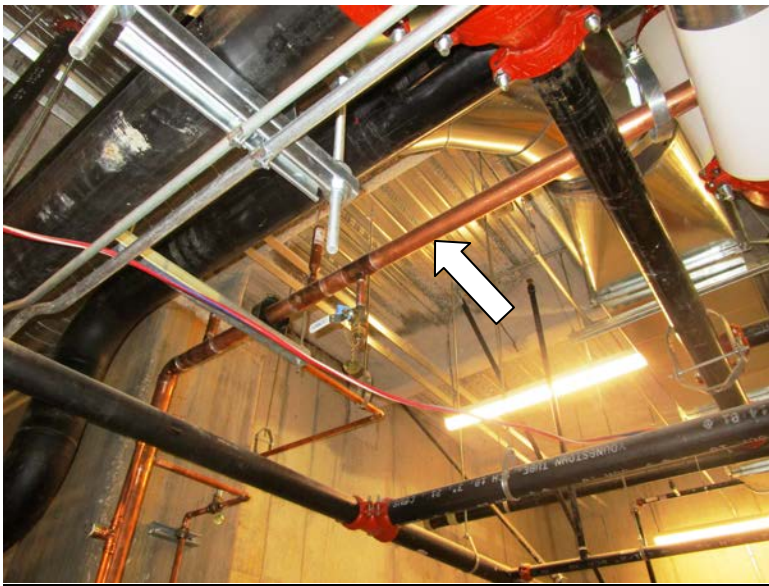
Photo 02  
Level 0 – Domestic water piping not yet insulated.

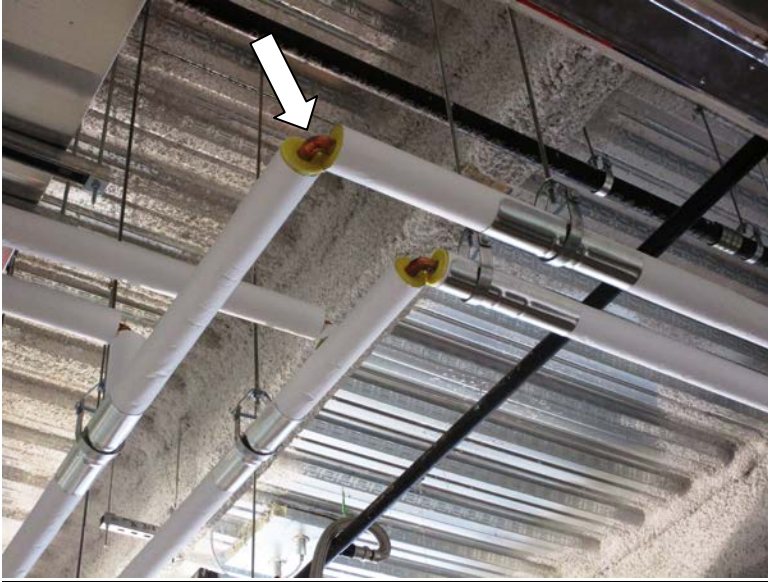
Photo 07

1. Conditions similar to those listed for Level 02.
2. Domestic water piping insulation has not been completed. Refer to Photo 07.

Level 03 – Domestic water piping insulation has not been completed. Primarily fittings and valves, some small sections of piping. This condition is typical through-out.

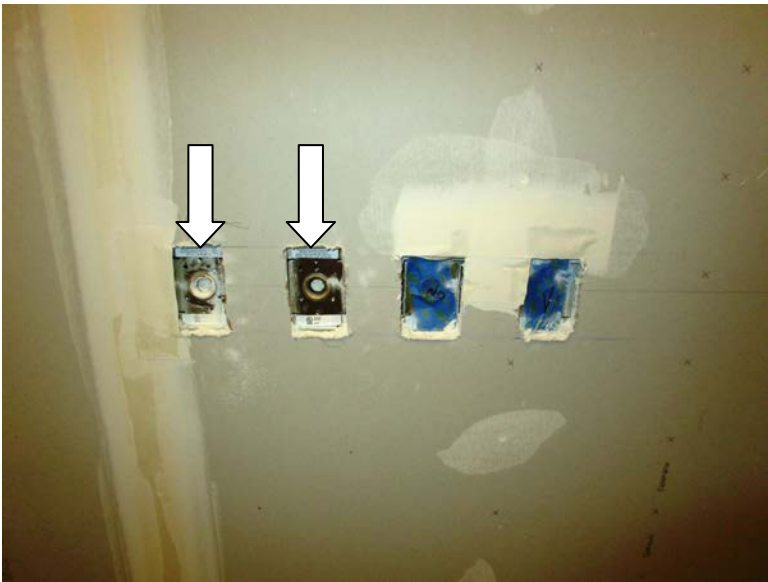
1. Central Vacuum unit has been installed. Piping to/from unit not yet complete. Refer to Photo 08.
2. Central Air Compressor has been installed. Piping to/from not yet complete. Refer to Photo 09
3. Wall inlets/outlets in Area B Sim Lab. To be cleaned and covered to protect from dust.  
Refer to Photo 10

Photo 10  
Level 01 Sim Lab - Med Gas wall inlets and outlets to be cleaned and covered to protect from dust.

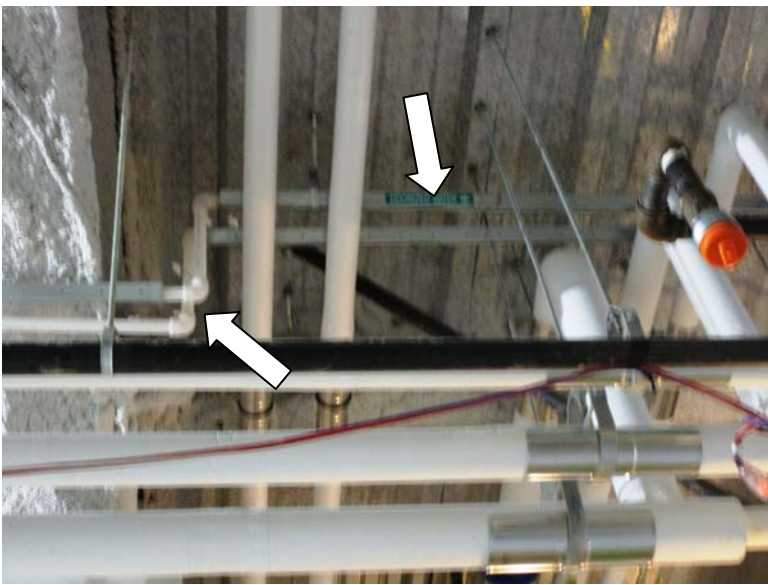
1. Pipe wrapping where exposed/required in plenum spaces has not yet been done.  
Refer to Photo 12.

Photo 12  
Level 02 – DI/RO pipe wrapping where exposed/required in plenum spaces has not yet been done.  
This condition is typical on all levels.

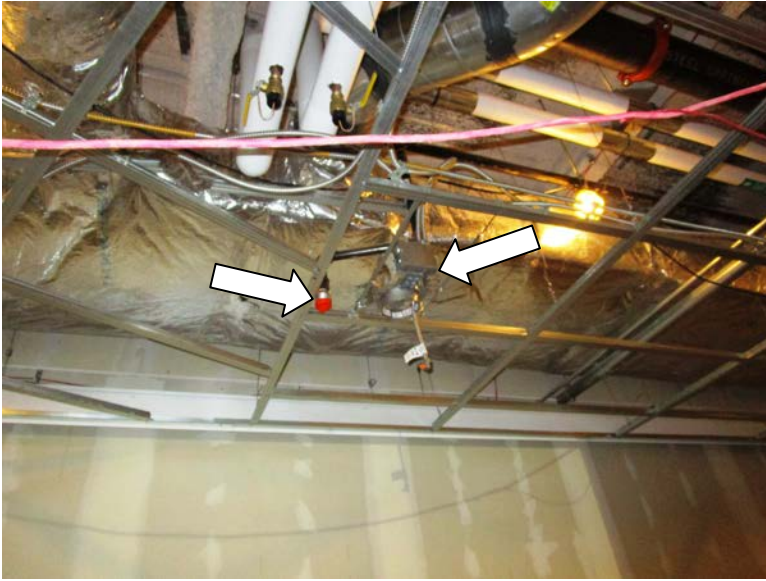
Photo 13

1. Fire Pump has not yet been installed.
2. Bulk mains appear to be installed.
3. Branch piping runs are installed.
4. A limited number of sprinkler heads have been installed.
5. A limited number of flex hose connectors have been installed, without the sprinkler head.
6. Pre-Action control cabinet for Sim Lab has not been installed.
7. Area B, in or about Corridor C140 – Verify sprinkler head and recessed luminaire are not in conflict with clearance requirements. Refer to Photo 13.

Level 01- Area B, in or about Corridor C140 – Verify sprinkler head and recessed luminaire are not in conflict with clearance requirements.
