## Observation Report

| File: | Webster University Interdisciplinary Science Bldg.<br>WT 14127.01 (7) | c: | |

### **Observations**

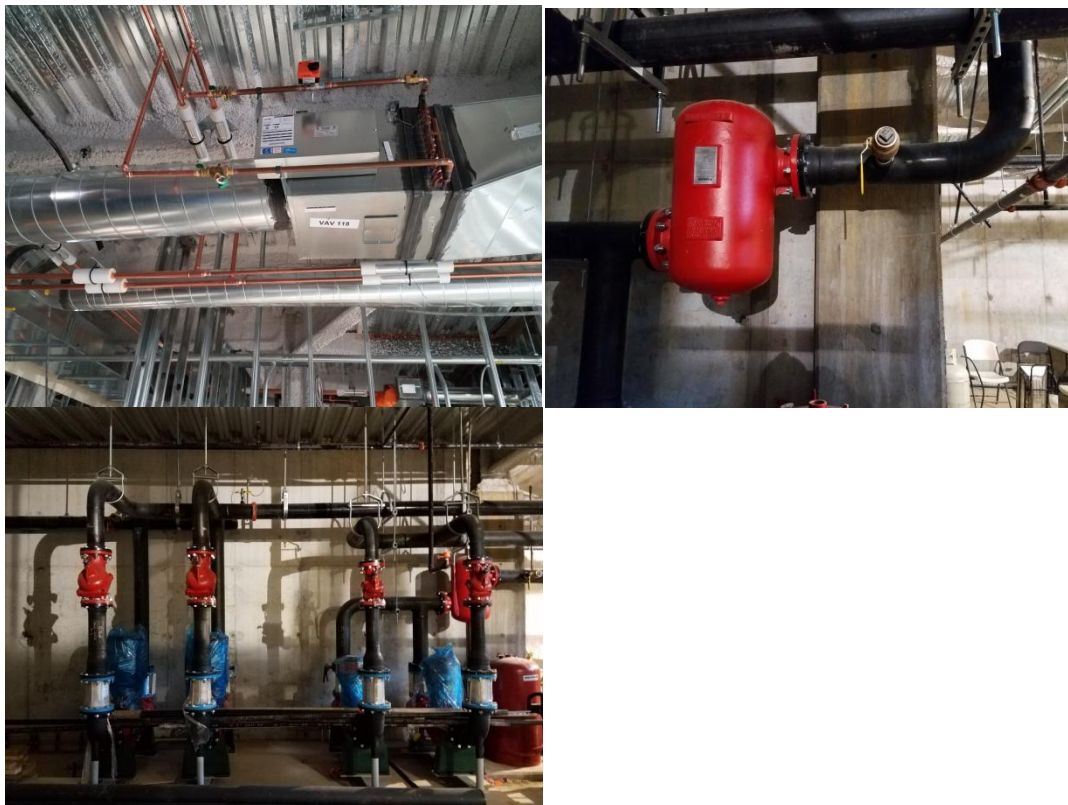
- Mechanical piping, ductwork, and equipment installation is in progress. The Basement and 1<sup>st</sup> Floor is farthest along.
- Clearance for VAV box access terminal looks very tight.

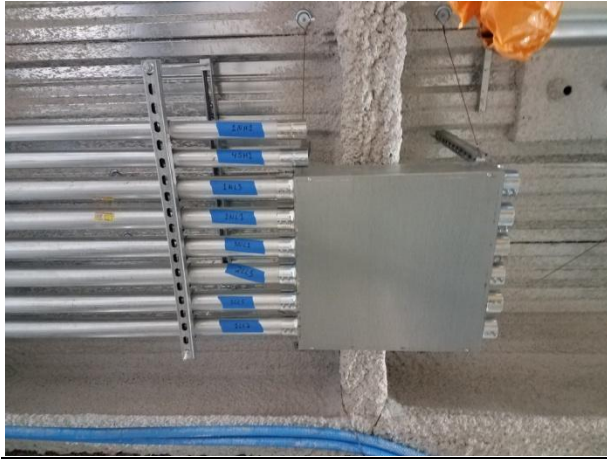
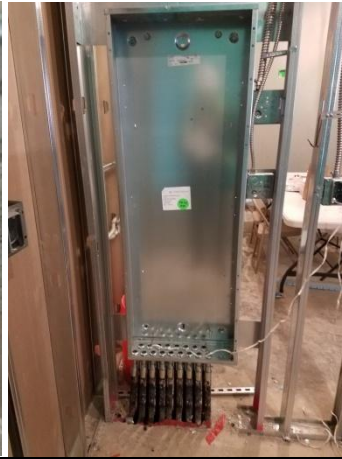
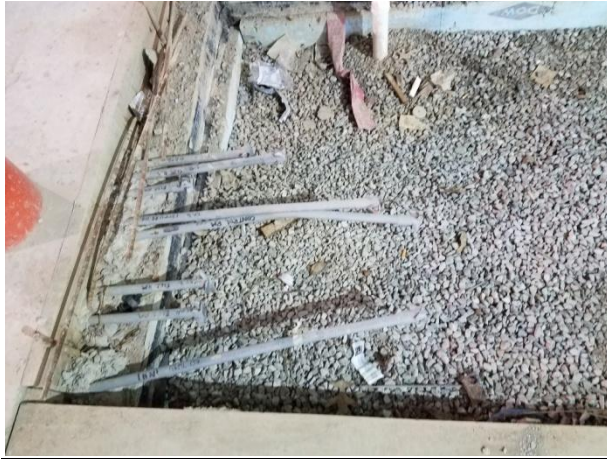
- Electrical systems installation is in progress. The Basement and 1<sup>st</sup> Floor is farthest along.
- Observed below slab, conduit ends are covered with duct tape. Conduit should be kept free of debris.
- Contractor should confirm that working clearances are maintained as installation progresses.

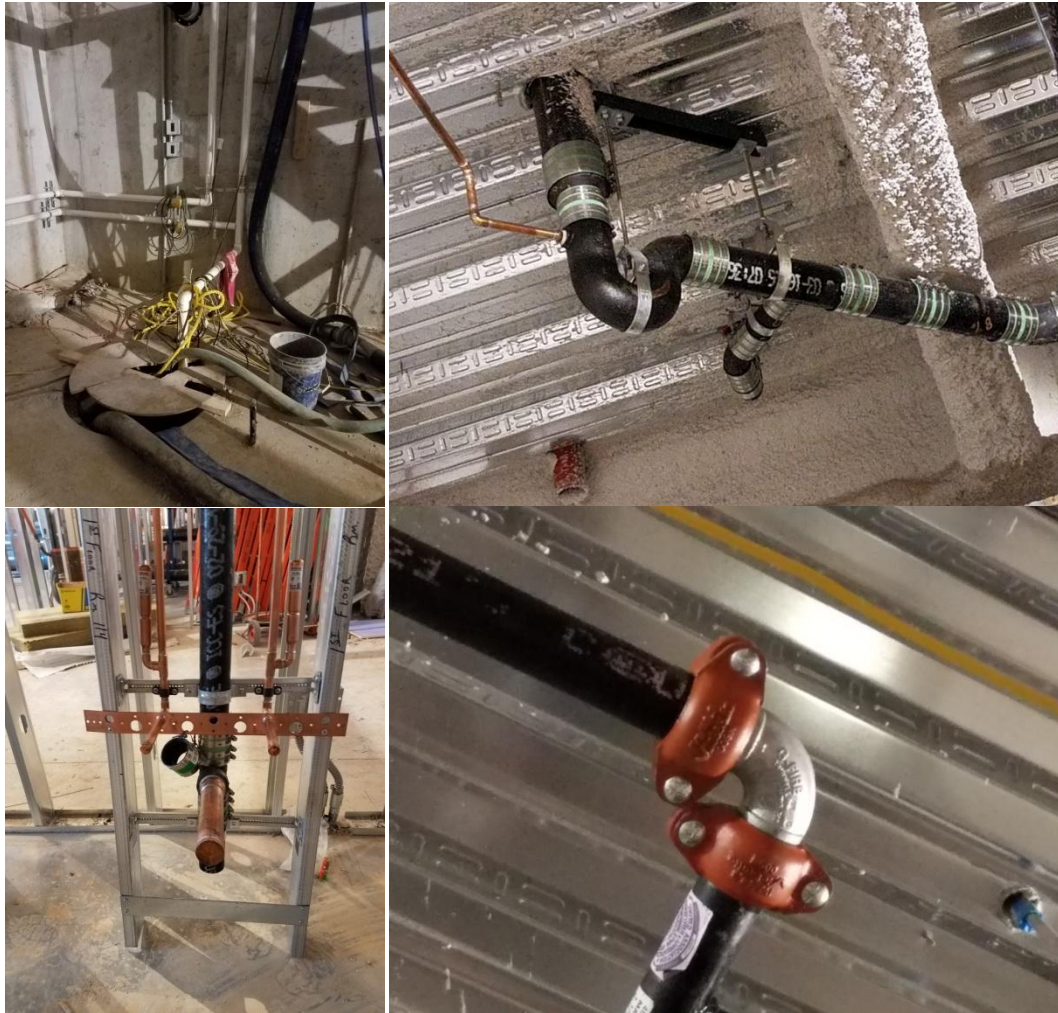
- Water, waste, and vent piping installation are in progress. The Basement and 1<sup>st</sup> Floor is farthest along.
- It appears that the contractor is prefabricating some of the sink risers off-site. This should hopefully help with quality control.
- It is unclear why there are what looks like galvanized grooved fittings on the fire sprinkler system when the piping is black steel.

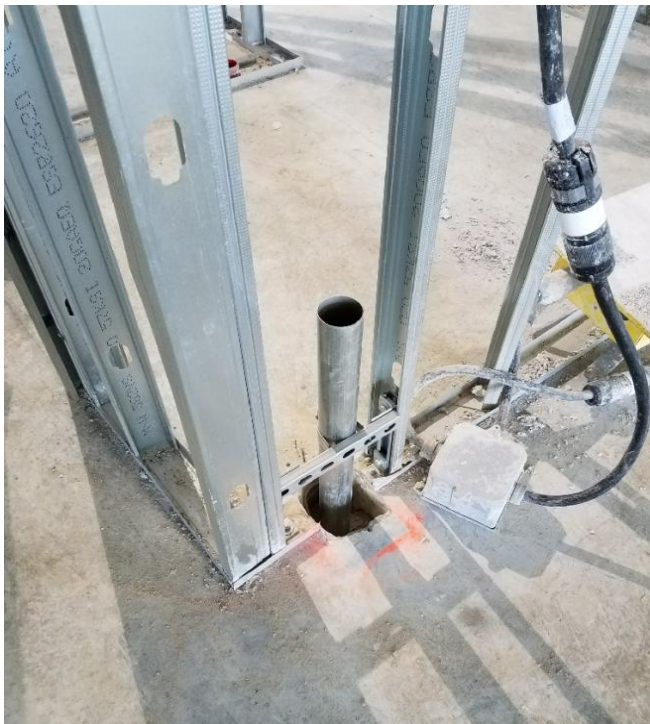
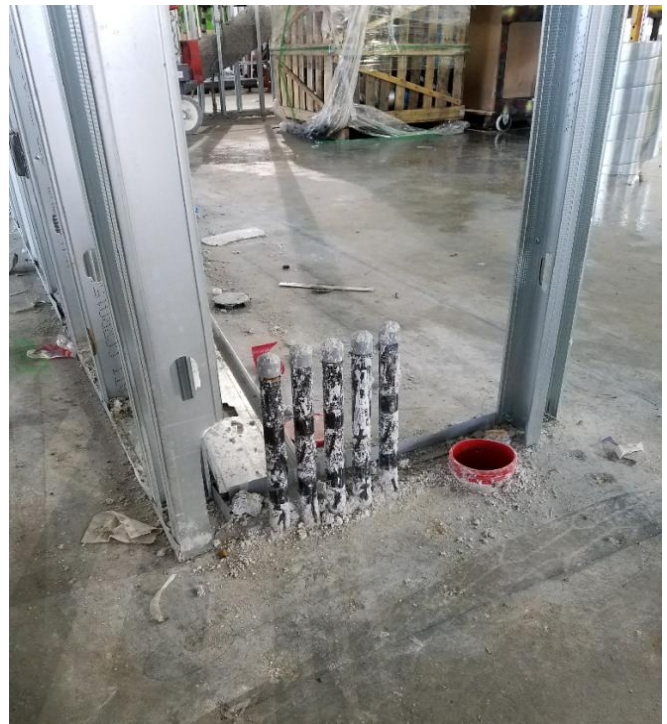
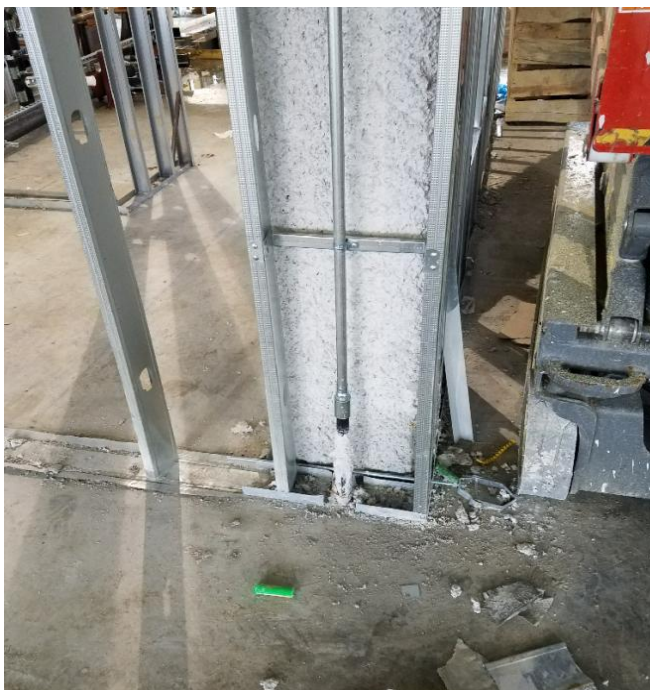
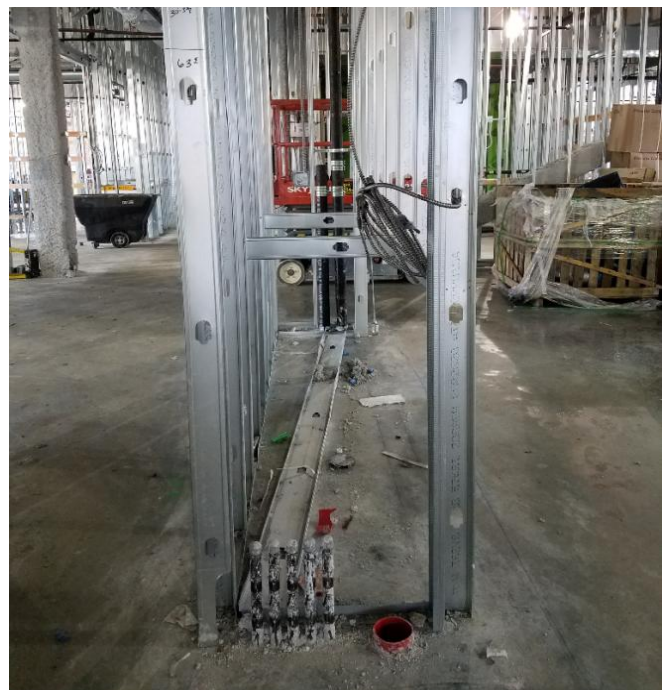
- Corridor C280 electrical conduit stub-ups.
- Grout gaps around conduits.

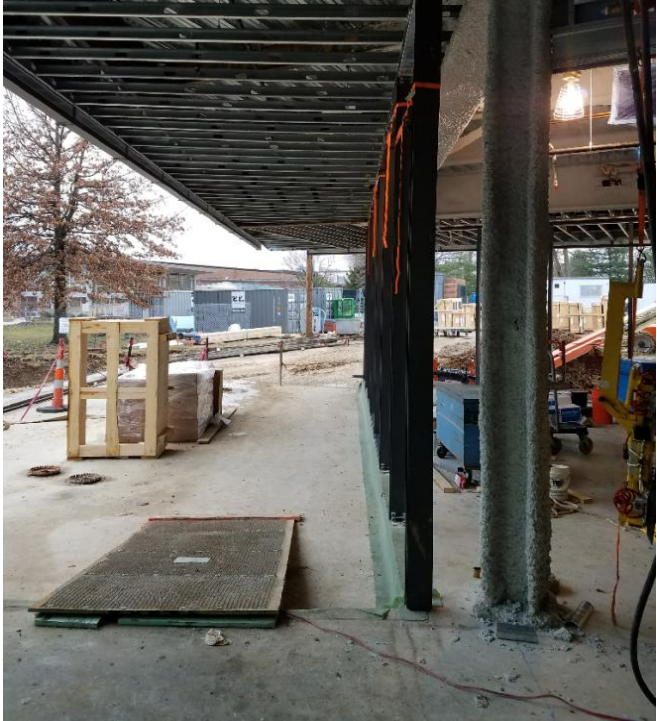
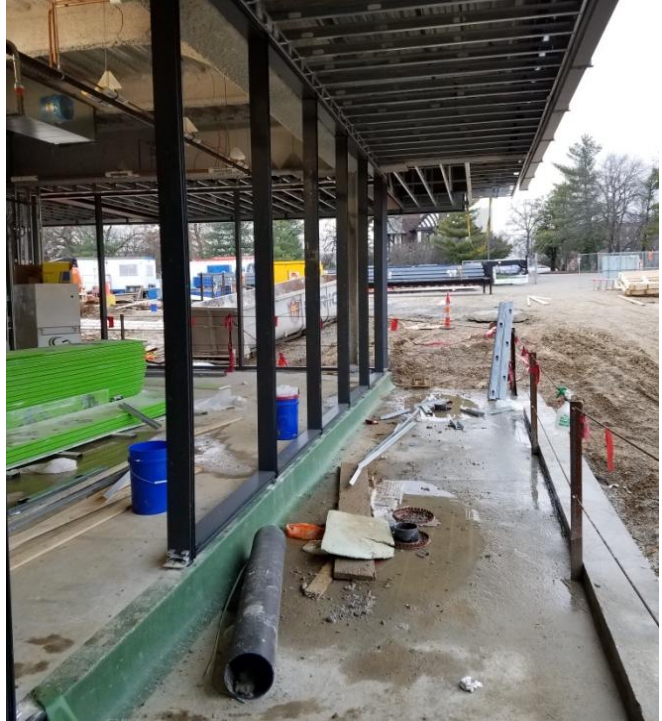
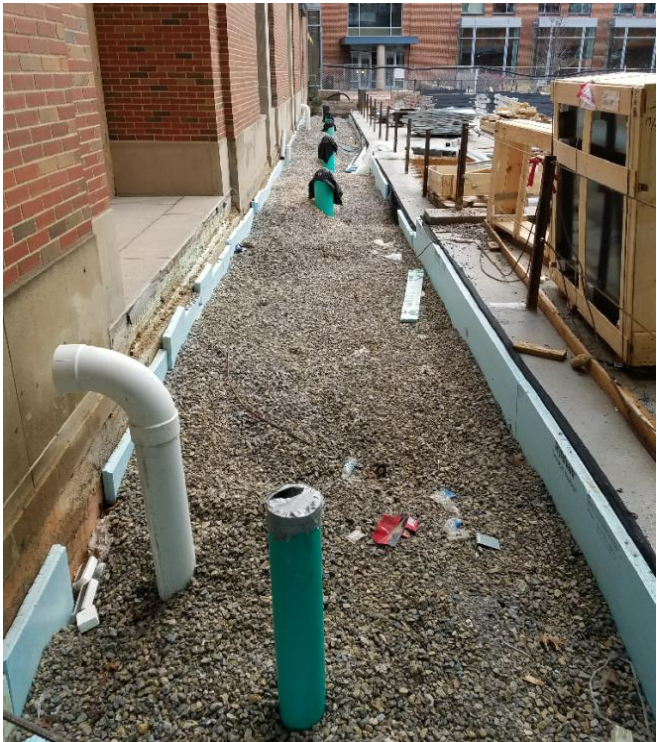
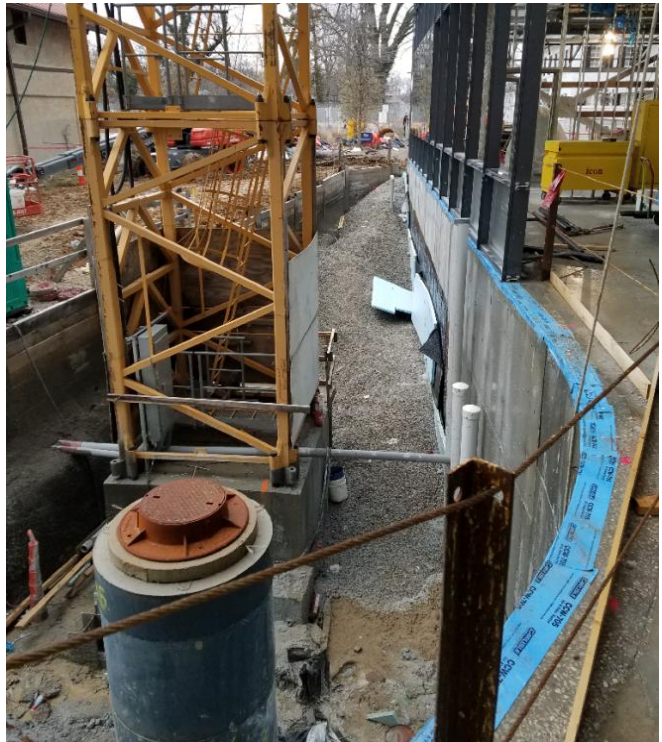
- Courtyard electrical and lighting Type EE rough-in not currently installed.

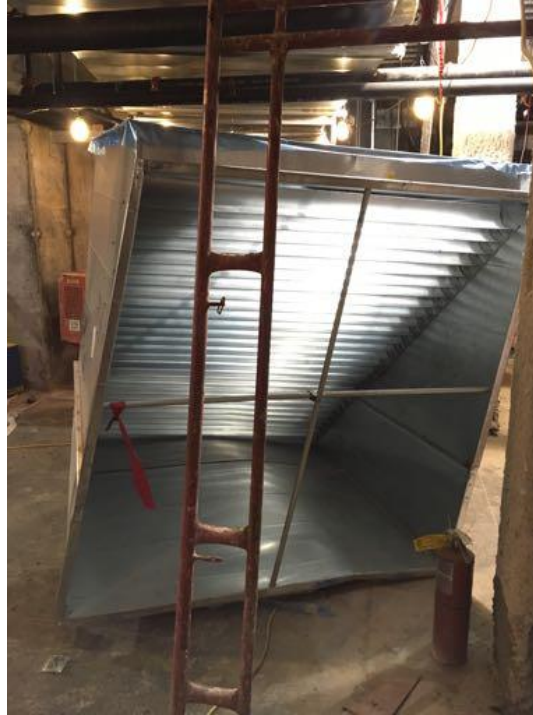
5. Mechanical work is ongoing.
6. Ductwork elbow on floor in basement mechanical room was observed to be dented, bent, and dirty with openings unprotected. Clean and refurbish as required.

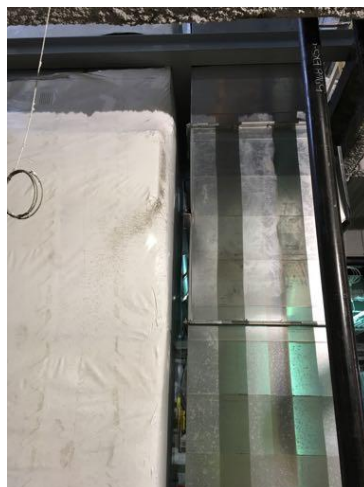
7. Main return duct riser has dent at support. Repair as required.

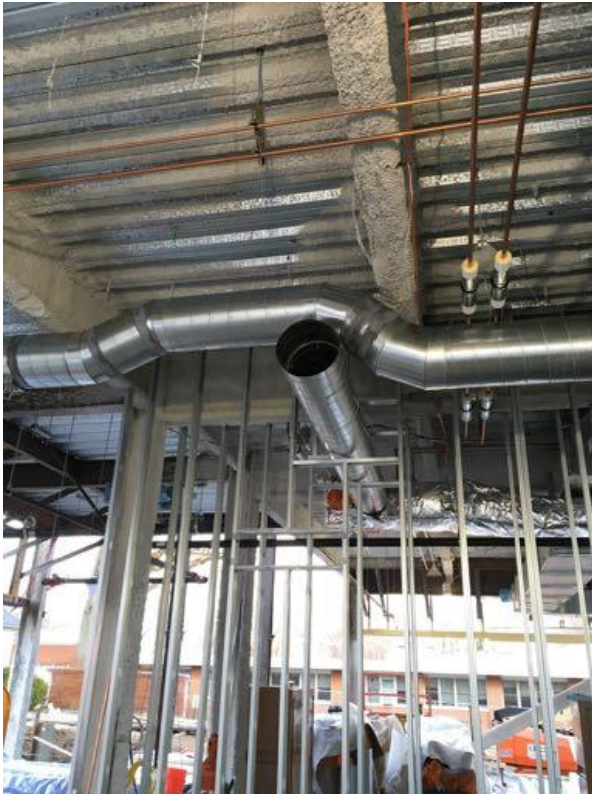
10. SAV-201 (below, left) inlet duct runnout opening missing protective film.
11. GEV-203 (below, right) opening missing protective film.

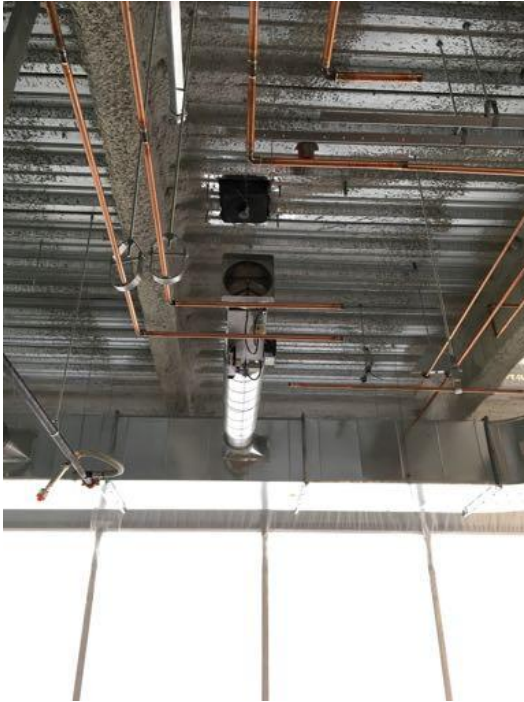
- 12. SAV-202 (below, left) opening missing protective film.
- 13. GEV-207 (below, right) duct tap at main opening missing protective film.

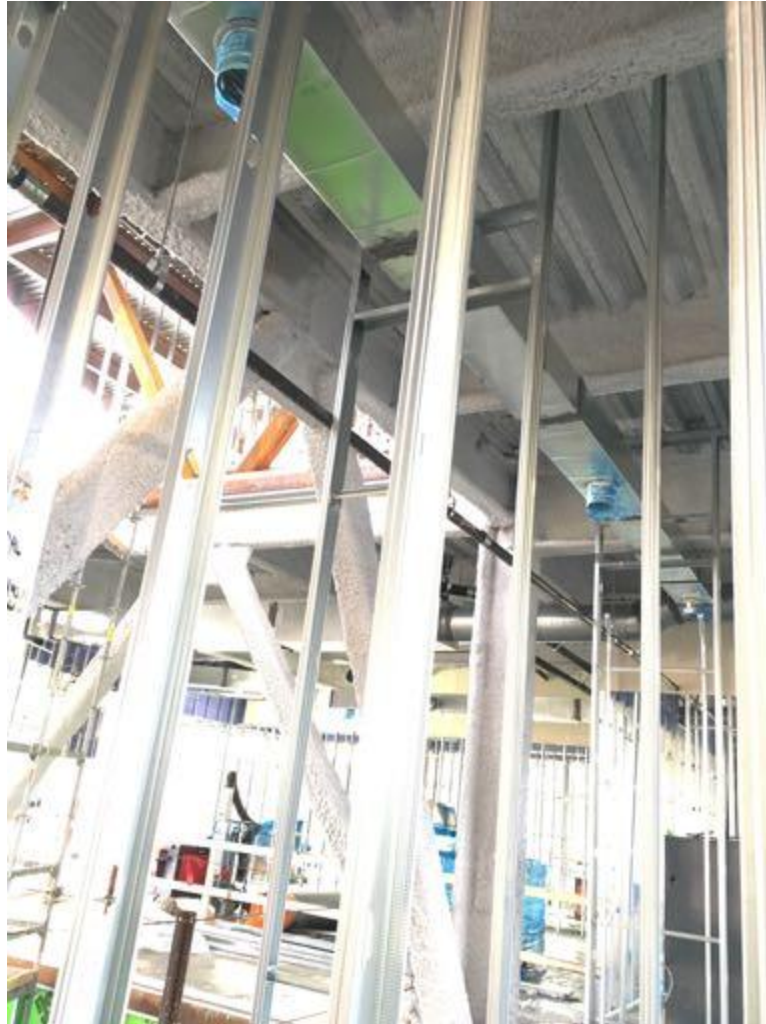
19. VAV-317 has bottom taps instead of side taps for branch ductwork. Contractor to ensure that flex duct to diffuser below has enough bends for noise mitigation. Do not install a straight run of flex duct to diffuser.

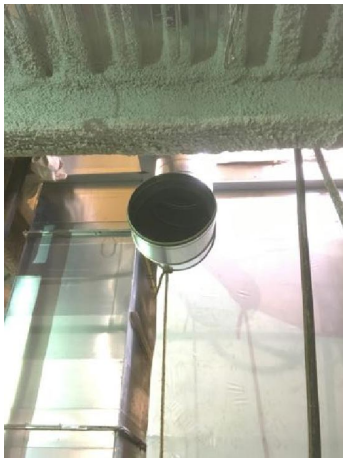
#22 Mechanical

**Description**  
Duct cover is missing.

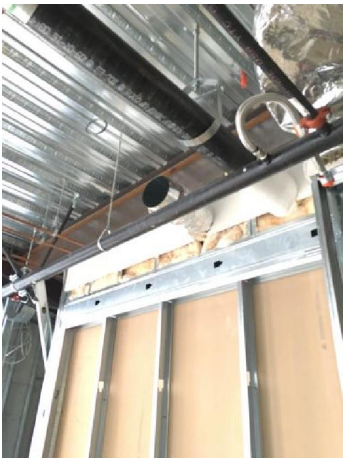
#21 Mechanical

Description  
Missing duct cover

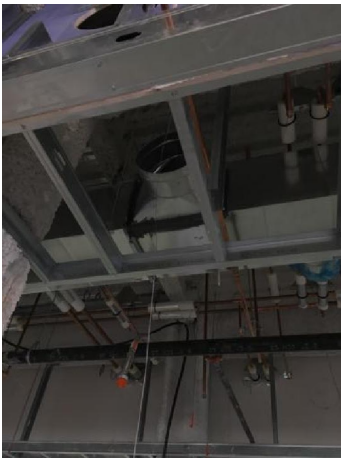
#20 Mechanical

Description  
Duct cover missing / blown off

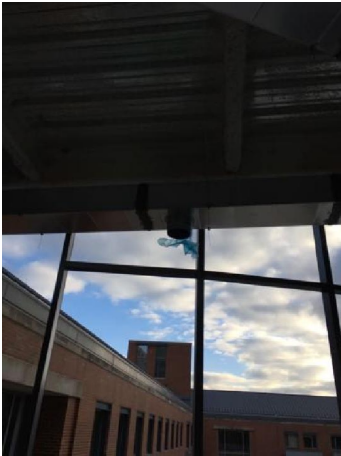
#19 Mechanical

Description  
Duct cover missing / blown off

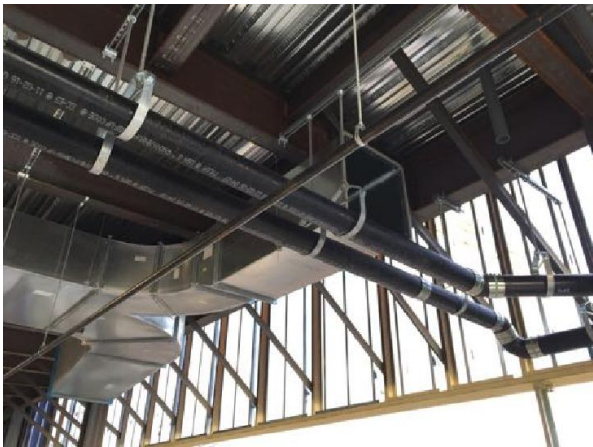
#16 Mechanical

Description  
Duct cover missing / blown off

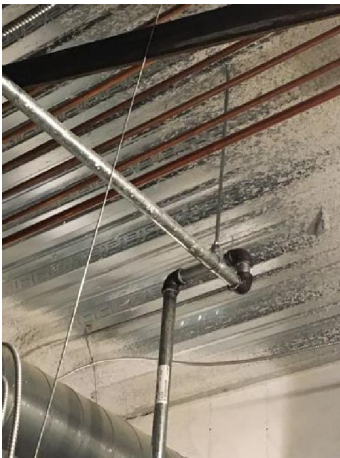
## #30 FP Sprinkler

**Description**  
End of line surge restraint missing.

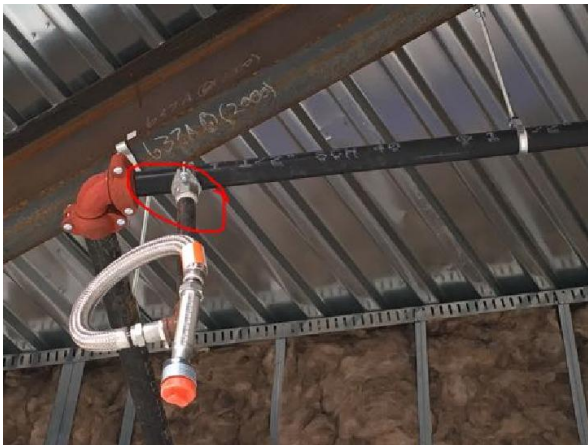
## #44 FP Sprinkler

Mech. Tee snap o let style not recommended for new installation.

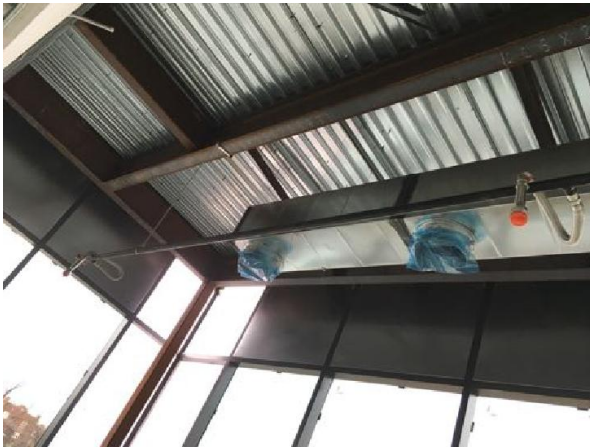
## #52 FP Sprinkler

Spkr bracing/ restraint is a work in progress however no branch line restraint has been observed.

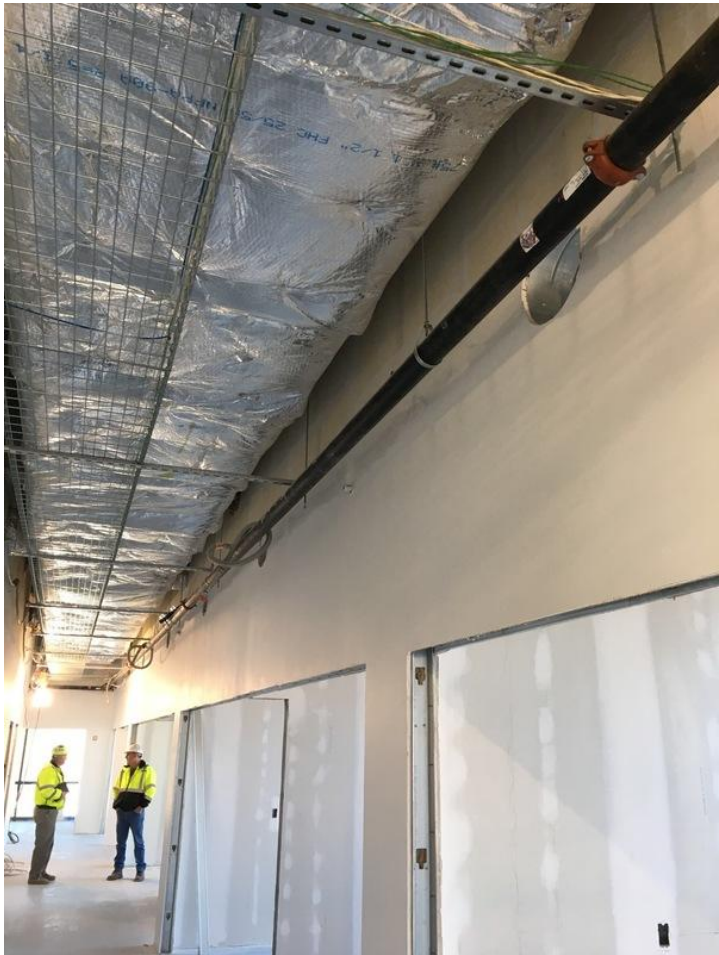
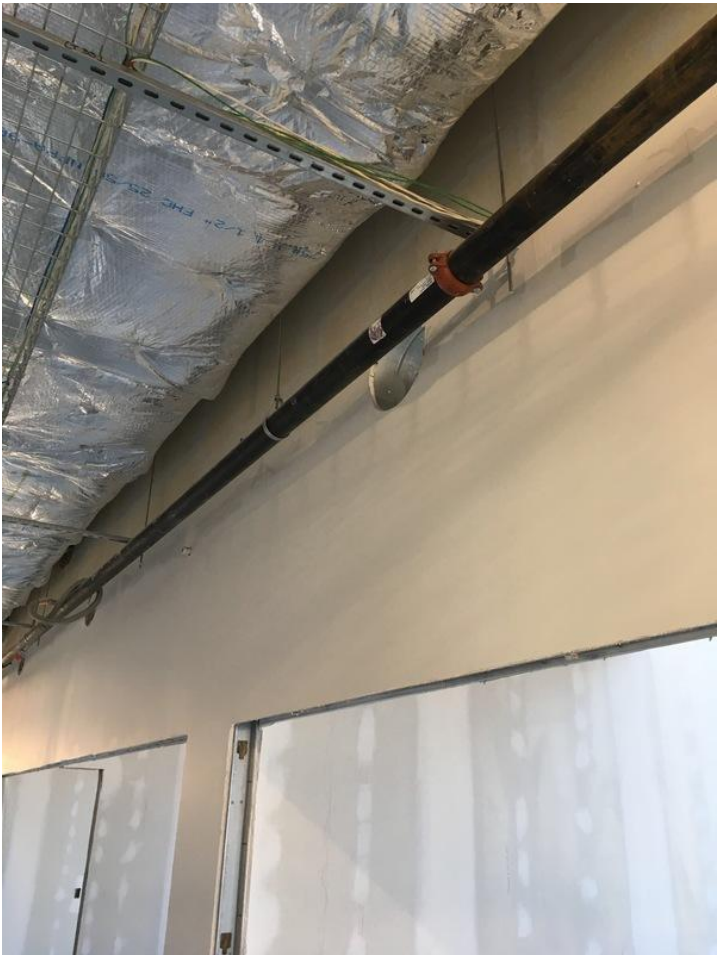
| Issue ID | Description | Location Detail | Location | Status | Company | Type | Date Created | Due Date |
|---|---|---|---|---|---|---|---|---|
| 000307 | Confirm intent is met at duct penetrations. | | Webster > LEVEL_03 | Open | <not set> | 11 Month Warranty Walk | 10 Mar 2017 | 15 Mar 2017 |

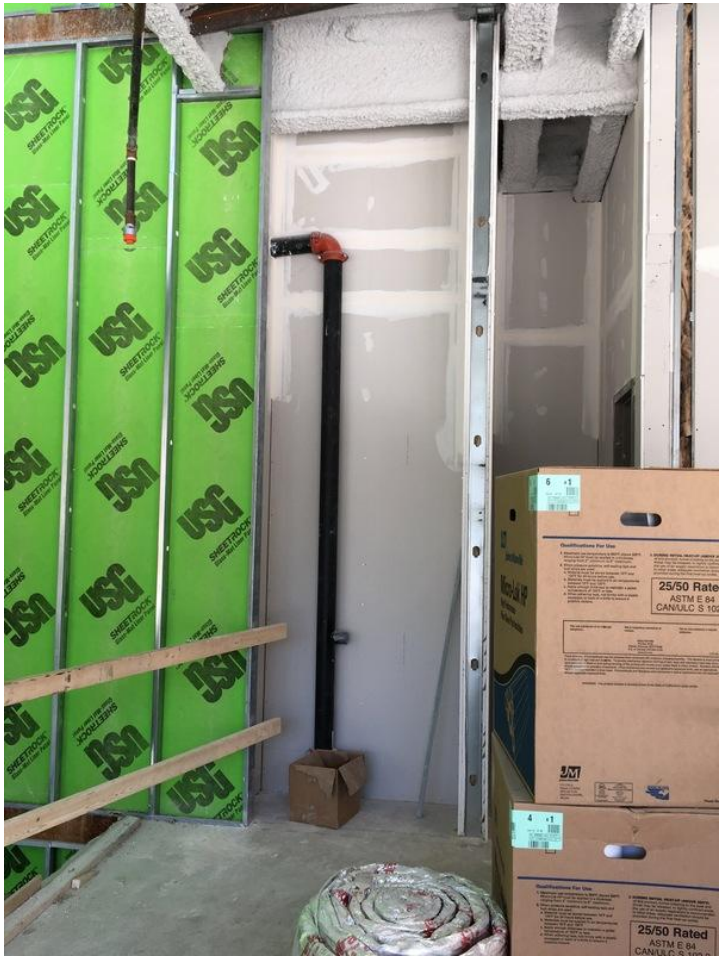
| Issue ID | Description | Location Detail | Location | Status | Company | Type | Date Created | Due Date |
|---|---|---|---|---|---|---|---|---|
| 000310 | Standpipe look out of square/plumb. | | Webster > LEVEL_02 | Open | <not set> | 11 Month Warranty Walk | 10 Mar 2017 | 15 Mar 2017 |

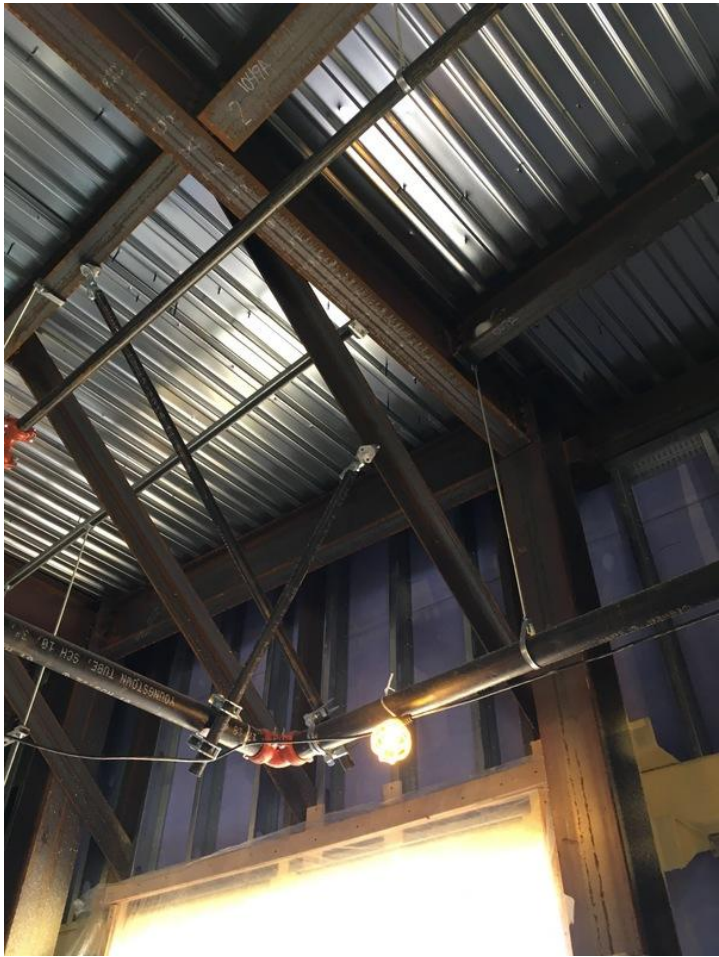
| Issue ID | Description | Location Detail | Location | Status | Company | Type | Date Created | Due Date |
|---|---|---|---|---|---|---|---|---|
| 000303 | Confirm with structural engineer that angle bracing is acceptable to attach to. | | Webster > LEVEL_04 | Open | Ahern Fire Protection | 11 Month Warranty Walk | 10 Mar 2017 | 15 Mar 2017 |

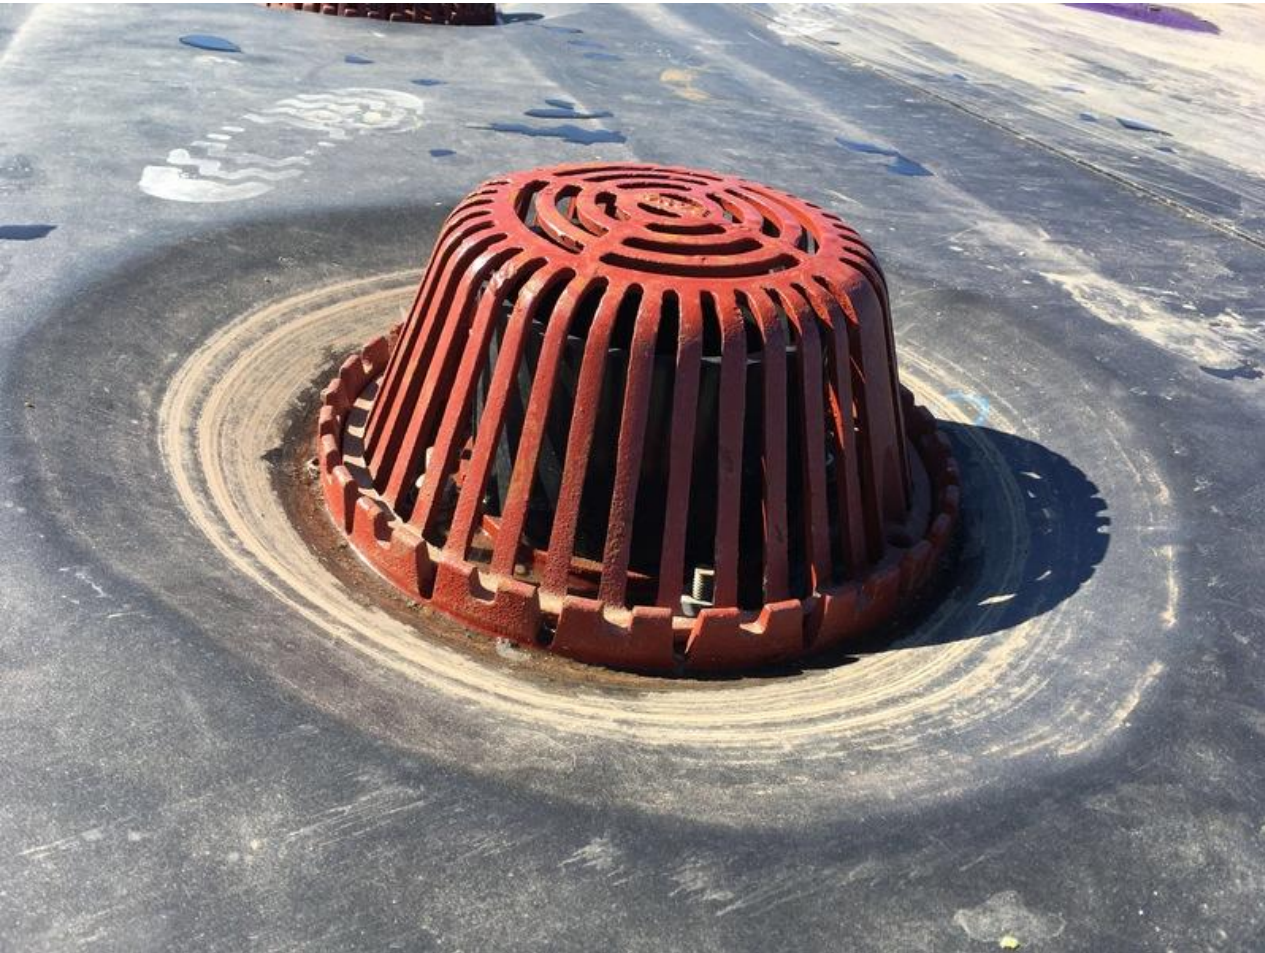
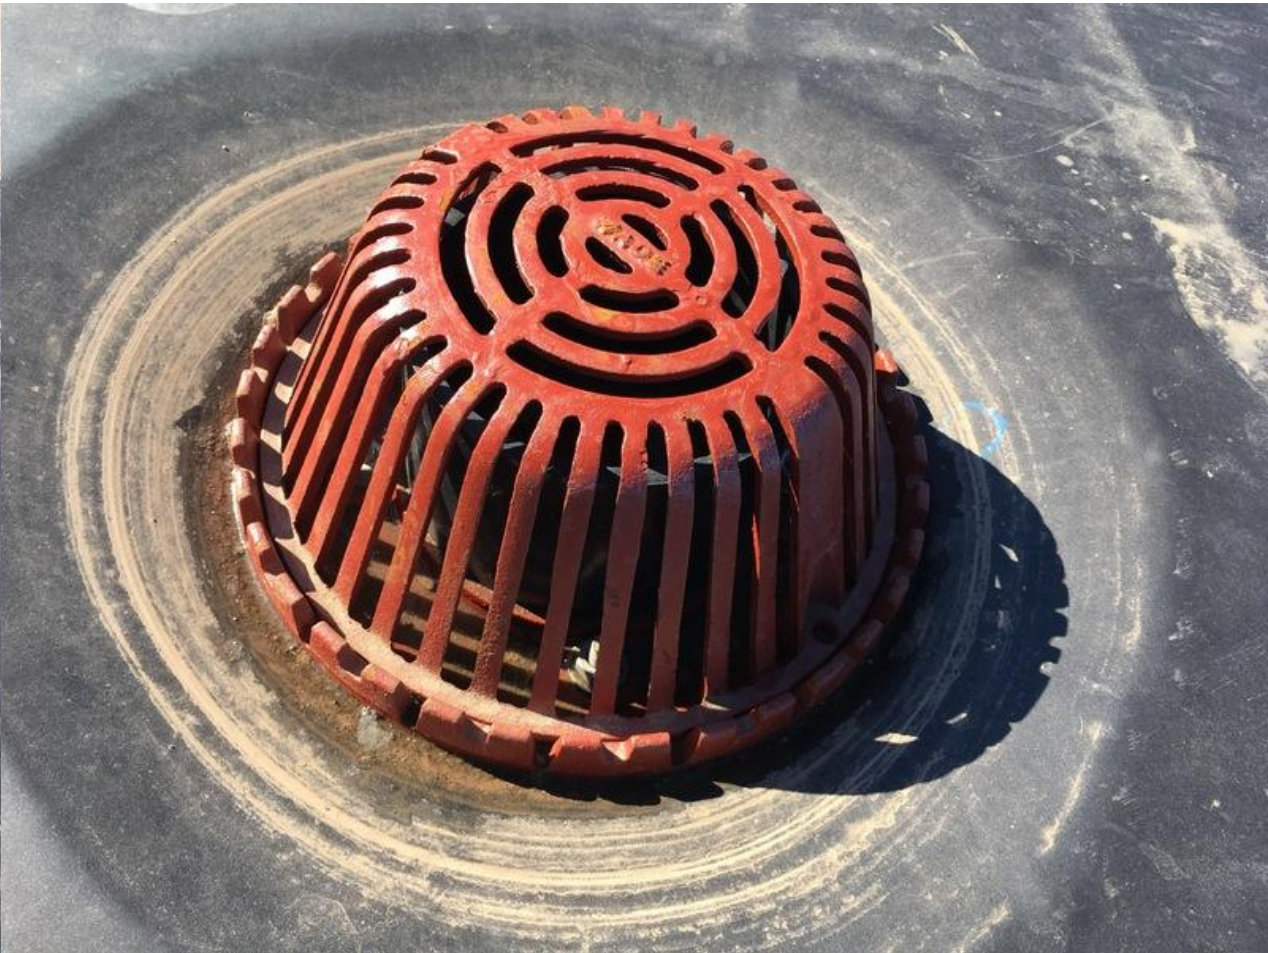
| Issue ID | Description | Location Detail | Location | Status | Company | Type | Date Created | Due Date |
|---|---|---|---|---|---|---|---|---|
| 000302 | Confirm roof drain overflow dam height is acceptable. | | Webster > Roof | Open | Deluca Plumbing | 11 Month Warranty Walk | 10 Mar 2017 | 15 Mar 2017 |

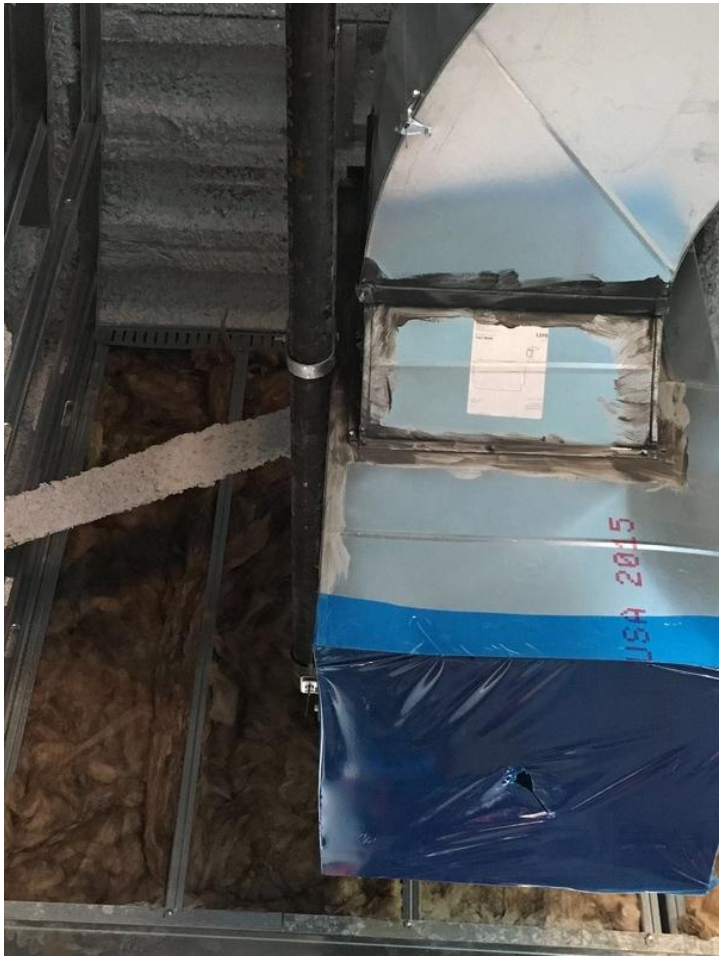
| Issue ID | Description | Location Detail | Location | Status | Company | Type | Date Created | Due Date |
|---|---|---|---|---|---|---|---|---|
| 000304 | Plumbing conflict with duct. | | Webster > LEVEL_03 | Open | Deluca Plumbing | 11 Month Warranty Walk | 10 Mar 2017 | 15 Mar 2017 |

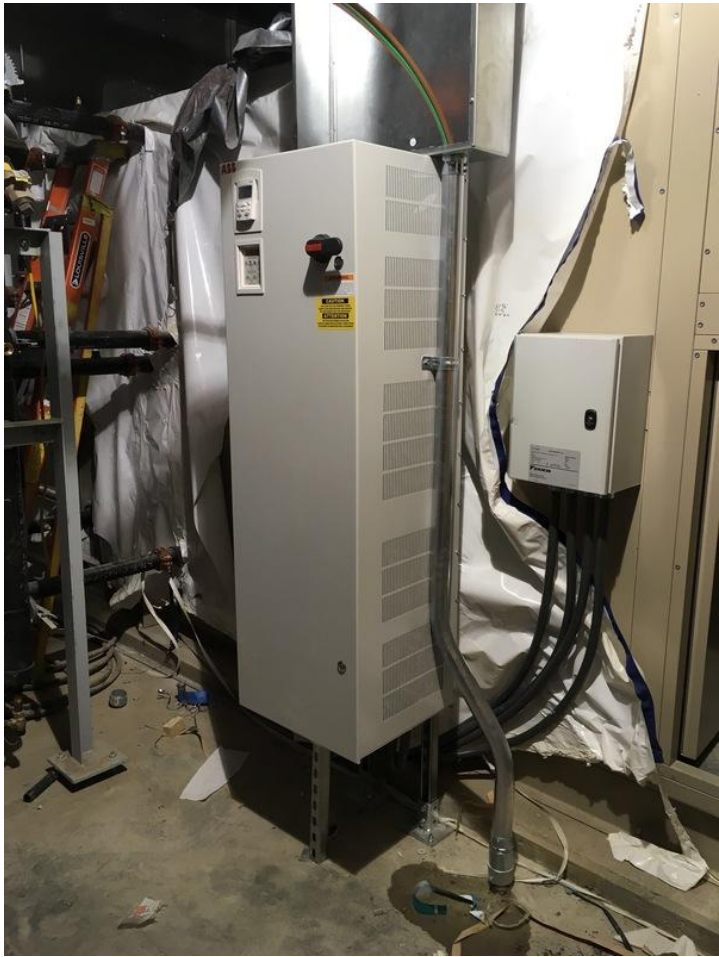
| Issue ID | Description | Location Detail | Location | Status | Company | Type | Date Created | Due Date |
|---|---|---|---|---|---|---|---|---|
| 000300 | Concerned about vfd mount stability. | | Webster > LEVEL_00 | Open | Guarantee Electric | 11 Month Warranty Walk | 10 Mar 2017 | 15 Mar 2017 |

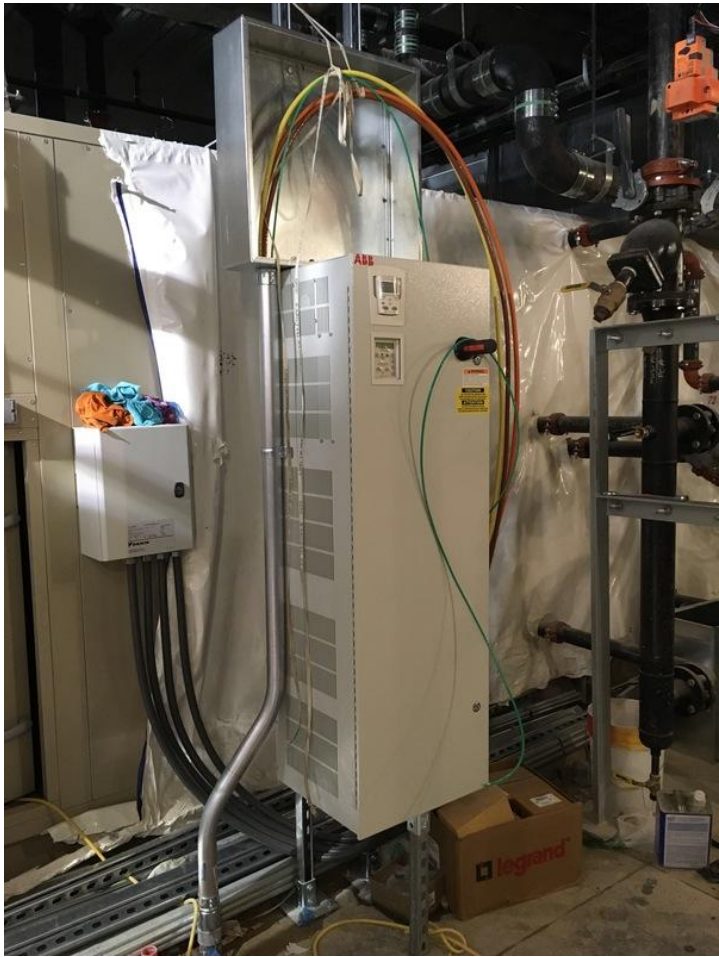
| Issue ID | Description | Location Detail | Location | Status | Company | Type | Date Created | Due Date |
|---|---|---|---|---|---|---|---|---|
| 000301 | Concerned about vfd mount stability. | | Webster > LEVEL_00 | Open | Guarantee Electric | 11 Month Warranty Walk | 10 Mar 2017 | 15 Mar 2017 |

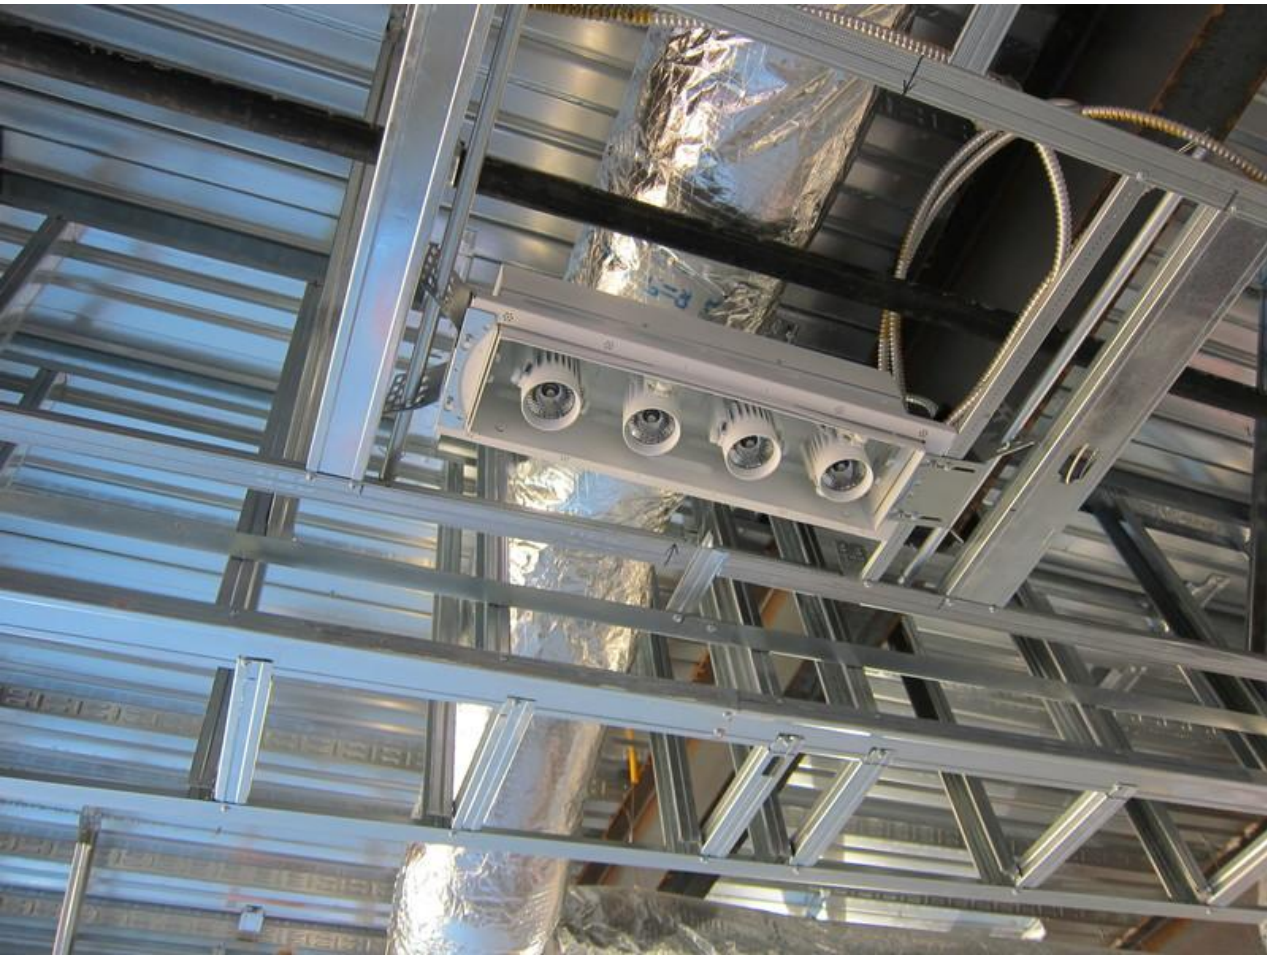
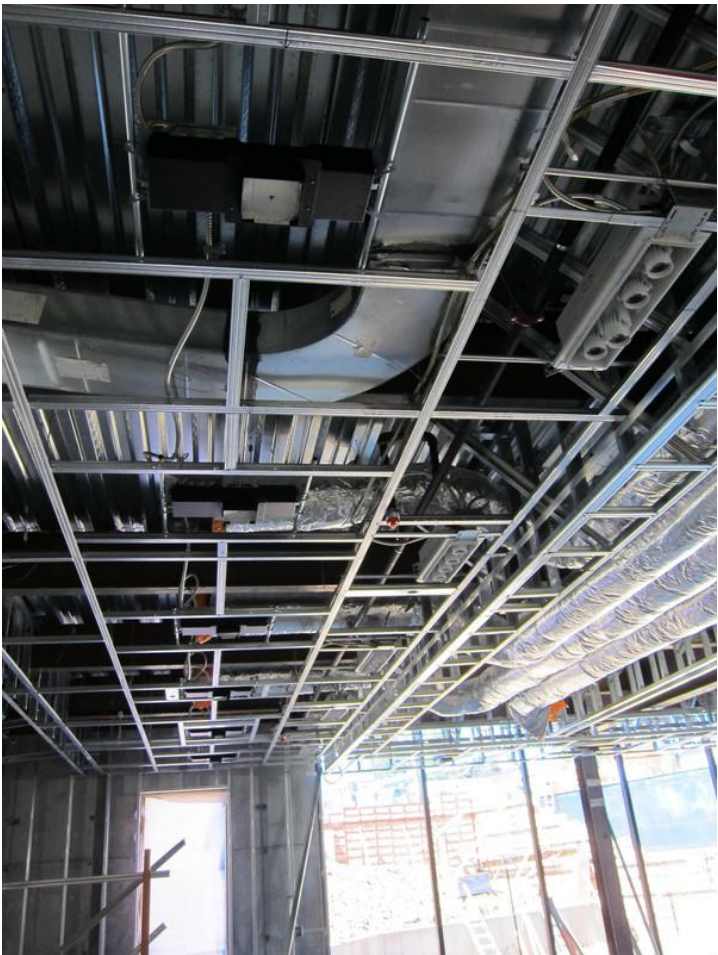
| Issue ID | Description | Location Detail | Location | Status | Company | Type | Date Created | Due Date |
|---|---|---|---|---|---|---|---|---|
| 000312 | Lighting is being installed in the Lecture Hall. It seems pretty early to install these lights. We are concerned about the high level of dust affecting the fixtures. Please consider temporary protection or consider delaying the lighting install until construction is further along. | | Webster > LEVEL_01 | Open | Guarantee Electric | 11 Month Warranty Walk | 13 Mar 2017 | 18 Mar 2017 |

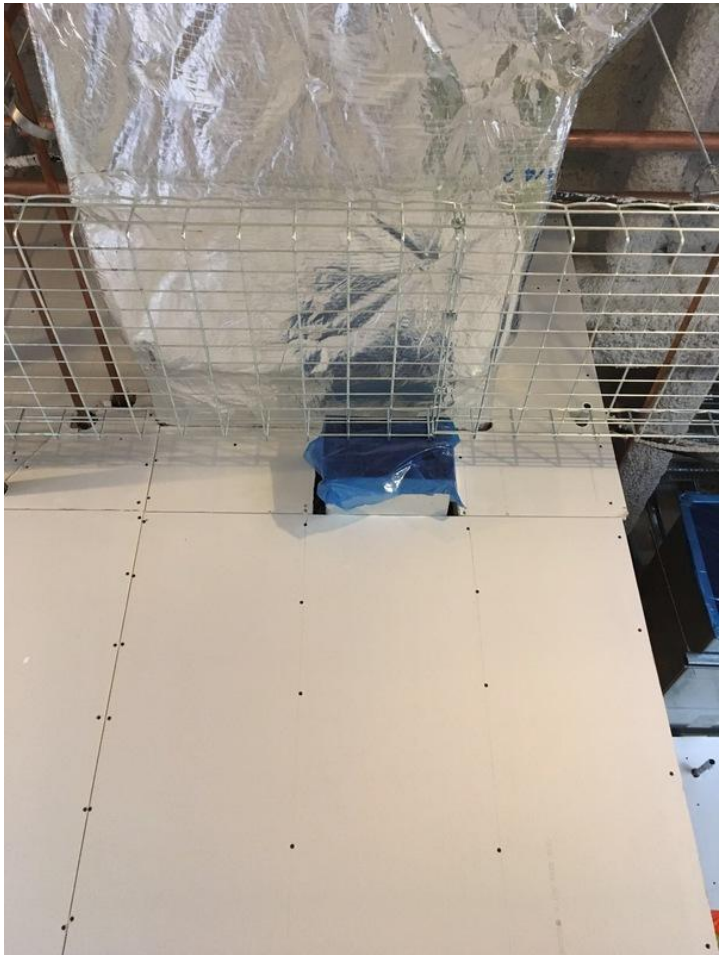
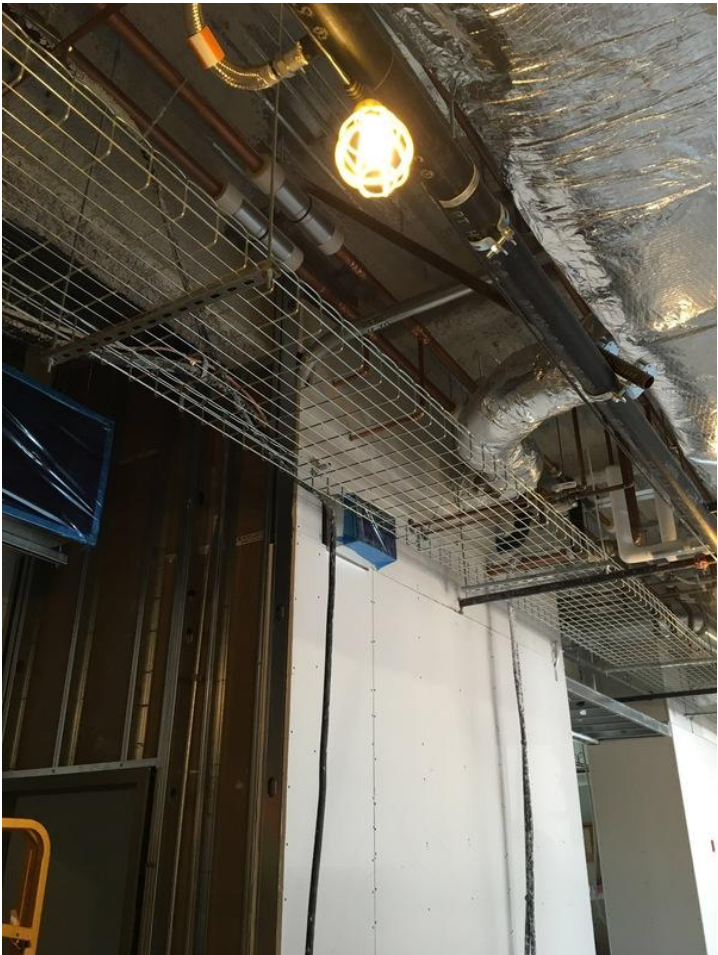
| Issue ID | Description | Location Detail | Location | Status | Company | Type | Date Created | Due Date |
|---|---|---|---|---|---|---|---|---|
| 000308 | Coordinate duct and cable tray. | | Webster > LEVEL_02 | Open | ICON Mechanical | 11 Month Warranty Walk | 10 Mar 2017 | 15 Mar 2017 |

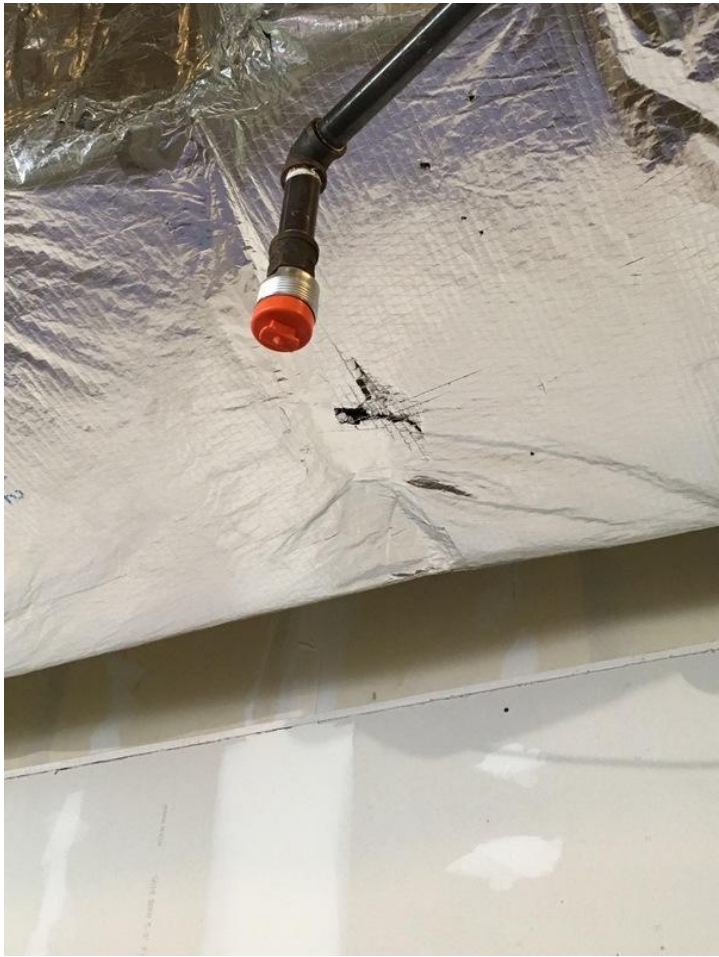
| Issue ID | Description | Location Detail | Location | Status | Company | Type | Date Created | Due Date |
|---|---|---|---|---|---|---|---|---|
| 000311 | Tear in duct insulation. | | Webster > LEVEL_01 | Open | ICON Mechanical | 11 Month Warranty Walk | 10 Mar 2017 | 15 Mar 2017 |
