## Observation Report

| File: | Webster University Interdisciplinary Science Bldg.<br>WT 14127.01 (7) | c: | |

### **Observations**

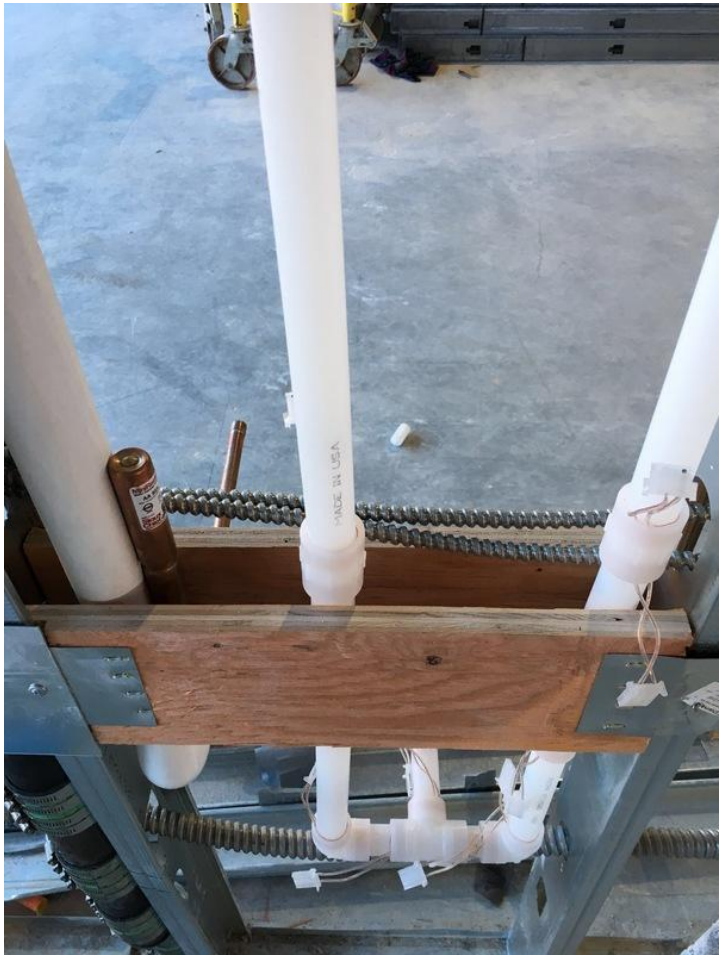
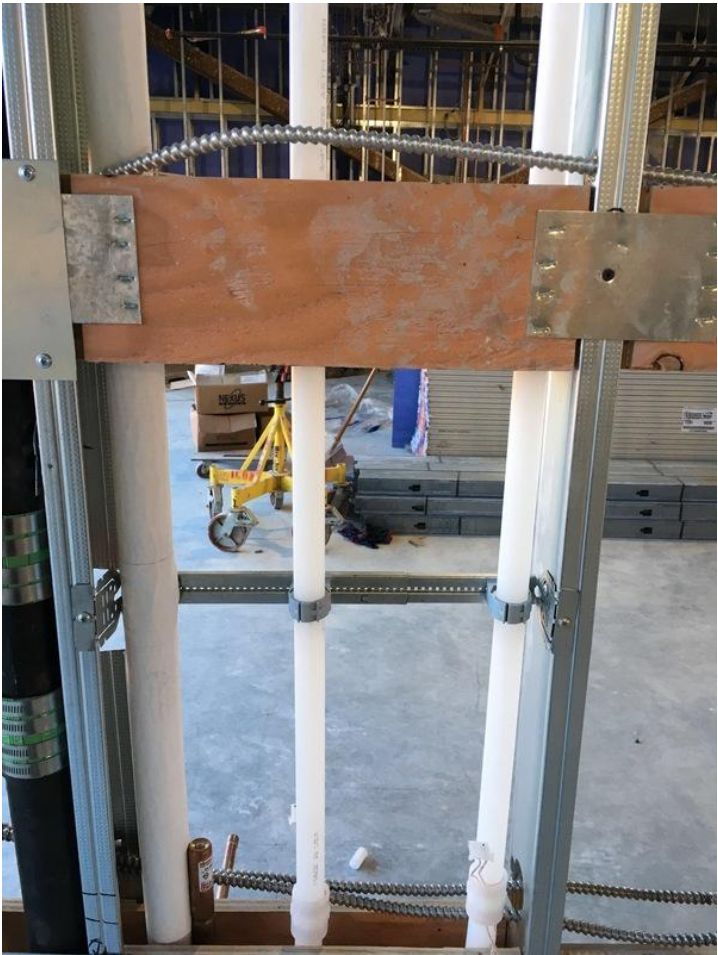
| Issue ID | Description | Location Detail | Location | Status | Company | Type | Date Created | Due Date |
|---|---|---|---|---|---|---|---|---|
| 000305 | Confirm nail plates are planned in locations with shallow piping and wood backing. | | Webster > LEVEL_03 | Open | Paric Corp. | 11 Month Warranty Walk | 10 Mar 2017 | 15 Mar 2017 |

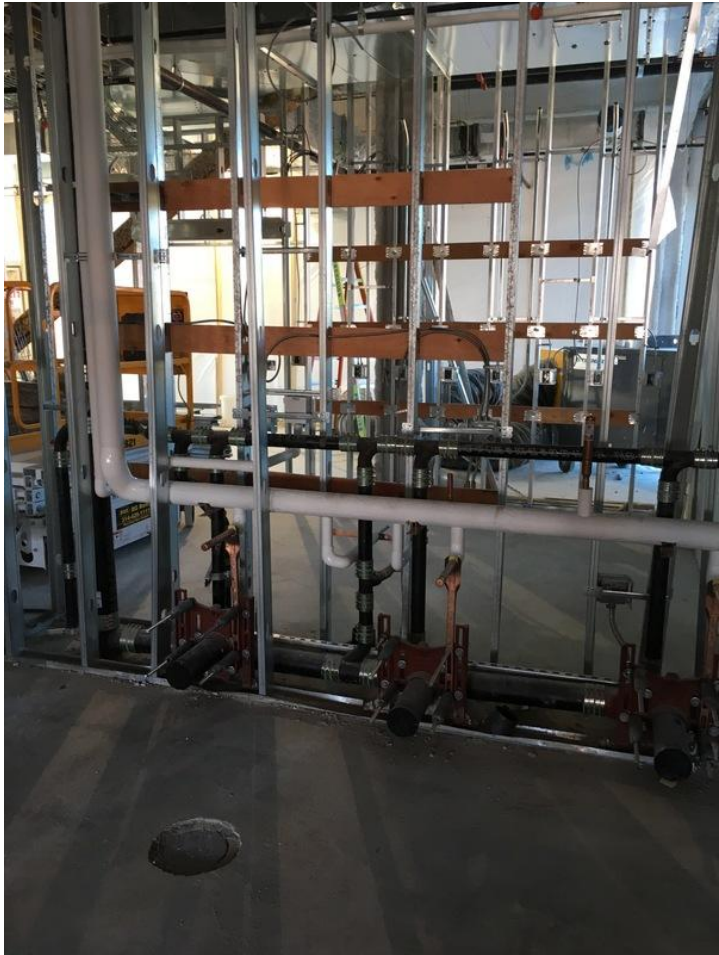
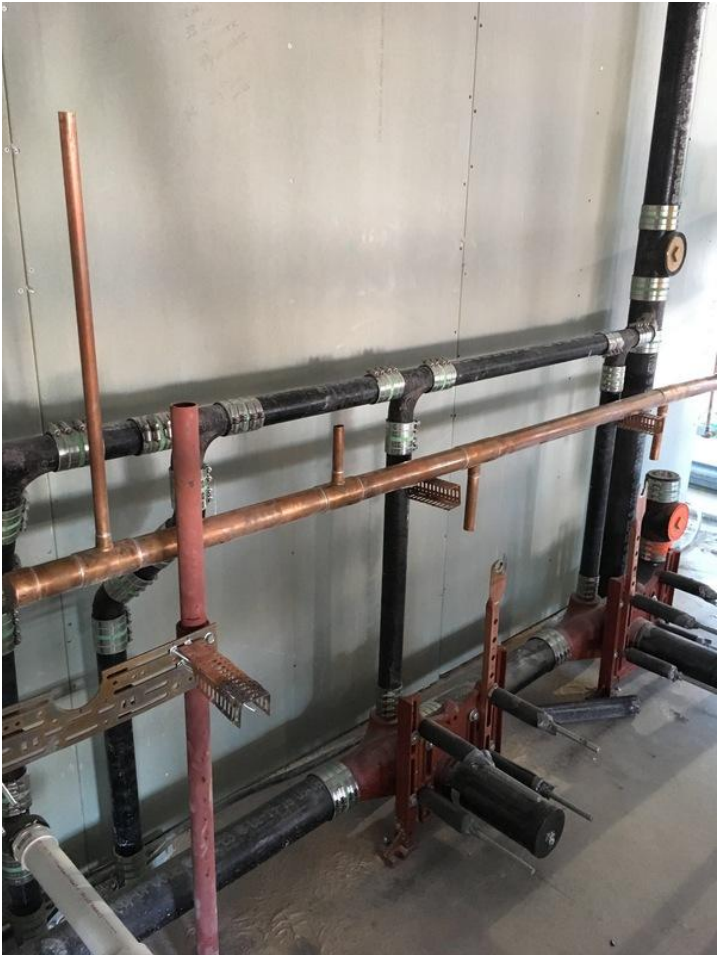
| Issue ID | Description | Location Detail | Location | Status | Company | Type | Date Created | Due Date |
|---|---|---|---|---|---|---|---|---|
| 000306 | Some insulation covered wet wall piping blocking confirmation that pull tees were replaced. What wasn't insulated shows pulled tees were replaced. | | Webster > LEVEL_03 | Open | Paric Corp. | 11 Month Warranty Walk | 10 Mar 2017 | 15 Mar 2017 |

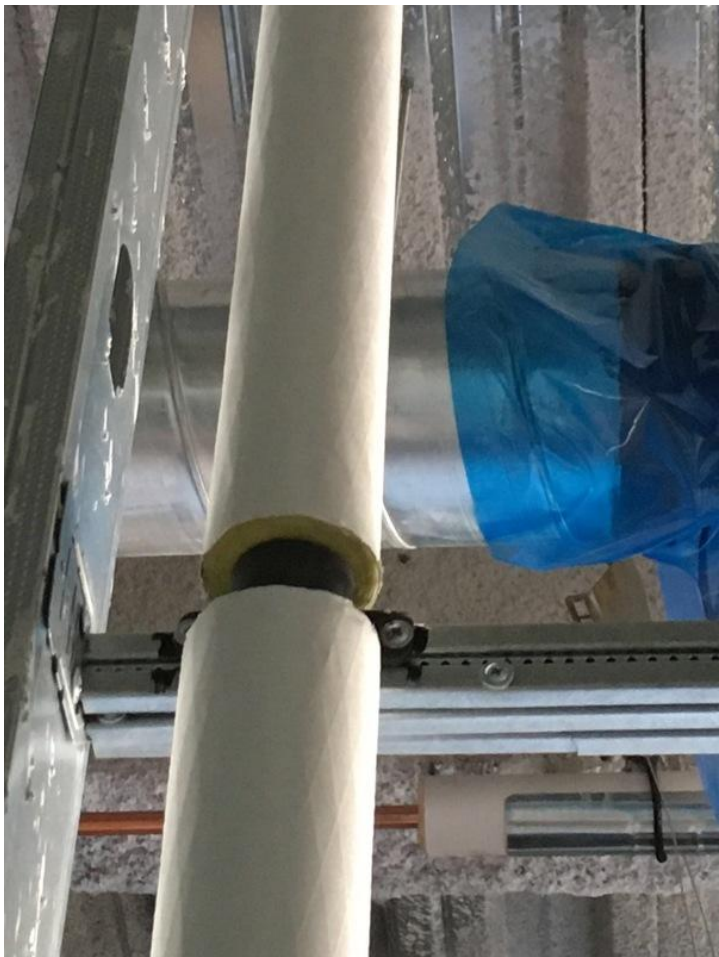
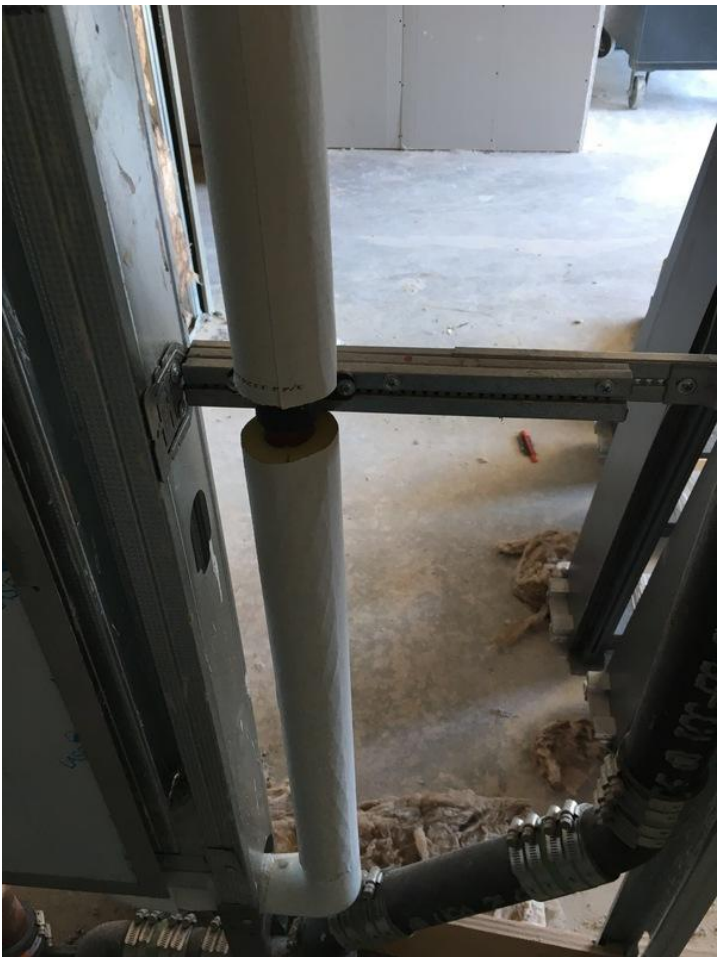
| Issue ID | Description | Location Detail | Location | Status | Company | Type | Date Created | Due Date |
|---|---|---|---|---|---|---|---|---|
| 000309 | Make sure insulation ends are sealed properly. | | Webster > LEVEL_02 | Open | Paric Corp. | 11 Month Warranty Walk | 10 Mar 2017 | 15 Mar 2017 |
