# Post-Construction Stormwater BMP Incident Report

| Project: <b>Webster University ISB</b> | | License #: <b>MO E-18668</b> |
| Incident Date(s): <b>6/16/2016 - 6/17/2016</b> | | Address: <b>5858 Delor Street 63109</b> |

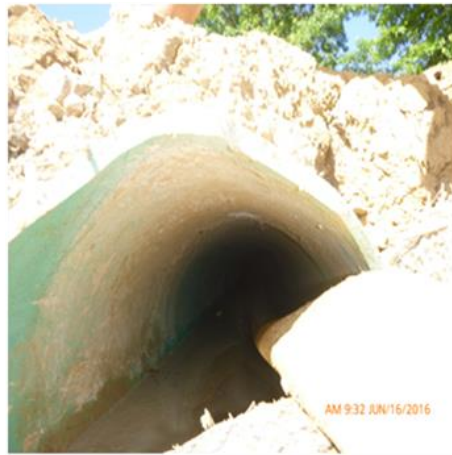
**VIEW INTO STORM SEWER CARRYING  
TURBID WATER TO HDS**

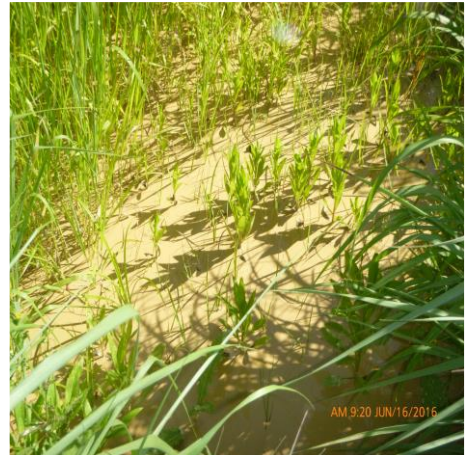
**REPRESENTATIVE VIEW OF DAMAGE TO  
10 PERCENT OF BASIN SURFACE AREA**

- \* Using an infiltrometer or other MSD approved method, test the bioretention basin soil in the damaged areas to document the boundary of the area
- \* to be repaired and the depth of soil removal necessary to return the soil profile to full functionality.

- \* Prepare a Bioretention Basin Remediation Plan to include plans, specifications and guidelines for the repairs proposed.
- \* Remove and legally dispose of plants within the designated repair area.

- \* Remove and legally dispose of soil within the designated repair area to the depth necessary to return the bioretention basin to full functionality.

- \* Return the bioretention basin surface to its original elevation using an MSD approved soil mix and mulch that matches the remainder of the basin.
- \* Provide in-situ testing of the replacement bioretention soil to confirm compliance with project specifications.

- \* Replace plants in compliance with the original MSD approved planting plan and specification.
- \* Water replacement plants in accordance with the original landscape specifications or another approved plan.

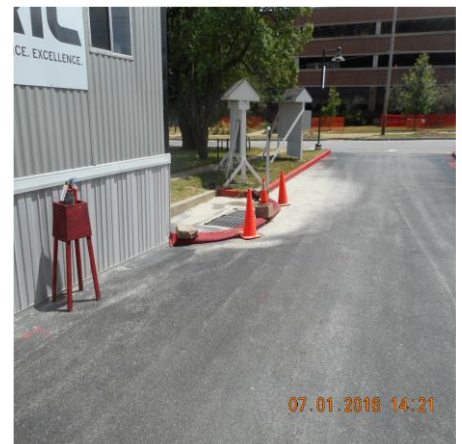
VIEW OF INLET PROTECTION AT  
FOUR GRATE INLET

REMOVE AND REPLACE FILTER FABRIC  
AT INLETS AS NEEDED

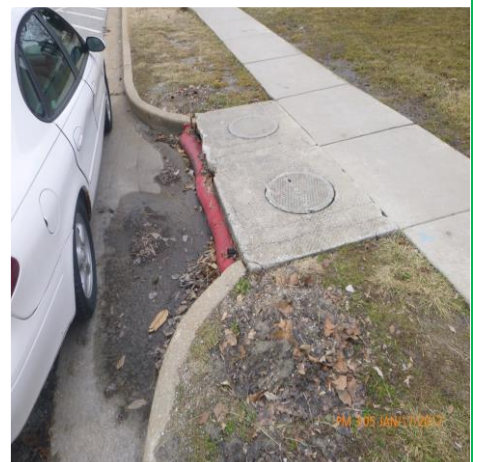
MONITOR SEDIMENT AT CURB INLET  
(GARDEN AVENUE)

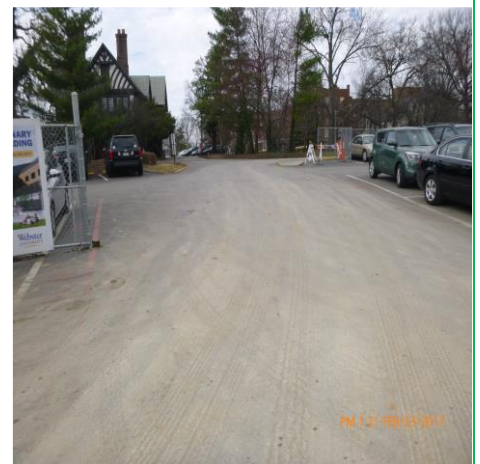
MONITOR SEDIMENT LEAVING SITE  
(PARKING LOT)
