## **ARCHITECTURAL PUNCH LIST (EXTERIOR FAÇADE & ROOF)**

**Project:** Webster University Interdisciplinary Science Building

**Project No:** CannonDesign #004561.01

**Date of Observation:** August 7, 2017

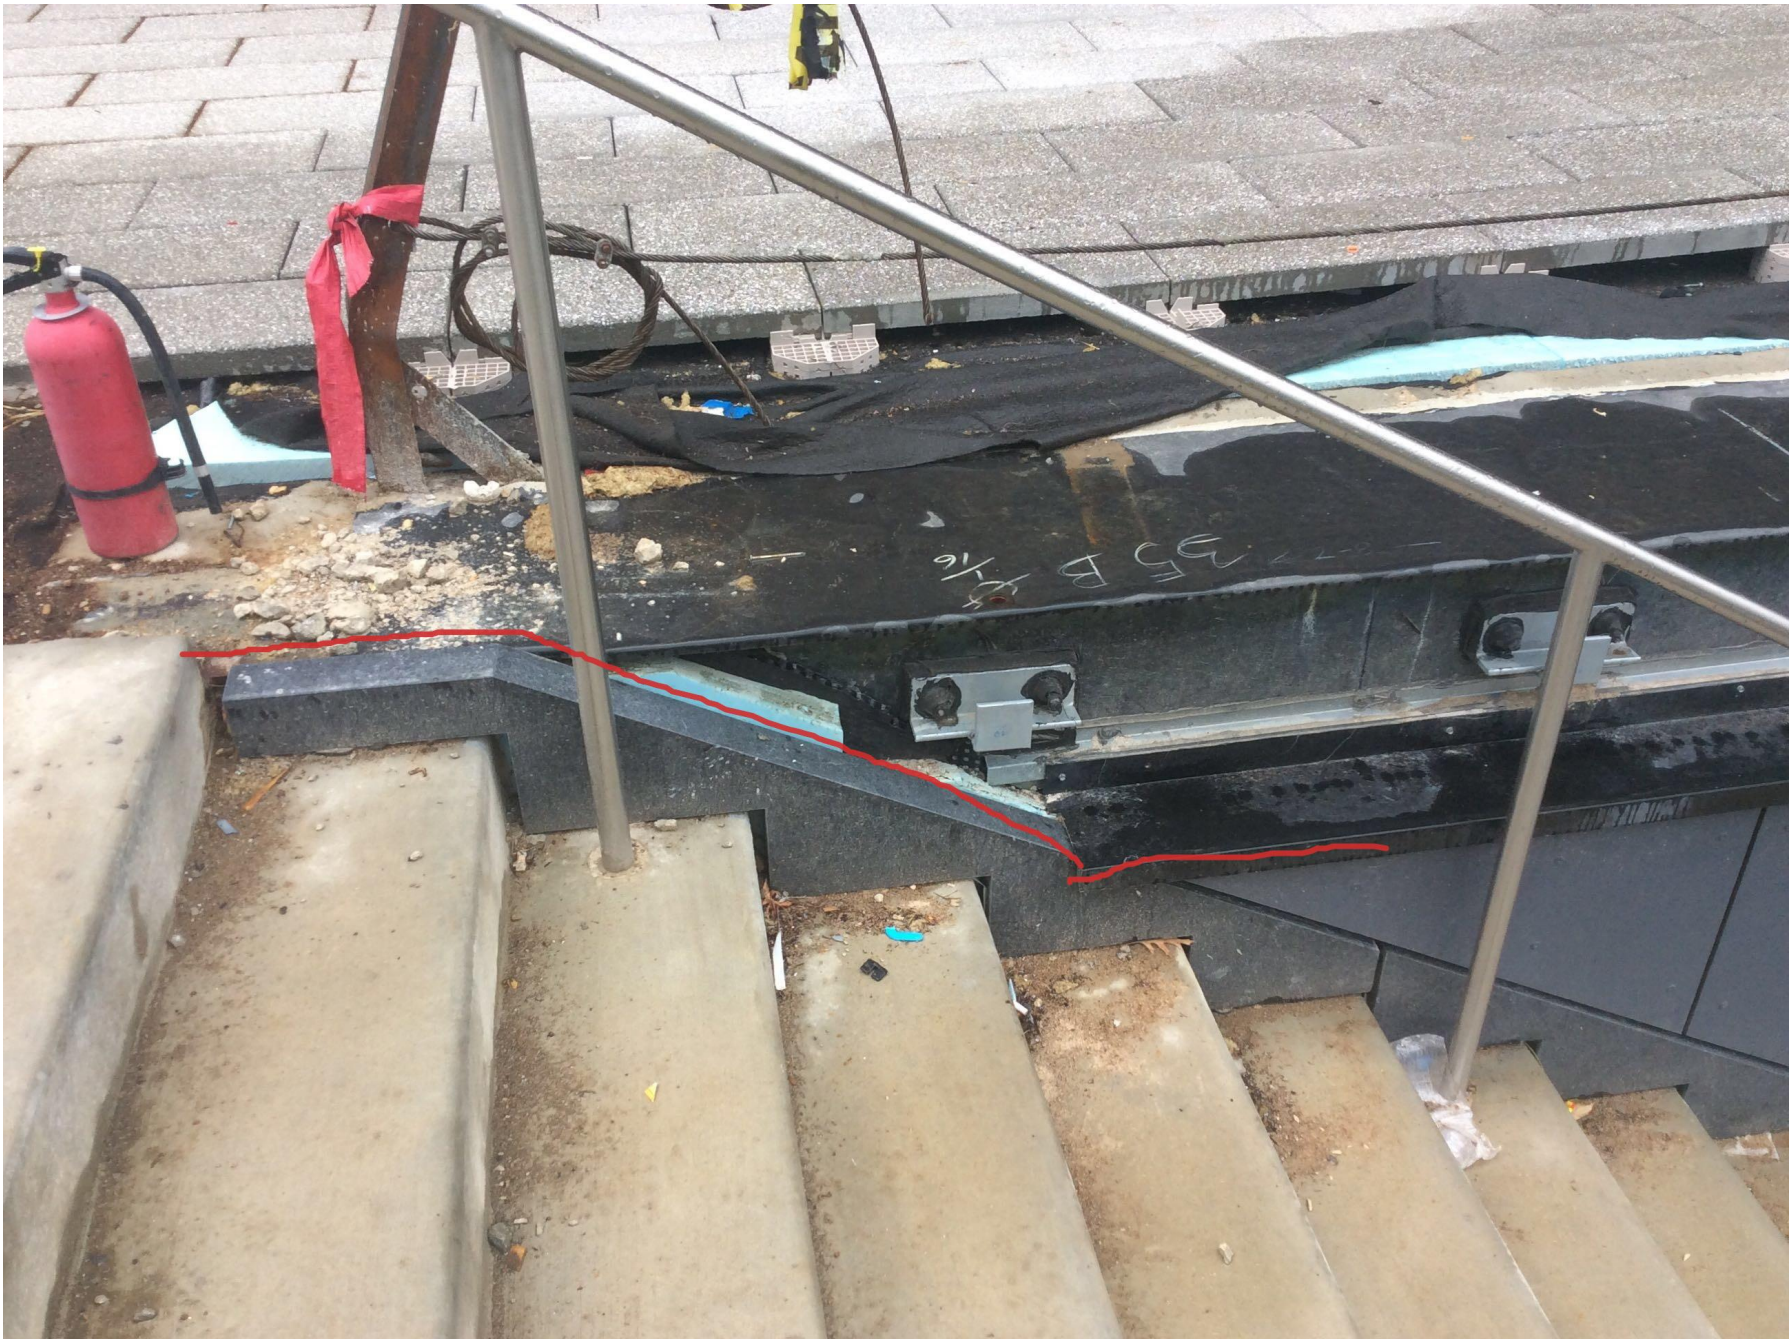
| Issue ID | Description | Location Detail | Location | Status | Company | Type | Date Created | Due Date |
|---|---|---|---|---|---|---|---|---|
| 002153 | Metal support to extend up to face of stair - north courtyard stair | | Site | Open | Atlas Iron Works | Architect Punch List | 07 Aug 2017 | 12 Aug 2017 |

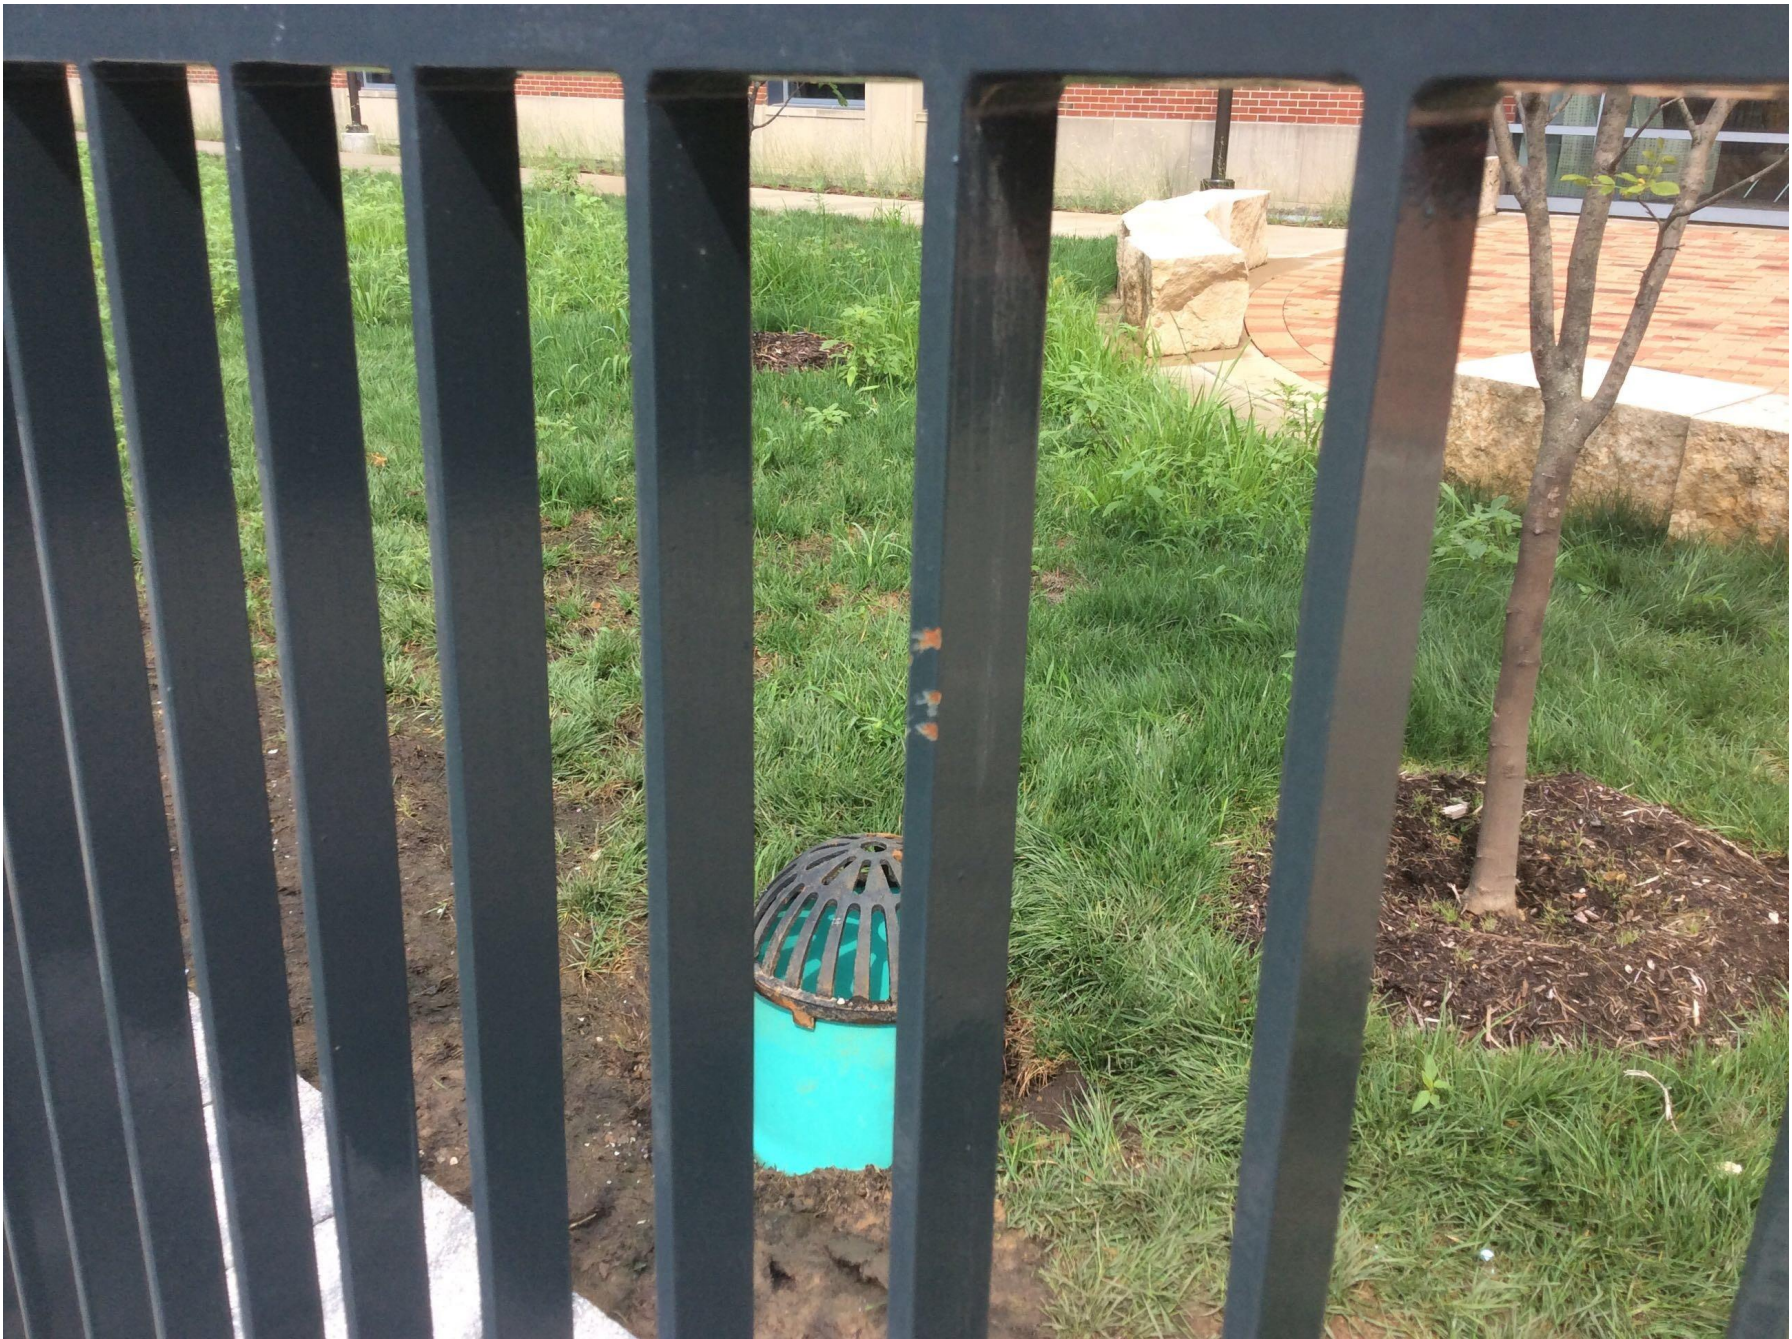
| Issue ID | Description | Location Detail | Location | Status | Company | Type | Date Created | Due Date |
|---|---|---|---|---|---|---|---|---|
| 002161 | Touchup paint chips on handrail - courtyard | | Site | Open | Atlas Iron Works | Architect Punch List | 07 Aug 2017 | 12 Aug 2017 |

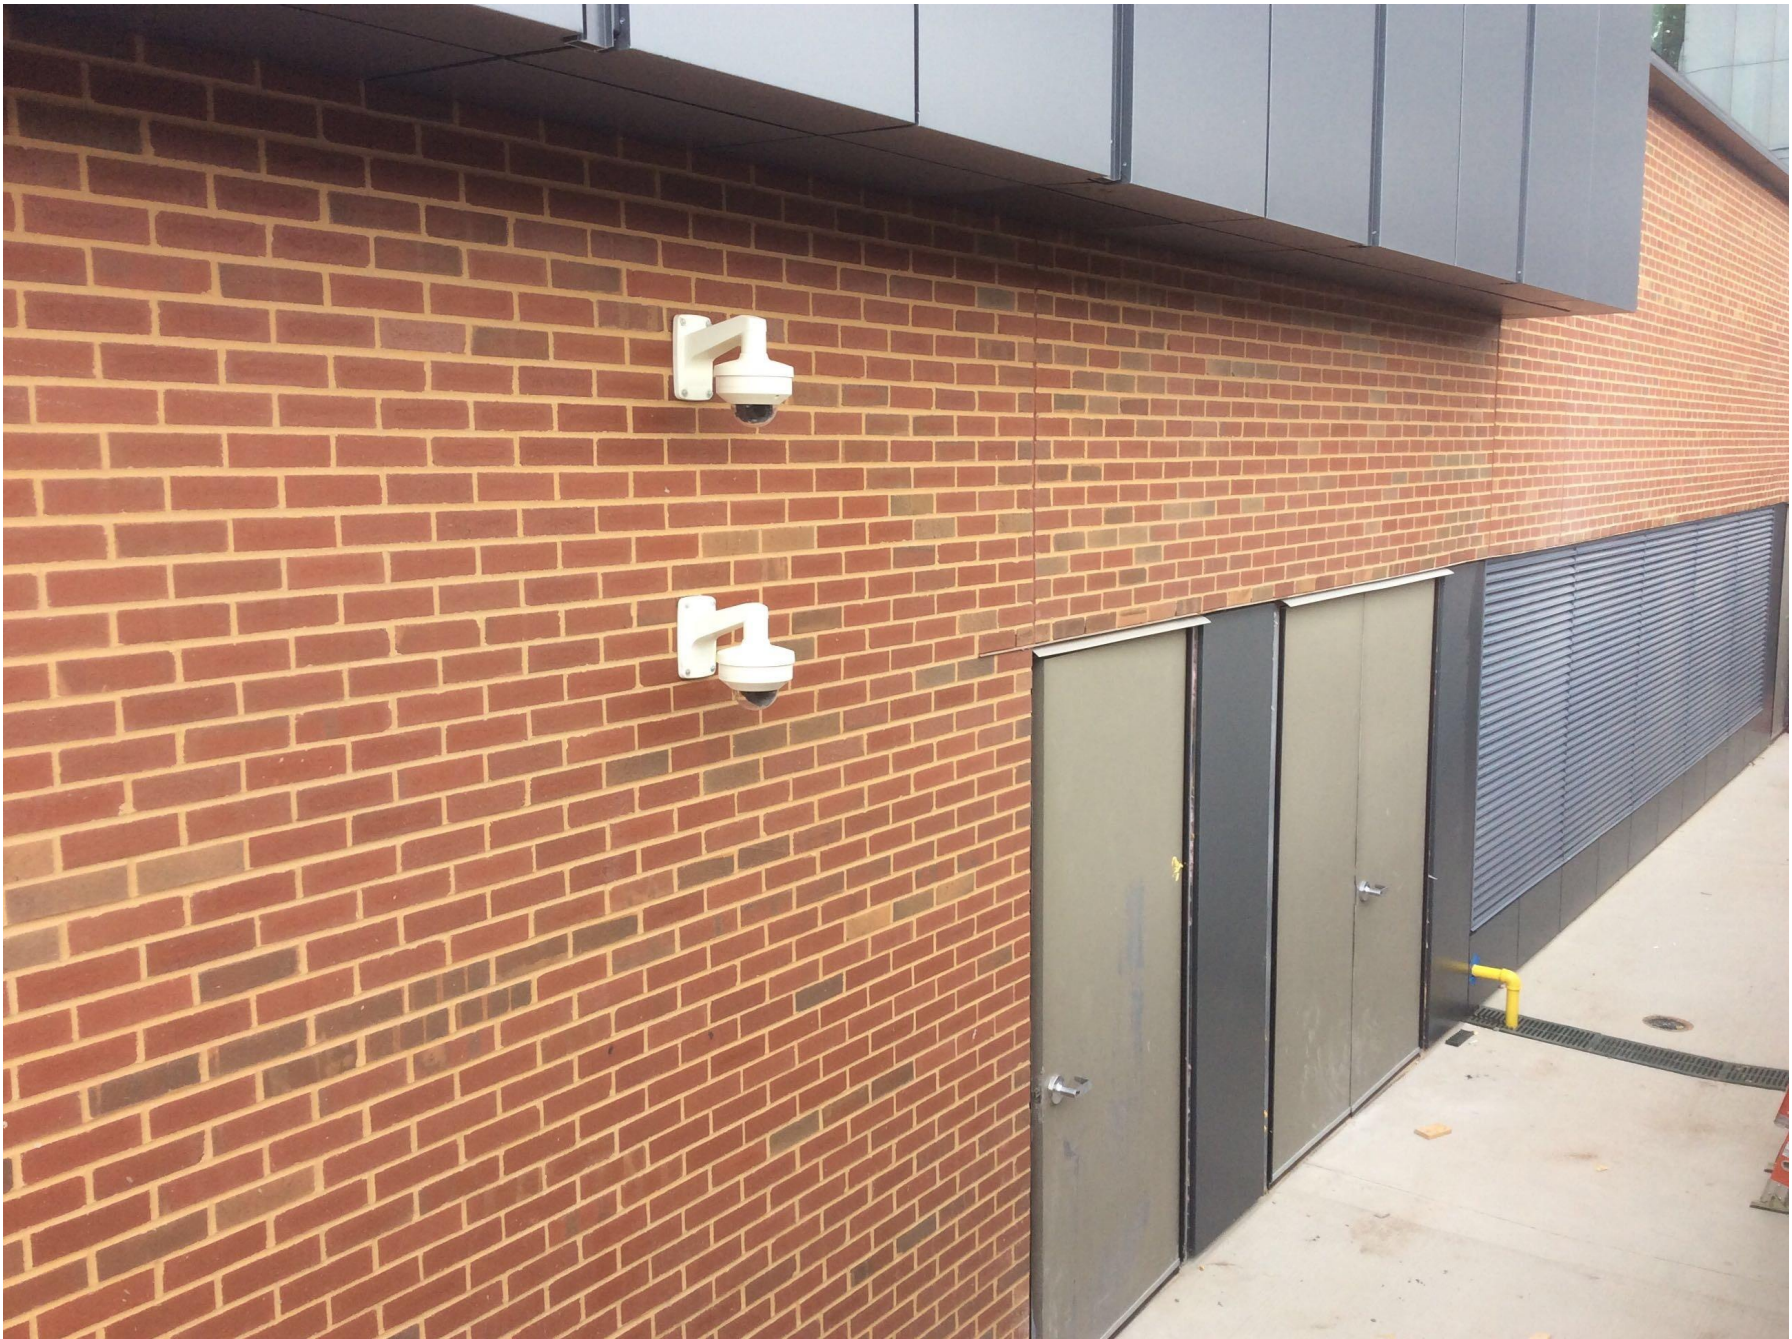
| Issue ID | Description | Location Detail | Location | Status | Company | Type | Date Created | Due Date |
|---|---|---|---|---|---|---|---|---|
| 002147 | Cameras to be mounted flush to wall, not on brackets | | Site | Open | Guarantee Electric | Architect Punch List | 07 Aug 2017 | 12 Aug 2017 |

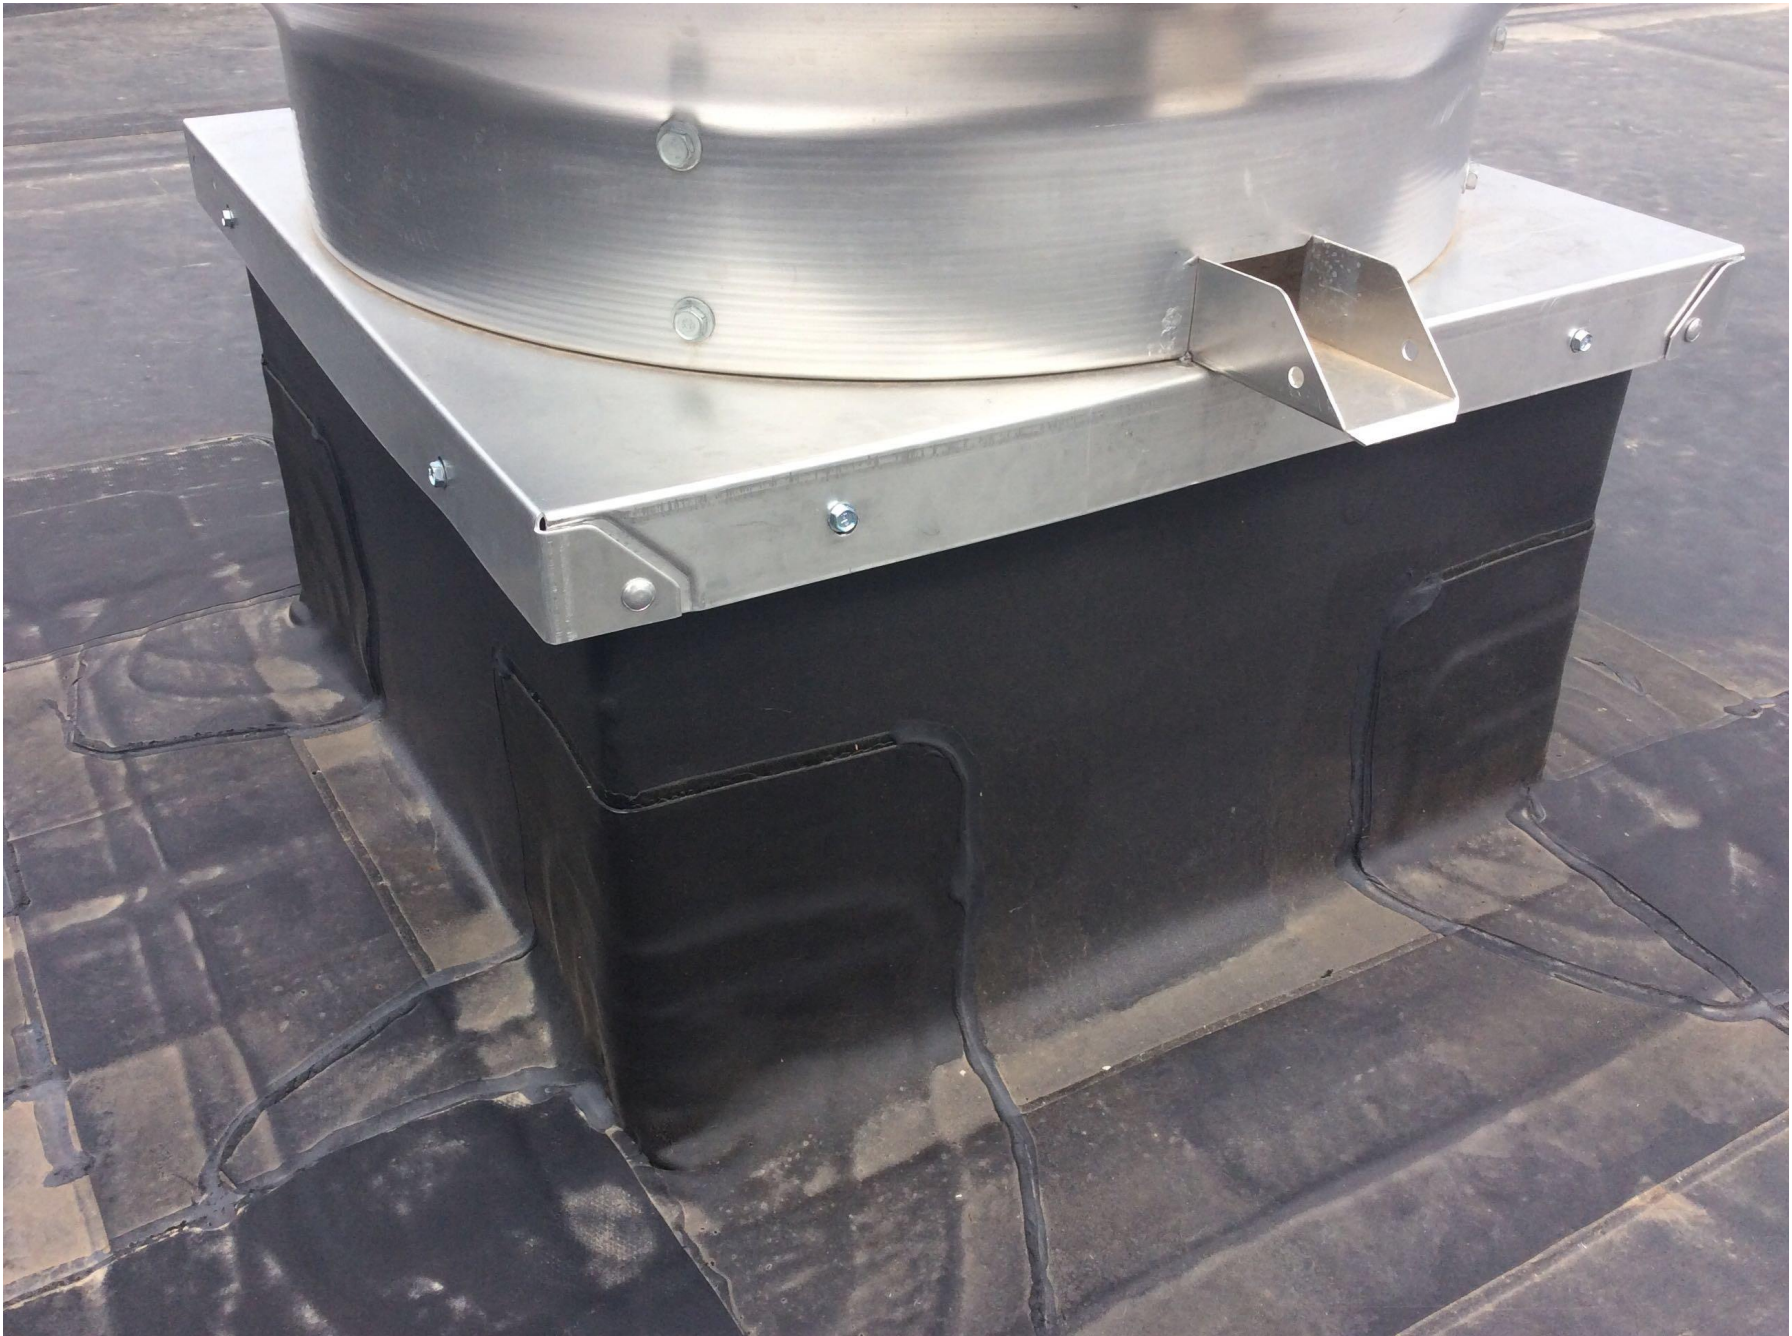
| Issue ID | Description | Location Detail | Location | Status | Company | Type | Date Created | Due Date |
|---|---|---|---|---|---|---|---|---|
| 002107 | Confirm all screws for rooftop mechanical equipment to stainless curbs are stainless, not galvanized. | | Webster > Roof | Open | ICON Mechanical | Architect Punch List | 07 Aug 2017 | 12 Aug 2017 |

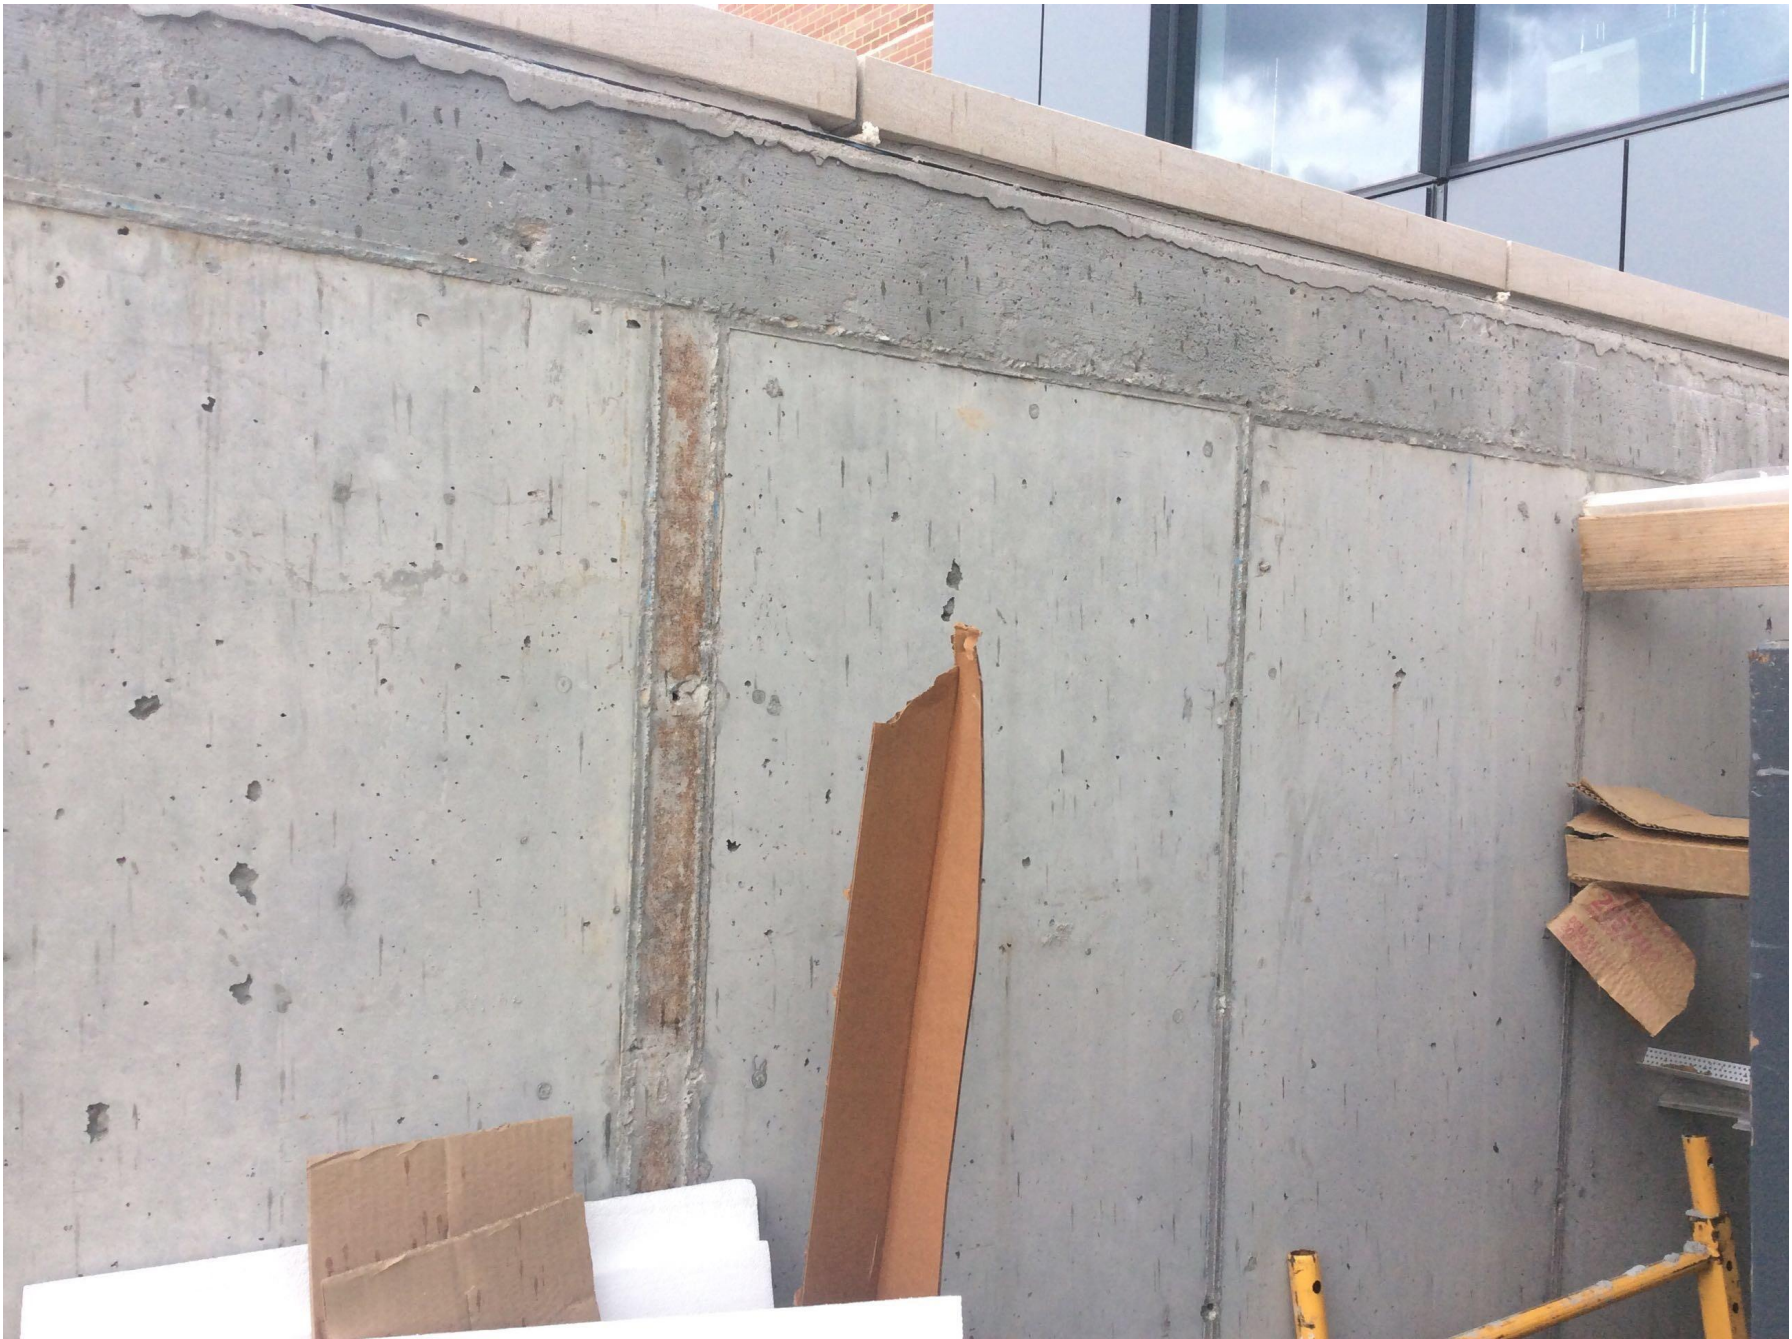
| Issue ID | Description | Location Detail | Location | Status | Company | Type | Date Created | Due Date |
|---|---|---|---|---|---|---|---|---|
| 002149 | Patch concrete in dumpster enclosure | | Site | Open | KCI Construction | Architect Punch List | 07 Aug 2017 | 12 Aug 2017 |

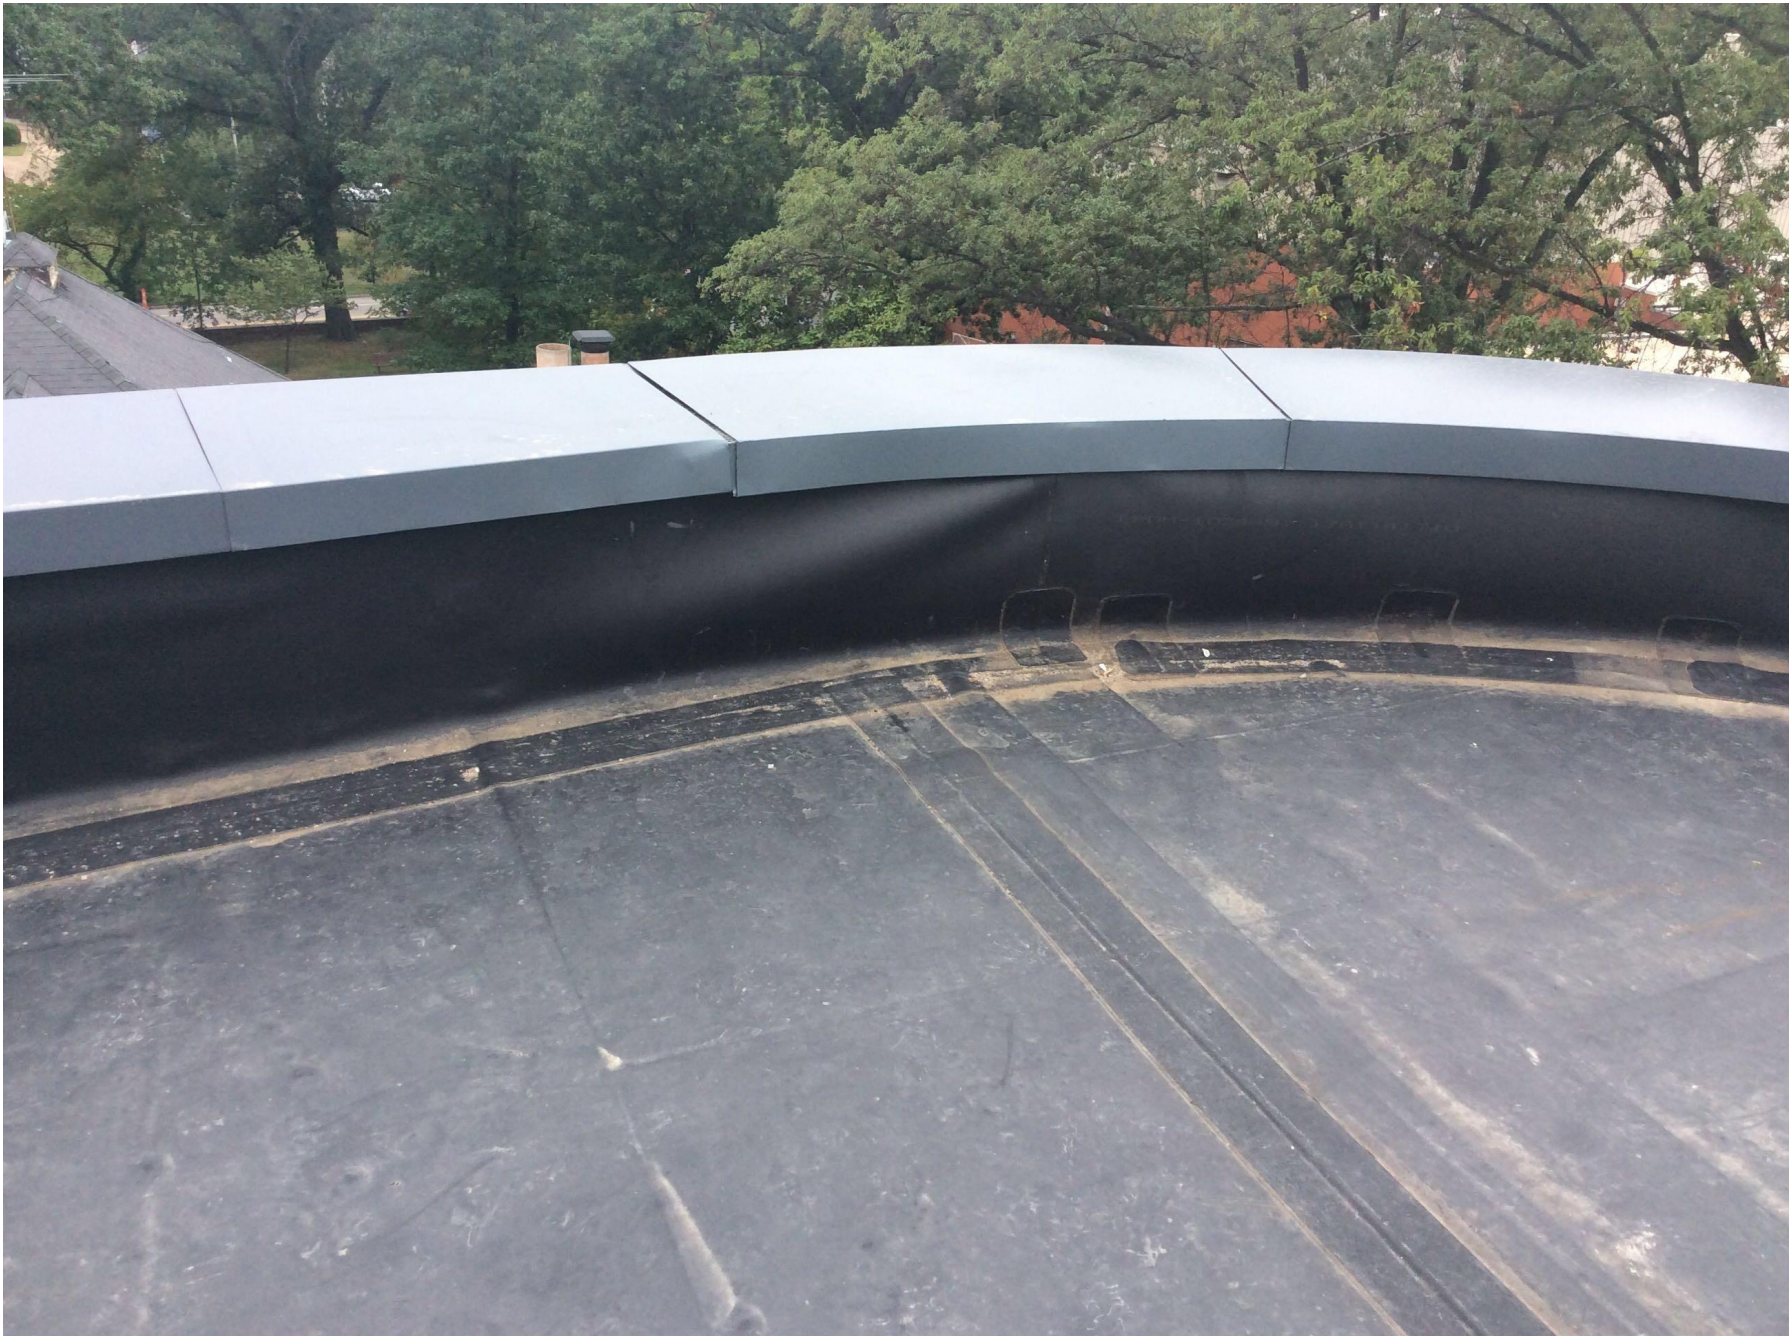
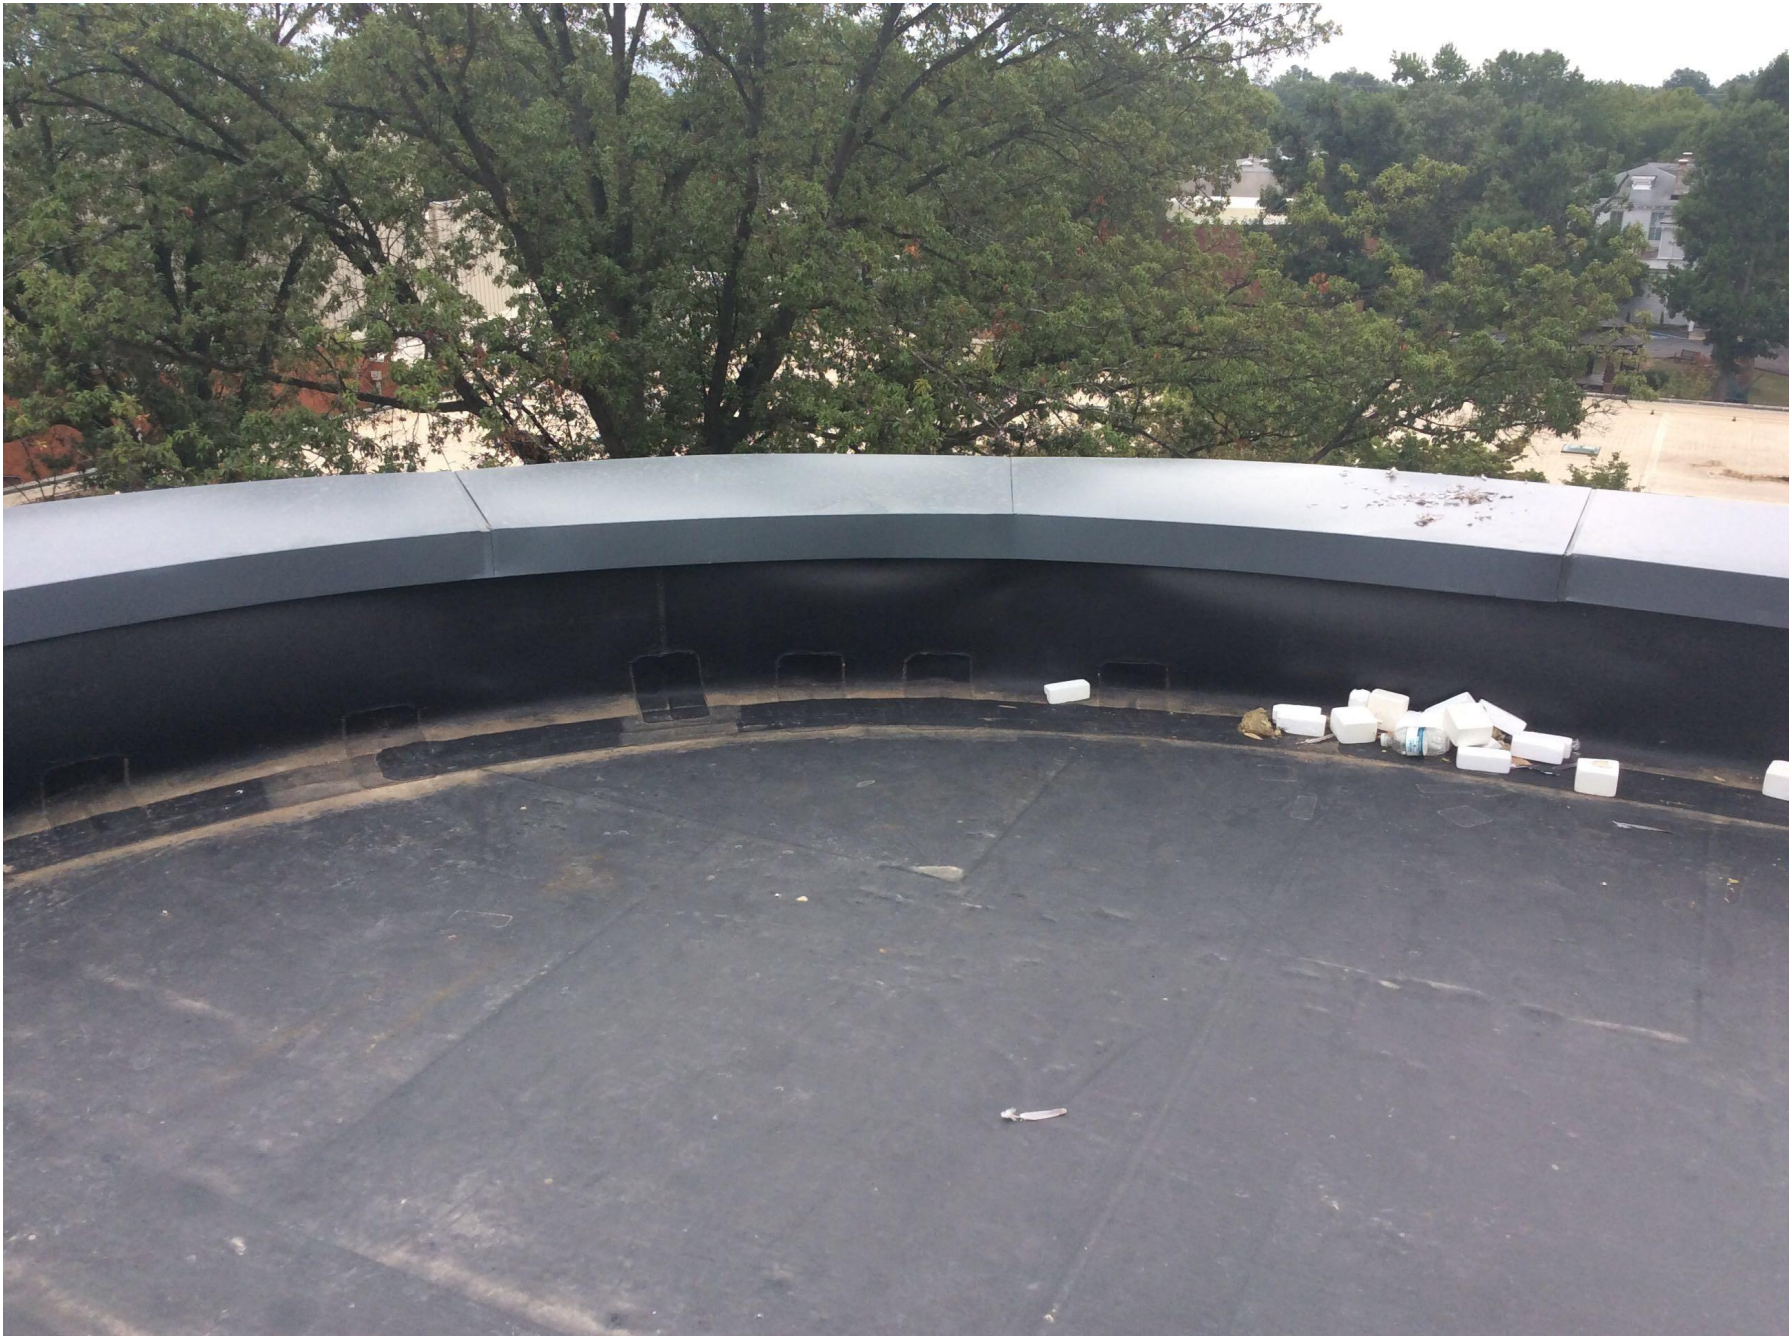
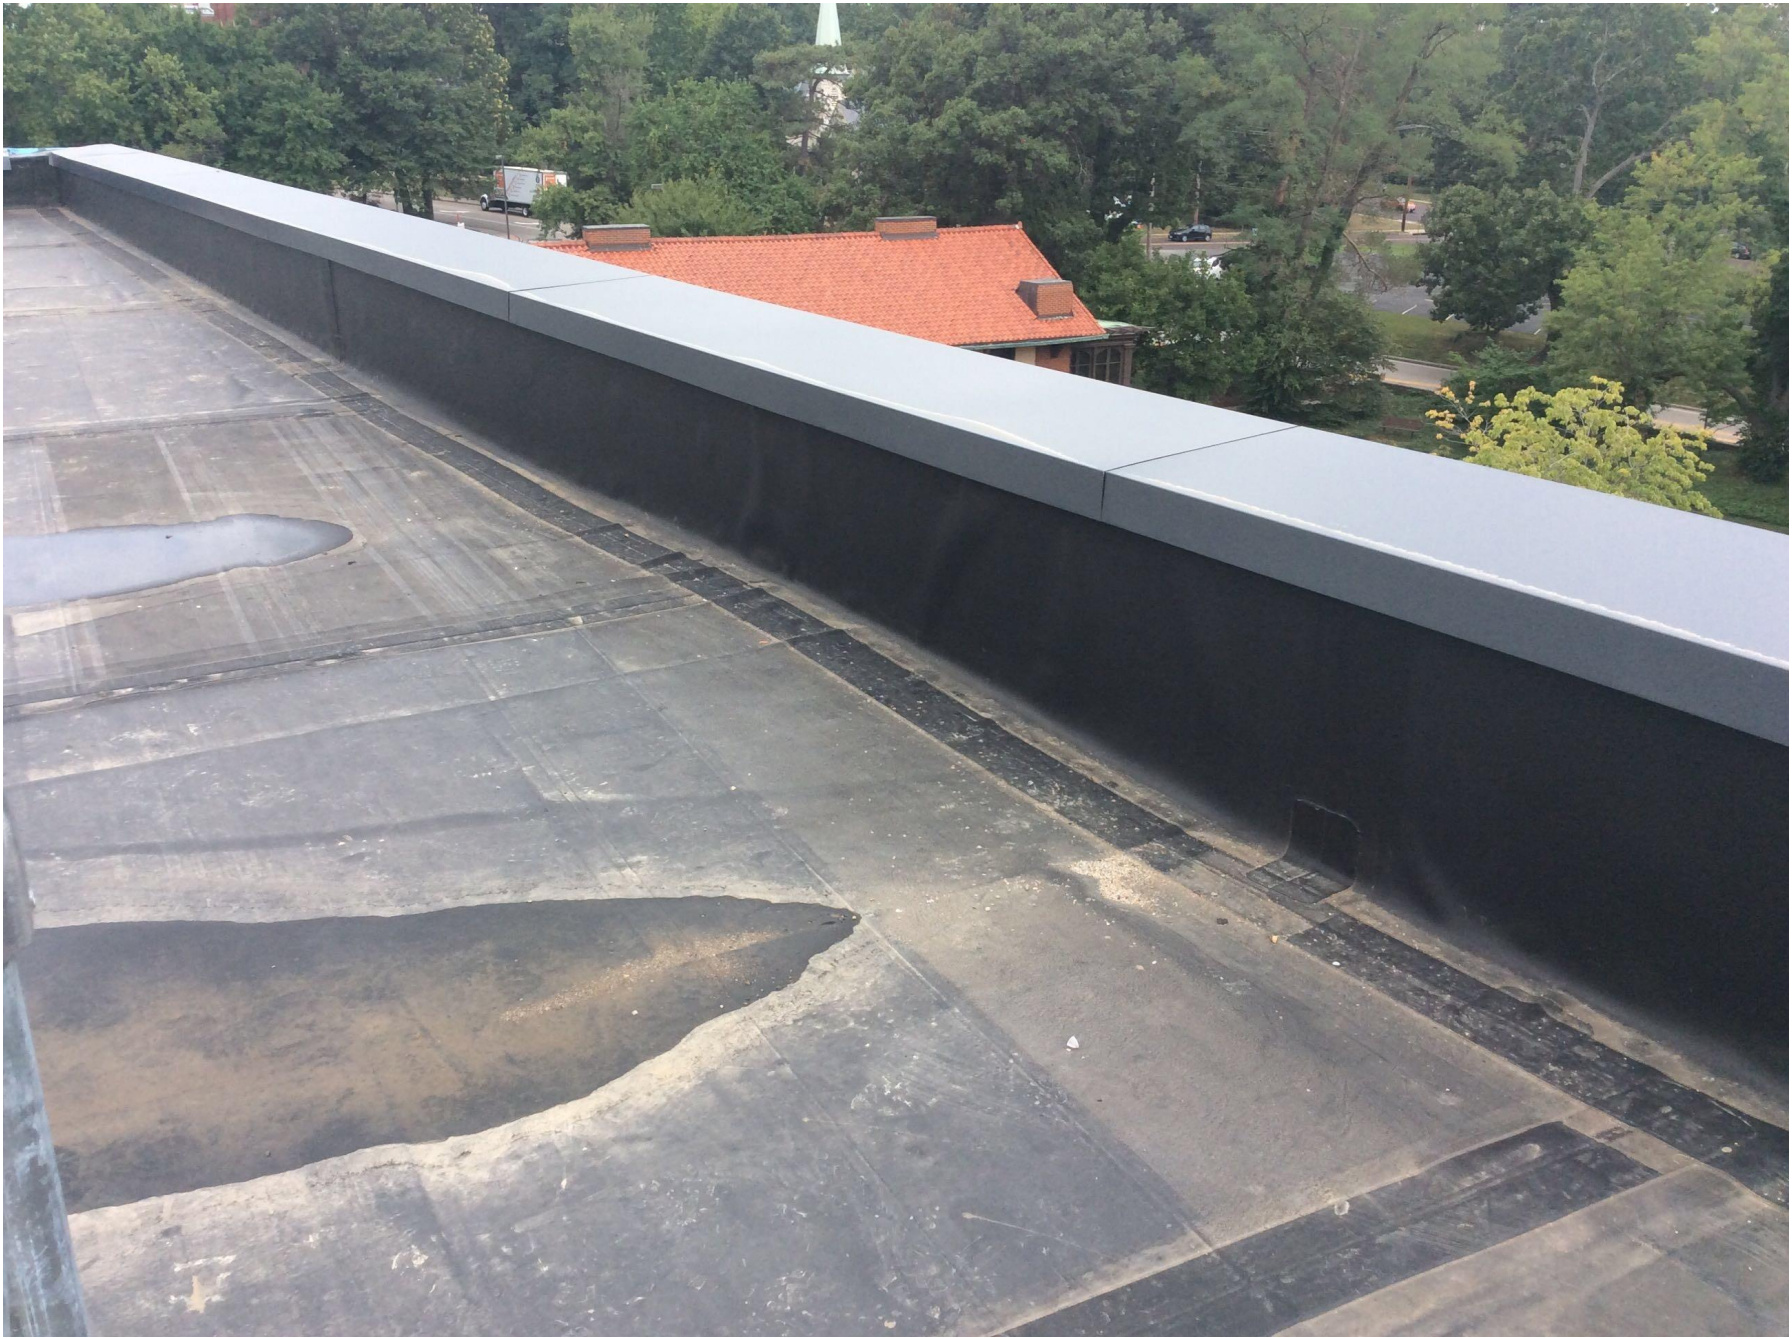
| Issue ID | Description | Location Detail | Location | Status | Company | Type | Date Created | Due Date |
|---|---|---|---|---|---|---|---|---|
| 002099 | Membrane needs to be fully adhered to parapet substrate at all locations | | Webster > Roof | Open | Kirberg Company | Architect Punch List | 07 Aug 2017 | 12 Aug 2017 |

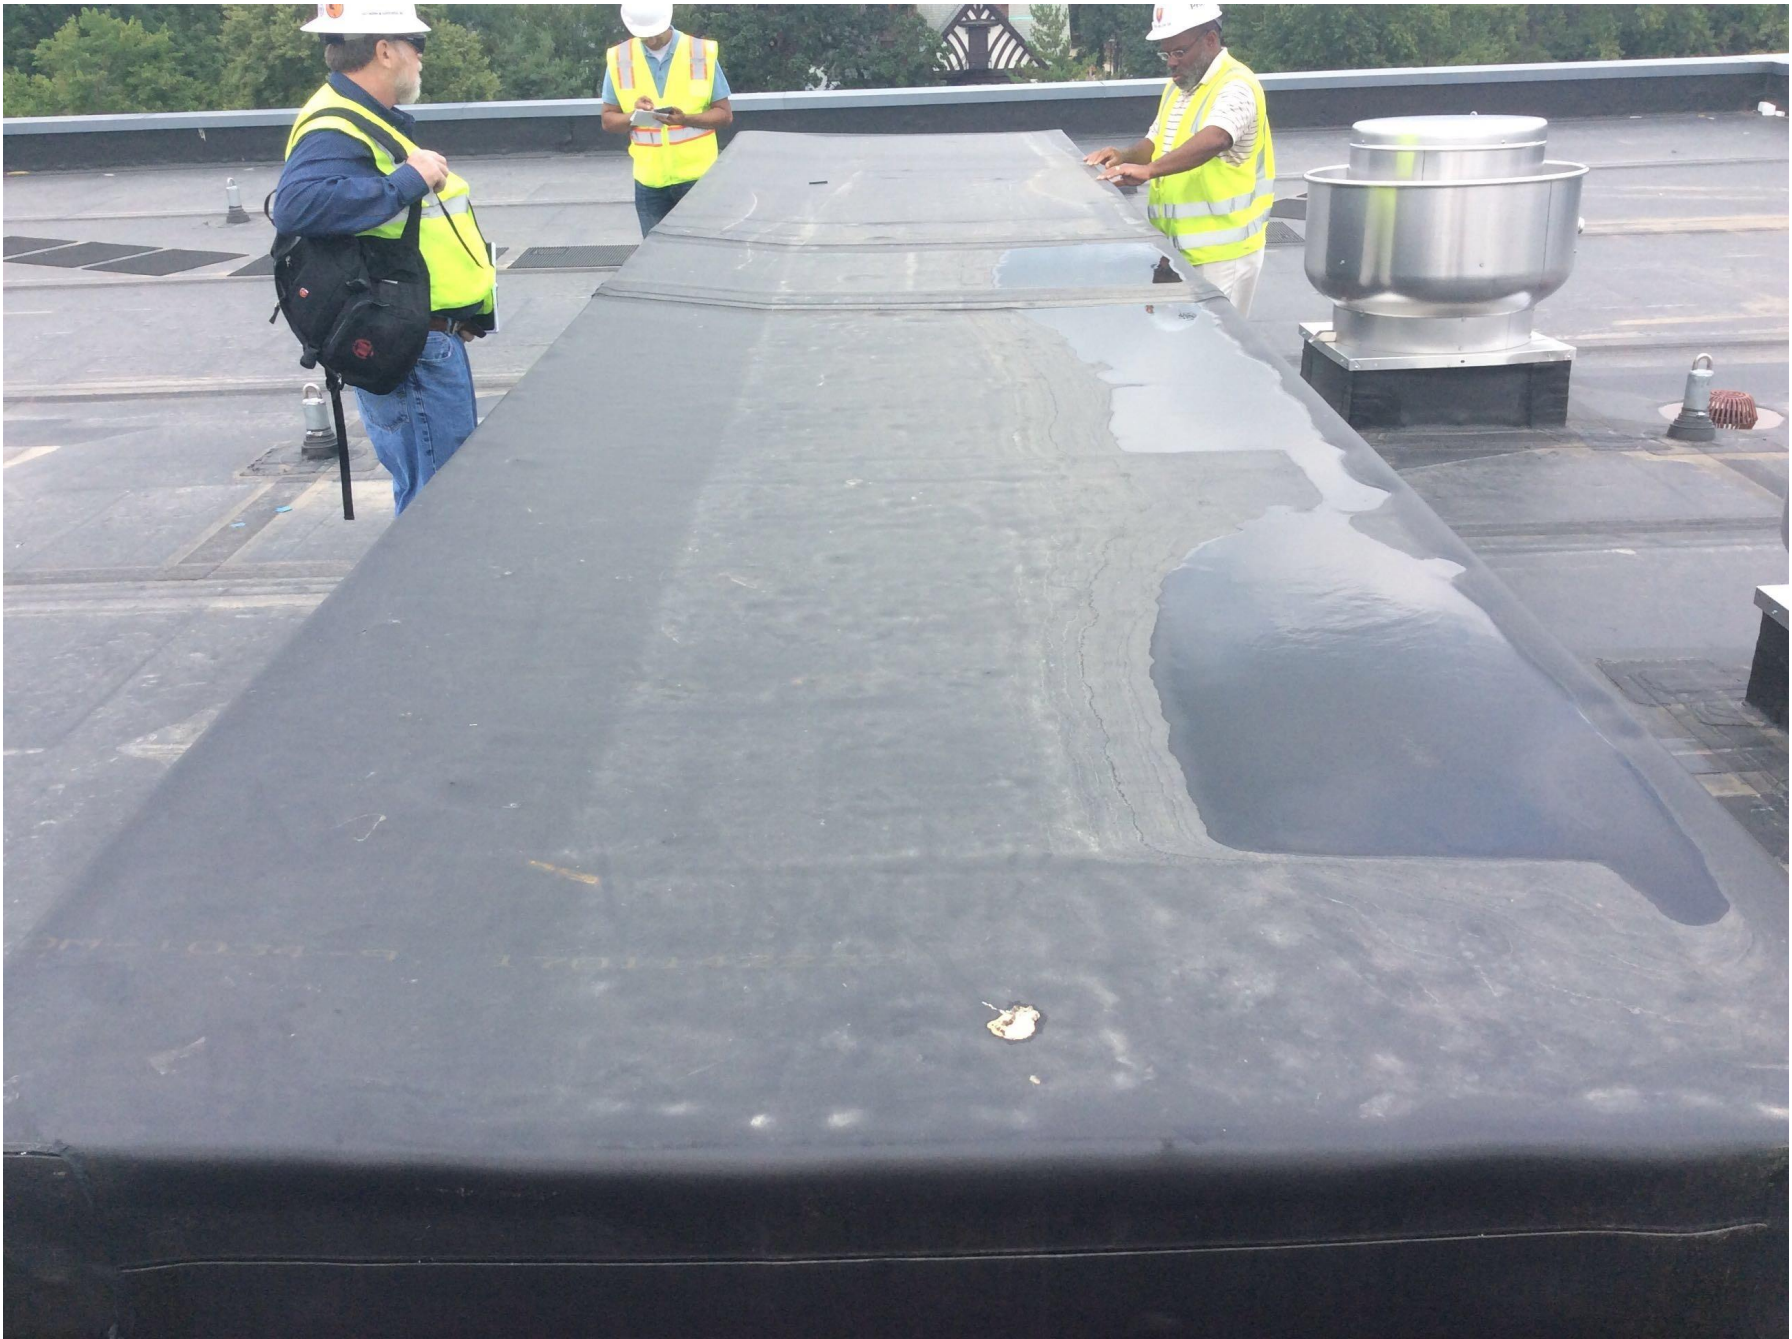
| Issue ID | Description | Location Detail | Location | Status | Company | Type | Date Created | Due Date |
|---|---|---|---|---|---|---|---|---|
| 002100 | Roof needs to slope so that there is no ponding above stair 1 | | Webster > Roof | Open | Kirberg Company | Architect Punch List | 07 Aug 2017 | 12 Aug 2017 |
