## **ARCHITECTURAL PUNCH LIST (EXTERIOR FAÇADE & ROOF)**

**Project:** Webster University Interdisciplinary Science Building

**Project No:** CannonDesign #004561.01

**Date of Observation:** August 7, 2017

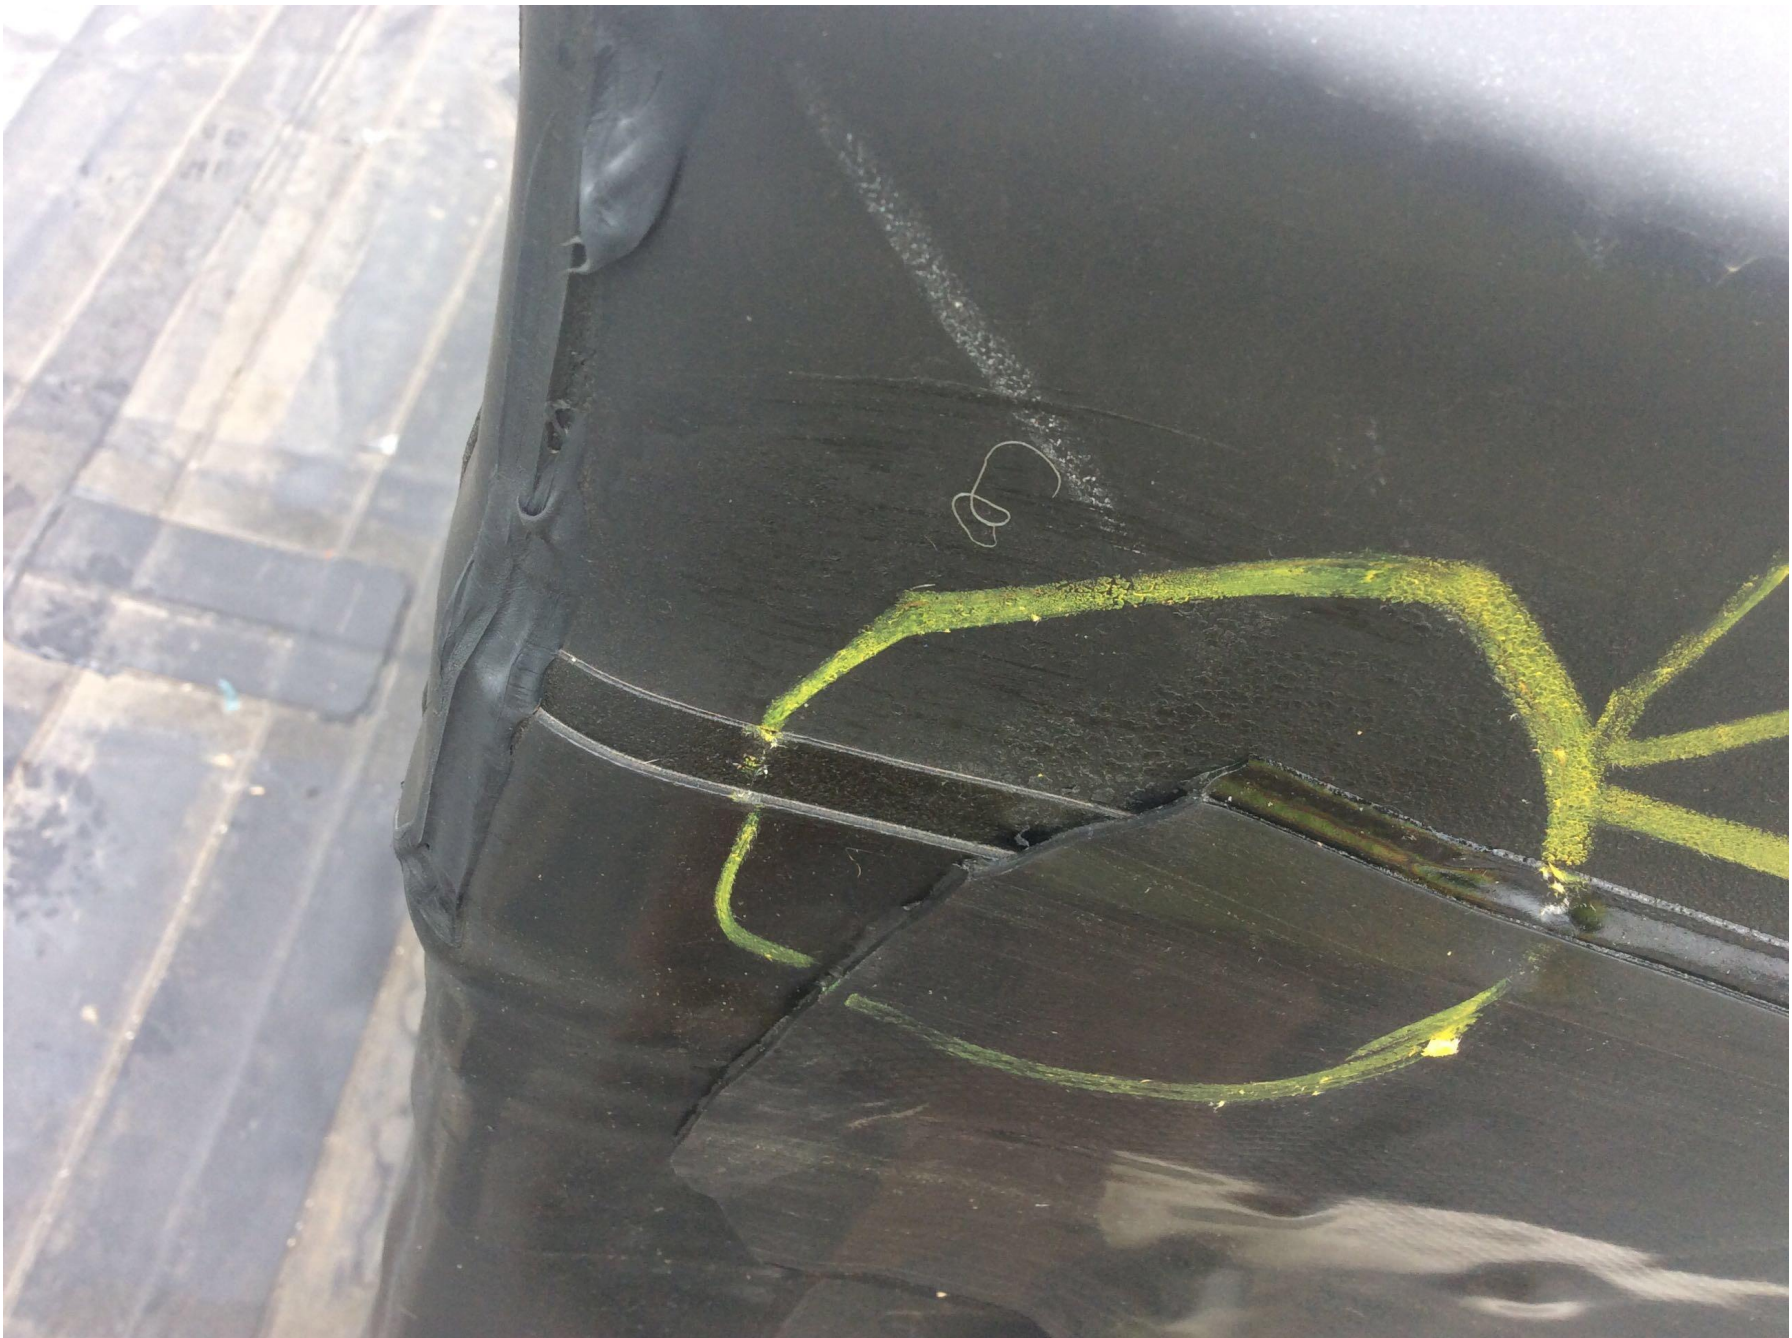
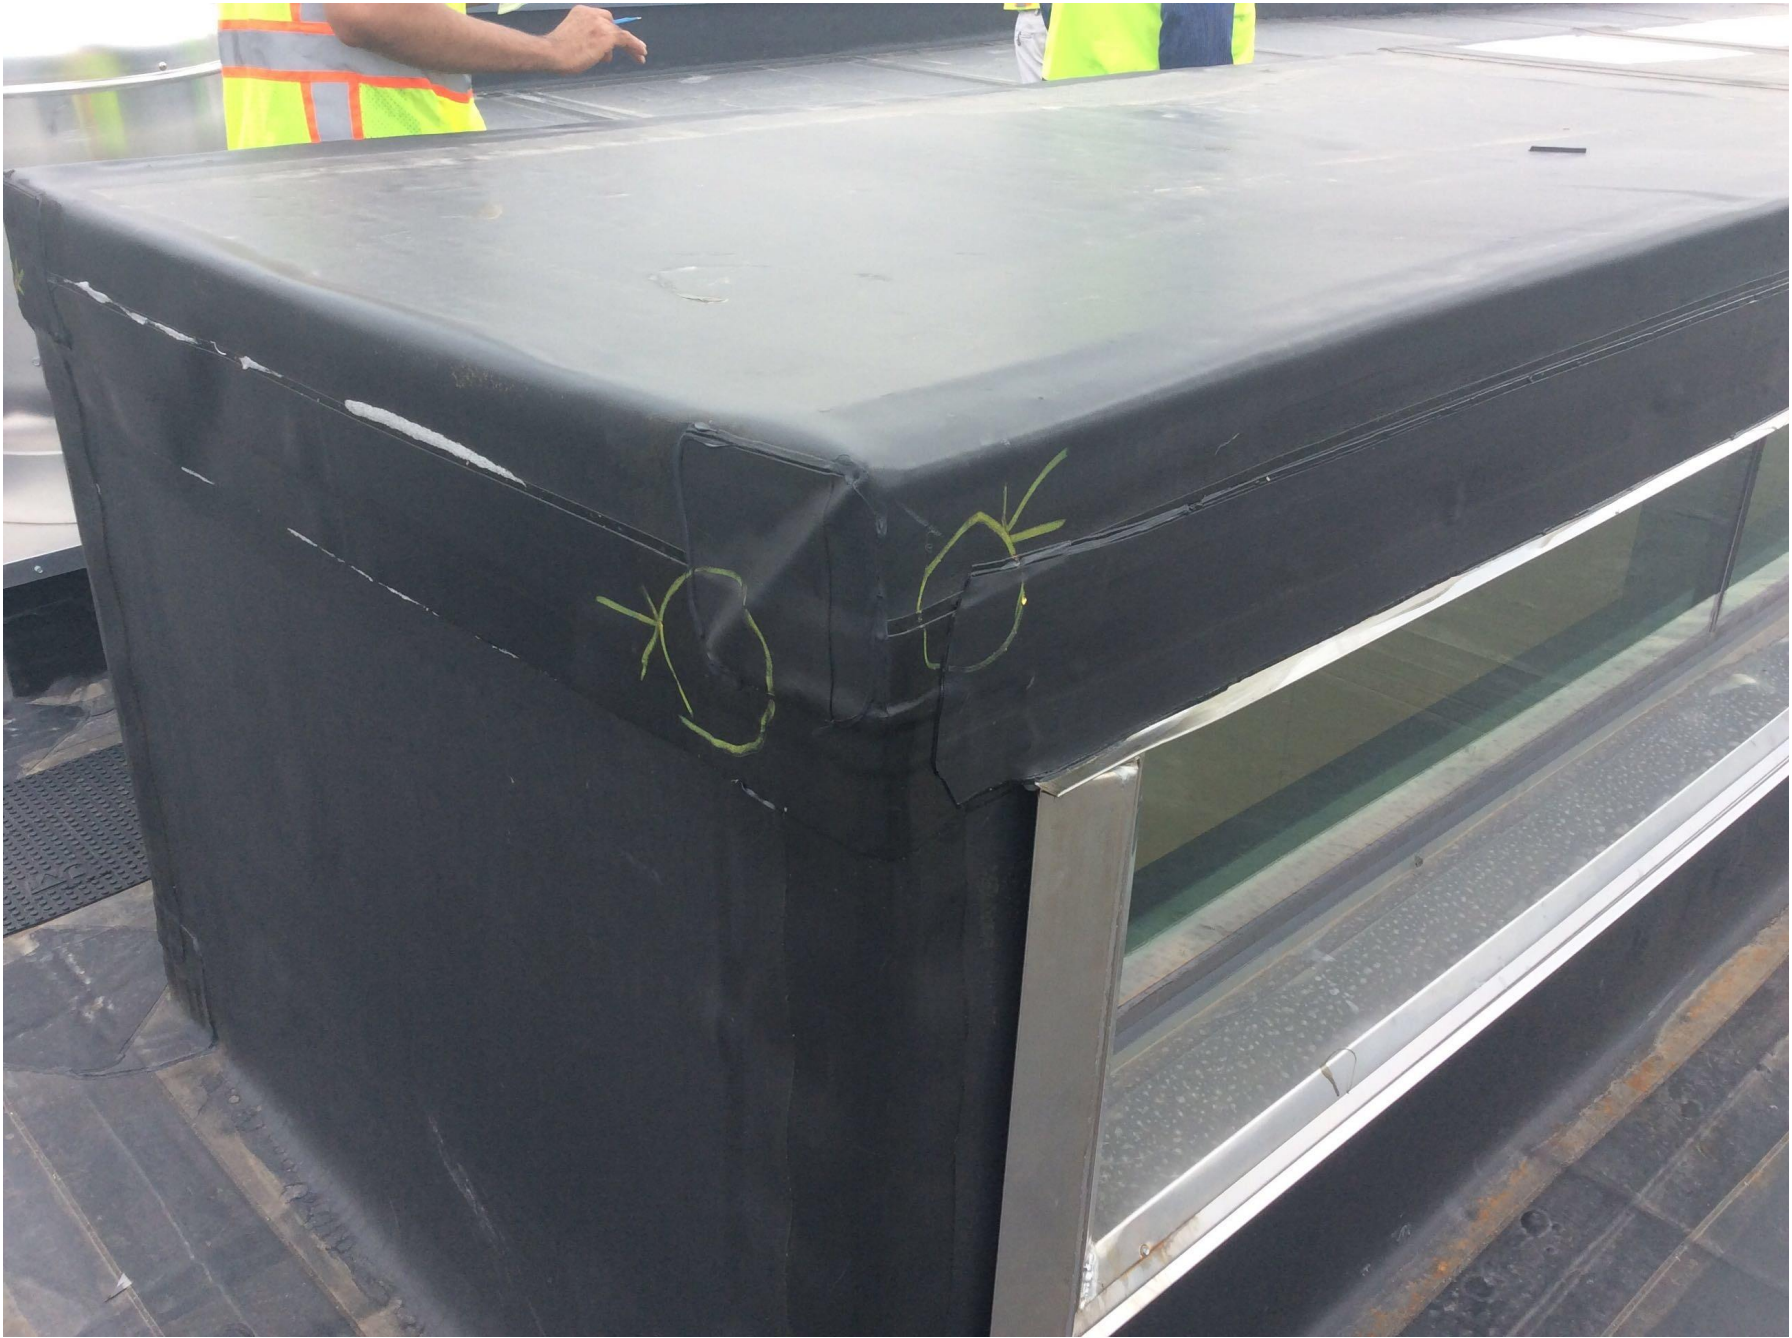
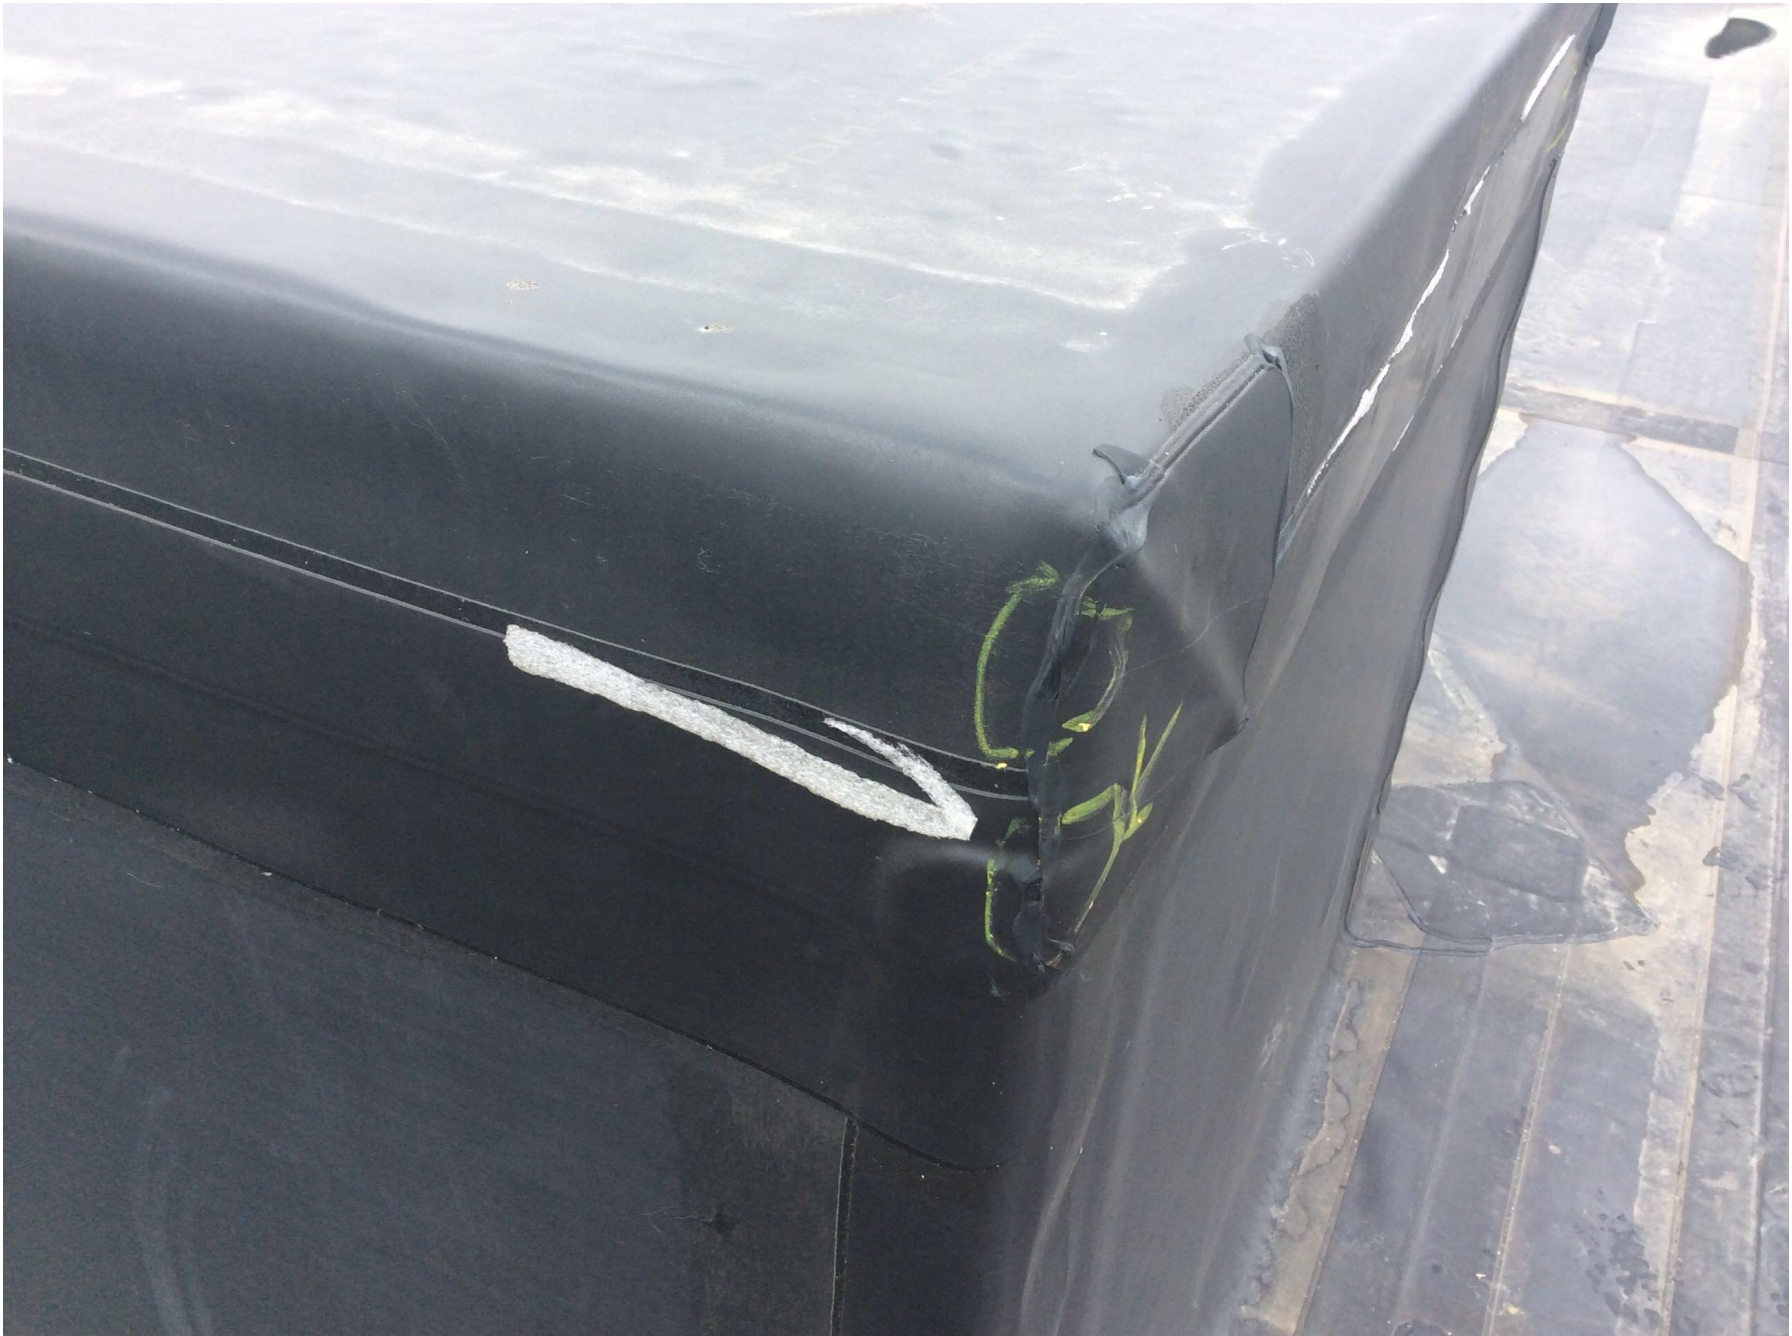
| Issue ID | Description | Location Detail | Location | Status | Company | Type | Date Created | Due Date |
|---|---|---|---|---|---|---|---|---|
| 002101 | Membrane needs to be sealed at terminations | | Webster > Roof | Open | Kirberg Company | Architect Punch List | 07 Aug 2017 | 12 Aug 2017 |

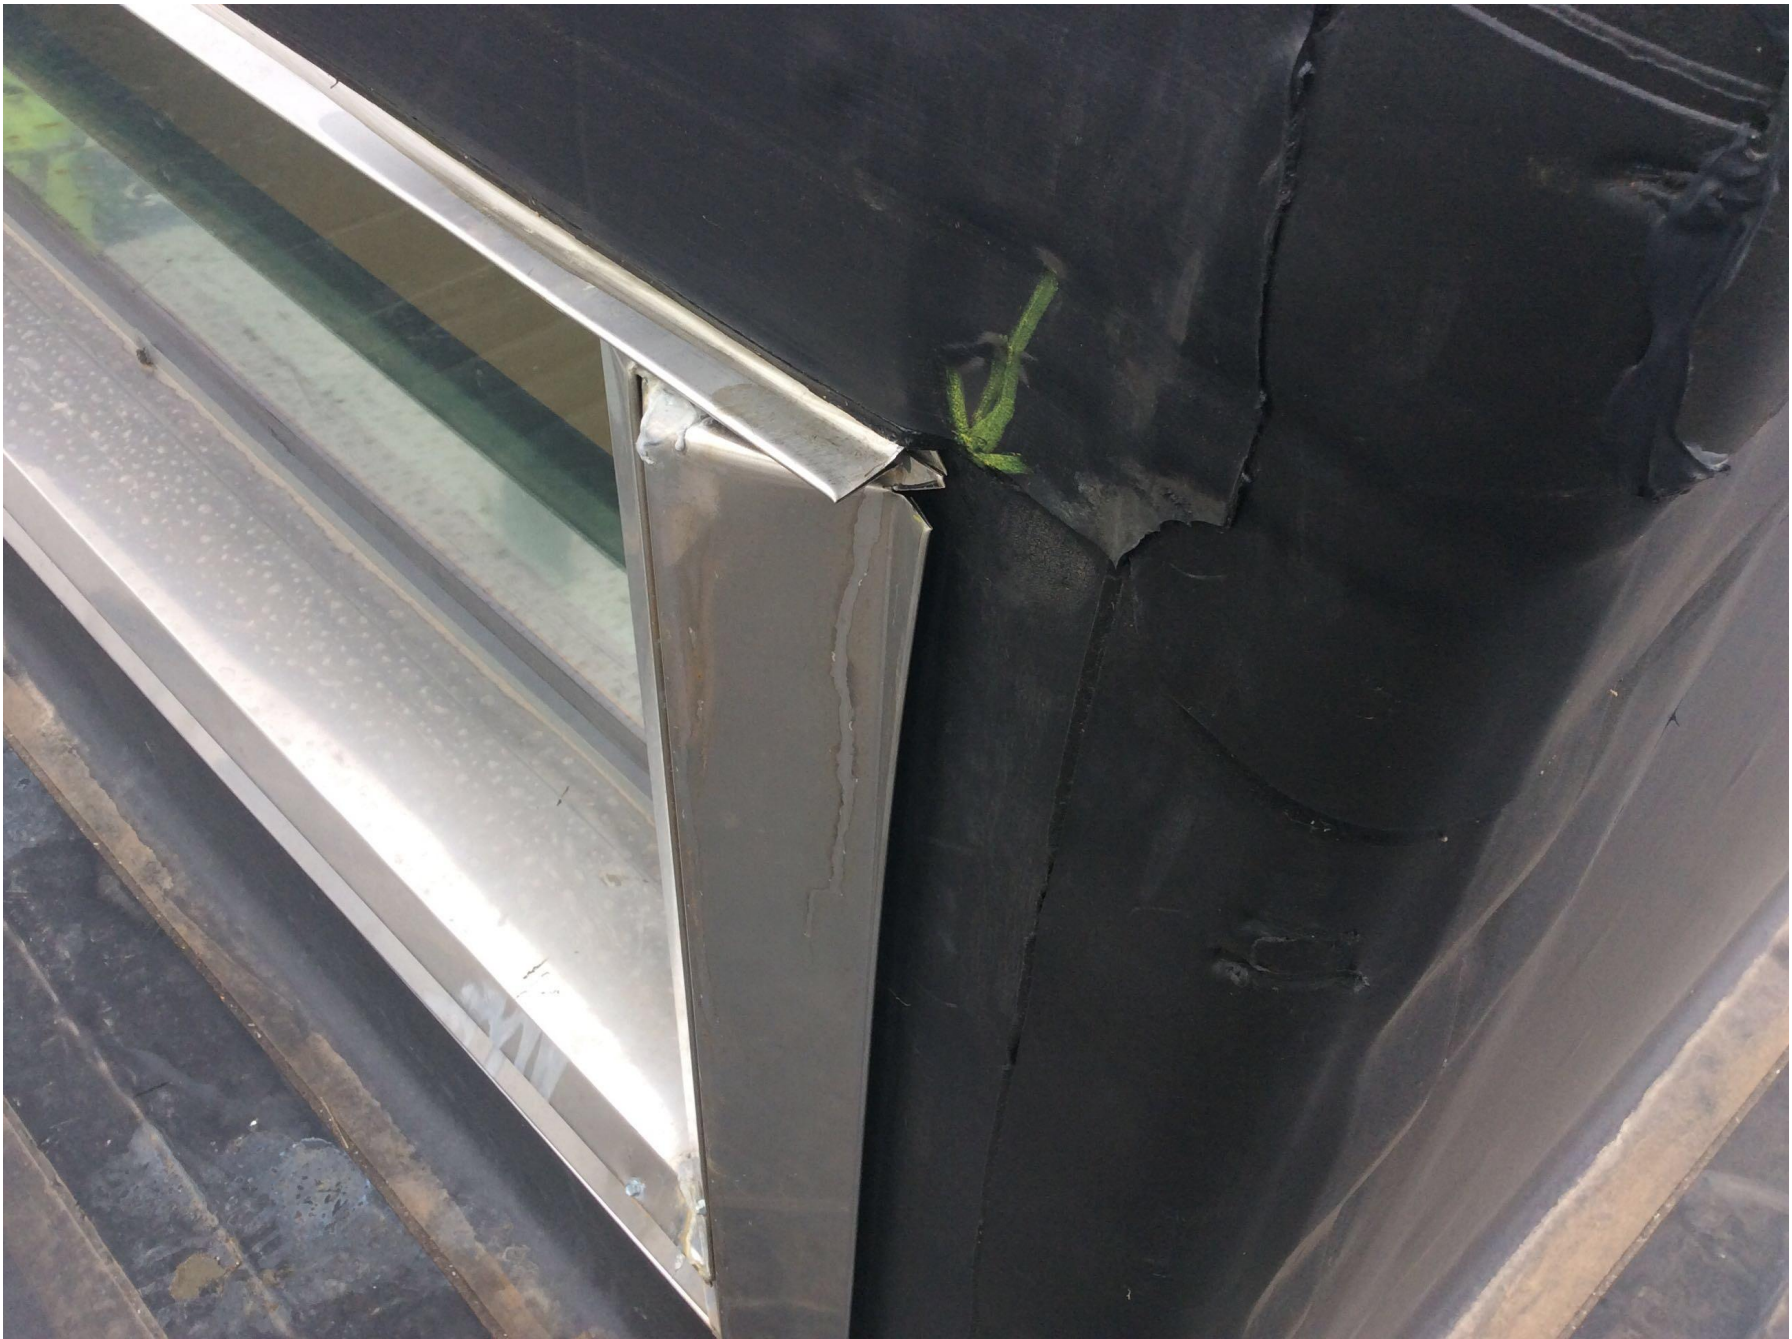
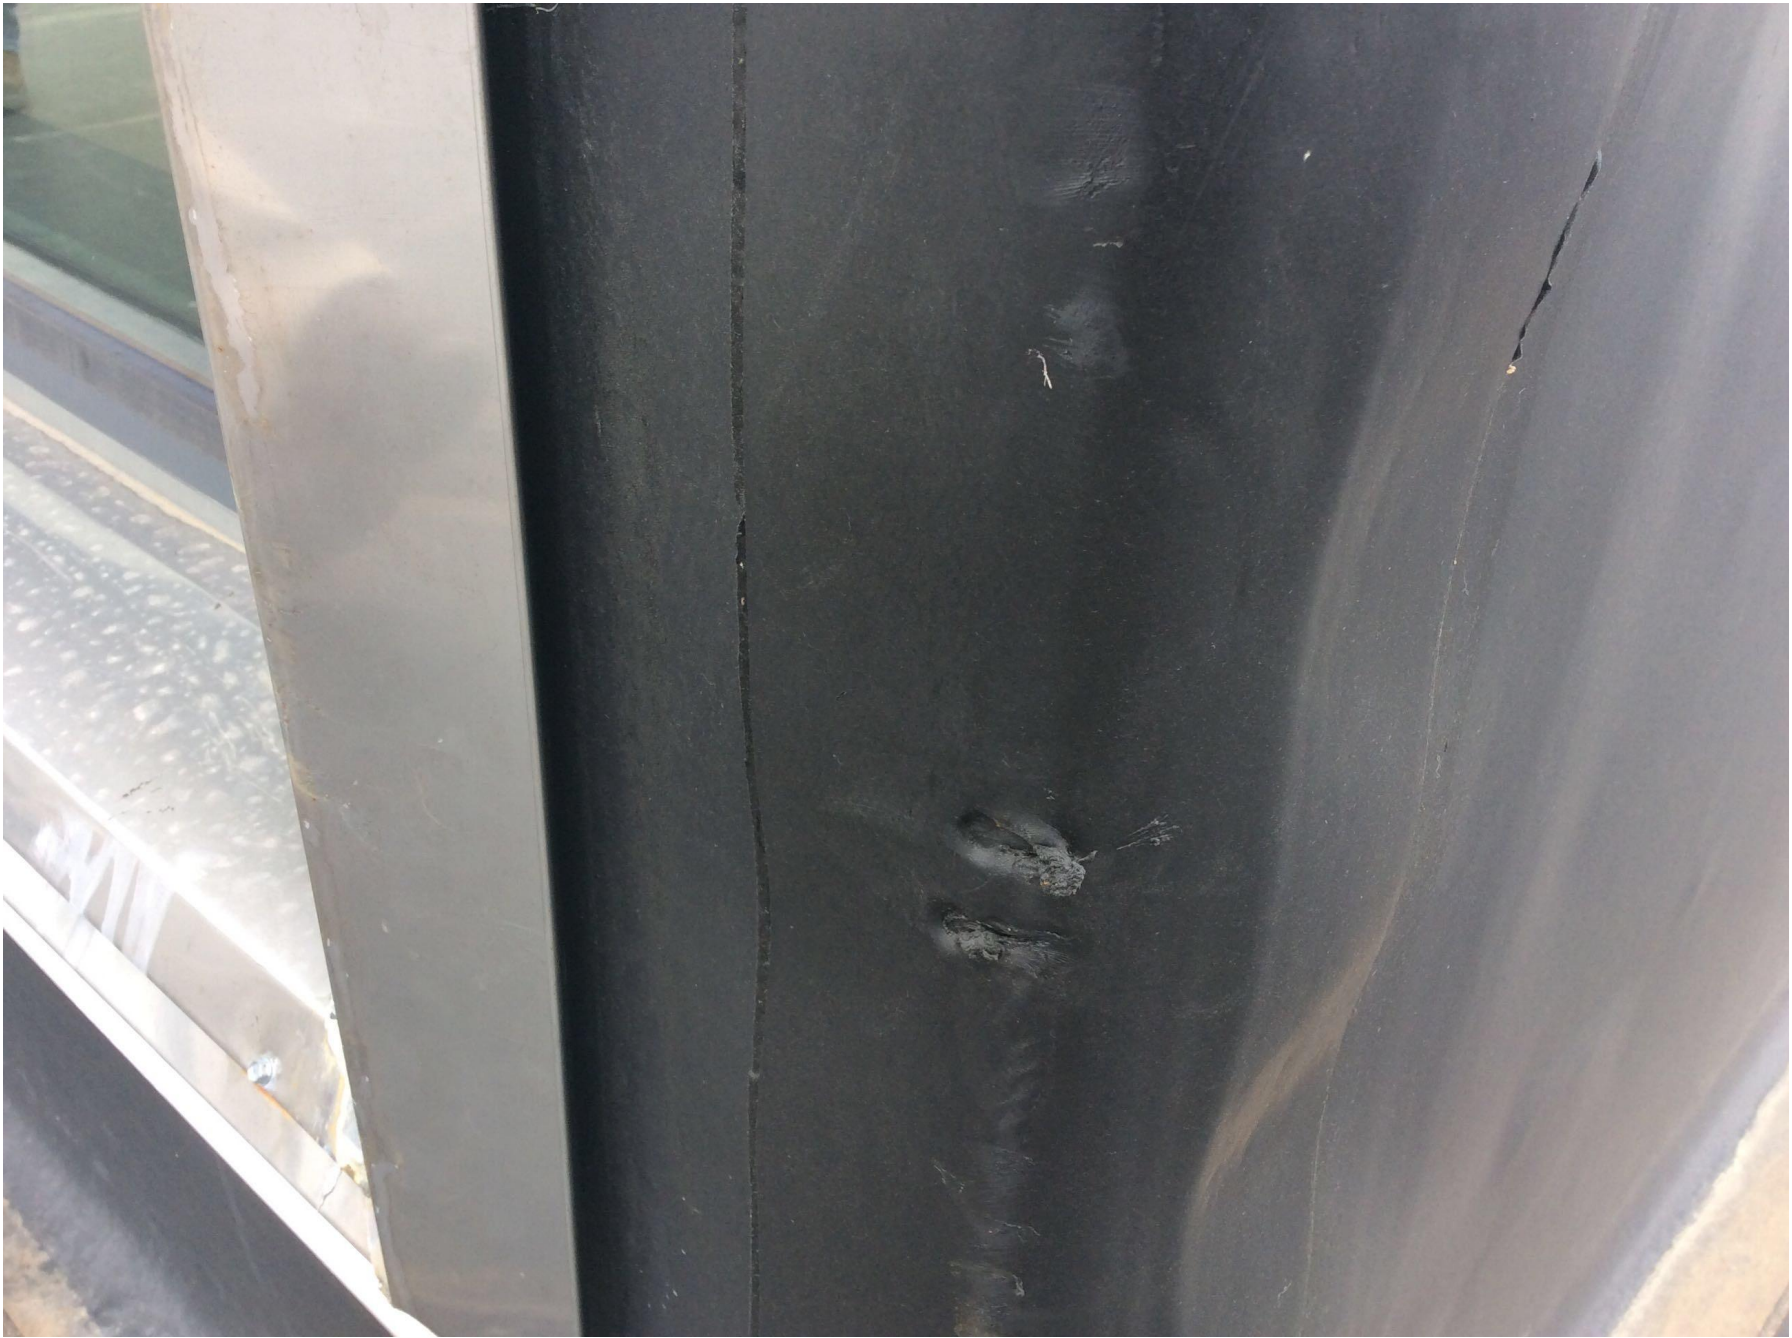
| Issue ID | Description | Location Detail | Location | Status | Company | Type | Date Created | Due Date |
|---|---|---|---|---|---|---|---|---|
| 002102 | Seal flashing to roof, repair damaged membrane as needed | | Webster > Roof | Open | Kirberg Company | Architect Punch List | 07 Aug 2017 | 12 Aug 2017 |

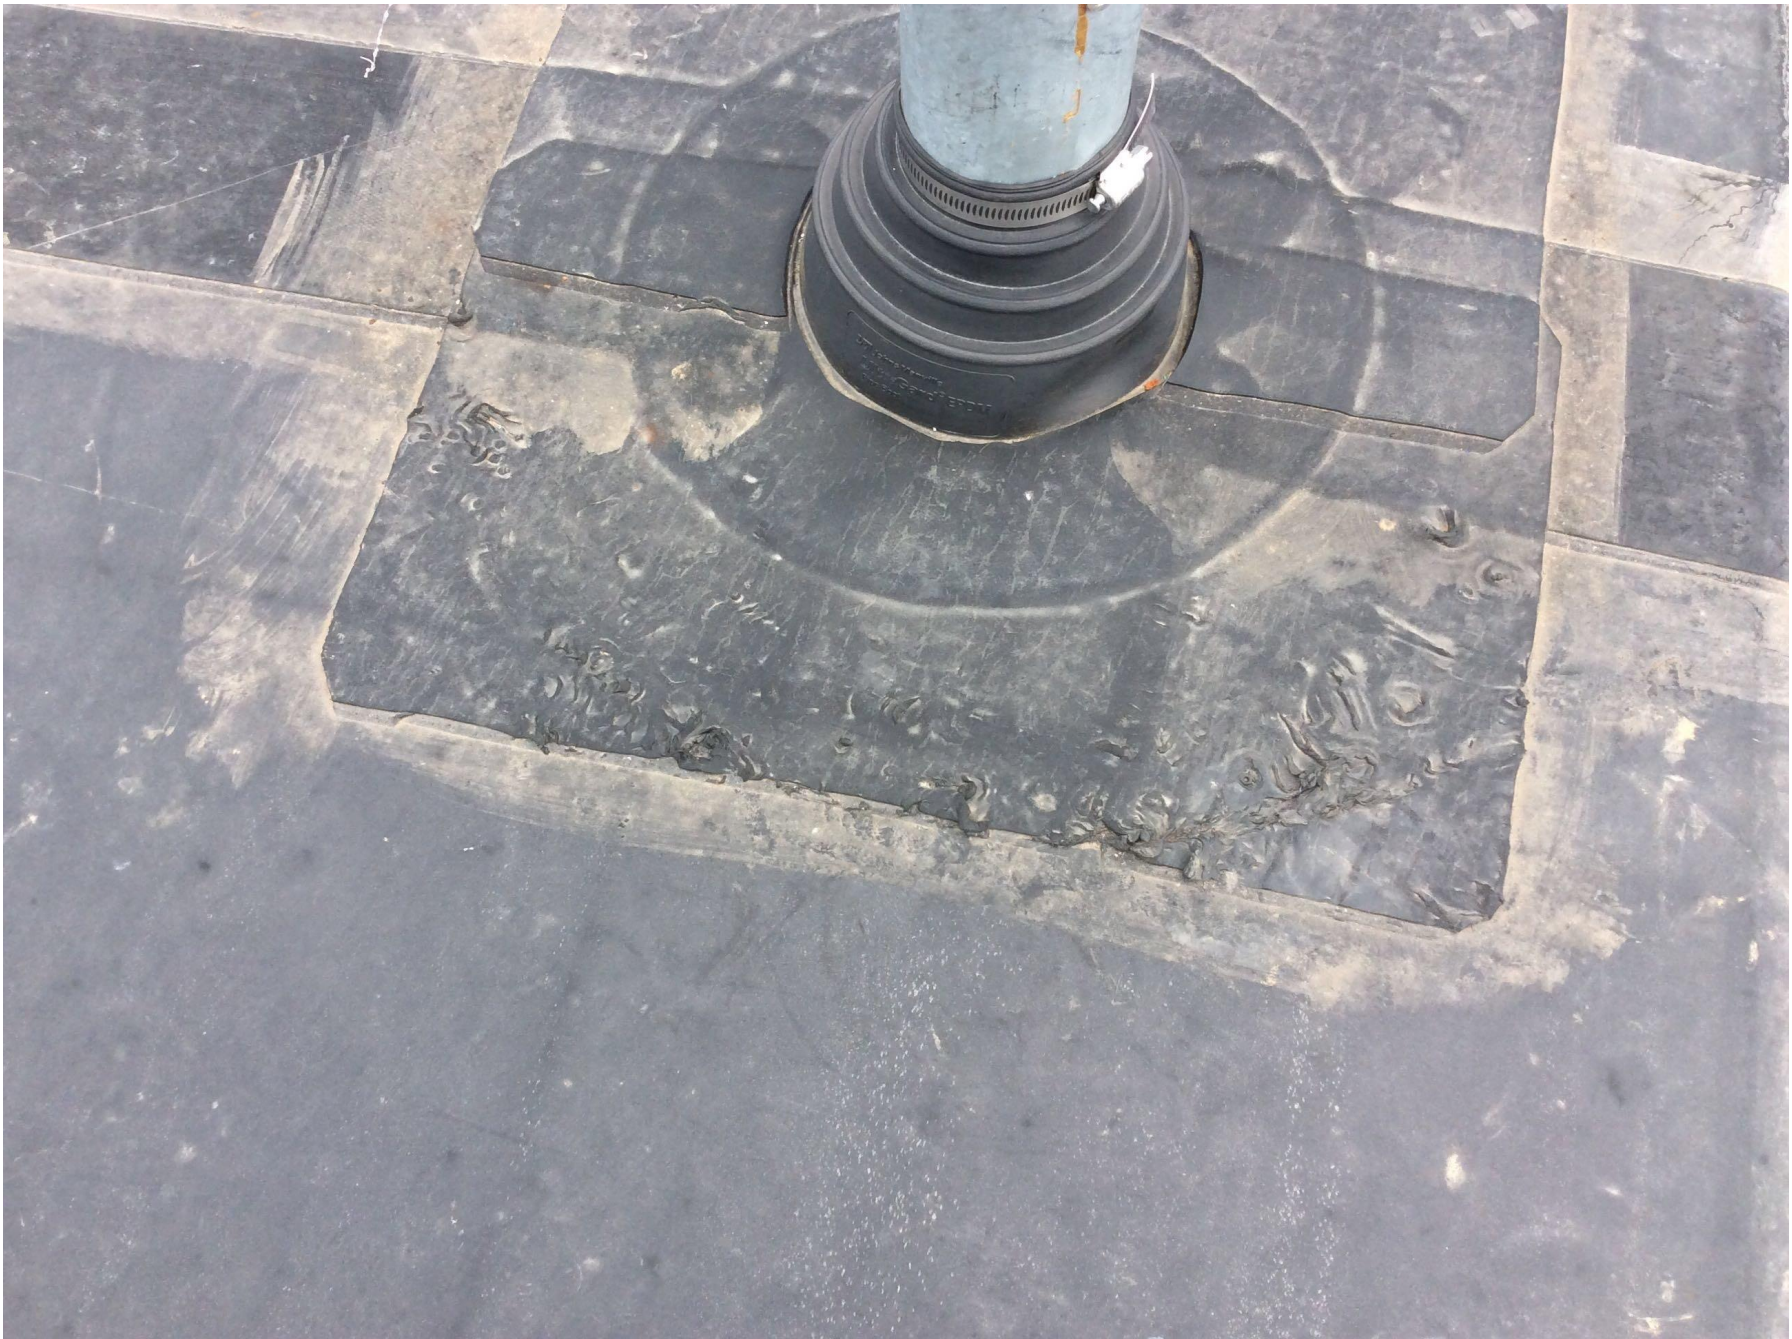
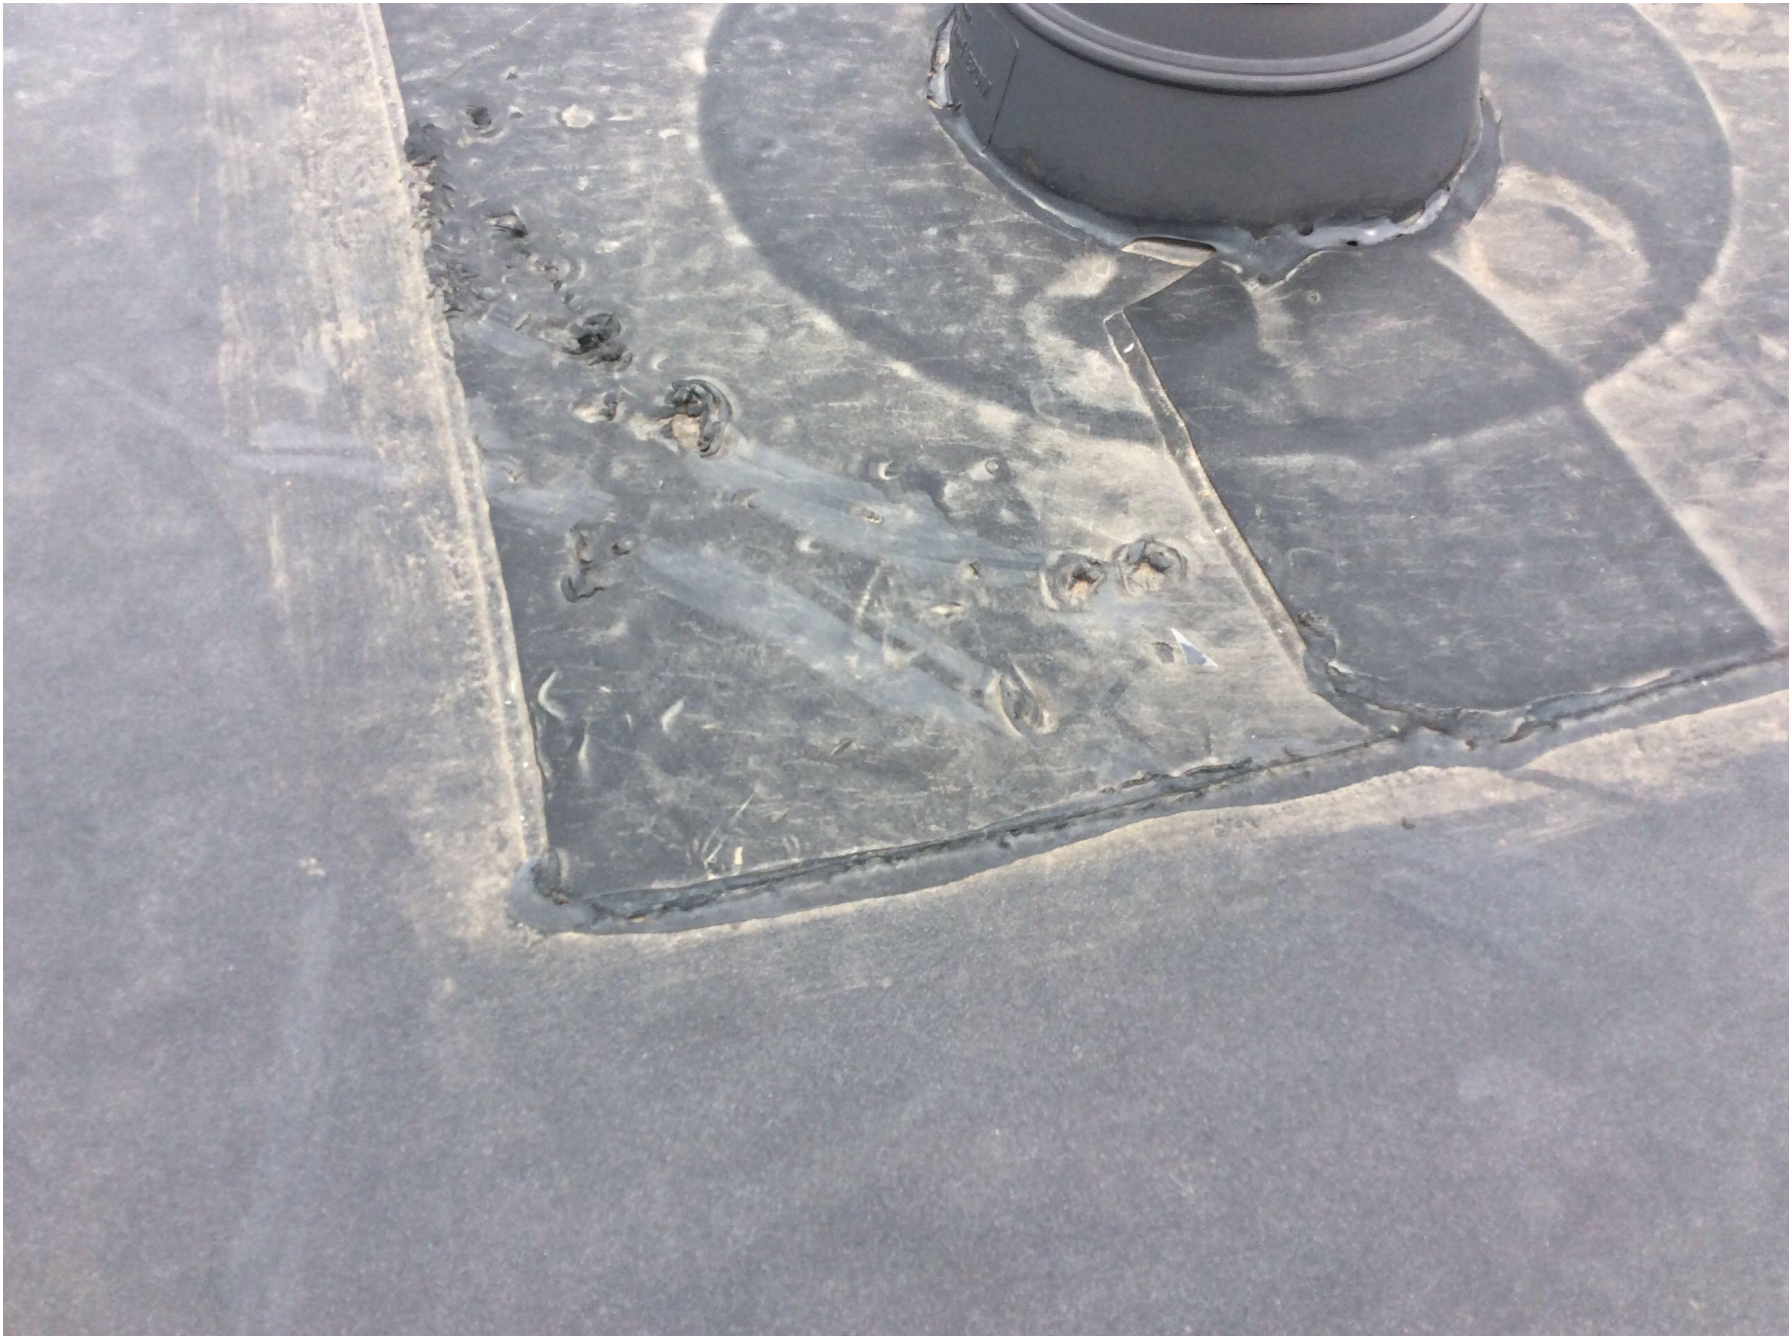
| Issue ID | Description | Location Detail | Location | Status | Company | Type | Date Created | Due Date |
|---|---|---|---|---|---|---|---|---|
| 002105 | Confirm gouges in pads at life safety tie offs do not affect roof membrane | | Webster > Roof | Open | Kirberg Company | Architect Punch List | 07 Aug 2017 | 12 Aug 2017 |

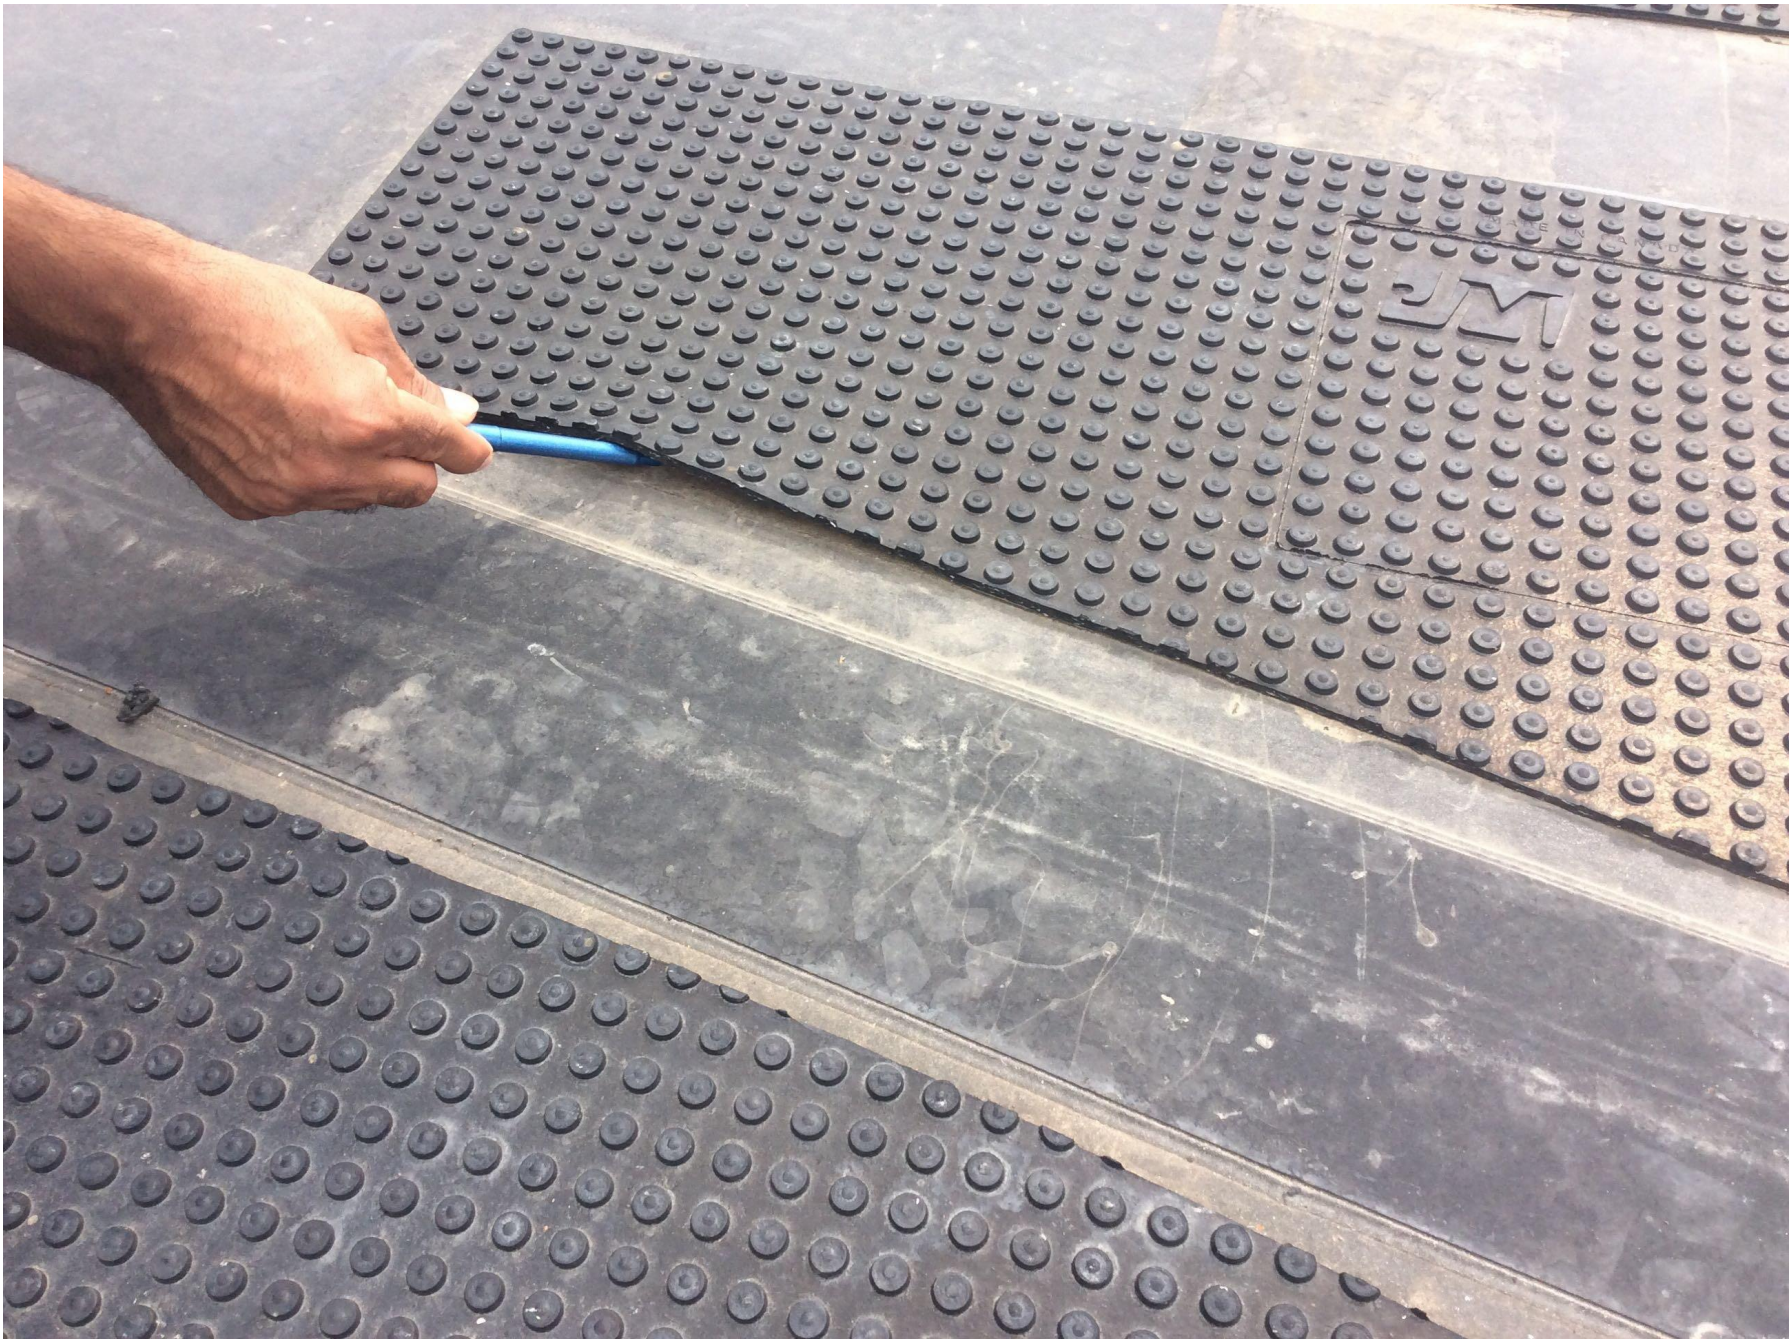
| Issue ID | Description | Location Detail | Location | Status | Company | Type | Date Created | Due Date |
|---|---|---|---|---|---|---|---|---|
| 002106 | Confirm walk off mats are adhered per specification (typical) | | Webster > Roof | Open | Kirberg Company | Architect Punch List | 07 Aug 2017 | 12 Aug 2017 |

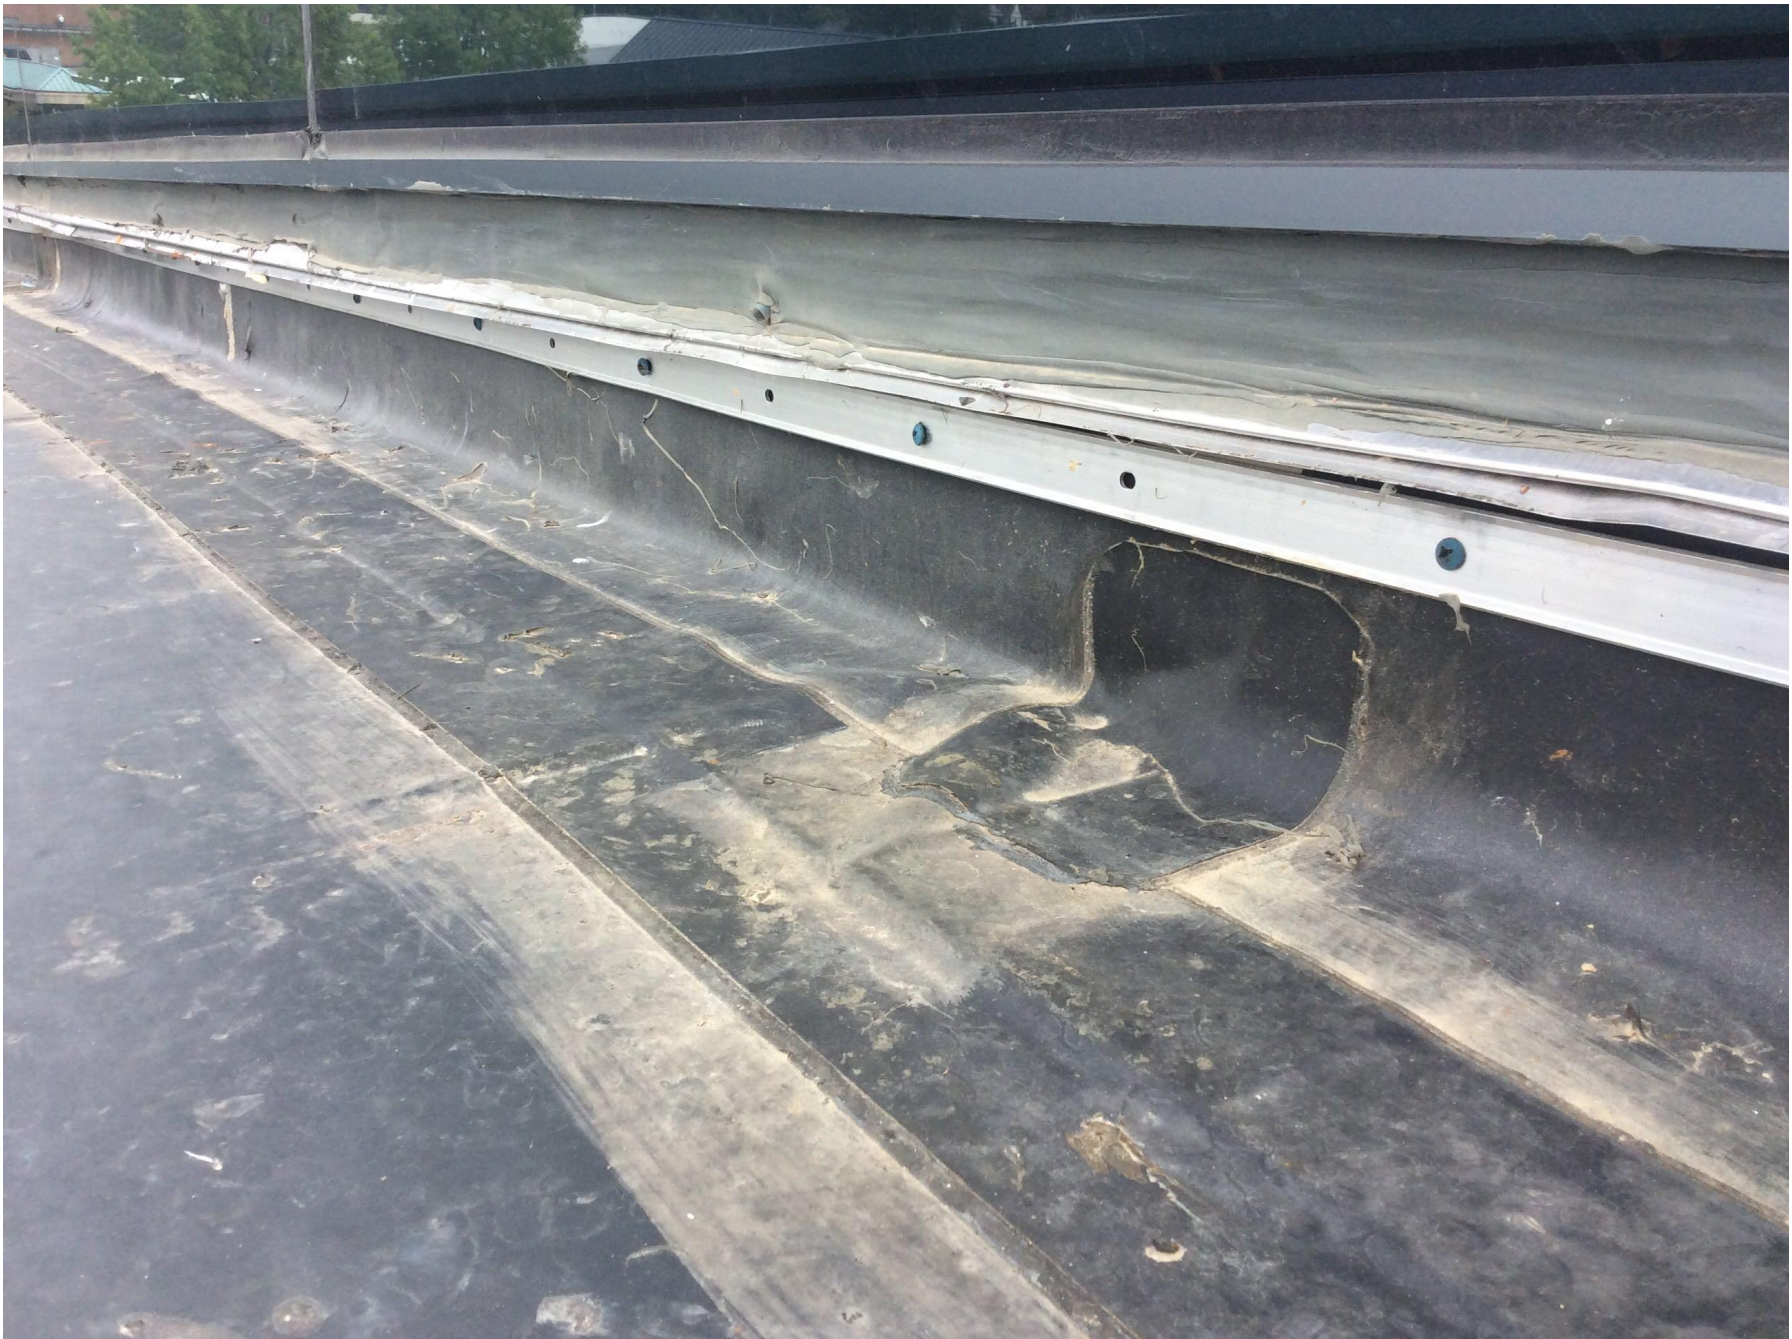
| Issue ID | Description | Location Detail | Location | Status | Company | Type | Date Created | Due Date |
|---|---|---|---|---|---|---|---|---|
| 002109 | Heads to be sealed at all turn bar fastener locations<br>Counter-flashing missing | | Webster > Roof | Open | Kirberg Company | Architect Punch List | 07 Aug 2017 | 12 Aug 2017 |
