## **ARCHITECTURAL PUNCH LIST (EXTERIOR FAÇADE & ROOF)**

**Project:** Webster University Interdisciplinary Science Building

**Project No:** CannonDesign #004561.01

**Date of Observation:** August 7, 2017

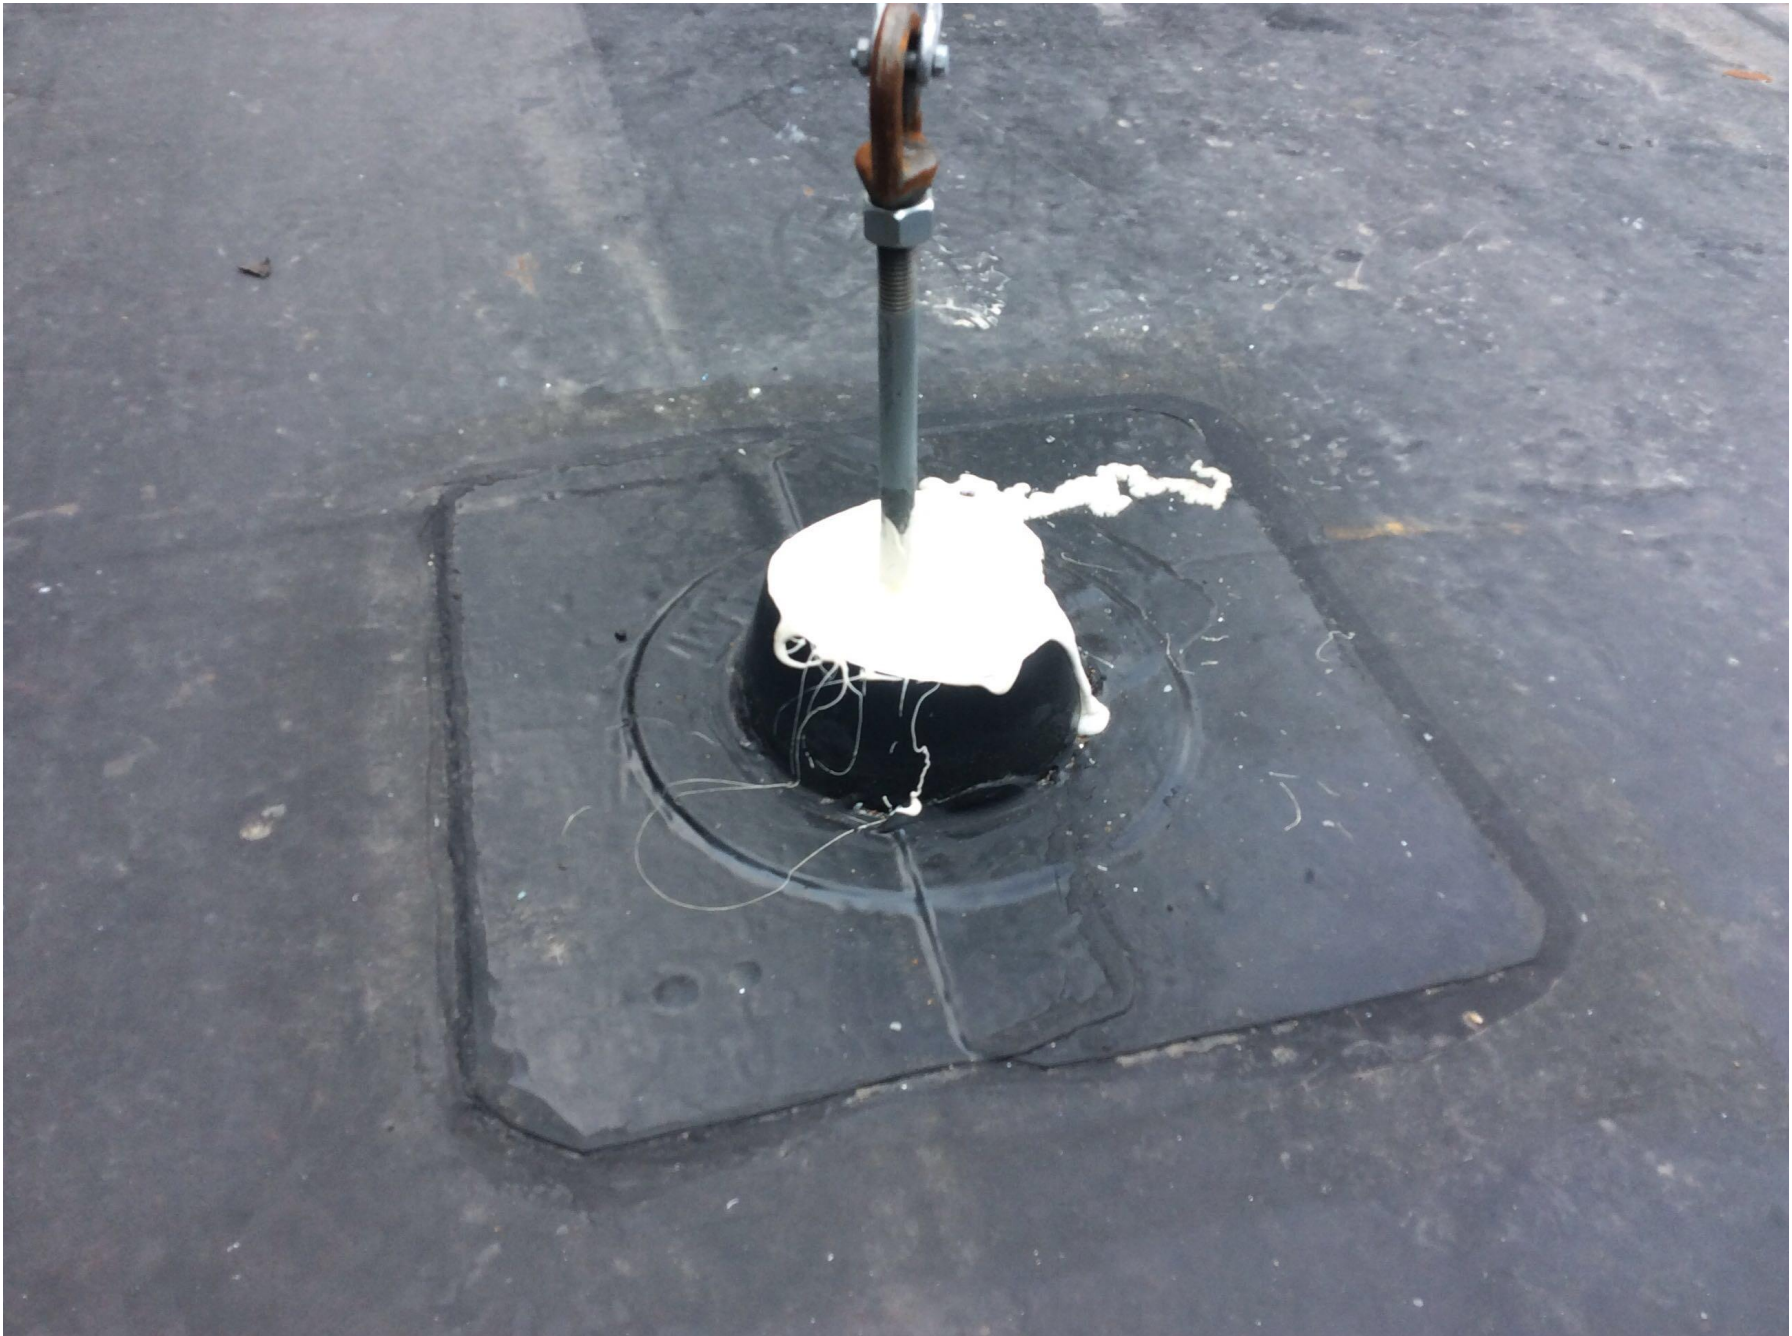
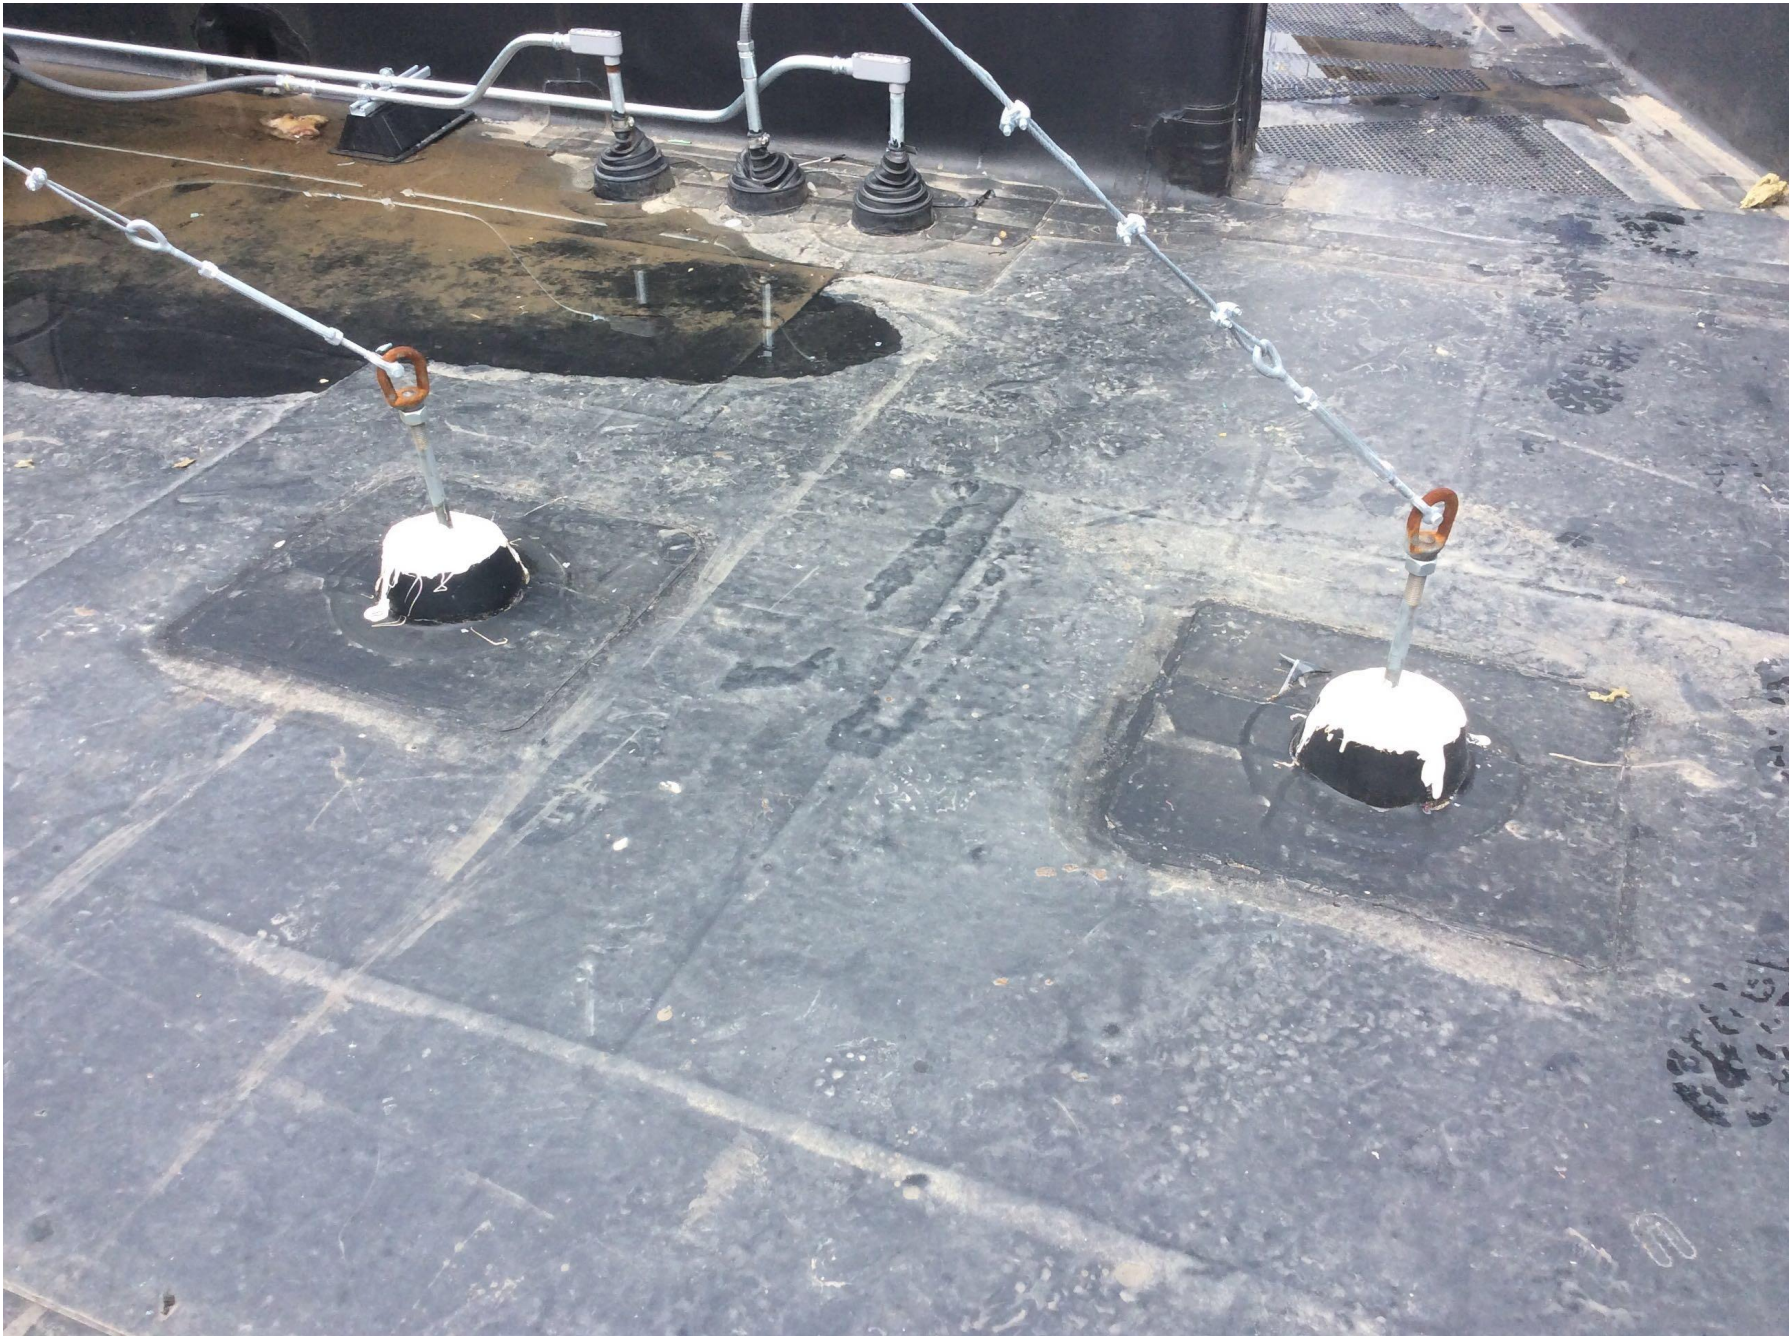
| Issue ID | Description | Location Detail | Location | Status | Company | Type | Date Created | Due Date |
|---|---|---|---|---|---|---|---|---|
| 002110 | Pourable sealant needs to be sloped at all locations<br><br>Such that there is no depression on top of sealant for the water to pool. | | Webster > Roof | Open | Kirberg Company | Architect Punch List | 07 Aug 2017 | 12 Aug 2017 |

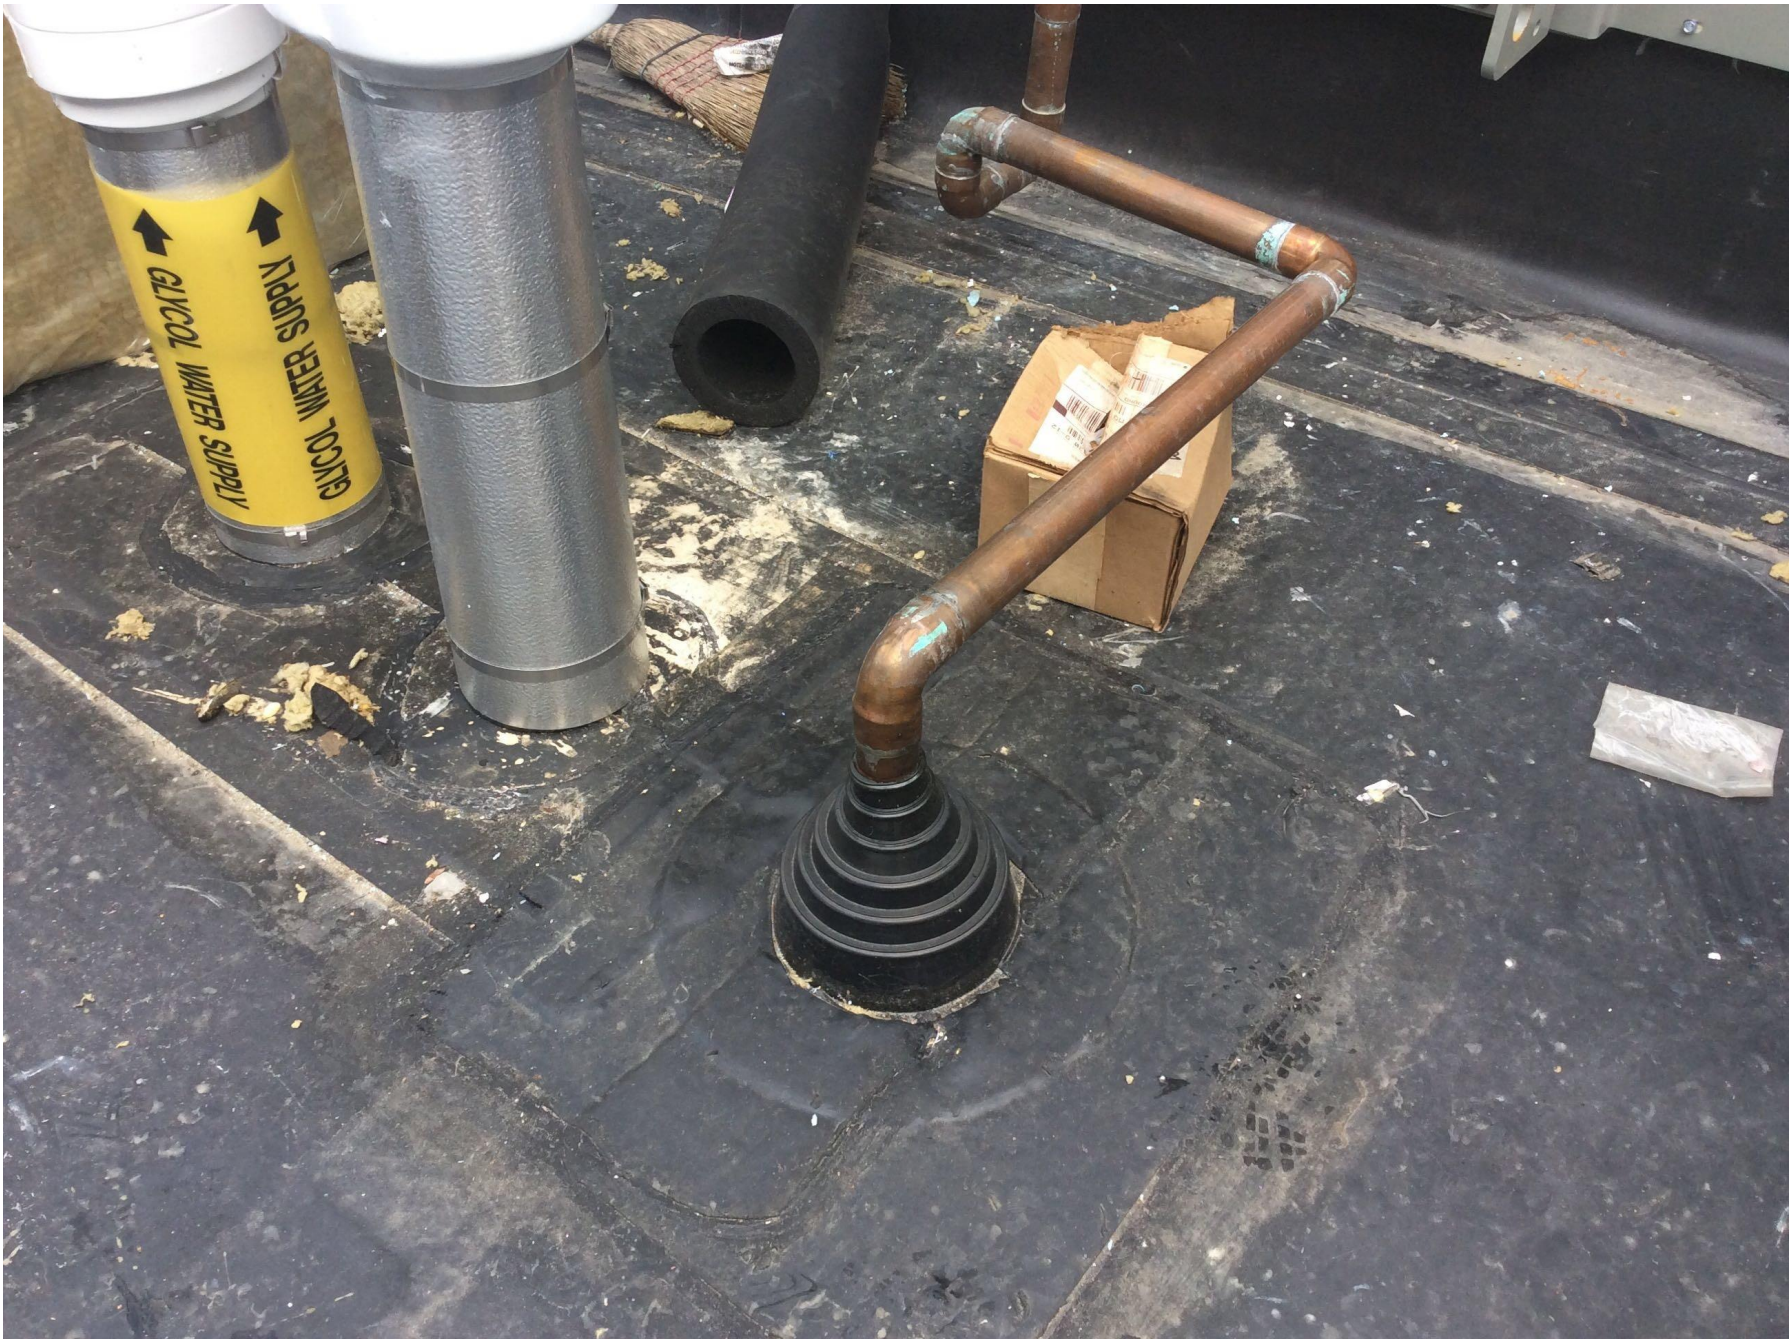
| Issue ID | Description | Location Detail | Location | Status | Company | Type | Date Created | Due Date |
|---|---|---|---|---|---|---|---|---|
| 002111 | Clamp needed at boot | | Webster > Roof | Open | Kirberg Company | Architect Punch List | 07 Aug 2017 | 12 Aug 2017 |

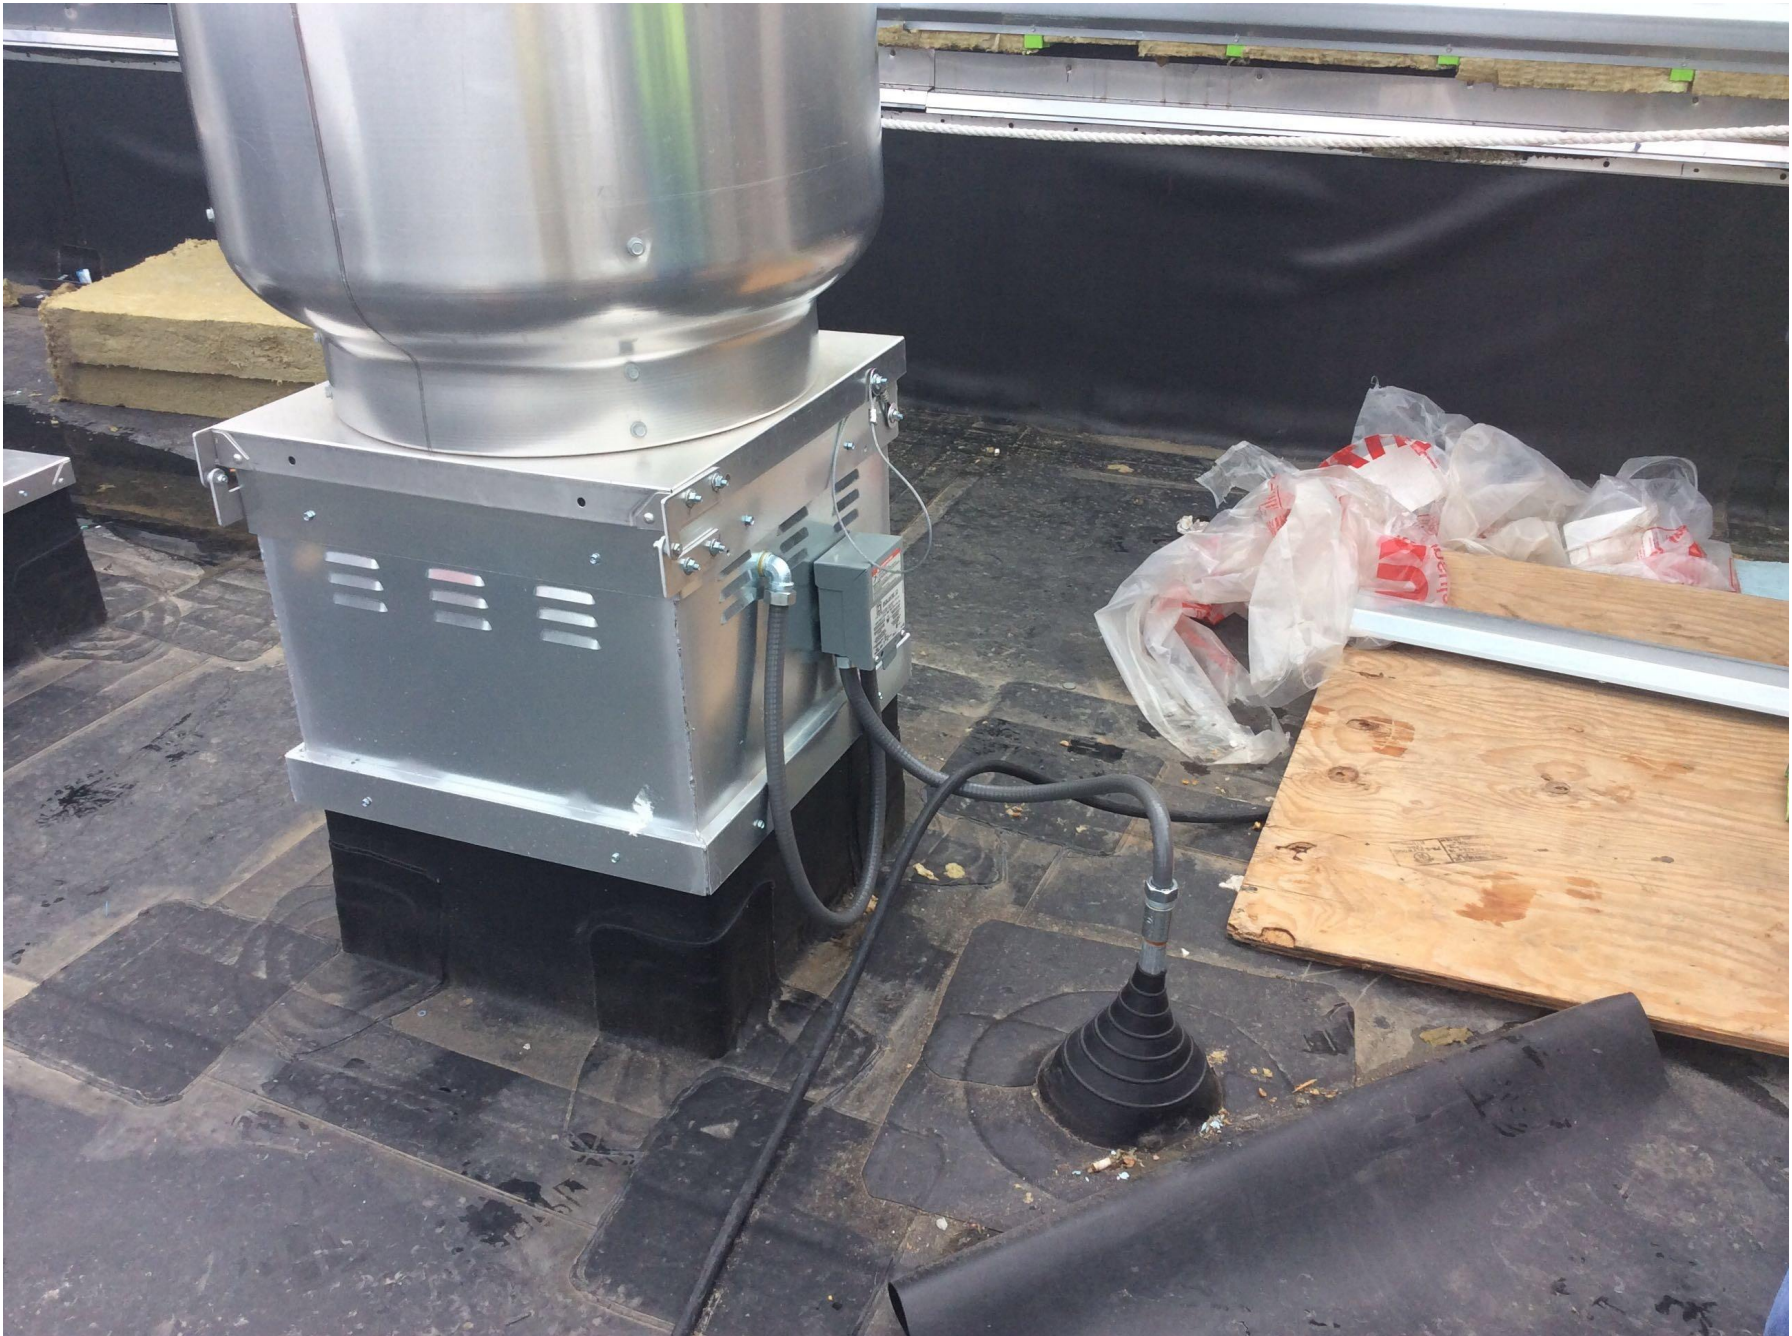
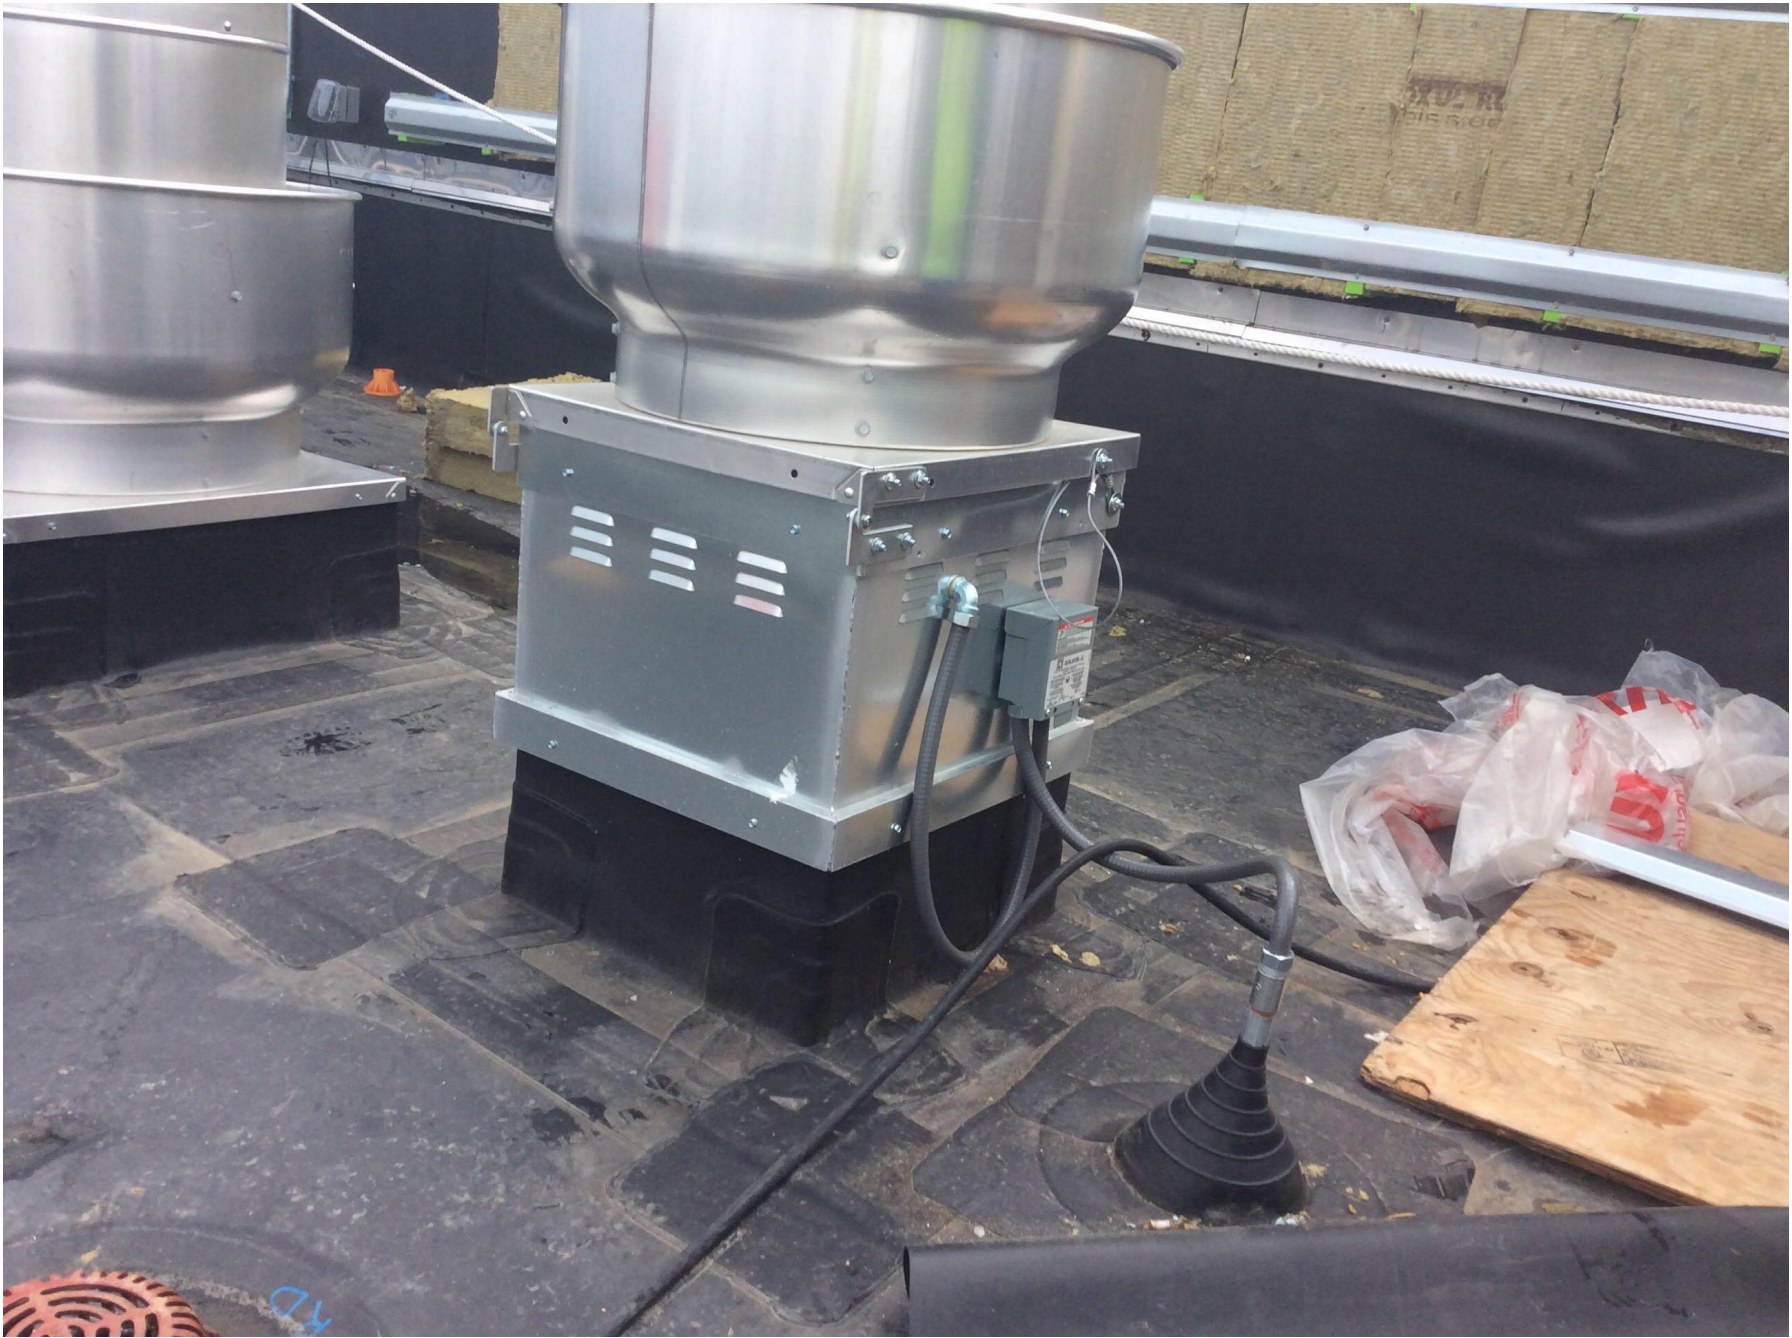
| Issue ID | Description | Location Detail | Location | Status | Company | Type | Date Created | Due Date |
|---|---|---|---|---|---|---|---|---|
| 002112 | Clamp and sealant needed at boot for fan | | Webster > Roof | Open | Kirberg Company | Architect Punch List | 07 Aug 2017 | 12 Aug 2017 |

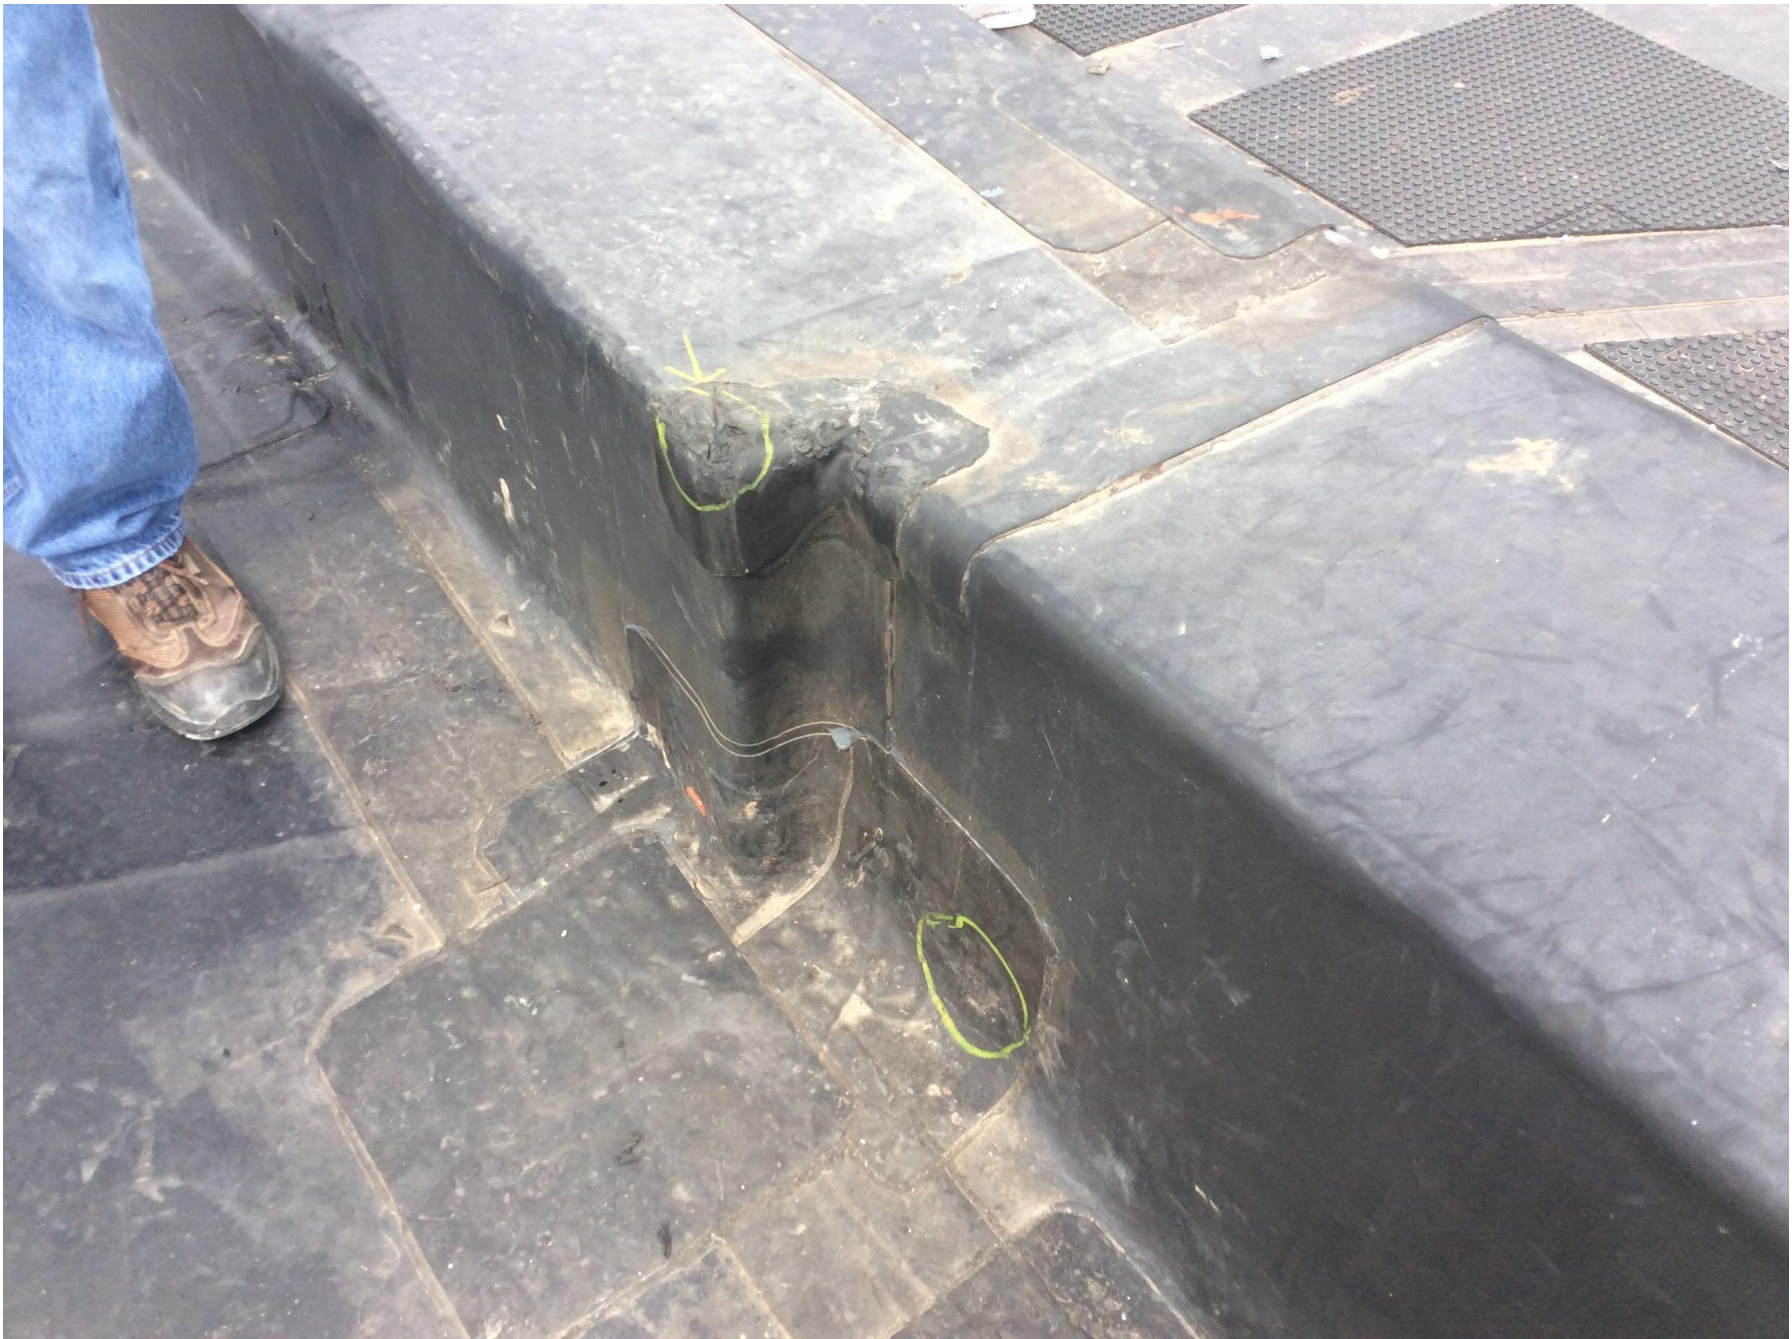
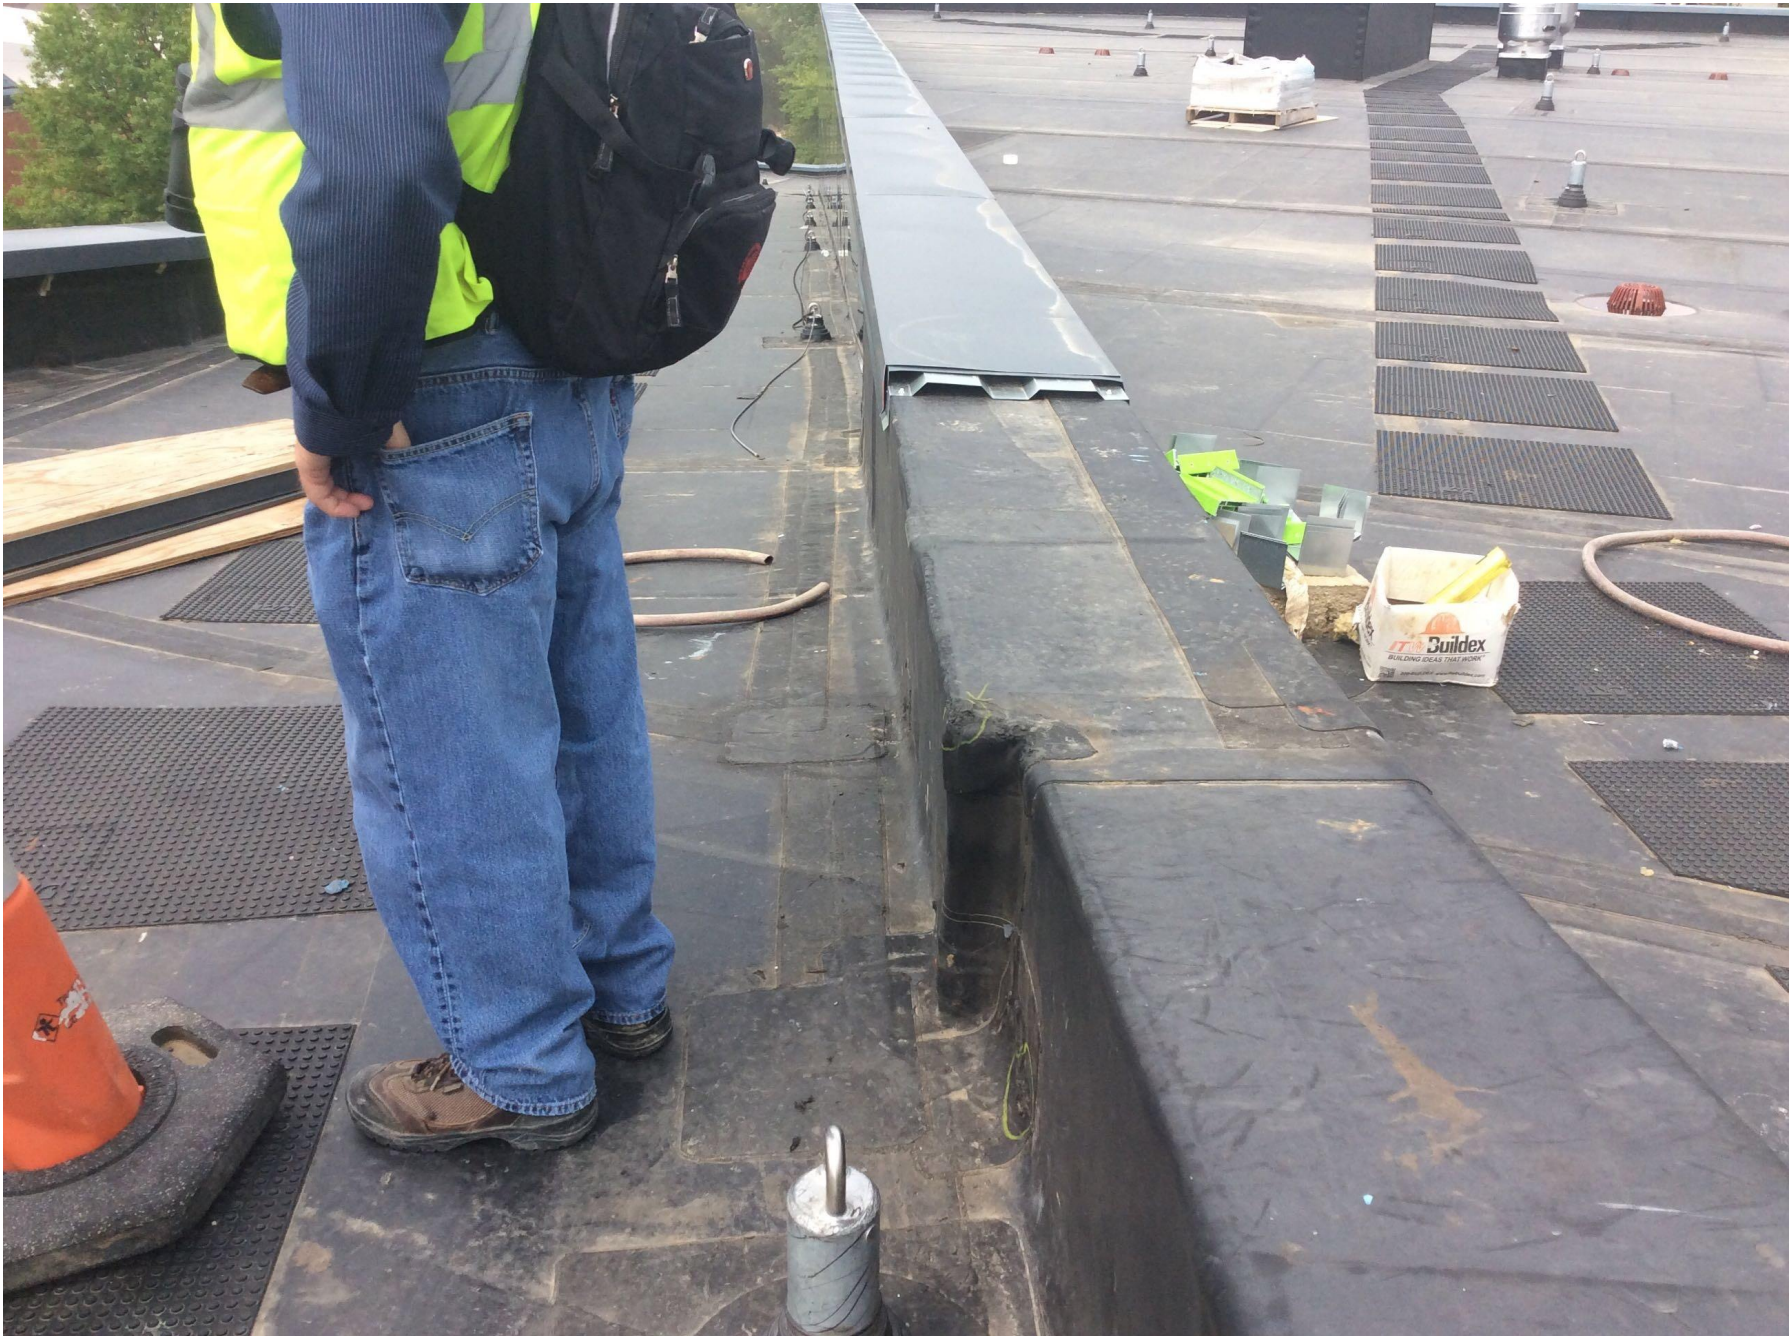
| Issue ID | Description | Location Detail | Location | Status | Company | Type | Date Created | Due Date |
|---|---|---|---|---|---|---|---|---|
| 002114 | Repair damaged membrane | | Webster > Roof | Open | Kirberg Company | Architect Punch List | 07 Aug 2017 | 12 Aug 2017 |
