## **ARCHITECTURAL PUNCH LIST (EXTERIOR FAÇADE & ROOF)**

**Project:** Webster University Interdisciplinary Science Building

**Project No:** CannonDesign #004561.01

**Date of Observation:** August 7, 2017

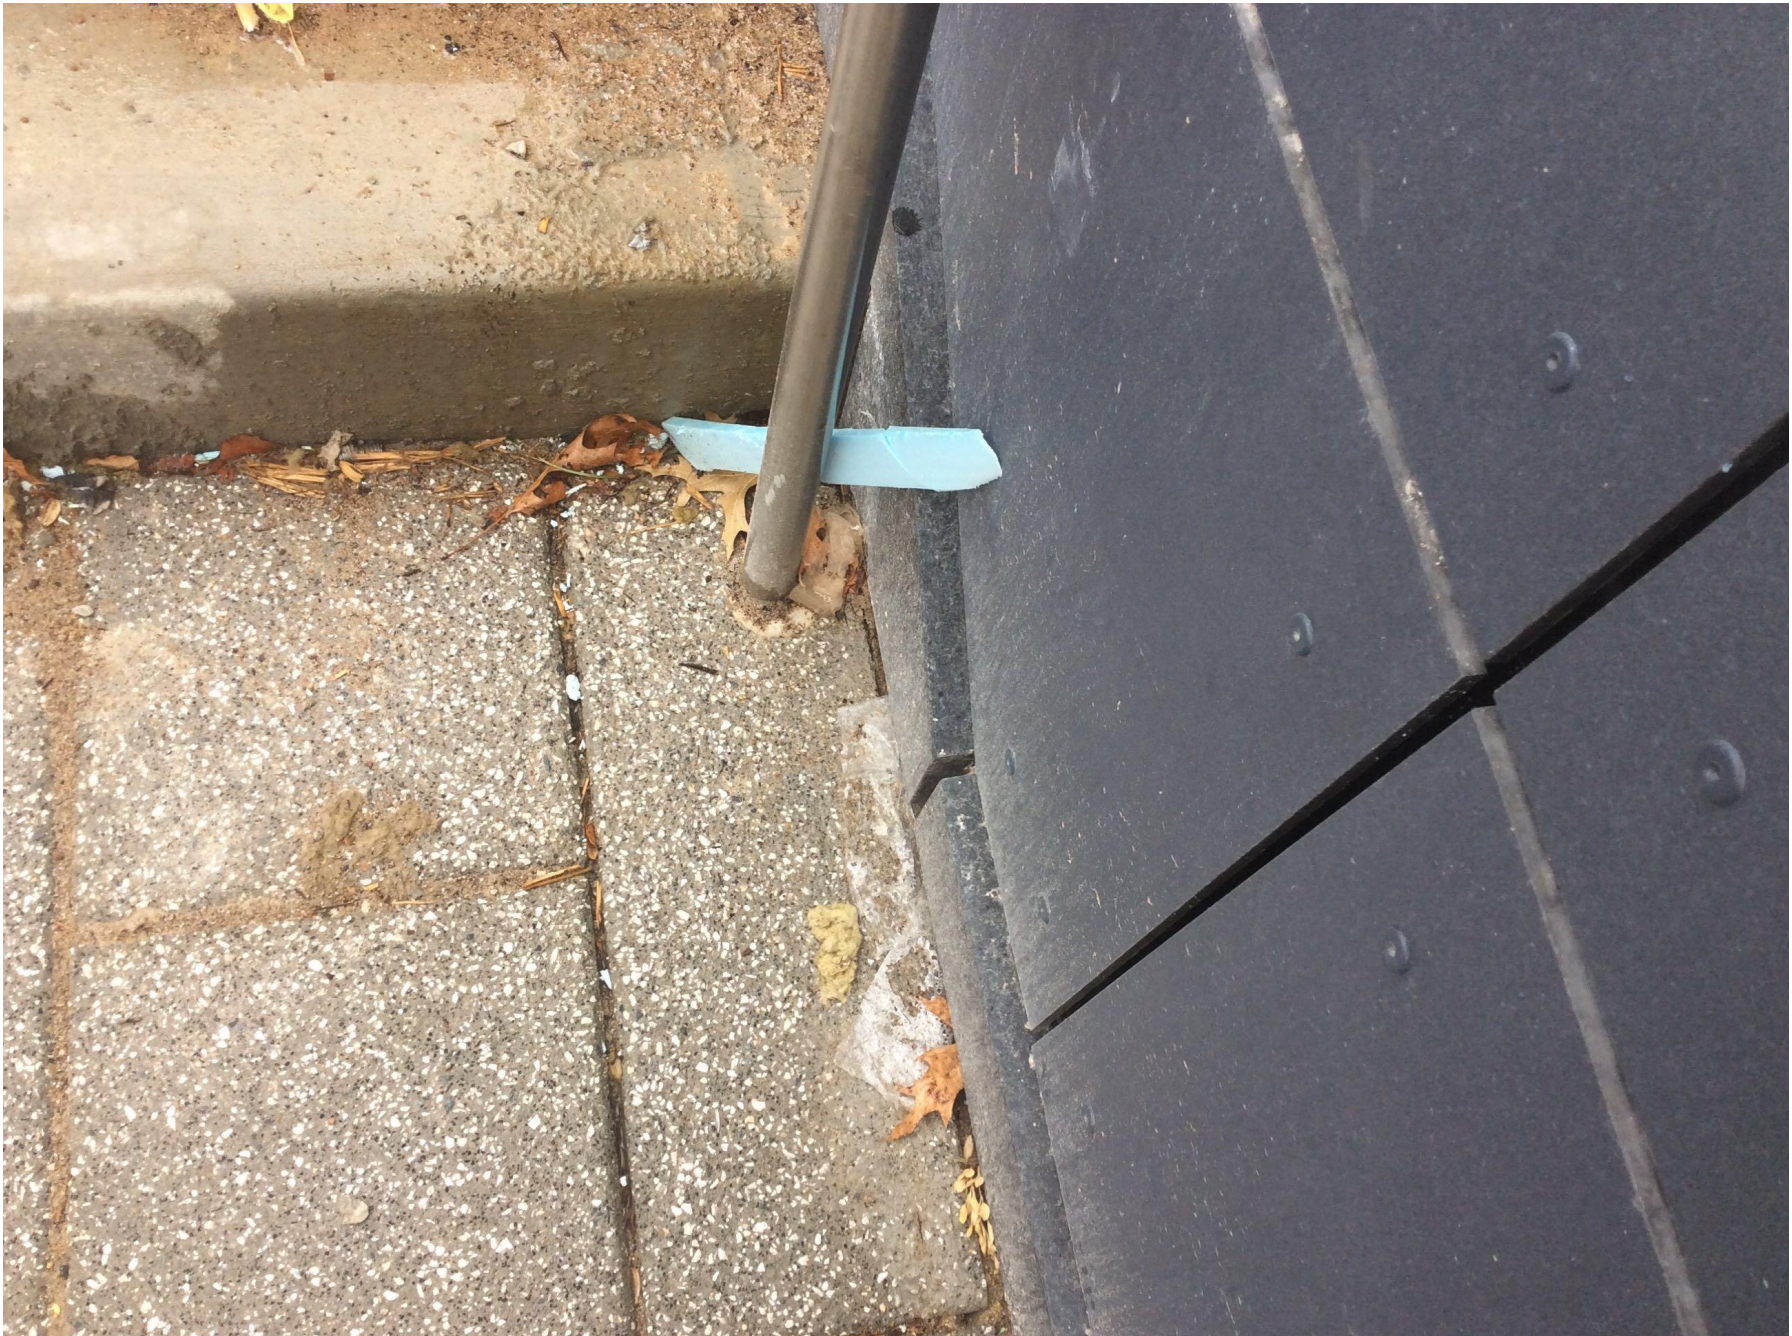
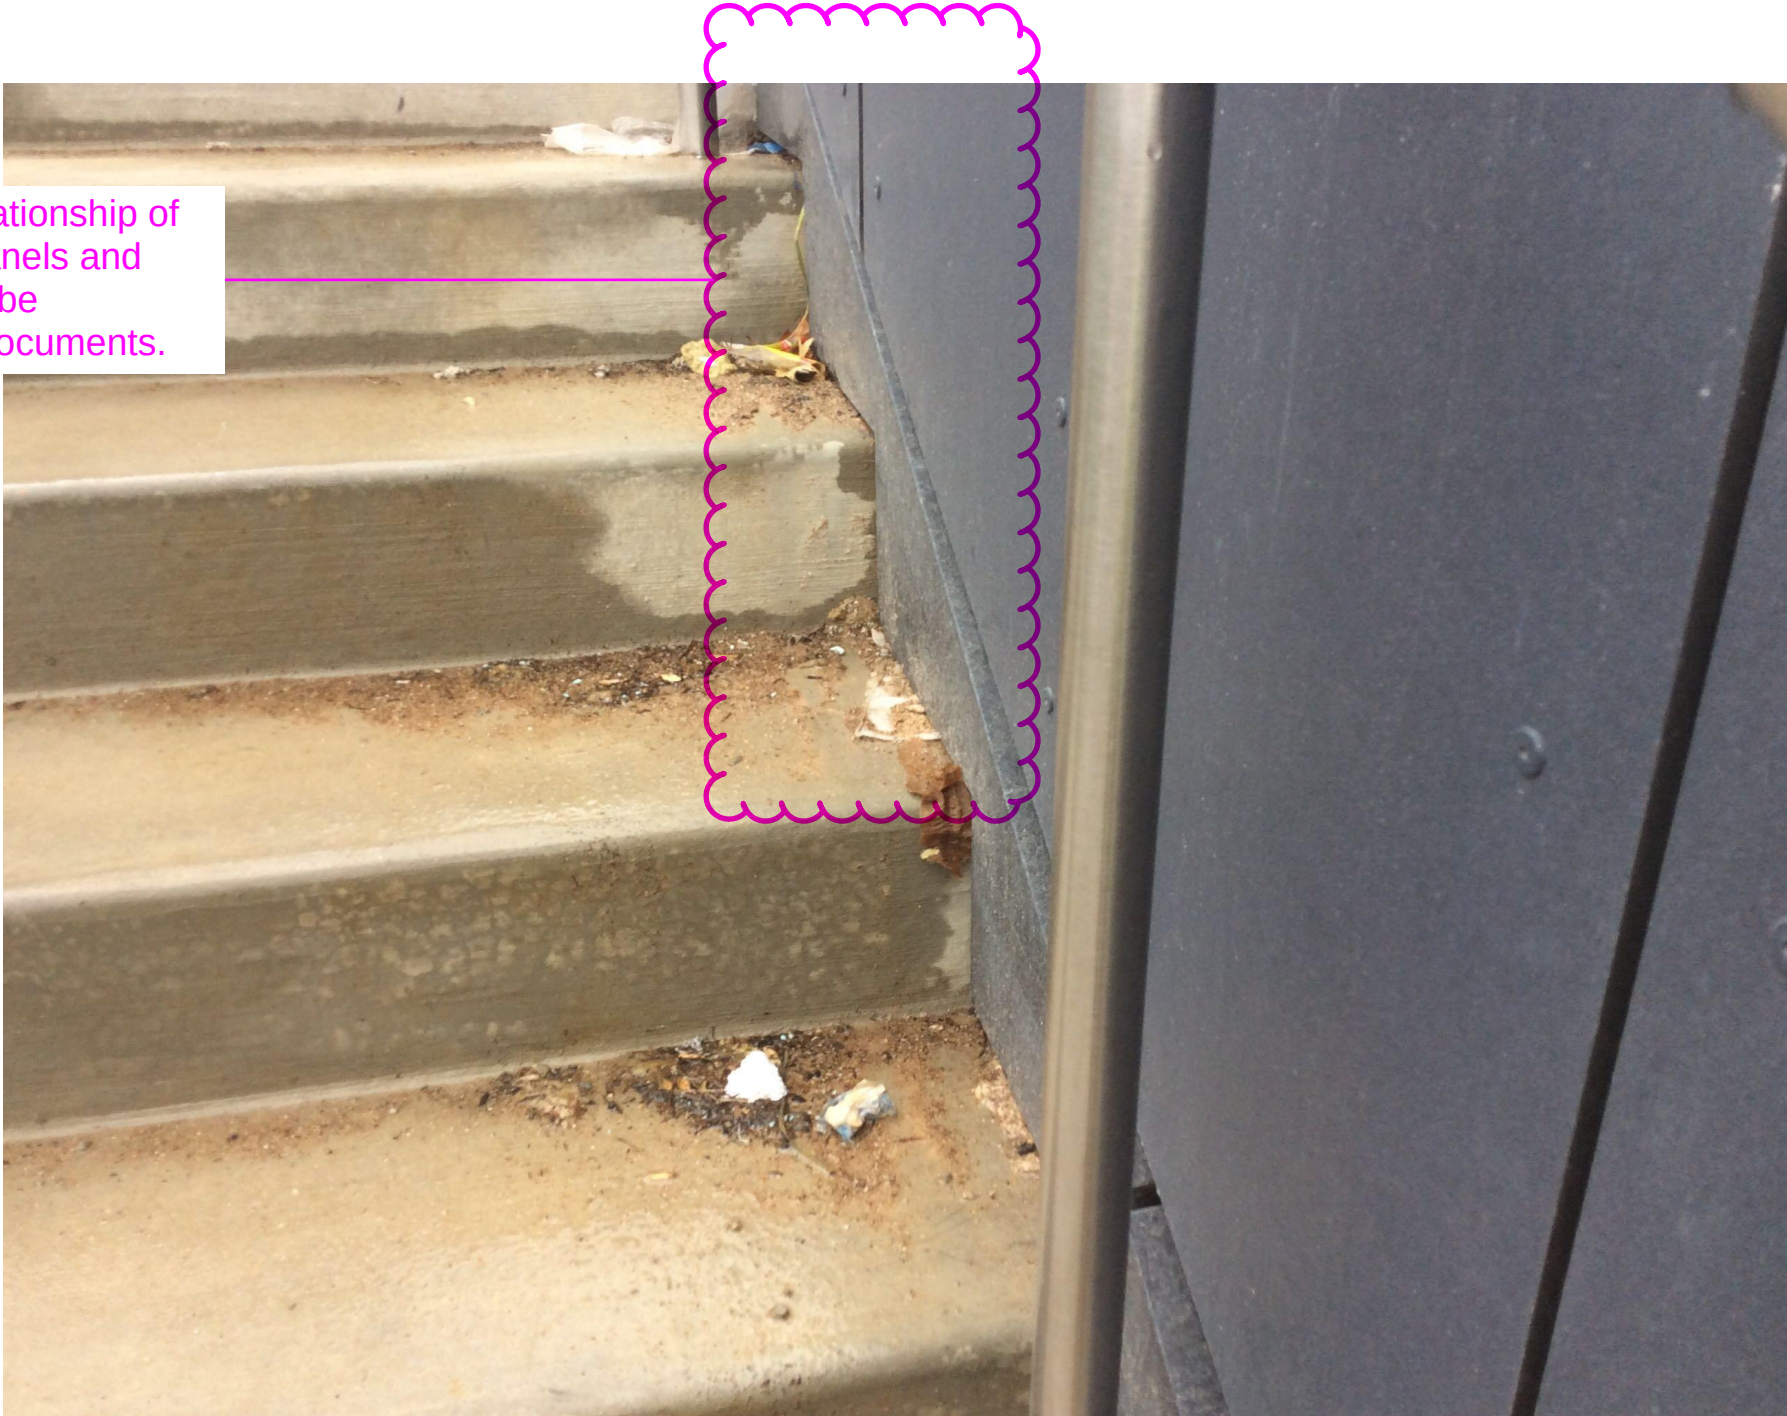
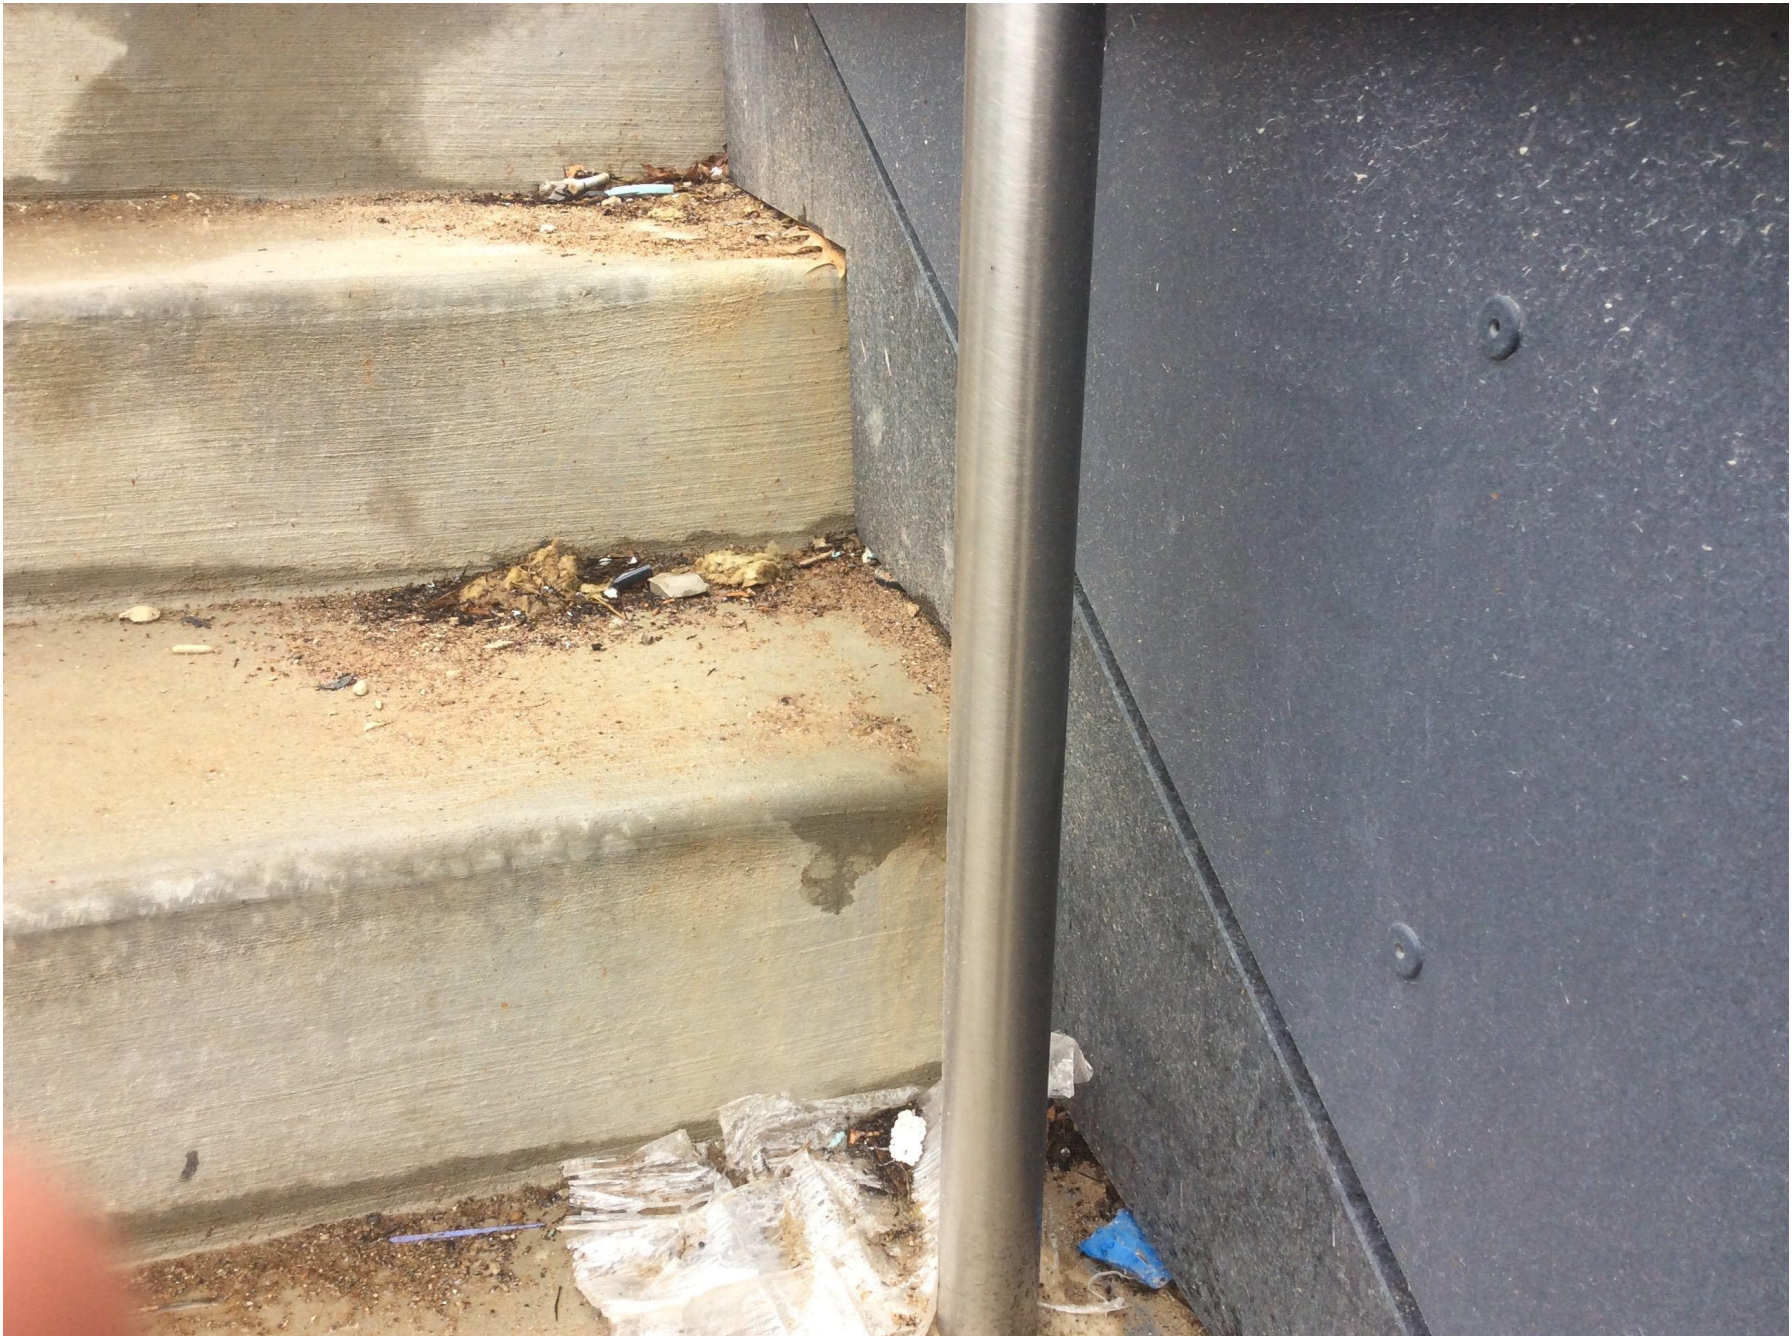
| Issue ID | Description | Location Detail | Location | Status | Company | Type | Date Created | Due Date |
|---|---|---|---|---|---|---|---|---|
| 002154 | Fiber cement paneling not consistent with granite base - north courtyard stair | | Site | Open | Kuenz Sheet Metal | Architect Punch List | 07 Aug 2017 | 12 Aug 2017 |

Dimensional relationship of  
Fiber cement panels and  
Granite base to be  
consistent per documents.

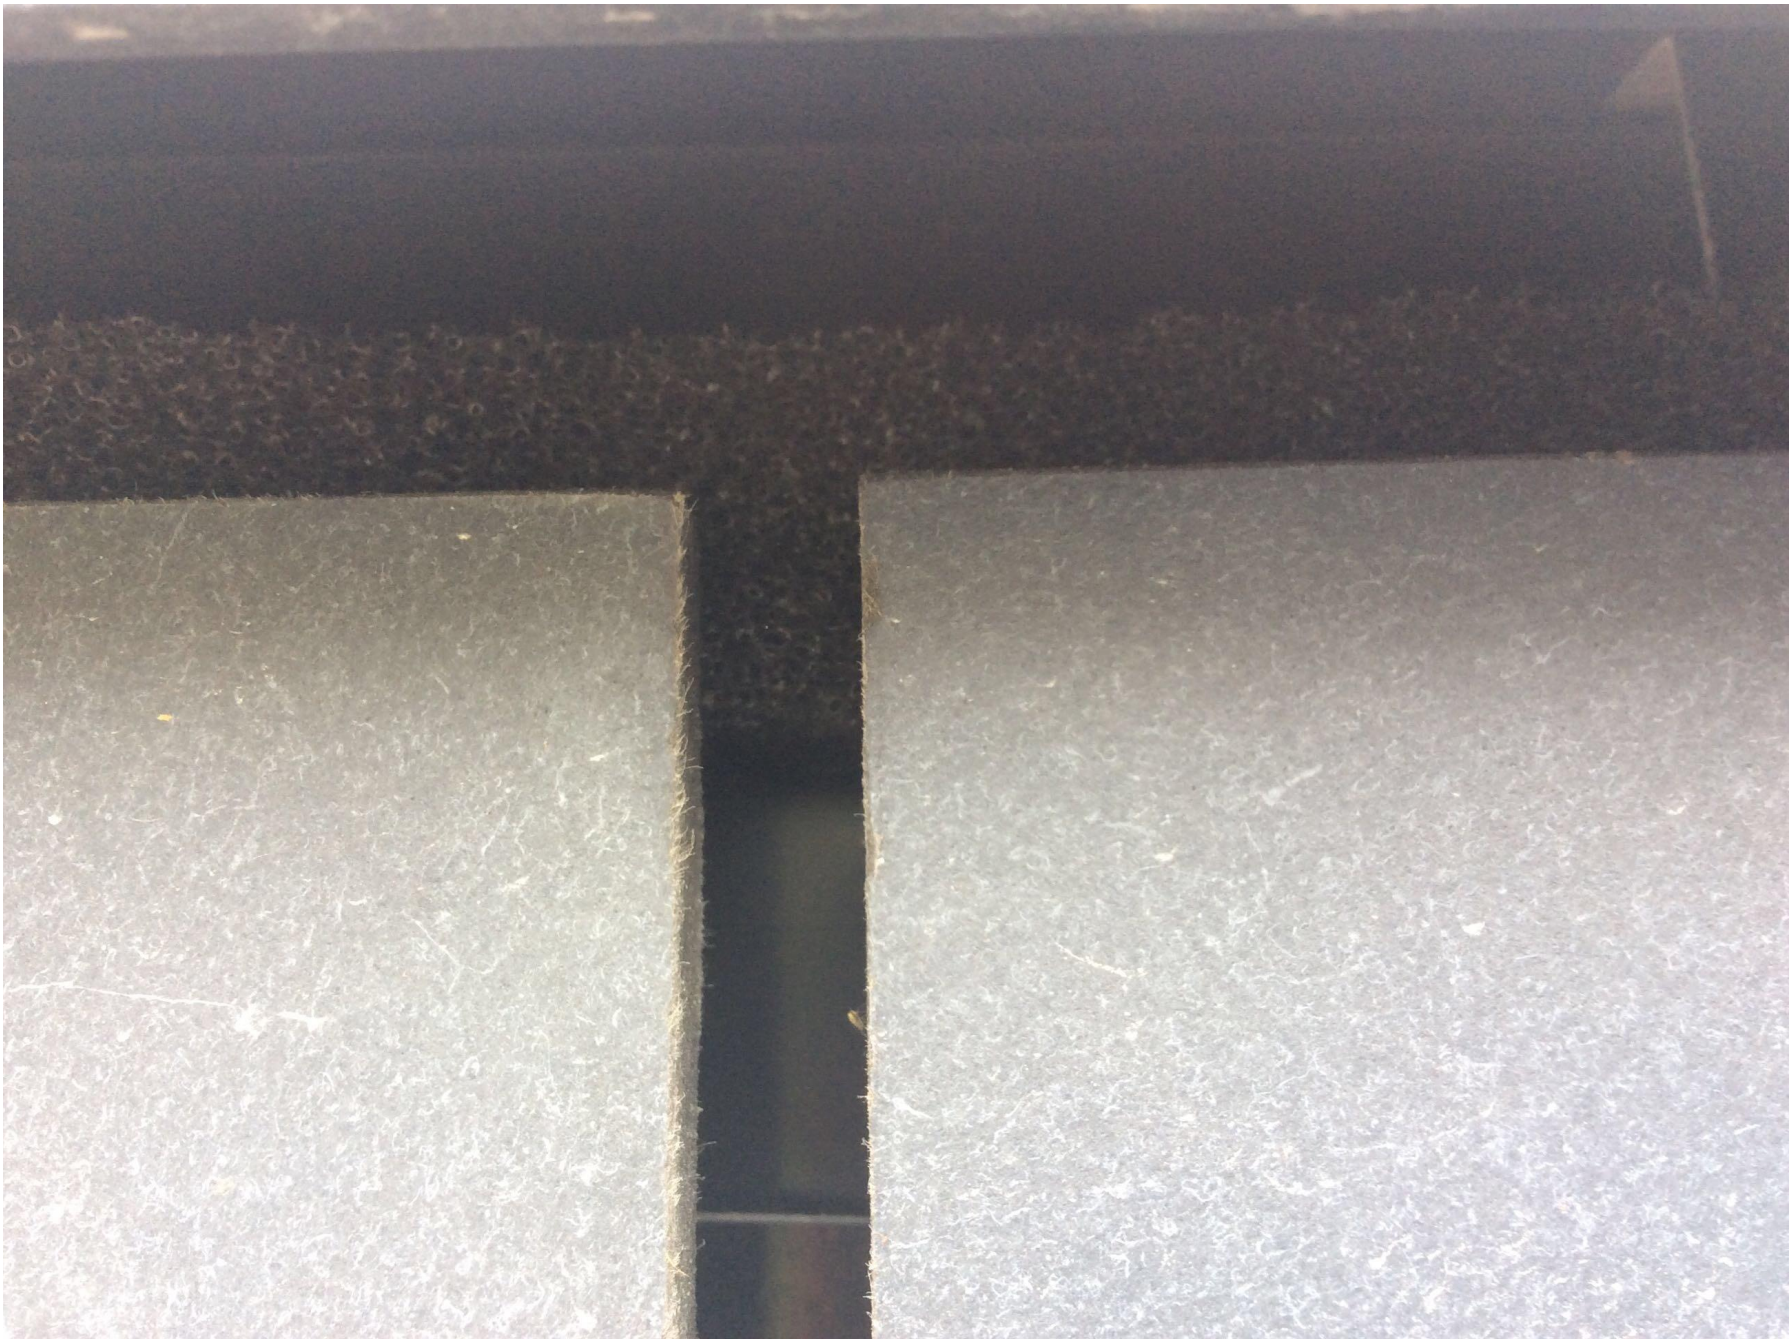
| Issue ID | Description | Location Detail | Location | Status | Company | Type | Date Created | Due Date |
|---|---|---|---|---|---|---|---|---|
| 002155 | Confirm bug screen is approved material | | Site | Open | Kuenz Sheet Metal | Architect Punch List | 07 Aug 2017 | 12 Aug 2017 |

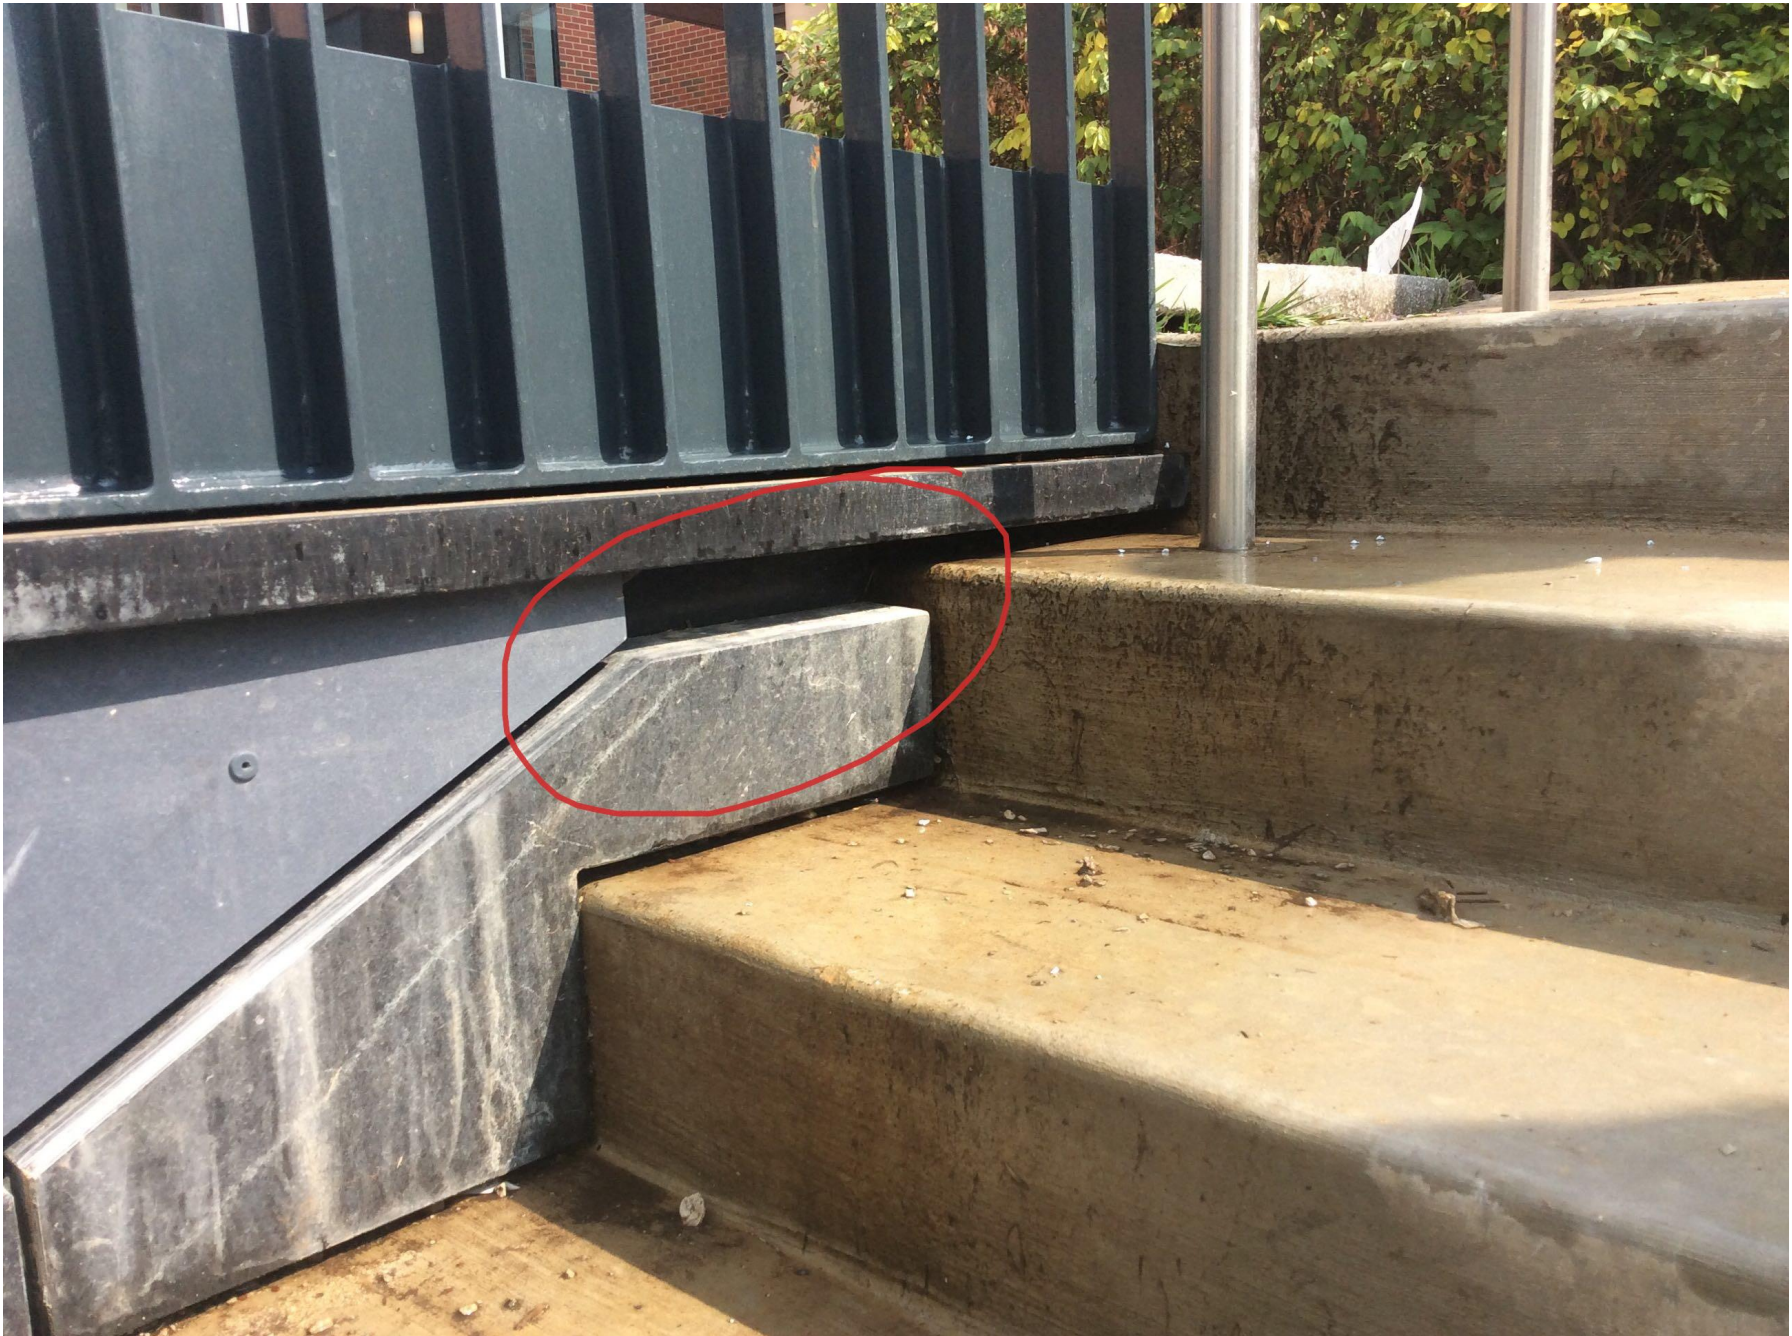
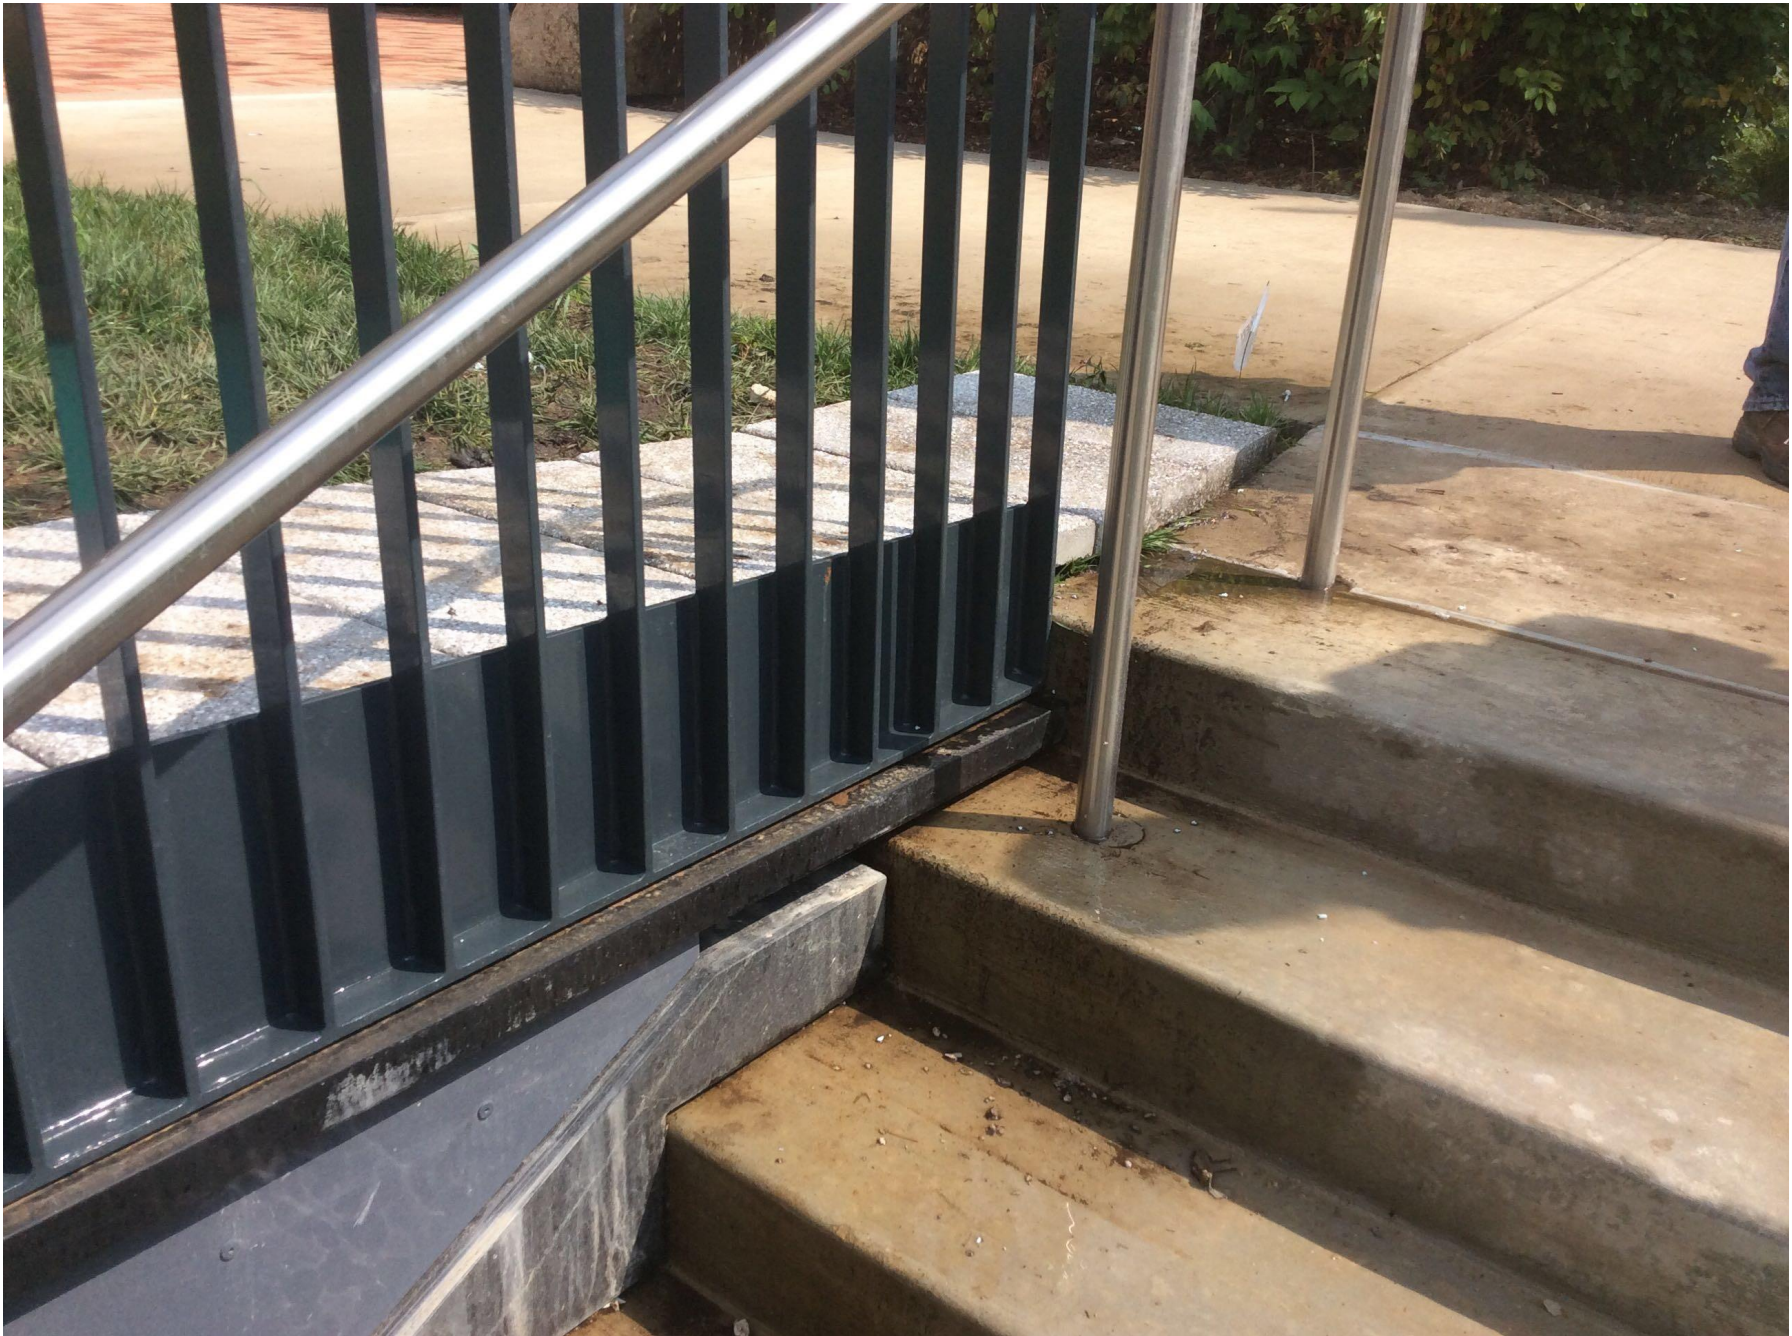
| Issue ID | Description | Location Detail | Location | Status | Company | Type | Date Created | Due Date |
|---|---|---|---|---|---|---|---|---|
| 002162 | Add fiber cement to fill void at south courtyard stair<br><br>OR Granite base to extend to the break metal cap. | | Site | Open | Kuenz Sheet Metal | Architect Punch List | 07 Aug 2017 | 12 Aug 2017 |

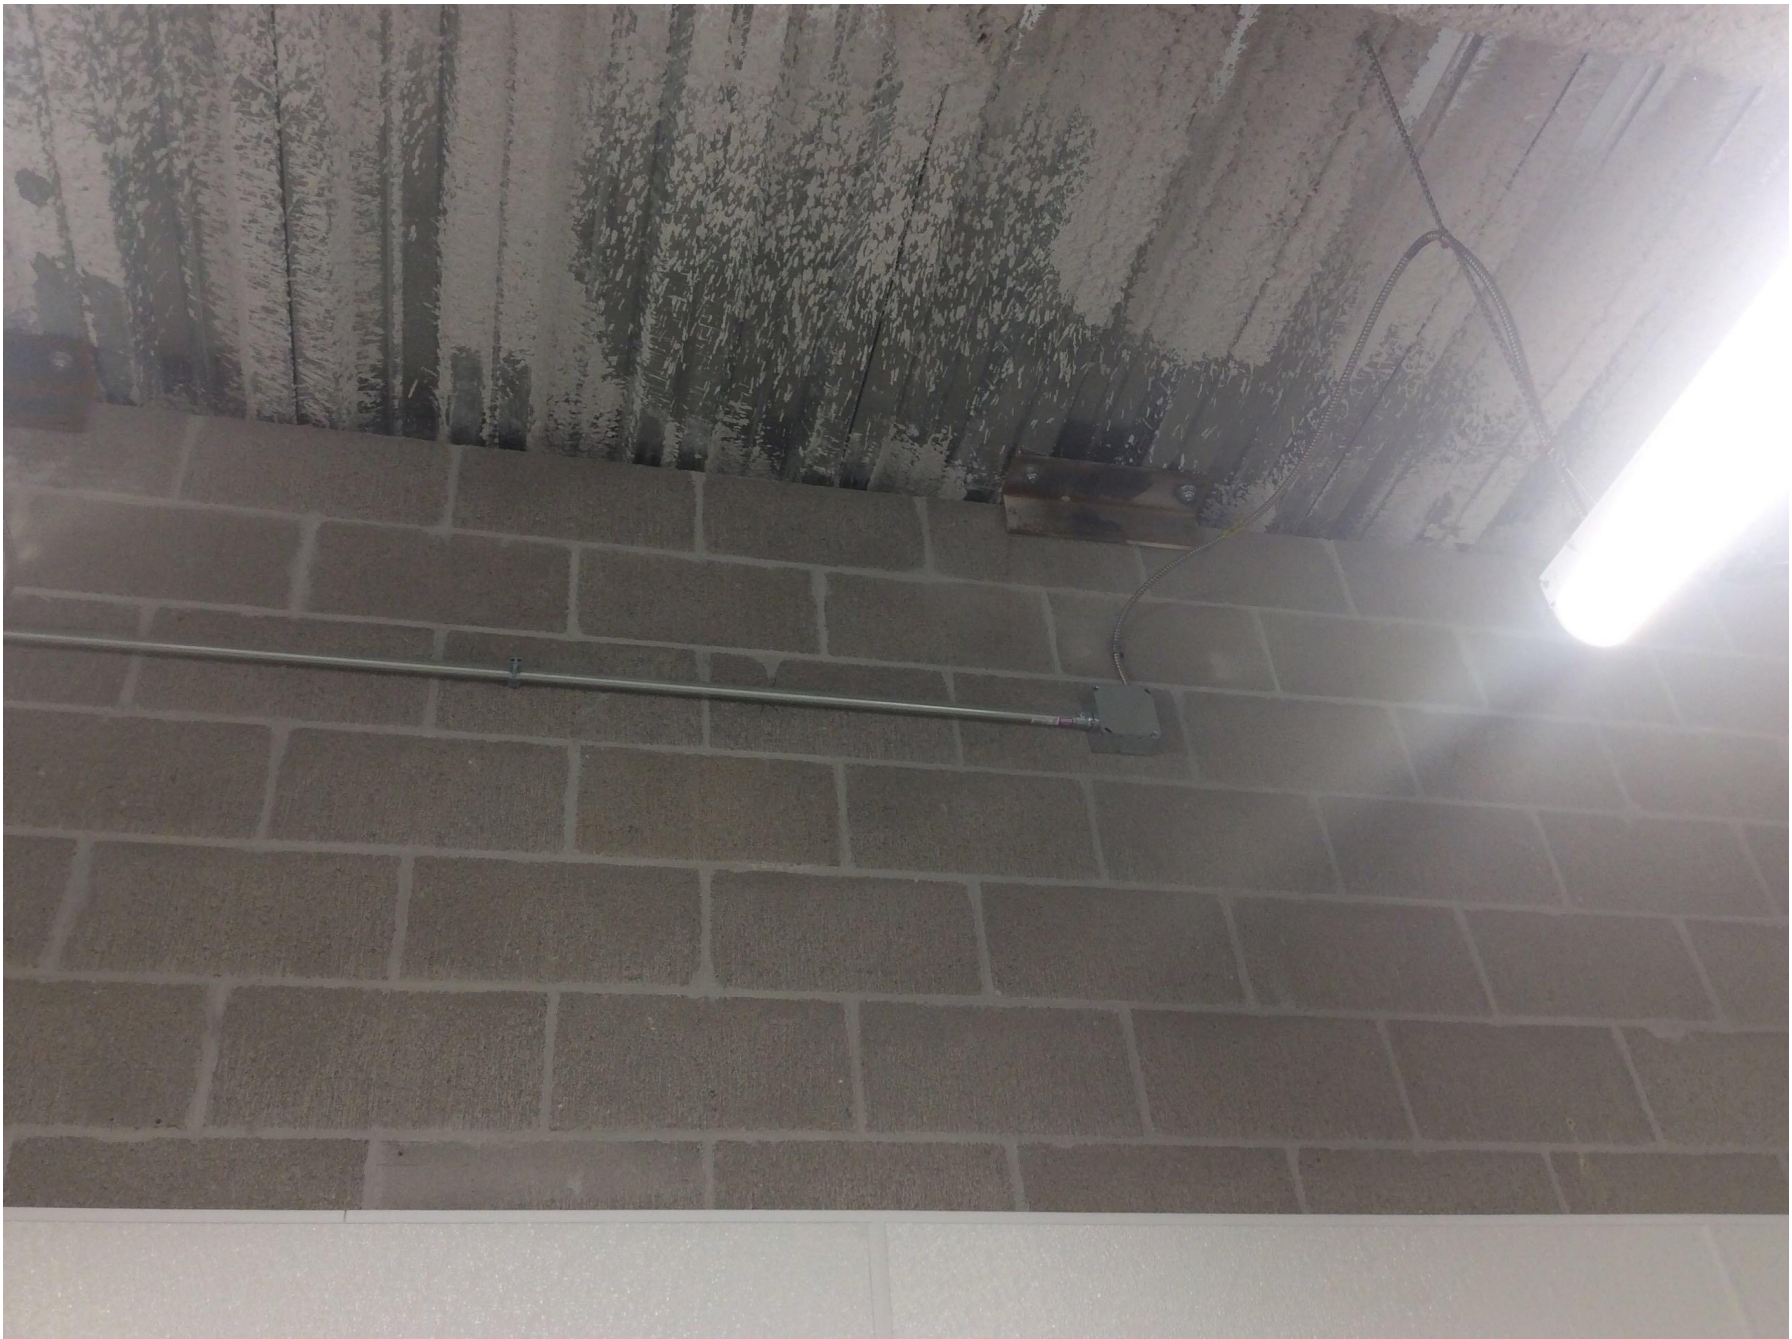
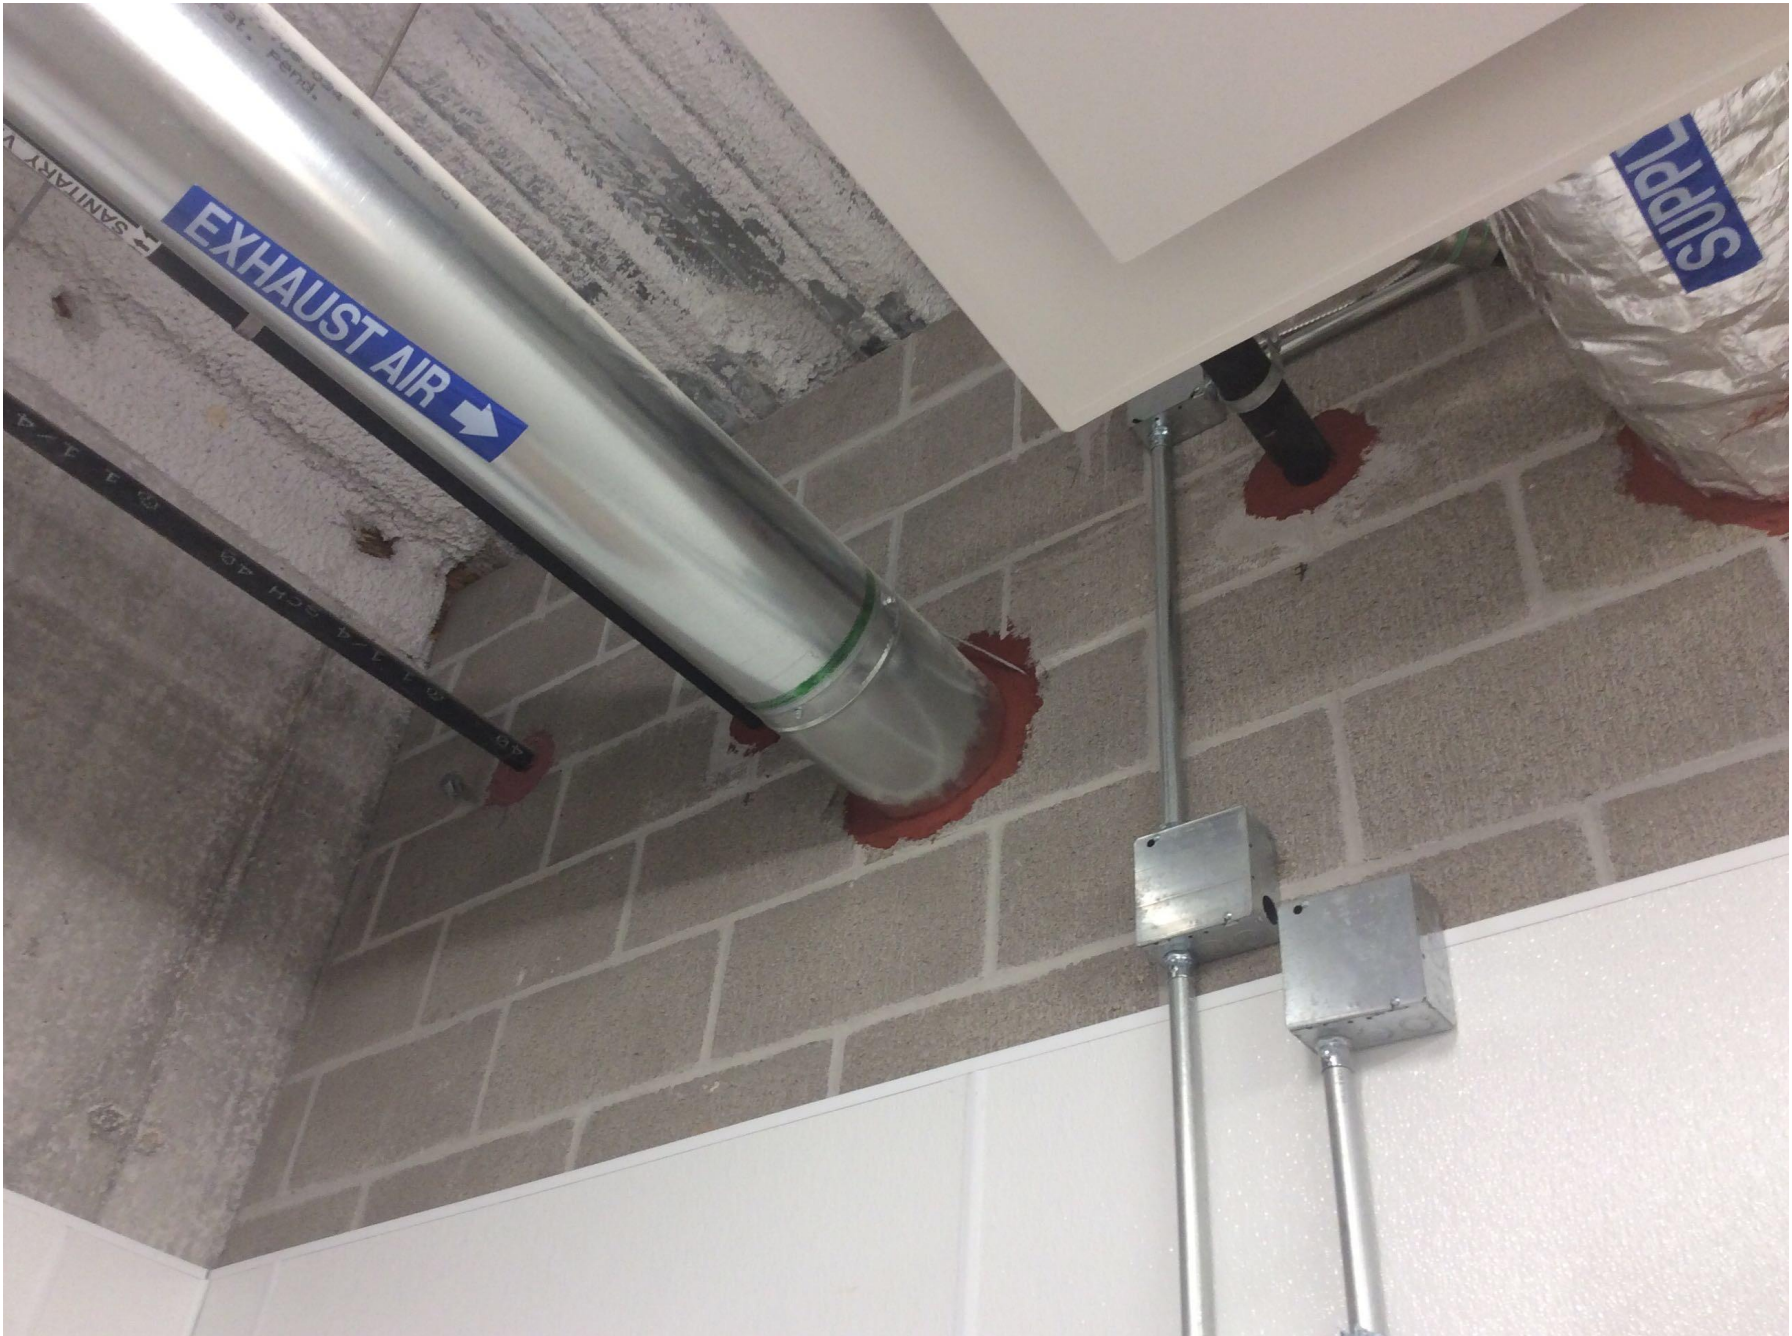
| Issue ID | Description | Location Detail | Location | Status | Company | Type | Date Created | Due Date |
|---|---|---|---|---|---|---|---|---|
| 002163 | Fire sealant needed at could to deck and concrete wall | | Webster > LEVEL_01 > 172A_RECYCLING | Open | Leonard Masonry, Inc. | Architect Punch List | 07 Aug 2017 | 12 Aug 2017 |
