## **ARCHITECTURAL PUNCH LIST (EXTERIOR FAÇADE & ROOF)**

**Project:** Webster University Interdisciplinary Science Building

**Project No:** CannonDesign #004561.01

**Date of Observation:** August 7, 2017

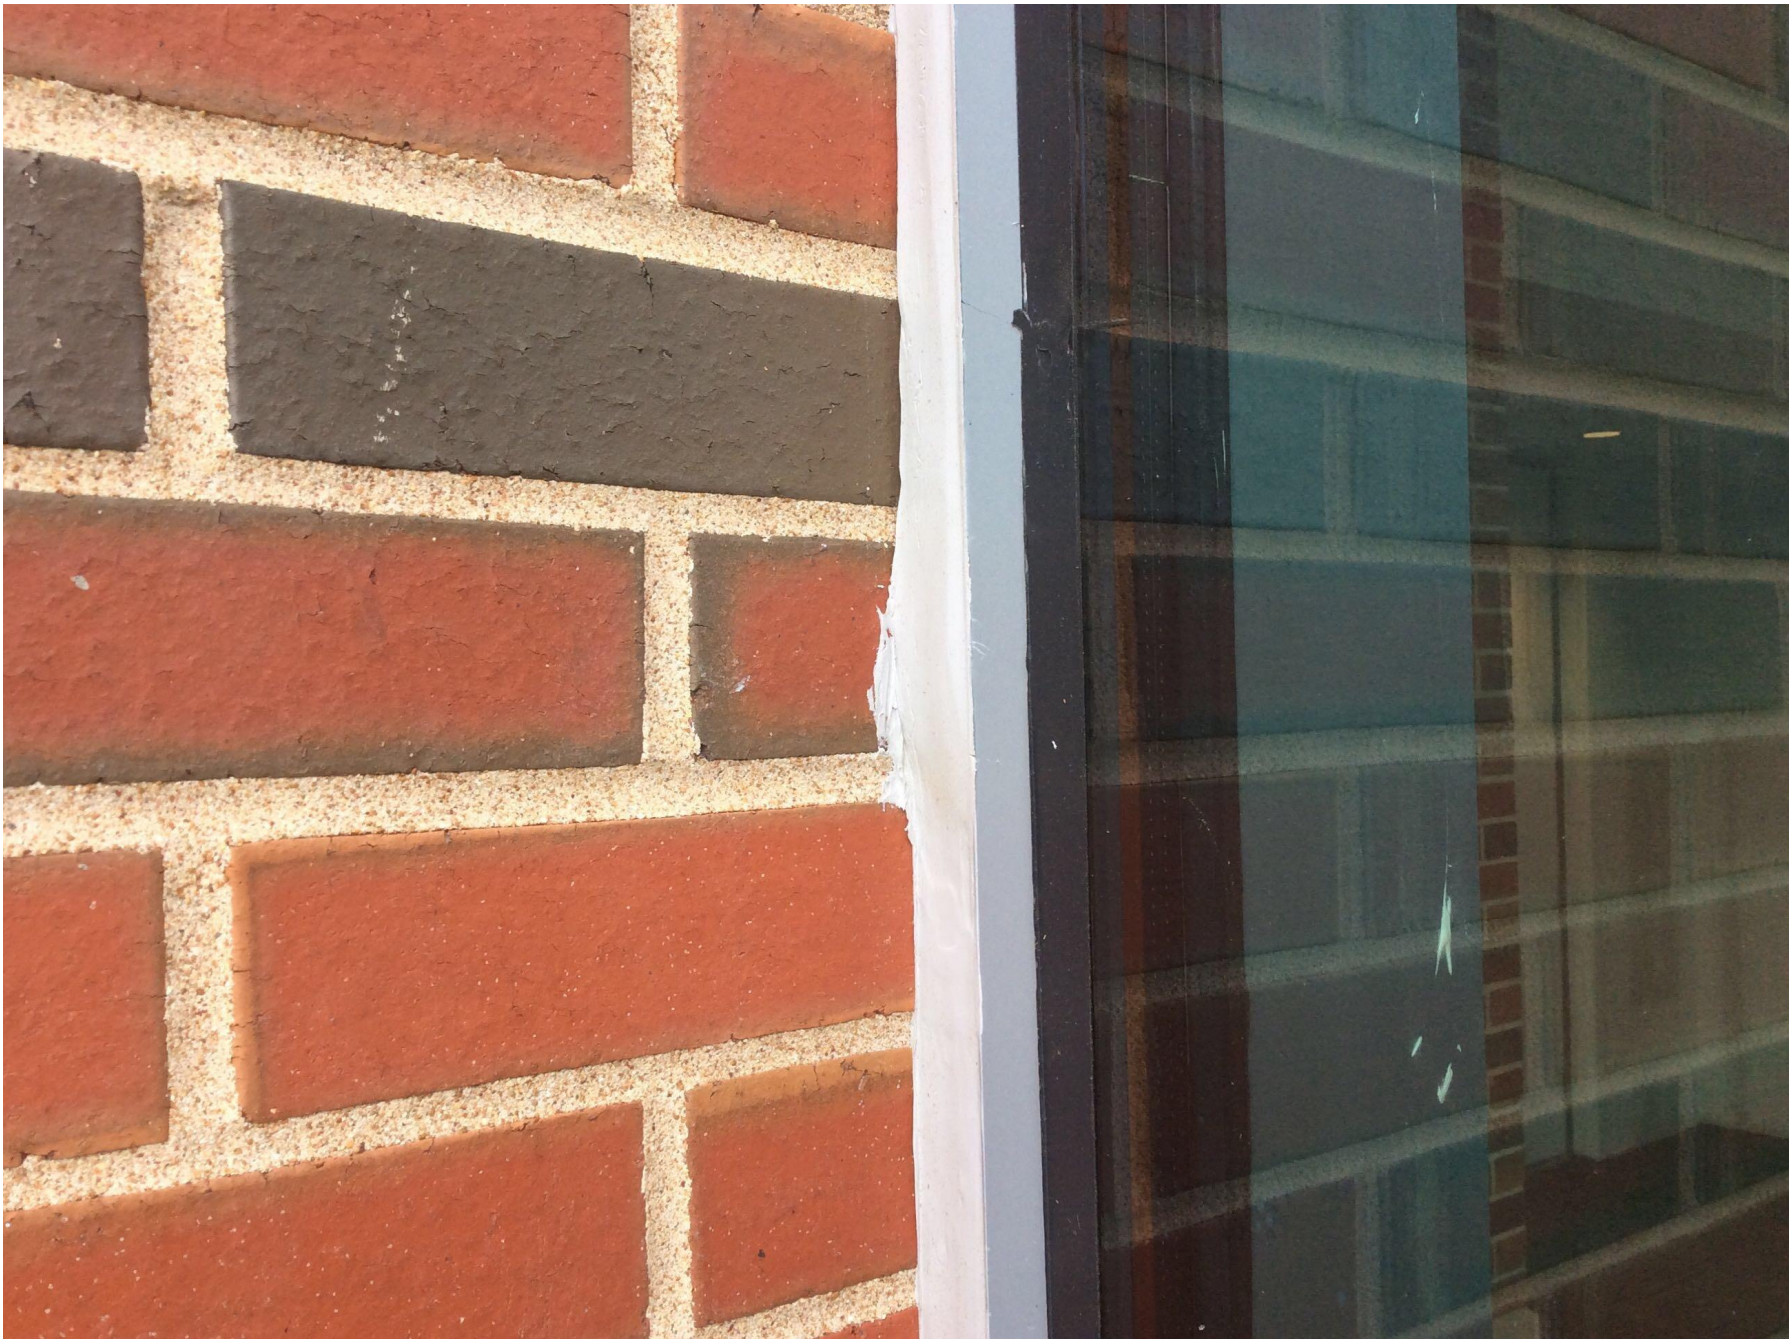
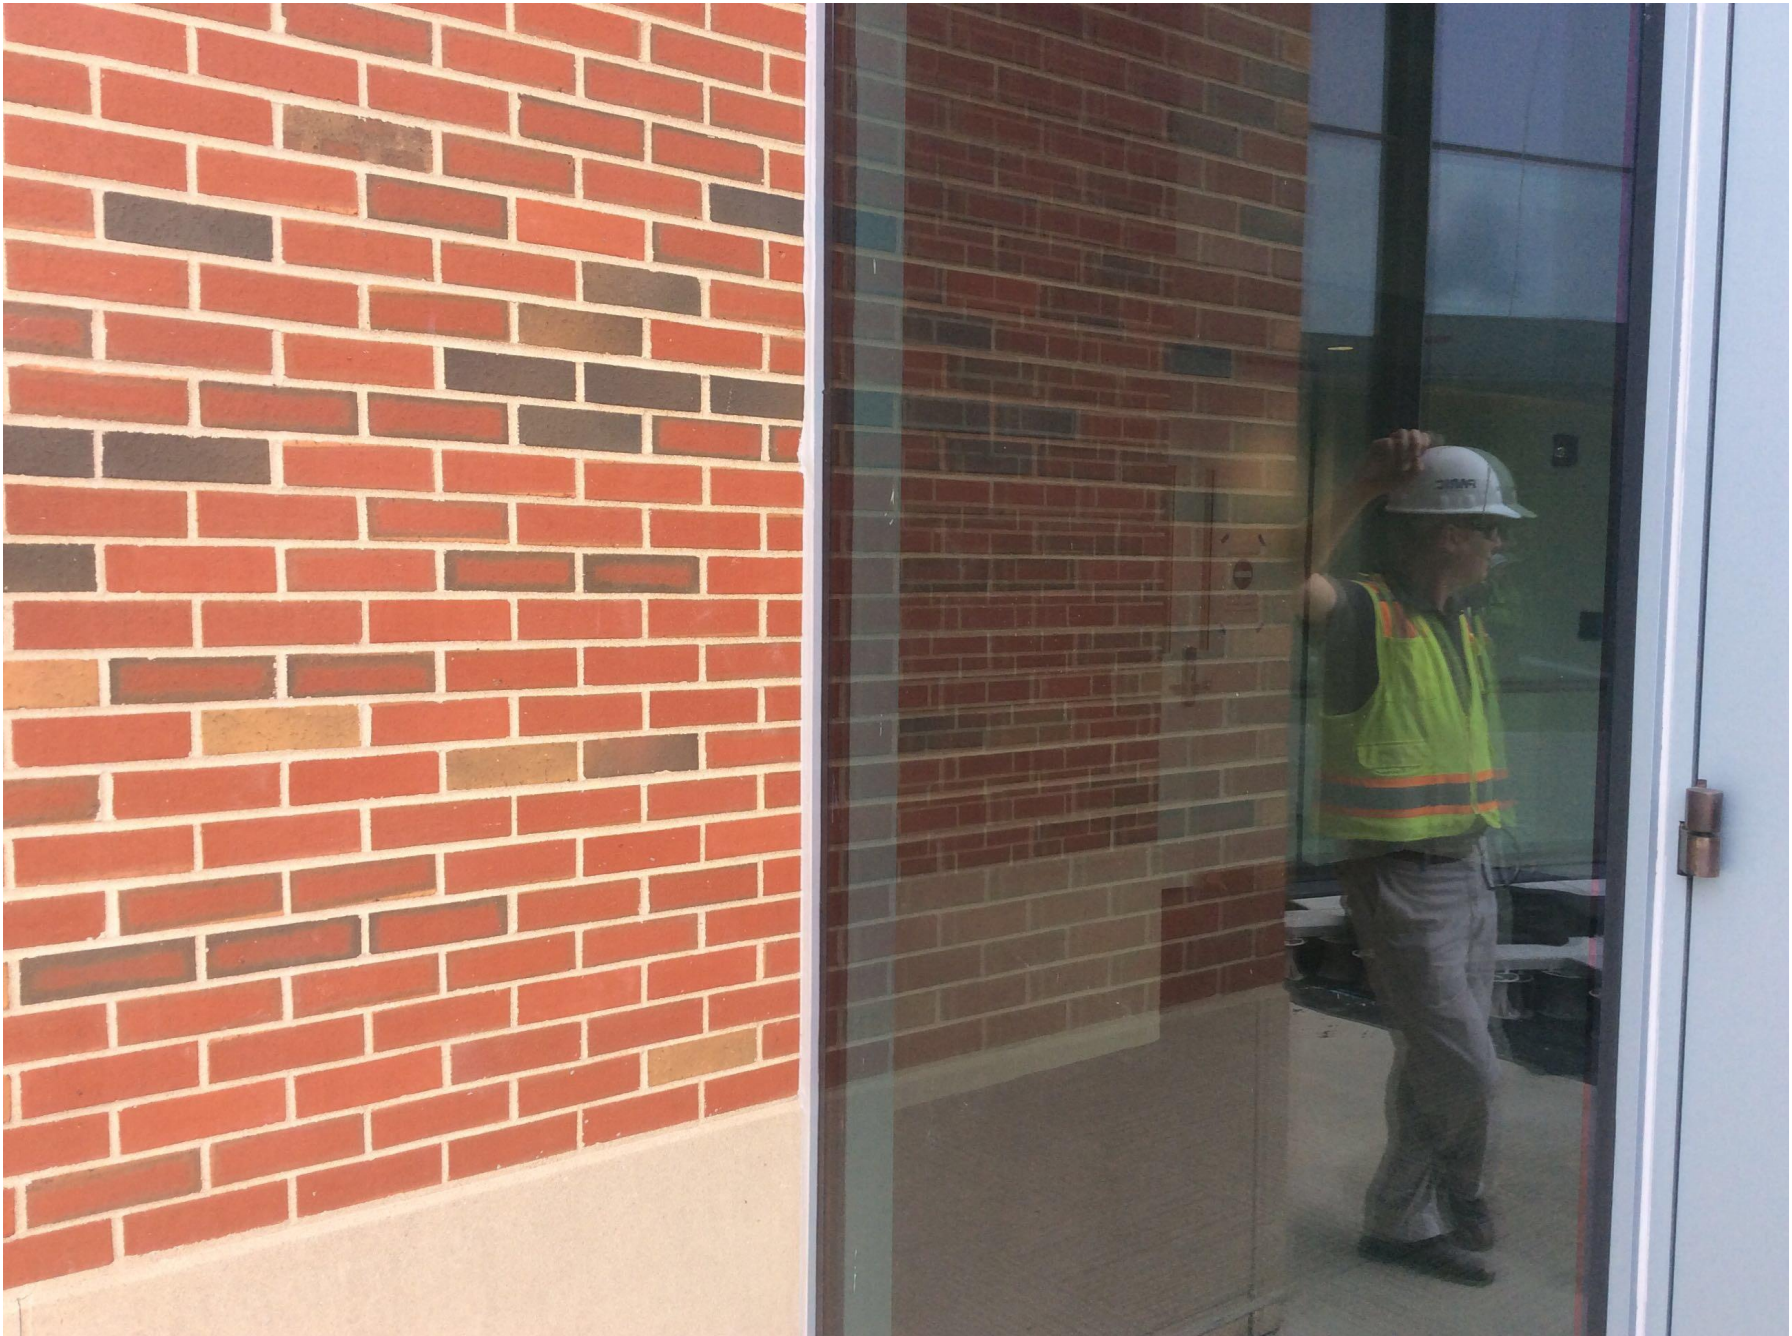
| Issue ID | Description | Location Detail | Location | Status | Company | Type | Date Created | Due Date |
|---|---|---|---|---|---|---|---|---|
| 002120 | Cleanup caulk - west eab connector | | Site | Open | National Glass & Glazing, Inc. | Architect Punch List | 07 Aug 2017 | 12 Aug 2017 |

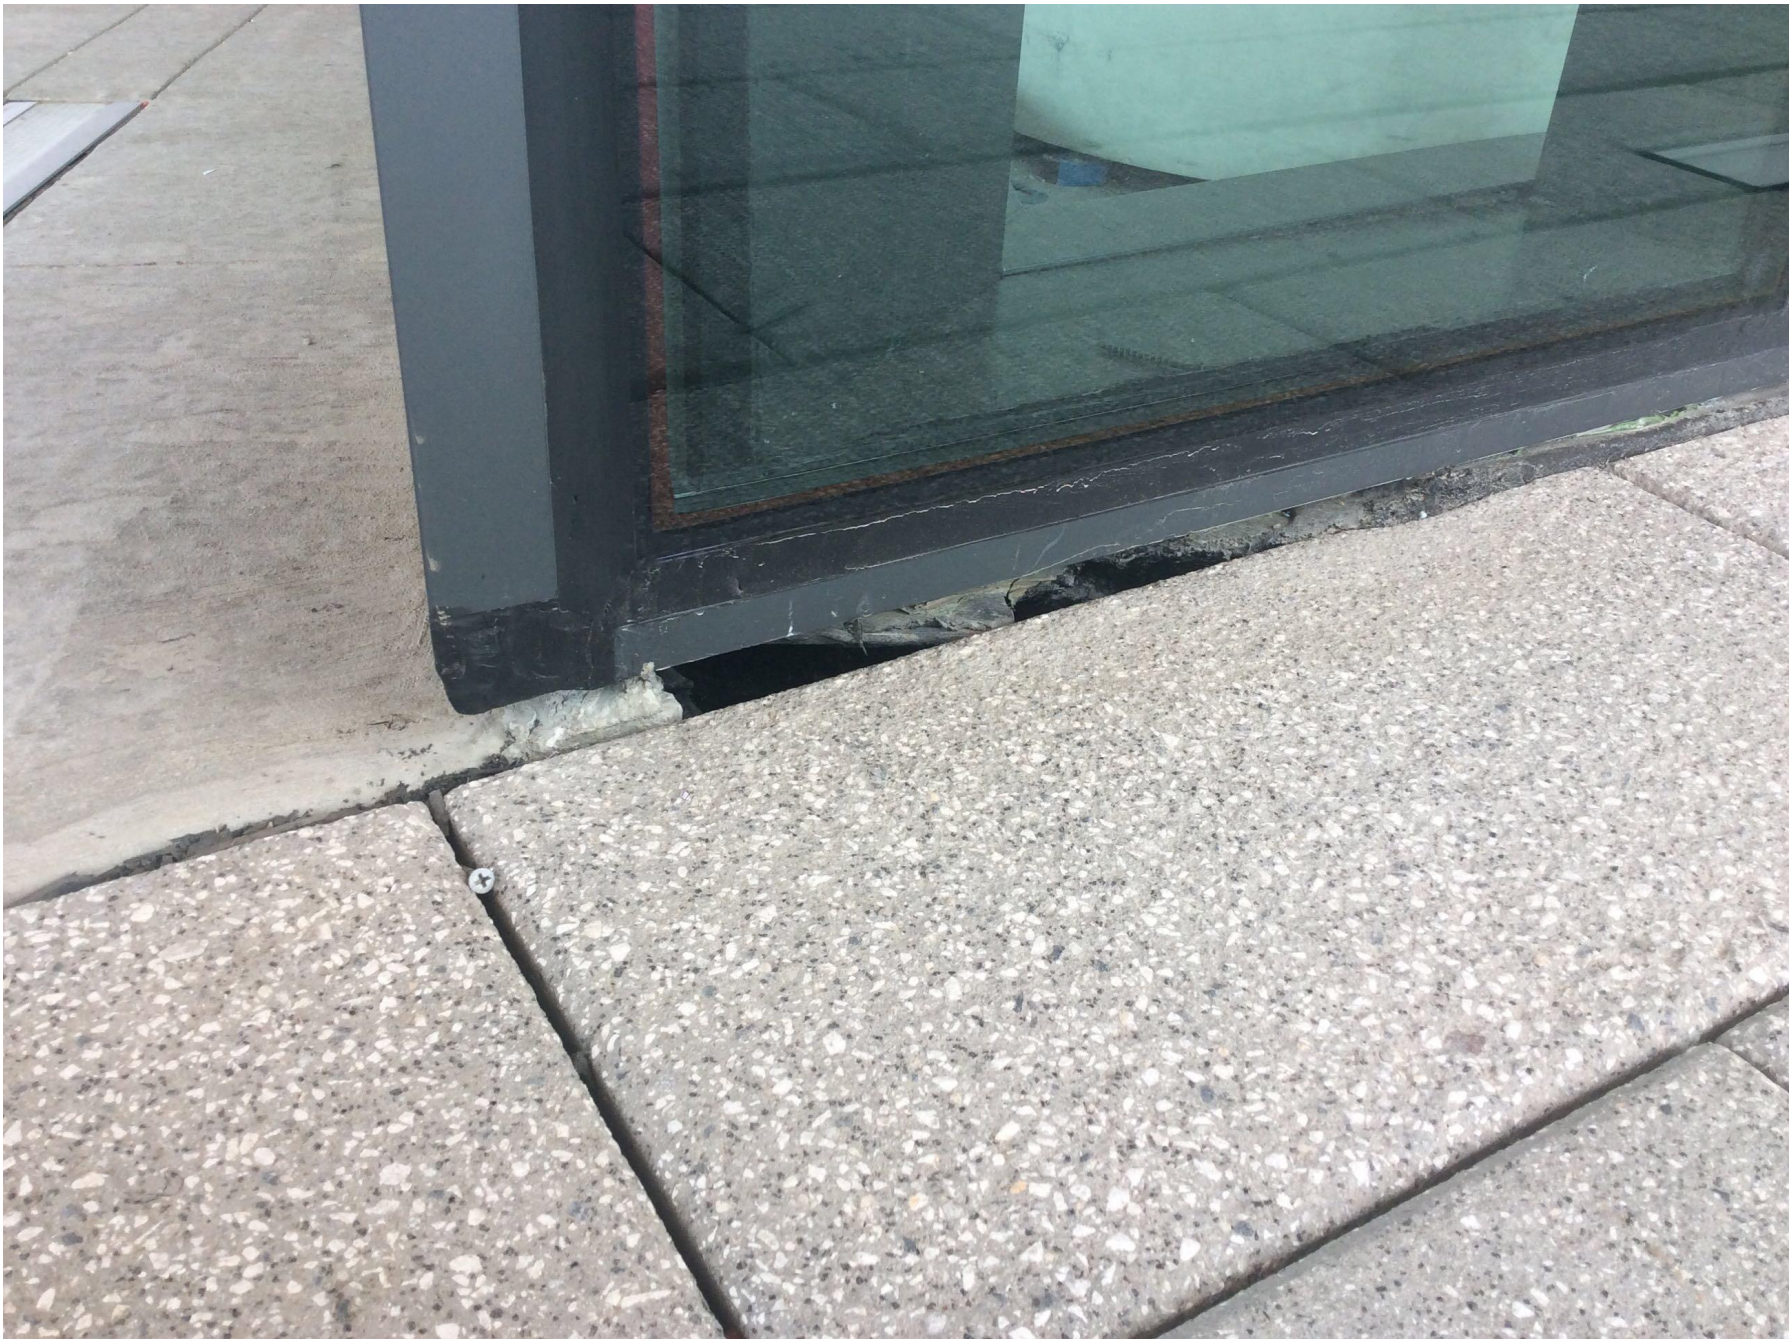
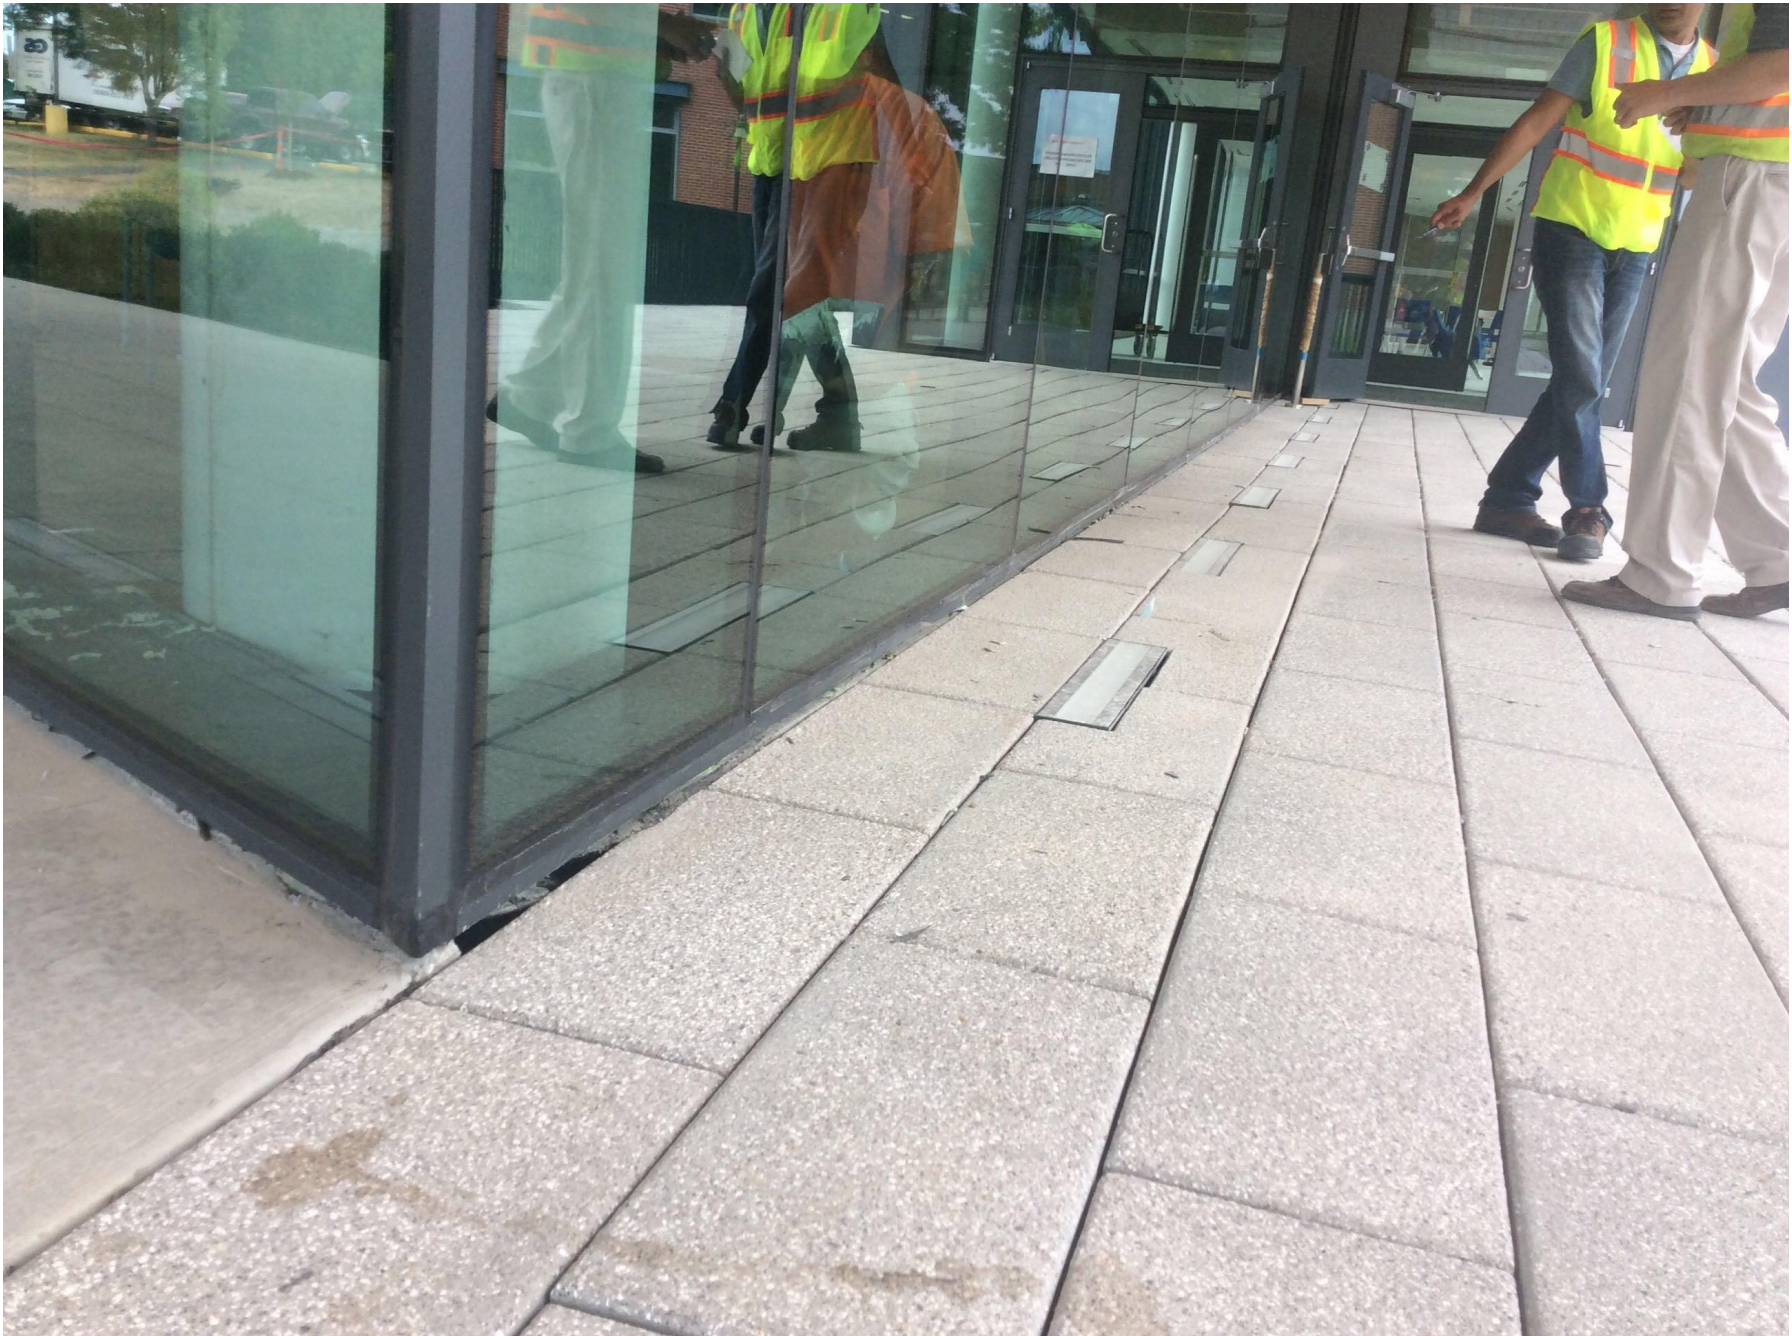
| Issue ID | Description | Location Detail | Location | Status | Company | Type | Date Created | Due Date |
|---|---|---|---|---|---|---|---|---|
| 002123 | Seal void at pavers and sidewalk to curtainwall - all locations<br><span>Do not seal to Pavers. Provide sealant between the bottom mullion and concrete floor below per documents.</span> | | Site | Open | National Glass & Glazing, Inc. | Architect Punch List | 07 Aug 2017 | 12 Aug 2017 |

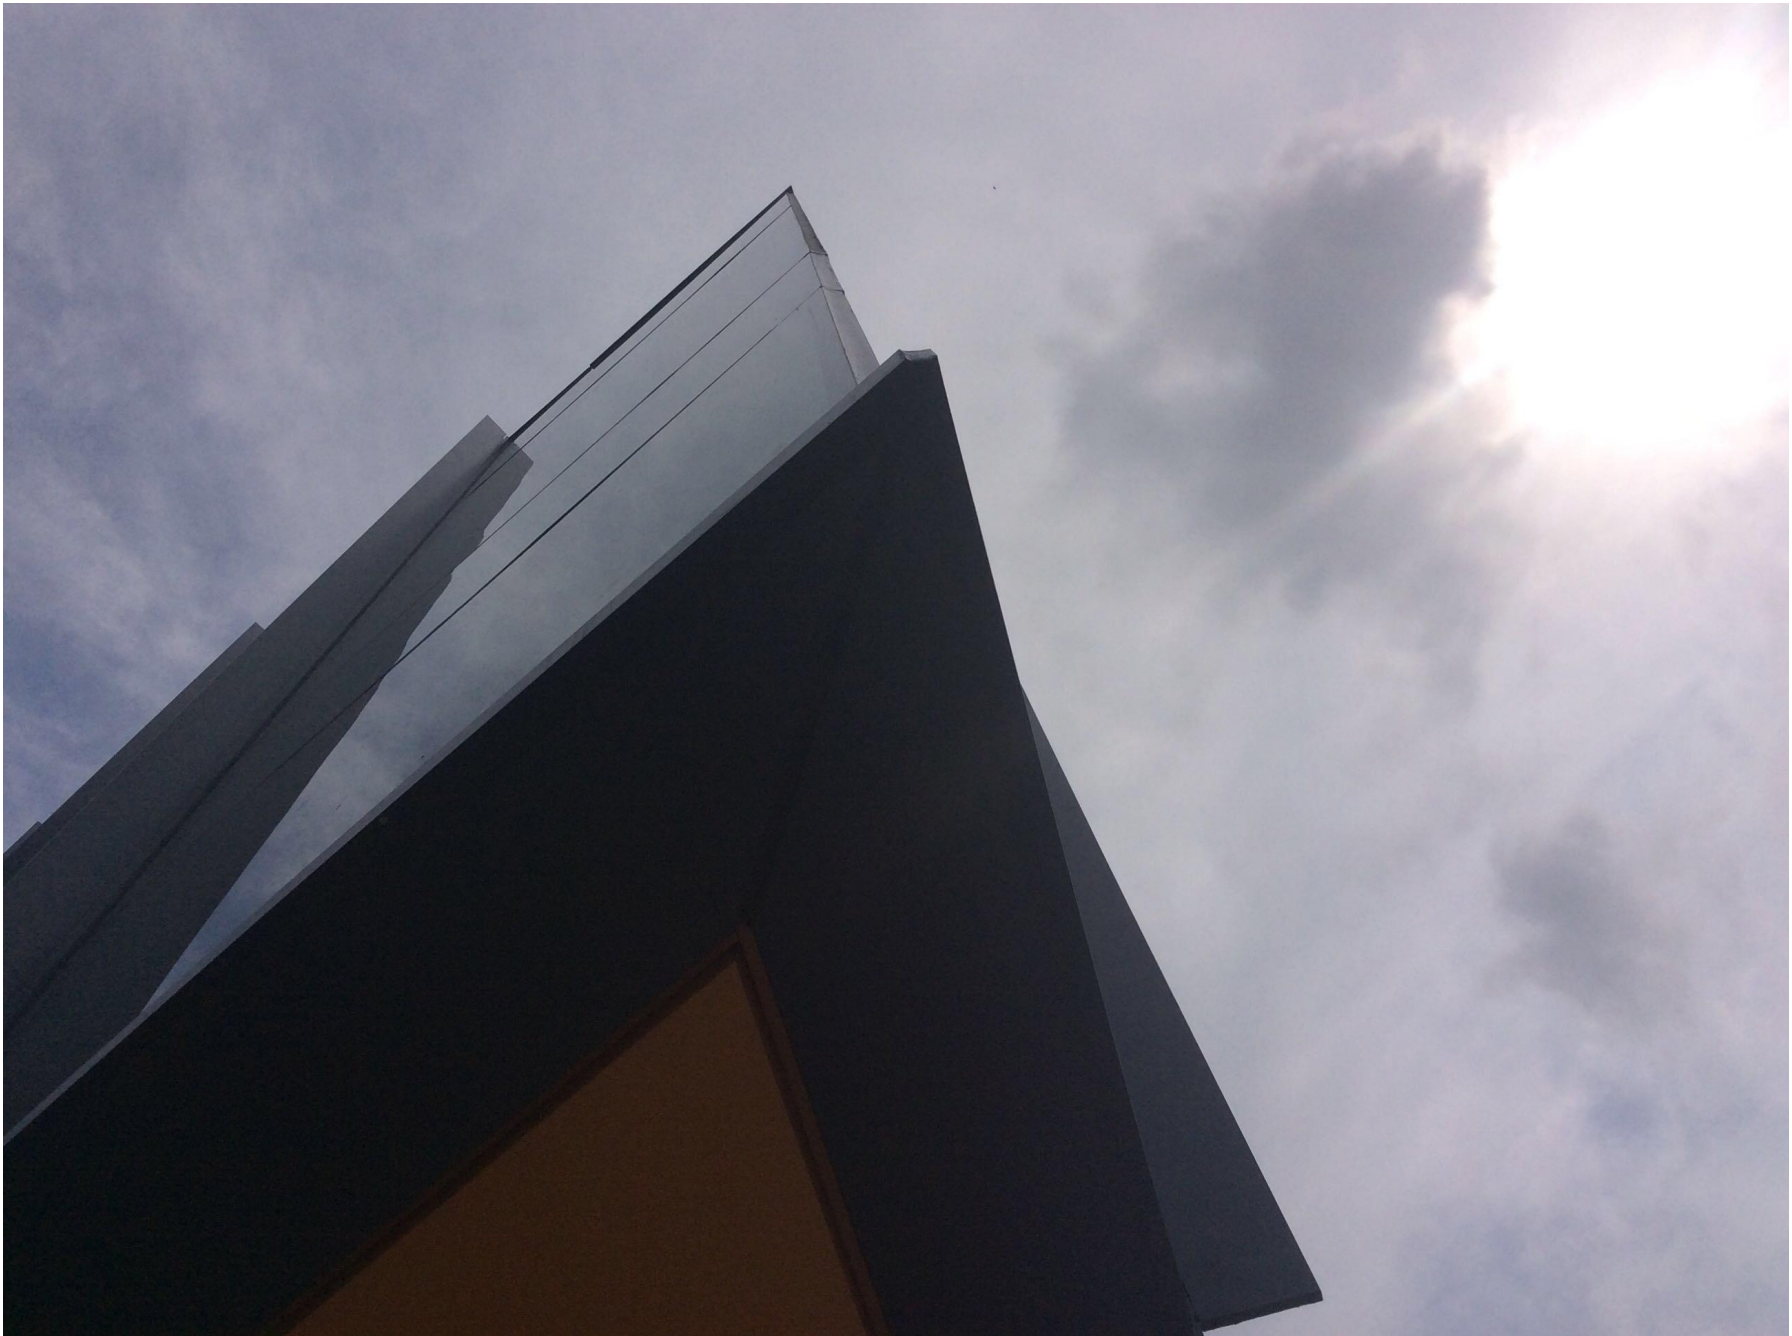
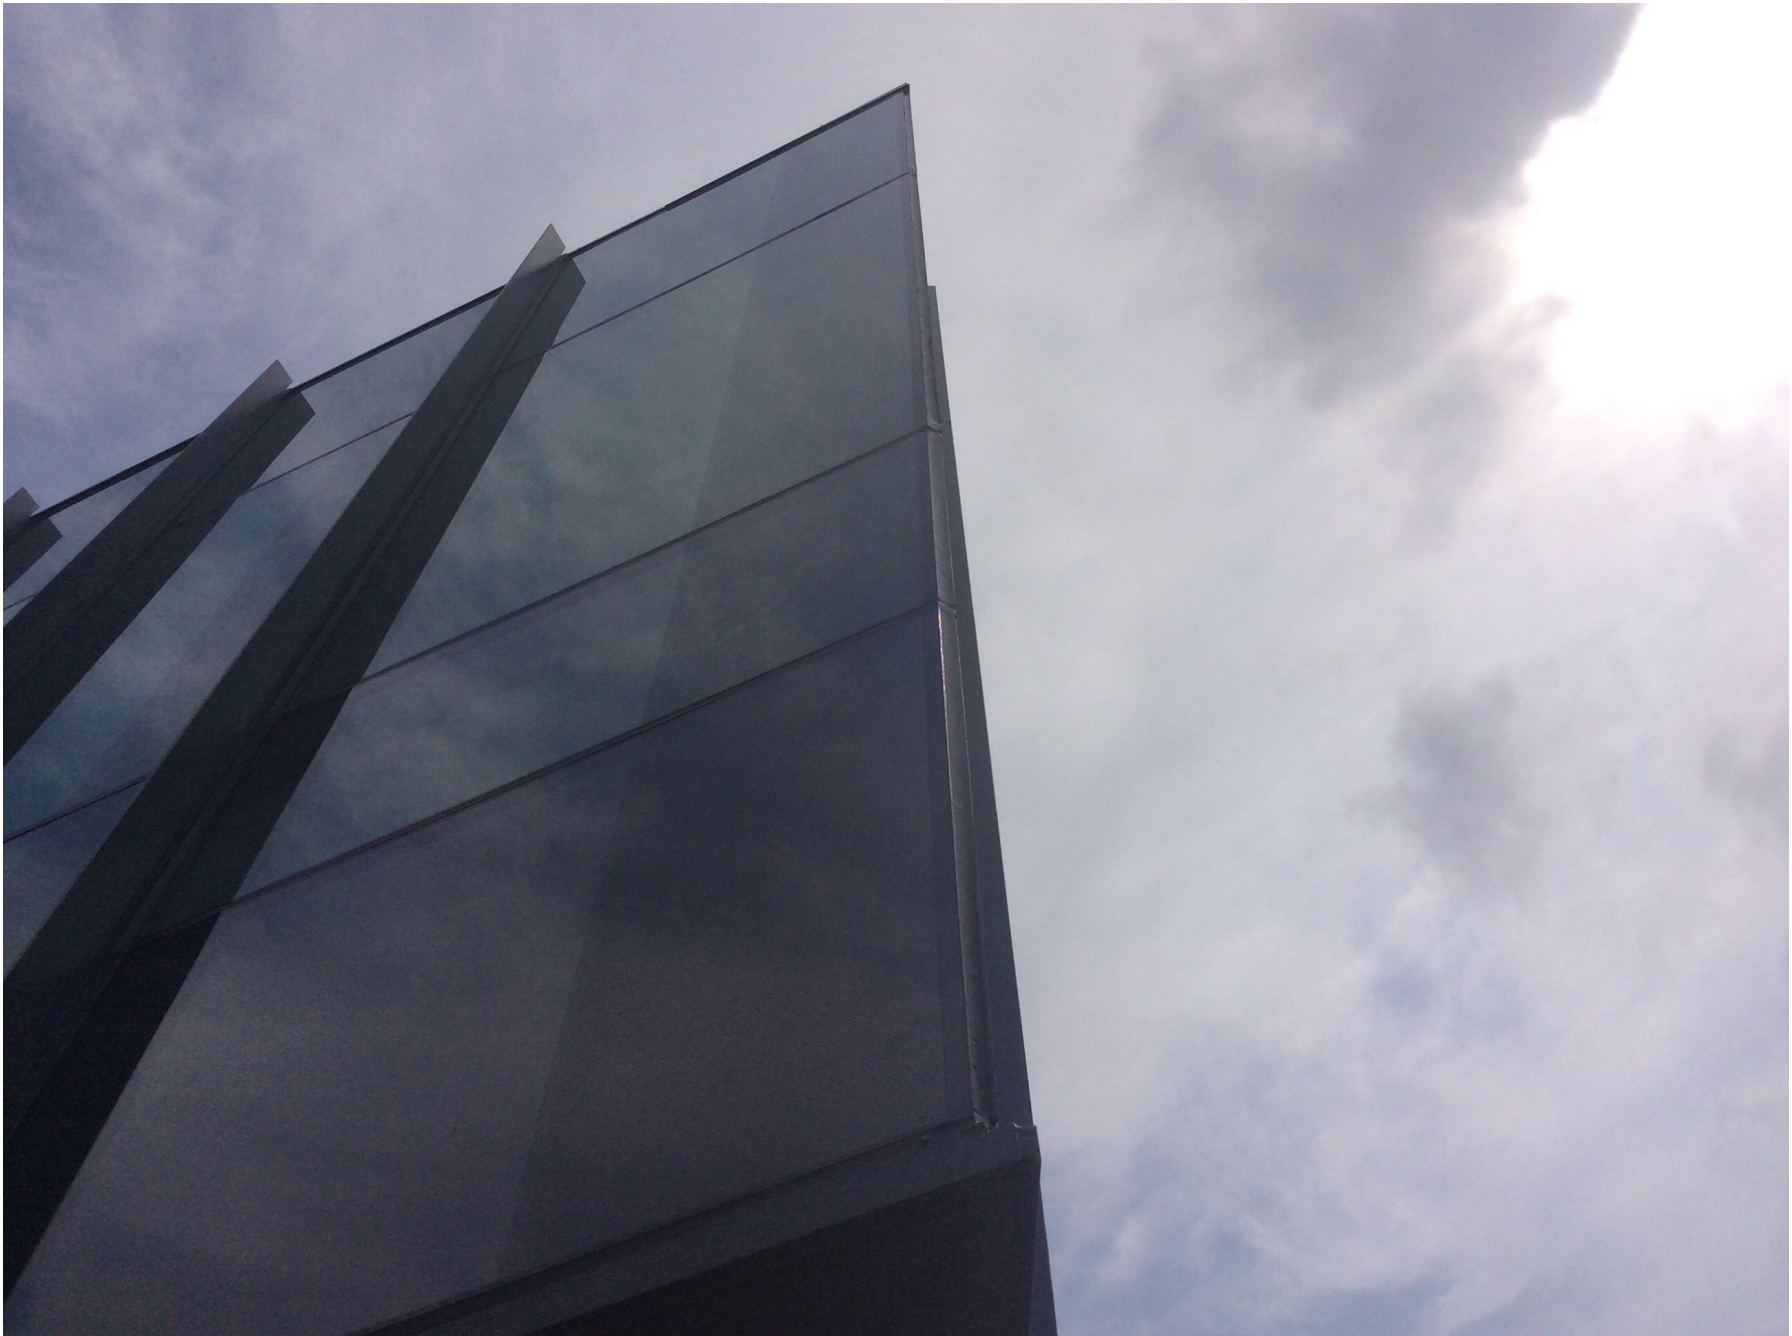
| Issue ID | Description | Location Detail | Location | Status | Company | Type | Date Created | Due Date |
|---|---|---|---|---|---|---|---|---|
| 002127 | Curtainwall sealant needs filled out at bottom and to be smooth at glass up to top, "feather out" snap covers at top and bottom. | | Site | Open | National Glass & Glazing, Inc. | Architect Punch List | 07 Aug 2017 | 12 Aug 2017 |

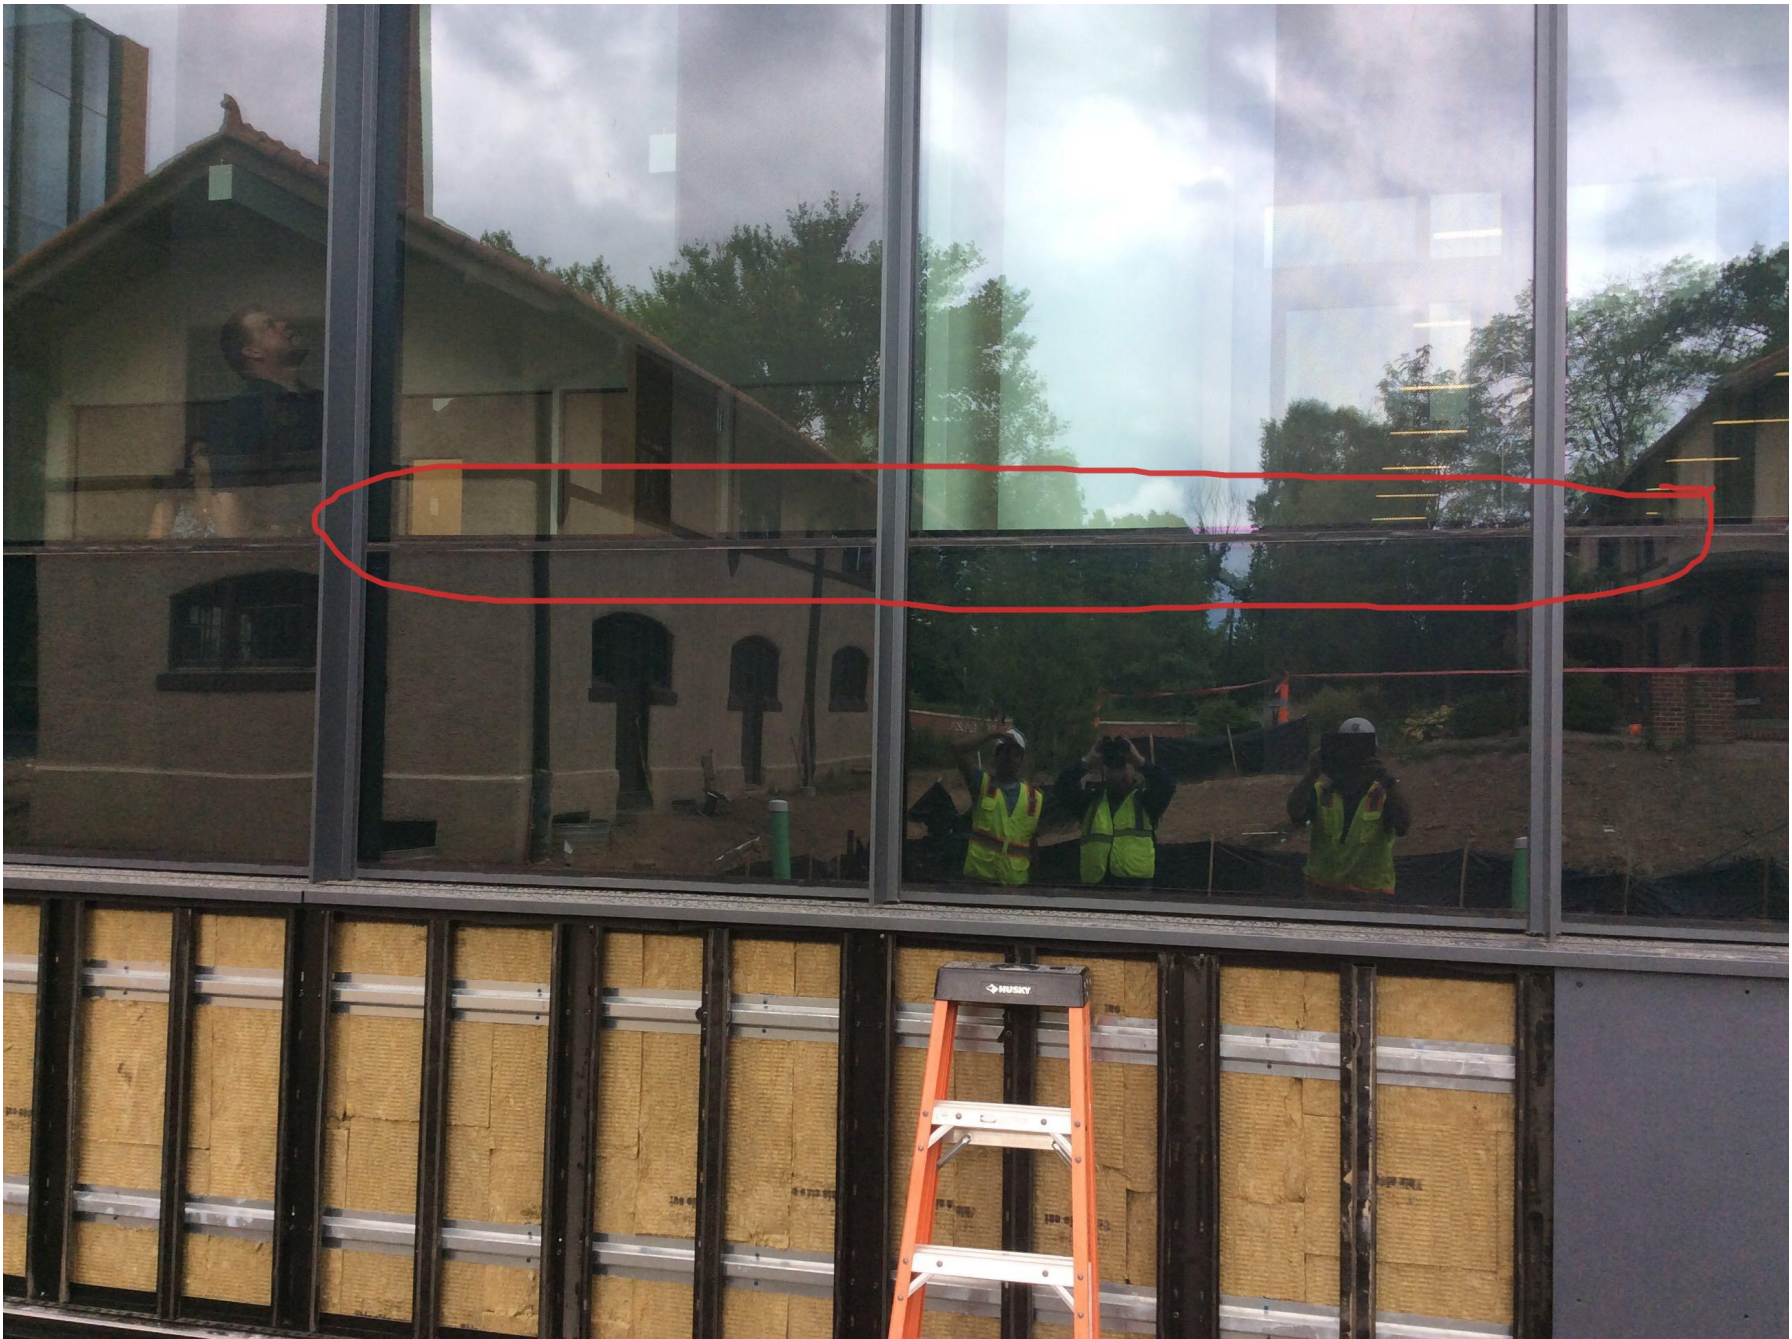
| Issue ID | Description | Location Detail | Location | Status | Company | Type | Date Created | Due Date |
|---|---|---|---|---|---|---|---|---|
| 002131 | Sealant needs to be consistent, not "bubbling" - north side above well | | Site | Open | National Glass & Glazing, Inc. | Architect Punch List | 07 Aug 2017 | 12 Aug 2017 |

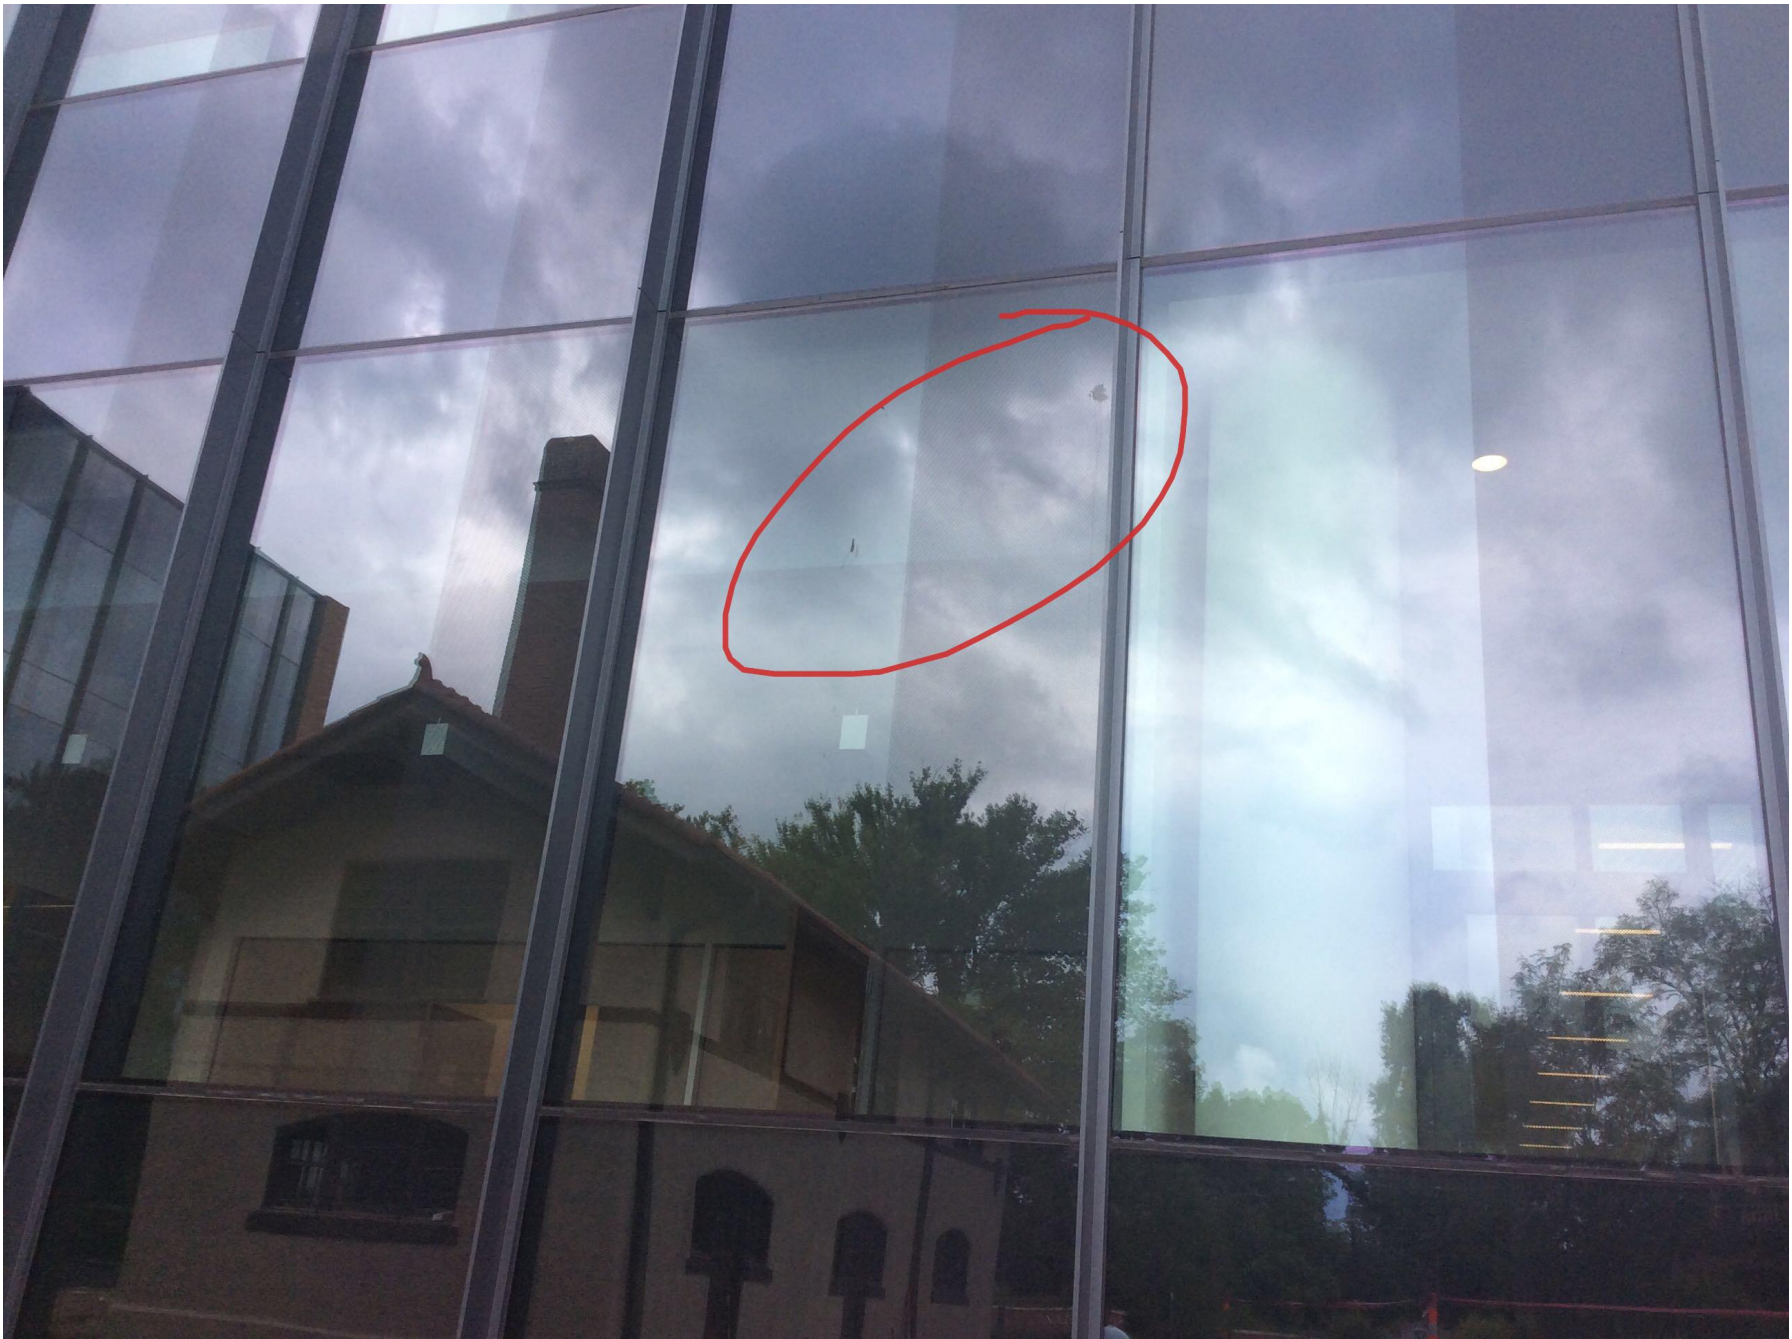
| Issue ID | Description | Location Detail | Location | Status | Company | Type | Date Created | Due Date |
|---|---|---|---|---|---|---|---|---|
| 002132 | Remove sealant from exterior of curtainwall | | Site | Open | National Glass & Glazing, Inc. | Architect Punch List | 07 Aug 2017 | 12 Aug 2017 |

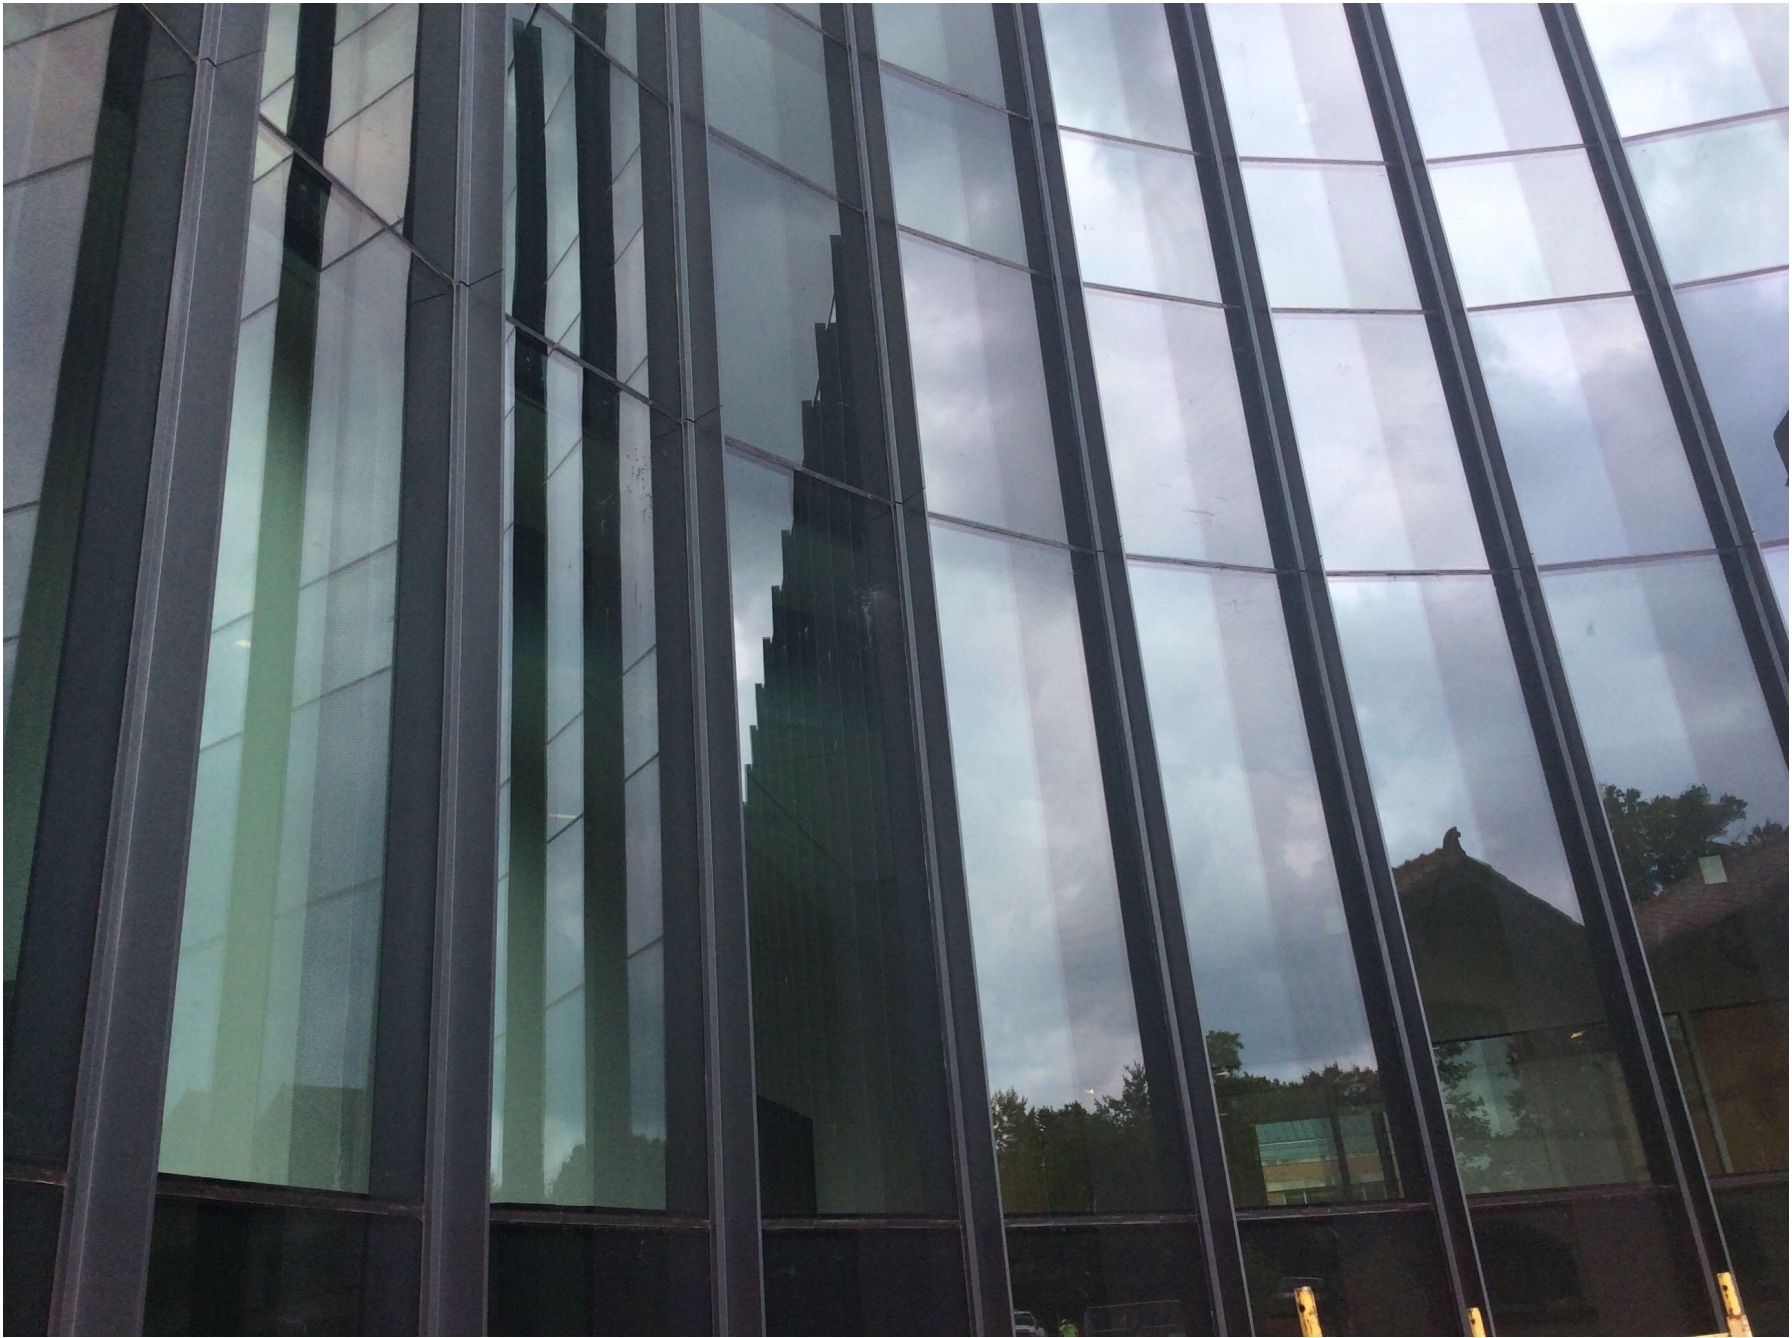
| Issue ID | Description | Location Detail | Location | Status | Company | Type | Date Created | Due Date |
|---|---|---|---|---|---|---|---|---|
| 002133 | Sealant needs to be consistent - north radius | | Site | Open | National Glass & Glazing, Inc. | Architect Punch List | 07 Aug 2017 | 12 Aug 2017 |
