## **ARCHITECTURAL PUNCH LIST (EXTERIOR FAÇADE & ROOF)**

**Project:** Webster University Interdisciplinary Science Building

**Project No:** CannonDesign #004561.01

**Date of Observation:** August 7, 2017

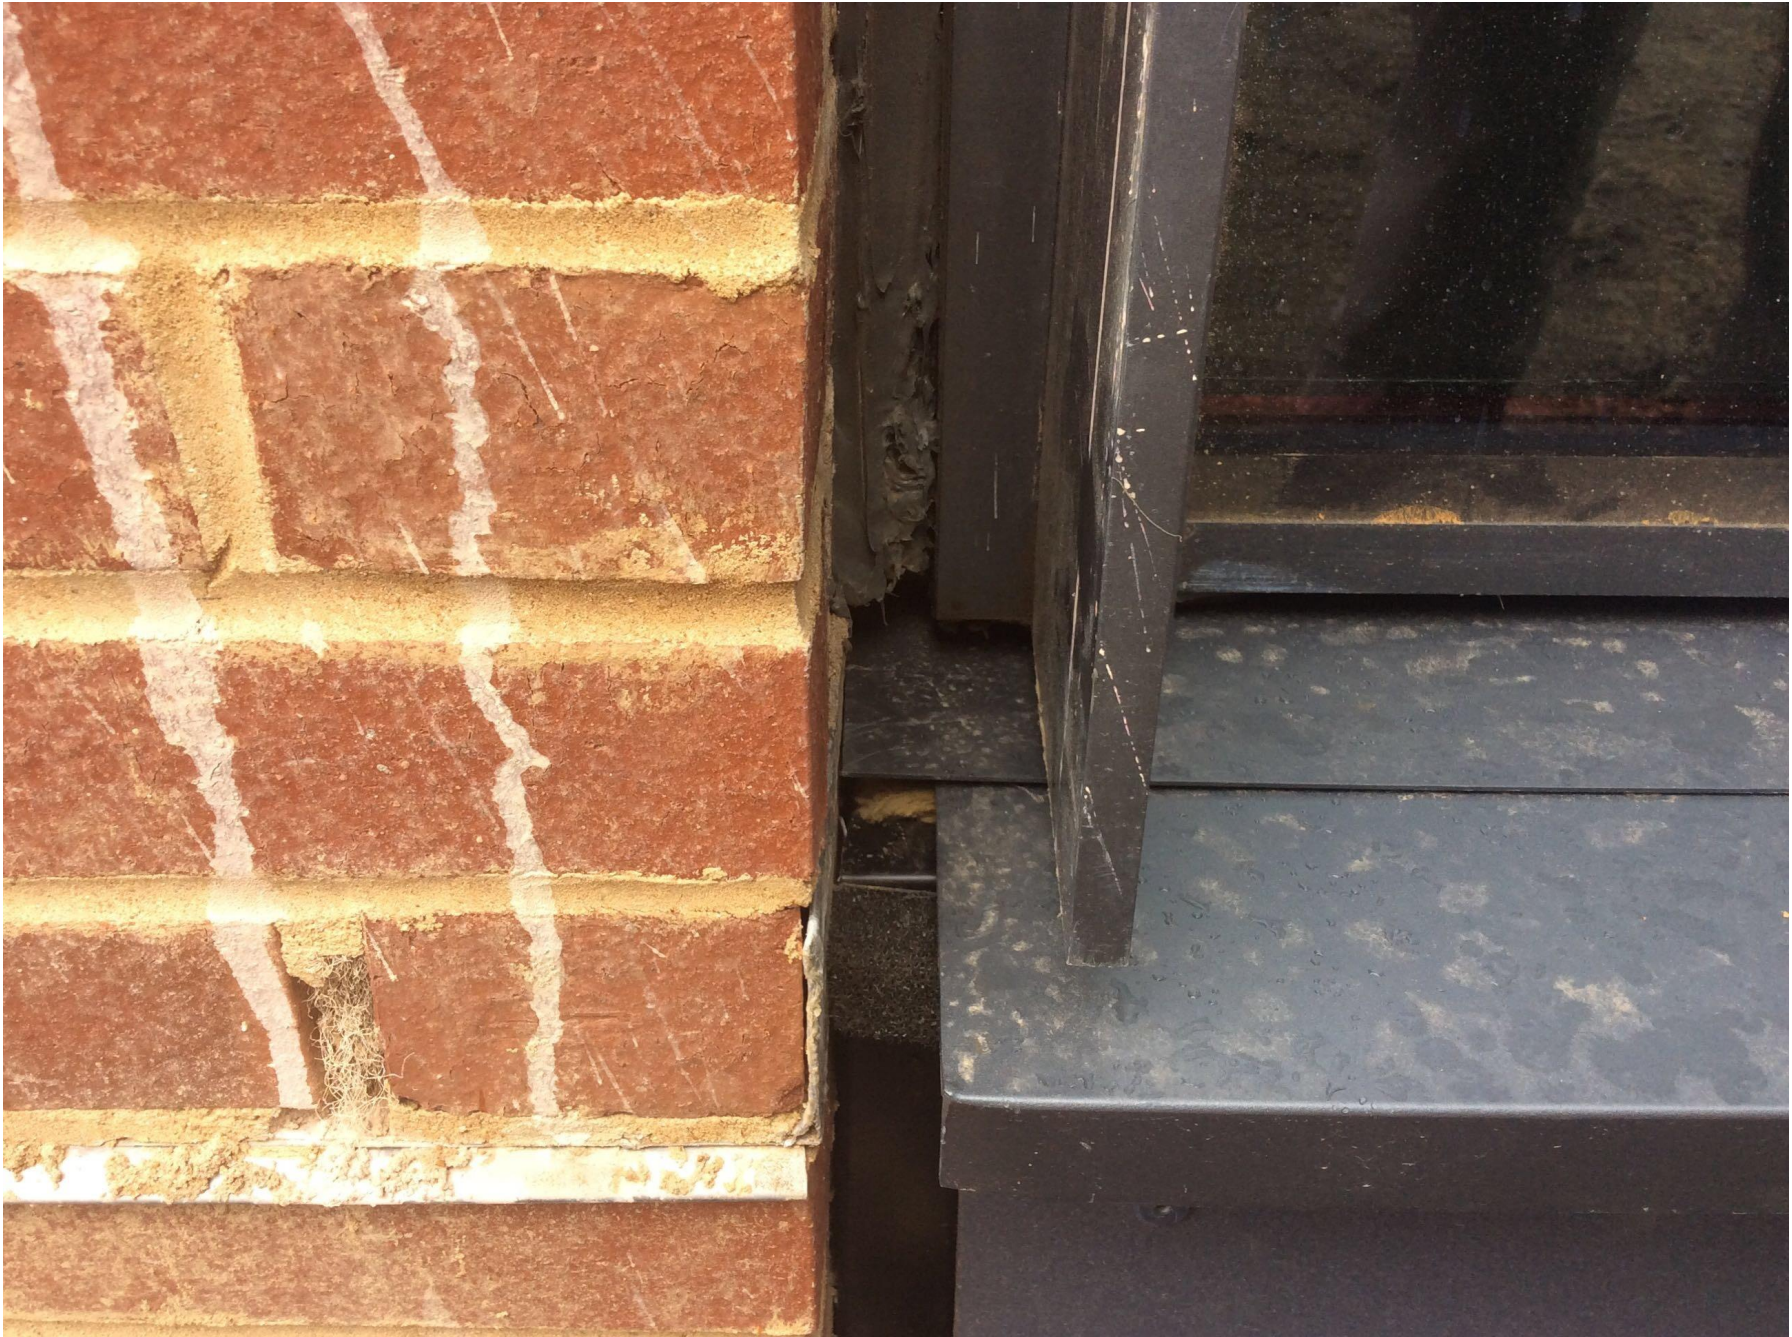
| Issue ID | Description | Location Detail | Location | Status | Company | Type | Date Created | Due Date |
|---|---|---|---|---|---|---|---|---|
| 002134 | Cleanup sealant joint curtainwall to masonry | | Site | Open | National Glass & Glazing, Inc. | Architect Punch List | 07 Aug 2017 | 12 Aug 2017 |

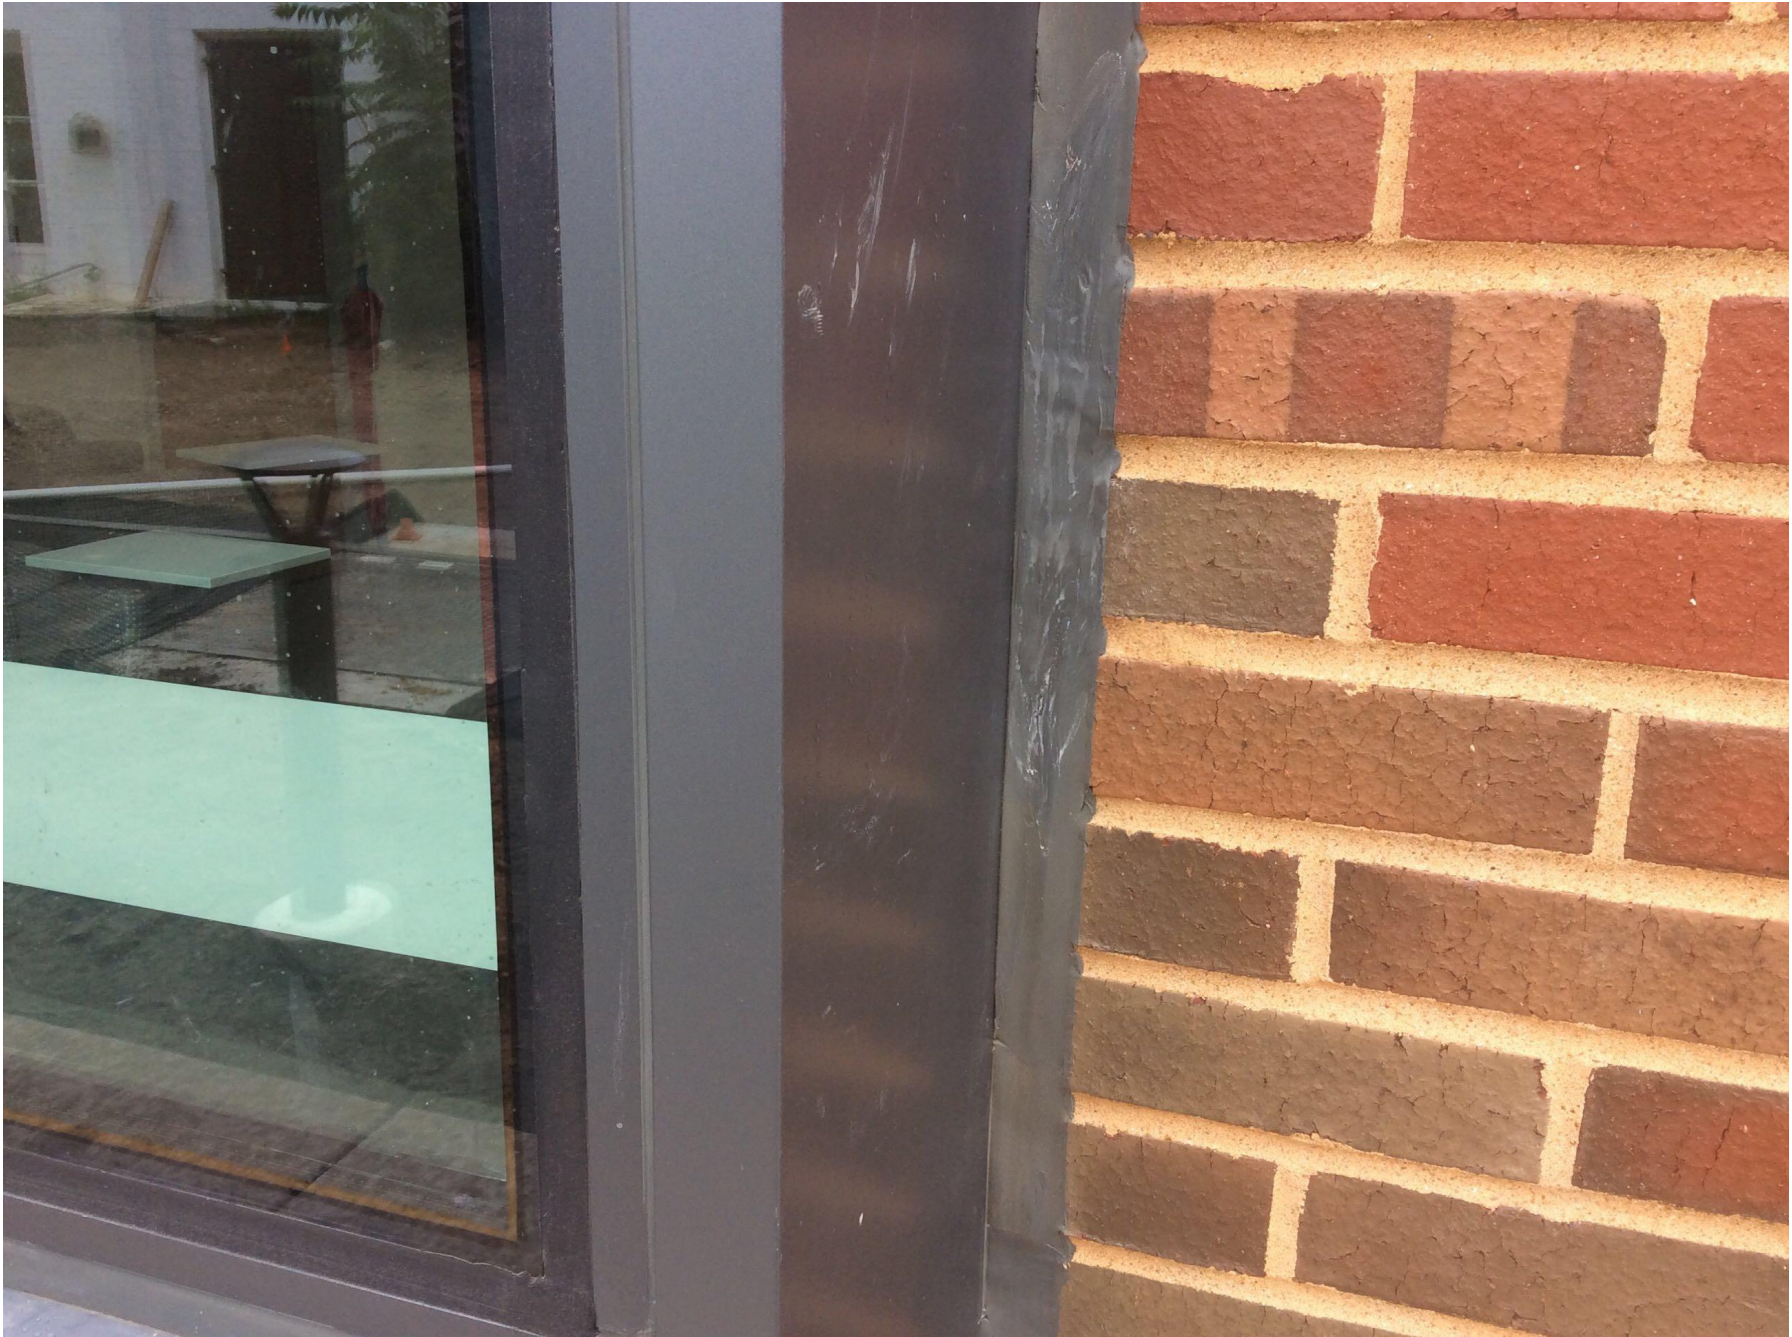
| Issue ID | Description | Location Detail | Location | Status | Company | Type | Date Created | Due Date |
|---|---|---|---|---|---|---|---|---|
| 002136 | Repair substandard sealant at north window | | Site | Open | National Glass & Glazing, Inc. | Architect Punch List | 07 Aug 2017 | 12 Aug 2017 |

At north vertical window, the vertical sealant joints along the jambs are wider and does not conform to documents. The sealant has to be tooled to have smooth consistent finish.

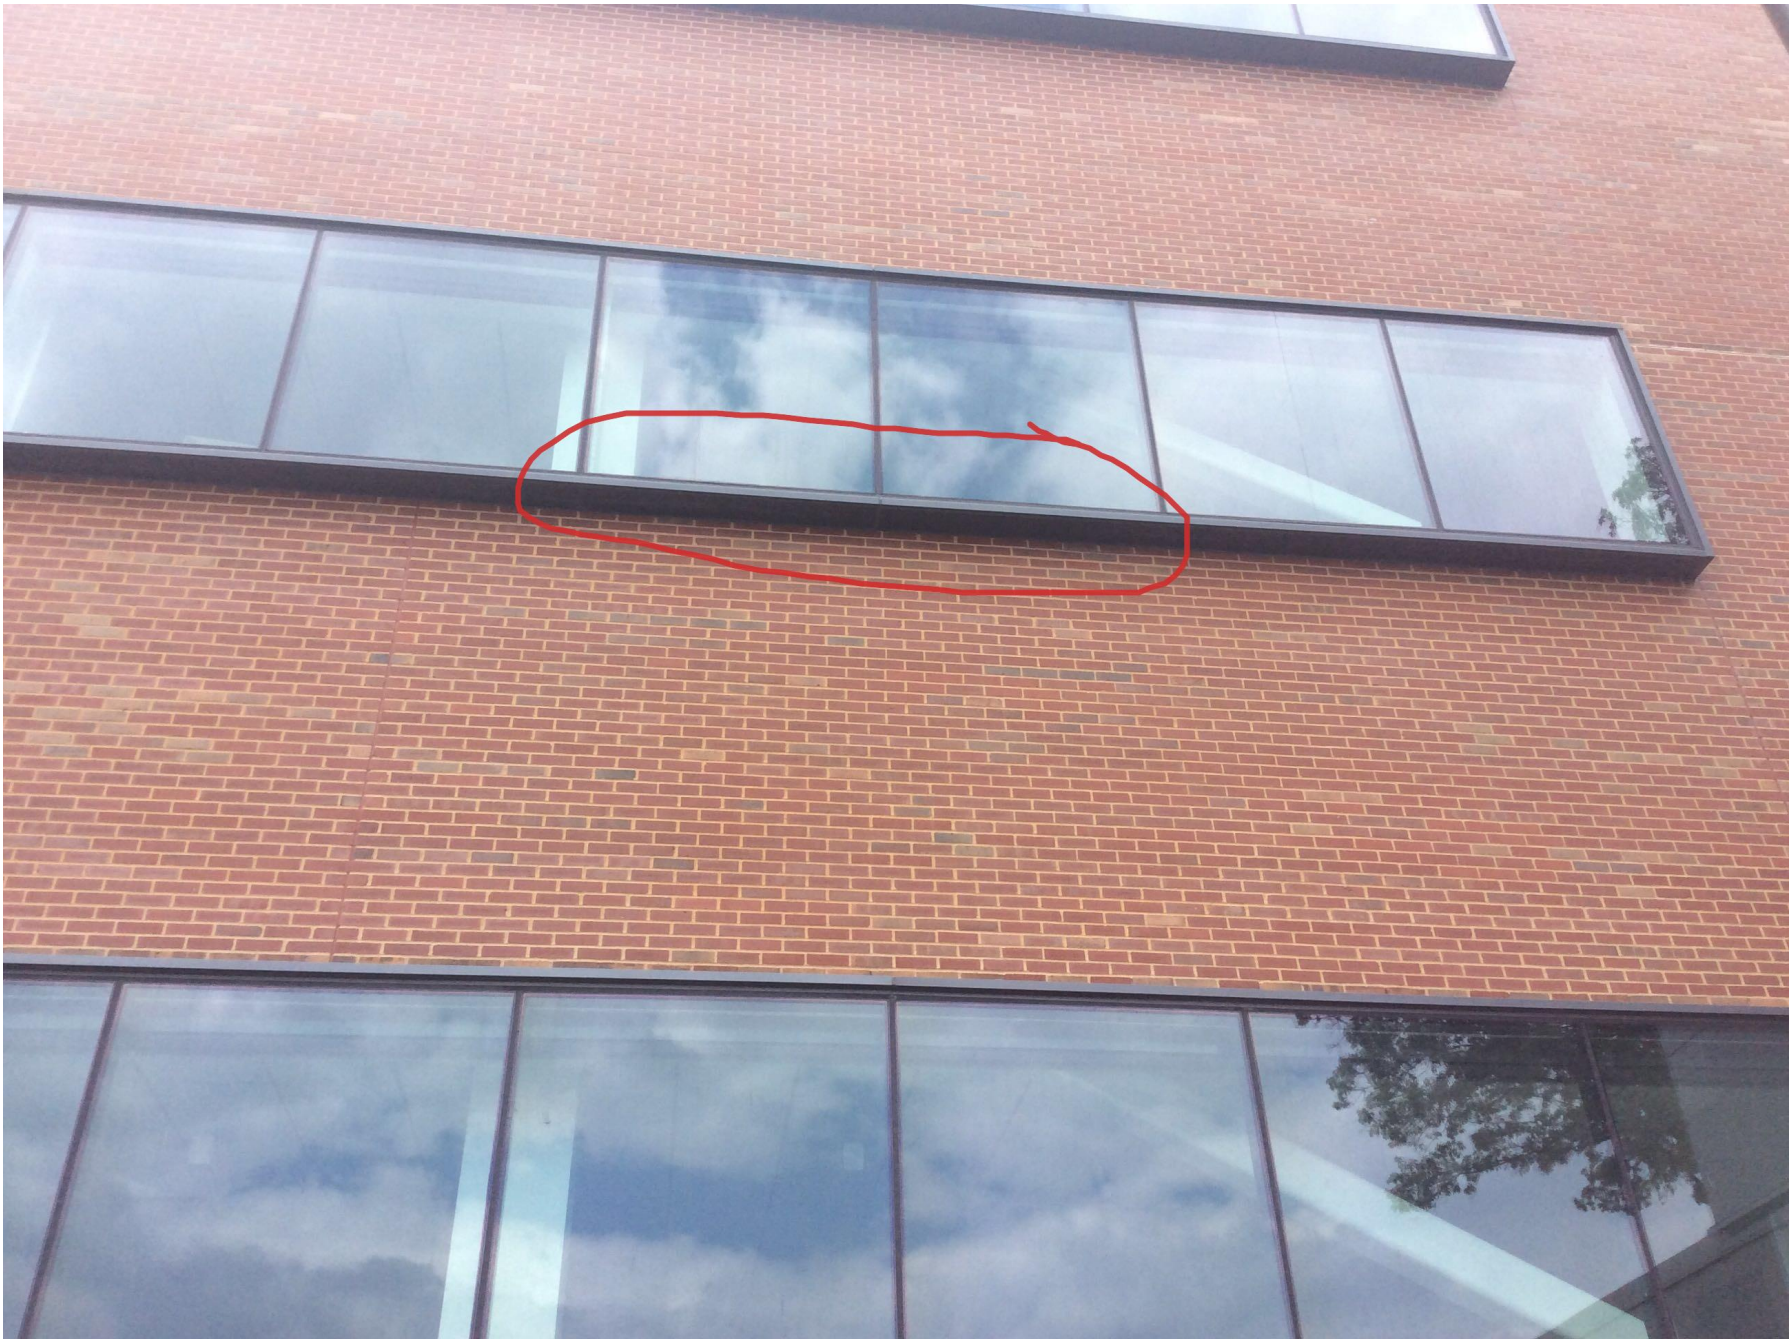
| Issue ID | Description | Location Detail | Location | Status | Company | Type | Date Created | Due Date |
|---|---|---|---|---|---|---|---|---|
| 002141 | Clean bottom of projected window - east | | Site | Open | National Glass & Glazing, Inc. | Architect Punch List | 07 Aug 2017 | 12 Aug 2017 |

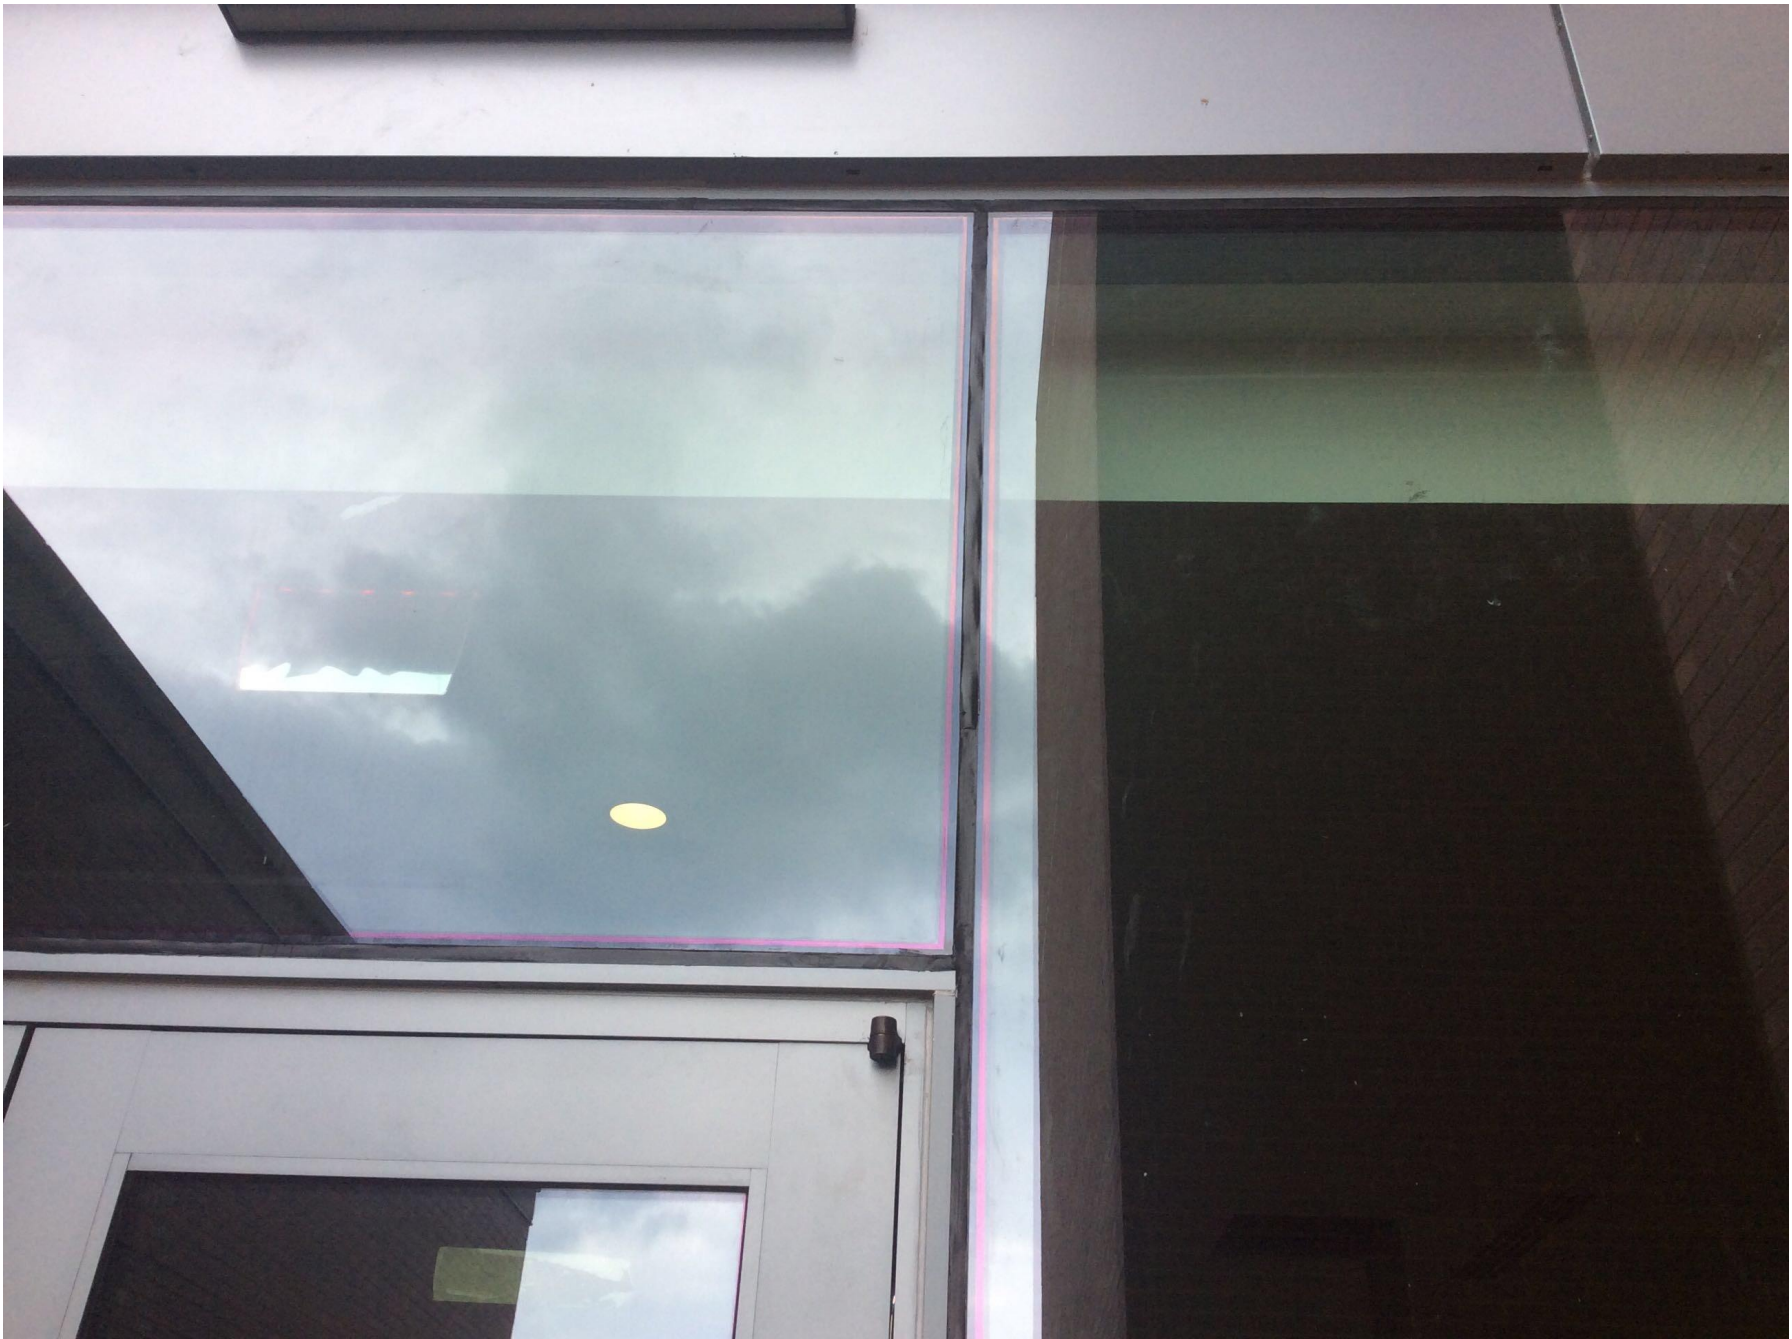
| Issue ID | Description | Location Detail | Location | Status | Company | Type | Date Created | Due Date |
|---|---|---|---|---|---|---|---|---|
| 002150 | Touchup sealant at curtainwall - eab connector - east | | Site | Open | National Glass & Glazing, Inc. | Architect Punch List | 07 Aug 2017 | 12 Aug 2017 |

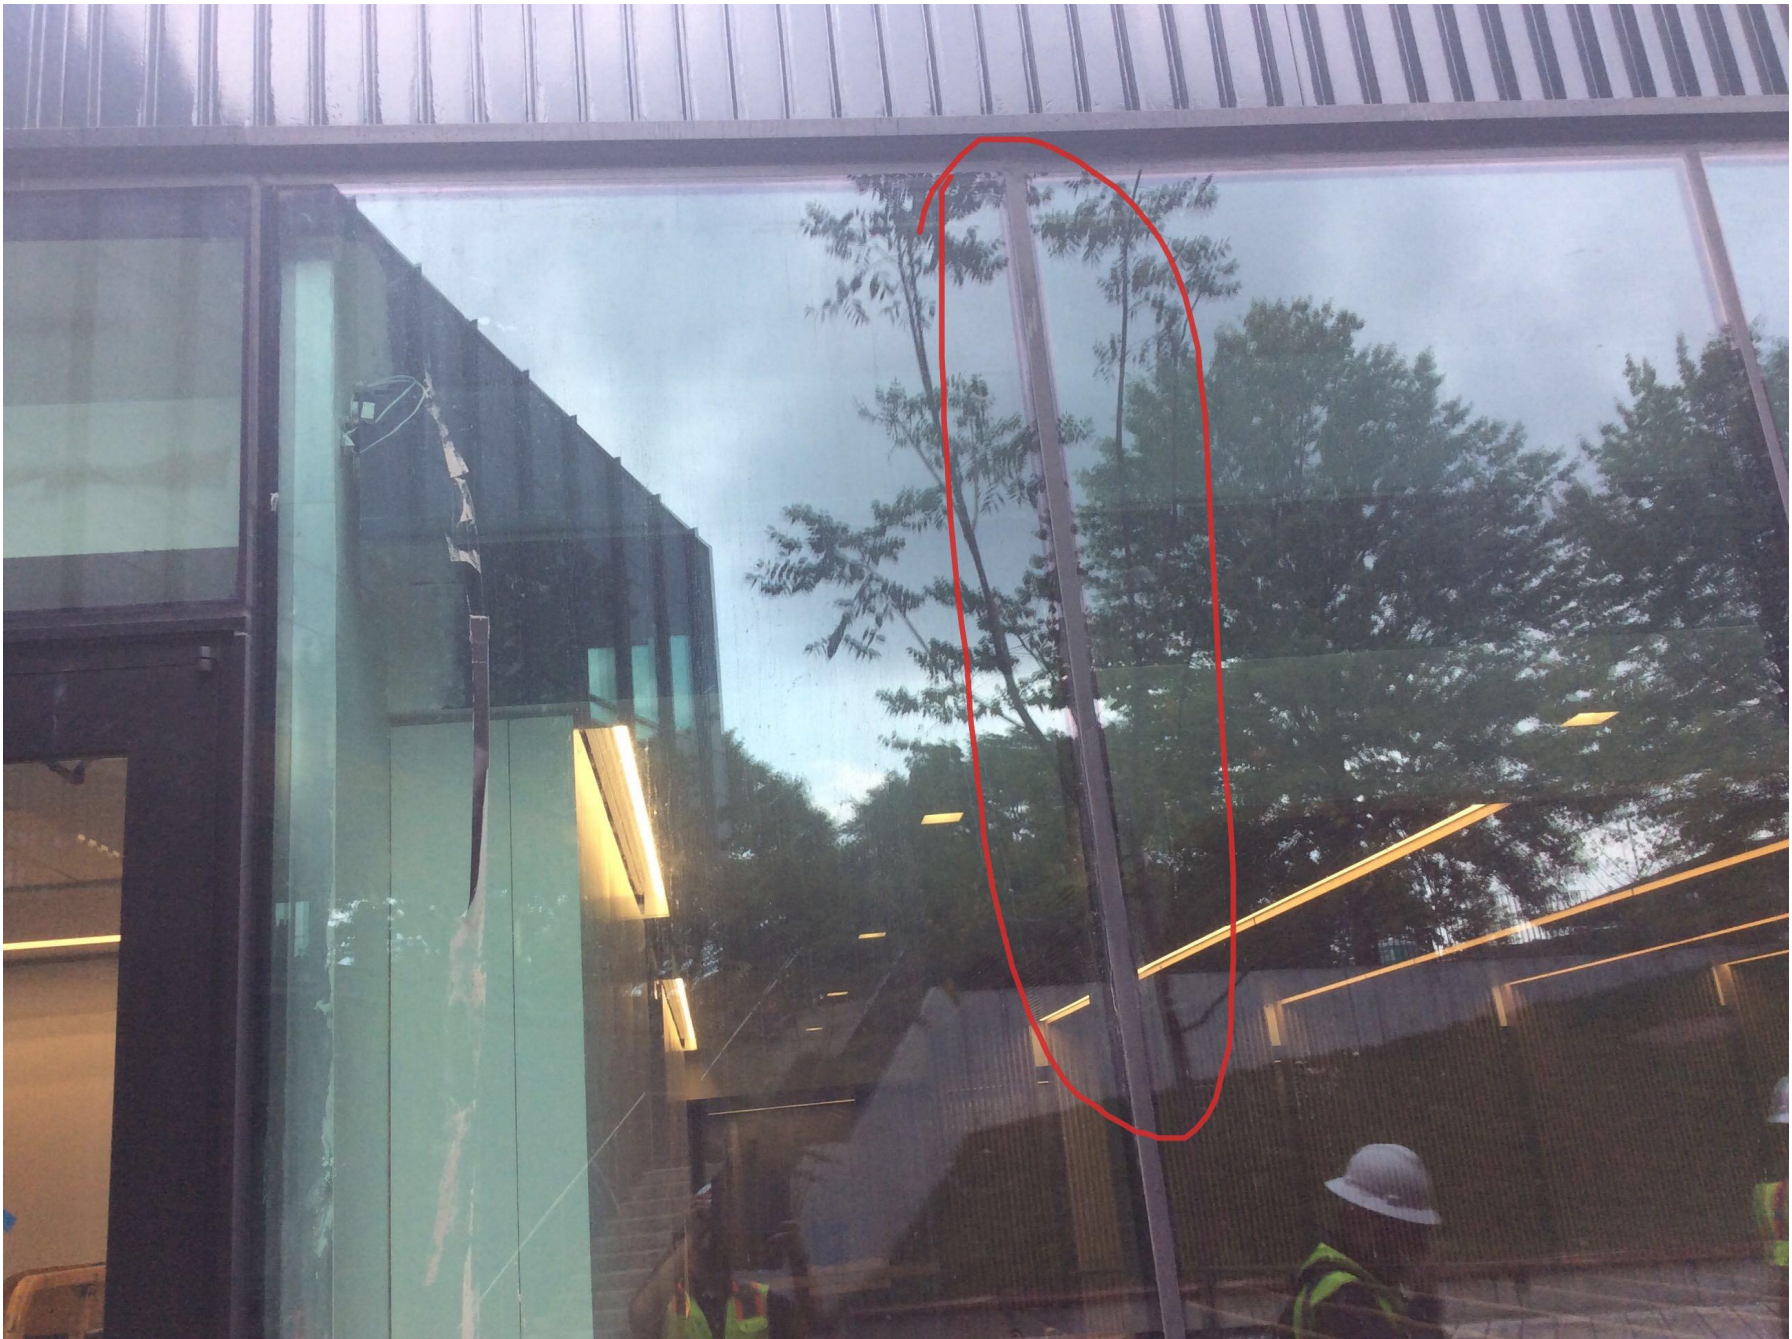
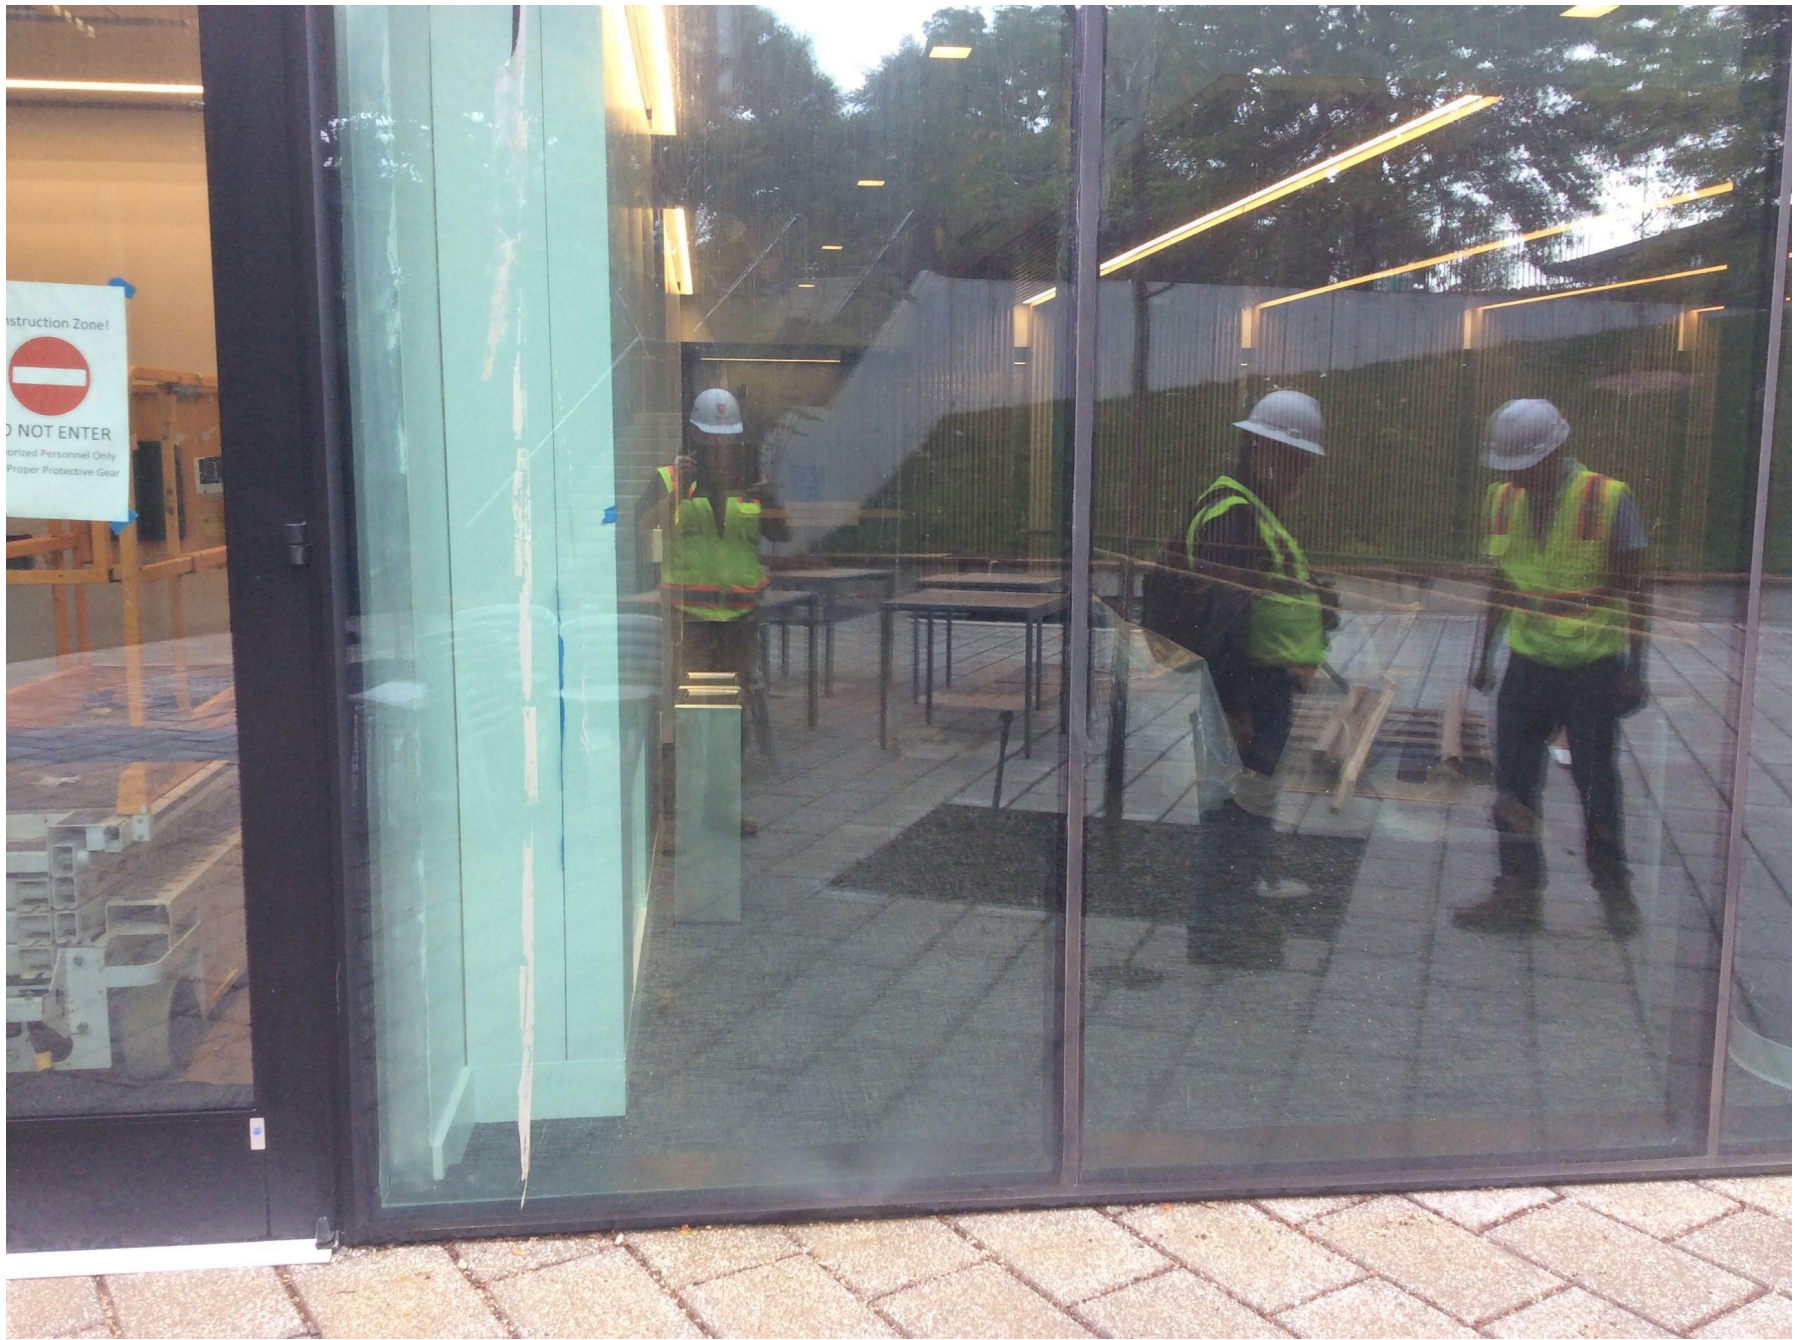
| Issue ID | Description | Location Detail | Location | Status | Company | Type | Date Created | Due Date |
|---|---|---|---|---|---|---|---|---|
| 002158 | Confirm why joint is larger at this location, - courtyard | | Site | Open | National Glass & Glazing, Inc. | Architect Punch List | 07 Aug 2017 | 12 Aug 2017 |

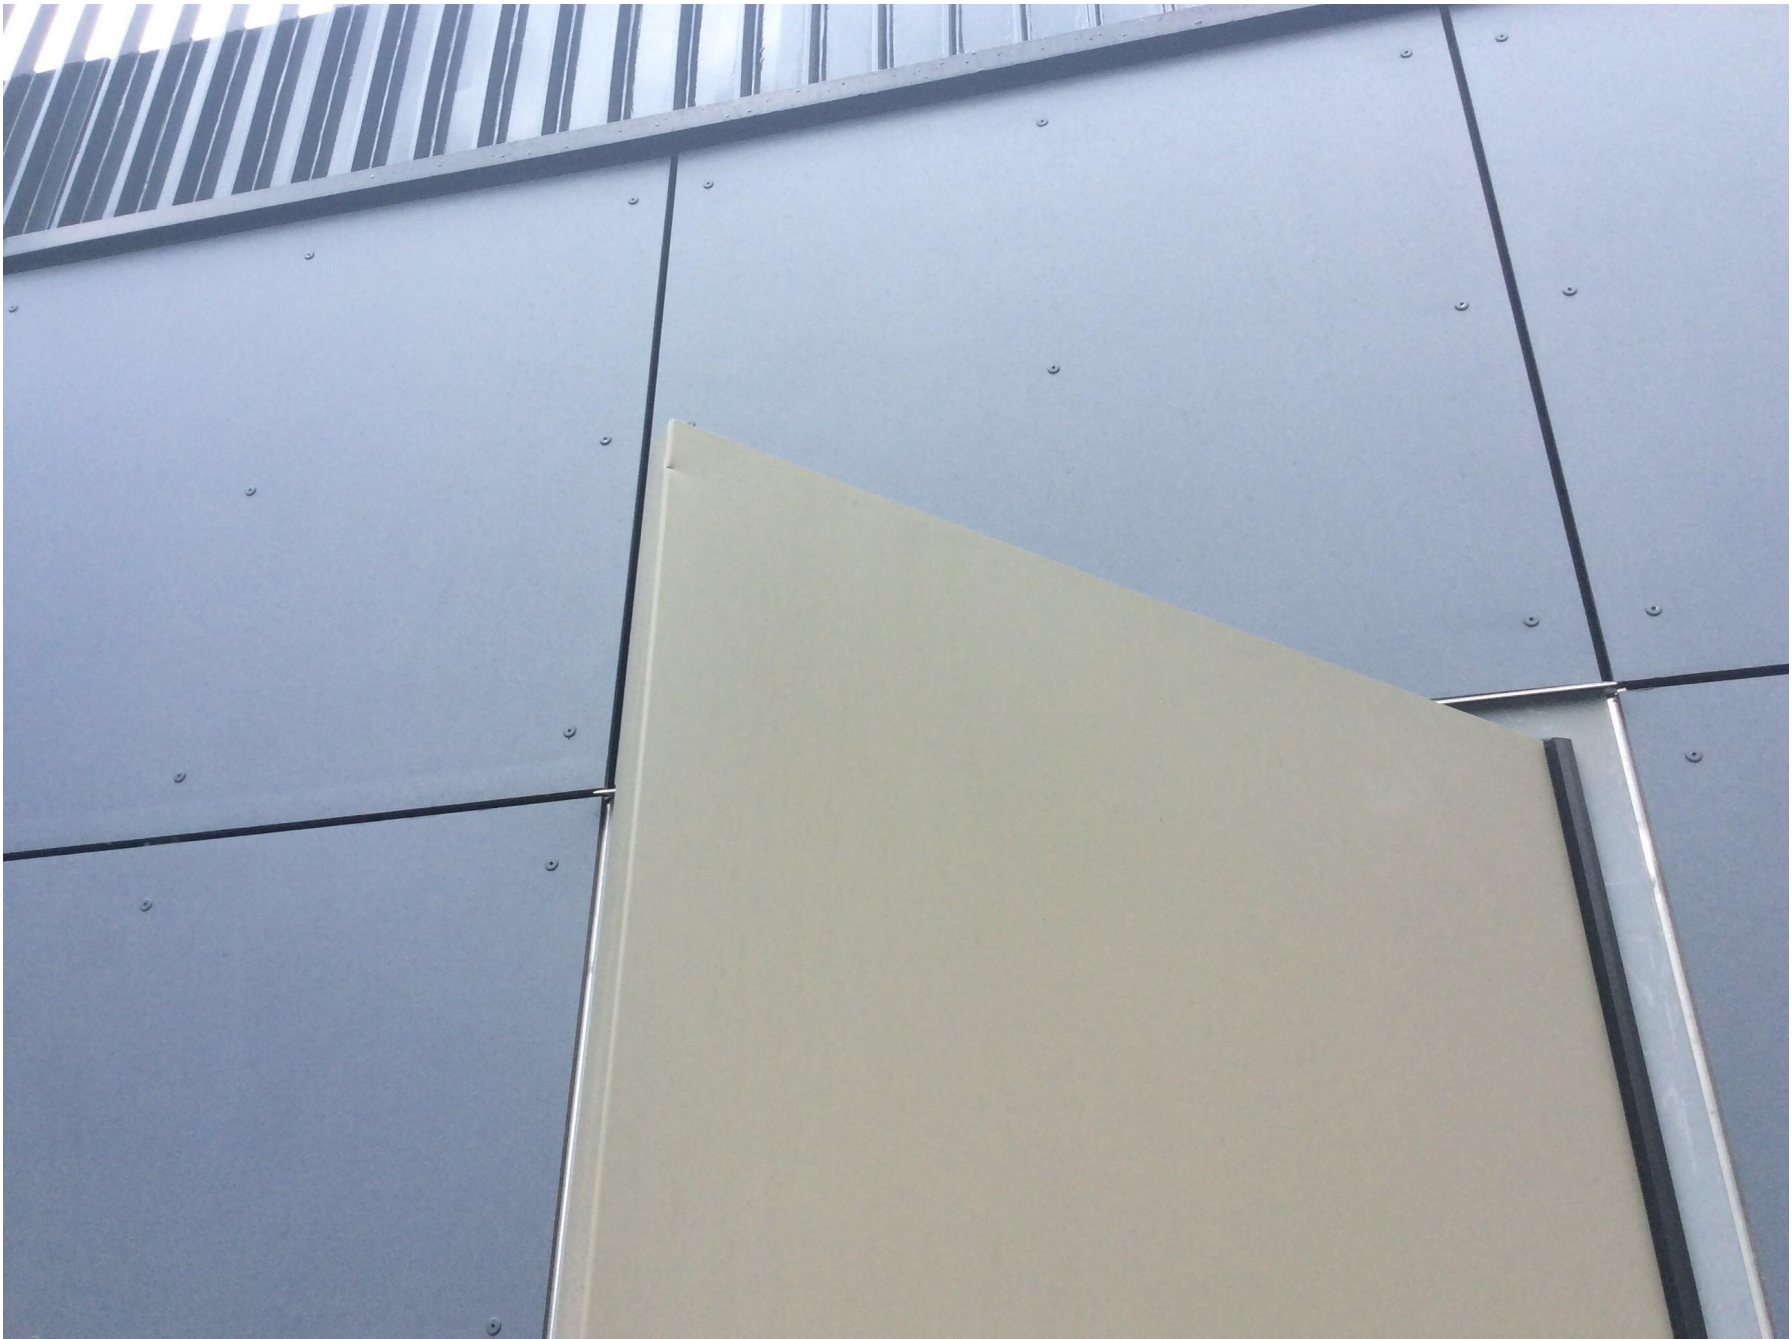
| Issue ID | Description | Location Detail | Location | Status | Company | Type | Date Created | Due Date |
|---|---|---|---|---|---|---|---|---|
| 002159 | Dent in door - courtyard | | Site | Open | PARIC (Self-Perform) | Architect Punch List | 07 Aug 2017 | 12 Aug 2017 |

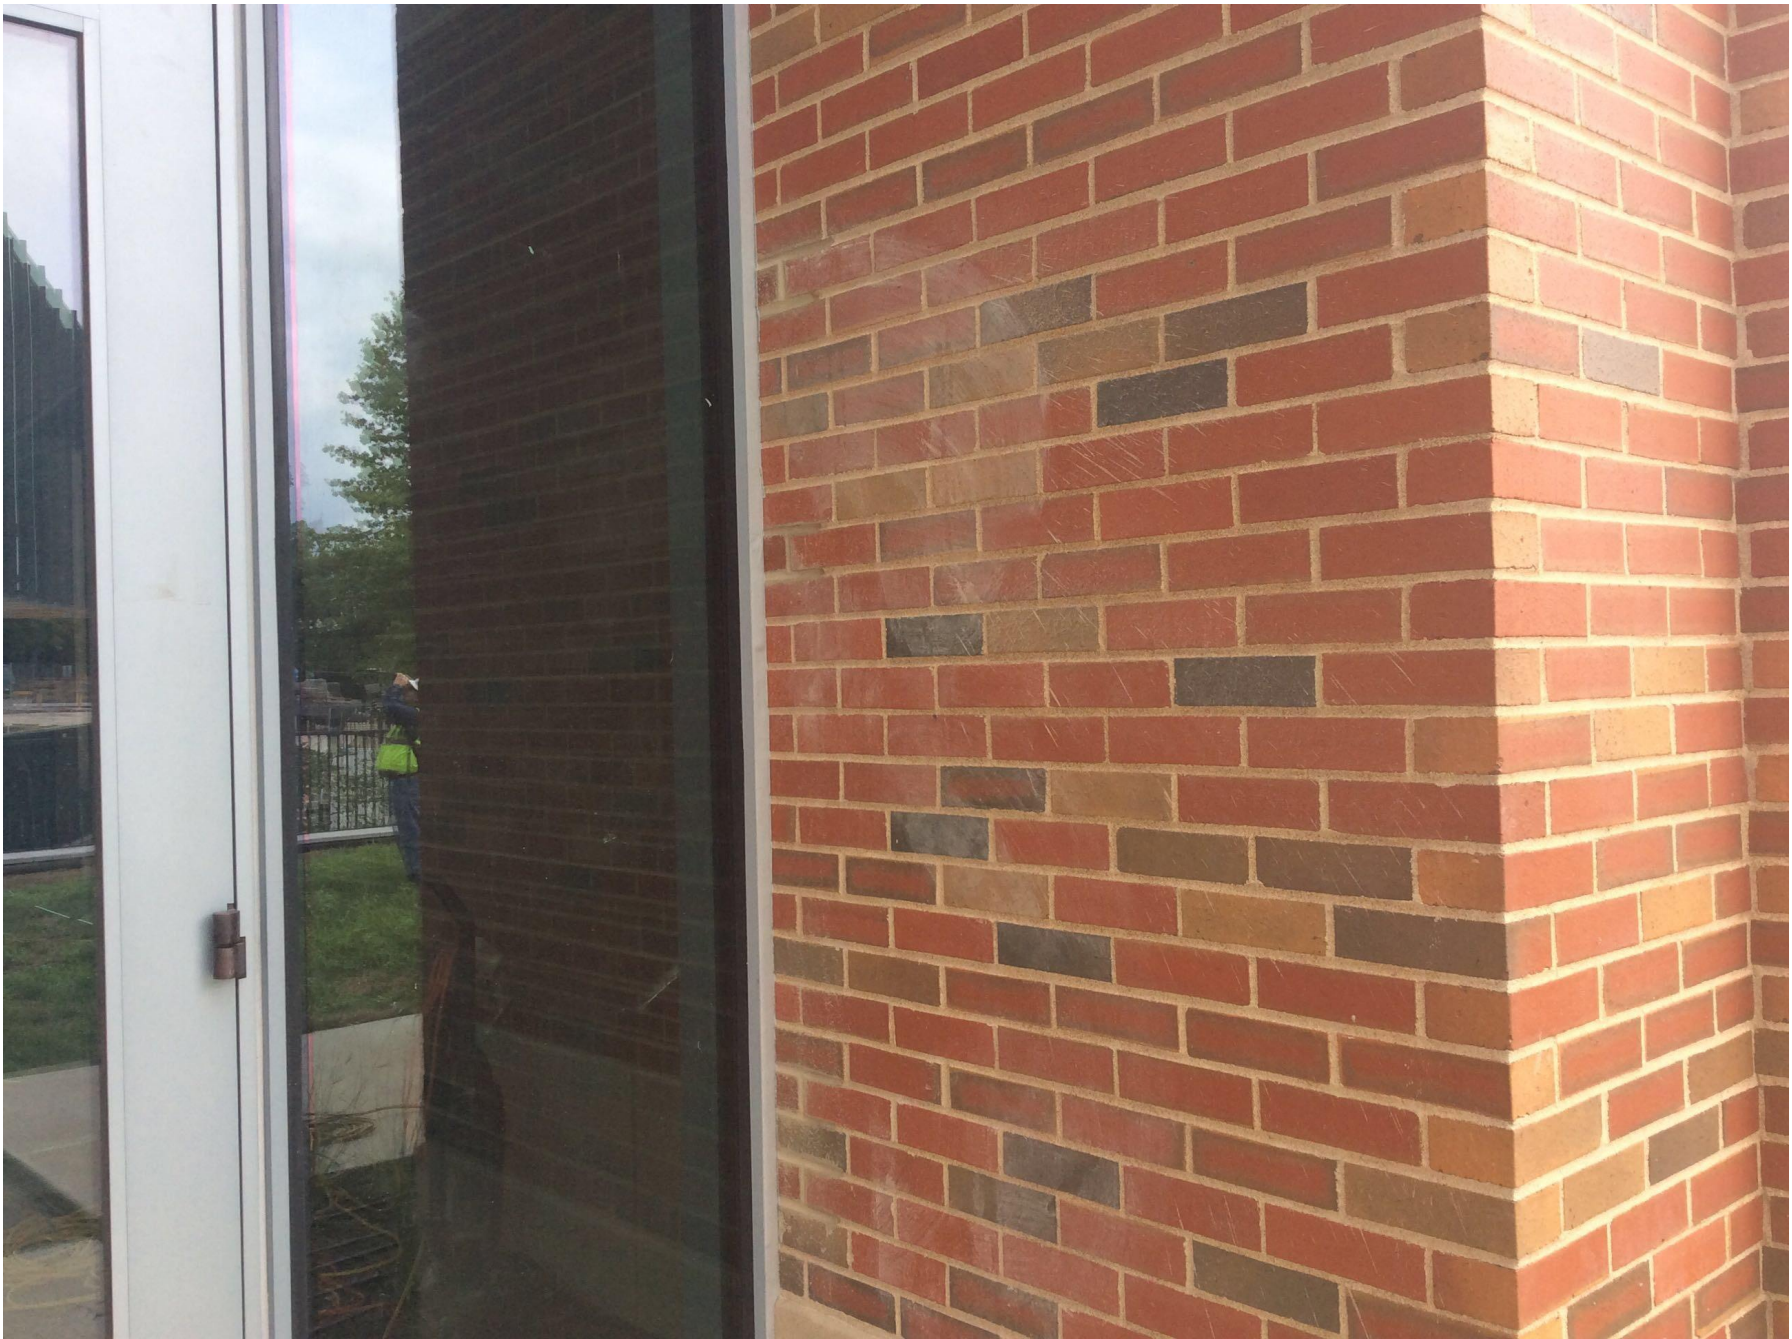
| Issue ID | Description | Location Detail | Location | Status | Company | Type | Date Created | Due Date |
|---|---|---|---|---|---|---|---|---|
| 002121 | Clean dirt from eab masonry - west eab connector | | Site | Open | Paric Corp. | Architect Punch List | 07 Aug 2017 | 12 Aug 2017 |

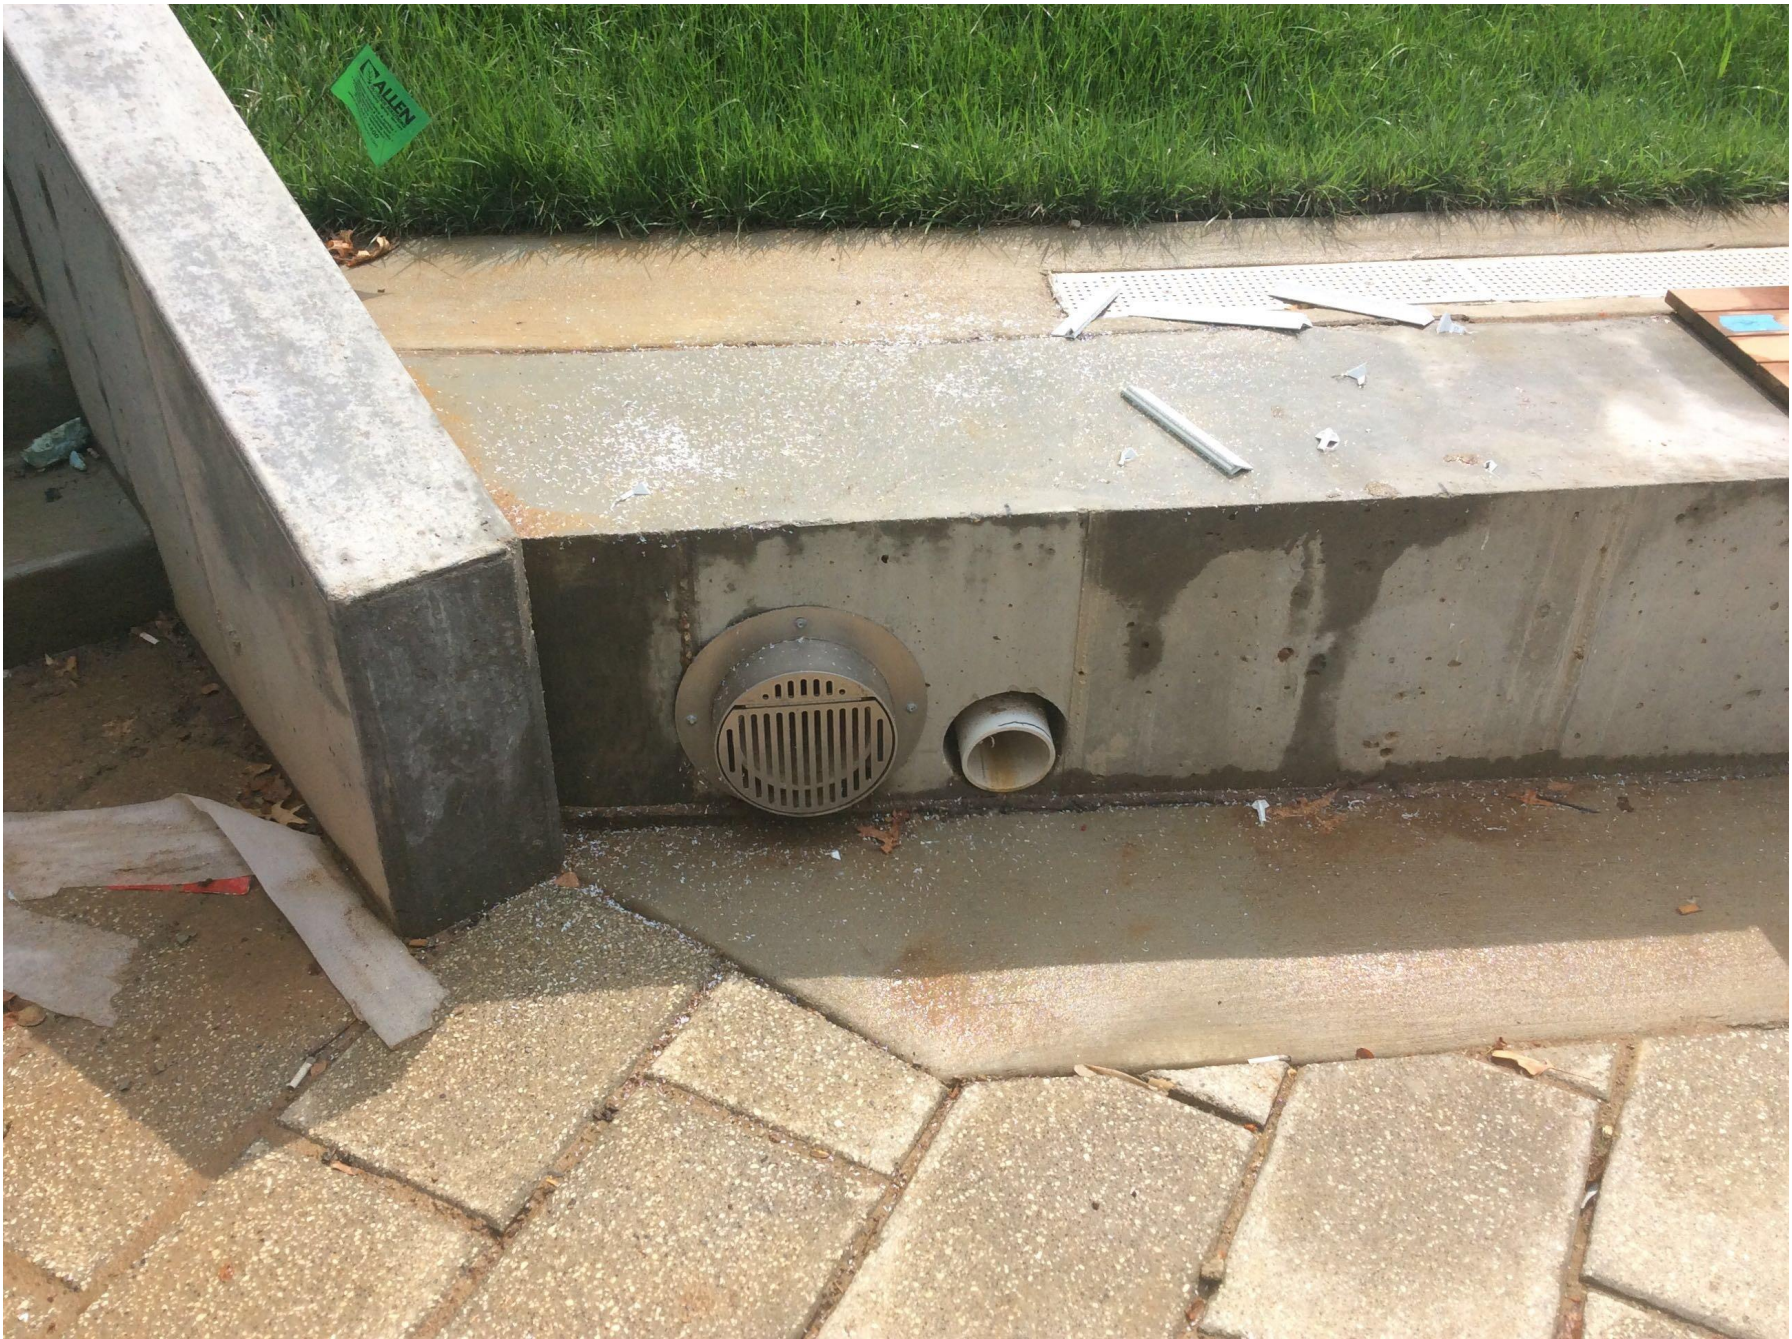
| Issue ID | Description | Location Detail | Location | Status | Company | Type | Date Created | Due Date |
|---|---|---|---|---|---|---|---|---|
| 002160 | Need cover at drain - scope?<br><br>For <u>both</u> exposed drains at each end of the seating wall. | | Site | Open | Paric Corp. | Architect<br>Punch List | 07 Aug 2017 | 12 Aug 2017 |
