## **ARCHITECTURAL PUNCH LIST (EXTERIOR FAÇADE & ROOF)**

**Project:** Webster University Interdisciplinary Science Building

**Project No:** CannonDesign #004561.01

**Date of Observation:** August 7, 2017

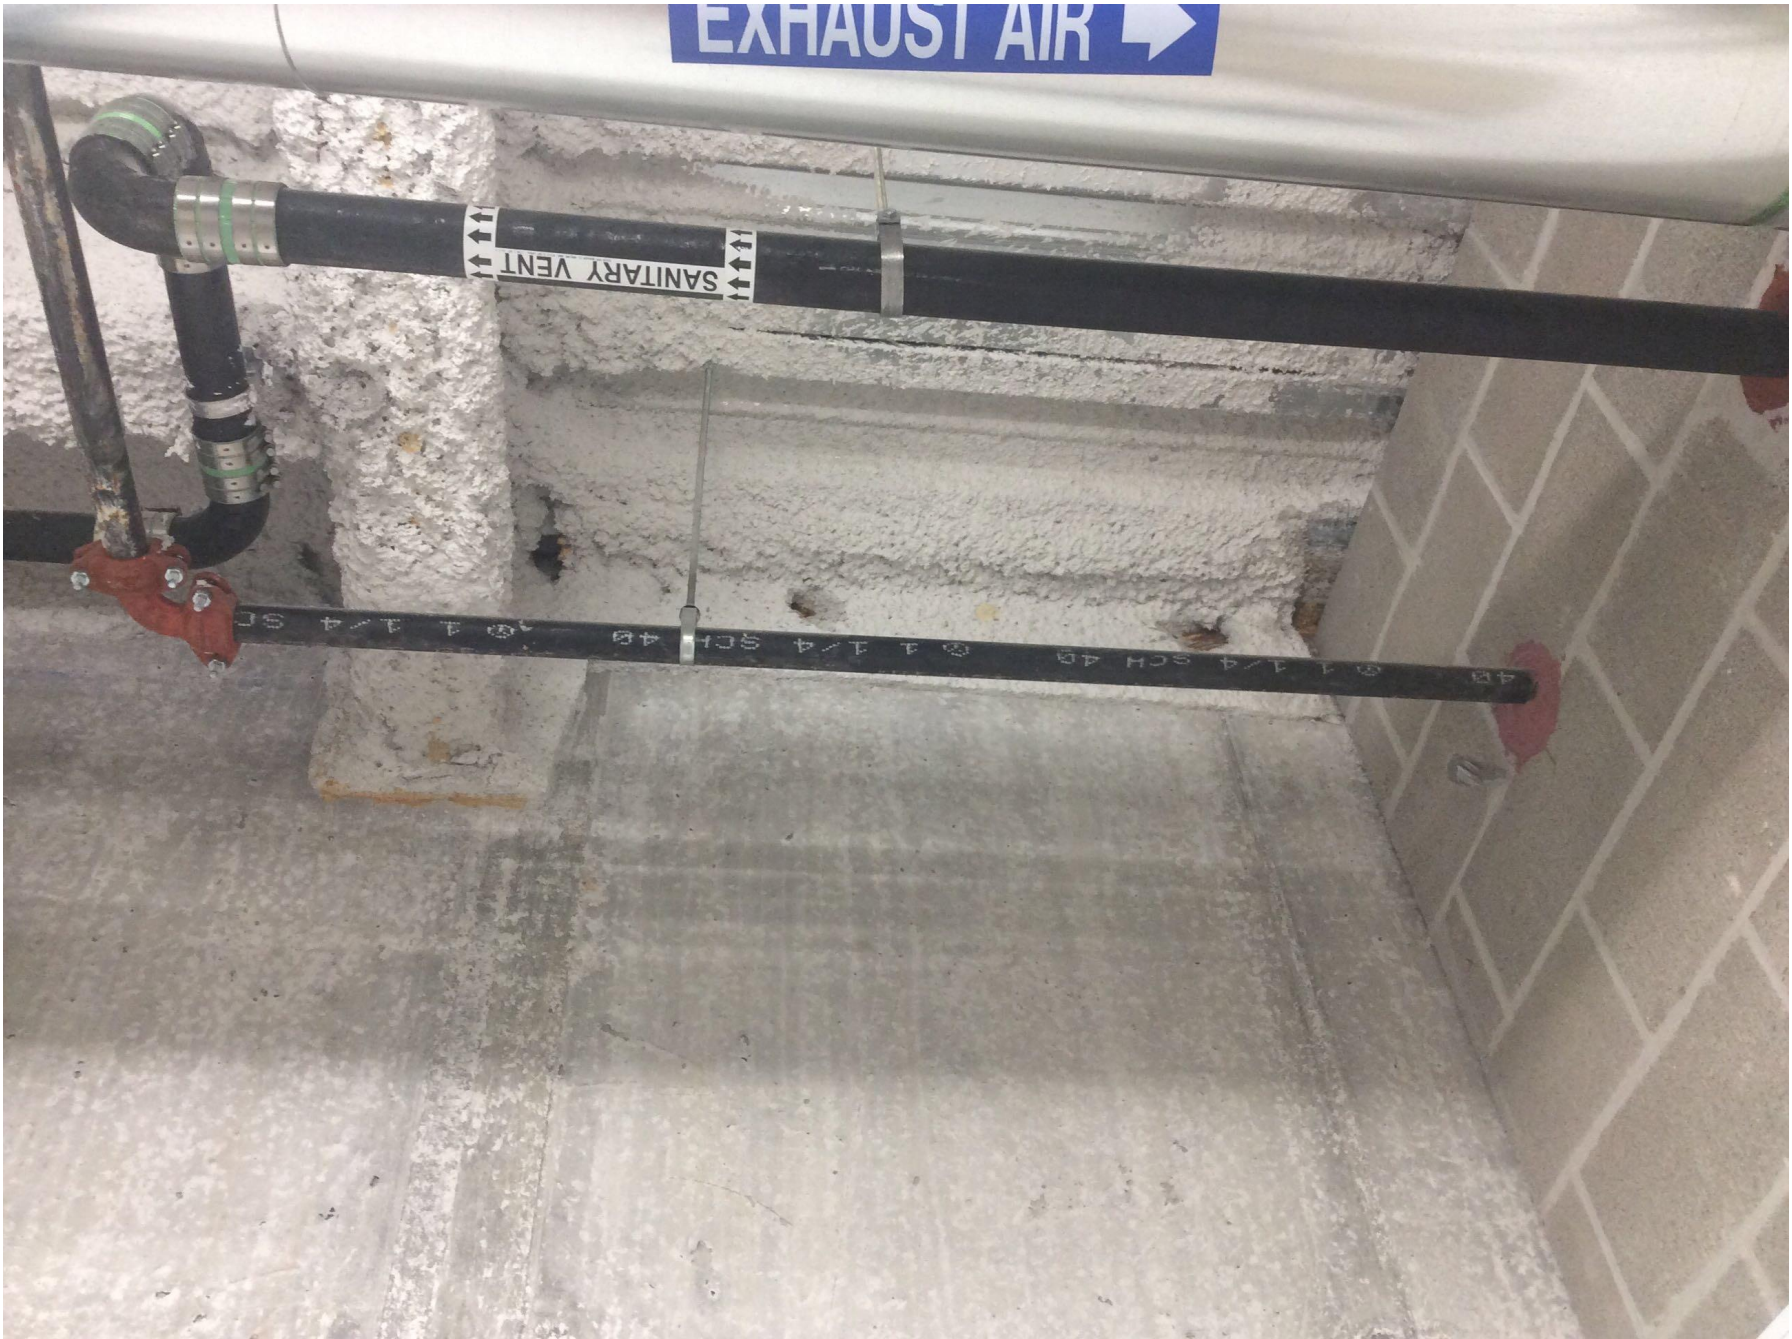
| Issue ID | Description | Location Detail | Location | Status | Company | Type | Date Created | Due Date |
|---|---|---|---|---|---|---|---|---|
| 002164 | Touchup fireproofing | | Webster > LEVEL_01 > 172A_RECYCLING | Open | Phillips Co. | Architect Punch List | 07 Aug 2017 | 12 Aug 2017 |

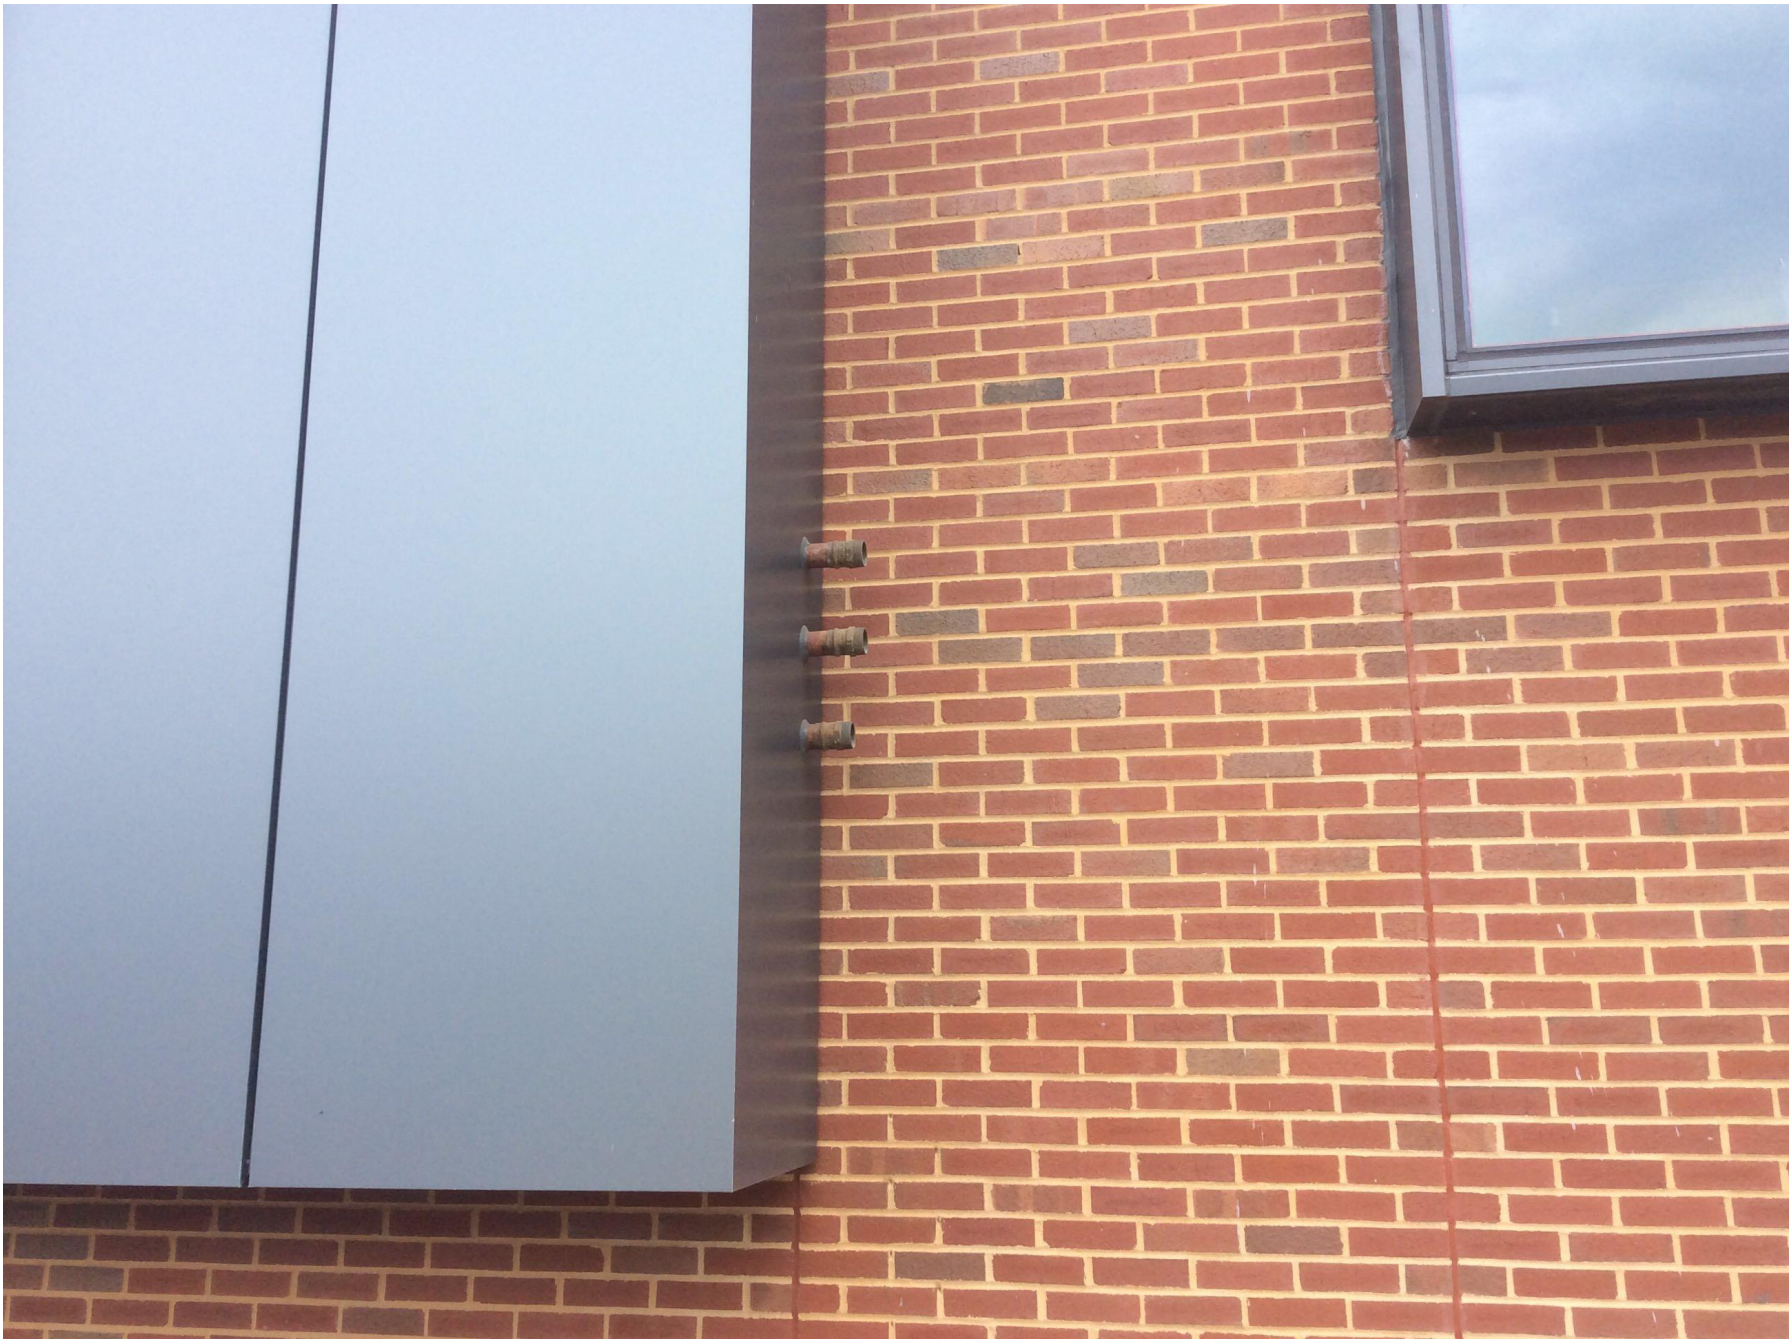
| Issue ID | Description | Location Detail | Location | Status | Company | Type | Date Created | Due Date |
|---|---|---|---|---|---|---|---|---|
| 002143 | Paint pipes to match metal panels | | Site | Open | Spectra Painting | Architect Punch List | 07 Aug 2017 | 12 Aug 2017 |

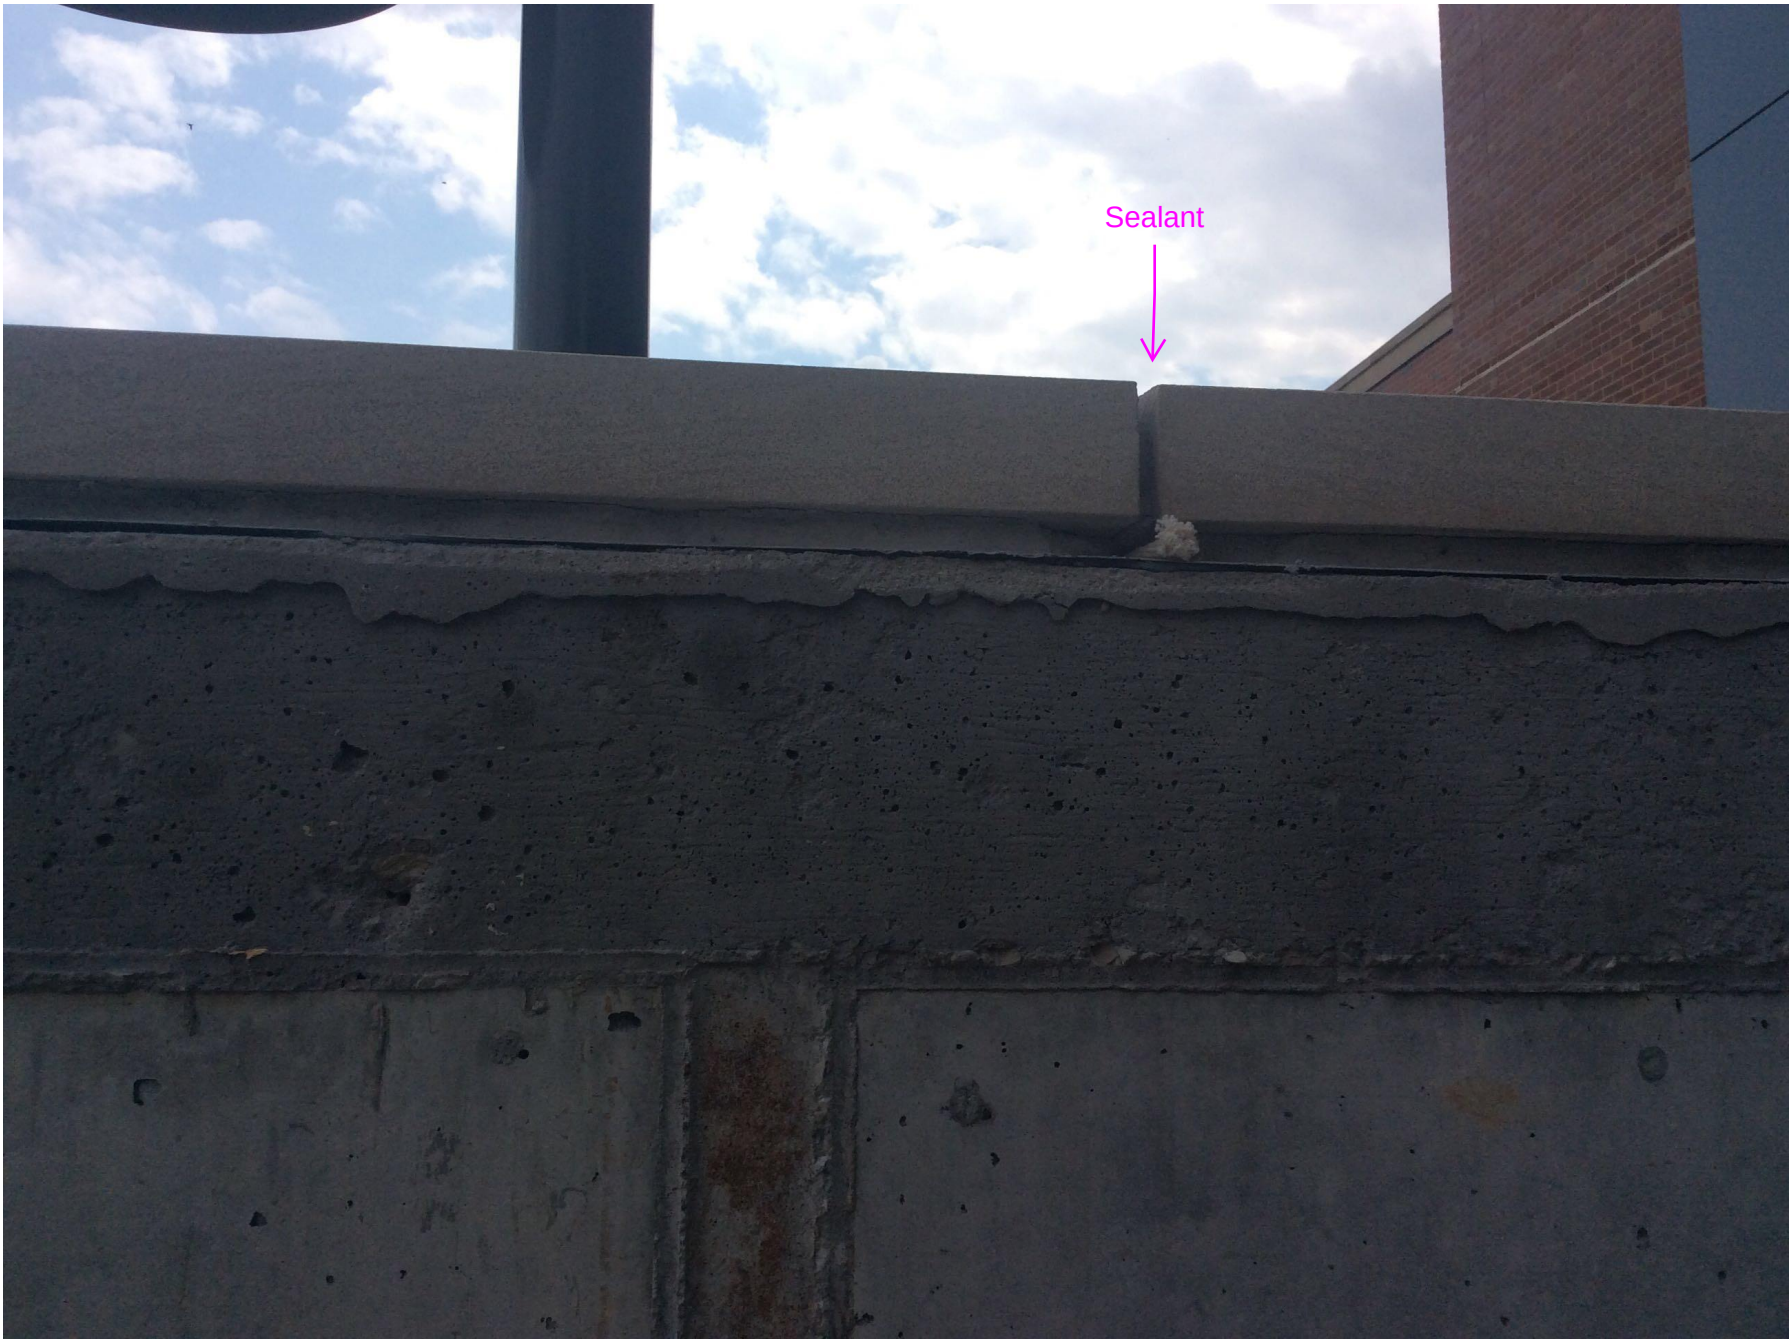
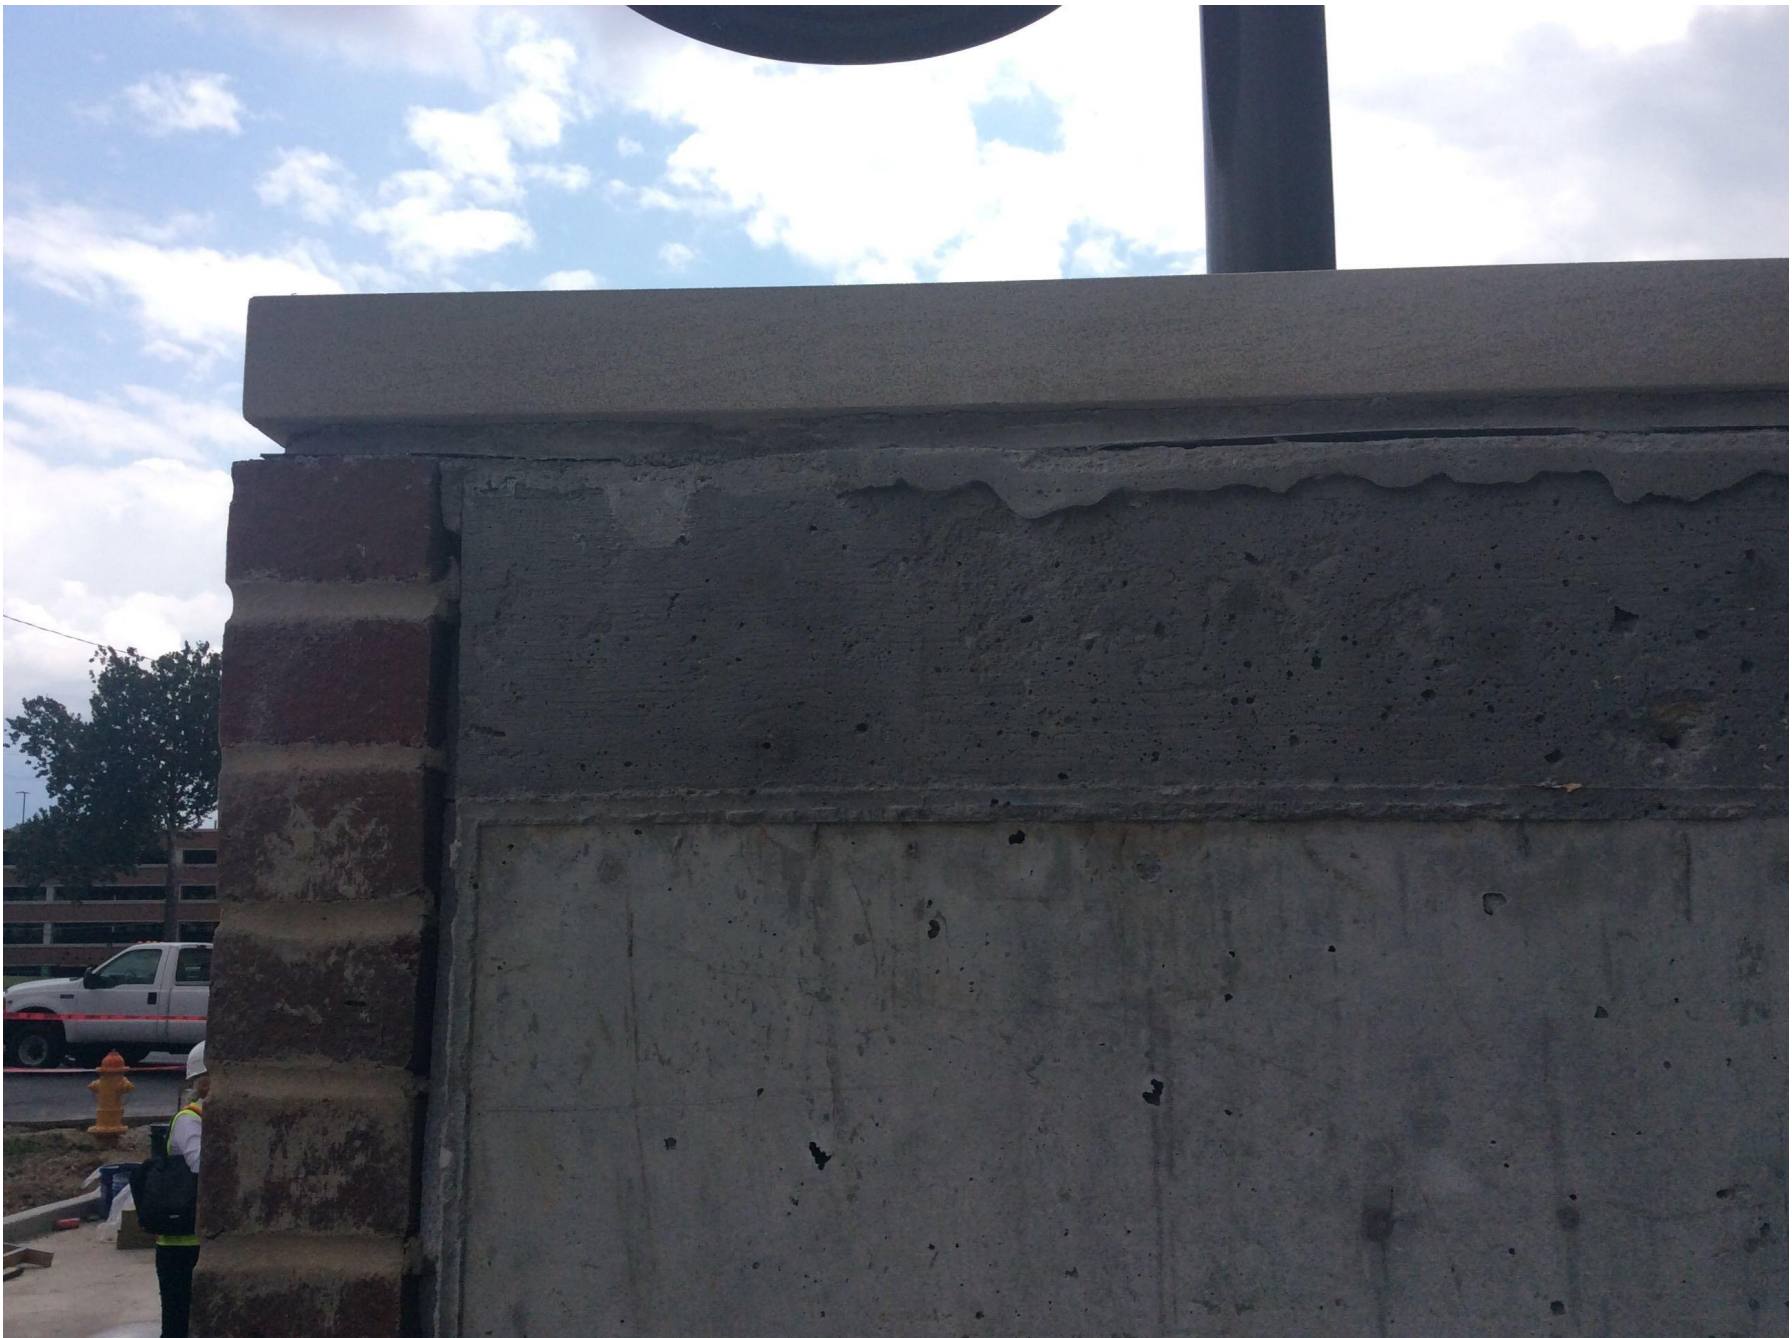
| Issue ID | Description | Location Detail | Location | Status | Company | Type | Date Created | Due Date |
|---|---|---|---|---|---|---|---|---|
| 002145 | Sealant needed at sky joint and horizontal joint of masonry cap | | Site | Open | Staat Tuckpointing | Architect Punch List | 07 Aug 2017 | 12 Aug 2017 |

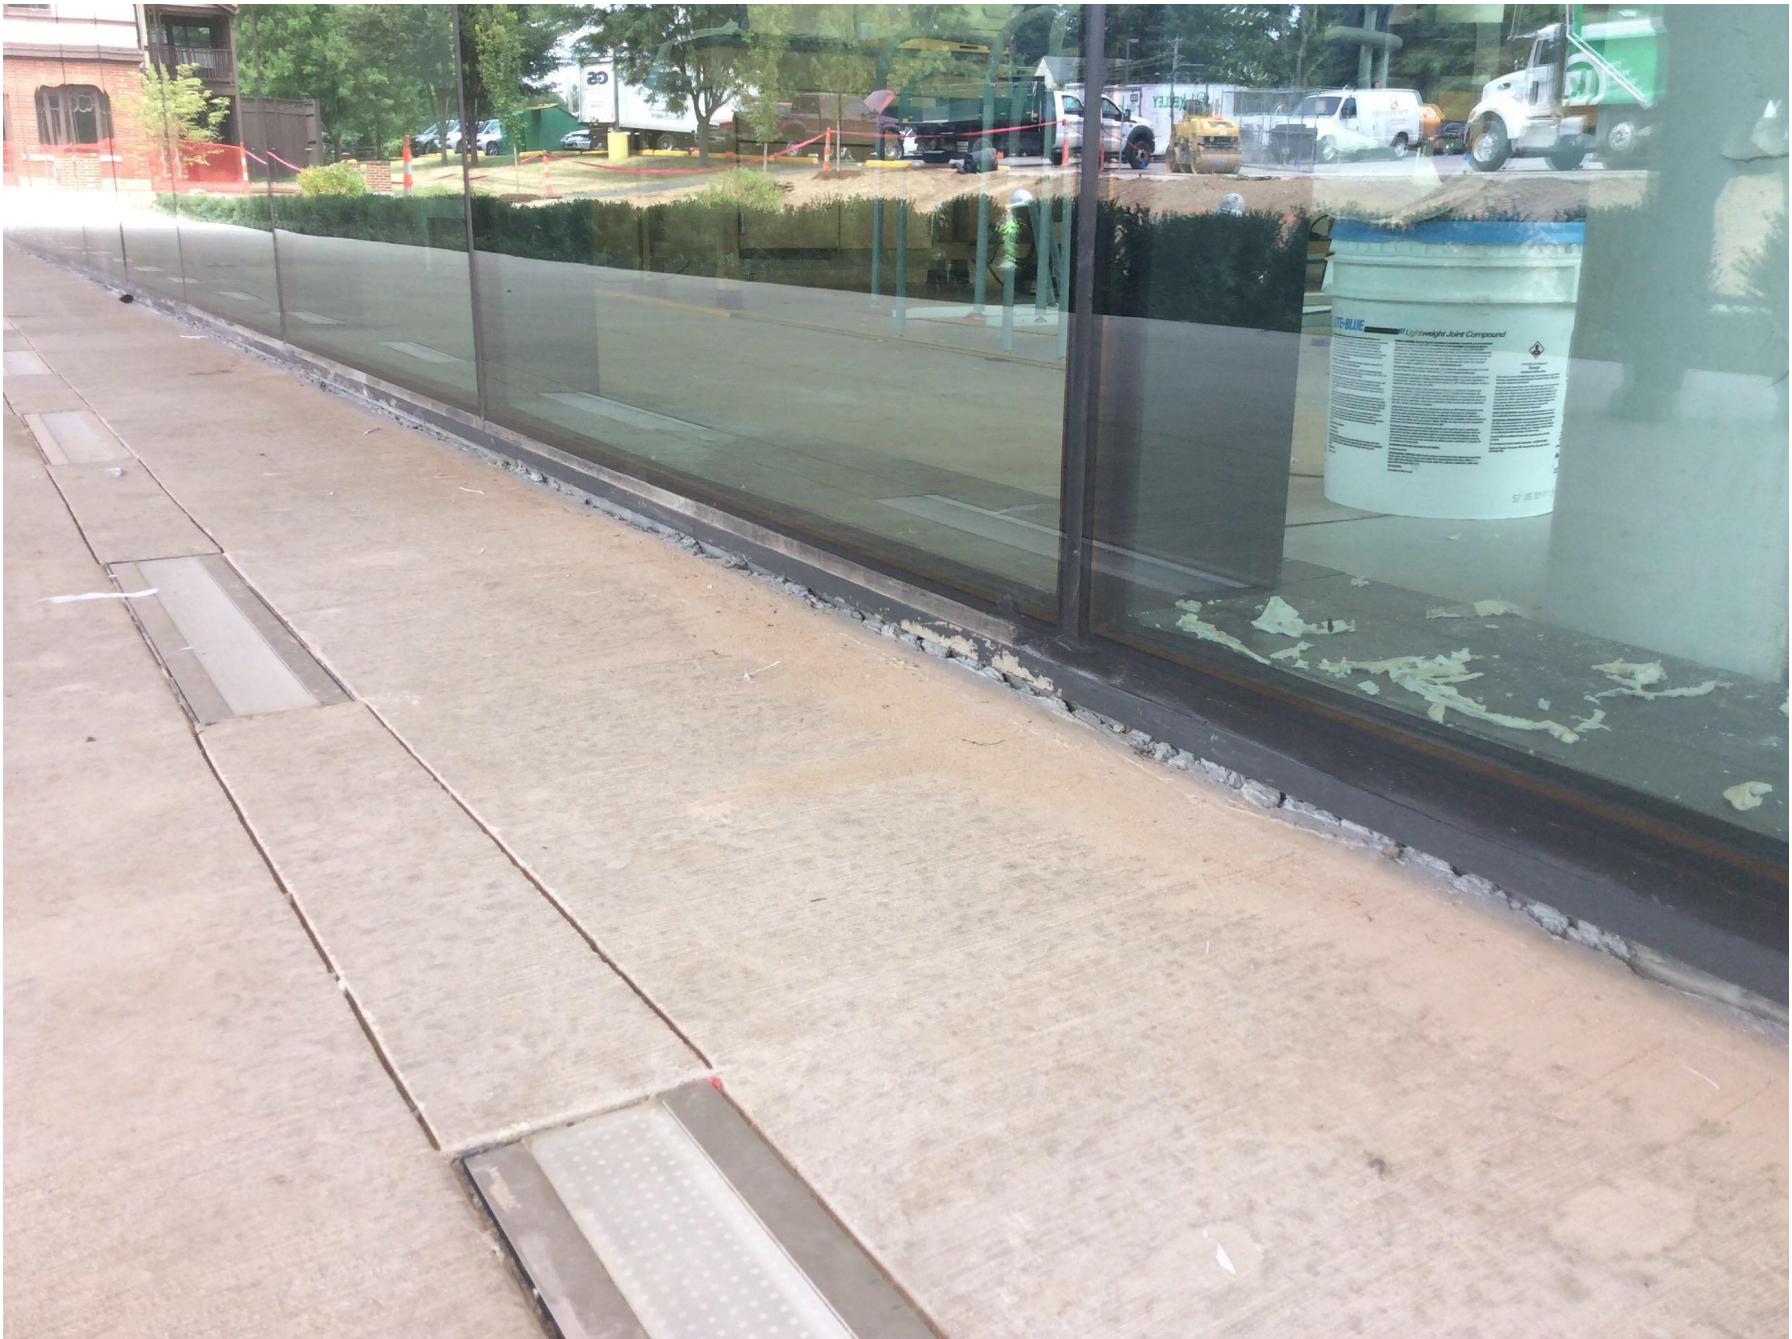
| Issue ID | Description | Location Detail | Location | Status | Company | Type | Date Created | Due Date |
|---|---|---|---|---|---|---|---|---|
| 002125 | Clean concrete from base of curtainwall - west | | Site | Open | Vee Jay Cement | Architect Punch List | 07 Aug 2017 | 12 Aug 2017 |

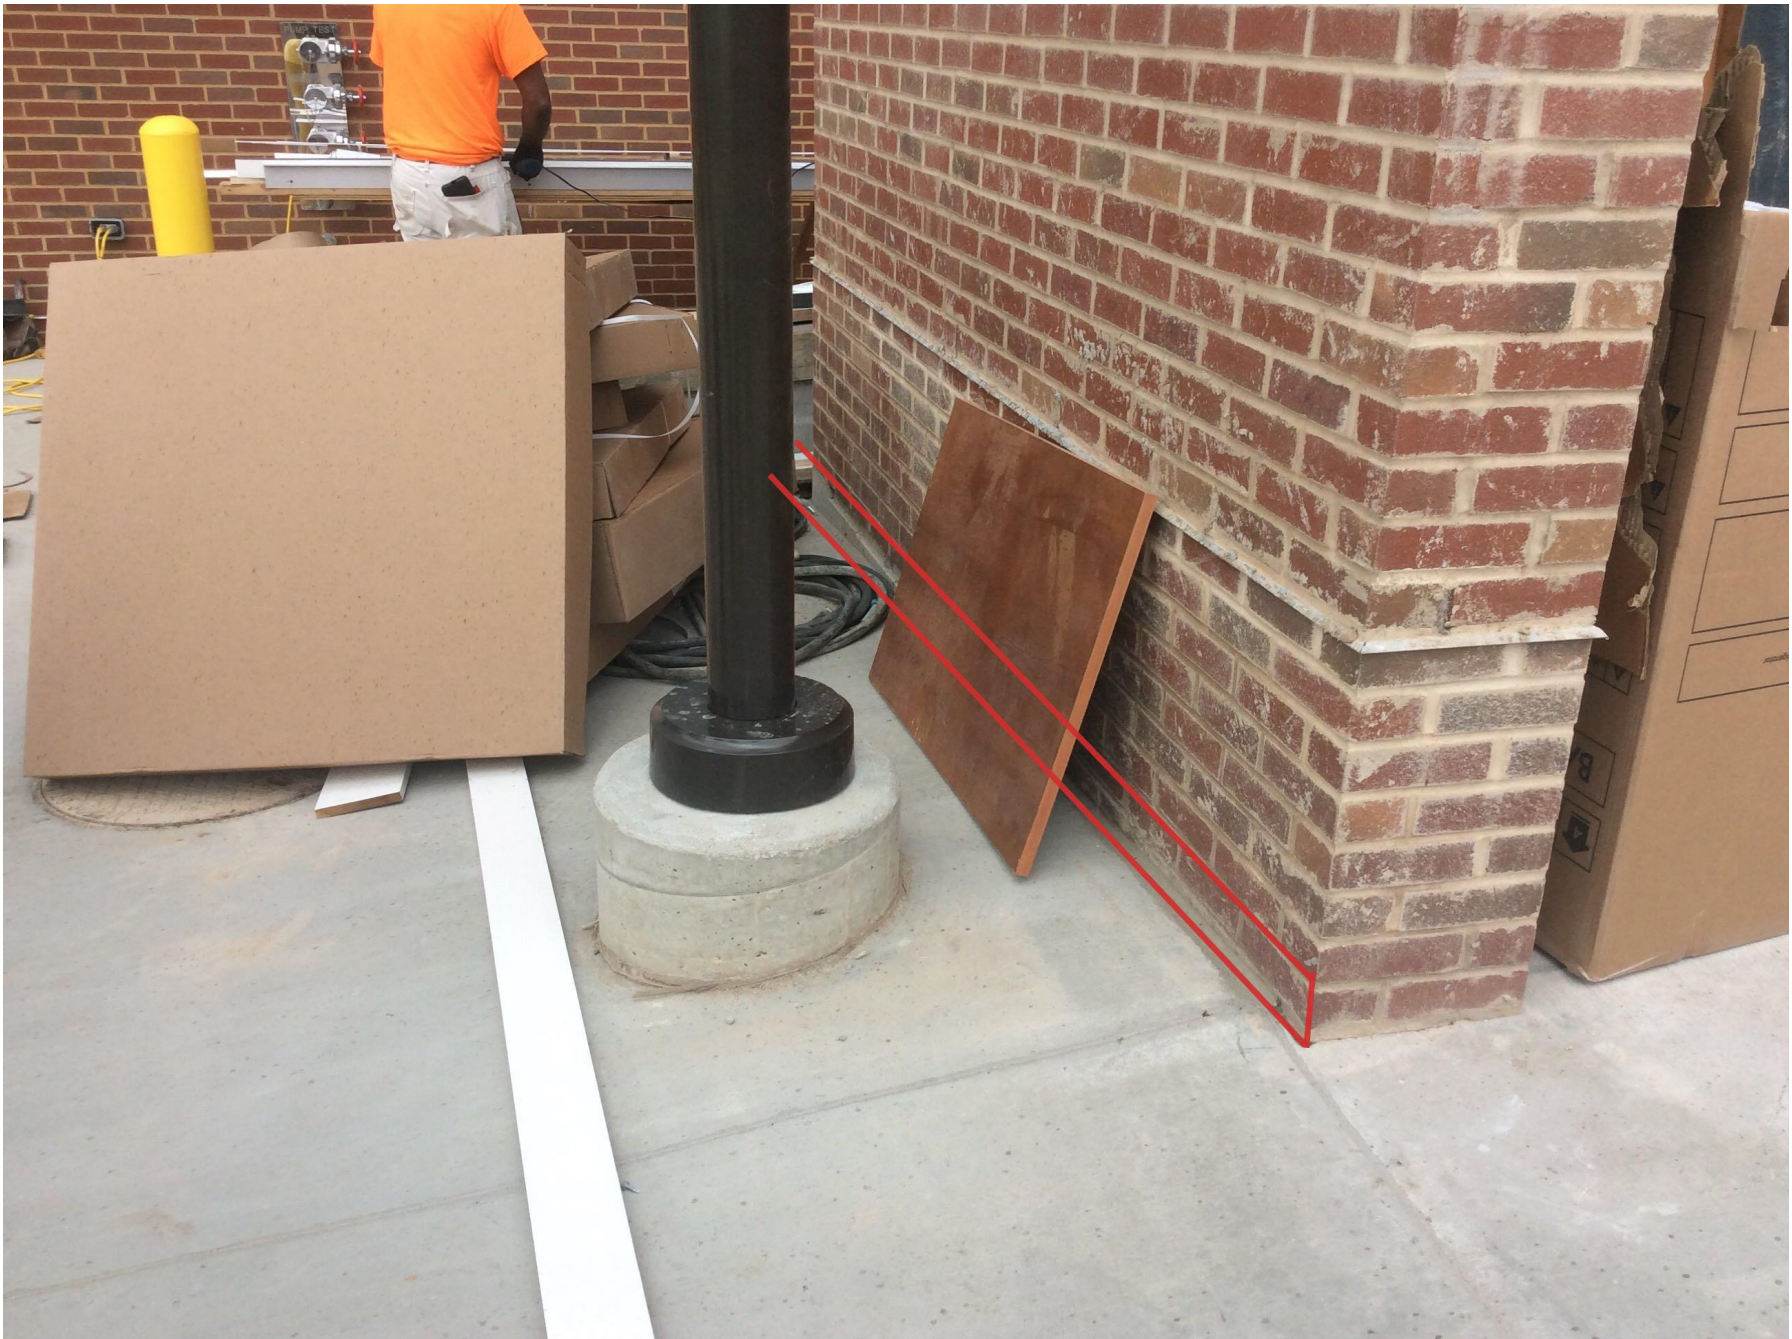
| Issue ID | Description | Location Detail | Location | Status | Company | Type | Date Created | Due Date |
|---|---|---|---|---|---|---|---|---|
| 002148 | Curb needed at dumpster | | Site | Open | Vee Jay Cement | Architect Punch List | 07 Aug 2017 | 12 Aug 2017 |

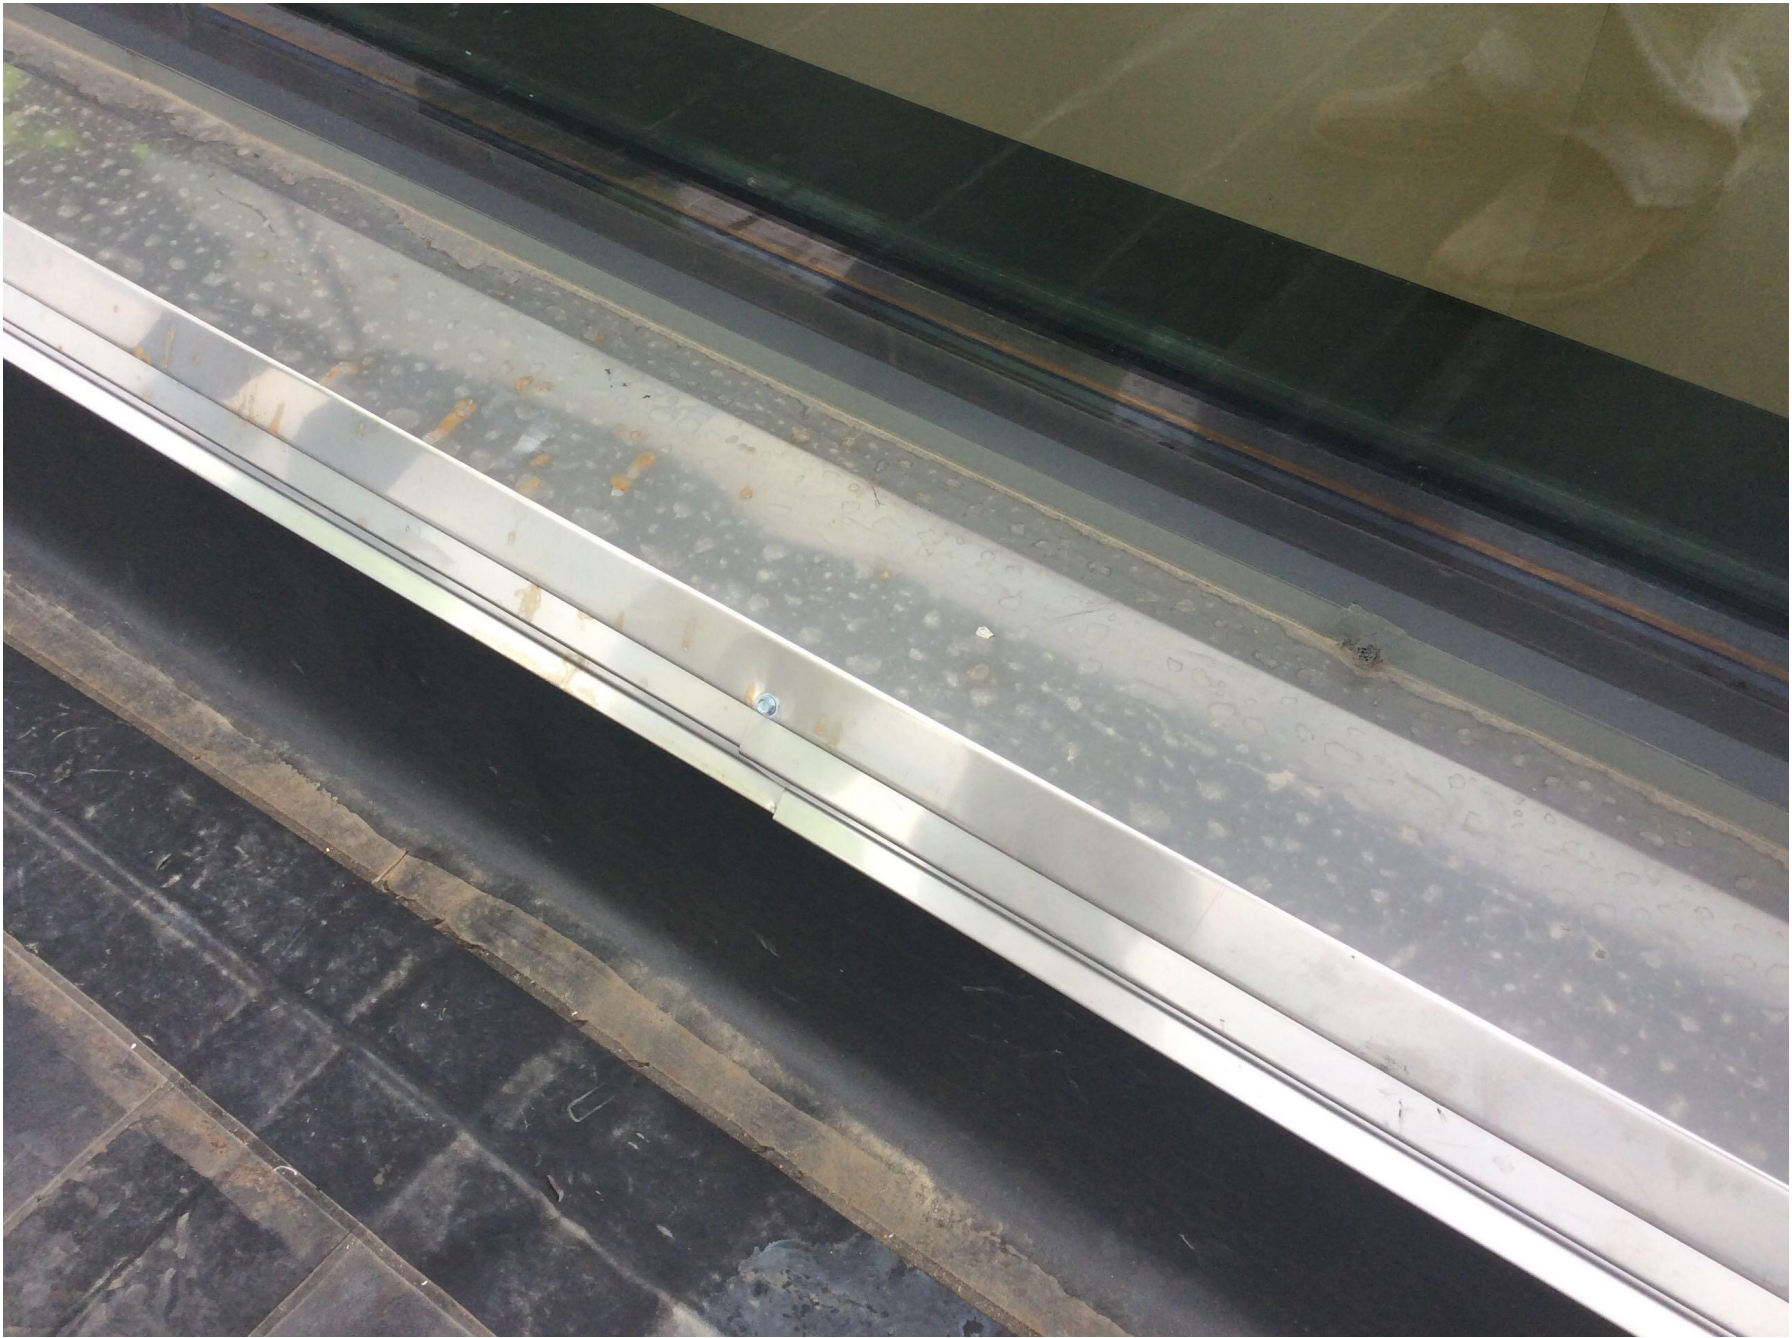
| Issue ID | Description | Location Detail | Location | Status | Company | Type | Date Created | Due Date |
|---|---|---|---|---|---|---|---|---|
| 002103 | Screws should be stainless at flashing | | Webster > Roof | Open | VOGEL<br>HEATING &<br>COOLING | Architect<br>Punch List | 07 Aug<br>2017 | 12 Aug<br>2017 |

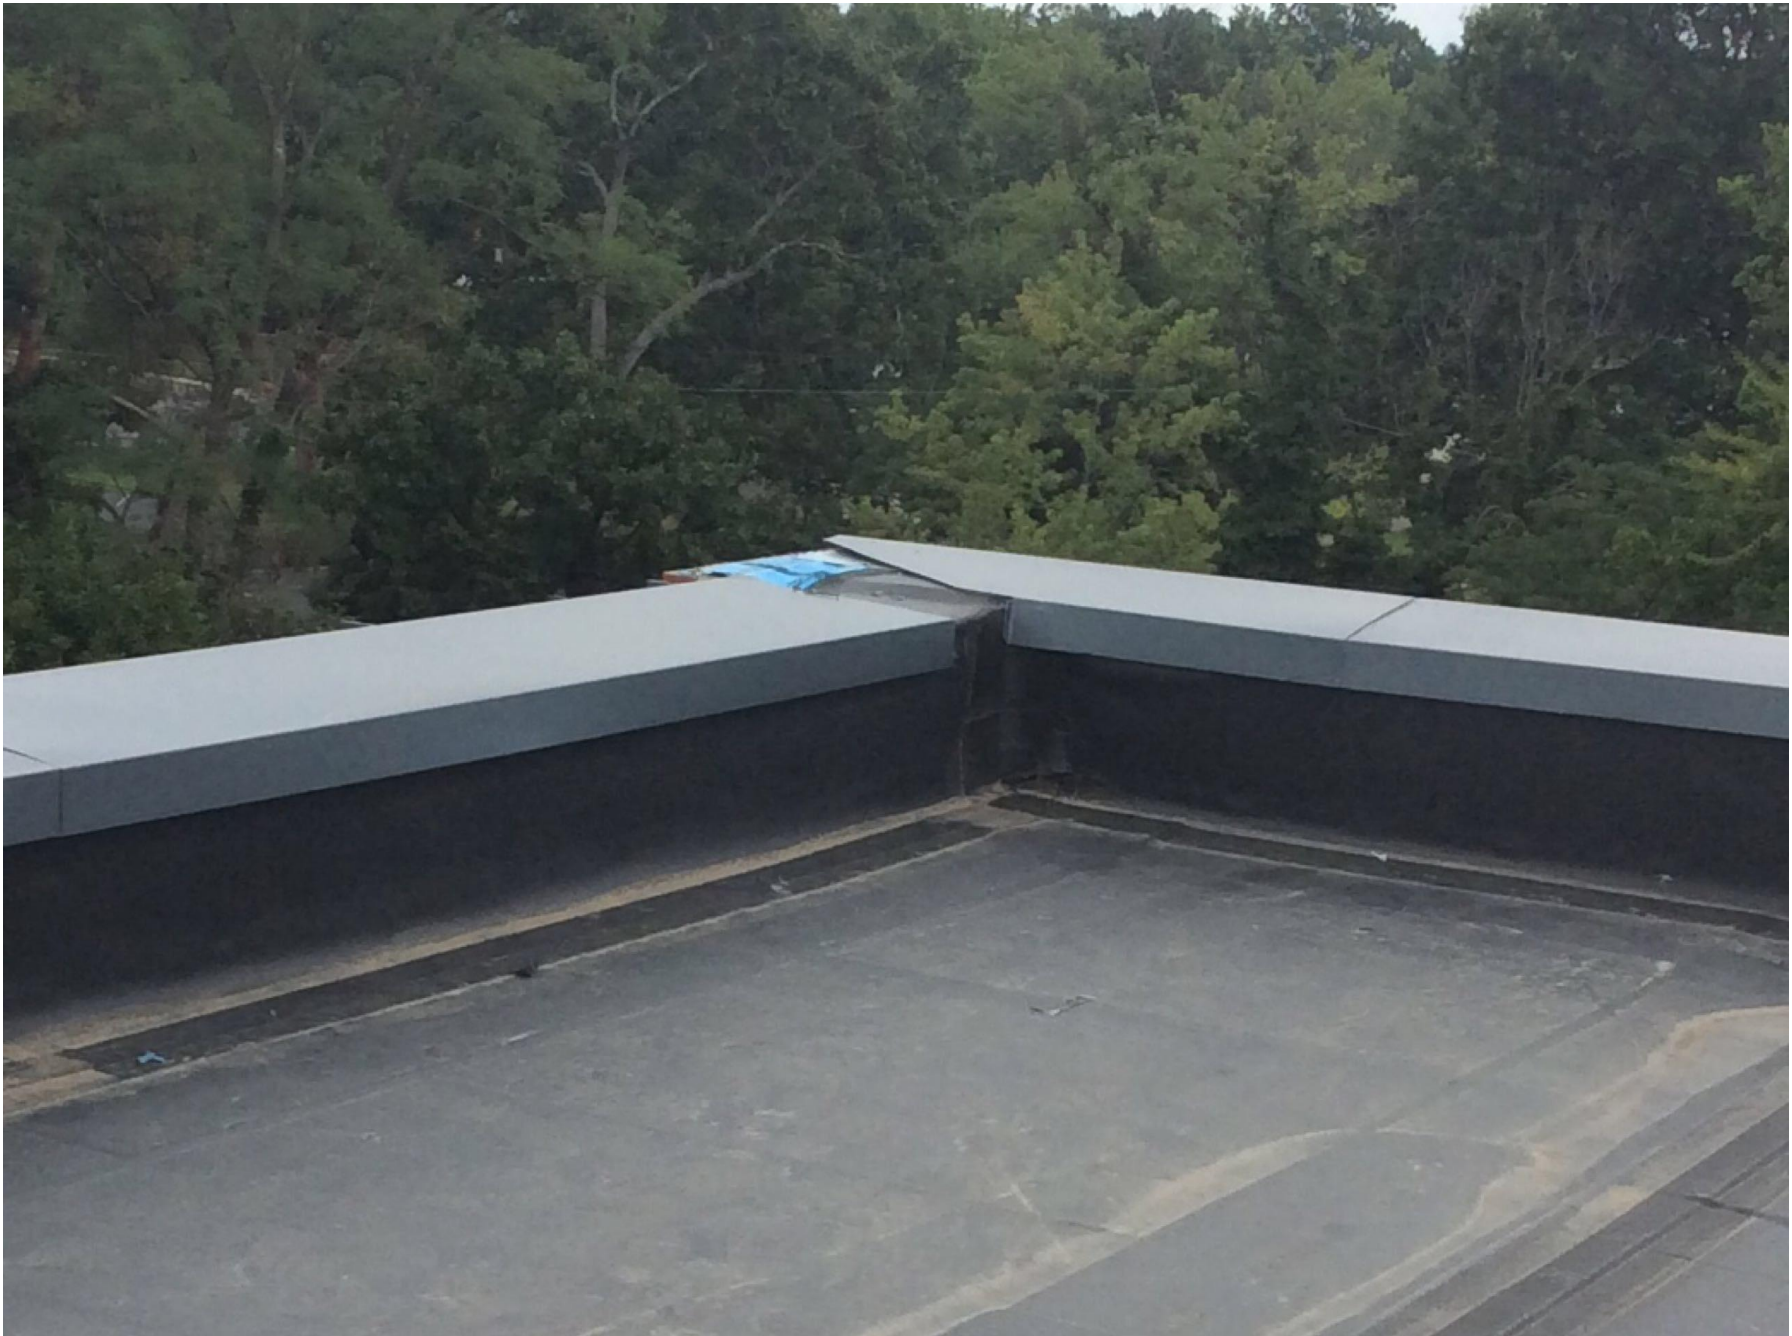
| Issue ID | Description | Location Detail | Location | Status | Company | Type | Date Created | Due Date |
|---|---|---|---|---|---|---|---|---|
| 002117 | Missing coping at corner | | Webster > Roof | Open | VOGEL<br>HEATING &<br>COOLING | Architect<br>Punch List | 07 Aug<br>2017 | 12 Aug<br>2017 |

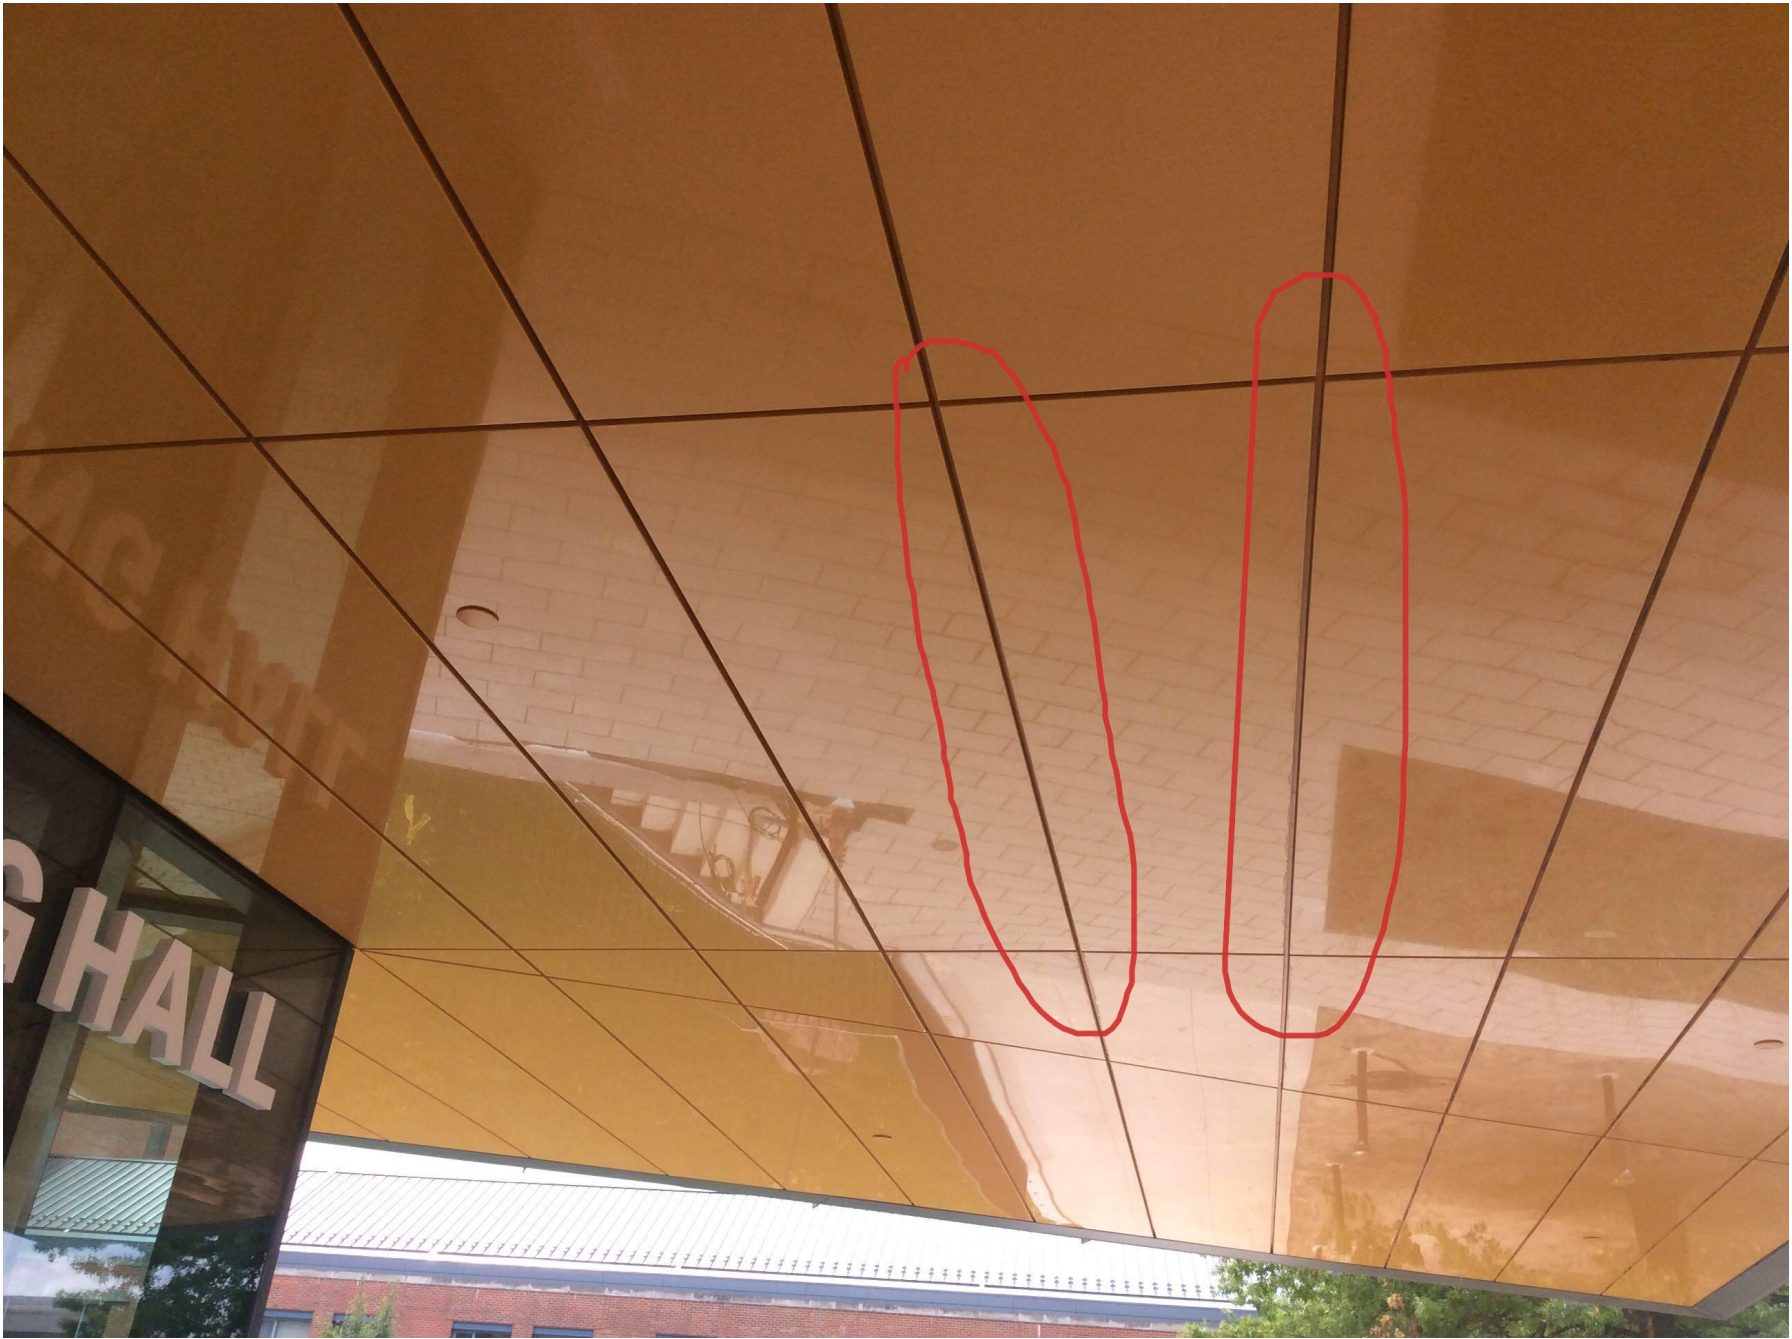
| Issue ID | Description | Location Detail | Location | Status | Company | Type | Date Created | Due Date |
|---|---|---|---|---|---|---|---|---|
| 002128 | Clean up marks along panel joints | | Site | Open | VOGEL HEATING & COOLING | Architect Punch List | 07 Aug 2017 | 12 Aug 2017 |
