## **ARCHITECTURAL PUNCH LIST (EXTERIOR FAÇADE & ROOF)**

**Project:** Webster University Interdisciplinary Science Building

**Project No:** CannonDesign #004561.01

**Date of Observation:** August 7, 2017

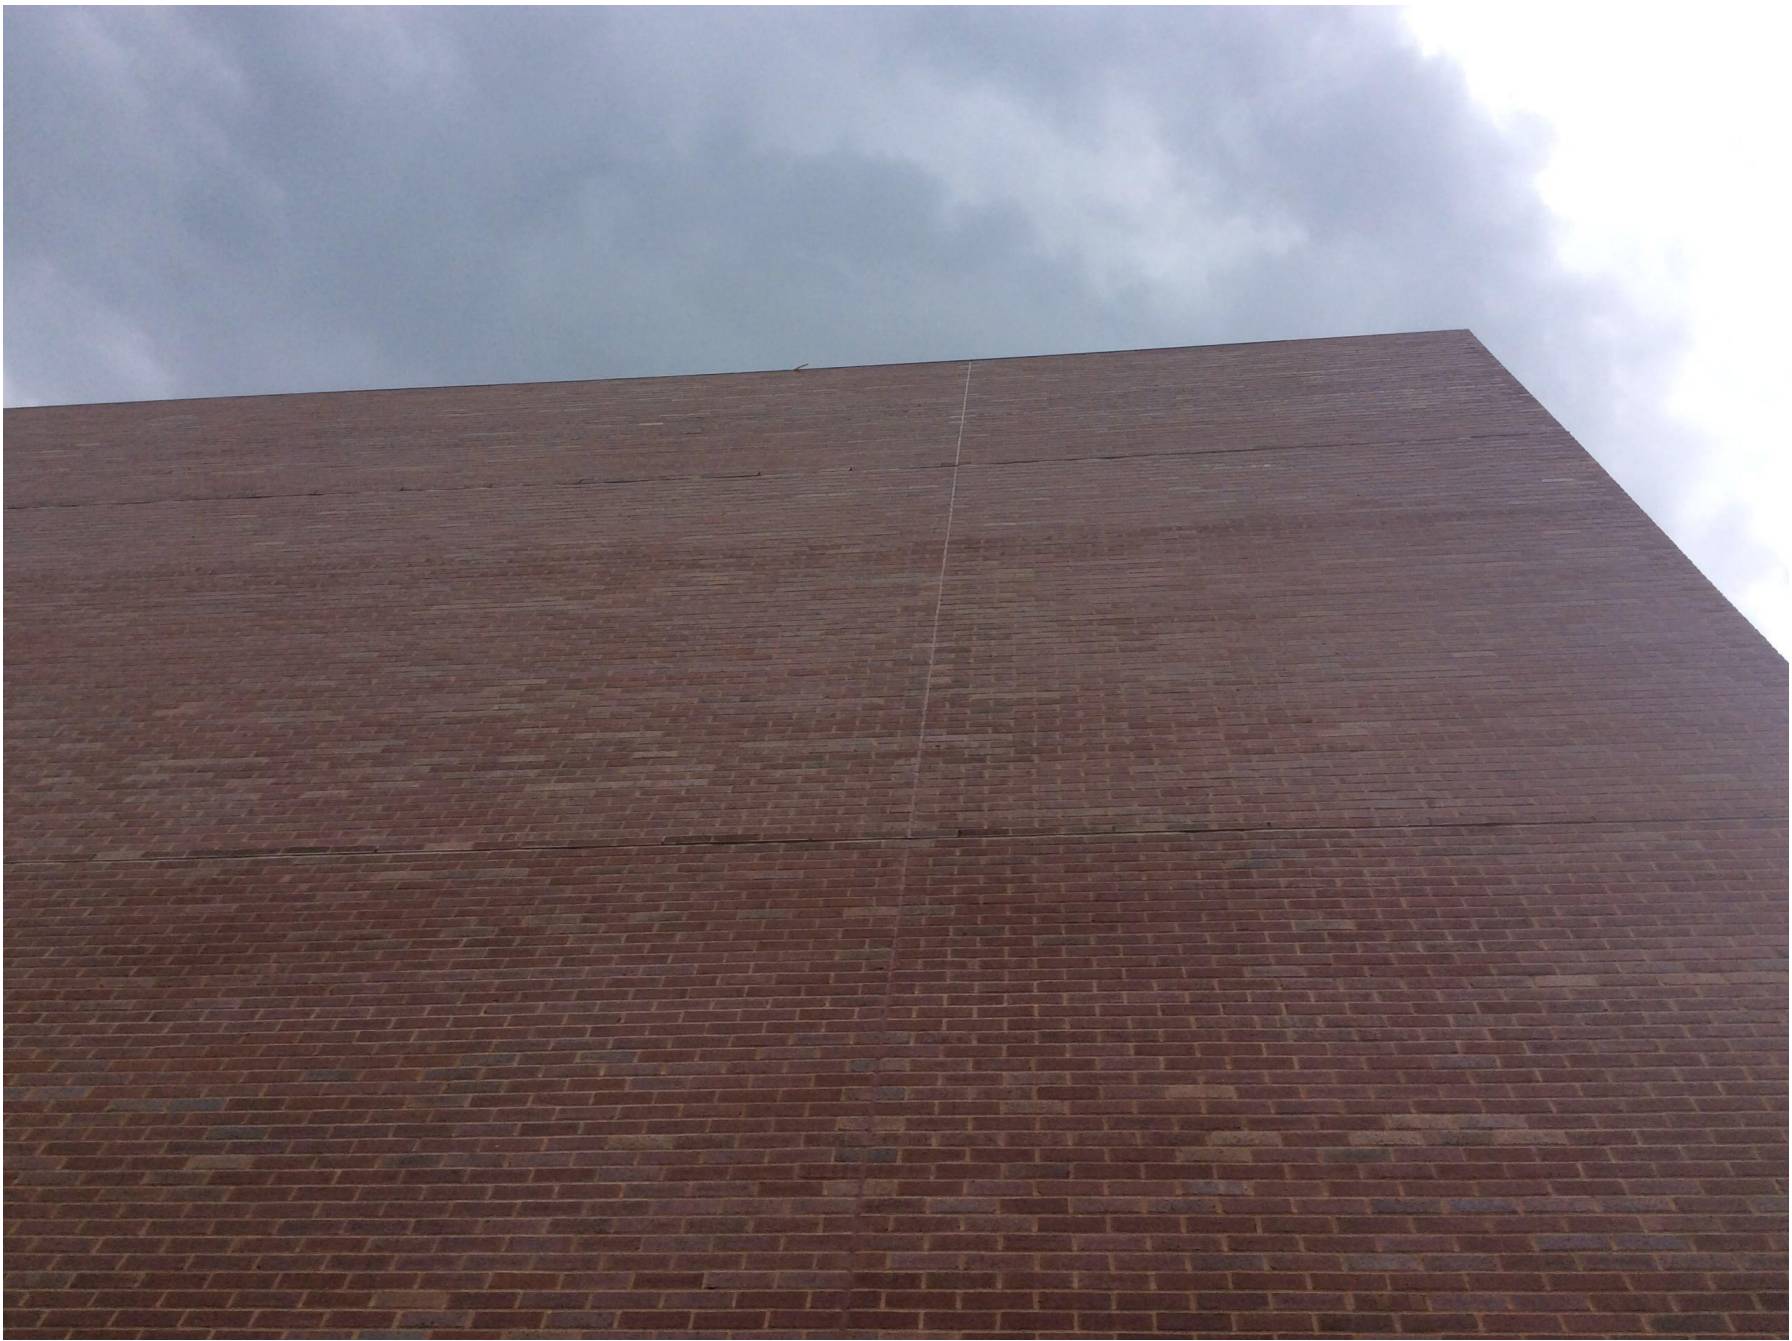
| Issue ID | Description | Location Detail | Location | Status | Company | Type | Date Created | Due Date |
|---|---|---|---|---|---|---|---|---|
| 002135 | Backer rod exposed from under coping - north | | Site | Open | VOGEL HEATING & COOLING | Architect Punch List | 07 Aug 2017 | 12 Aug 2017 |

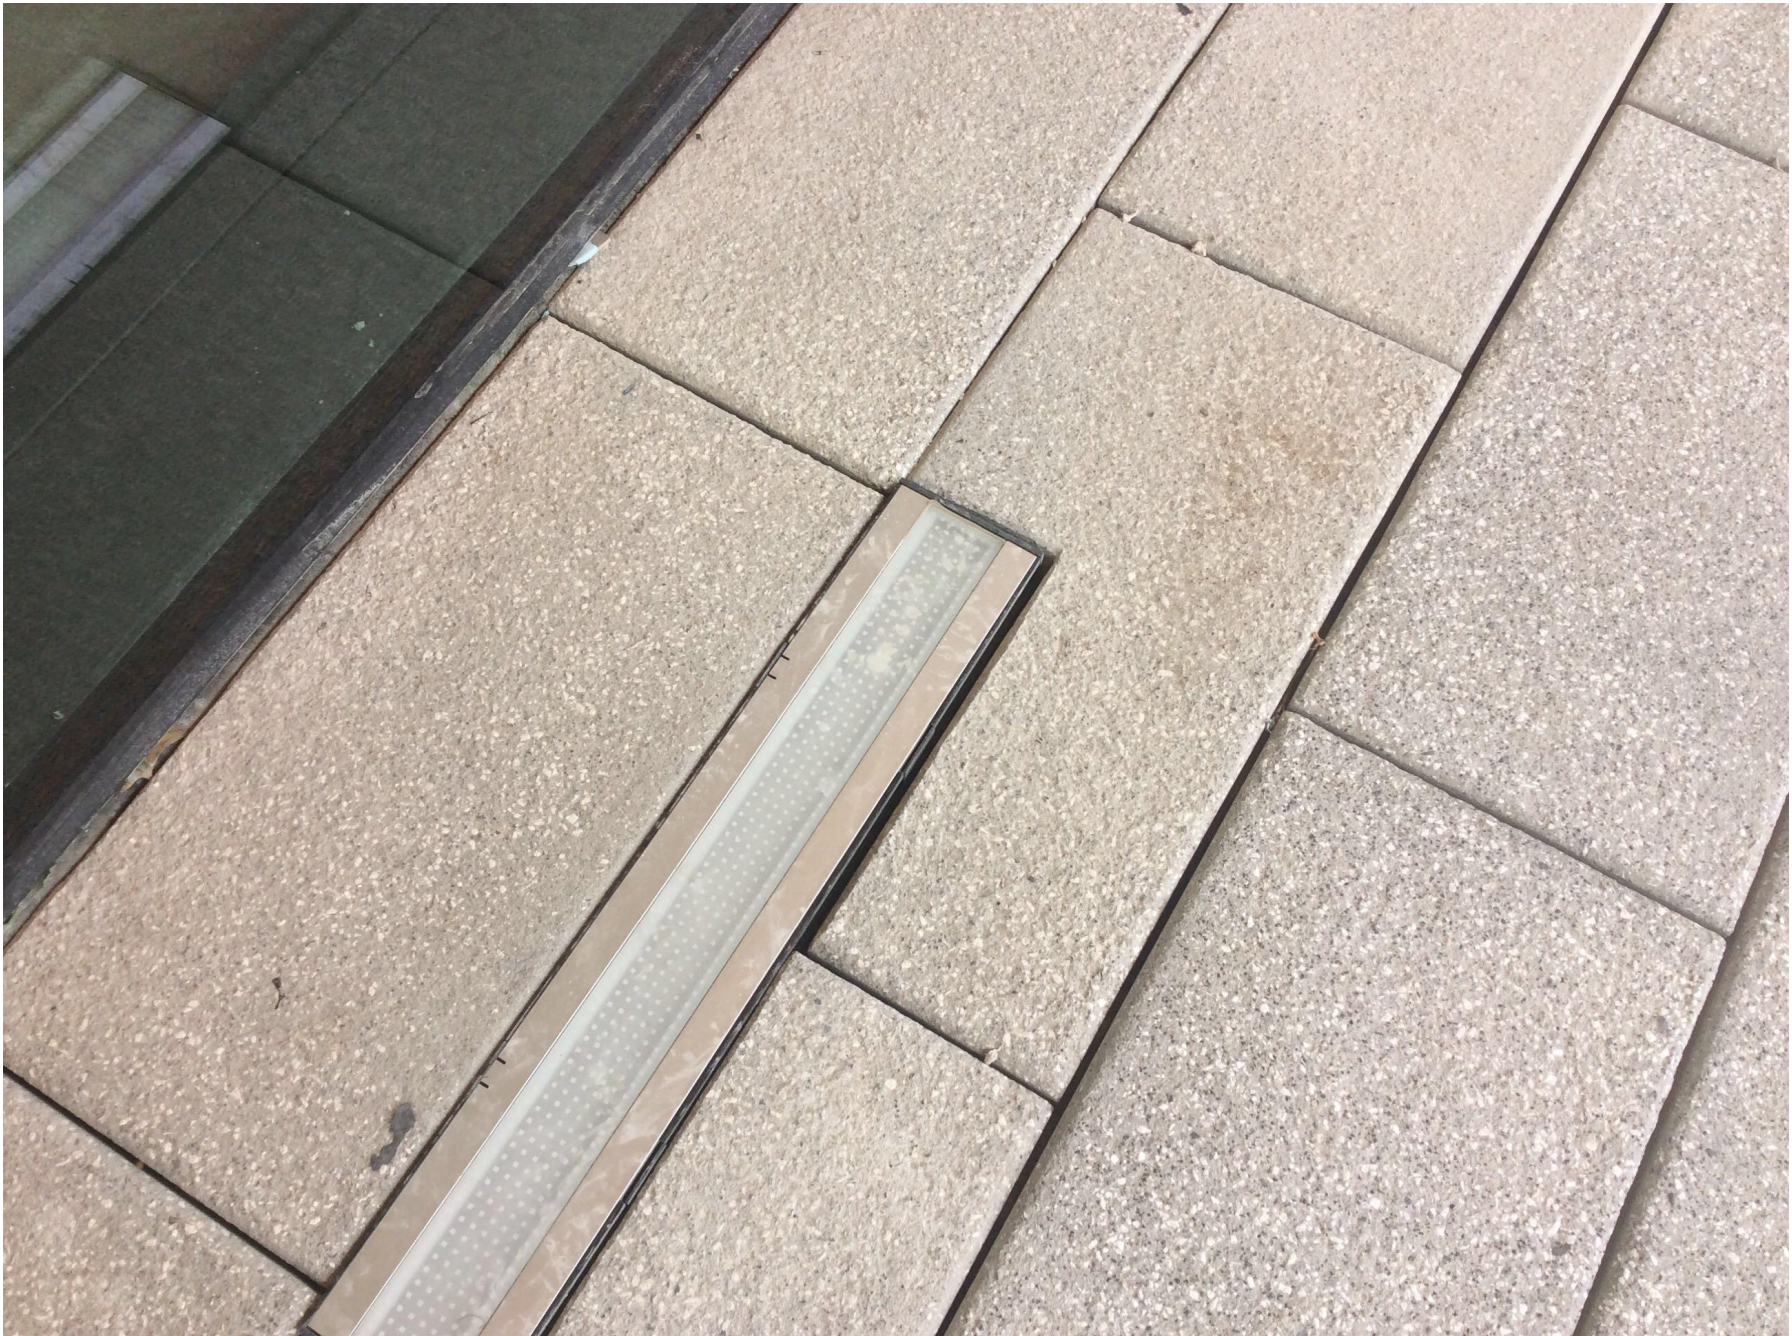
| Issue ID | Description | Location Detail | Location | Status | Company | Type | Date Created | Due Date |
|---|---|---|---|---|---|---|---|---|
| 002124 | Paver to be replaced so that there is thinner gap at light | | Site | Open | Western Specialty Contractors | Architect Punch List | 07 Aug 2017 | 12 Aug 2017 |
