## Observation Report

| Architect: | Cannon Design | Location: | Webster ISB - General |
| File: | Webster University Interdisciplinary Science Bldg.<br>WT 14127.01 (7) | c: | Jason Szachnieski &<br>Devin Gates (Paric) |

### **Level 2 - Mechanical Observations**

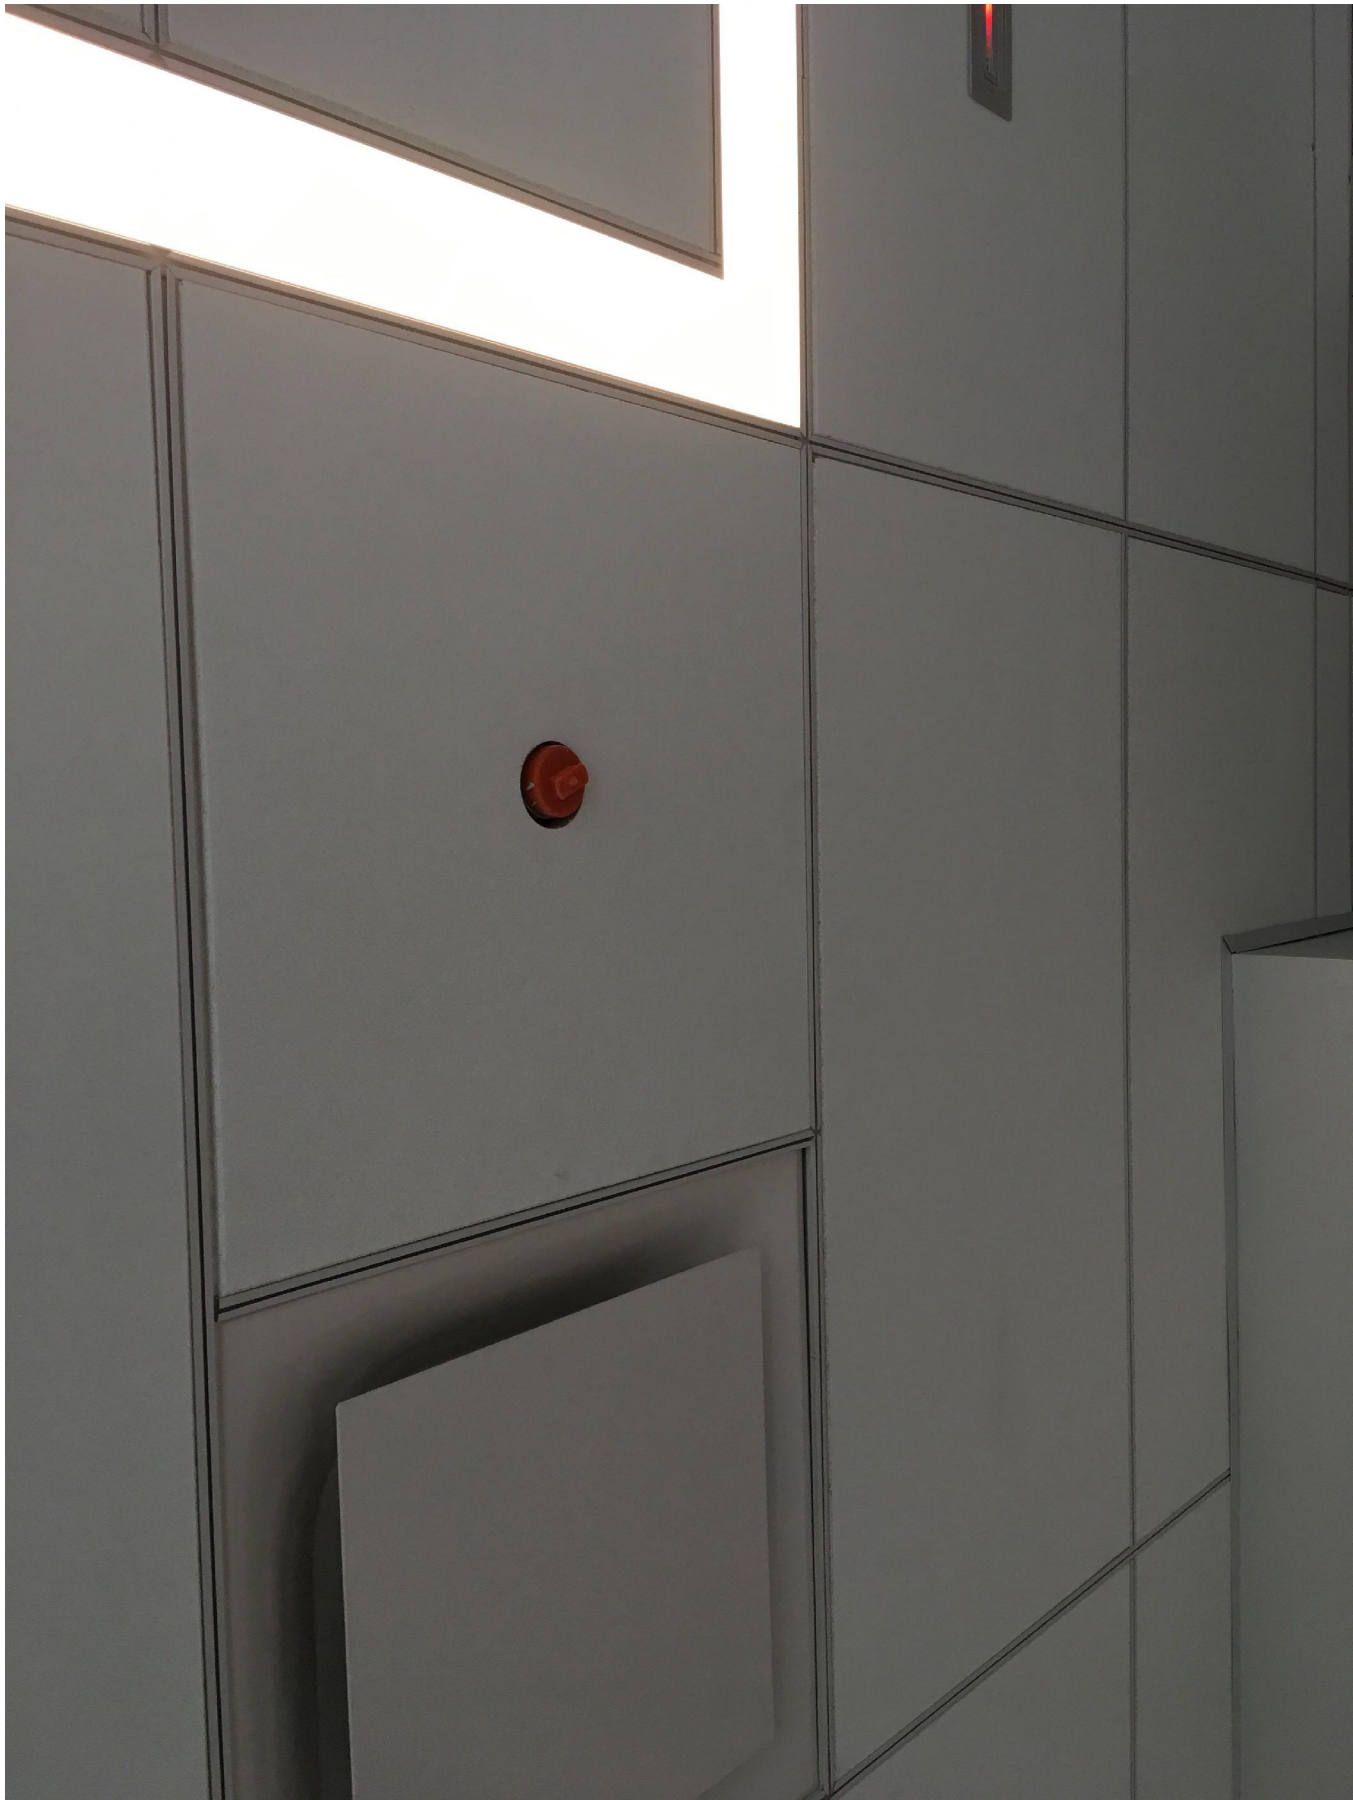
Attached Images for ID 001192

C280: Sprinkler installation incomplete at North End of Corridor

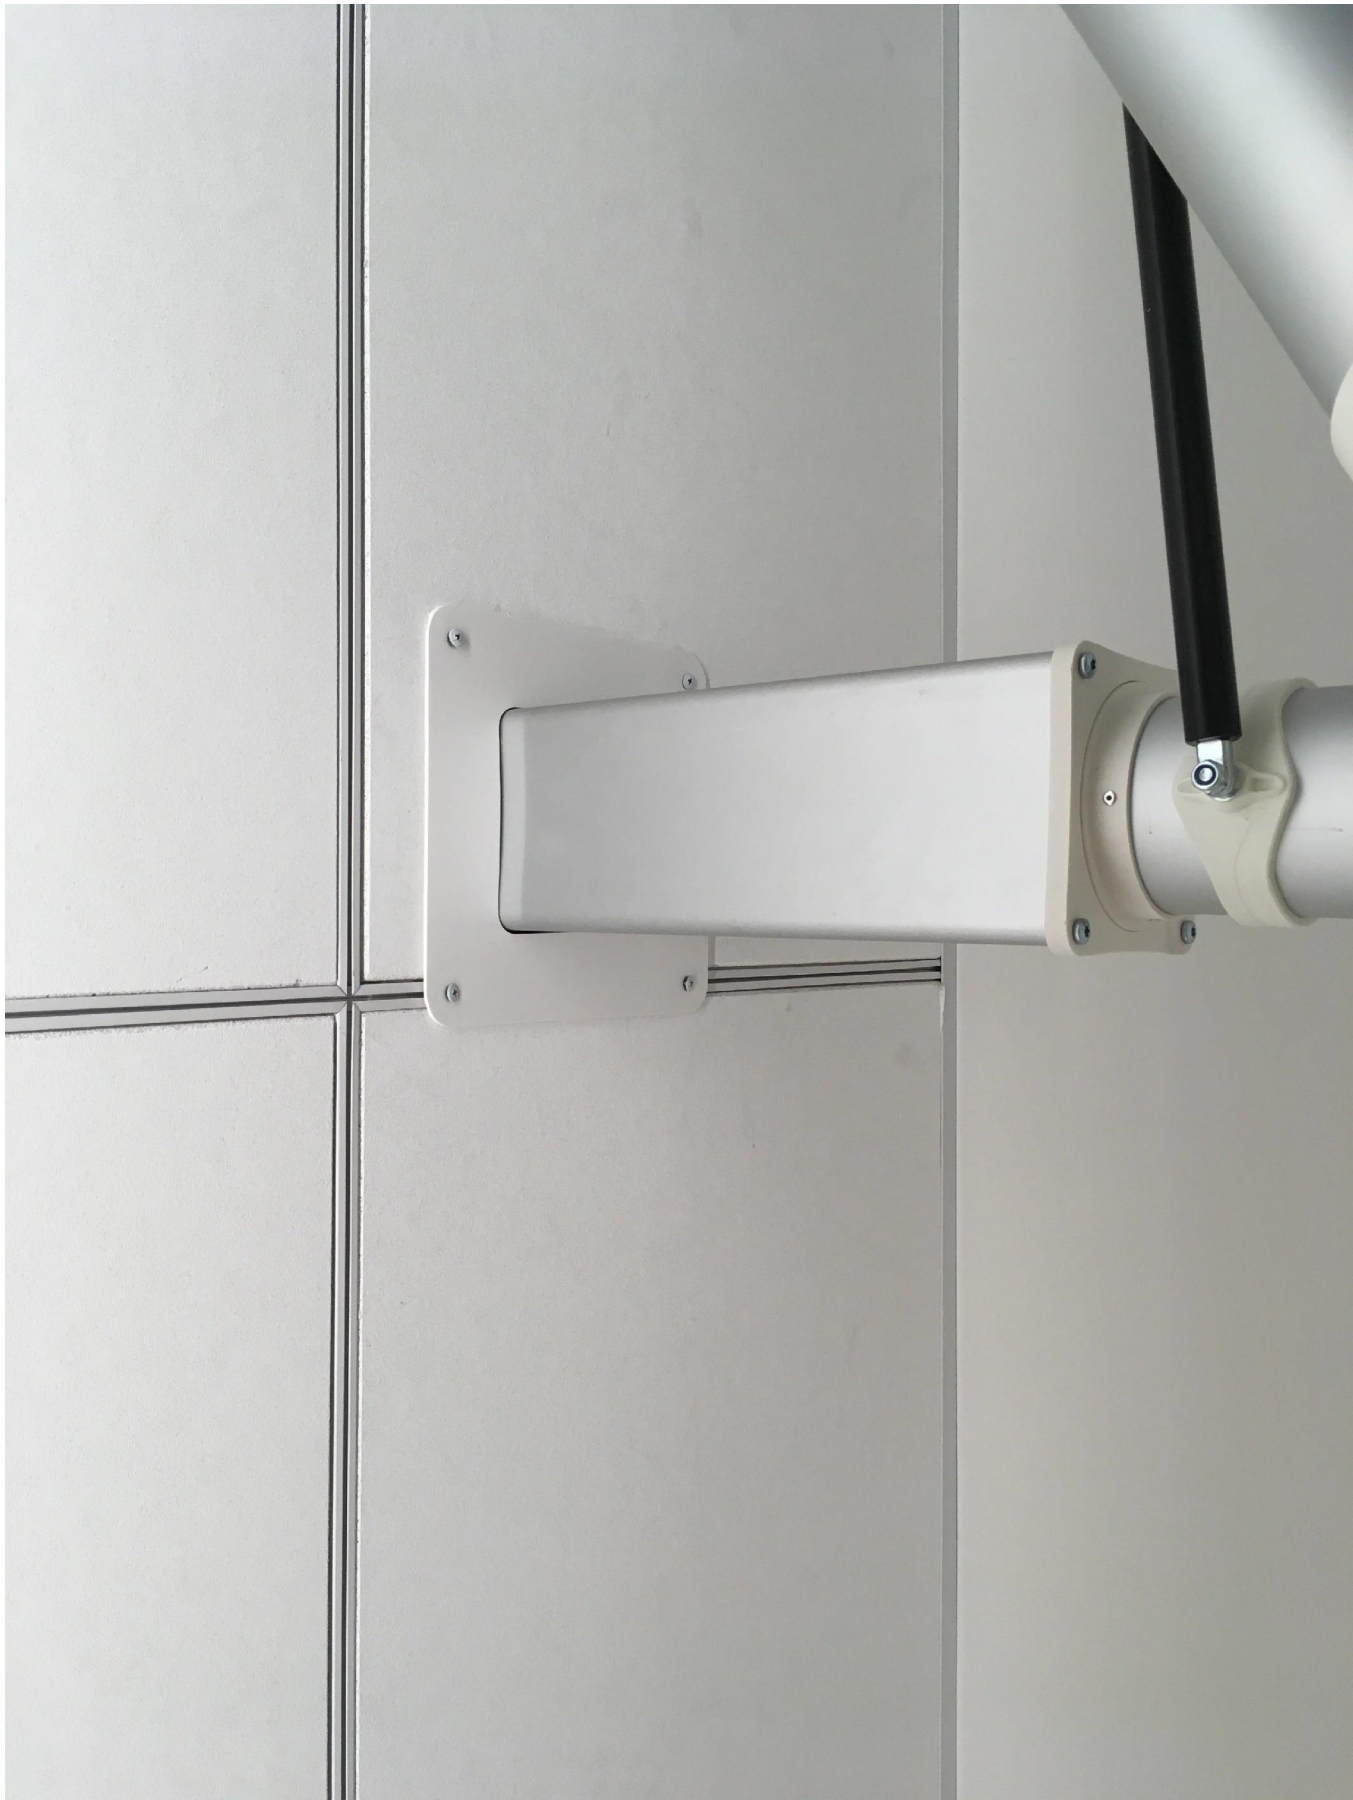
Attached Images for ID 001193

| <b>Description</b><br>292: Tighten loose screws through base plate of snorkel exhaust. | | | | |

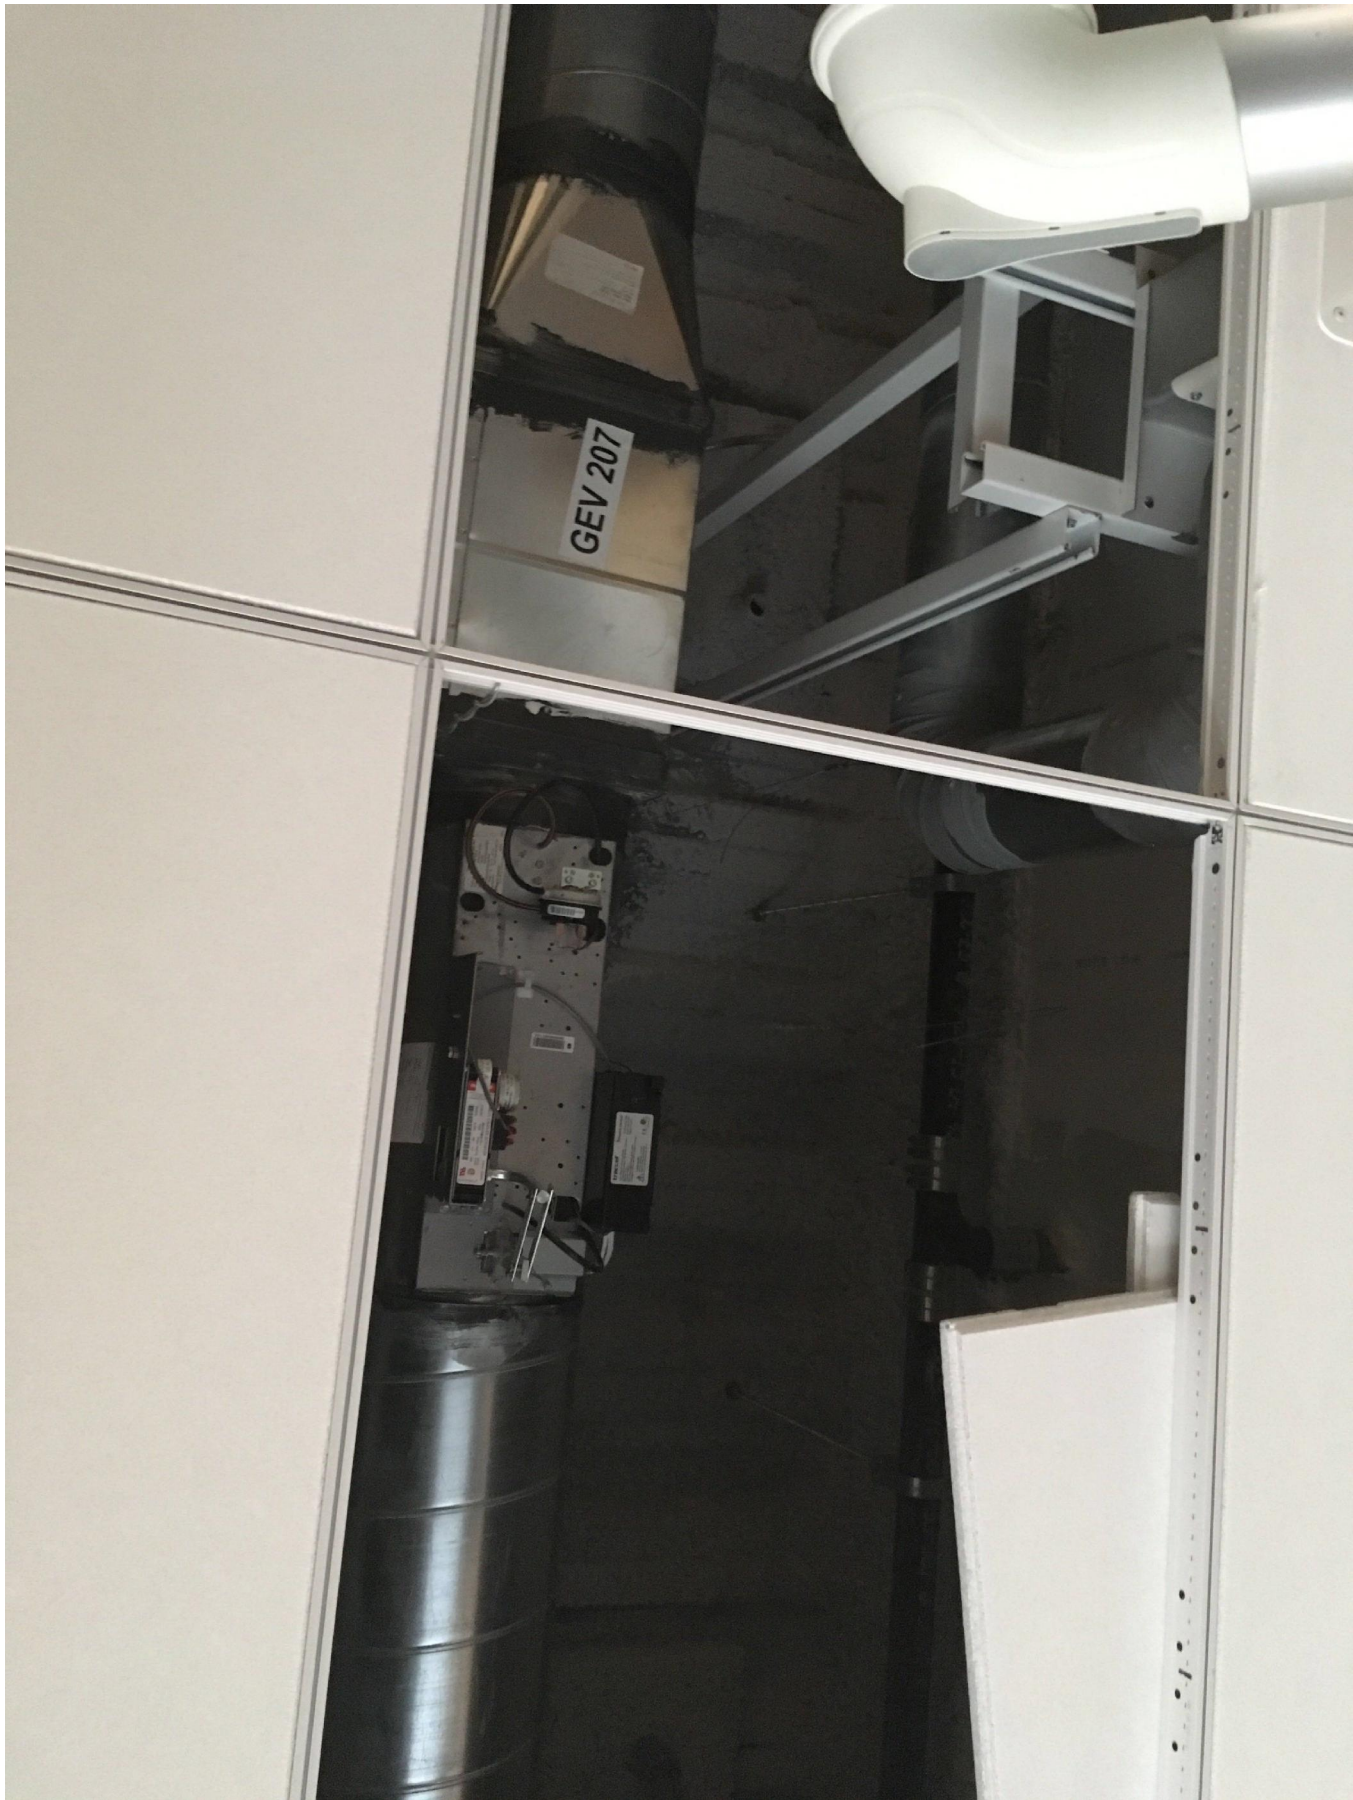
Attached Images for ID 001194

**Description**  
292: SAV-205: Install cover after finishing installation.

| Alex Chambers (achambers@iconmech.com)<br>17 Jul 2017 9:19 AM | Cover not require. This is finished product. |

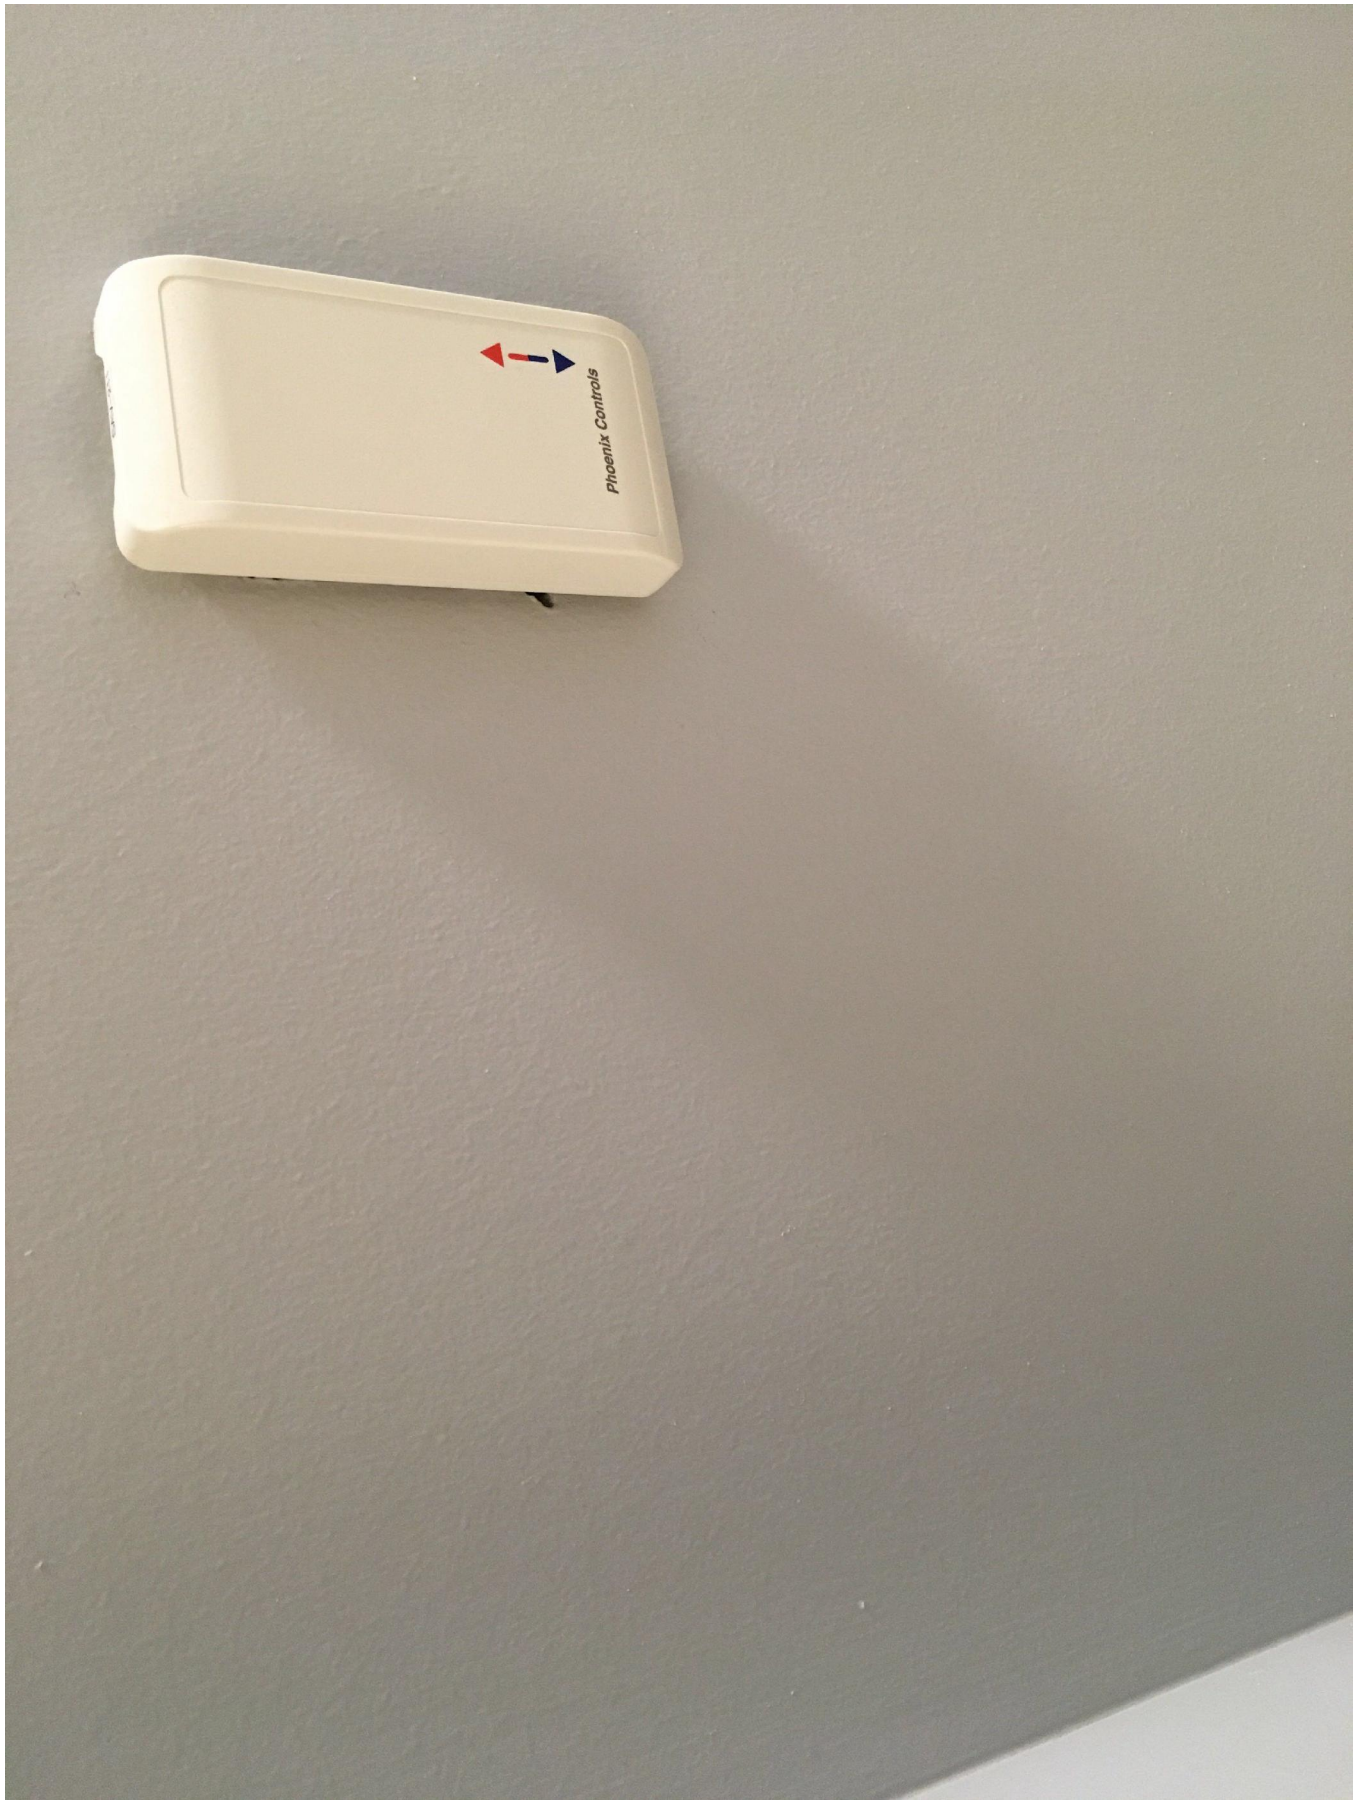
Attached Images for ID 001195

| <b>Description</b><br>272A: Patch wall at thermostat for SAV - 211 | | | | |

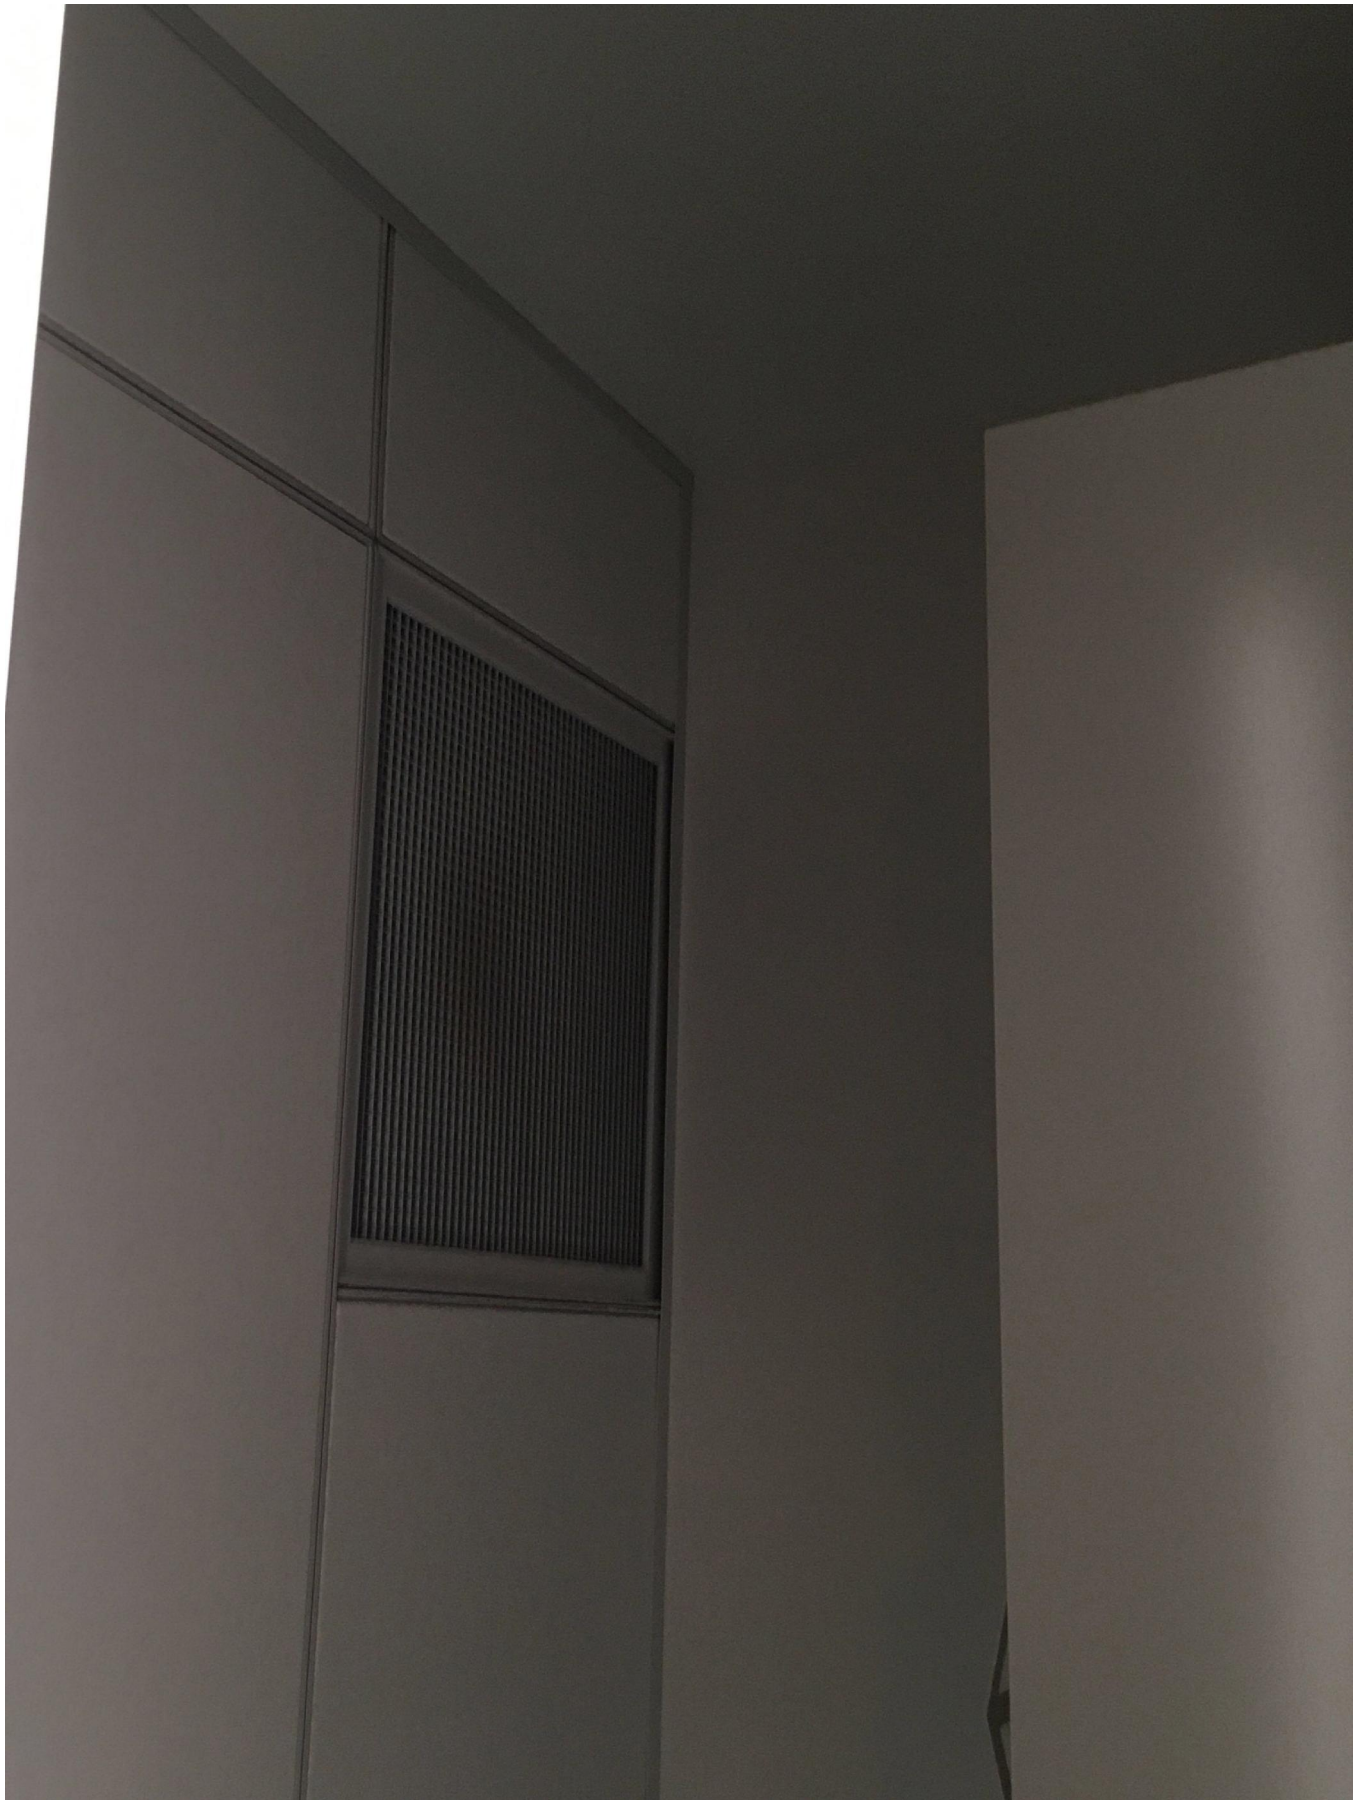
Attached Images for ID 001198

**Description**  
289A: Exhaust grill does not fit flush in ceiling grid which causes a gap at the wall. Fix gap or relocate exhaust grill as required. If relocating exhaust grill, then use flex duct to extend ductwork.

| Alex Chambers (achambers@iconmech.com)<br>17 Jul 2017 9:13 AM | Exhaust grille installed where shown. Relocation will result in additional charge. |

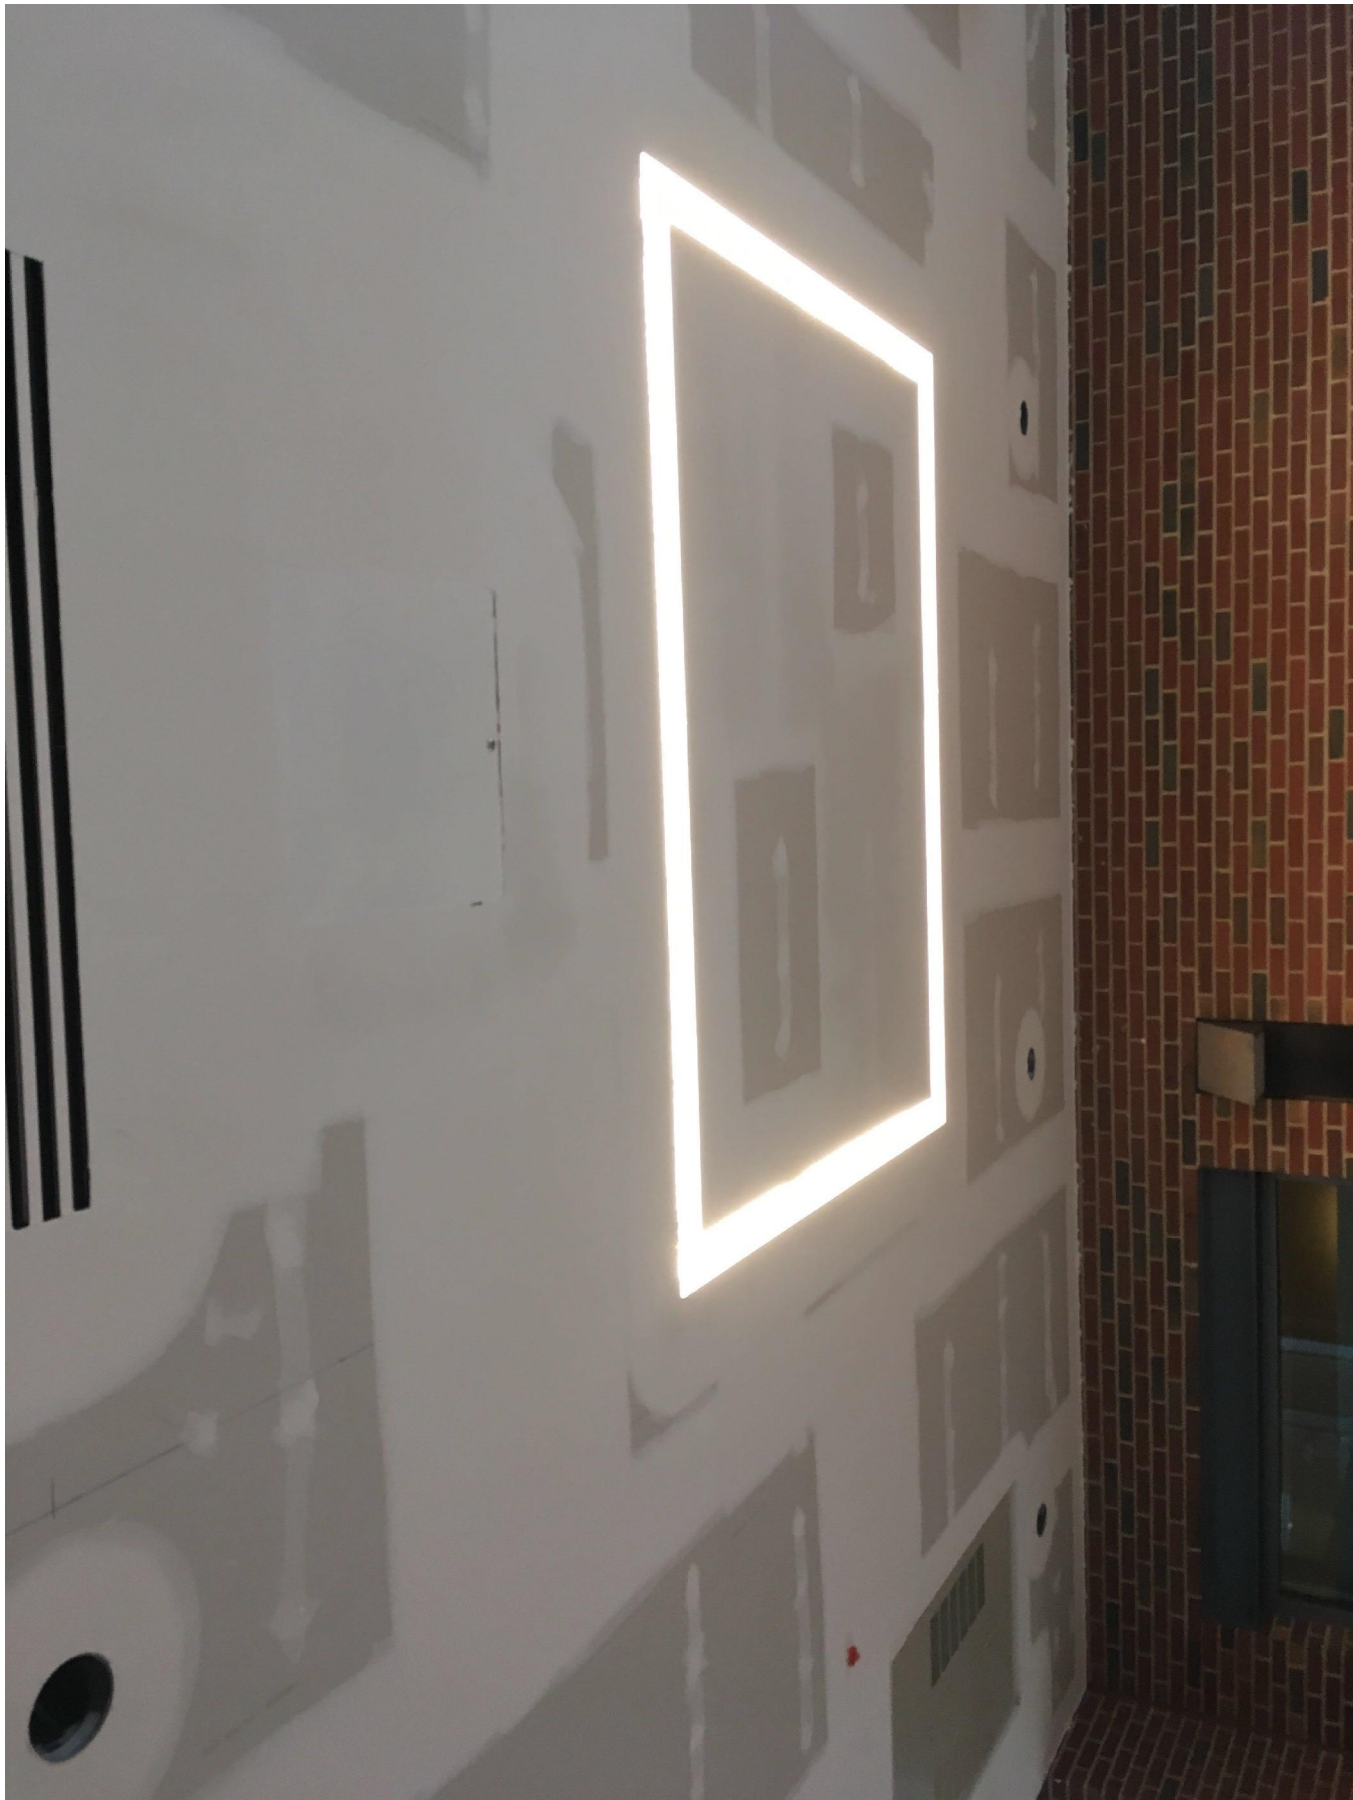
Attached Images for ID 001200

| <b>Description</b><br>Installation is ongoing in EAB connector. | | | | |

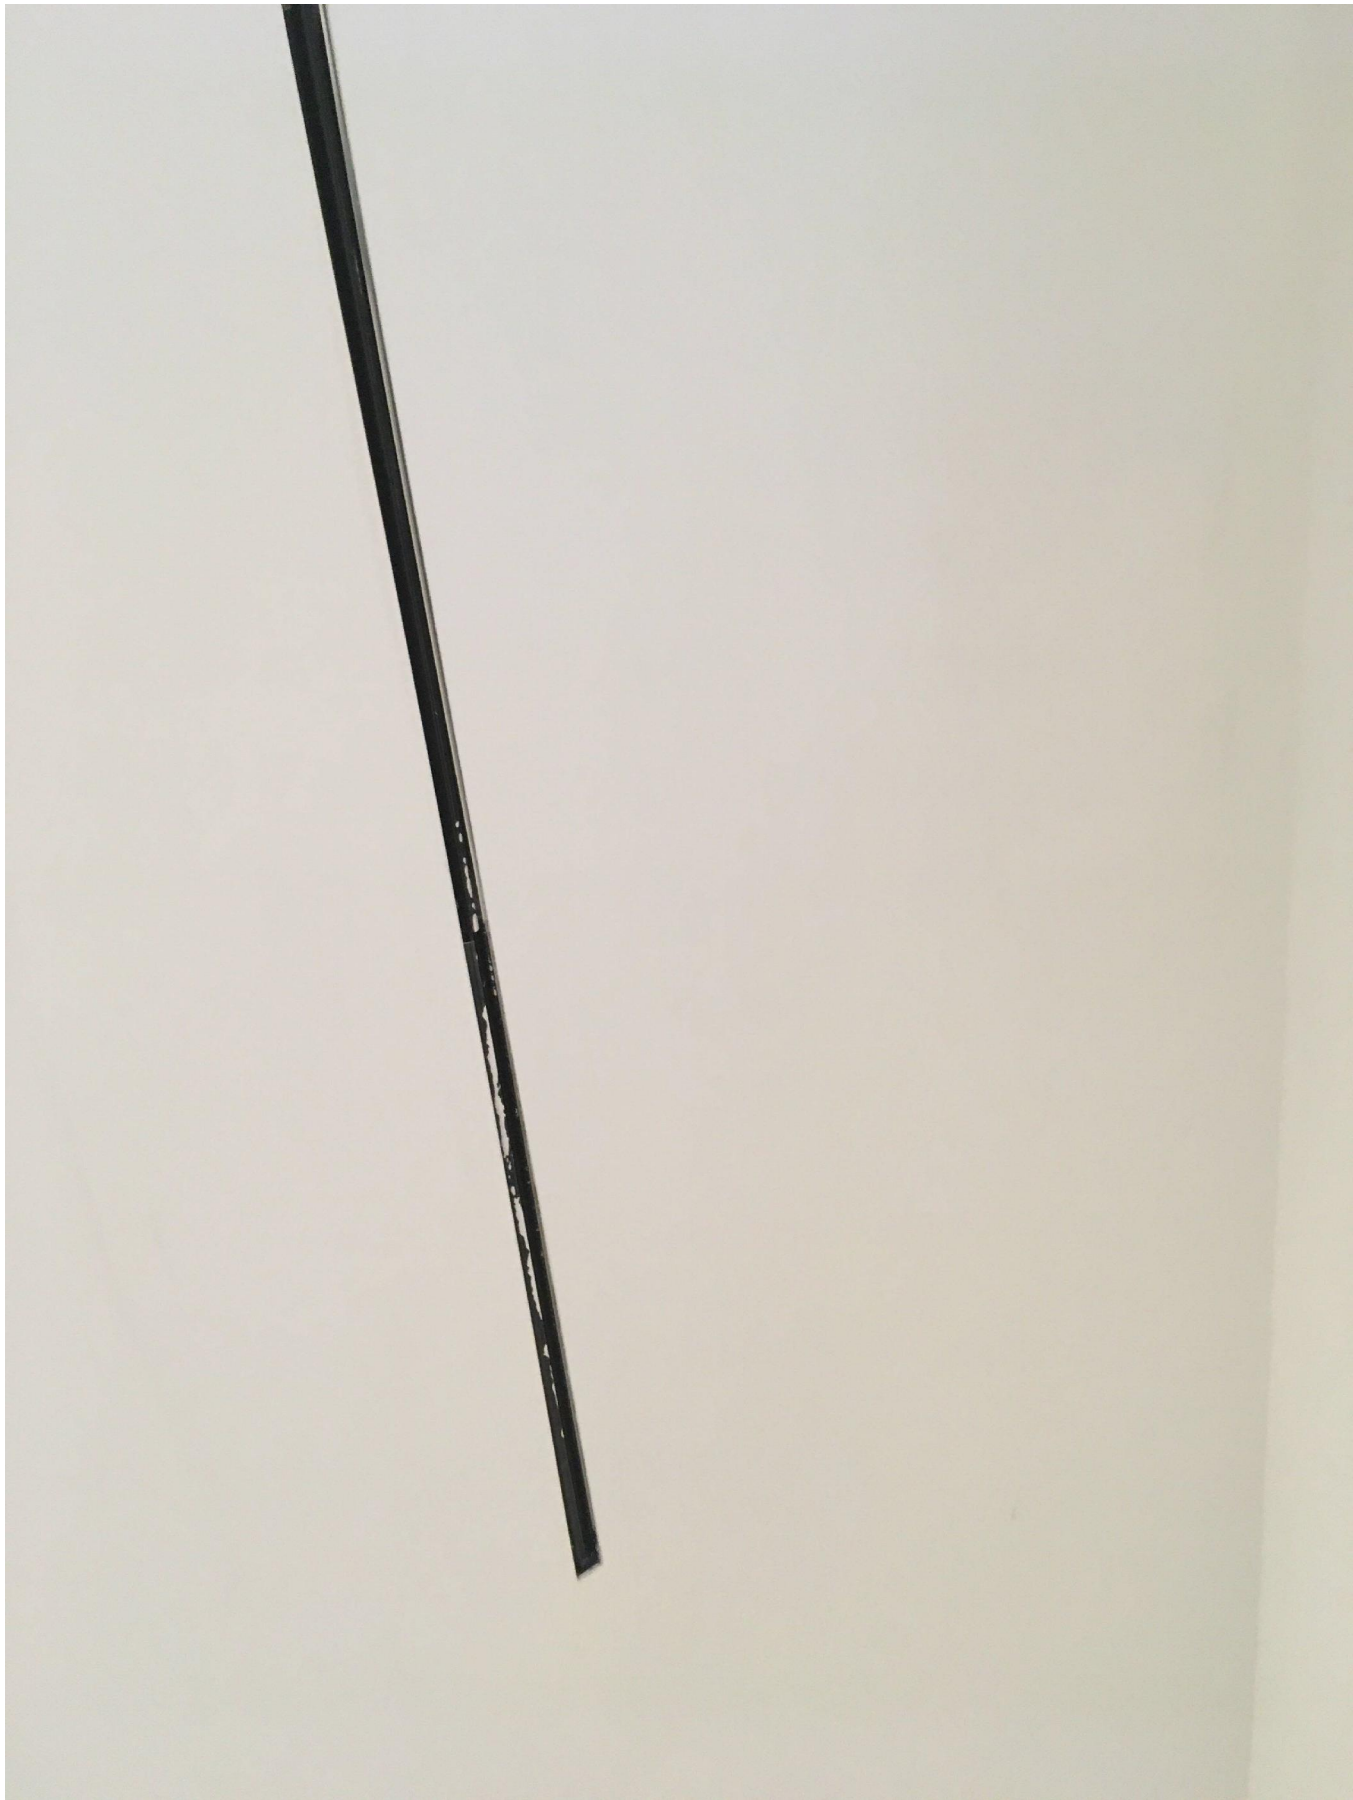
Attached Images for ID 001201

| <b>Description</b><br>Clean white paint off of black blades of slot diffuser in Corridor near 2nd Floor Elev 1 Doors | | | | |

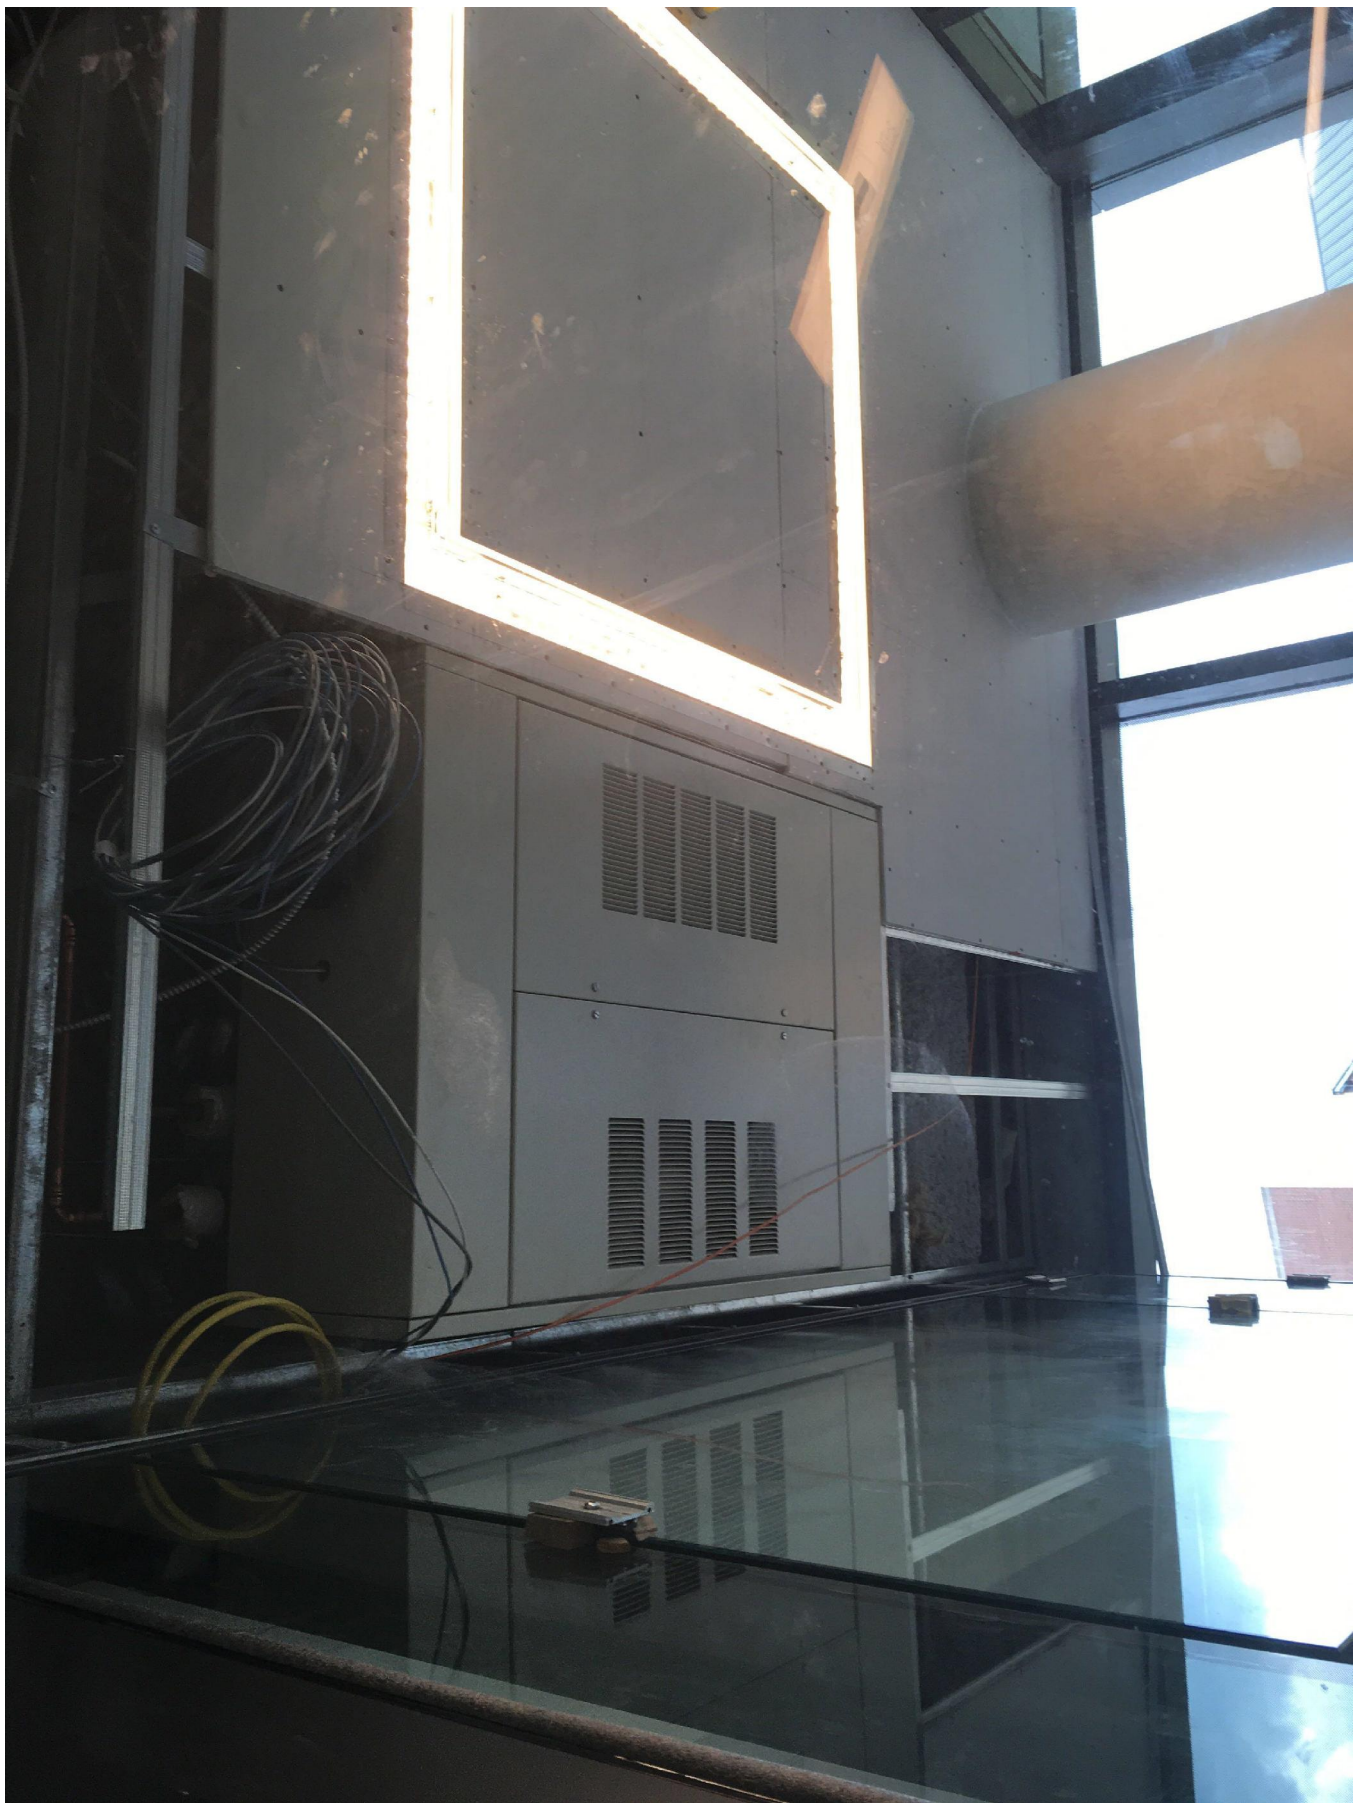
Attached Images for ID 001203

| <b>Description</b><br>C250A Vest: Installation in progress in vestibule | | | | |

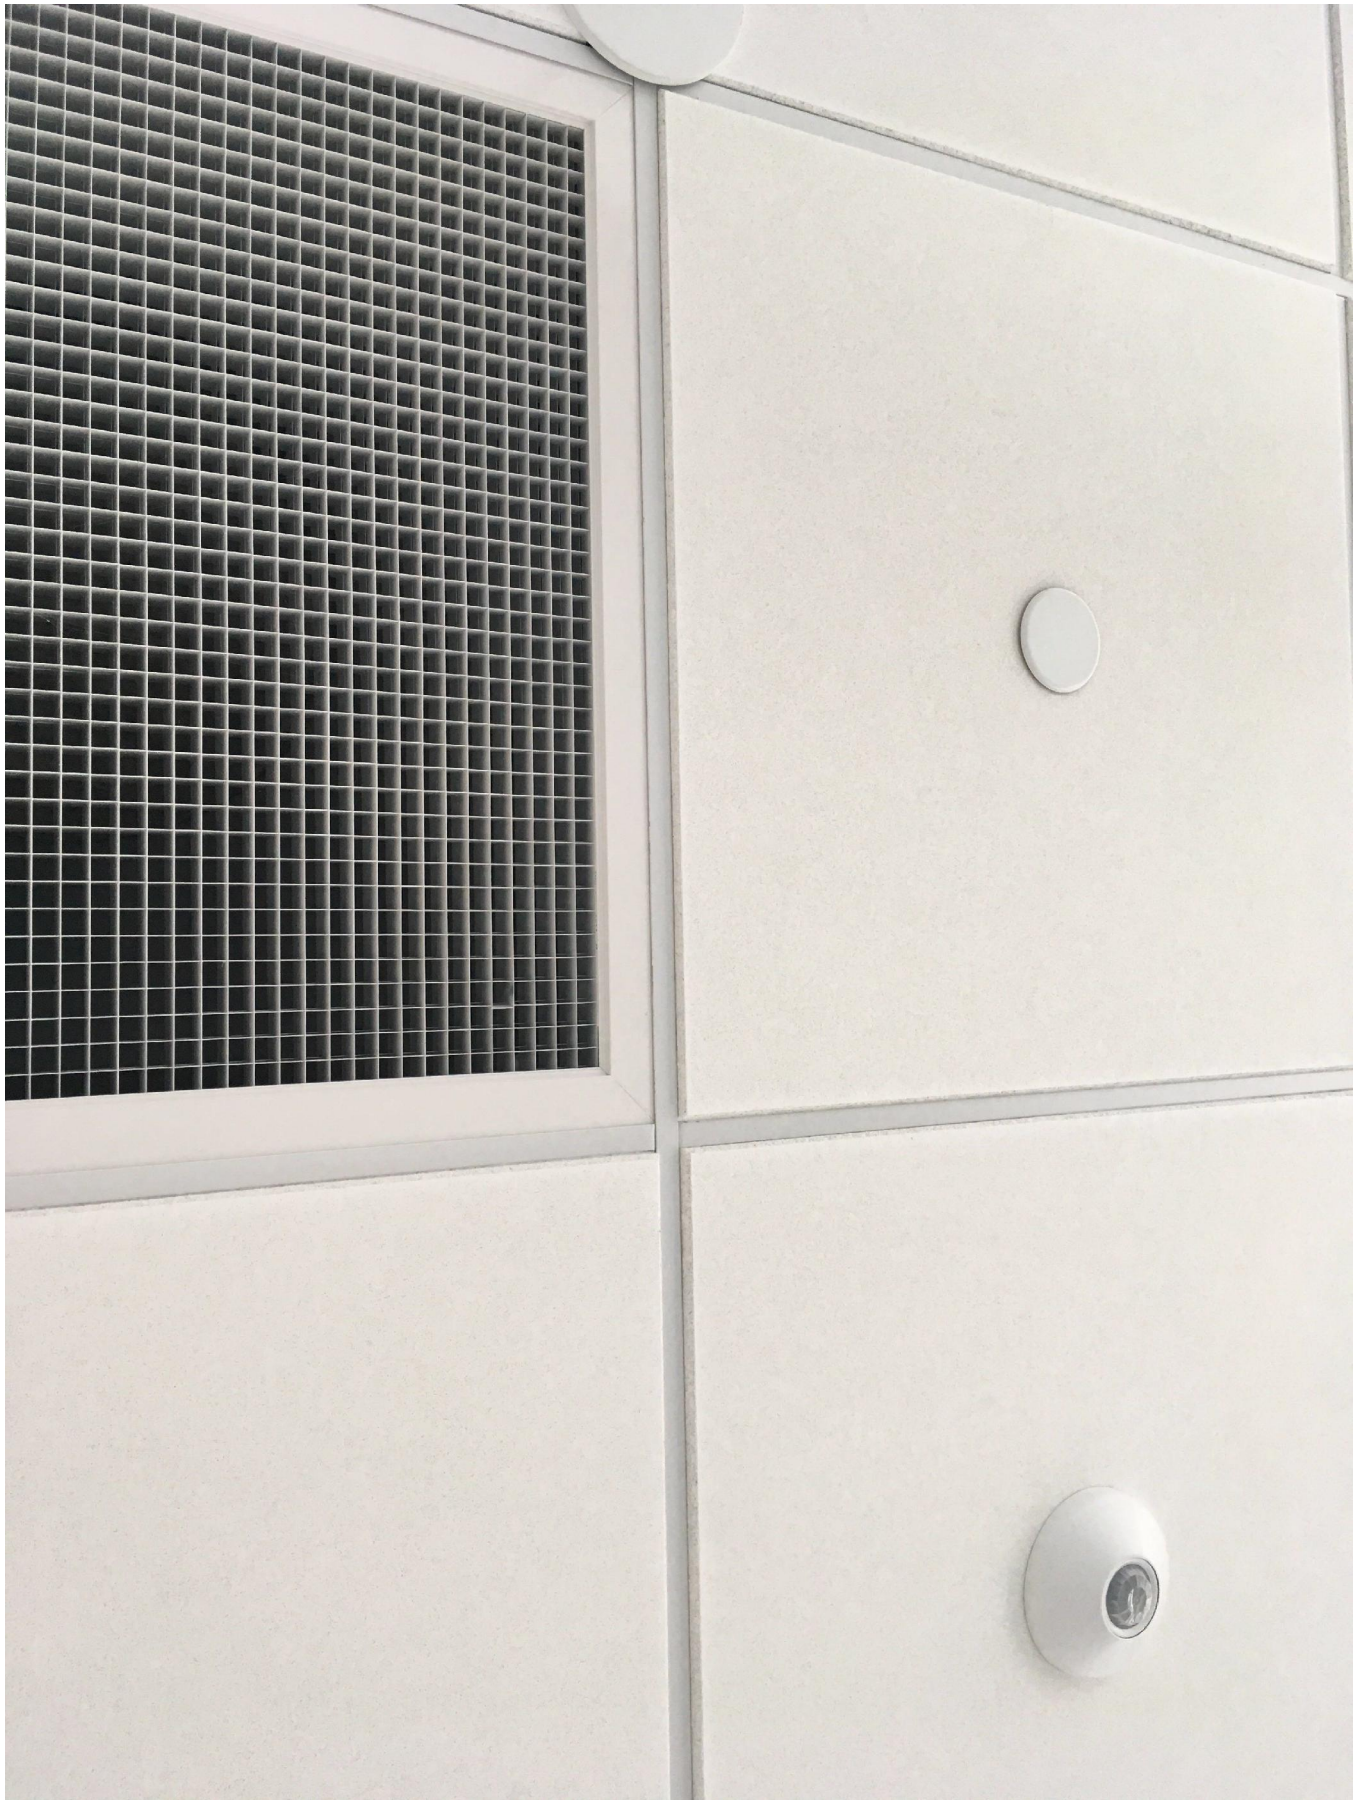
Attached Images for ID 001204

Rm 215: Adjust blades in return grill so that they do not appear to be bent
