## Observation Report

| Architect: | Cannon Design | Location: | Webster ISB - General |
| File: | Webster University Interdisciplinary Science Bldg.<br>WT 14127.01 (7) | c: | Jason Szachnieski &<br>Devin Gates (Paric) |

### **Level 2 - Mechanical Observations**

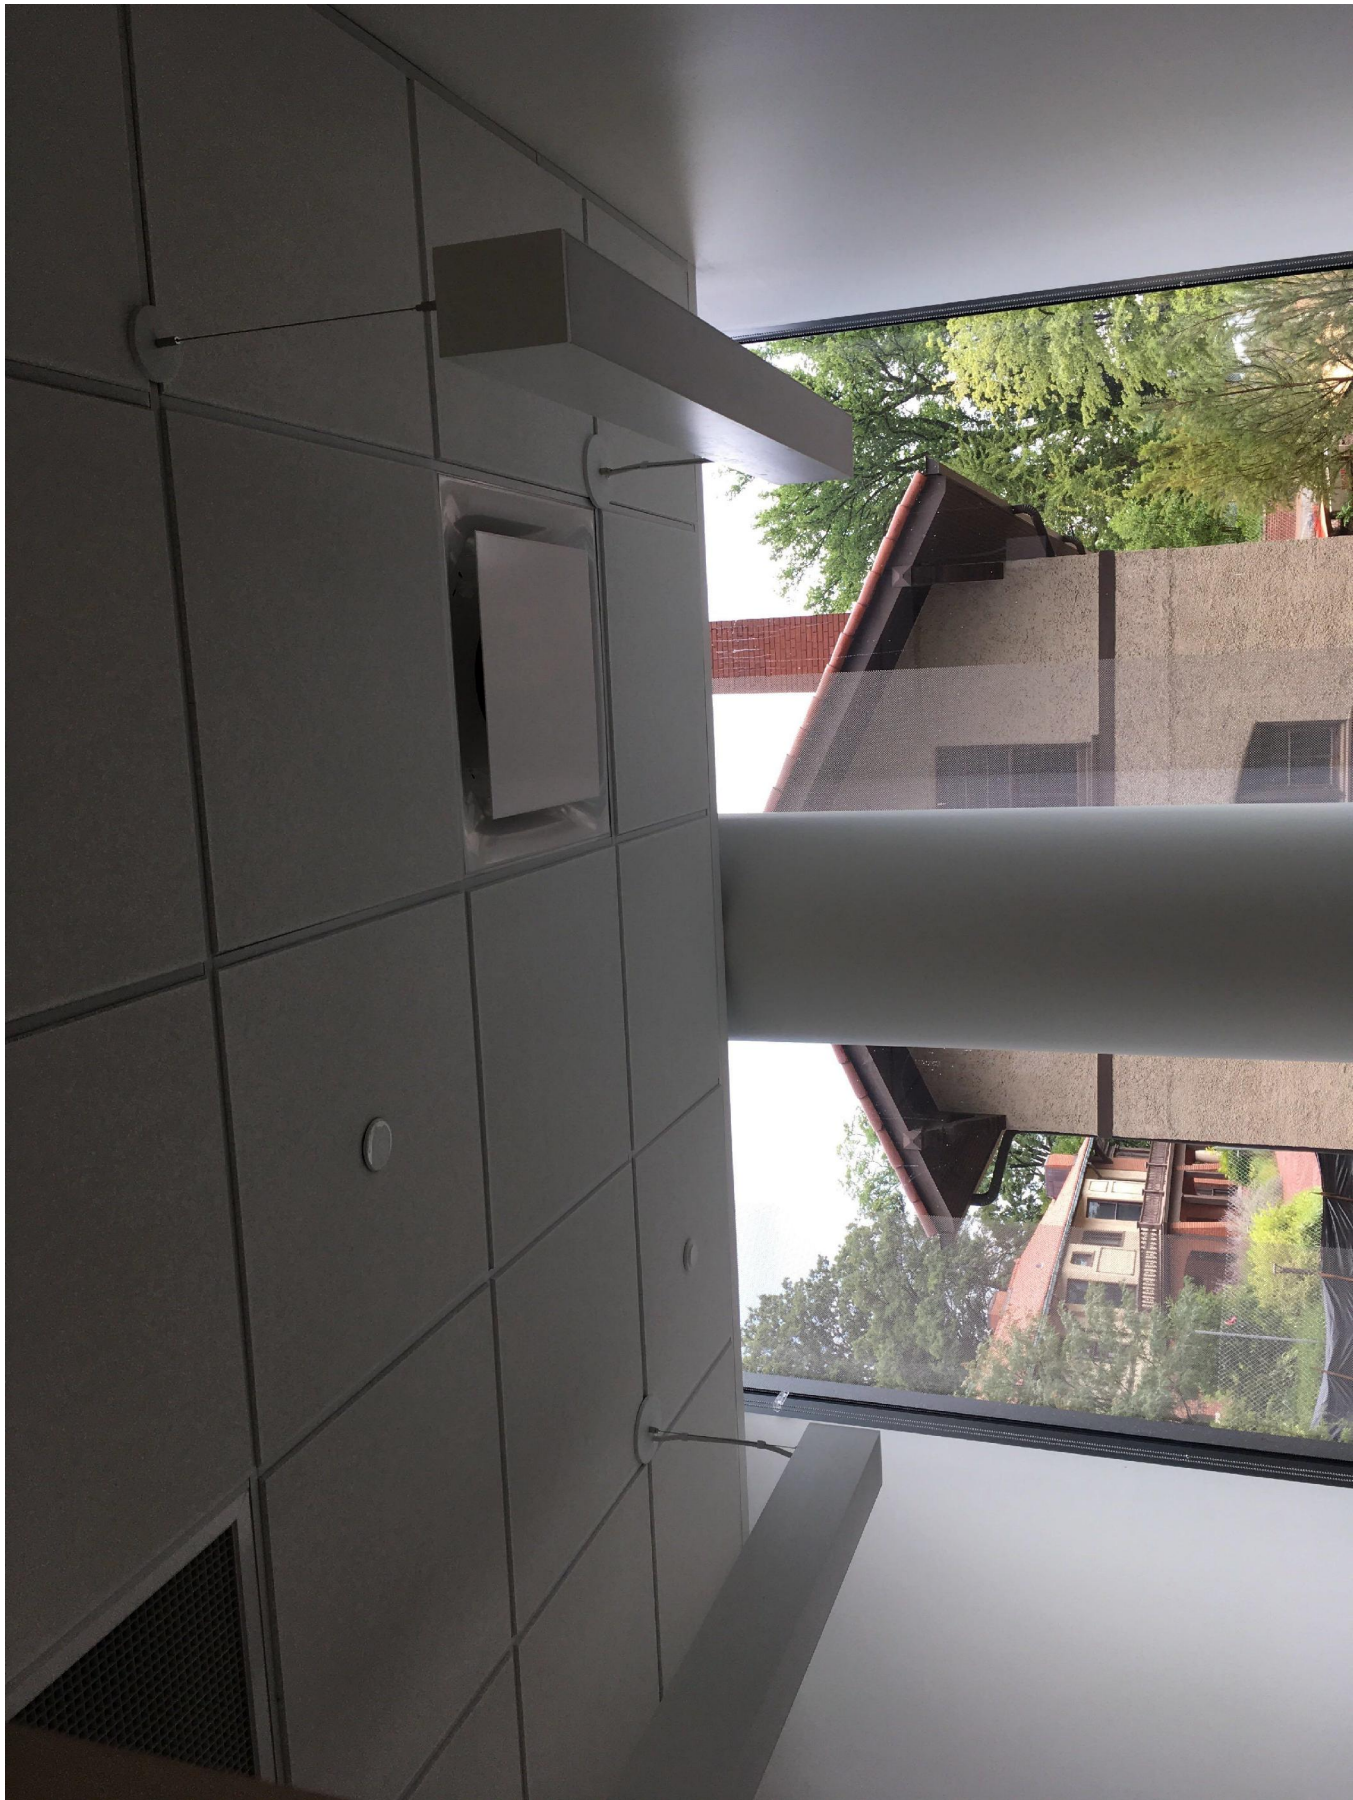
Attached Images for ID 001205

**Description**  
Supply diffuser installed in the wrong spot in ceiling, and is too close to thermostat which may cause false readings. Move supply diffuser away from thermostat to location shown on plan
