## Observation Report

| File: | Webster University Interdisciplinary Science Bldg.<br>WT 14127.01 (7) | c: | Jason Szachnieski &<br>Devin Gates (Paric) |

### **Level 3 - Mechanical Observations**

| Name | Webster ISB Level 3 Mechanical Punch |

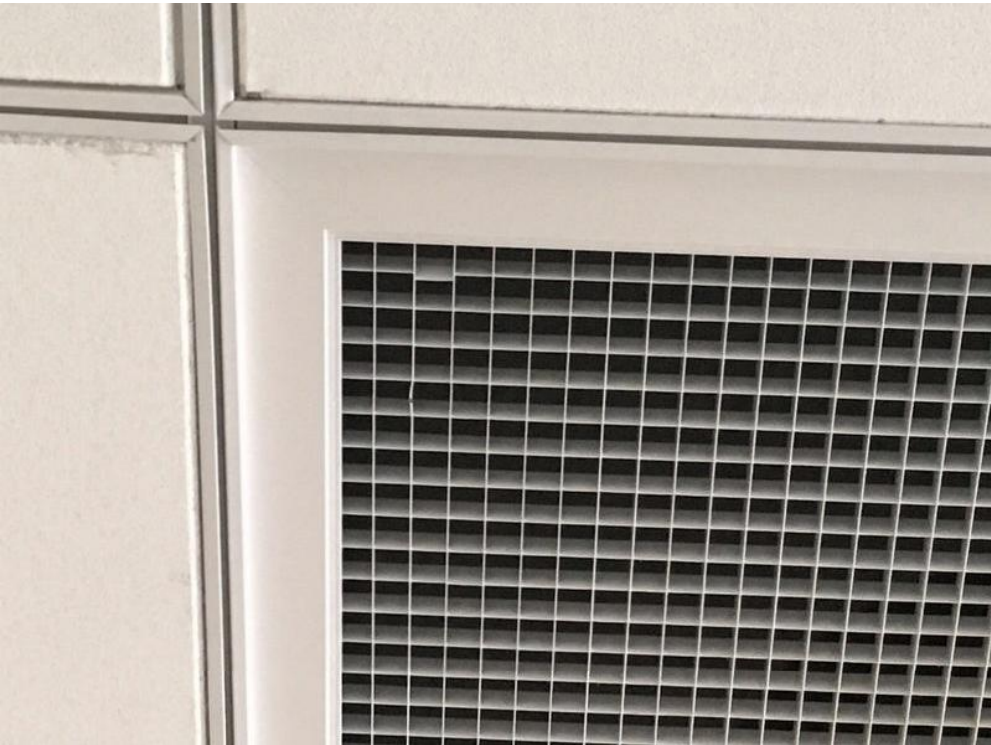
Attached Images for ID 001161

Exhaust grill has bent and broken tabs. Repair or replace as required

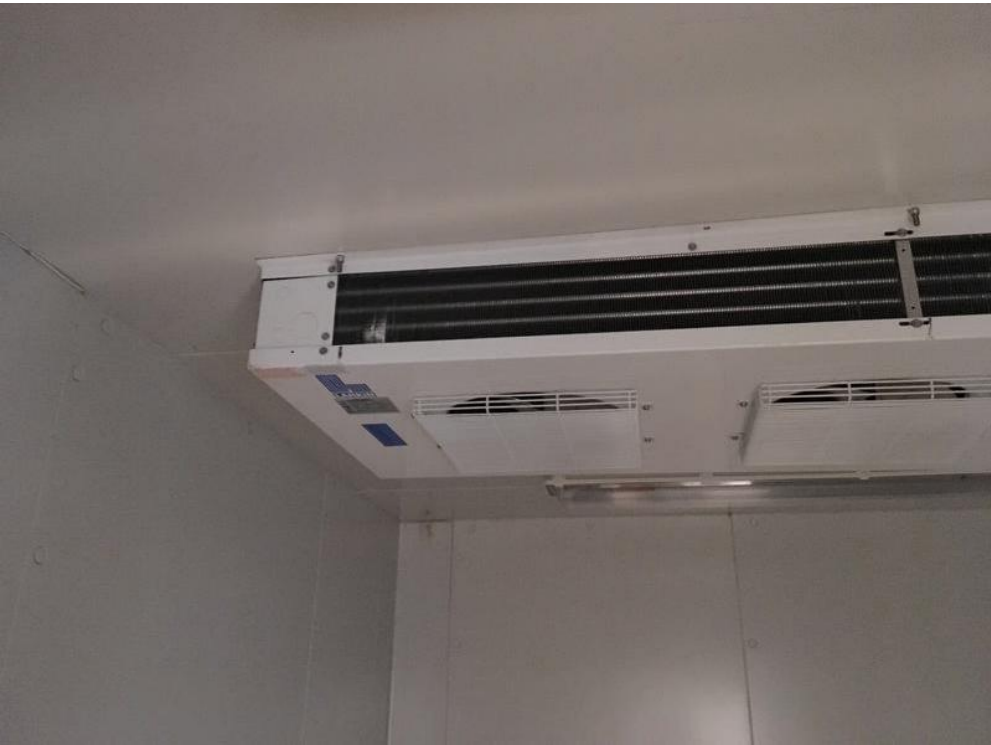
Attached Images for ID 001163

Straighten fins on cold room unit

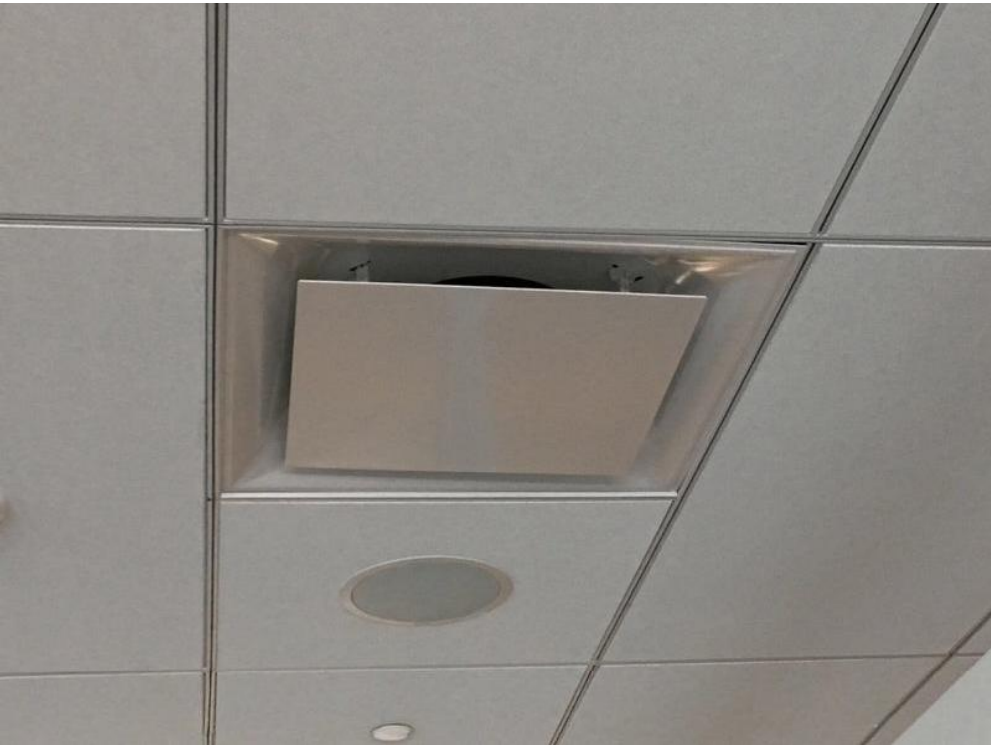
Attached Images for ID 001164

Supply diffuser plaque is at an angle. Adjust as required

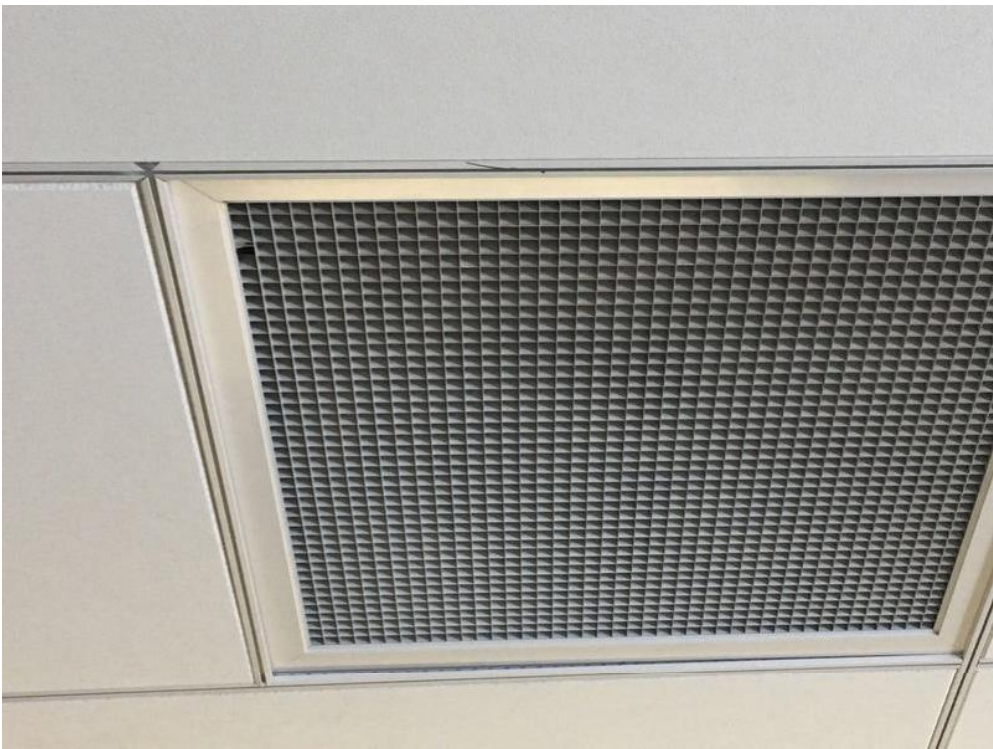
Attached Images for ID 001166

**Description**  
Exhaust grill has bent and broken tabs. Fix or replace as required. Exhaust grill also does not sit flush and ceiling. Adjust as required. Touch up scratchon ceiling grid

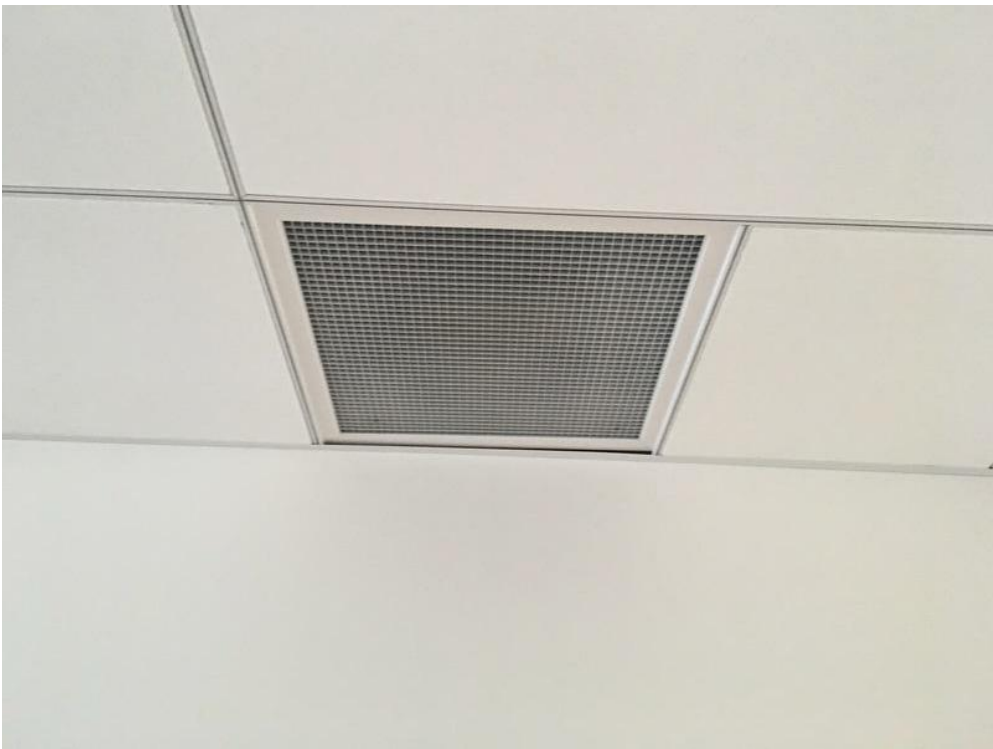
Attached Images for ID 001167

**Description**  
Exhaust grill has gap at wall. Fix or relocate exhaust grille required. If contractor relocates exhaust grill, then use flex duct to extend ductwork.

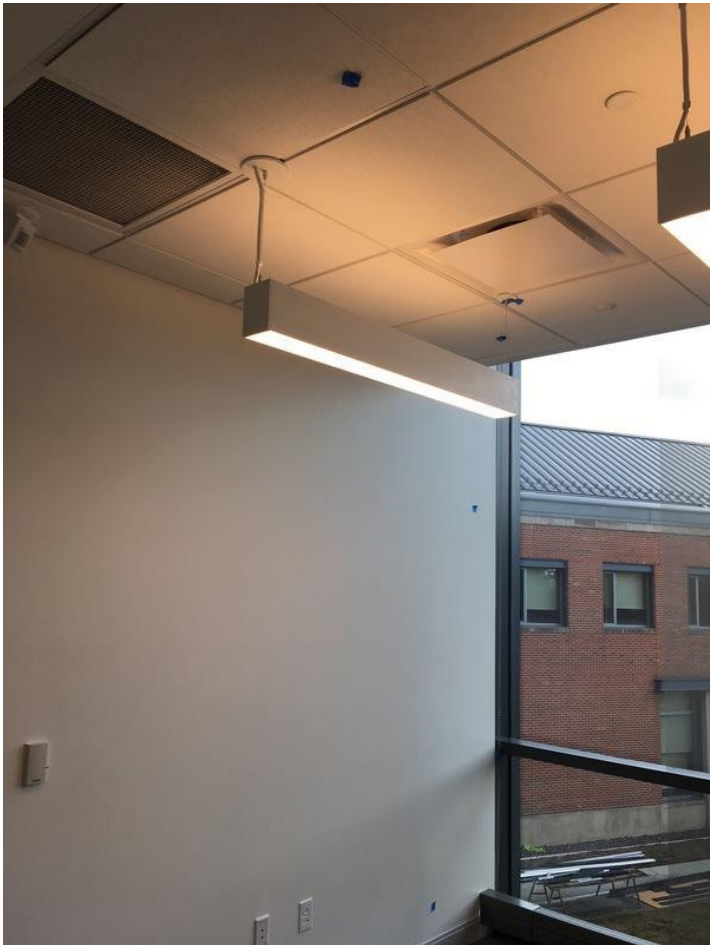
Attached Images for ID 001171

**Description**  
360: Move supply diffuser to next row of ceiling tiles farther away from thermostat to prevent false readings. Also adjust supply diffuser plaque as required for appearance.

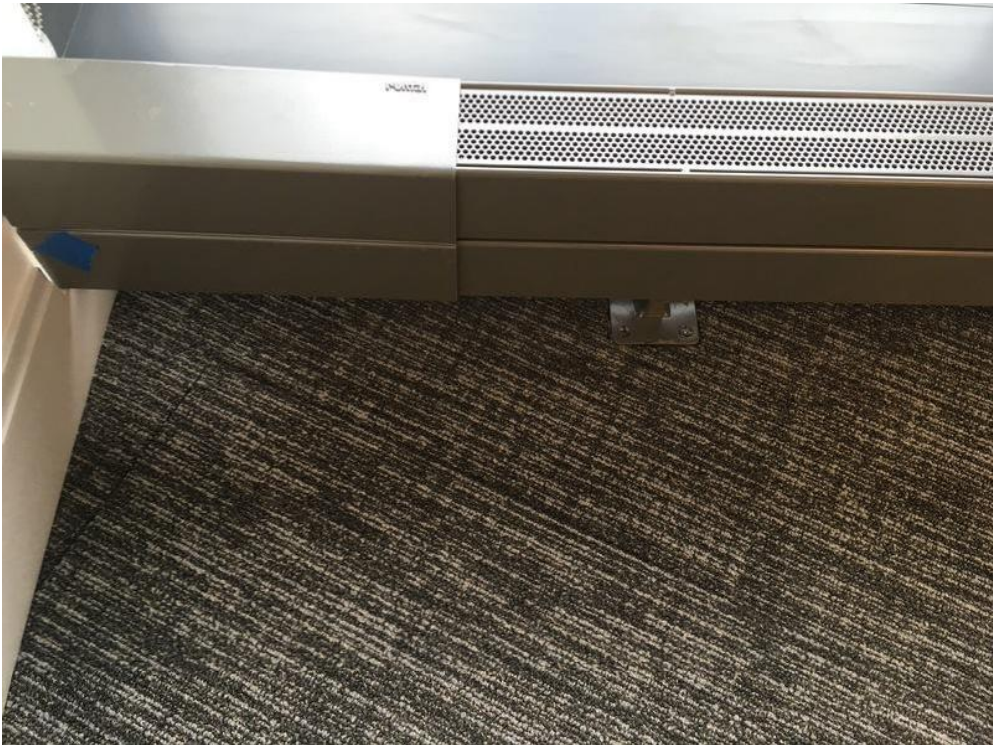
Attached Images for ID 001172

| 362: Install missing screws and fin tube radiation bases. |

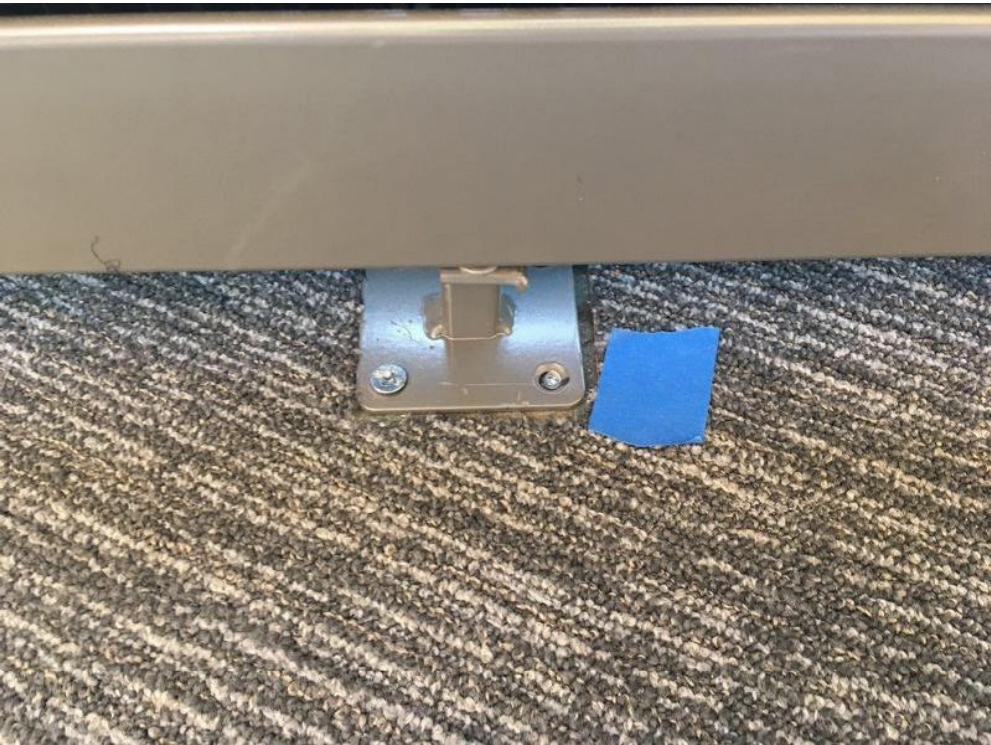
Attached Images for ID 001173

| <b>Description</b><br>354: Screw was sheared off in floor at FTR base. Remove broken screw from floor and replace with new screw as required. | |

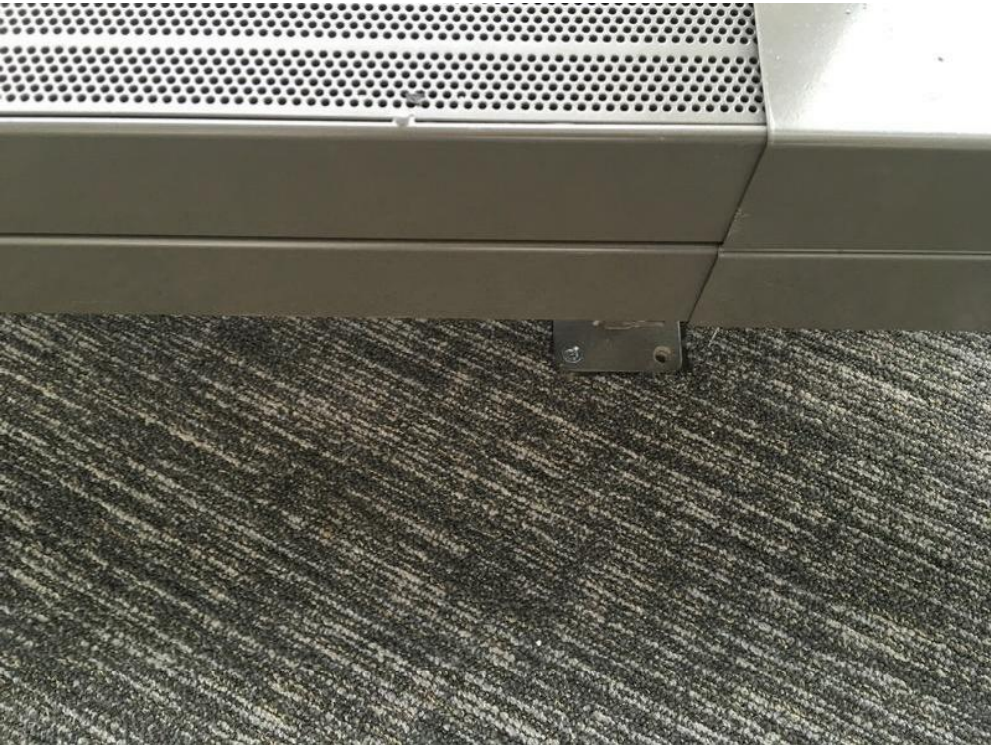
Attached Images for ID 001174

352: Install missing screw in FTR pedestal base.

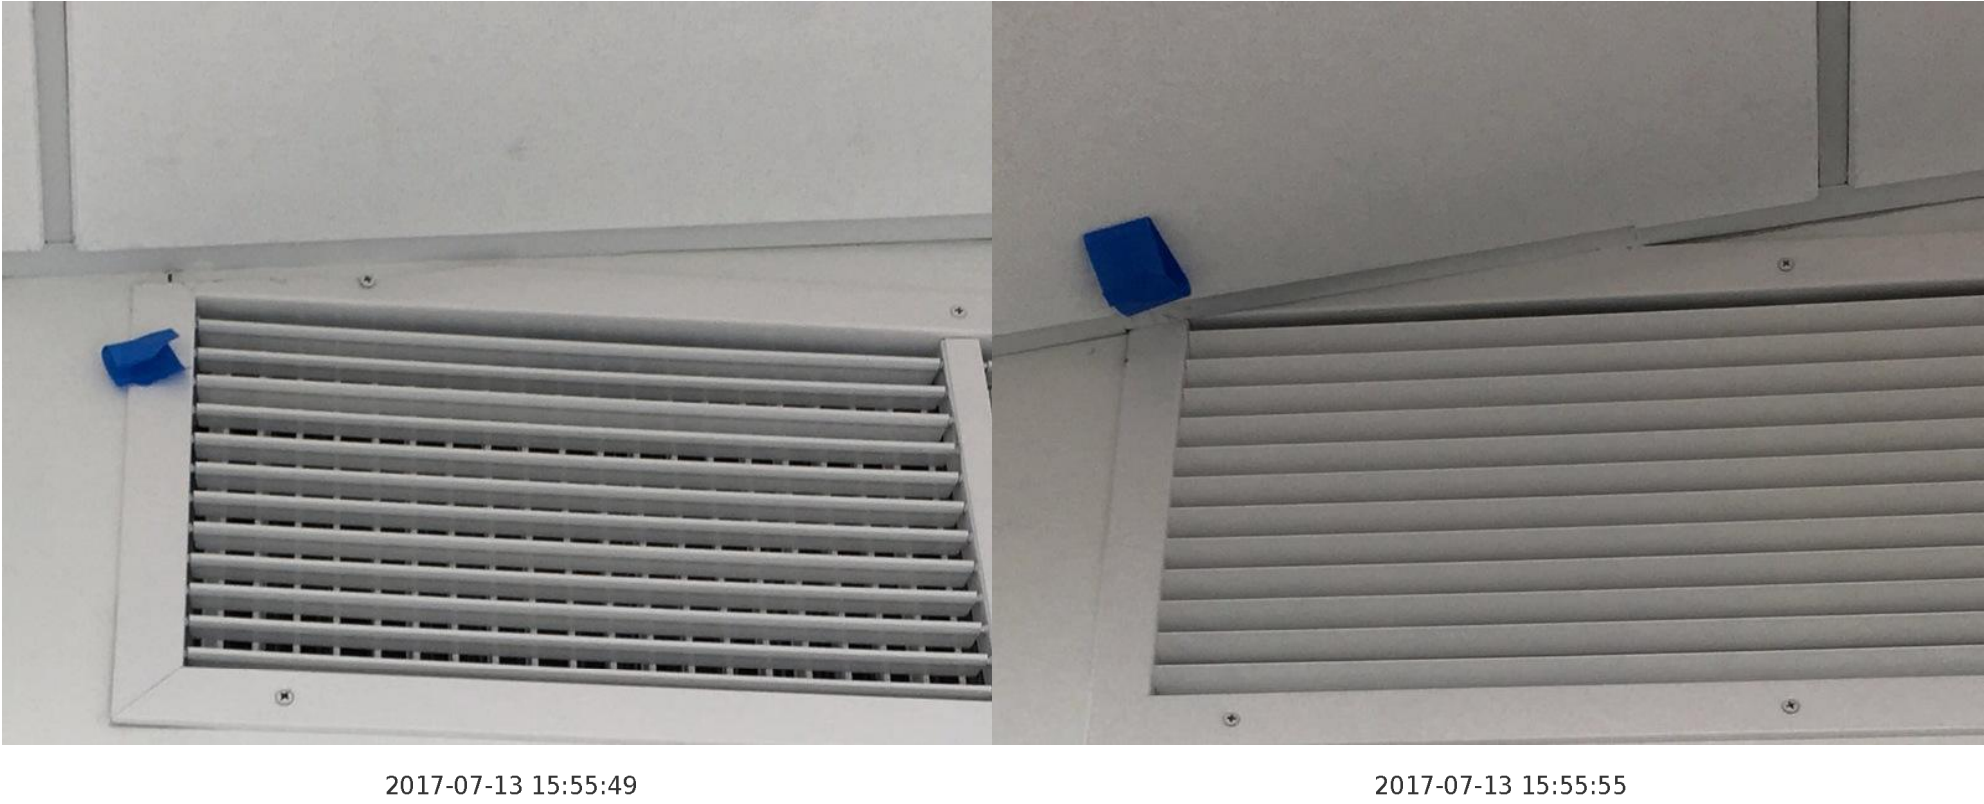
**Attached Images for ID 001175**

**Description**  
342: Touch up field fabricated edges of sidewall grills as required for a smooth looking appearance.

**Comments for ID 001175**  
Alex Chambers (achambers@iconmech.com) 17 Jul 2017 8:50 AM Per Paric direction, diffusers were cut to accommodate ceiling construction.

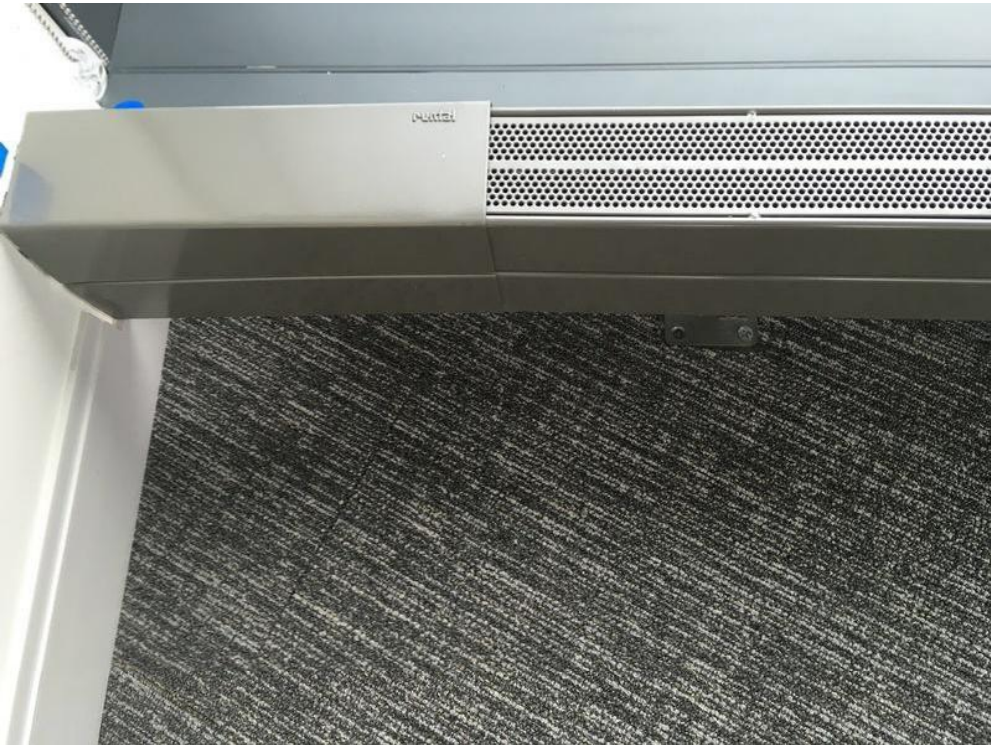
Attached Images for ID 001176

342: Install missing pedestal base screw

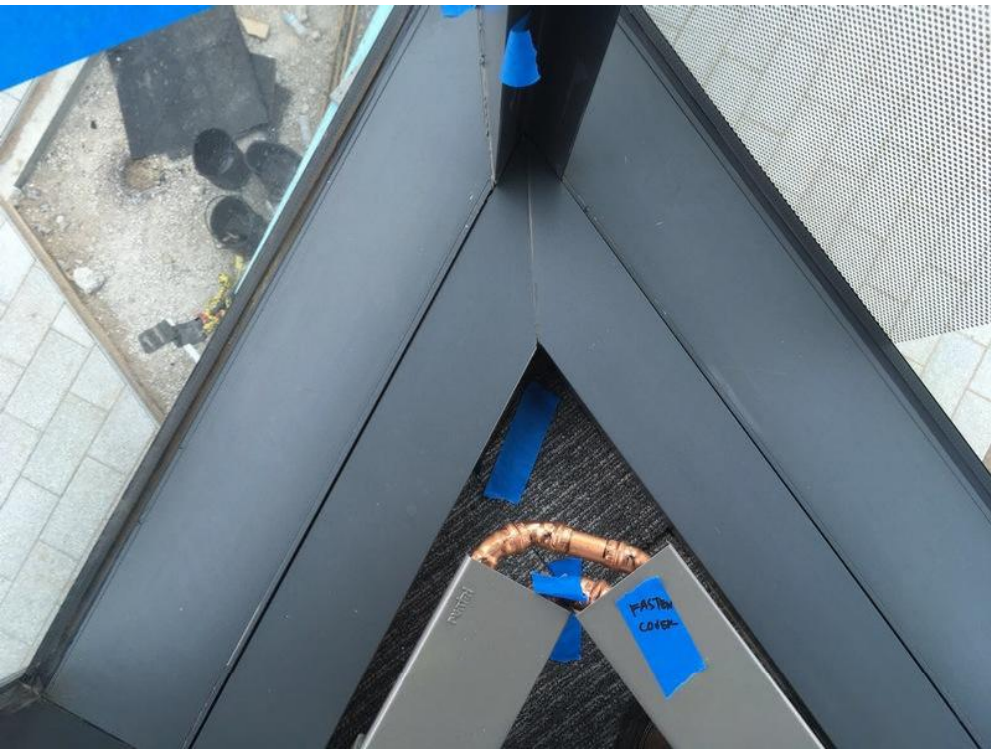
Attached Images for ID 001177

342: Install missing pipe cover.

cover not missing. Piping to be painted per architect.

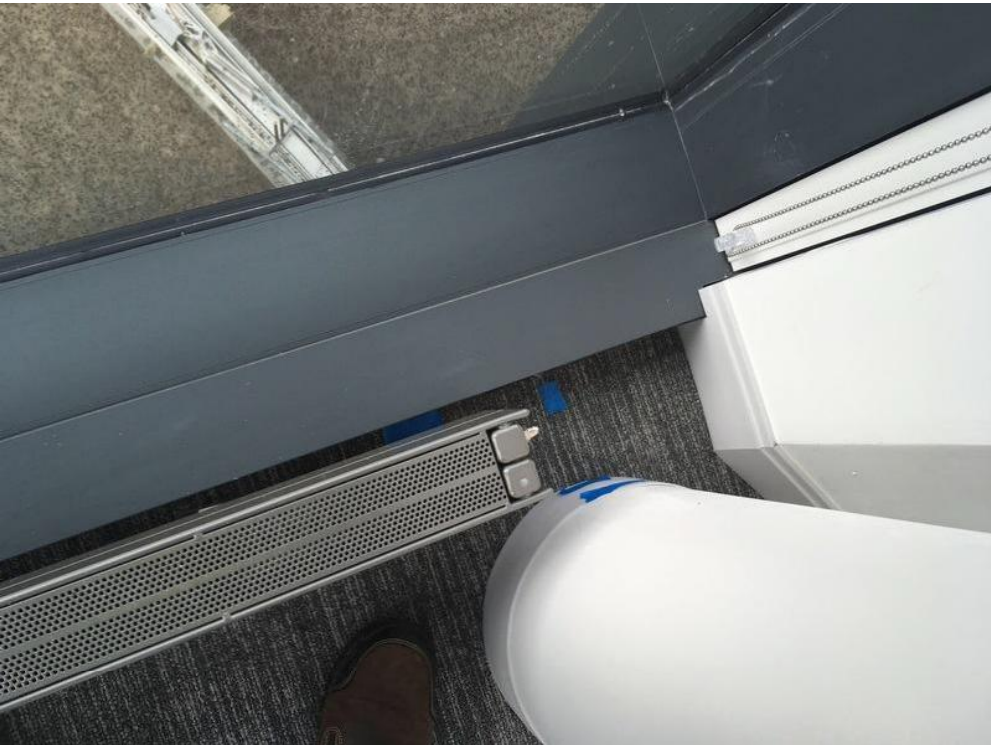
Attached Images for ID 001178

342: Install missing finned tube radiation end cap

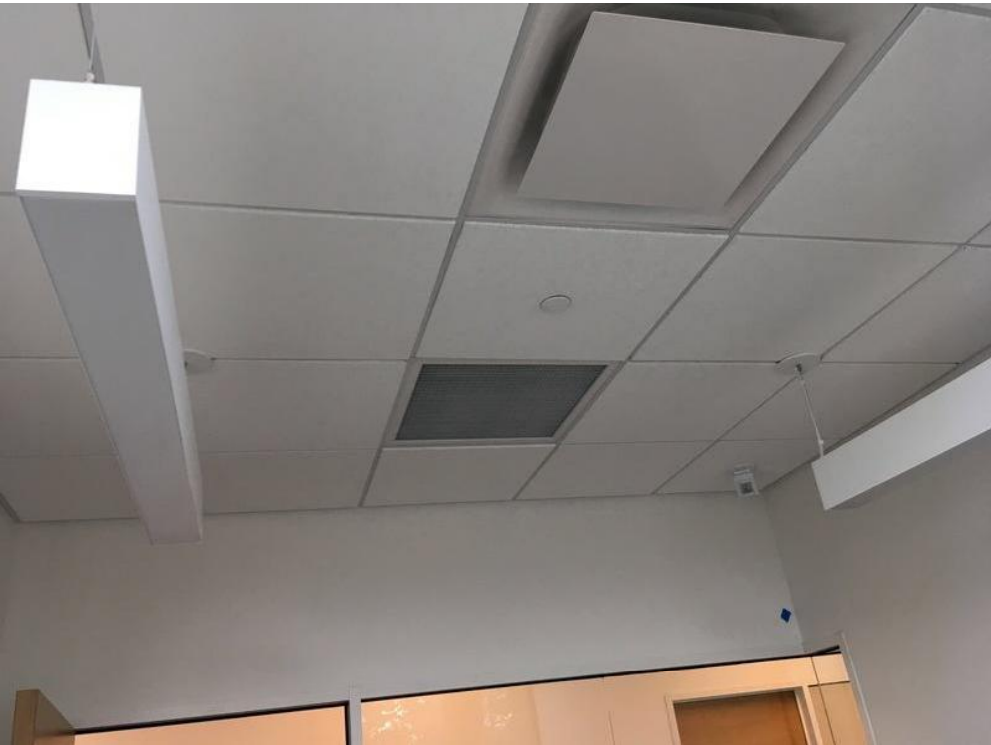
Attached Images for ID 001179

Move return grill farther away from supply diffuser in ceiling grid

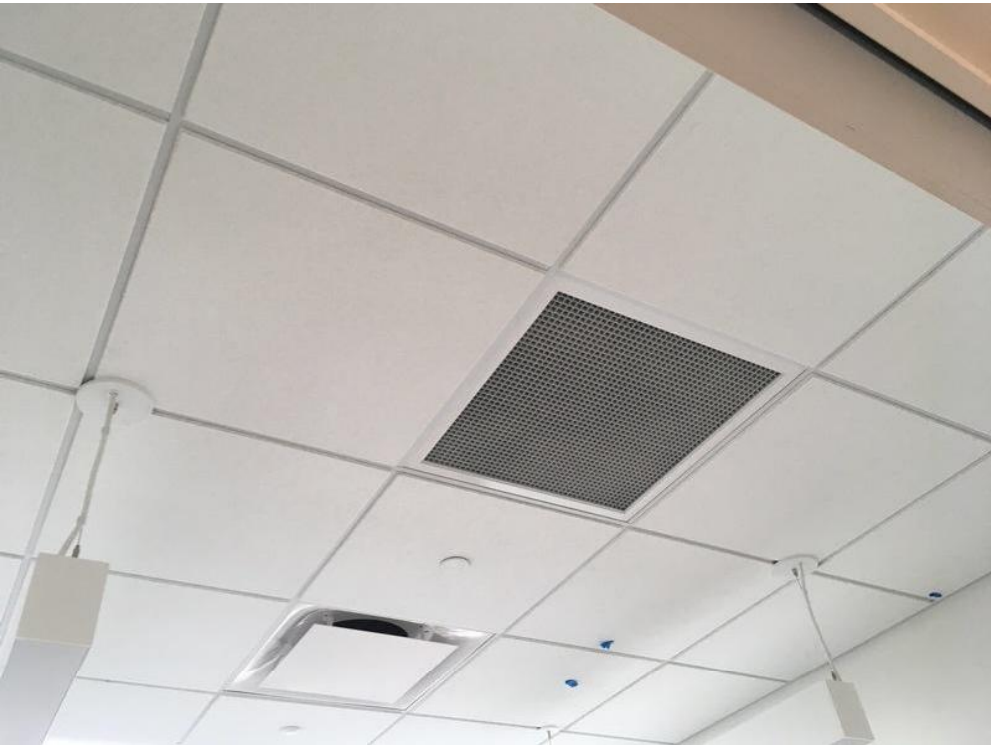
Attached Images for ID 001180

Move return grill farther away from supply diffuser in ceiling grid.

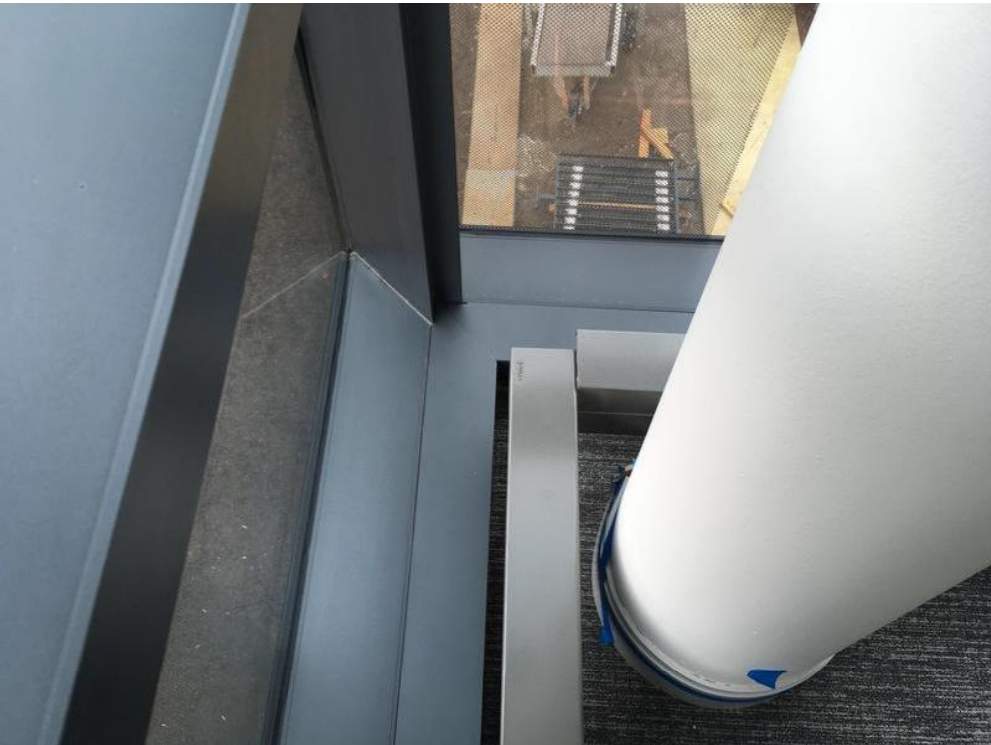
Attached Images for ID 001181

325: Extend and caps as required for flush install at corner

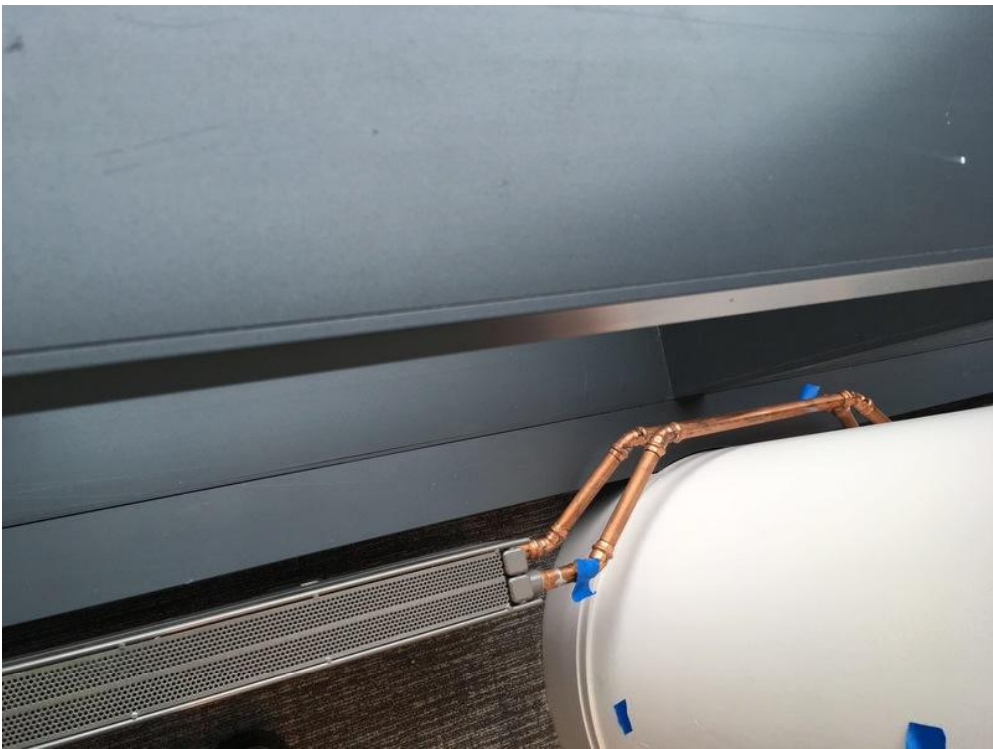
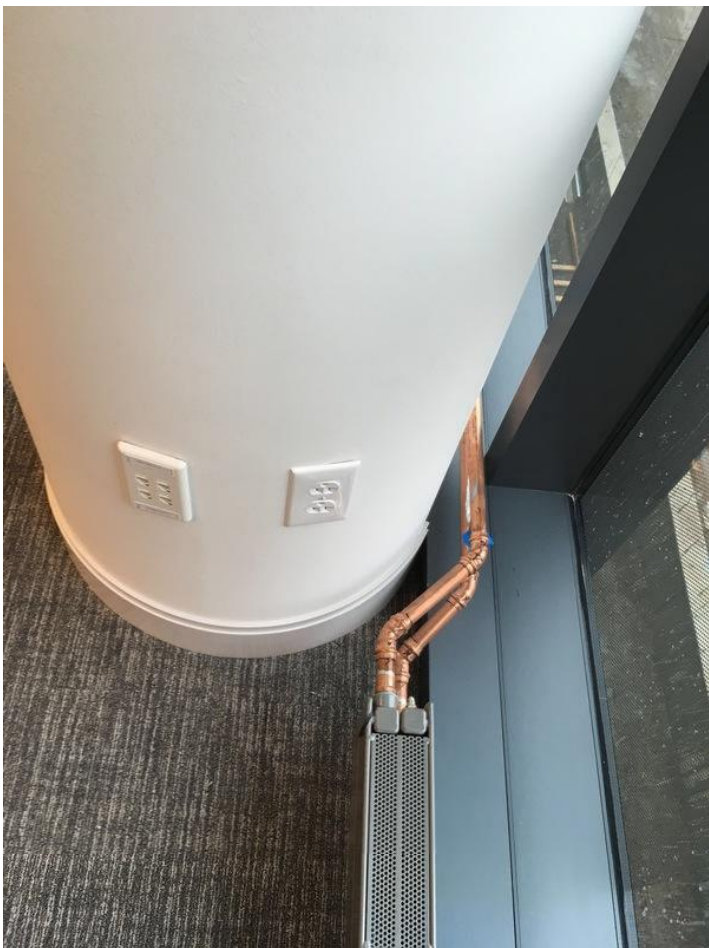
Attached Images for ID 001182

305: Install missing pipe covers as required.

Per architect, piping is to be painted.

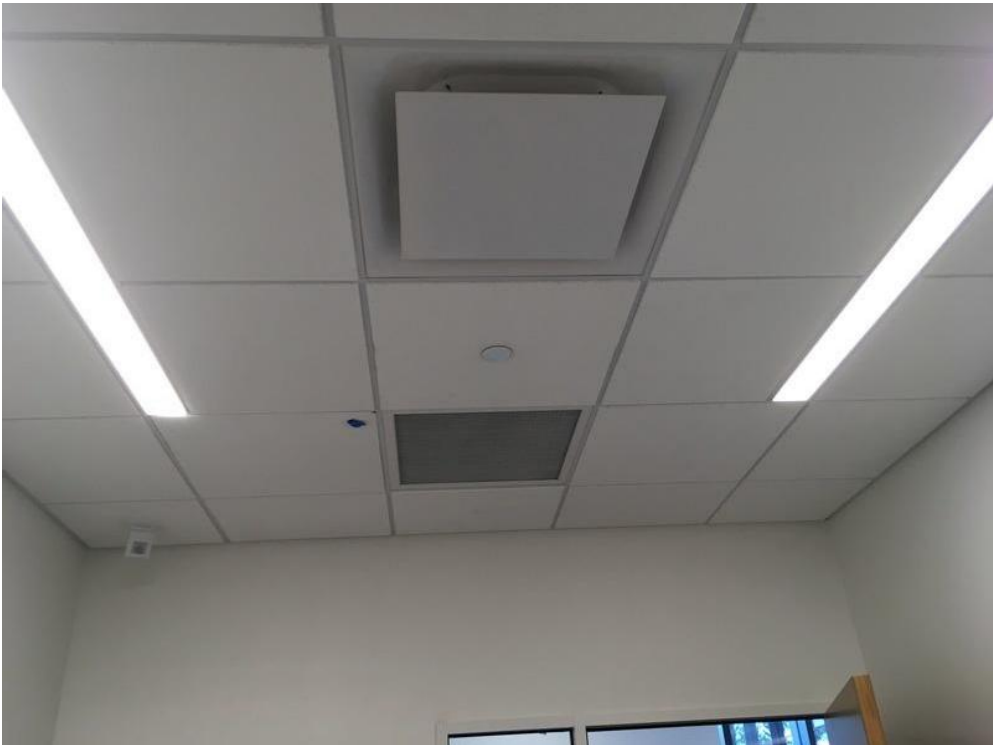
Attached Images for ID 001186

**Description**  
Move return grill away from supply.

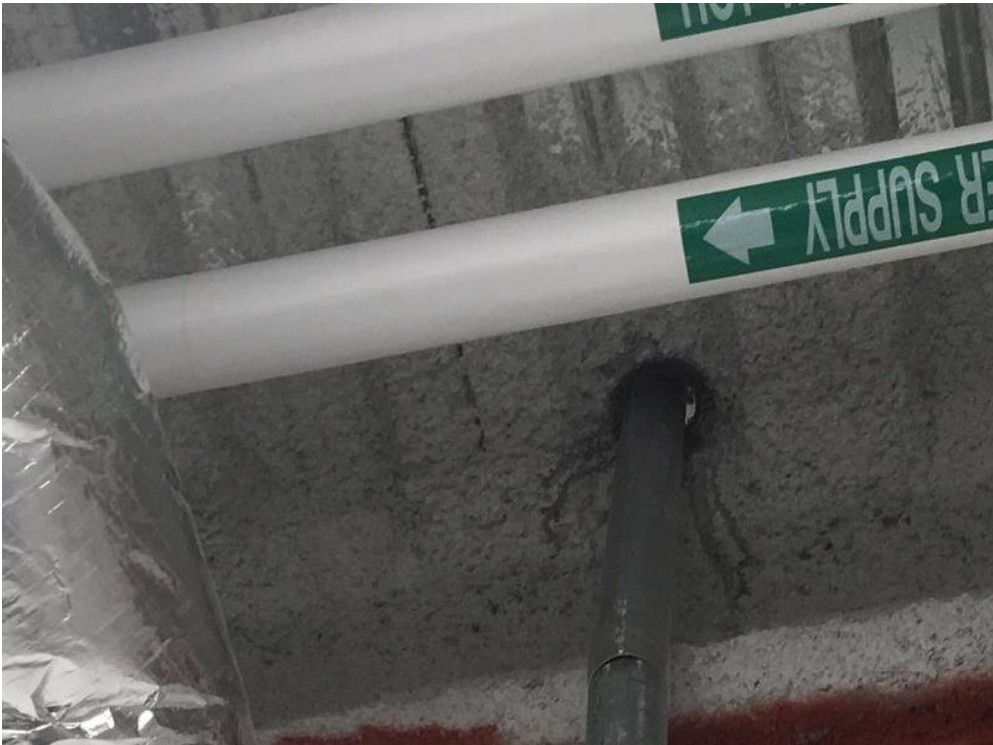
Attached Images for ID 001187

| <b>Description</b><br>310B: Seal conduit penetrations in floor above. | | | | |

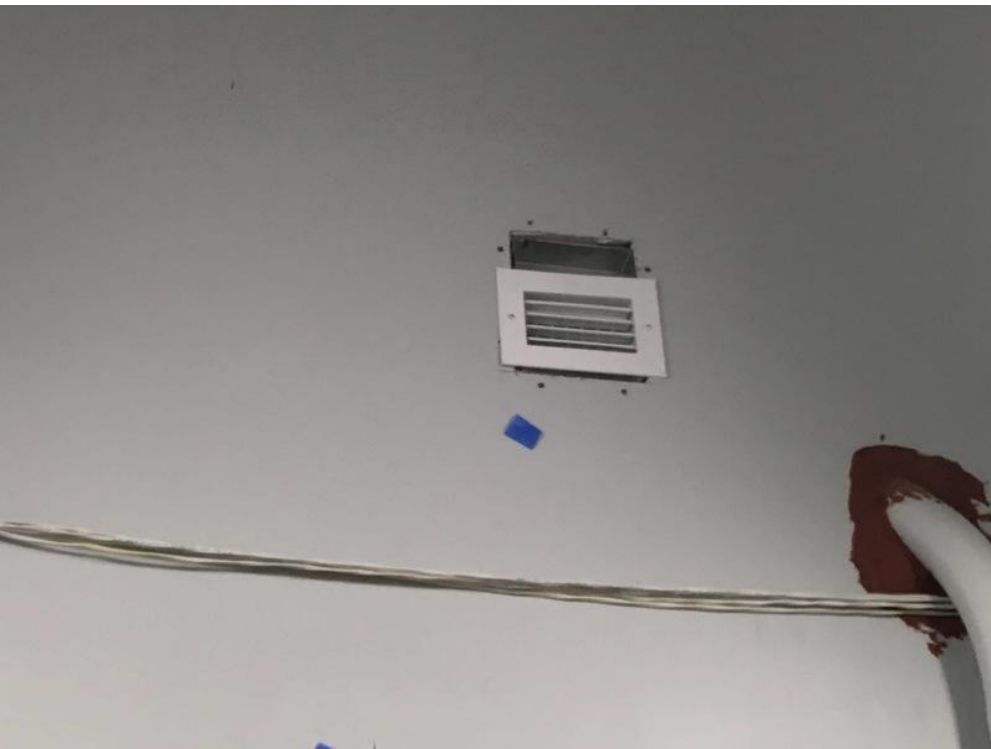
Attached Images for ID 001188

310A: Installation does not appear to be correct. Install the appropriate sized grill. Patch wall as required.

| Alex Chambers (achambers@iconmech.com)<br>17 Jul 2017 9:18 AM | Drywall needs to be finished |

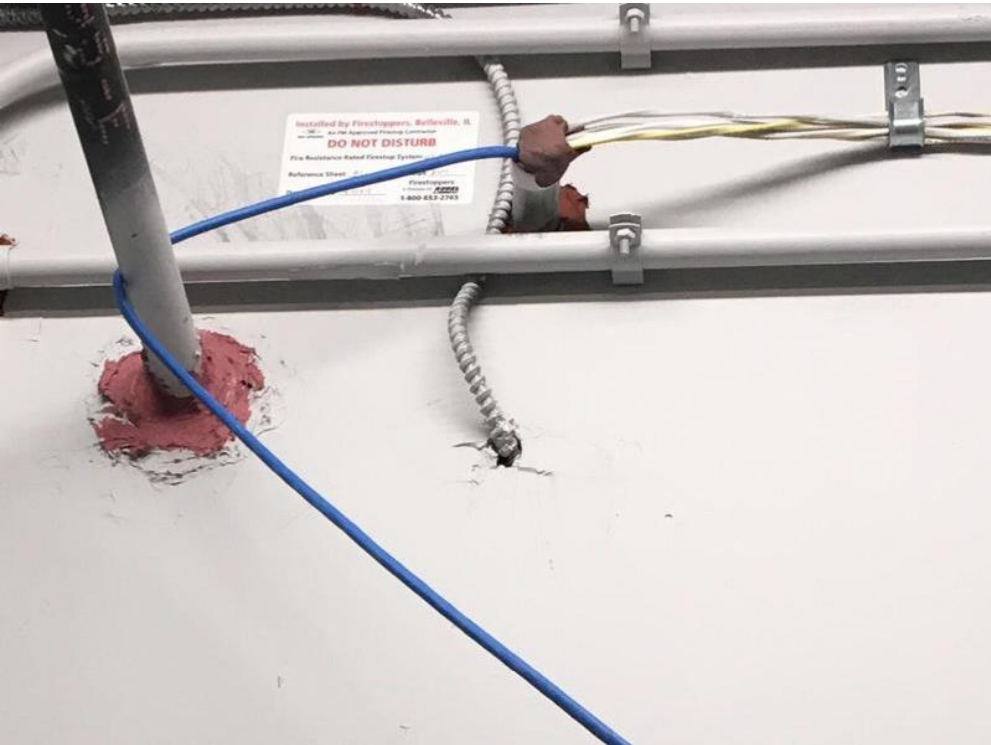
Attached Images for ID 001189

| 310A: Seal all wall penetrations |

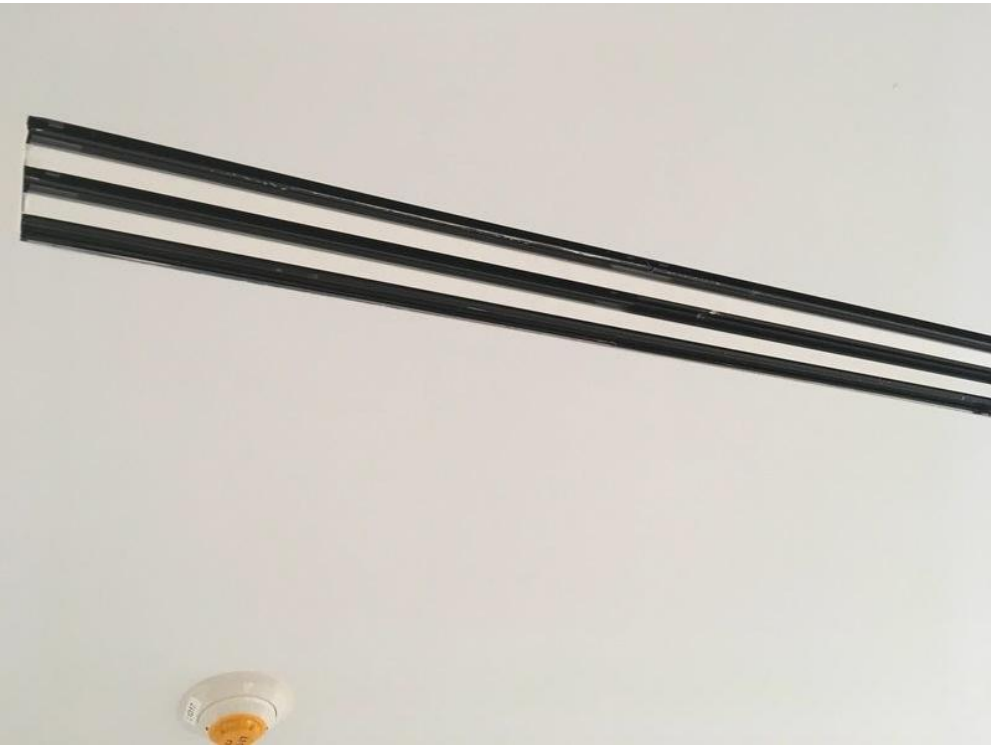
Attached Images for ID 001191

C370: Clean white paint off of black blades of slot diffuser located in front of Elev 1 Doors
