## Observation Report

| Architect: | Cannon Design | Location: | Webster ISB - General |
| File: | Webster University Interdisciplinary Science Bldg.<br>WT 14127.01 (7) | c: | Jason Szachnieski &<br>Devin Gates (Paric) |

### **Roof- Mechanical Observations**

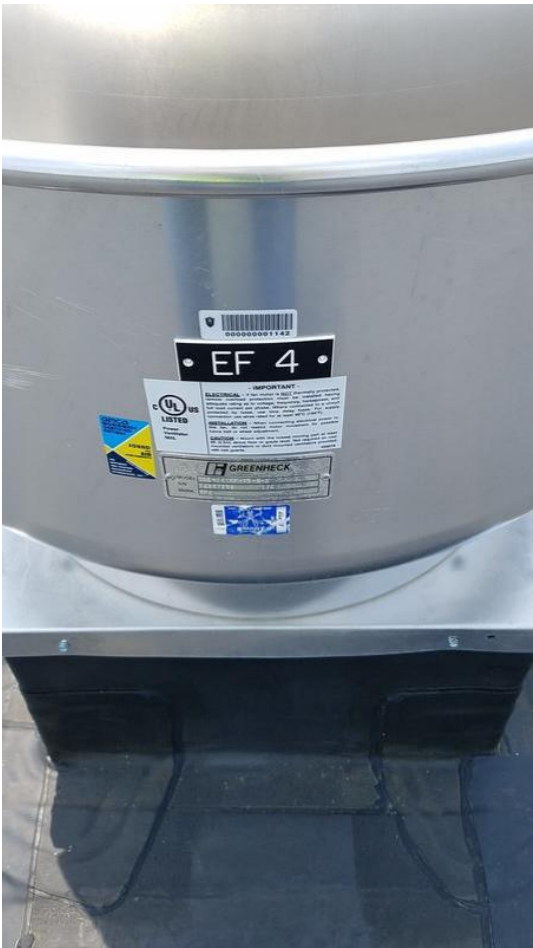
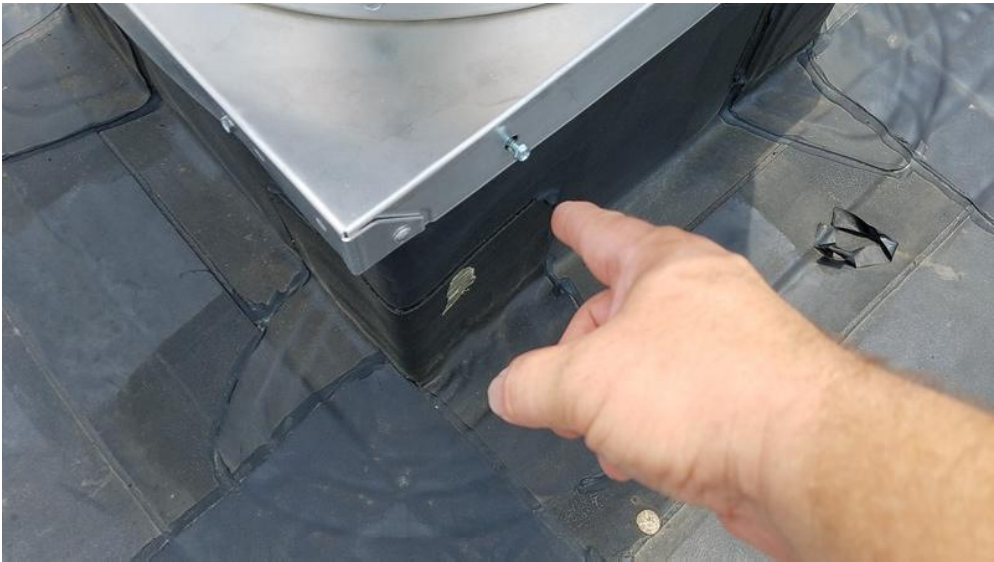
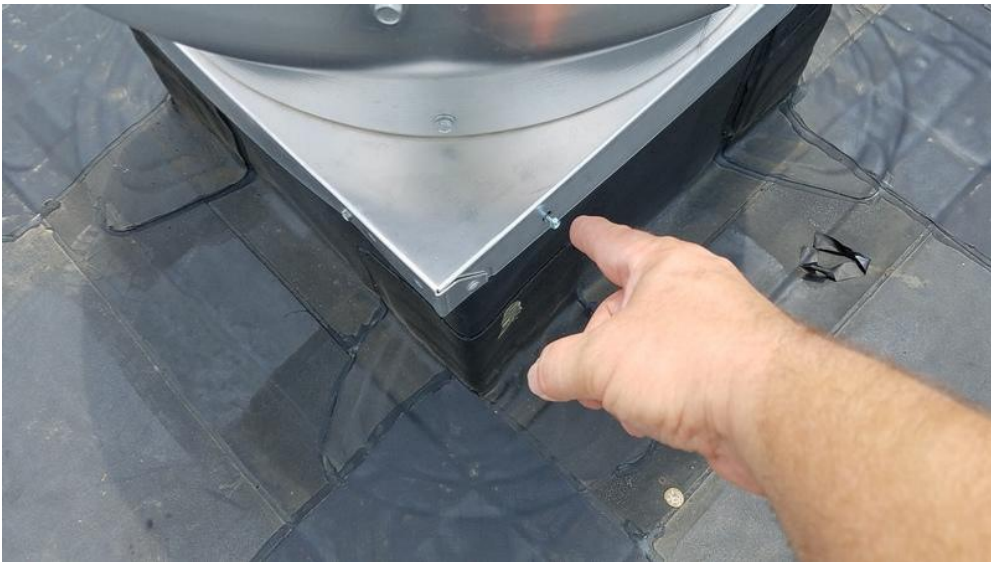
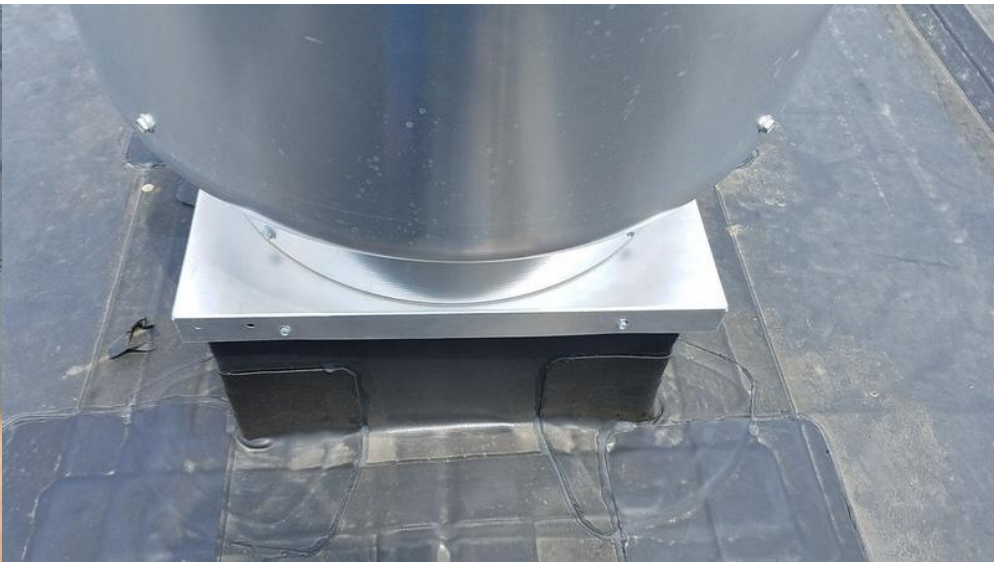
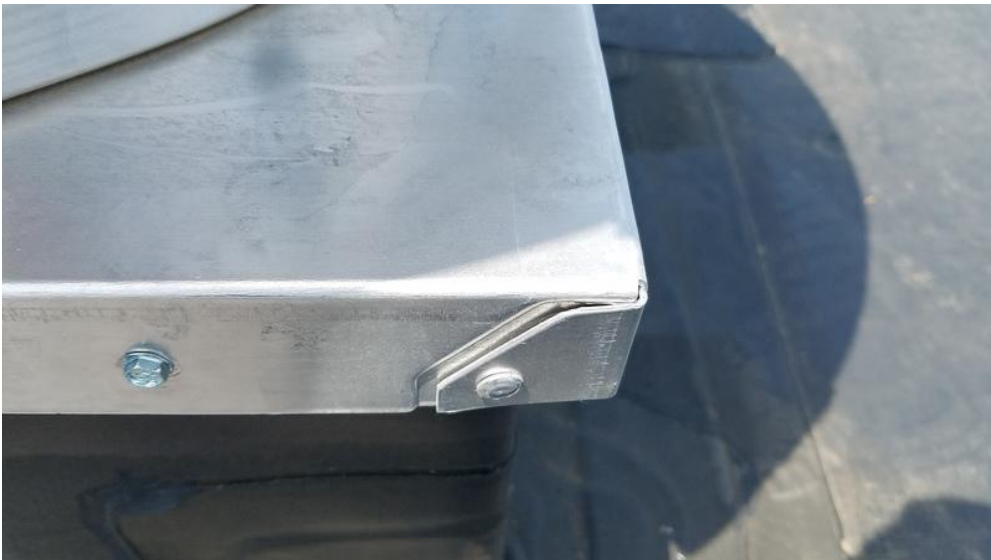
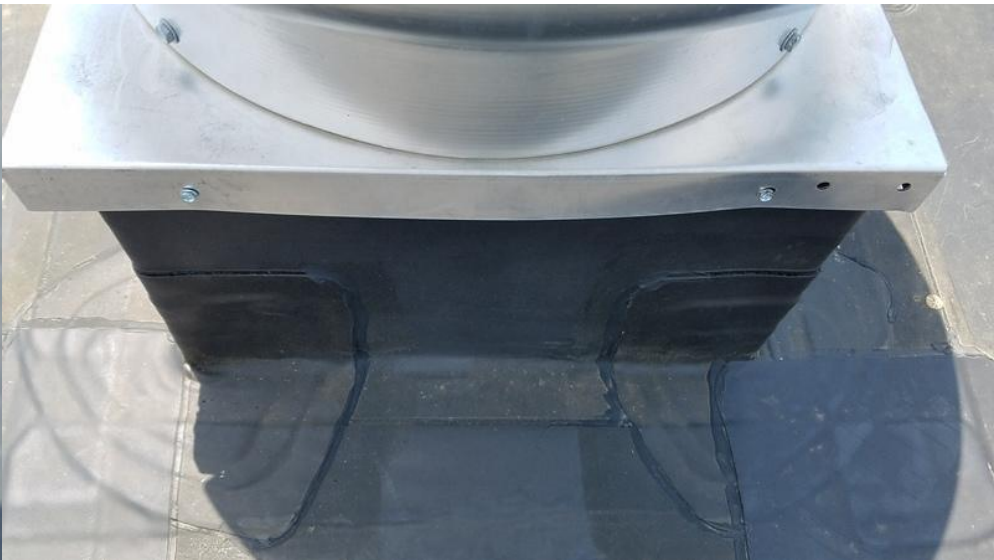
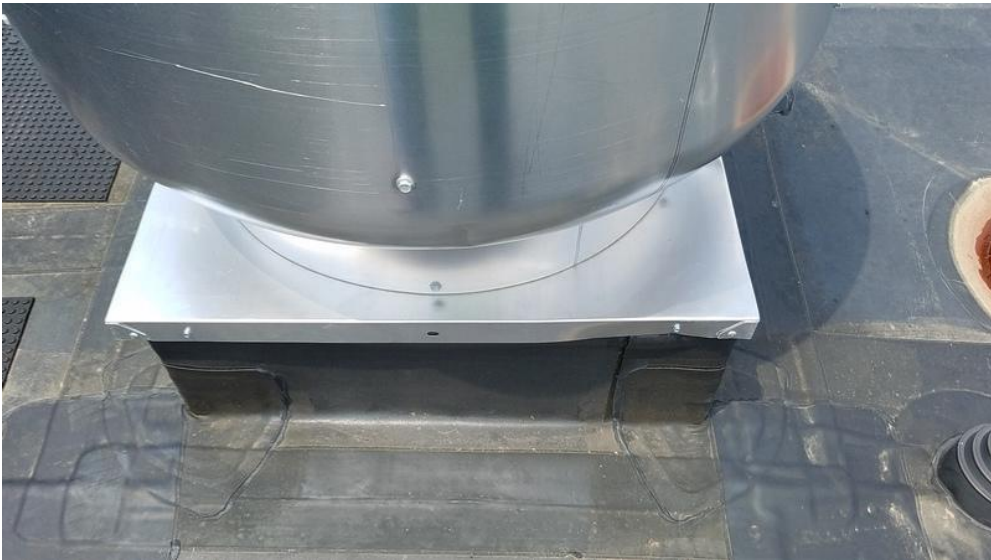
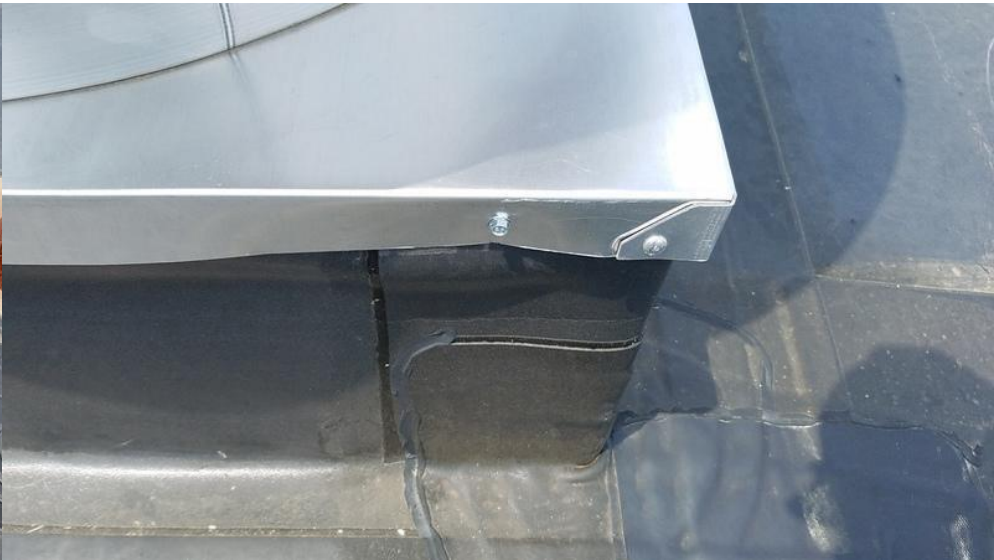
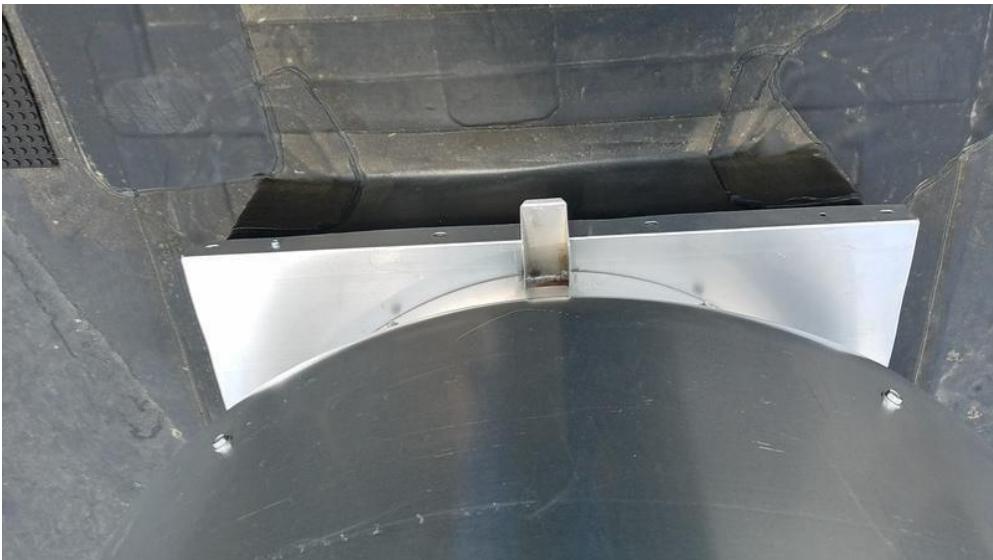
**Description**  
EF-4: Tighten loose screws through roof curbs, add screws where missing, and seal all seams and unused screw holes water tight on roof curbs.

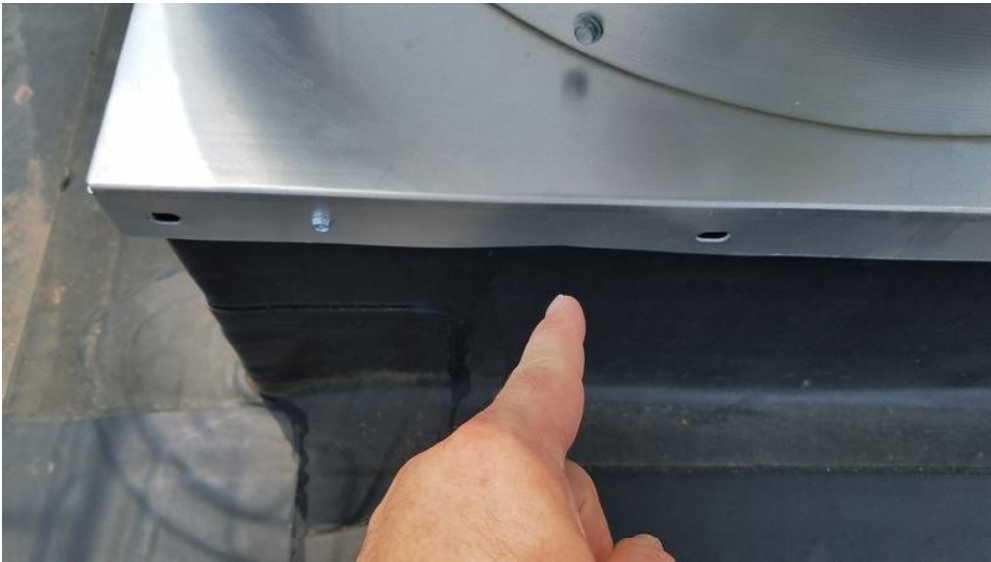
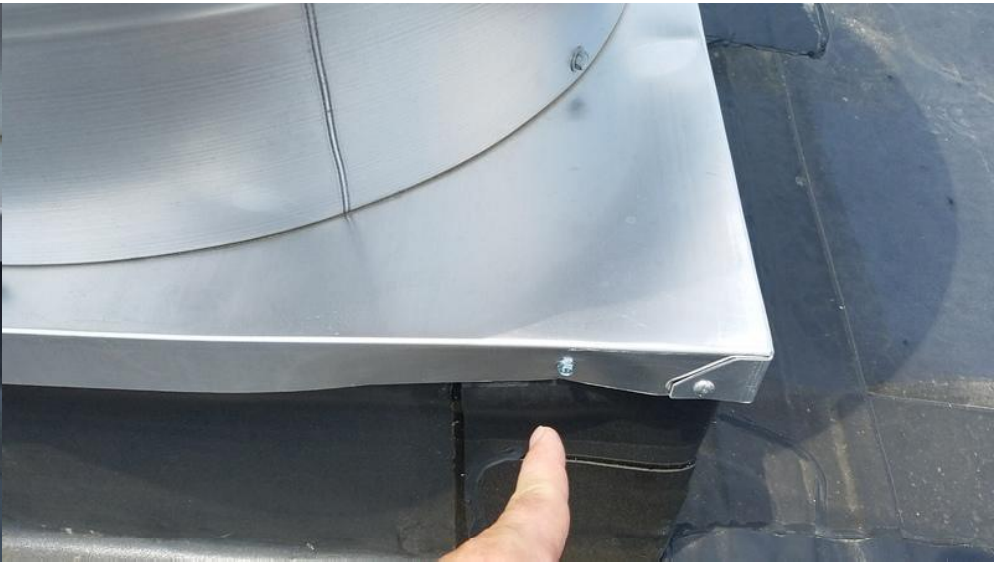
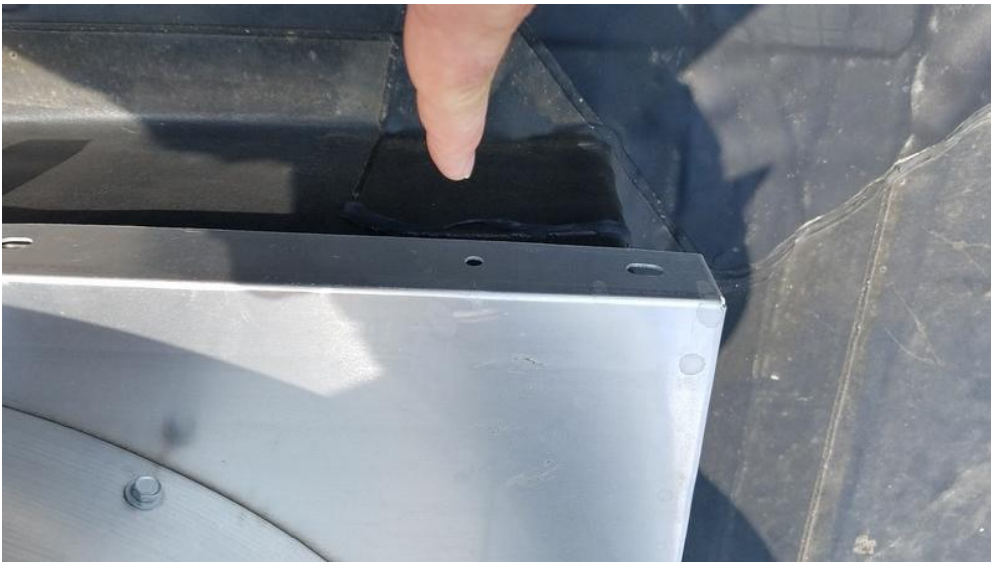
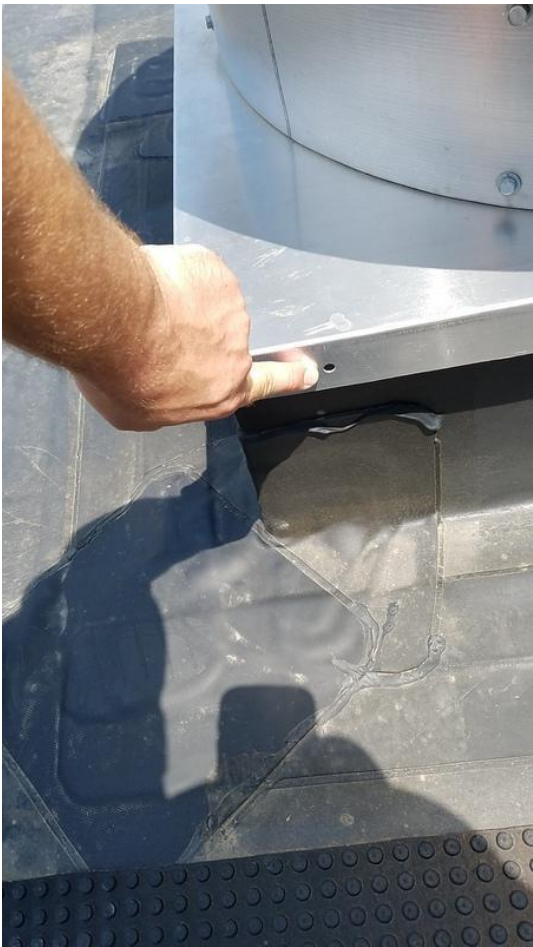
**Description**  
EF-3: Tighten loose screws through roof curbs, add screws where missing, and seal all seams and unused screw holes water tight on roof curbs.

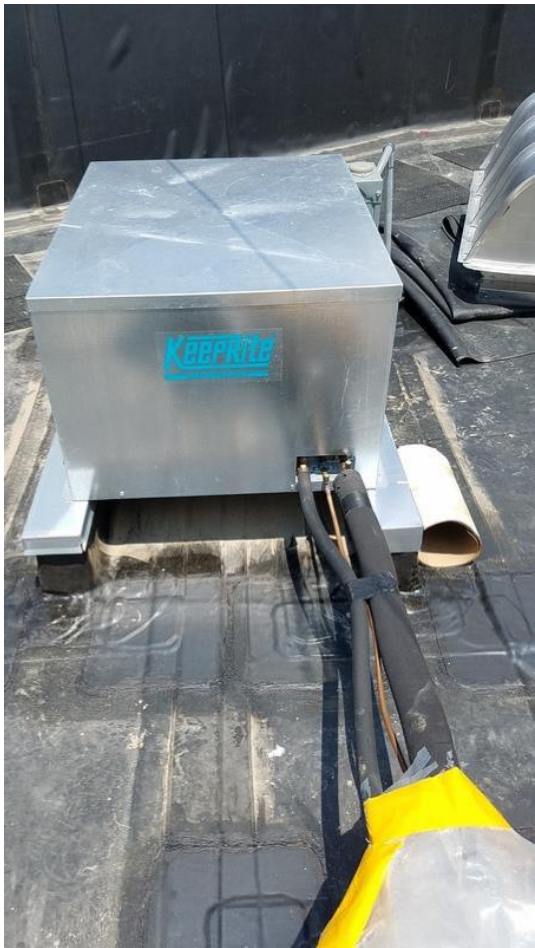
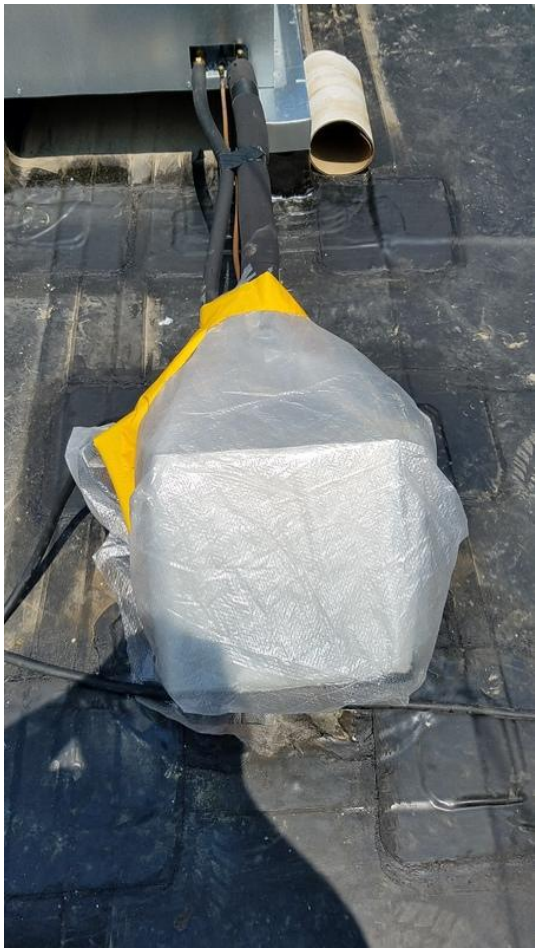
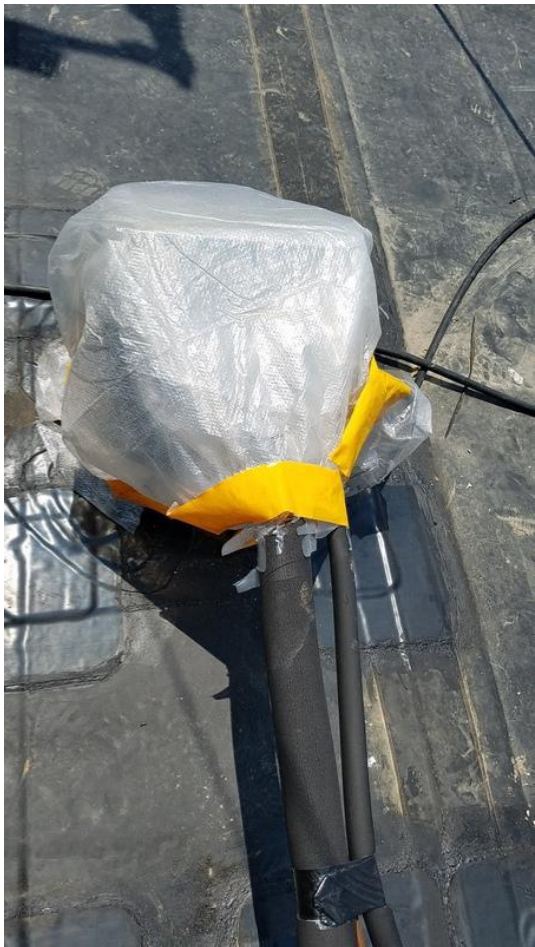
**Description**  
Cold Room Condensing Unit: Provide Pipe Curb and properly seal all pipe curb and roof penetrations.

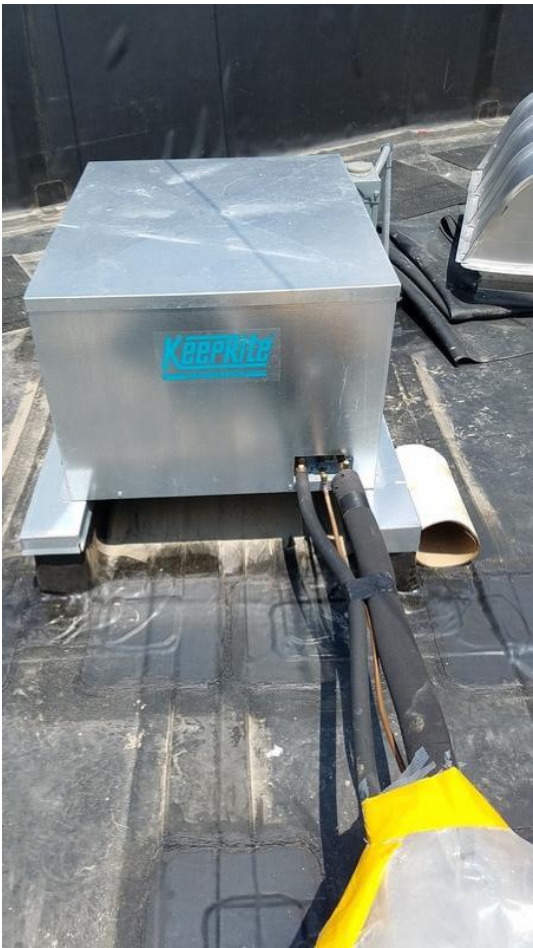
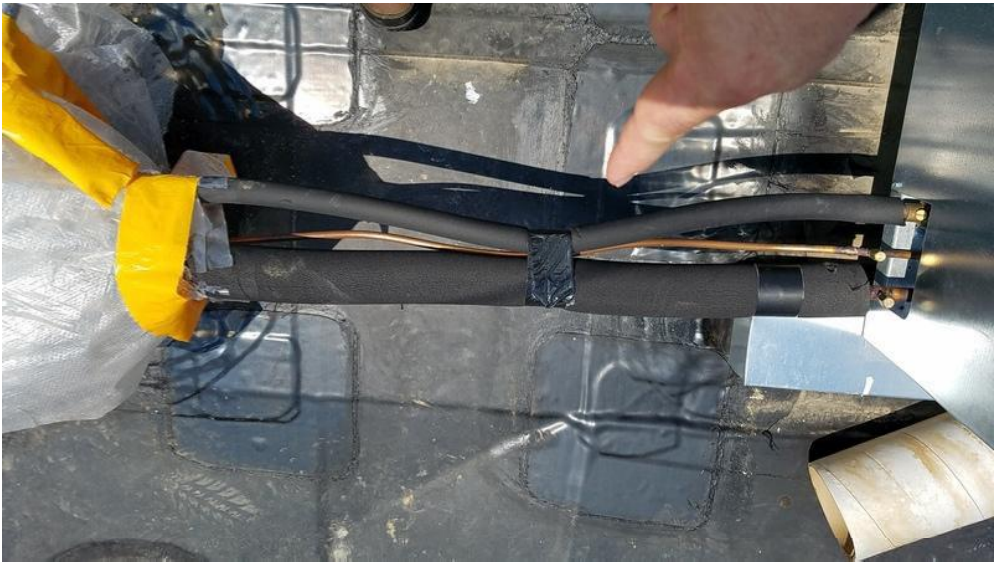
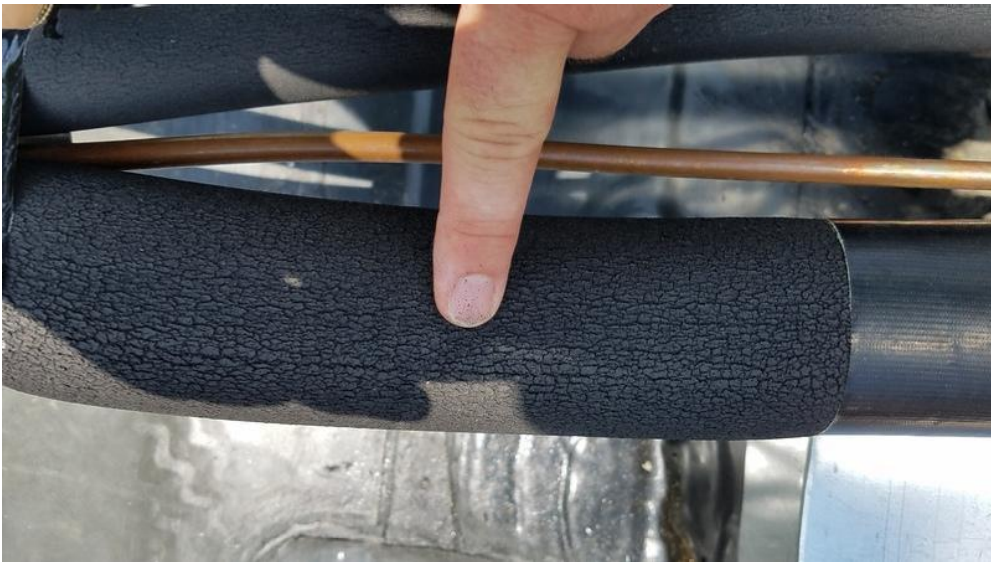
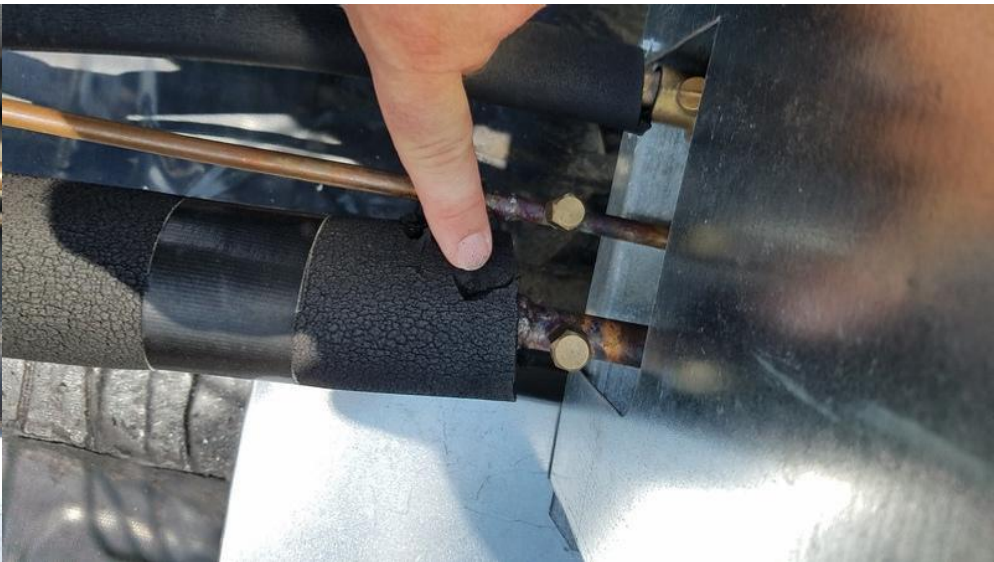
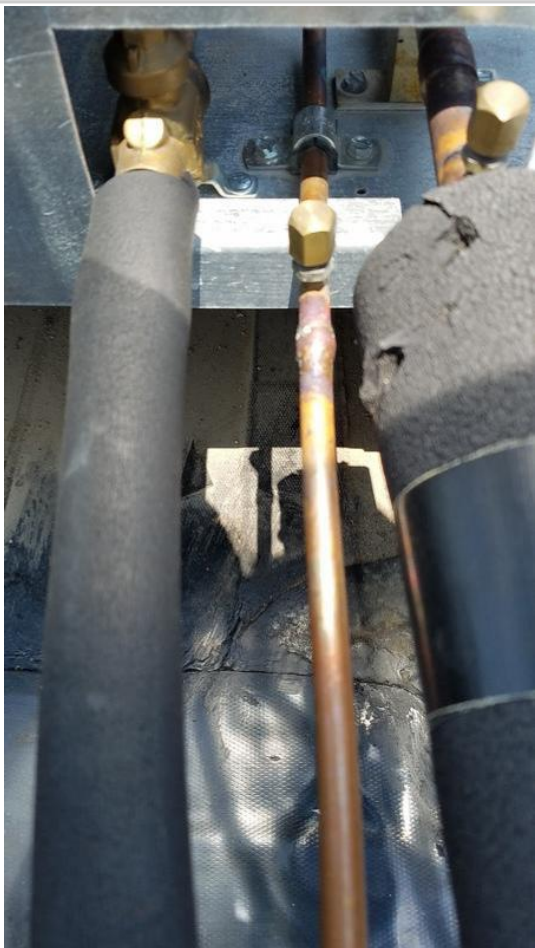
**Description**  
Cold Room Condensing Unit: Provide jacketing on all exterior pipe insulation. Refer to spec for requirements. Insulation already shows signs of deterioration. Repair/replace where required.

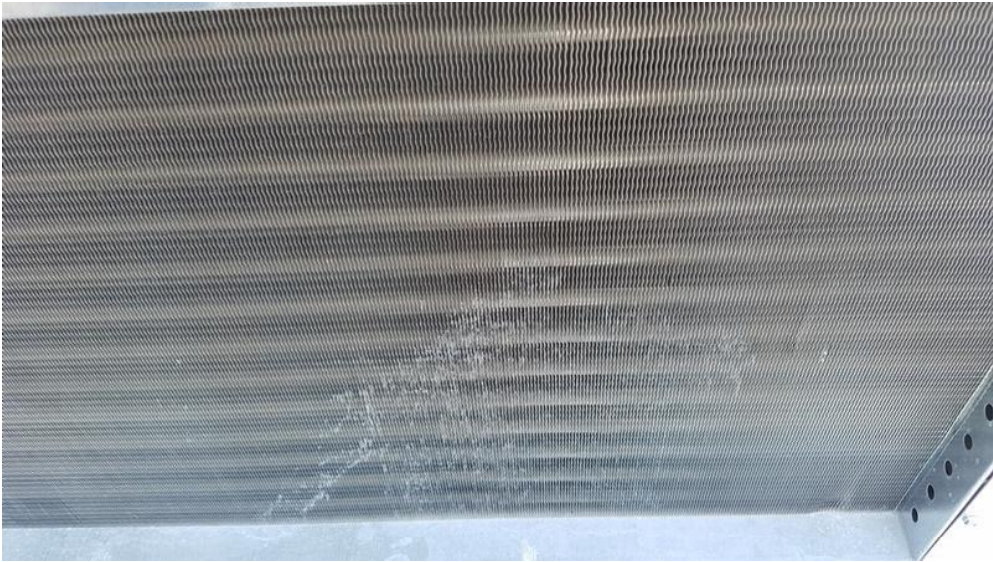
| Cold Room Condensing Unit: Clean and straighten condenser fins |

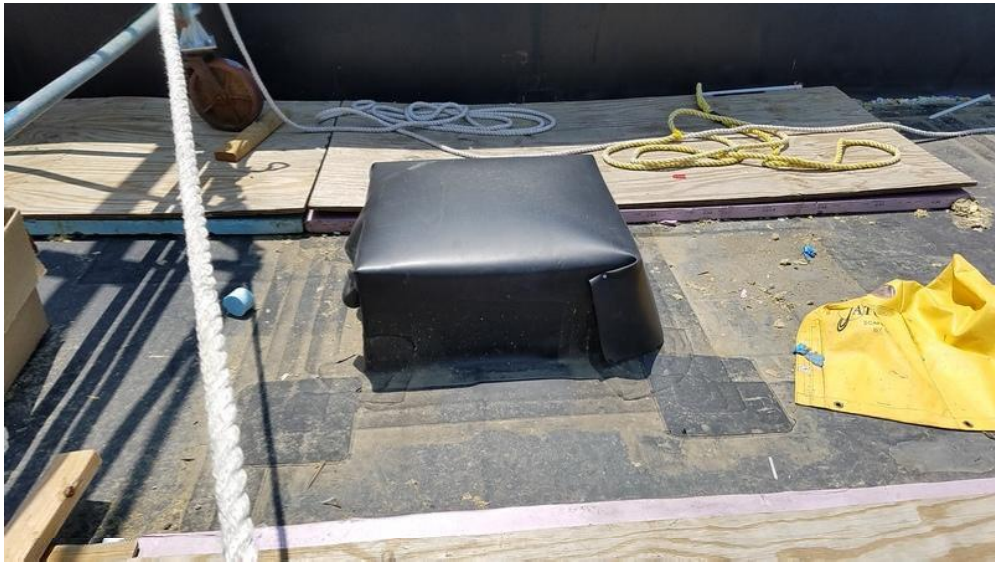
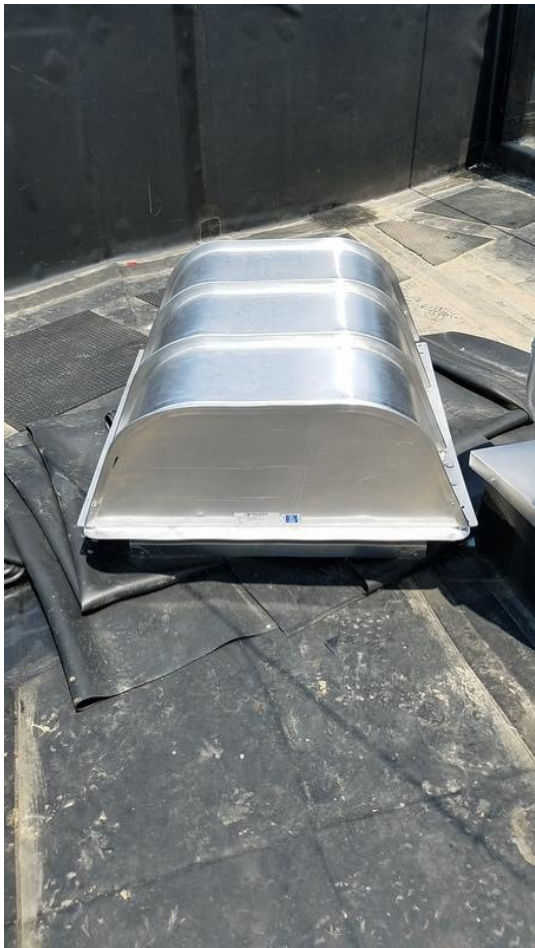
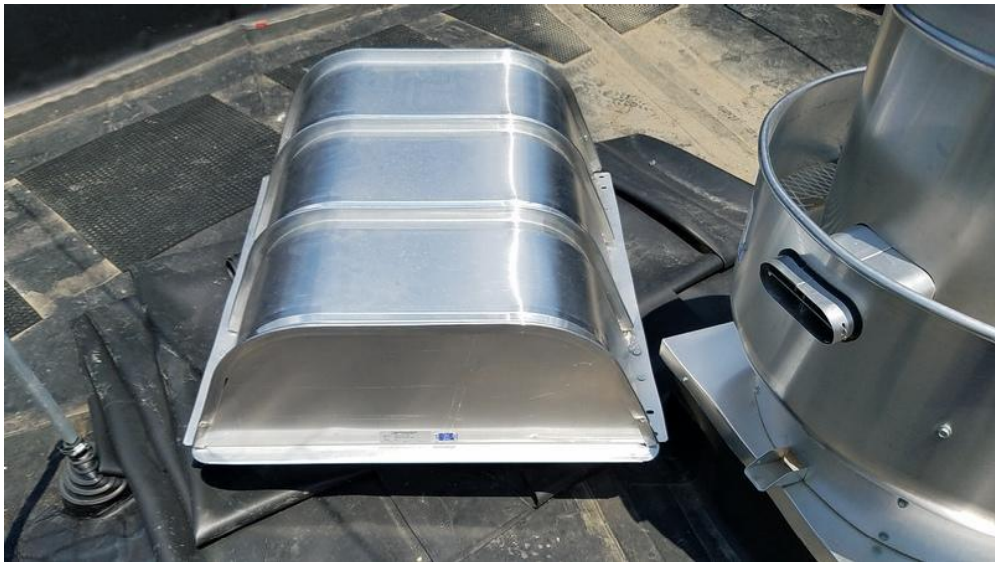
**Description**  
H1 EAB Exhaust Roof Hood on ISB: Exhaust hood is not currently installed. However, roof curb opening is covered and existing EF located EAB attic is running with no way to discharge to the exterior of the building. This needs immediate attention.

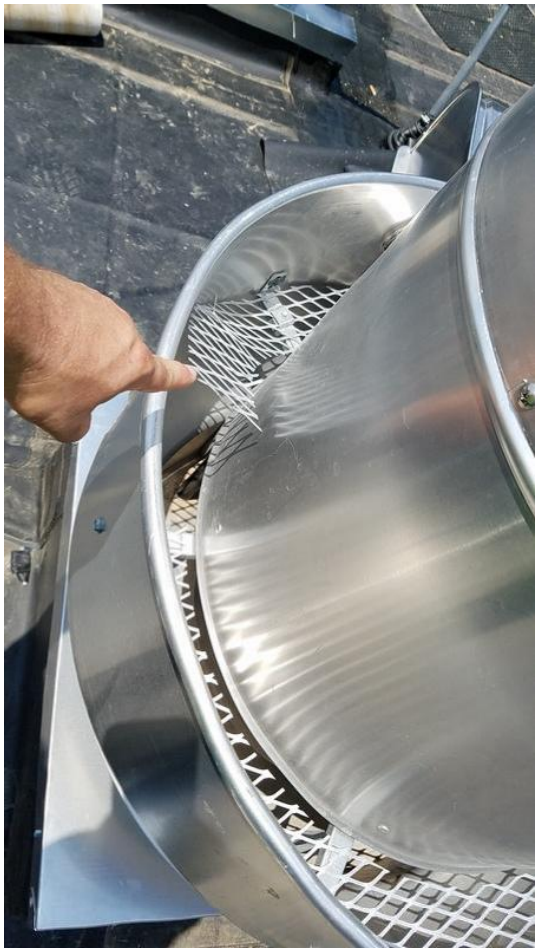
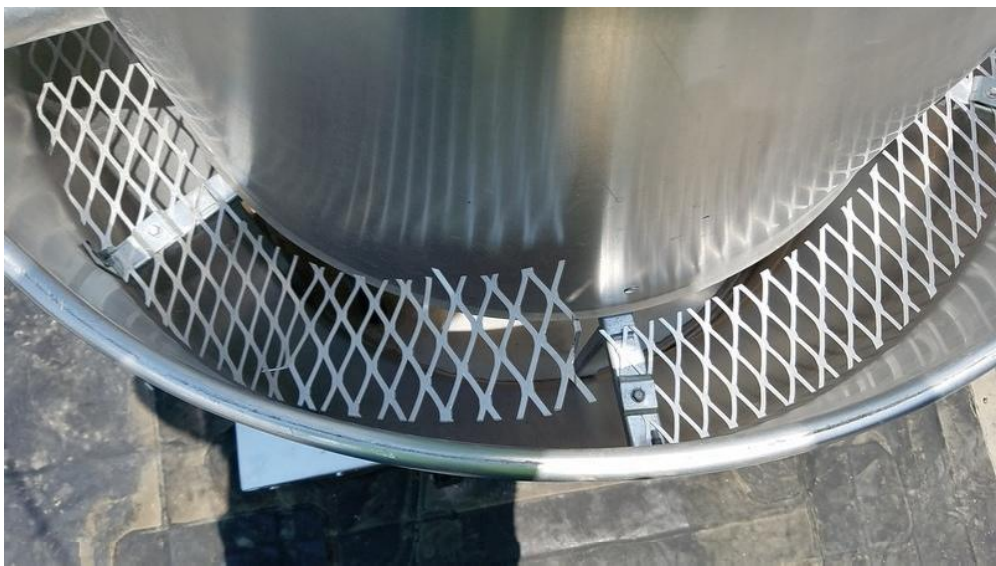
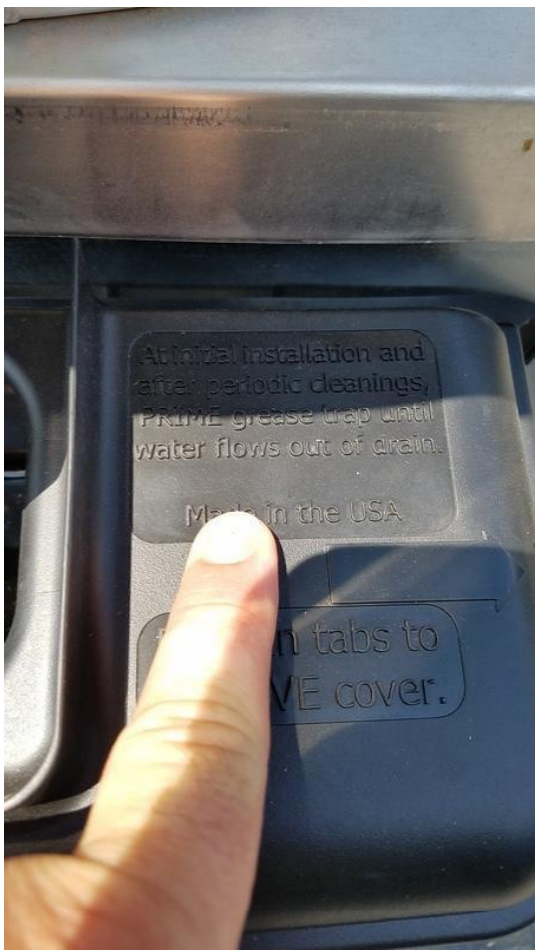
KEF-1 wire guard / bird guard is loose and bent. Repair/replace as required. Prime grease trap per manufacturer instructions.

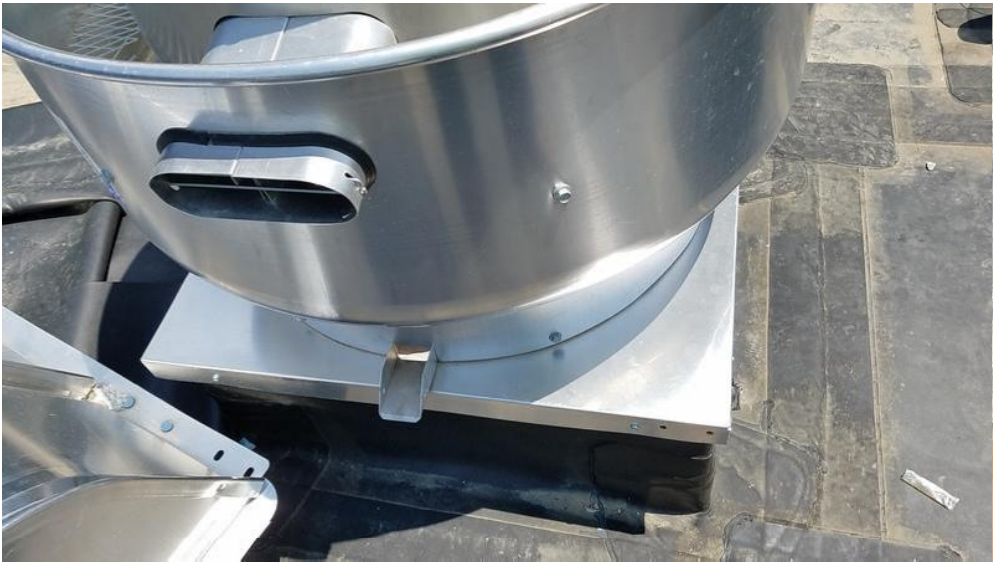
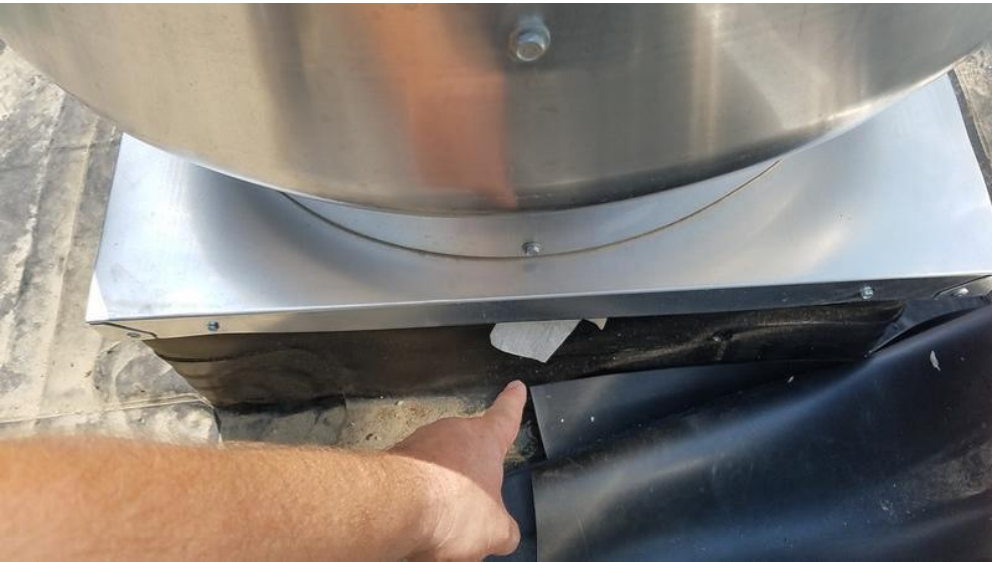
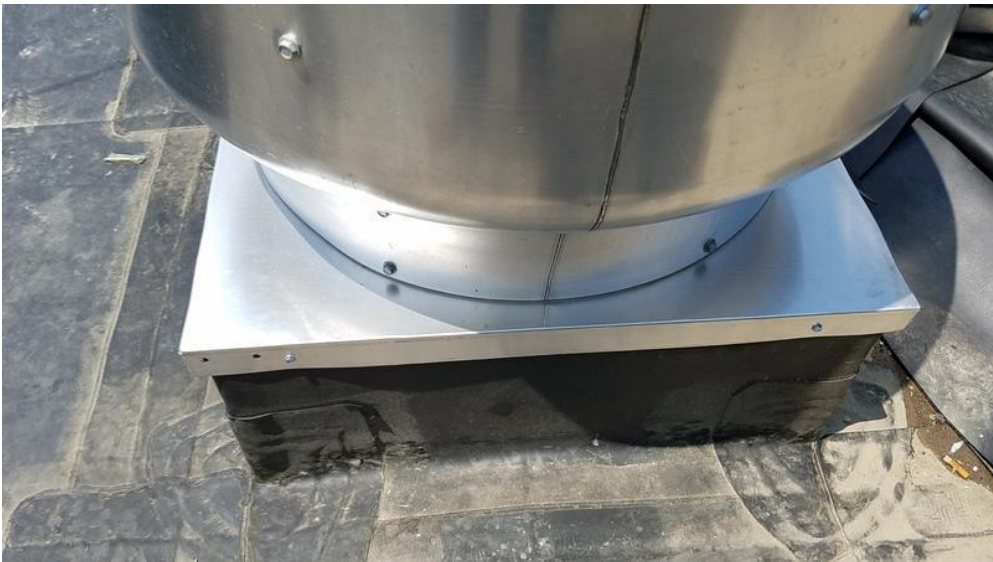
**Description**  
EF-1: Tighten loose screws through roof curbs, add screws where missing, and seal all seams and unused screw holes water tight on roof curbs.

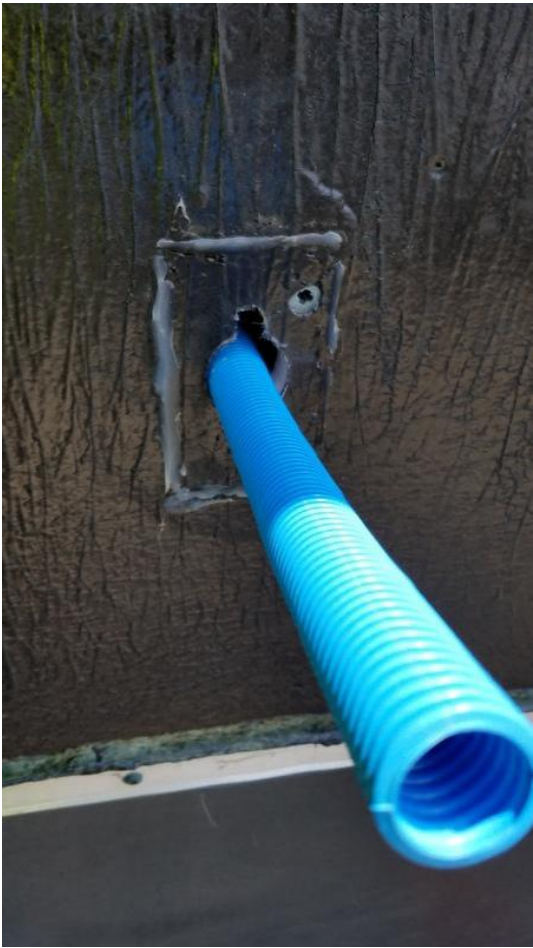
Seal wall penetration around conduit after installation is complete.

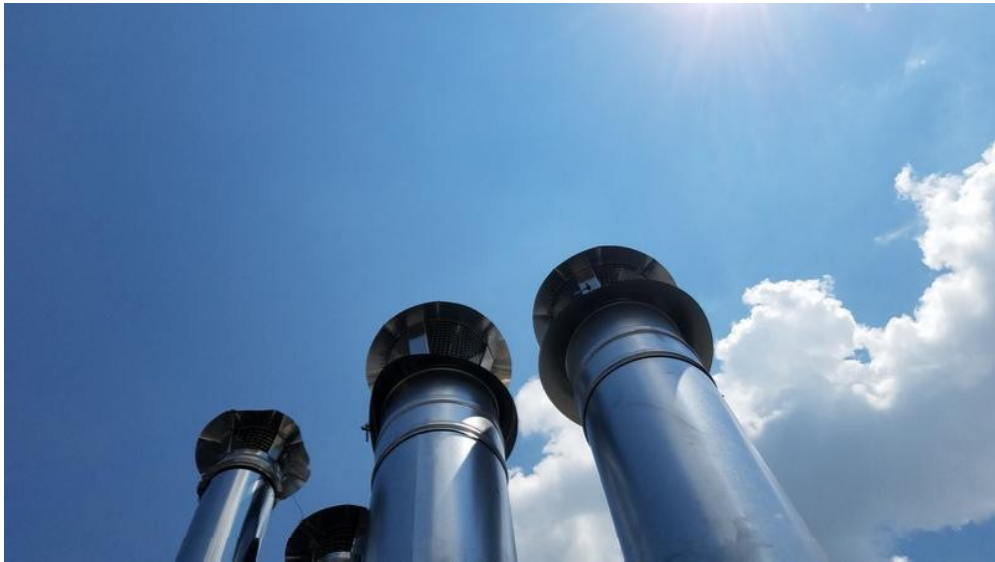
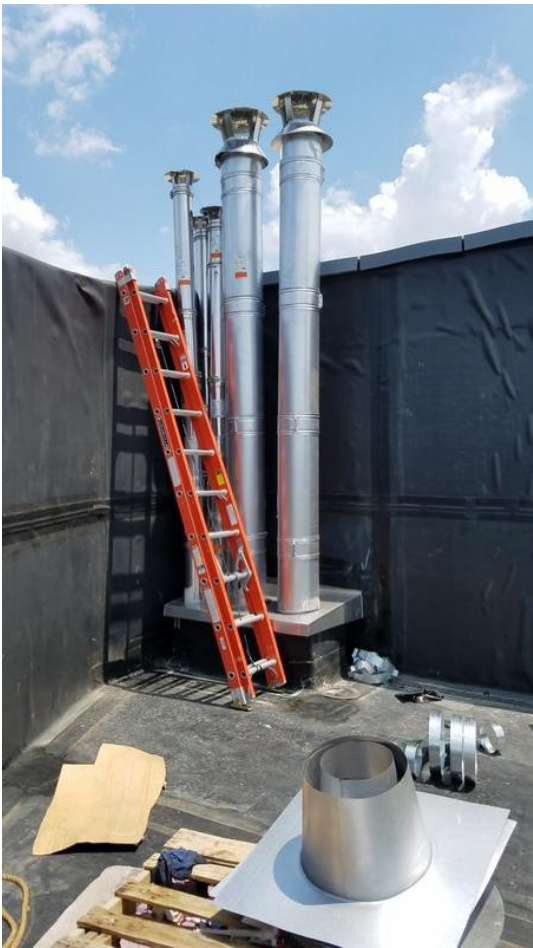
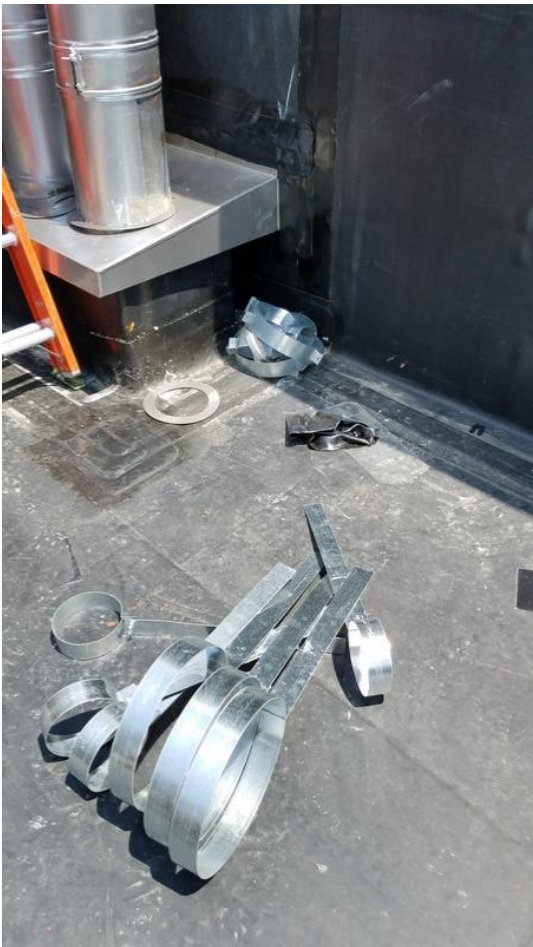
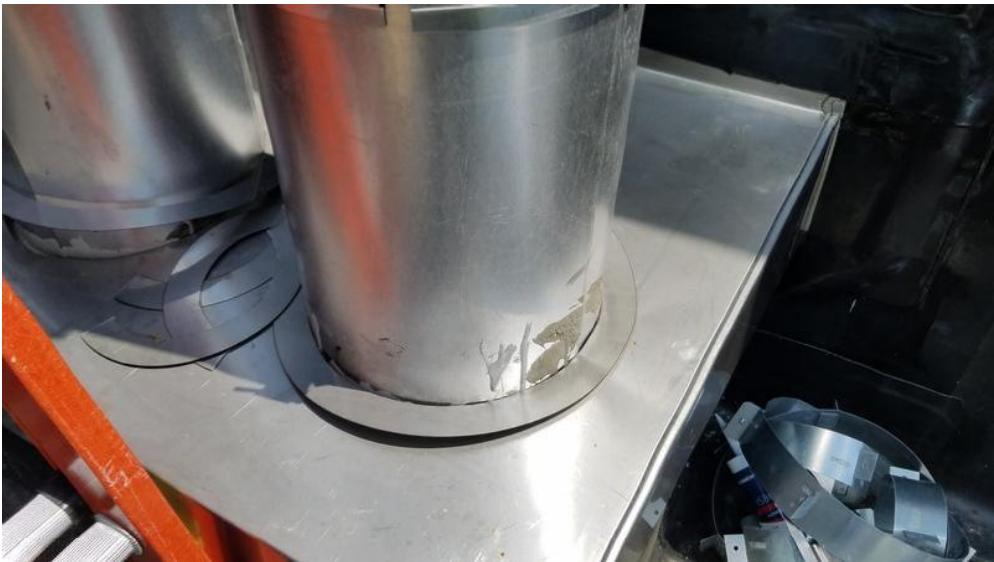
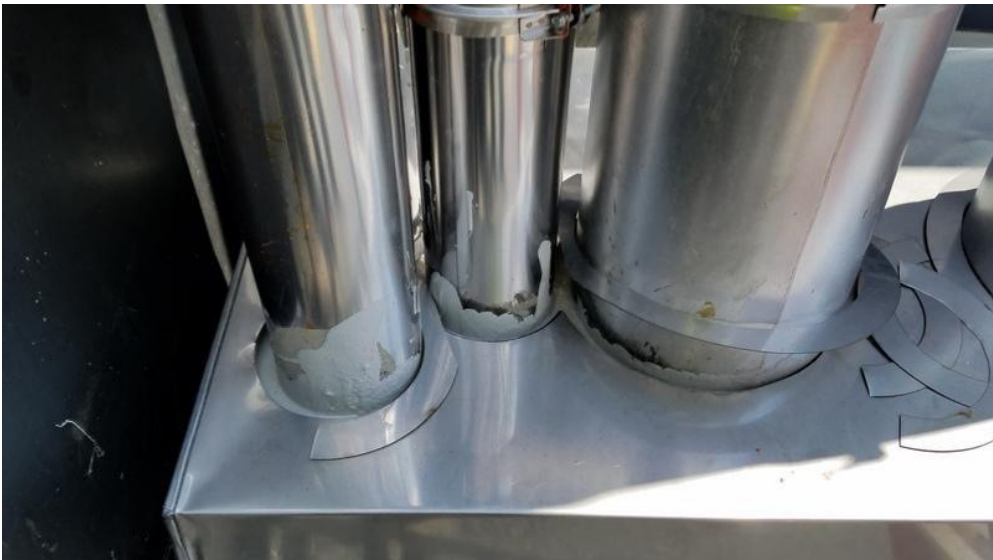
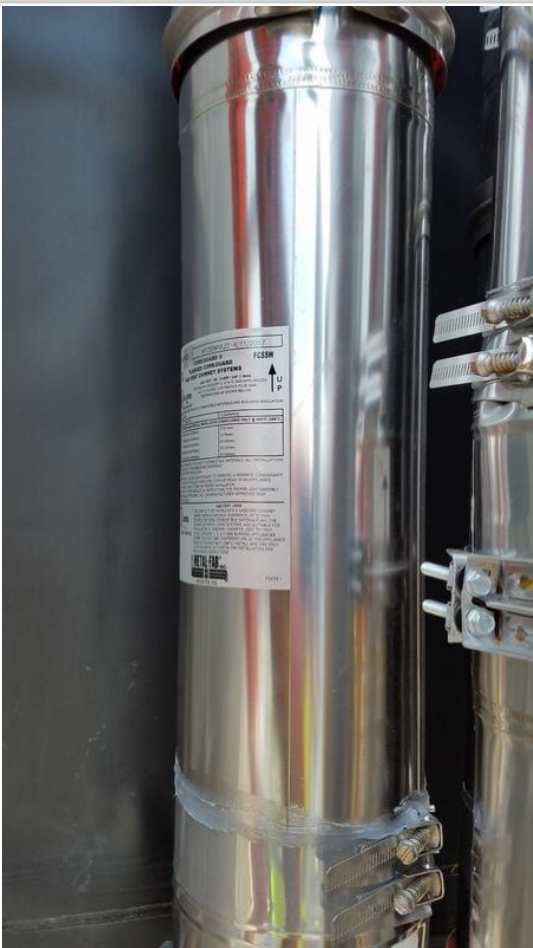
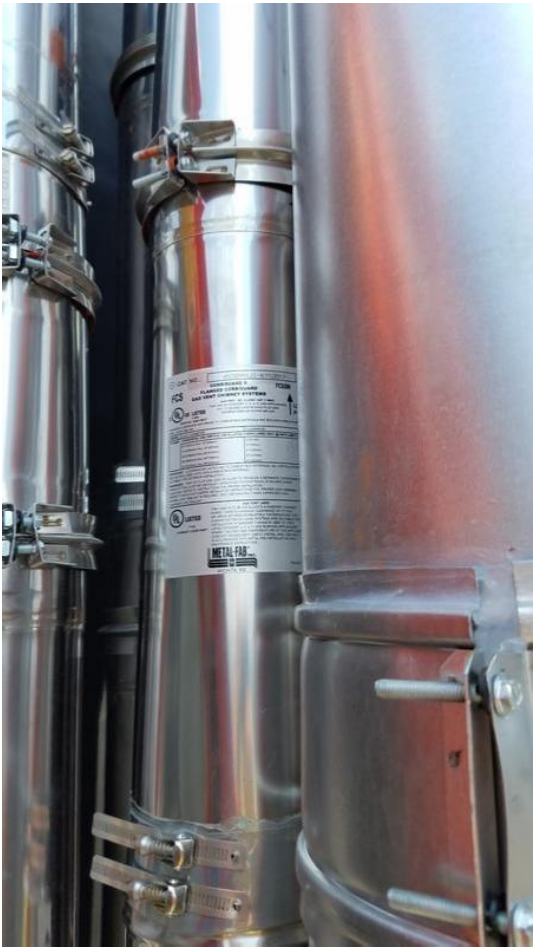
**Description**  
Boiler & Water Heater Flues: Installation incomplete during punch. Finish installation, seal all flashing and roof curb seams/holes, etc. to be weather-proof.
