## Observation Report

| Architect: | Cannon Design | Location: | Webster ISB - General |
| File: | Webster University Interdisciplinary Science Bldg.<br>WT 14127.01 (7) | c: | Jason Szachnieski &<br>Devin Gates (Paric) |

### **Roof- Mechanical Observations**

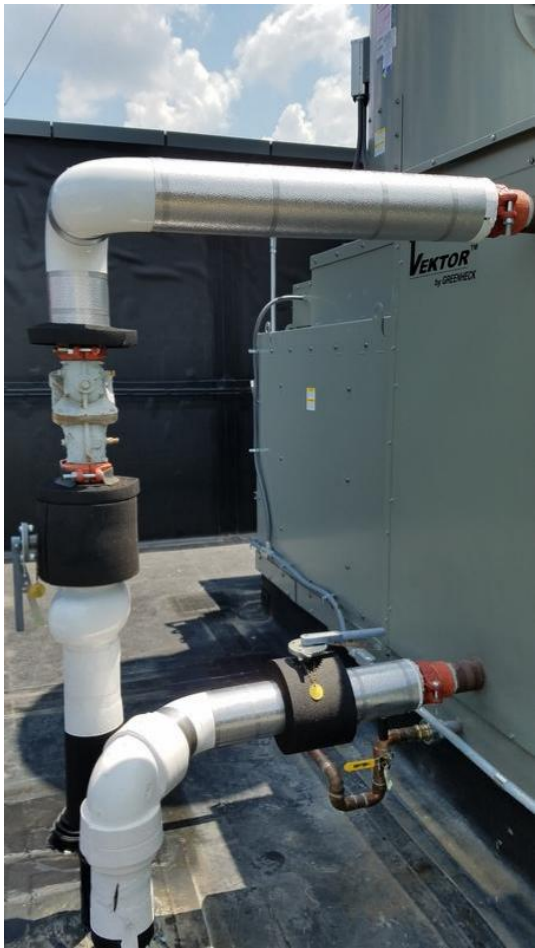
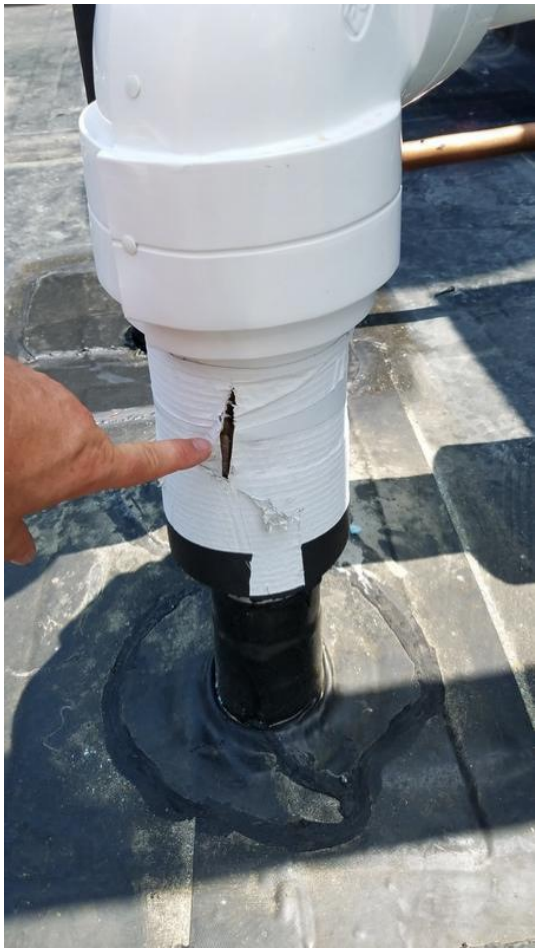
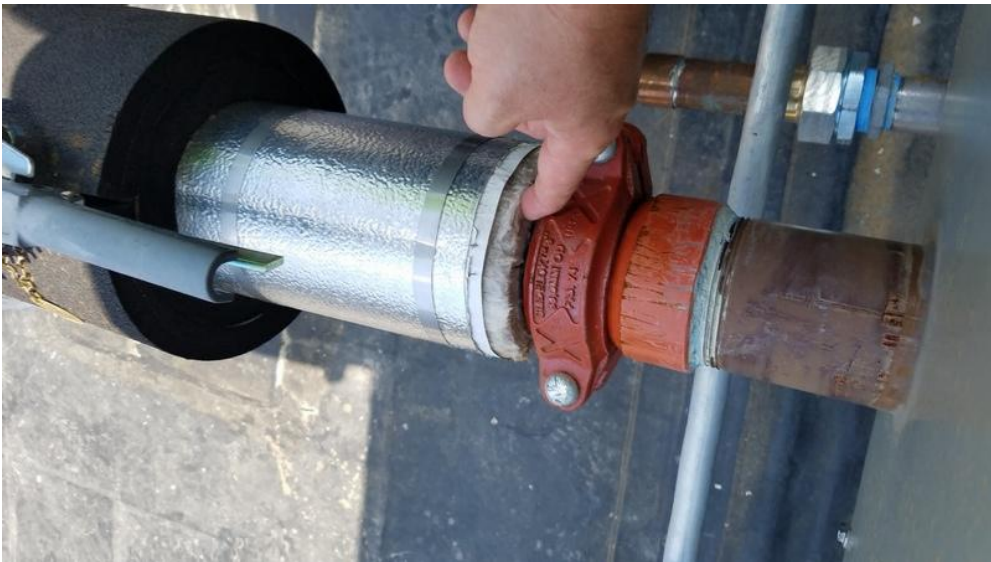
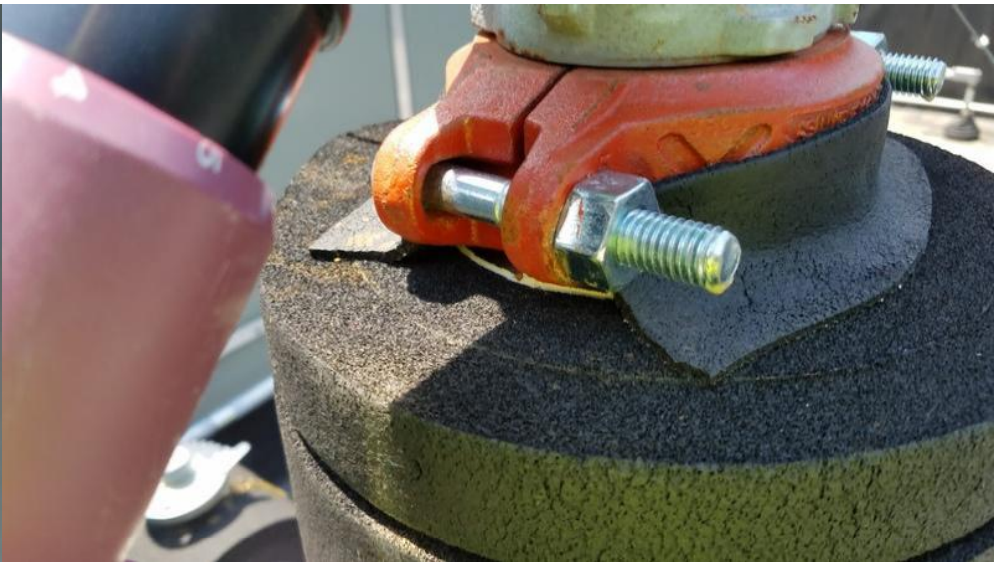
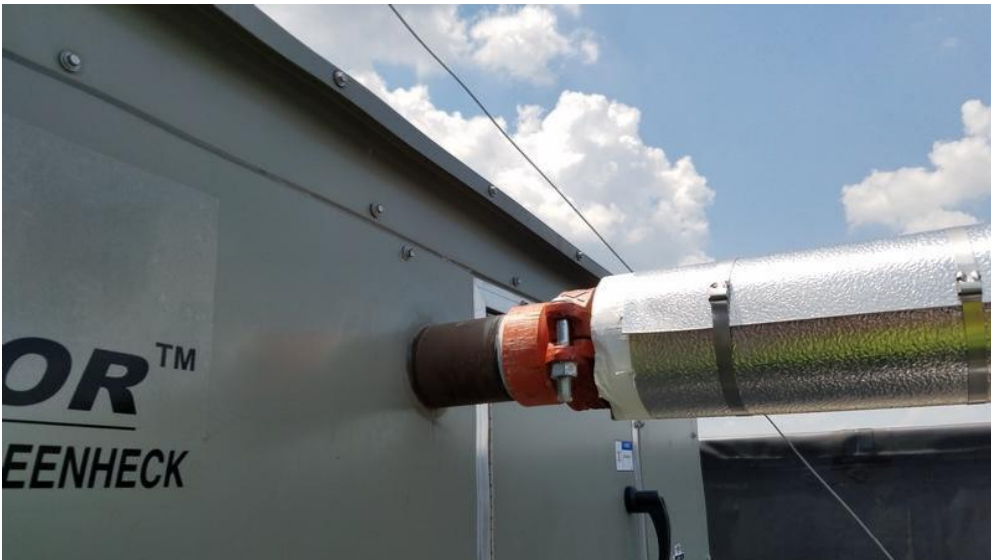
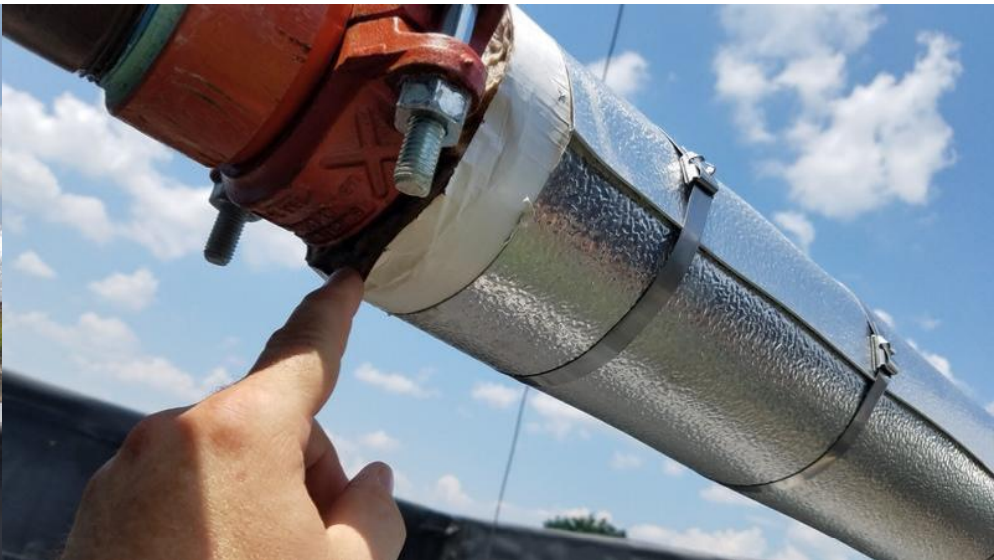
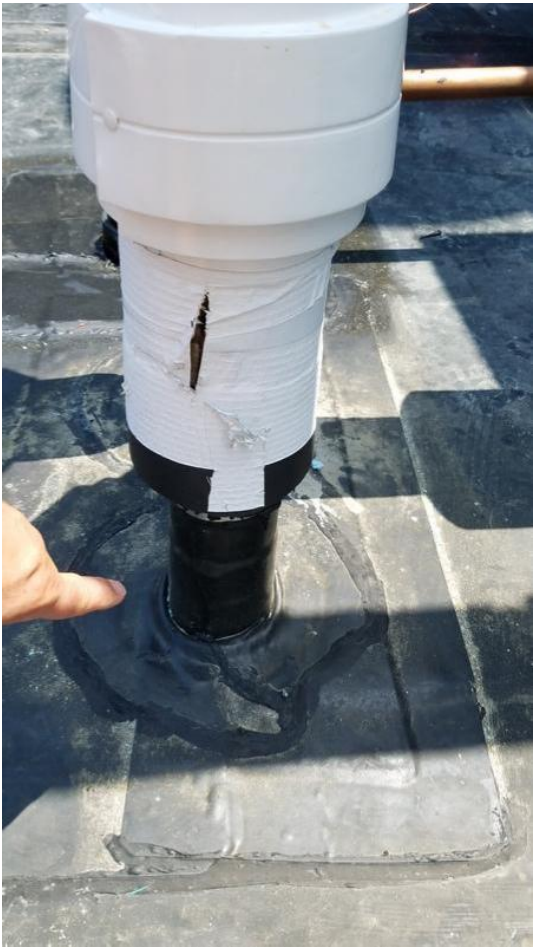
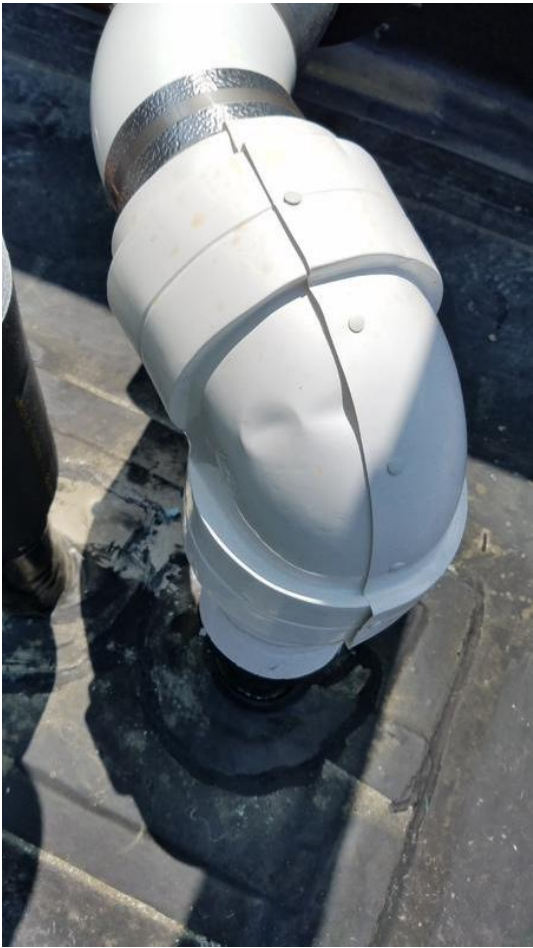
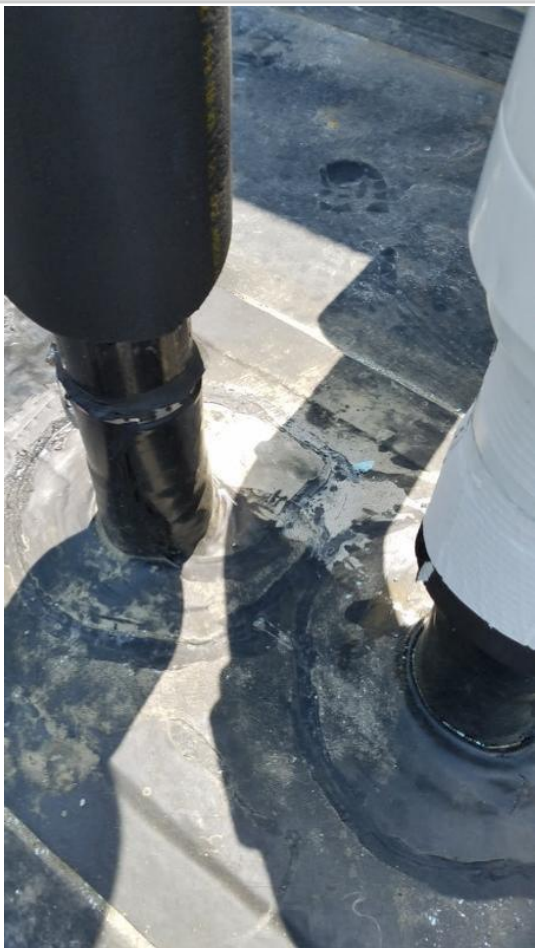
**Description**  
HEF-1: Finish insulation, seal ends of fiberglass insulation, repair/replace damaged insulation, and provide jacketing for all exterior piping per specification.

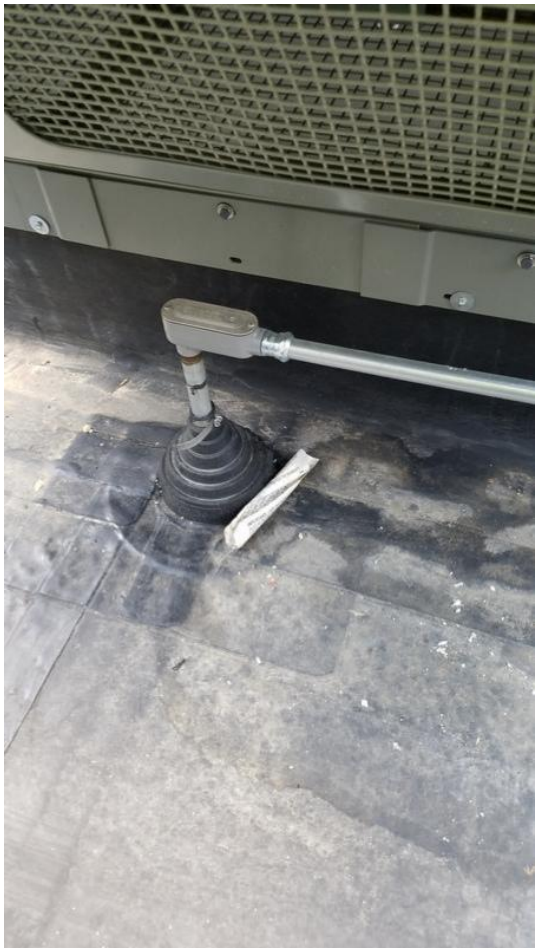
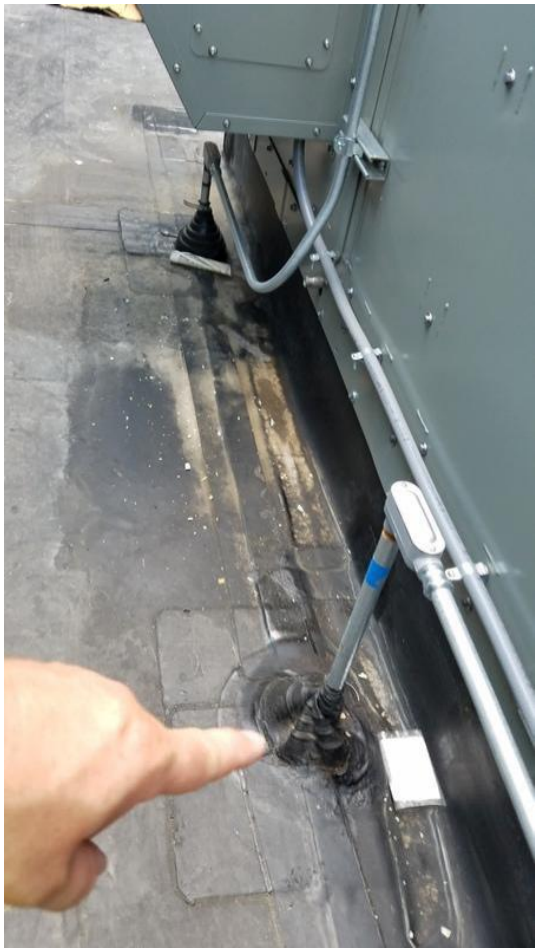
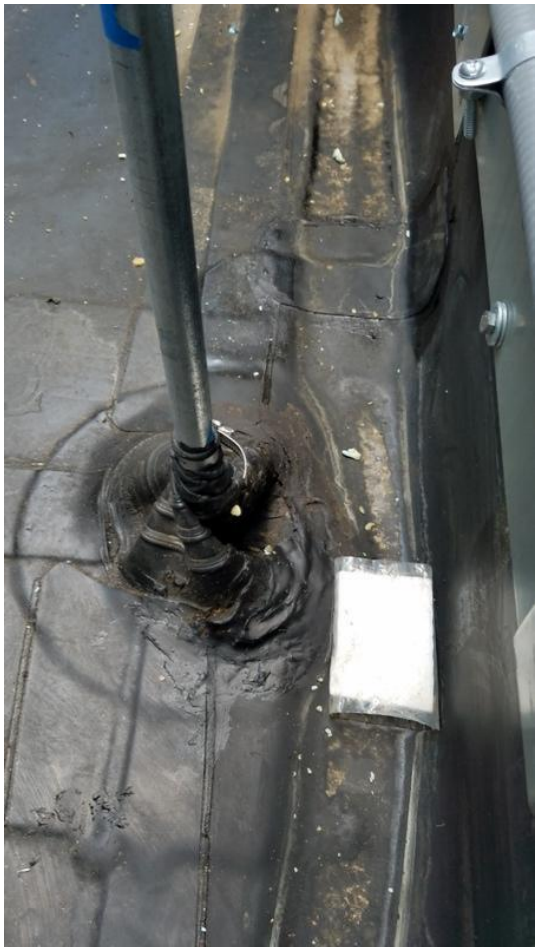
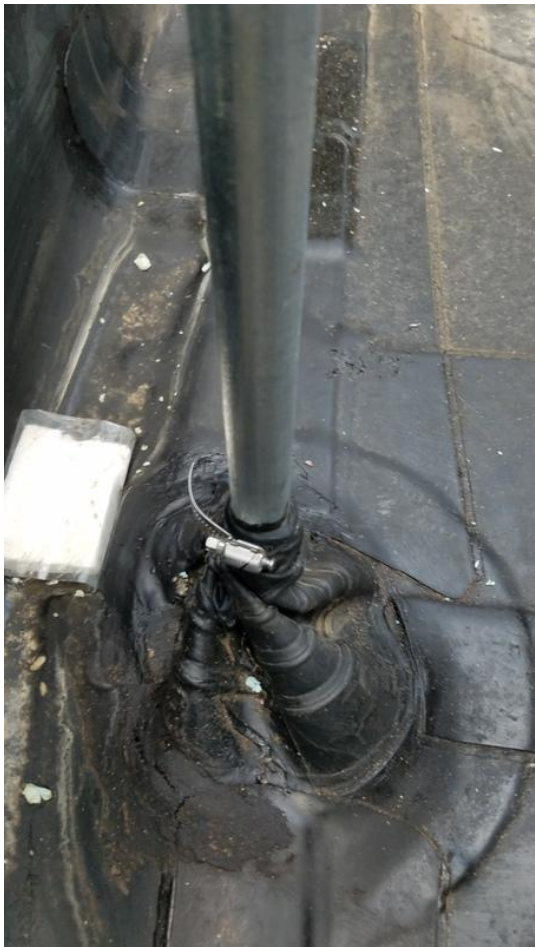
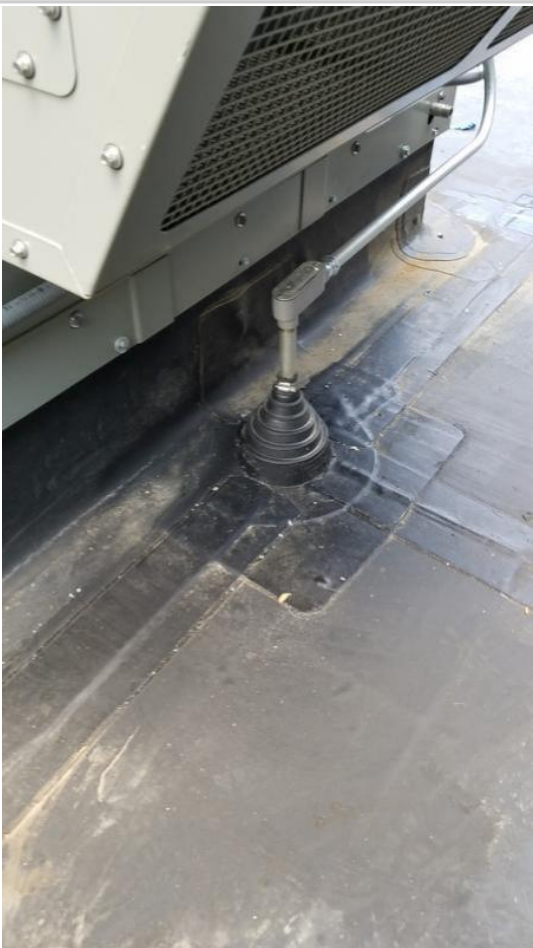
**Description**  
HEF-1 Roof Penetrations: Ensure all roof penetrations are properly sealed. Replace incorrect boot for conduit roof penetration with correct boot similar to other locations.

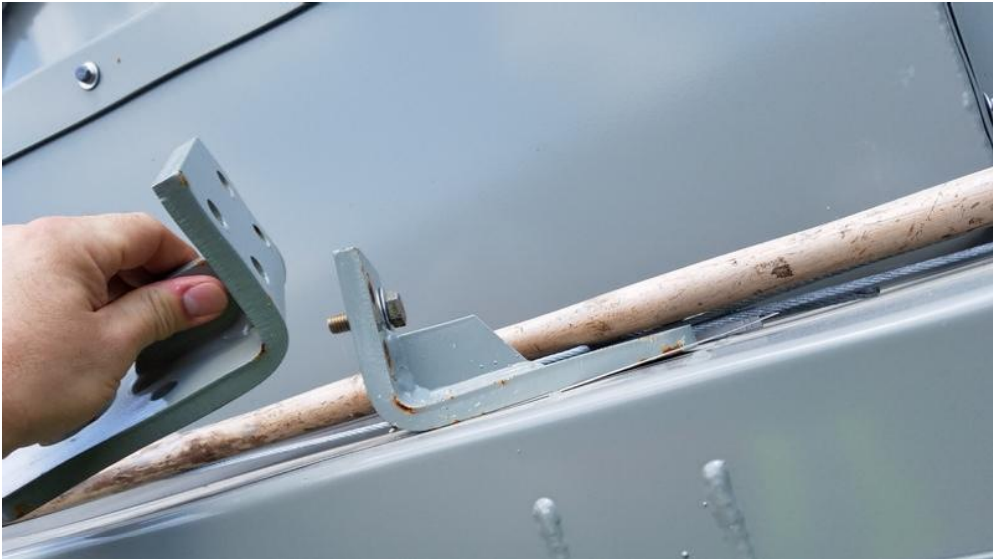
HEF-1: Verify purpose of loose brackets sitting on top of unit and install as required per manufacturer recommendations.

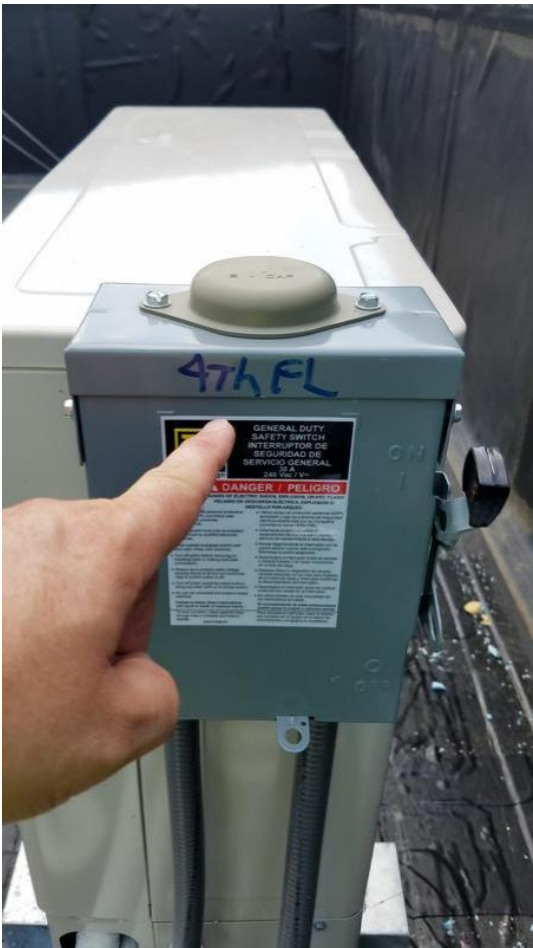
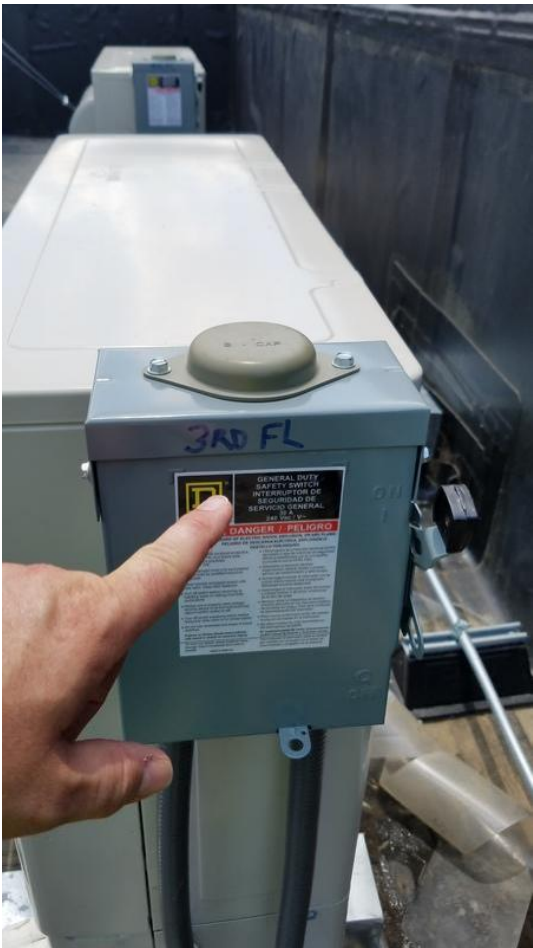
**Description**  
Provide Equipment labels / tags for ACCU-3 & ACCU-4 on roof. Apply labels constructed per specifications and attach to north side of equipment out of direct sunlight.
