## **Heitmann & Associates, Inc.**

Site Observation Visit# 02

Report #02-Waterproofing

**Project Name:** Webster University- ISB  
**Project Location:** Webster Groves  
**Project Number:** 2014061.20  
**Client:** Webster University  
**Report Prepared By:** George Crow - Heitmann & Associates, Inc.  
**Date of Report:** September 19, 2016

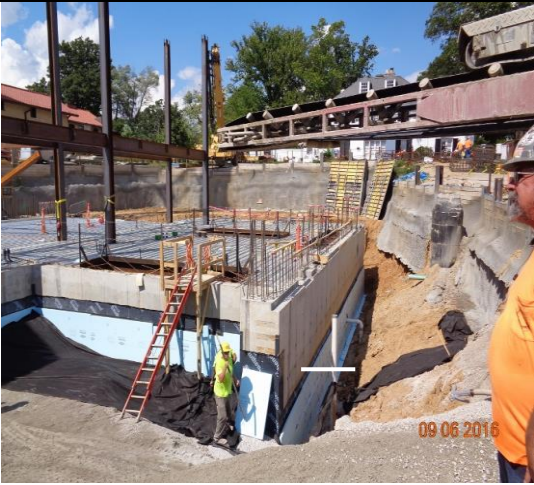
| ITEM # | DATE | DESCRIPTION | | COMMENTS/ RESOLUTION | STATUS |
|---|---|---|---|---|---|
| 02.1 | 9-6-16 | View looking North at corner of column lines 8 and C – Level 0. | | Installation of sheet membrane waterproofing, drainage mat and rigid board insulation in progress. Work to this point is acceptable | Installation progressing |

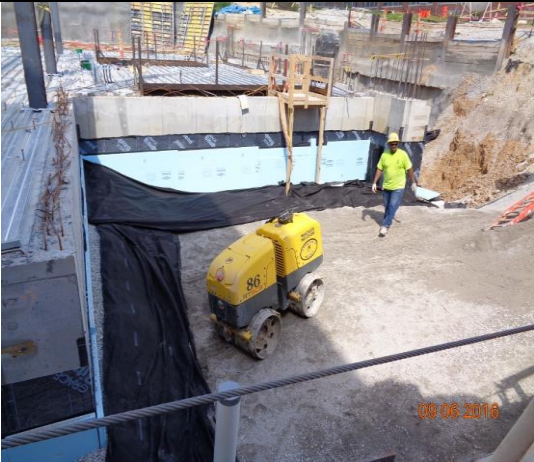
| ITEM # | DATE | DESCRIPTION | | COMMENTS/ RESOLUTION | STATUS |
|---|---|---|---|---|---|
| 02.2 | 9-6-16 | View looking North at corner of column lines 7 and C.3- Level 0. | | Compacting gravel back fill. | Back fill installation progressing. |

During this review, placement and compaction of the gravel backfill was observed. Verification of the compaction density should be provided by Paric.

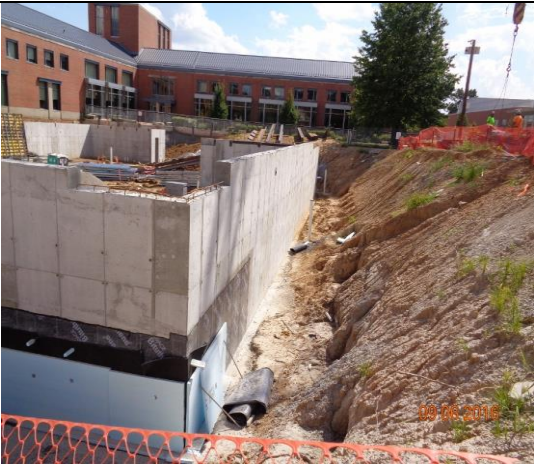
| ITEM # | DATE | DESCRIPTION | | COMMENTS/ RESOLUTION | STATUS |
|---|---|---|---|---|---|
| 02.3 | 9-6-16 | View looking South along column line 1.6 – Level 1 foundation wall. | | Installation of waterproofing membrane, drainage mat and rigid insulation board proceeding. | In progress. |

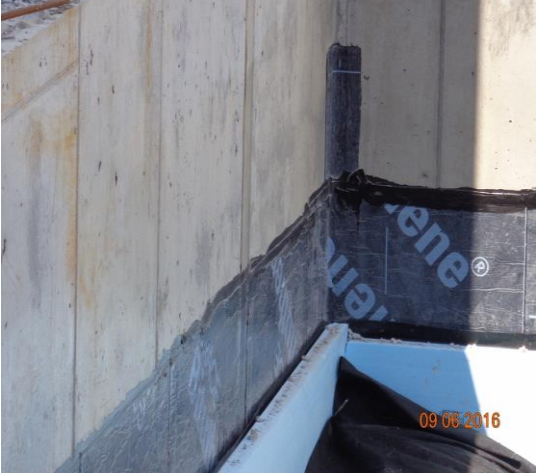
| 02.4 | 9-6-16 | View of foundation wall corner at the intersection of column lines 8 and C.3- Level 0. | | Stripping in of sheet membrane at all corners continues to be the typical application prior to installing the sheet membrane primary field. | Installation in progress. |

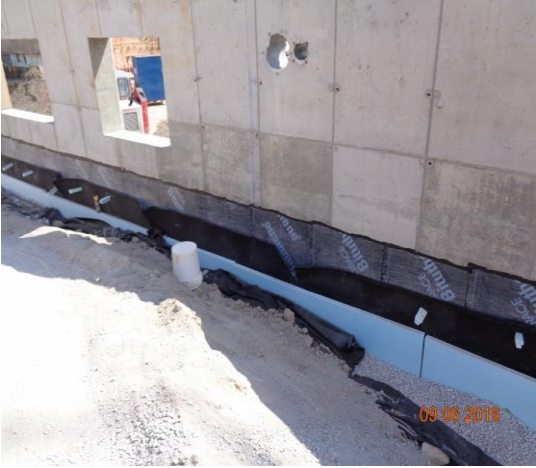
| 02.5 | 9-6-16 | View looking South at North Elevation of foundation wall along column line C.3 between column lines 3 and 1.9. | | Window openings at Level 01 and view of gravel backfill being placed. | Installation in progress. |
