## **Heitmann & Associates, Inc.**

Site Observation Visit# 03

Report #03-Mockup-Phase 1

**Project Name:** Webster University- ISB  
**Project Location:** Webster Groves  
**Project Number:** 2014061.20  
**Client:** Webster University  
**Report Prepared By:** George Crow - Heitmann & Associates, Inc.  
**Date of Report:** October 7, 2016

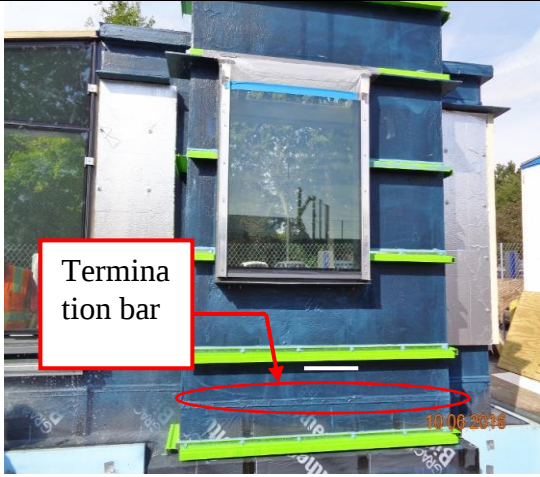
1. All attachments of furring members, clips and termination bars were subjected to direct water spray with no noted water observed in the mockup interior.
2. Specific test criteria and results will be forthcoming in Mid America Testing Laboratory's report.
3. During observation of the testing, HAI noted that the horizontal metal plate behind the termination bar was not installed. This metal plate is intended to be a minimum of 16 gage, 4-6 inches in height, running horizontally and screwed to the stud exterior face to provide a place of attachment for the termination bar screws that don't align with the steel studs (refer to 3.1, 3.2 and 3.3).
4. This condition also occurs at the parapet walls.

| DATE | DESCRIPTION | | COMMENTS/<br>RESOLUTION | STATUS |
|---|---|---|---|---|
| 10-6-16 | View of mockup exterior identifying termination bar location. –Screw spacing of termination bar is 8 inches o.c. | | Paric to verify that metal plate is installed on the building at all required locations. | Mockup development in progress |

The project team needs to determine if the metal horizontal plate can be added to the mockup with minimal re-work. Close attention needs to be paid to ensure that the metal plate is located where required on the building.

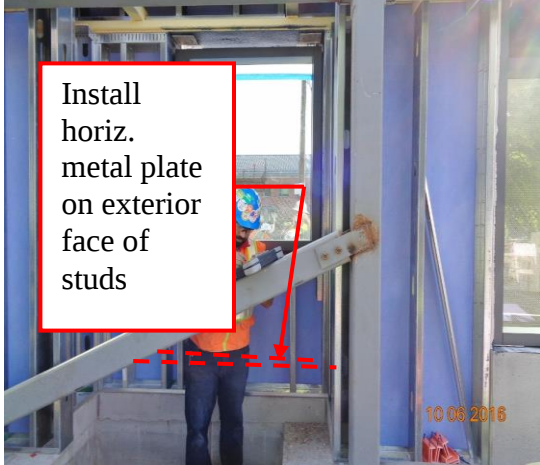
| DATE | DESCRIPTION | | COMMENTS/<br>RESOLUTION | STATUS |
|---|---|---|---|---|
| 10-6-16 | View inside face of mockup | | Paric-verify if metal plate can be added to mockup. | Mockup development in progress |

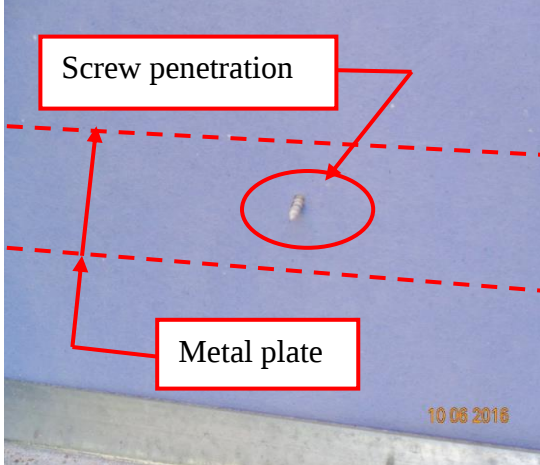
| DATE | DESCRIPTION | | COMMENTS/<br>RESOLUTION | STATUS |
|---|---|---|---|---|
| 10-6-16 | Close up of screw penetration at inside of mock up | | Paric-verify if metal plate can be added to mockup. | Mockup development in progress |
