# Heitmann & Associates, Inc.

Site Observation Visit# 04

Report #04-Mockup

| <b>Project Name:</b> | Webster University- ISB |

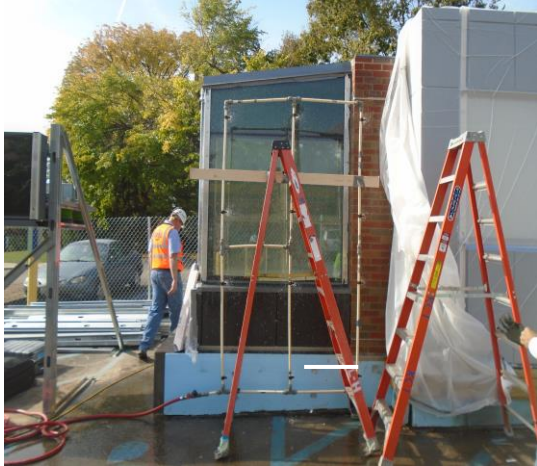
| DATE | DESCRIPTION | | COMMENTS/<br>RESOLUTION | STATUS |
|---|---|---|---|---|
| 4.1 | View of mockup exterior of the far left window unit under a static test of 10 PSF. | | Static pressure water testing. | Mockup testing in progress |

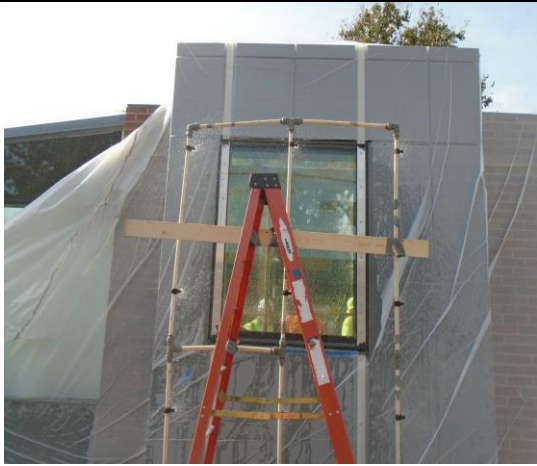
| DATE | DESCRIPTION | | COMMENTS/<br>RESOLUTION | STATUS |
|---|---|---|---|---|
| 4.2 | View of mockup exterior of the middle window unit under a static test of 10 PSF. Refer to photographs 4.4 and 4.5 for view of leaks. | | Static pressure water testing. | Mockup testing in progress |

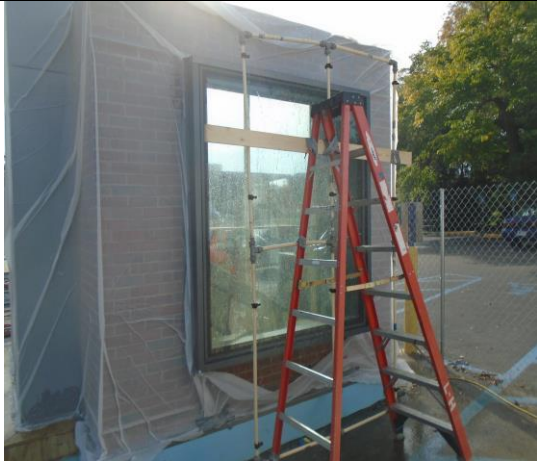
| DATE | DESCRIPTION | | COMMENTS/<br>RESOLUTION | STATUS |
|---|---|---|---|---|
| 4.3 | View of mockup exterior of the far right window unit under a static test of 9 PSF. | | Static pressure water testing. | Mockup testing in progress |

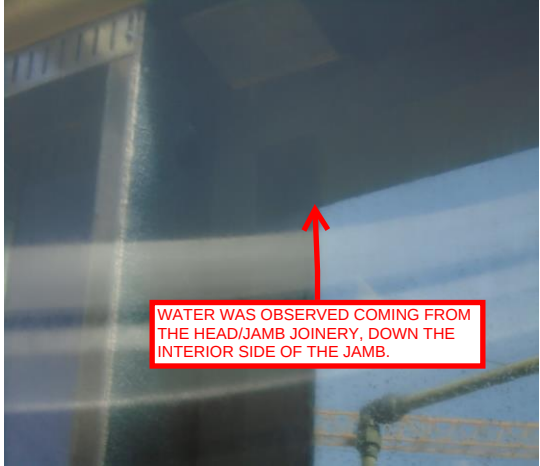
3. During our observation on Wednesday, HAI noted that the head/jamb condition should be hose tested by isolating the components below the head flashing to recreate the leak the head/jamb joinery. After isolating this area water was introduced and began leaking into the vertical and out below the sill. It was determined that the joinery seal that was missing at the sill was also missing at the head. NGG confirmed that this seal will be installed, although they will not remove the glass therefore the entire length of the joint will not be sealed.

| 4.5 | Leak that occurred at approximately 13 minutes into the static test. The leak appeared to come from the jamb/head joinery condition. | | The leak appeared to come from the jamb/head joinery condition. | During investigation and hose testing, it appeared the leak was caused by a joinery seal between the head and the jamb. |

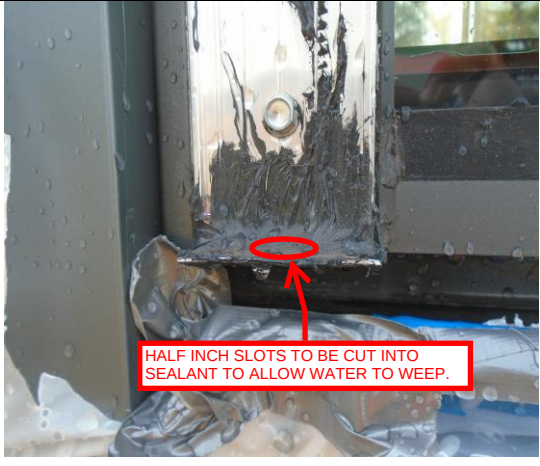
| 4.6 | Vertical pressure bar that is sealed at the bottom to the mullion end cap. | | HAI did not agree with sealing the bottom of the pressure bar to the mullion end cap. This will trap water in the system. | A half inch slot is to be cut into the sealant to allow any water in the glazing cavity to weep properly. |

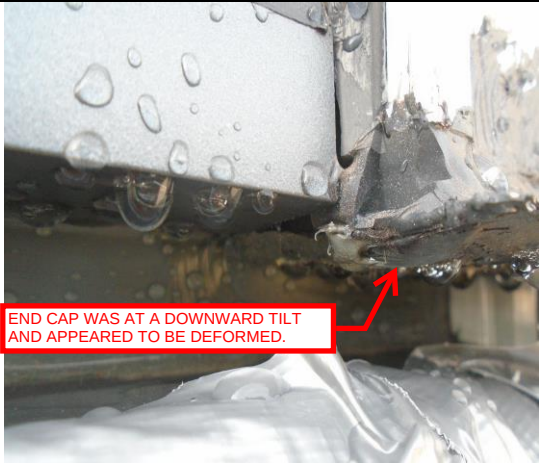
| 4.7 | Mullion end cap appeared to be bent/deformed. These mullion end caps extend under the mullion and over the primary perimeter seal. | | If this part is deformed then there may be an issue with sealing the perimeter seal in this area. | These items need to be checked under a quality control before additional sealant is added in areas around it. |

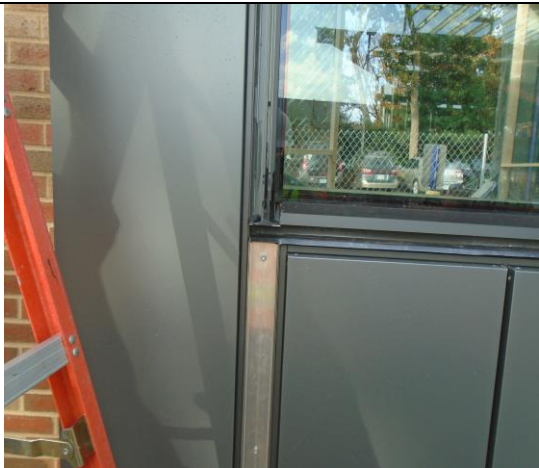
| 4.8 | Investigating jamb/sill joinery where leak occurred. NGG removed the pressure bar for inspection. Refer to following photograph for a closer look. | | Pressure bar was removed to investigate further. | Mockup development in progress |

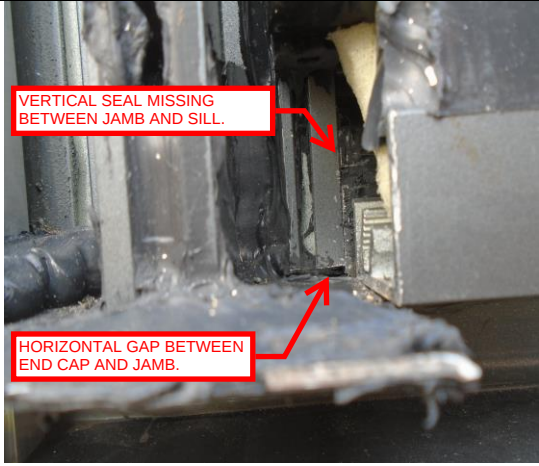
| 4.9 | Mullion end cap not fully sealed to jamb as well as sill horizontal not sealed to jamb. | | NGG noted that a vertical seal was missing at the sill/jamb joinery. Also note that a horizontal gap is between the end cap and the jamb. This will allow water to infiltrate. | Both of these seals are critical in preventing water infiltration and needs to be installed properly. |

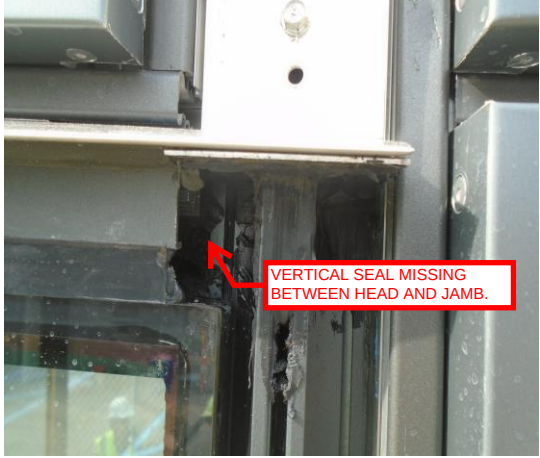
| 4.10 | Jamb appeared to not be sealed to head horizontal. | | It appeared that the head horizontal was also missing a vertical seal where it joins the jamb. This is similar to photograph 4.9 above. | These seals are critical in preventing water infiltration and needs to be installed properly. |

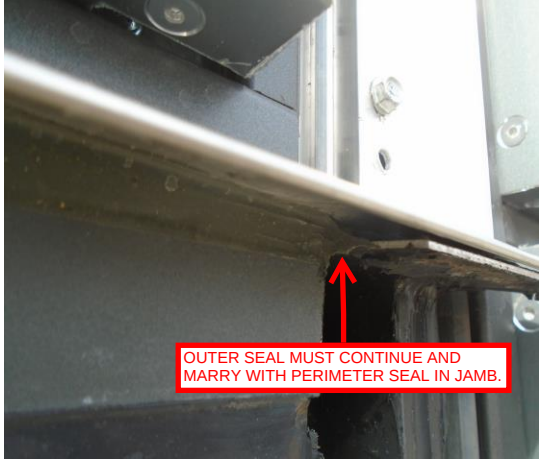
| 4.11 | Secondary seal appeared to stop at jamb. | | The outer line of sealant appears to stop as it reaches the jamb. This seal needs to be continuous and marry to the outer seal in the jamb. | The outer seal needs to be installed per the drawings. |

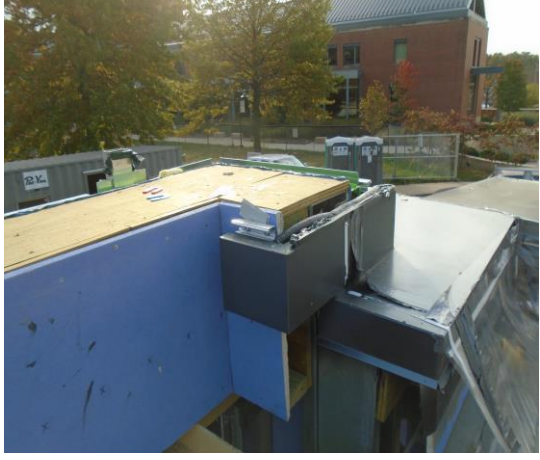
| 4.12 | Parapet cap removed to install more sheathing and extend AVB back to the interior side. | | The parapet cap was not installed to performance requirements. | Paric added sheathing and AVB to make the parapet cap as close to job condition as possible. |

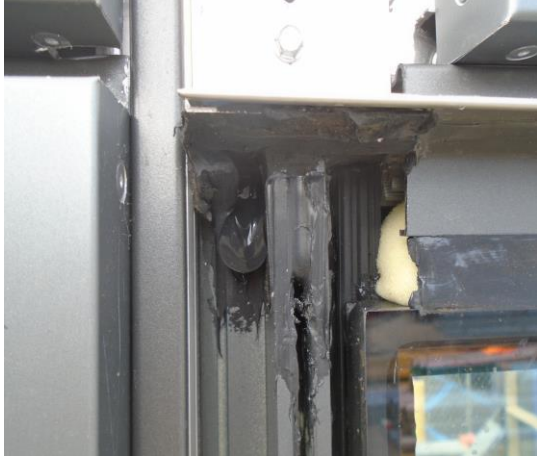
| 4.13 | Jamb mullion at metal panel transition does not match mock up shop drawings. No perimeter seal is visible nor the stainless steel flashing. | | Panel to glazing transition does not appear to match the shop drawings. | Coordinate location of metal joint filler and perimeter seals so this doesn't conflict with two lines of sealant on the project. |

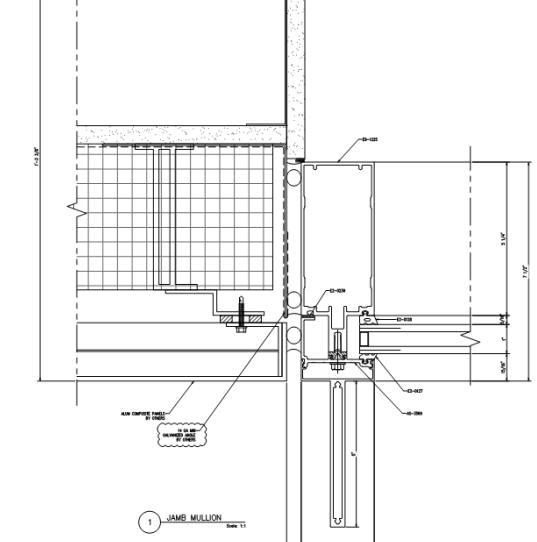
| 4.14 | Detail 1/M15 for the above condition. | | Panel to glazing transition does not appear to match the shop drawings. | Coordinate location of metal joint filler and perimeter seals so this doesn't conflict with two lines of sealant on the project. |
