## Site Visit Notes – Round Two Mock-up Testing

**Date/Time:** November 08, 2016  
**Prepared by:** Scott Klingsick, KWA  
**Project Title:** Webster University – Interdisciplinary Science Building  
**KWA Project No.:** 2014-0119  
**Cannon Project No.:** 004561.00  
**Project Location:** 470 East Lockwood Avenue  
 Webster Groves, MO 63119

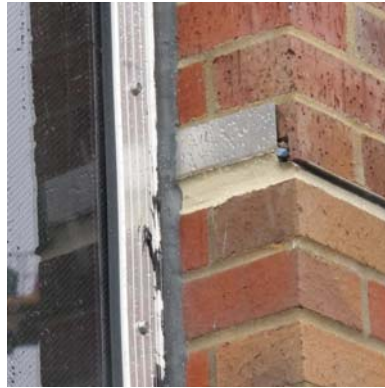
- End dams are exposed at the south section corners at the lipped brick. Brick with a lipped corner will be required to be installed on the building.

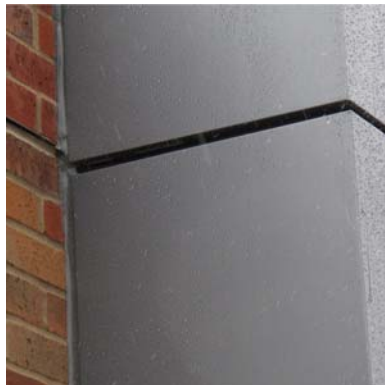
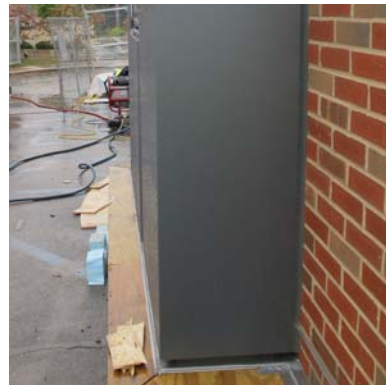
- Metal panel joints are not consistent. Joints vary in size/thickness across the length of the joint. Metal panels do not align in the same vertical plane.

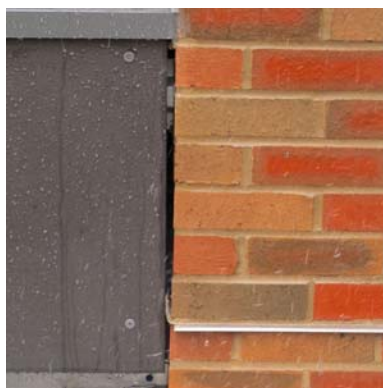
- Fiber cement panel joint adjacent to the brick is not consistent in width along its length. Support framing behind panels is visible. Fasteners do not match fiber cement color.

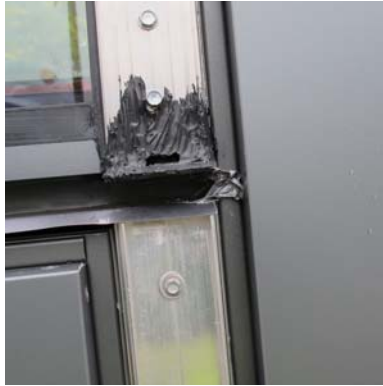
- Sealant is required at the top and bottom of all snap-on fin clips. Bottom sealant must allow for system to weep. Sealant was not installed at top of fin clips at flashing.

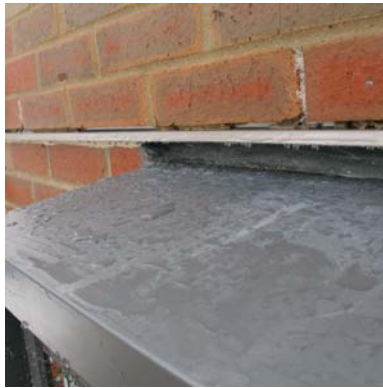
- Mortar at lipped brick should be installed above thru-wall flashings. Head joint weeps should extend to thru-wall flashing.
