## Akins Consulting Services, LLP

### SITE ACTIVITY REPORT FOR 01/31/2017

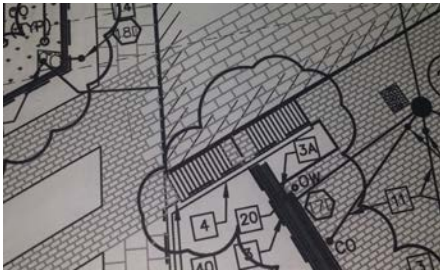
ACS representative visited the Job Site to observe foundation trench excavation. Photograph 1 shows the location observed and Photograph 2 shows the foundation trench observed on January 31, 2017.

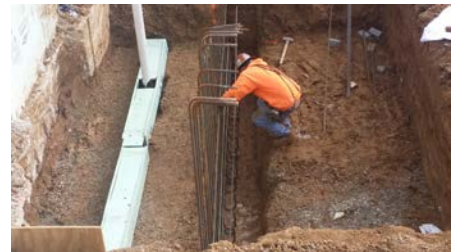
Photograph 2

The foundation trench excavation had already been completed prior to my arrival. The exposed surface of the trench was evaluated and found to be in compliance with the design bearing capacity. Trench excavation observed during this visit was in accordance with good earthwork practice.
