## **Heitmann & Associates, Inc.**

Site Observation Visit# 01

Report #01-Waterproofing

**Project Name:** Webster University- ISB  
**Project Location:** Webster Groves  
**Project Number:** 2014061.20  
**Client:** Webster University  
**Report Prepared By:** George Crow - Heitmann & Associates, Inc.  
**Date of Report:** September 16, 2016

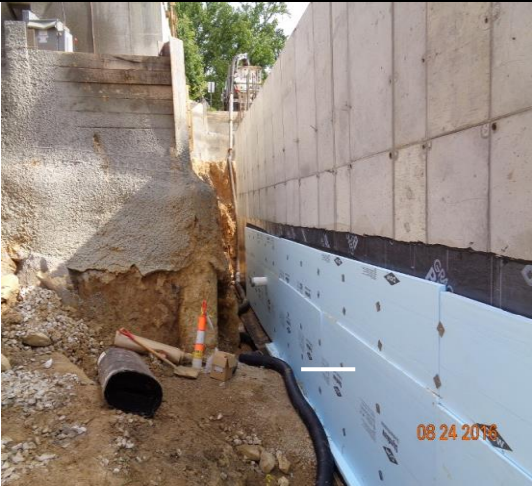
2. Superior waterproofing was in the process of installing the waterproofing membrane, drainage mat and rigid insulation board along column line 5 (Refer to Item 01.1).

| ITEM # | DATE | DESCRIPTION | | COMMENTS/ RESOLUTION | STATUS |
|---|---|---|---|---|---|
| 01.1 | 8-24-16 | View looking North along column line 5 | | Installation of sheet membrane waterproofing, drainage mat and rigid board insulation in progress. Work to this point is acceptable | Installation progressing |

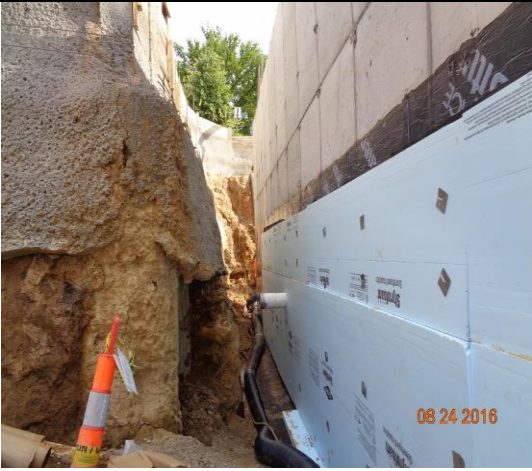
3. Superior's representative indicated that the pipe sleeve penetration through the foundation wall at column line 5 was sealed with waterproofing membrane (Refer to Item 01.2).

| ITEM # | DATE | DESCRIPTION | | COMMENTS/ RESOLUTION | STATUS |
|---|---|---|---|---|---|
| 01.2 | 8-24-16 | Pipe penetration in foundation wall at column line 5. | | Pipe sleeve installed and sealed to foundation wall with waterproofing membrane. | When pipe is installed through sleeve- "Link Seal" is required per Detail 3/ P0501. |

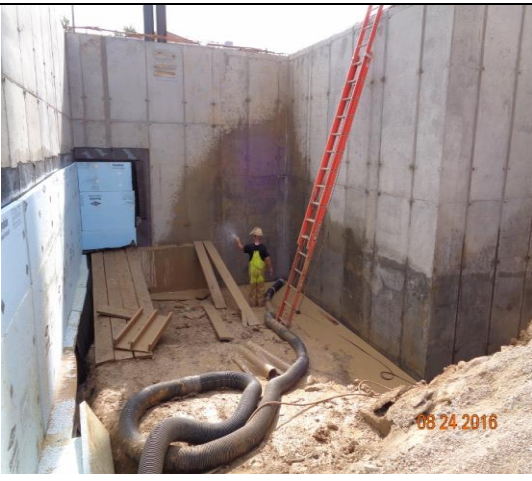
4. As a result of the previous day's rainstorm, at some locations the foundation walls had a film of dirt on the surface. The construction crew was in the process of cleaning the foundation walls with a water hose in preparation for installation of the waterproofing membrane (Refer to Item 01.3).

| ITEM # | DATE | DESCRIPTION | | COMMENTS/ RESOLUTION | STATUS |
|---|---|---|---|---|---|
| 01.3 | 8-24-16 | View looking East at foundation wall on column line 6 between column lines C.3 and B.3. | | In the process of dewatering the foundation and cleaning foundation wall. | In progress |

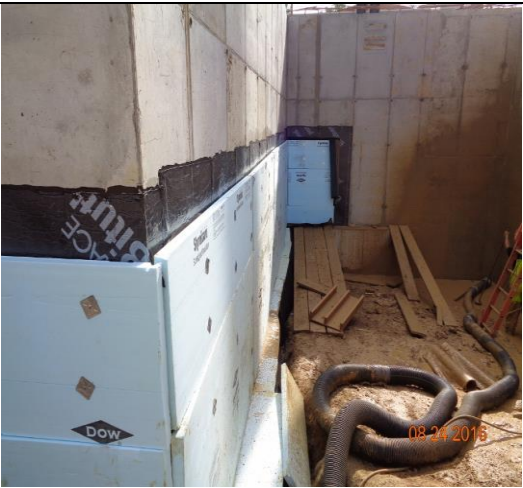
5. The rigid insulation board was being installed by adhesively attaching the base plate of the stick pins to the previously installed sheet membrane. The drainage mat and insulation board were then slid over the stick pins with the insulation being secured with plates on the stick pins (Refer to Item 01.4). Several locations were checked and found that the insulation was properly secured.

| 01.4 | 8-24-16 | View of foundation wall corner at the intersection of column lines 5 and C.3. | | View shows typical installation of waterproofing membrane, drainage mat with the rigid insulation board secured to the foundation wall with stick pins. | The installation in general followed good practice. The terminations at the grade beam were not completed during this review. |
