## **Heitmann & Associates, Inc.**

Site Observation Visit# 05

Report #05-Mockup

**Project Name:** Webster University- ISB  
**Project Location:** Webster Groves  
**Project Number:** 2014061.20  
**Client:** Webster University  
**Report Prepared By:** Ryan Fennewald - Heitmann & Associates, Inc.  
**Date of Report:** December 14, 2016

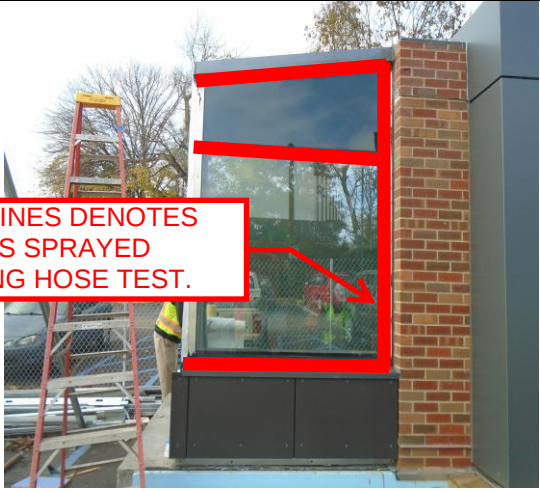
| DATE | DESCRIPTION | | COMMENTS/<br>RESOLUTION | STATUS |
|---|---|---|---|---|
| 5.1 | View of mockup exterior window. | <p>RED LINES DENOTES JOINTS SPRAYED DURING HOSE TEST.</p> | Hose water testing to occur at this unit. | Mockup testing in progress |

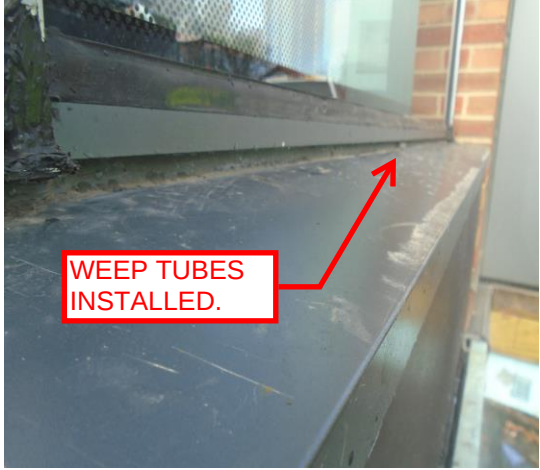
| DATE | DESCRIPTION | | COMMENTS/<br>RESOLUTION | STATUS |
|---|---|---|---|---|
| 5.2 | Close up view of the sill. | <p>WEEP TUBES INSTALLED.</p> | Sill horizontal with weep tubes installed. | Mockup testing in progress |

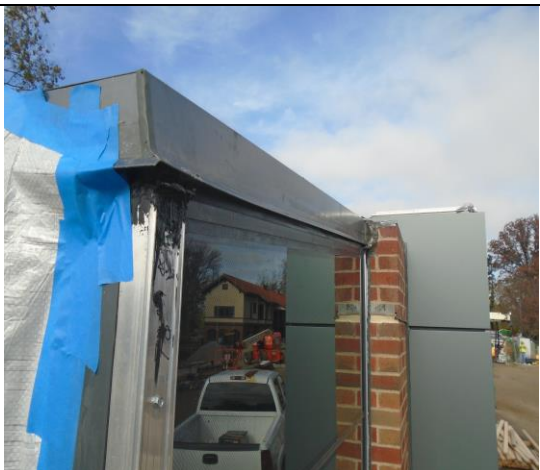
3. At the conclusion of testing, it was discovered by physical touch that moisture was on the interior of the head horizontal. This area was difficult to inspect prior to testing as structural supports as well as studs and sheathing blocks the view to this area. HAI felt moisture when feeling along the top of the horizontal. Since water wasn't observed during testing and the moisture felt in this area didn't appear to be significant by volume, the area was dried off and tested again. No water was observed or felt after the area was retested. It was opined that the moisture was most likely from dew or rain from the previous day.

| DATE | DESCRIPTION | | COMMENTS/<br>RESOLUTION | STATUS |
|---|---|---|---|---|
| 5.3 | Close up view of the head. | | Head horizontal with perimeter seals installed for water testing. | Mockup testing in progress |

4. HAI considers the testing of the remediated sealant joint at the curtain wall head successful.
