Field Report

DATE	Jan. 20, 2016	**REPORT NO.**	**006**
PROJECT:	Webster University Interdisciplinary Science Building 8274 Big Bend Blvd. Webster Groves, MO 63119	**DATE OF VISIT:** **TIME:** **WEATHER:**	Jan. 10, 2017 3:40 pm 35°F
PROJECT #	004560.01		
PRESENT AT SITE:	Kelvin Patel (CD), Devin Gates (Paric)

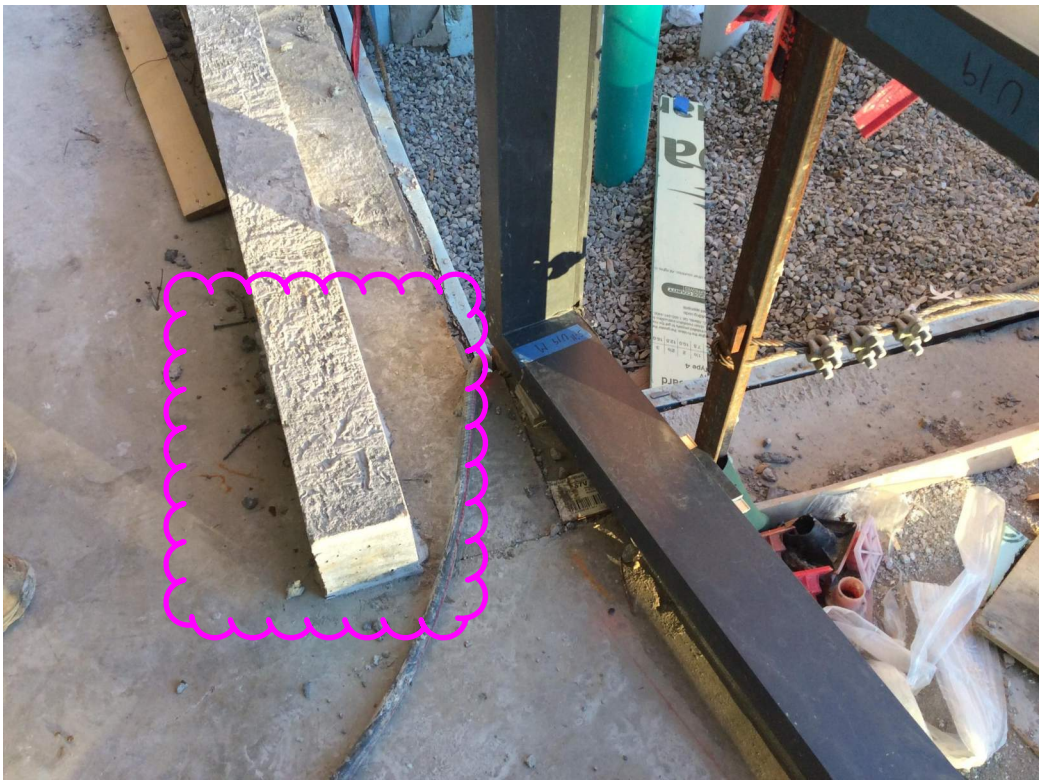
1. At level 02, Curb for the exterior metal panel wall along col. line B between 4 and 5 is too long and in front of curtainwall.
ACTION: Remove excess curb, refer 4/A0403 is determine the required curb length.

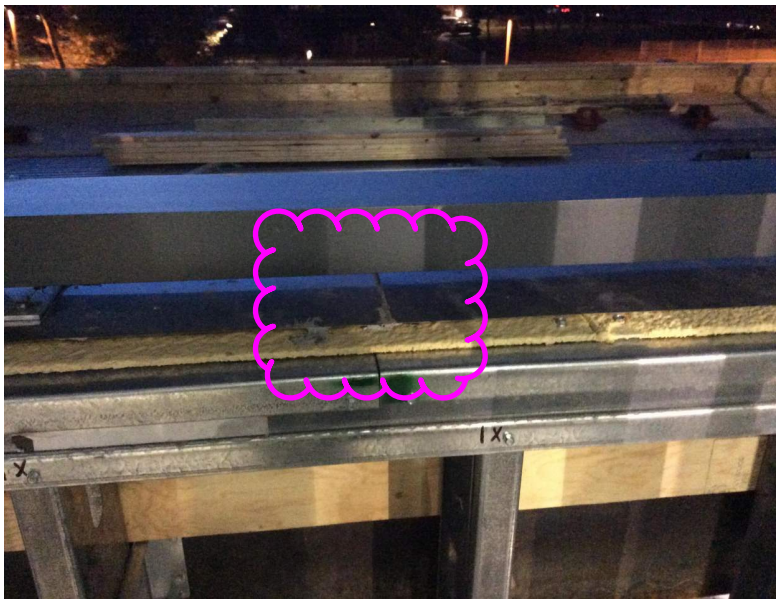
2. At level 04 clearstory curtainwall, the stainless steel flashing lap below bottom mullion is not adequate.
ACTION: Lap sheet metal flashing per contract documents.

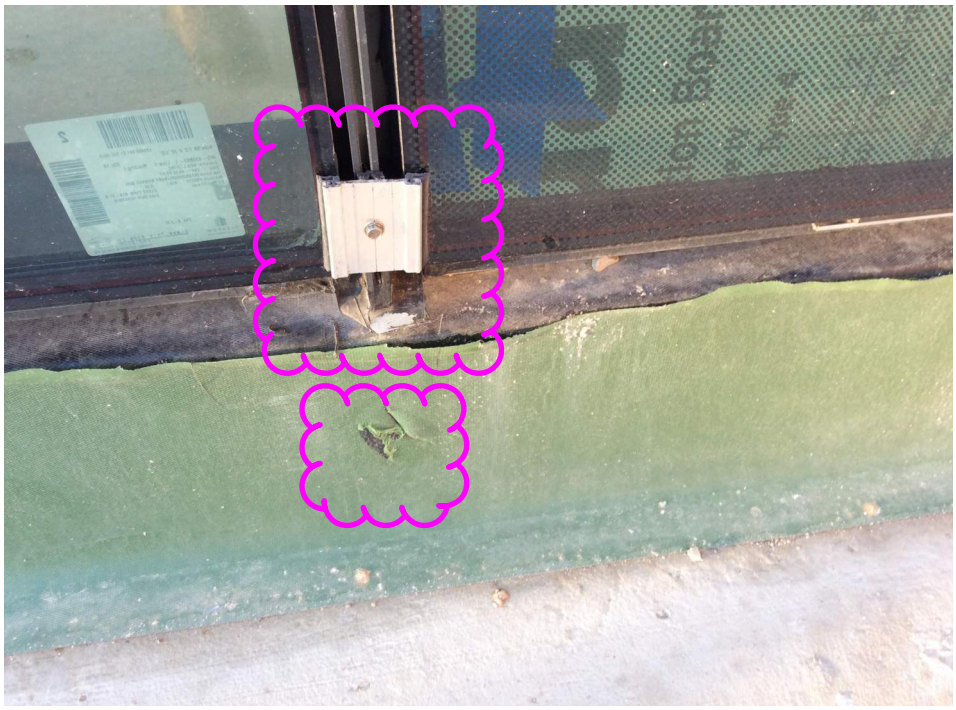
3. At level 02, along col. line 8 at base of curtainwall -
   a) The bottom closure plates for mullion snap covers were bent or deformed.
   b) Fluid applied waterproofing was punctured.

ACTION:
a) Straighten or replace bottom closure plates prior to installation of snap covers.
b) Patch punctured fluid applied waterproofing.
