Field Report

DATE	Dec. 13, 2016	**REPORT NO.**	**005**
PROJECT:	Webster University Interdisciplinary Science Building 8274 Big Bend Blvd. Webster Groves, MO 63119	**DATE OF VISIT:** **TIME:** **WEATHER:**	Dec. 13, 2016 3:40 pm 35°F Cloudy
PROJECT #	004560.01		
PRESENT AT SITE:	Kelvin Patel (CD), Lynn Grossman (CD) Steve Ray (Paric)

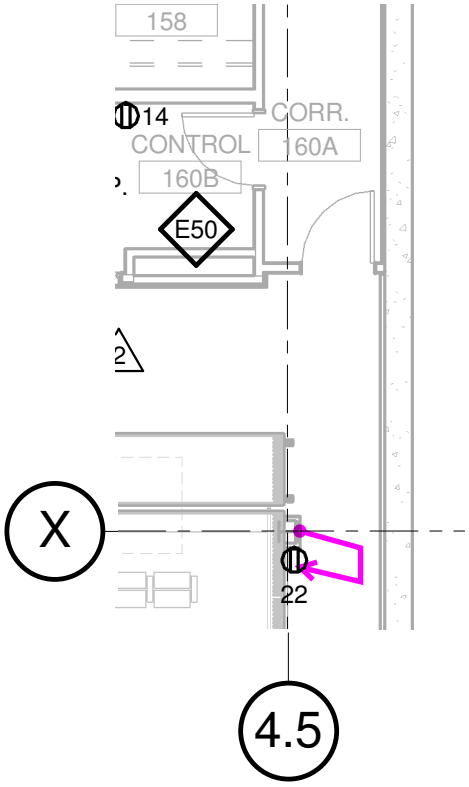
1. At level 01, Electrical oultet on column at col. line 4.5 and X is not located per documents. It is currently on the corridor side.
ACTION: Contractor to move the electrical outlet on south side of the column per documents.

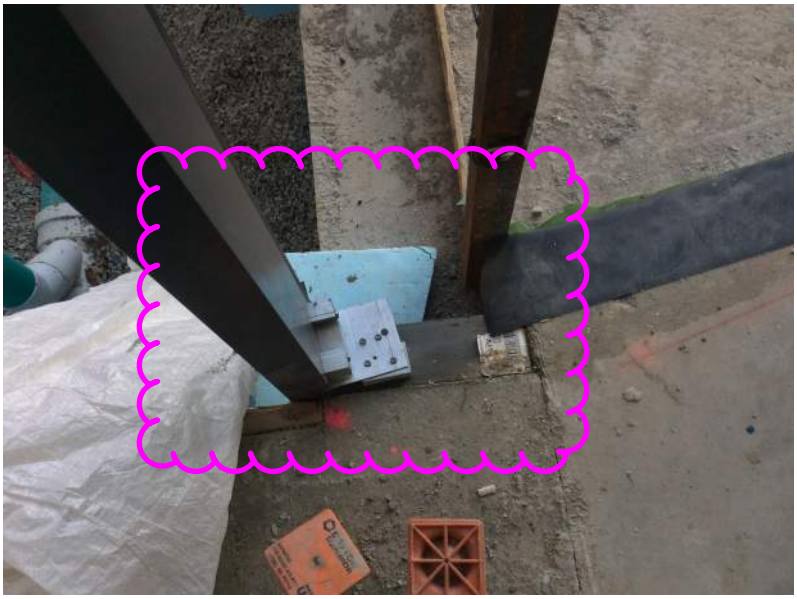
4. All level 02, no concrete floor / substrate below curtainwall end near column line 5 and B.
ACTION: Provide solid floor or substrate for curtianwall support and installation of AVB.
