Field Report

DATE	Aug. 22, 2016	**REPORT NO.**	**001**
PROJECT:	Webster University Interdisciplinary Science Building 8274 Big Bend Blvd. Webster Groves, MO 63119	**DATE OF VISIT:** **TIME:** **WEATHER:**	Aug. 11, 2016 2:00 pm 91°F Sunny
PROJECT #	004560.01		
PRESENT AT SITE:	Kelvin Patel, Kathy Williams, Scott Klingsick

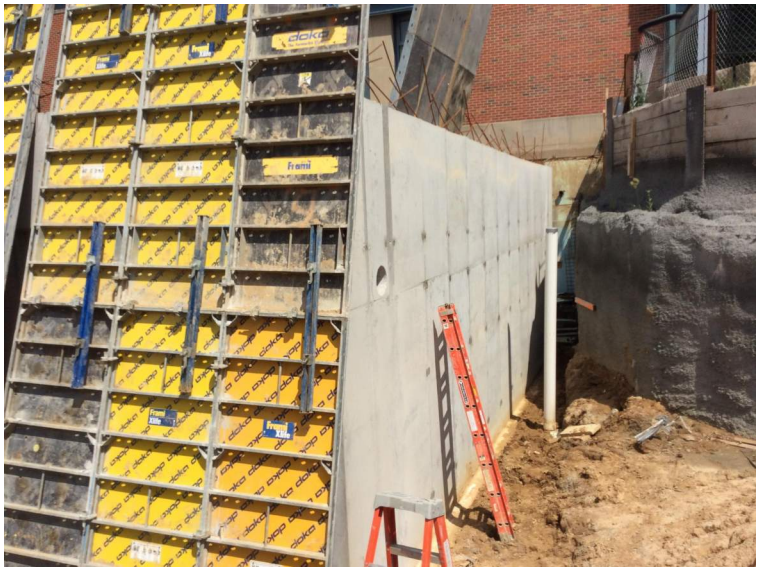
5. The green roof overflow drain penetration in the concrete wall at the south of the lecture hall on level 01 has crack around it.
ACTION: Repair crack - provide epoxy injection or hydraulic cement product data for approval.

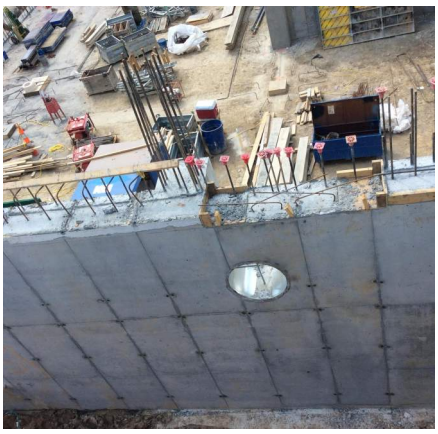
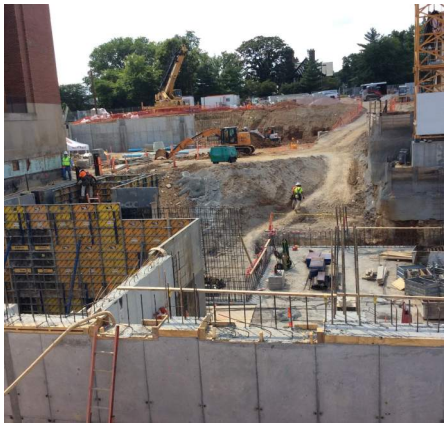
6. Some construction photographs...
