Field Report

DATE	Sept. 16, 2016	**REPORT NO.**	**002**
PROJECT:	Webster University Interdisciplinary Science Building 8274 Big Bend Blvd. Webster Groves, MO 63119	**DATE OF VISIT:** **TIME:** **WEATHER:**	Sept. 06, 2016 3:50 pm 93°F Sunny
PROJECT #	004560.01		
PRESENT AT SITE:	Kelvin Patel (CD), Jason Szachnieski (Paric)

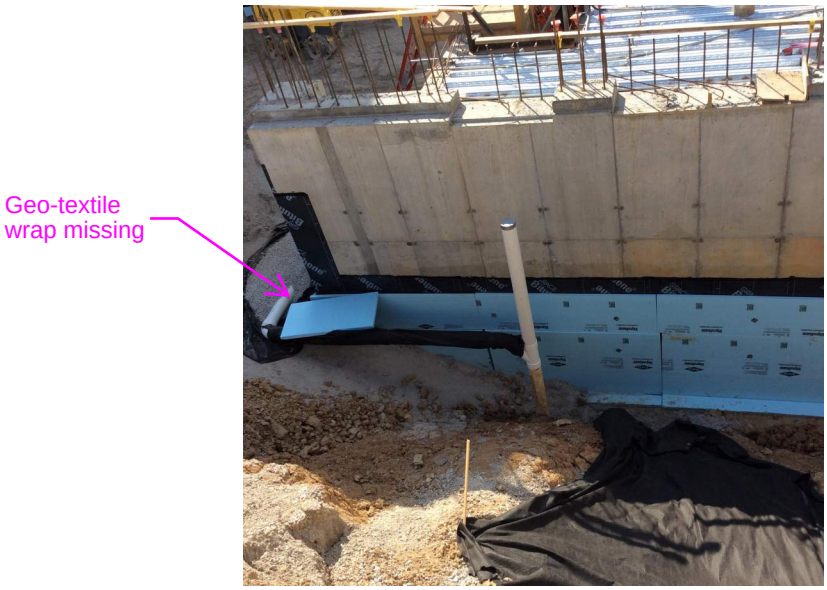
5. Observed backfill in process at corner of grid C.3 and 8, the geo-textile wrap on drain-tile seem to be missing.
ACTION: Contractor to provide geotextile wrapped draintile as directed in RFI 258.

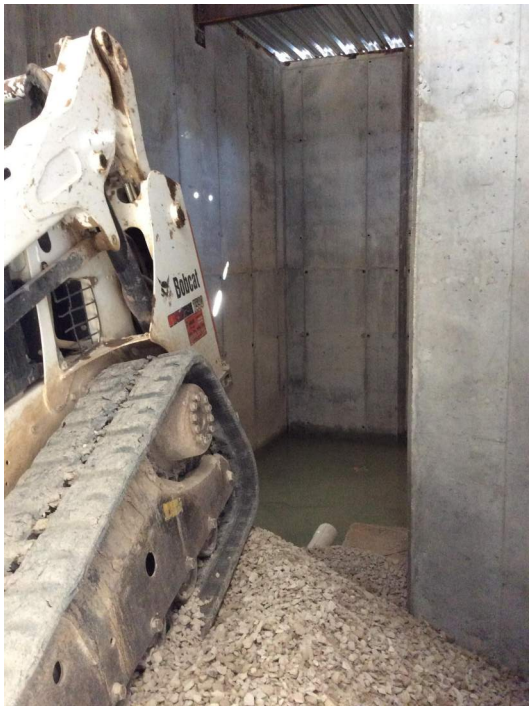
6. Elevator pits at level 00 were filled with water.
ACTION: Dewatering to be done per specifications.

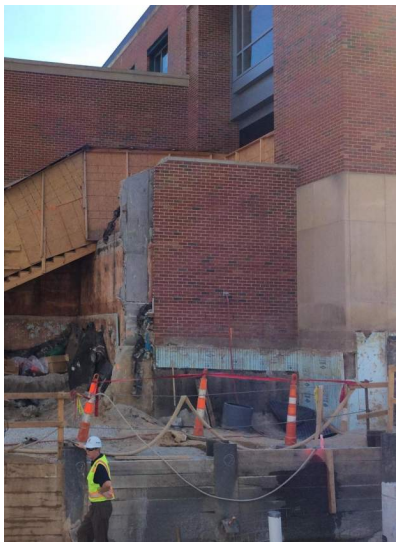
7. All the waterproofing at the foundation walls of existing EAB on the north & south side is damaged.
ACTION: Waterproofing to be restored properly prior to backfill.
