Field Report

DATE	Nov. 15, 2016	**REPORT NO.**	**004**
PROJECT:	Webster University Interdisciplinary Science Building 8274 Big Bend Blvd. Webster Groves, MO 63119	**DATE OF VISIT:** **TIME:** **WEATHER:**	Nov. 15, 2016 4:20 pm 61°F Cloudy
PROJECT #	004560.01		
PRESENT AT SITE:	Kelvin Patel (CD), Jason Szachnieski (Paric)

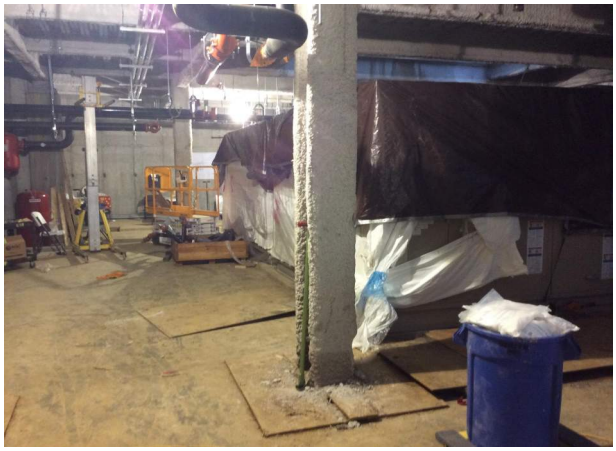
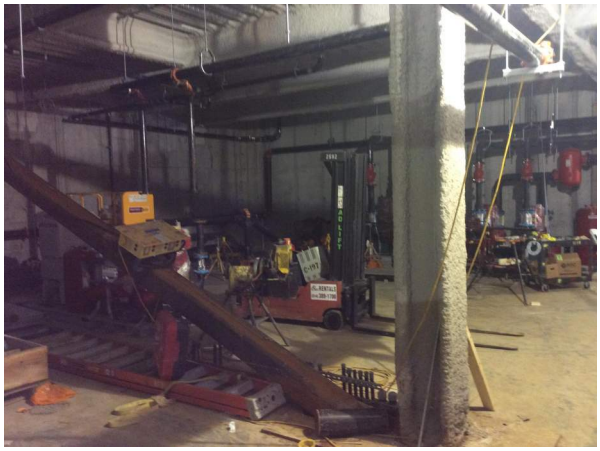
3. Level 00 photographs...

Level 00:
Level 00 concrete slab was poured. Sprayed fire-proofing was completed on structural steel. Equipment was placed on pads and piping & ductwork was ongoing.

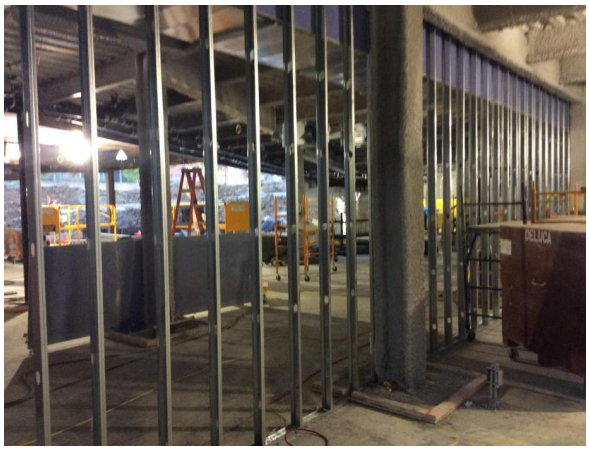
4. Level 01 photographs...

Level 01:
Level 01 concrete slab in Area 'B' was poured. Lecture Hall slab on grade preparations were ongoing. Area 'A' slab-on-grade area was not poured. Sprayed fire-proofing was completed on structural steel in Area 'A'. Non-Structural Metal Framing (NSMF) was started.

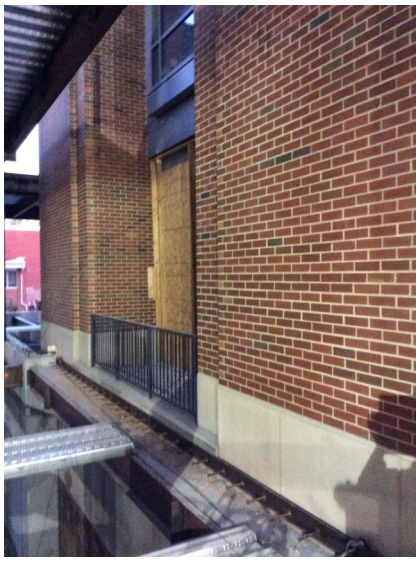
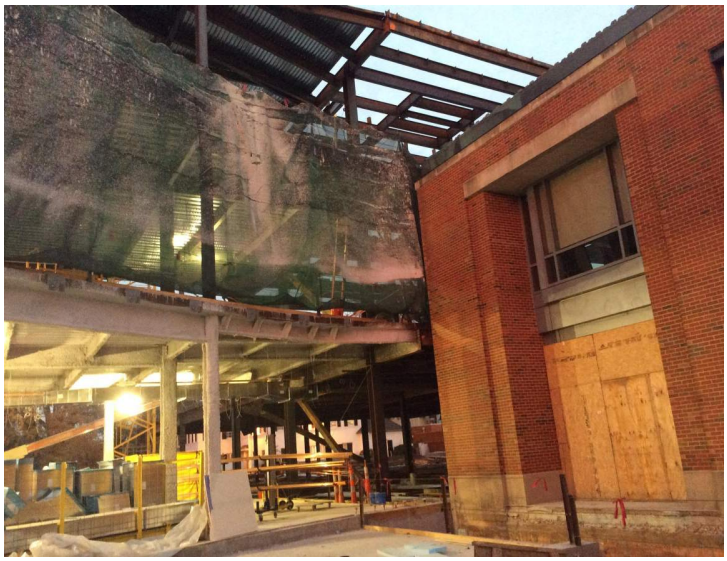
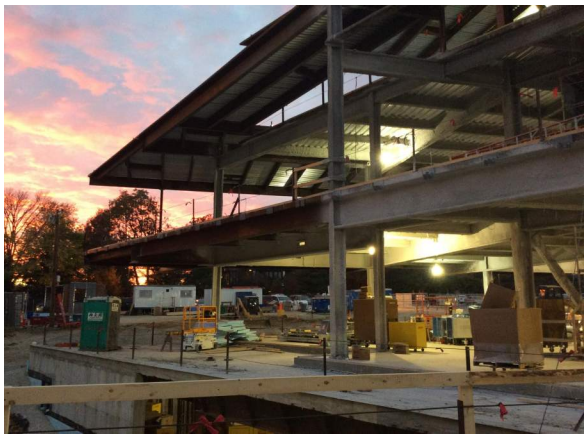
5. Level 02 photographs...

Level 02:
Area 'A' steel deck construction was ongoing. Area 'B' concrete over metal deck was poured. Sprayed fire-proofing was completed on structural steel in Area 'A'.

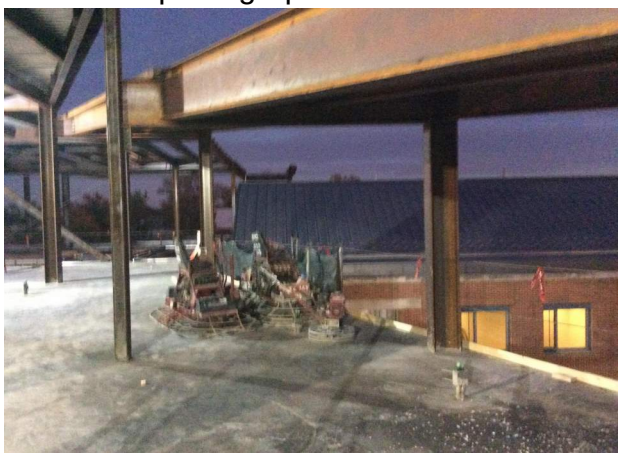
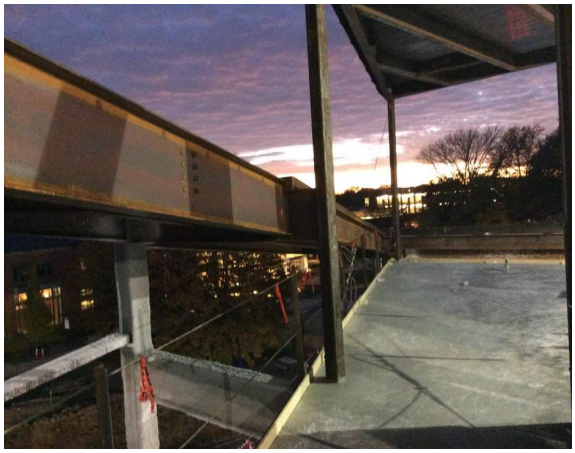
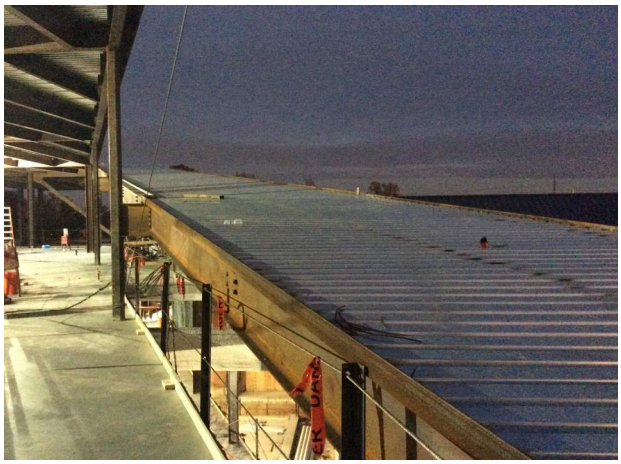
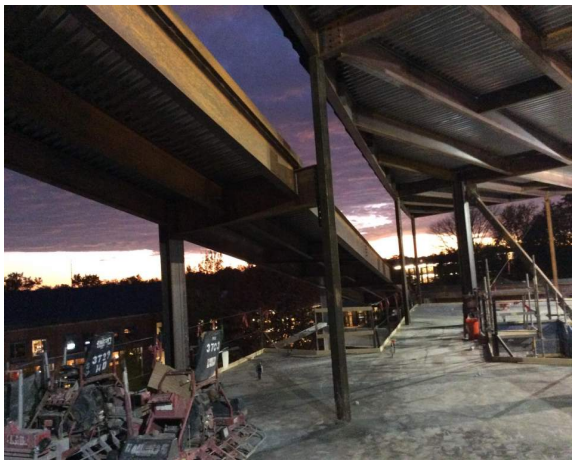
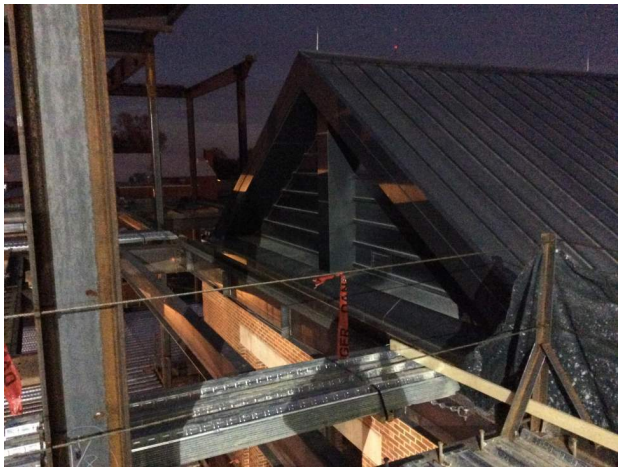
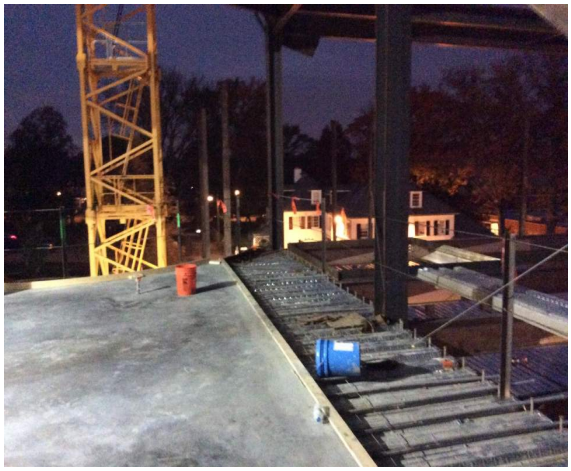
7. Level 04 photographs...

Level 04:
Area 'A' steel erection and steel deck construction was not started. Area 'B' concrete over metal deck was poured.
