CANNONDESIGN

Field Report

DATE	Apr. 10, 2017	**REPORT NO.**	**009**
PROJECT:	Webster University Interdisciplinary Science Building 8274 Big Bend Blvd. Webster Groves, MO 63119	**DATE OF VISIT:** **TIME:** **WEATHER:**	Apr. 04, 2017 3:35 pm 61°F
PROJECT #	004560.01		
PRESENT AT SITE:	Kelvin Patel (CD), Jim Holtrop (AcoustiControl), Jason Szachnieski (Paric)

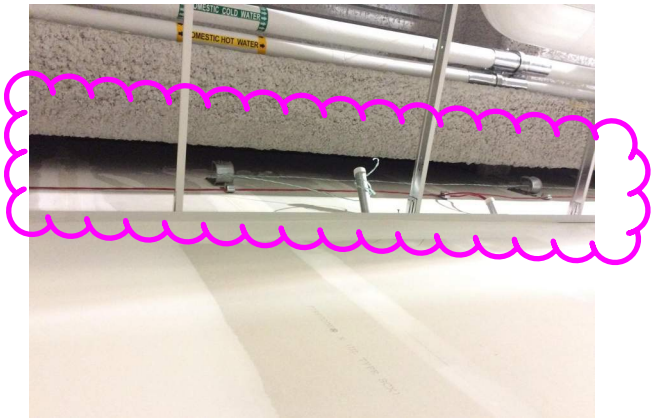
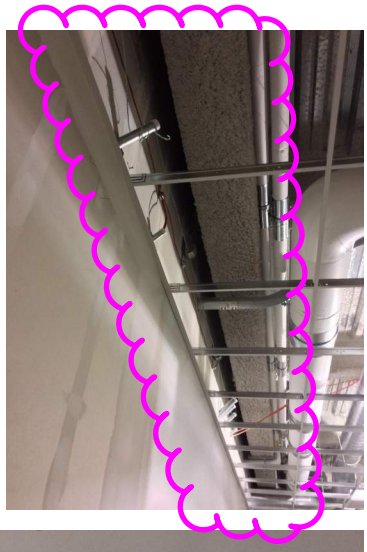
1. At all levels, application of acoustical sealant to seal the top and bottom of partition wall is not continuous with visible gaps/voids. Also, it is absent at some locations like structural beam penetrations along the same walls.
ACTION: All sealant installations per specification 079200. Refer to upcoming Acoustical engineer's report for more comments.

SEAL STRUCTURAL PENETRATIONS

SEAL PARTITION END ABOVE CEILING

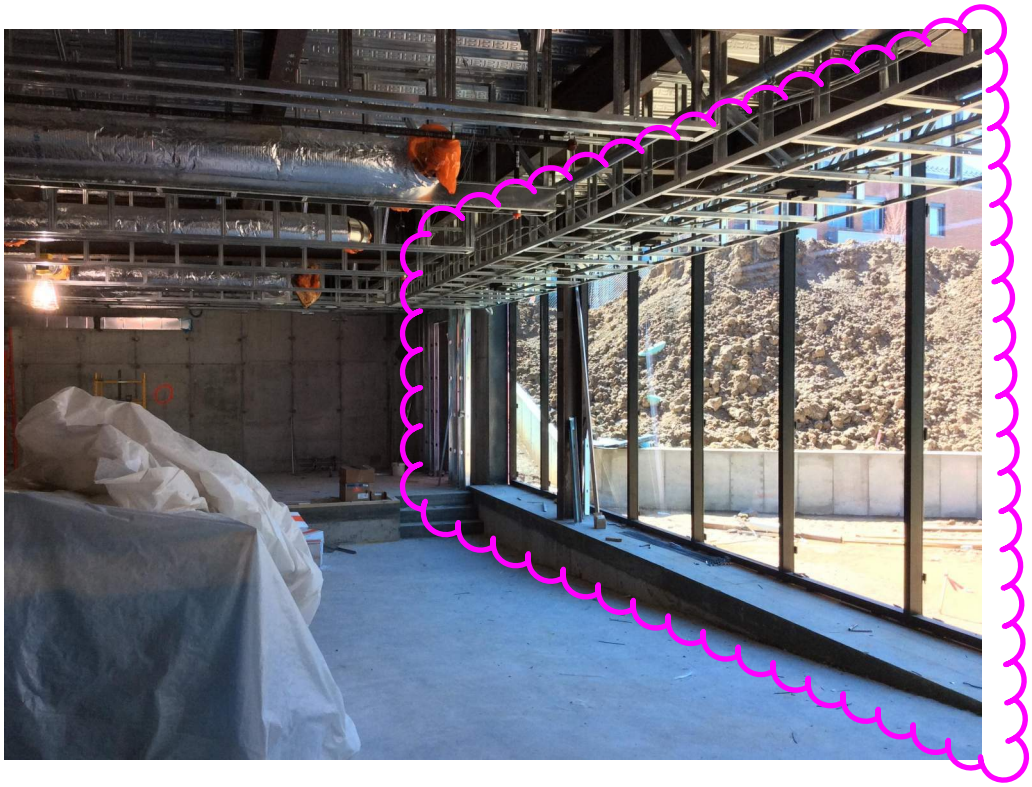
2. At level 01, Curtainwall type EGS-2A at Lecture Hall, the bottom mullions appears to be rotated and improperly installed.
ACTION: Contractor to remediate.

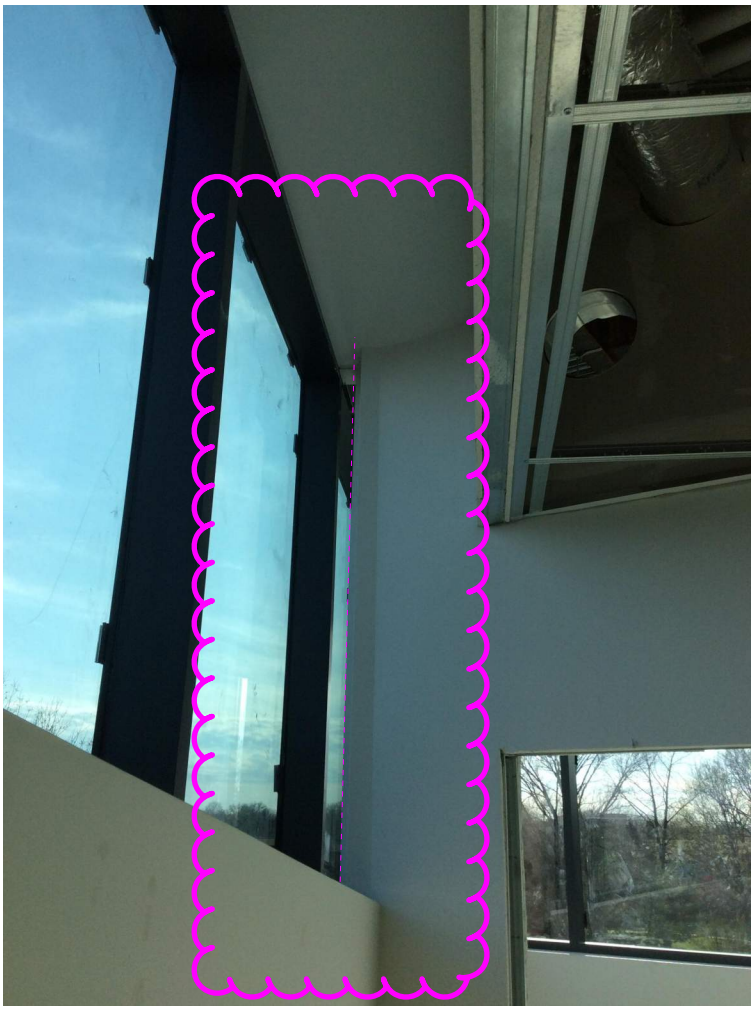
3. At room 342 on level 03, the partition wall ending at curtainwall on south appears to be curving inward and not leveled vertically.
ACTION: Contractor to remediate.
