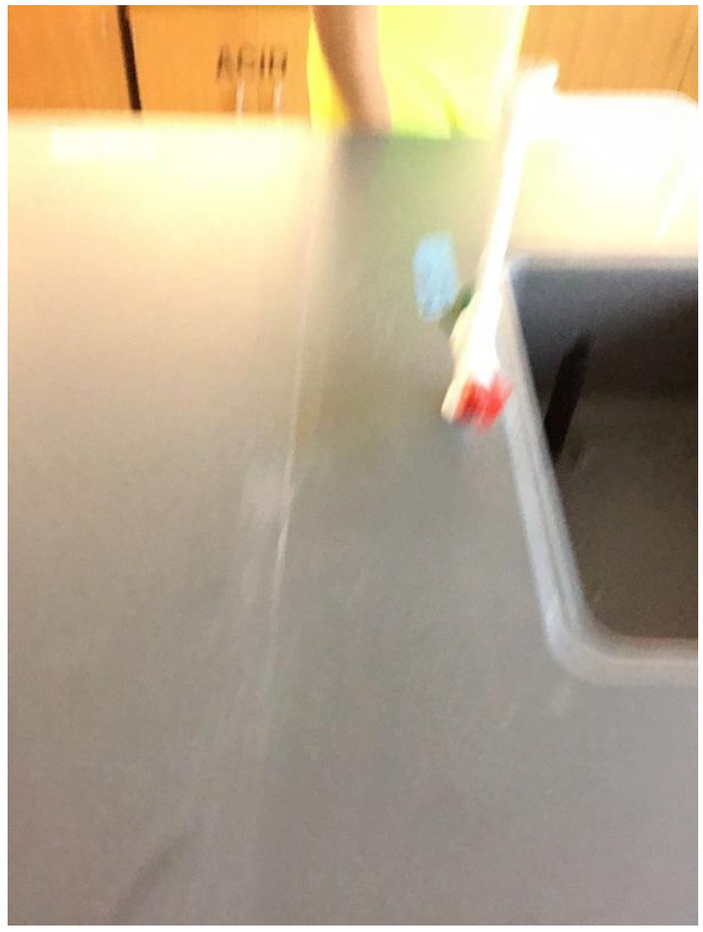
Issue ID	Description	Location Detail	Location	Status	Company	Type	Date Created	Due Date
000815	Epoxy "bubble" on surface.		Webster > LEVEL_04 > 480_CHEM LAB - ORGANIC	Work Completed	Carroll Seating	Architect Punch List	11 Jul 2017	16 Jul 2017

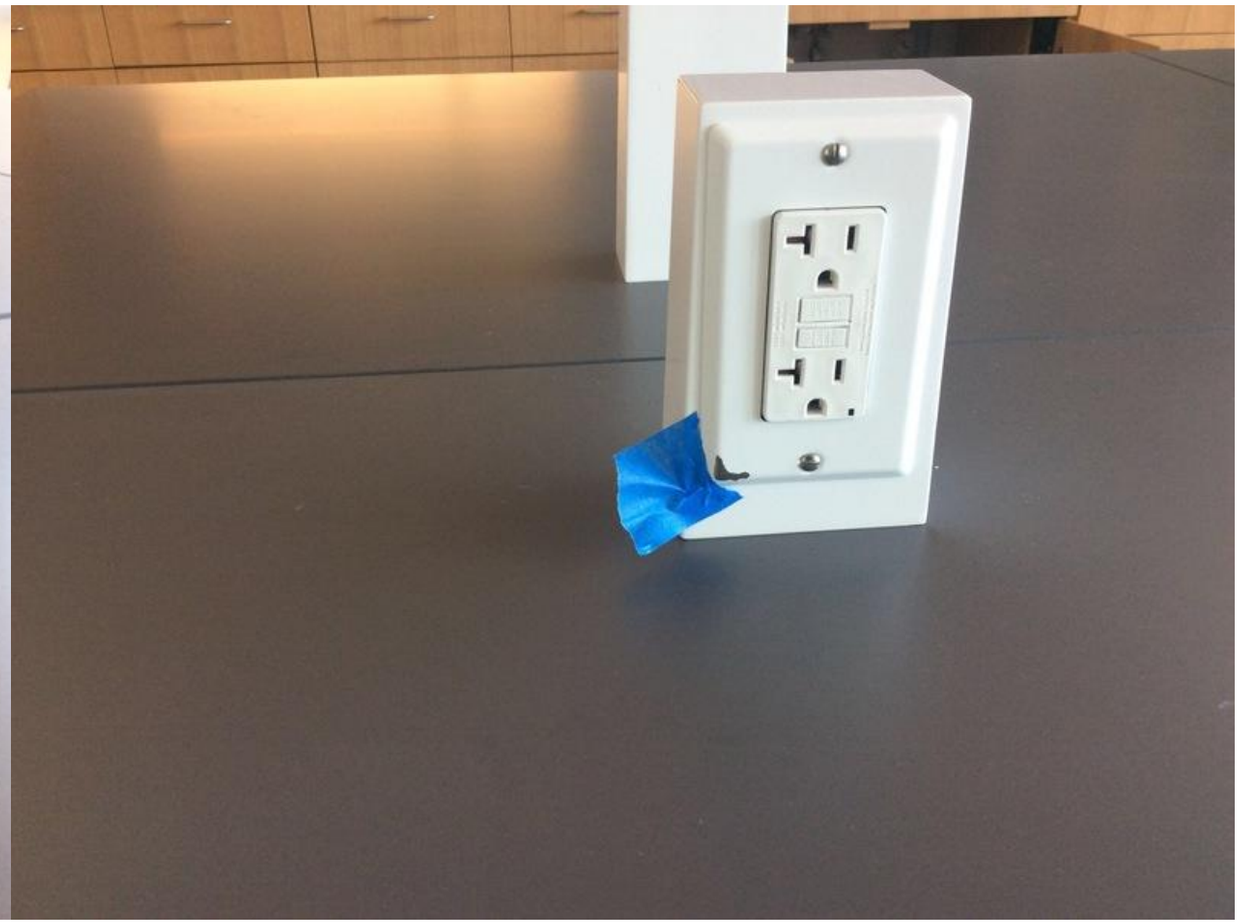
Issue ID	Description	Location Detail	Location	Status	Company	Type	Date Created	Due Date
000844	Chipped paint on faceplates (multiple locations)		Webster > LEVEL_04 > 491_CHEM LAB PHYSICAL	Open	Carroll Seating	Architect Punch List	12 Jul 2017	17 Jul 2017

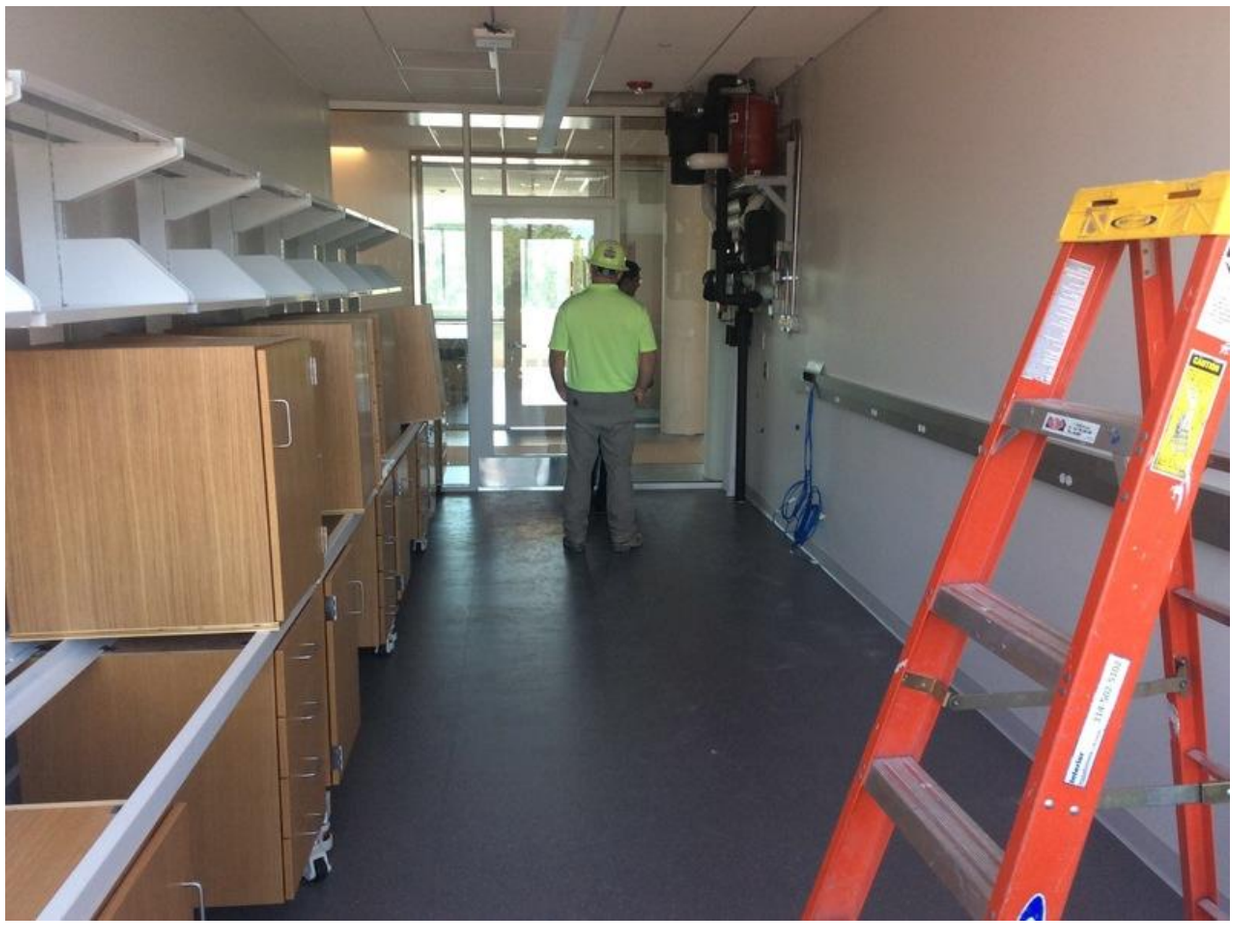
Issue ID	Description	Location Detail	Location	Status	Company	Type	Date Created	Due Date
000853	Remainder of millwork to be installed		Webster > LEVEL_04	Open	Carroll Seating	Architect Punch List	12 Jul 2017	17 Jul 2017

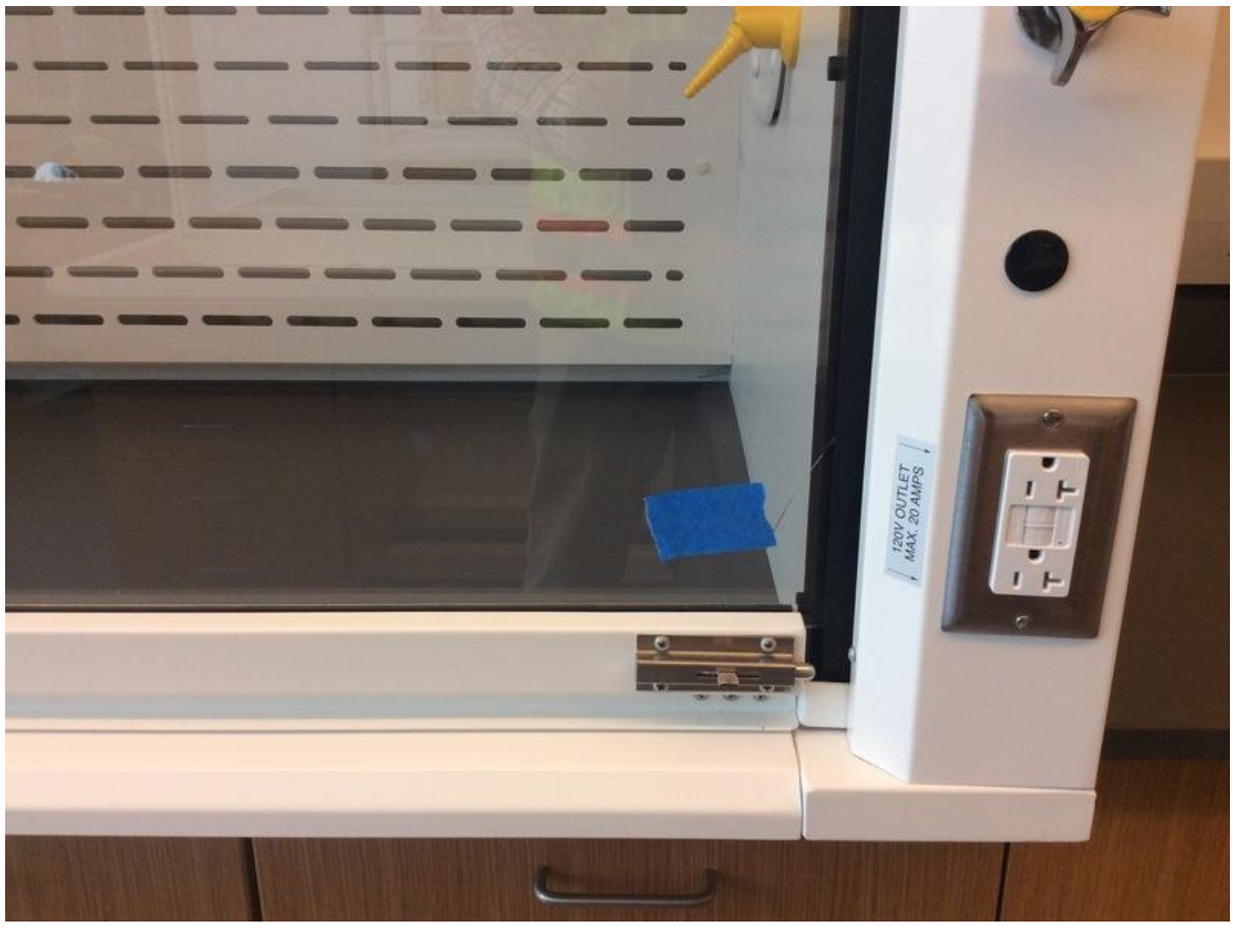
Issue ID	Description	Location Detail	Location	Status	Company	Type	Date Created	Due Date
000860	Broken glass at fume hood		Webster > LEVEL_04 > 483_CHEM LAB - RESEARCH	Open	Carroll Seating	Architect Punch List	12 Jul 2017	17 Jul 2017

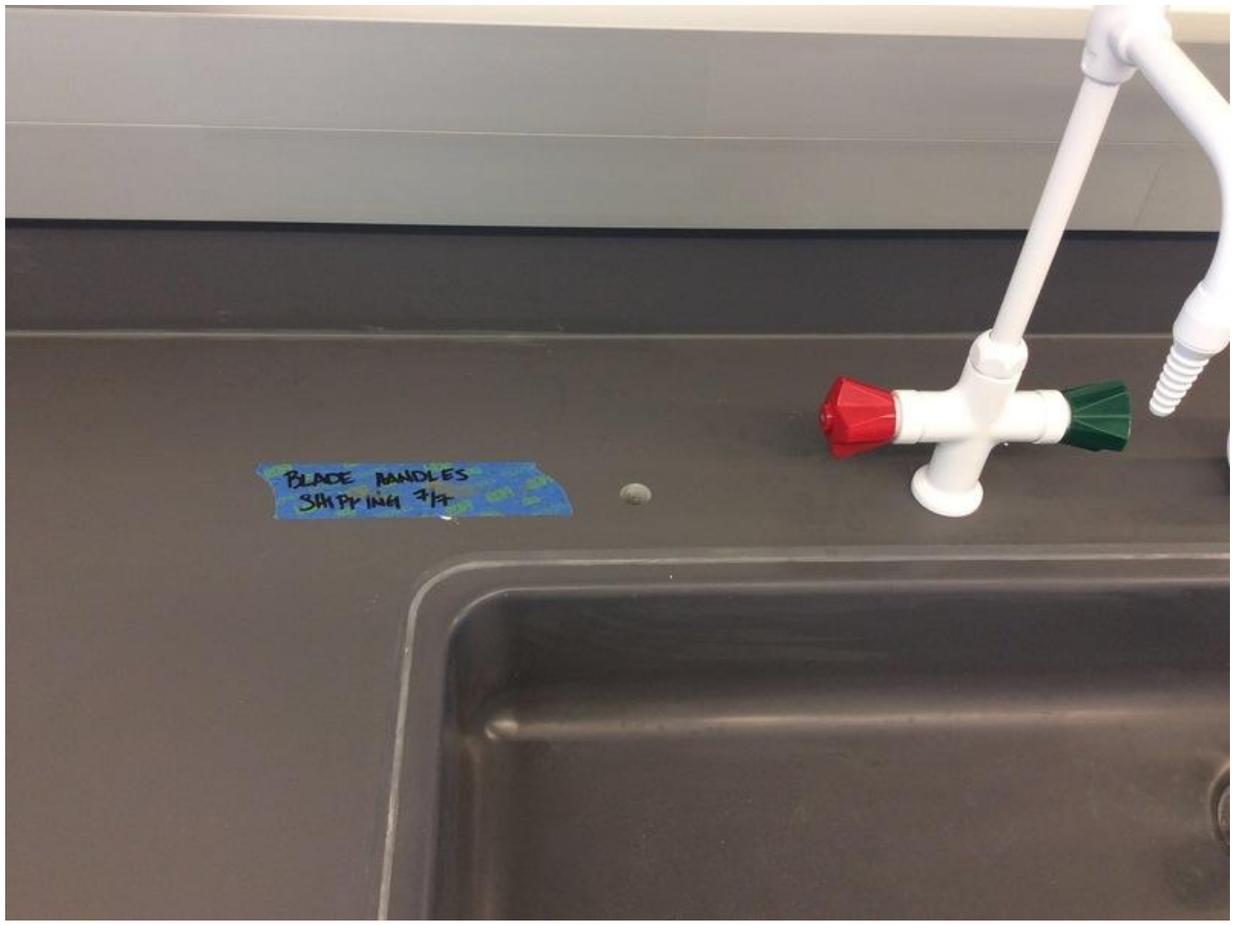
Issue ID	Description	Location Detail	Location	Status	Company	Type	Date Created	Due Date
000862	Missing blade handles (shipping 7/7)		Webster > LEVEL_04 > 483_CHEM LAB - RESEARCH	Open	Carroll Seating	Architect Punch List	12 Jul 2017	17 Jul 2017

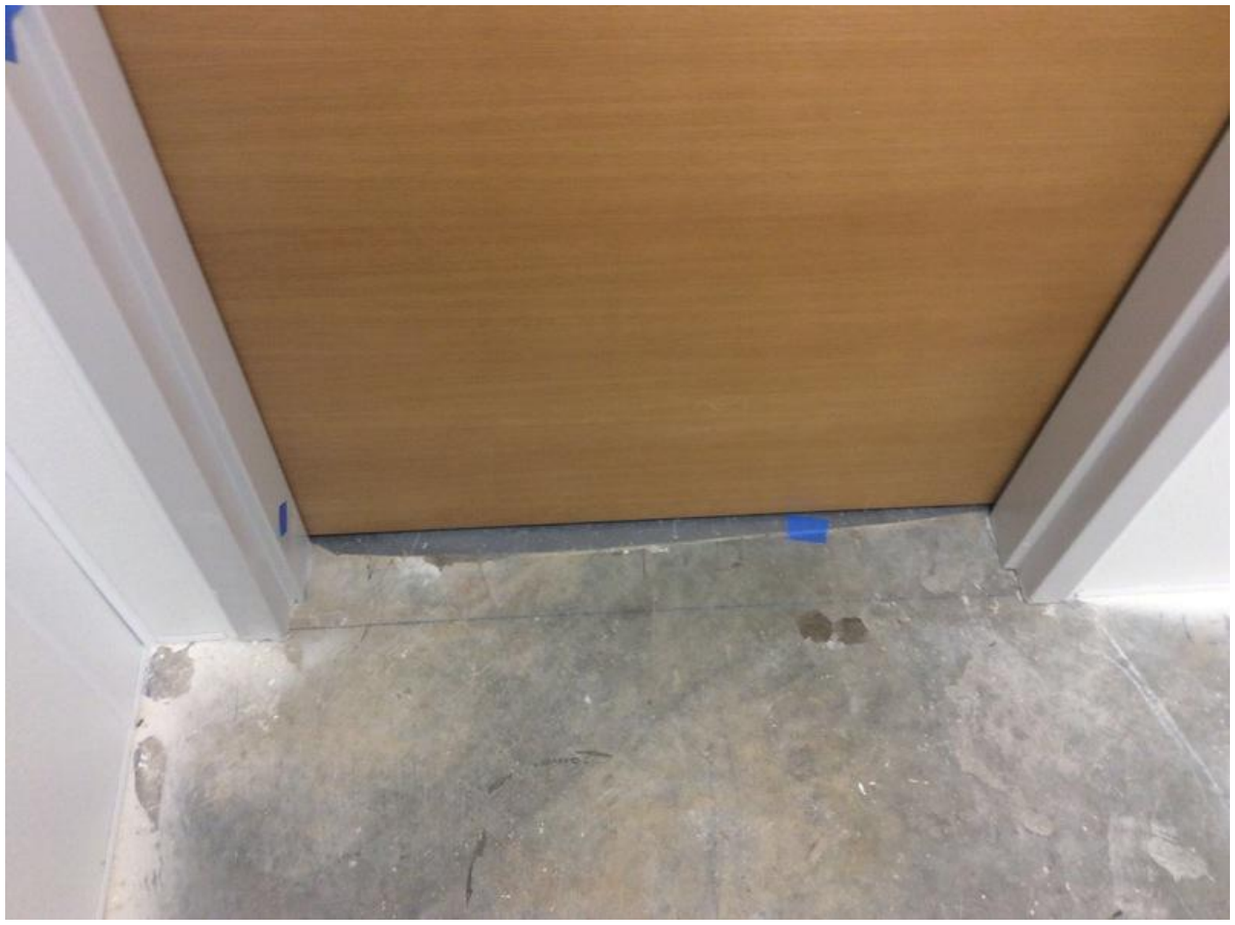
Issue ID	Description	Location Detail	Location	Status	Company	Type	Date Created	Due Date
000886	Missing transition strip		Webster > LEVEL_04 > 475_LAB WASTE - CHEM	Open	Flooring Systems, Inc.	Architect Punch List	12 Jul 2017	17 Jul 2017

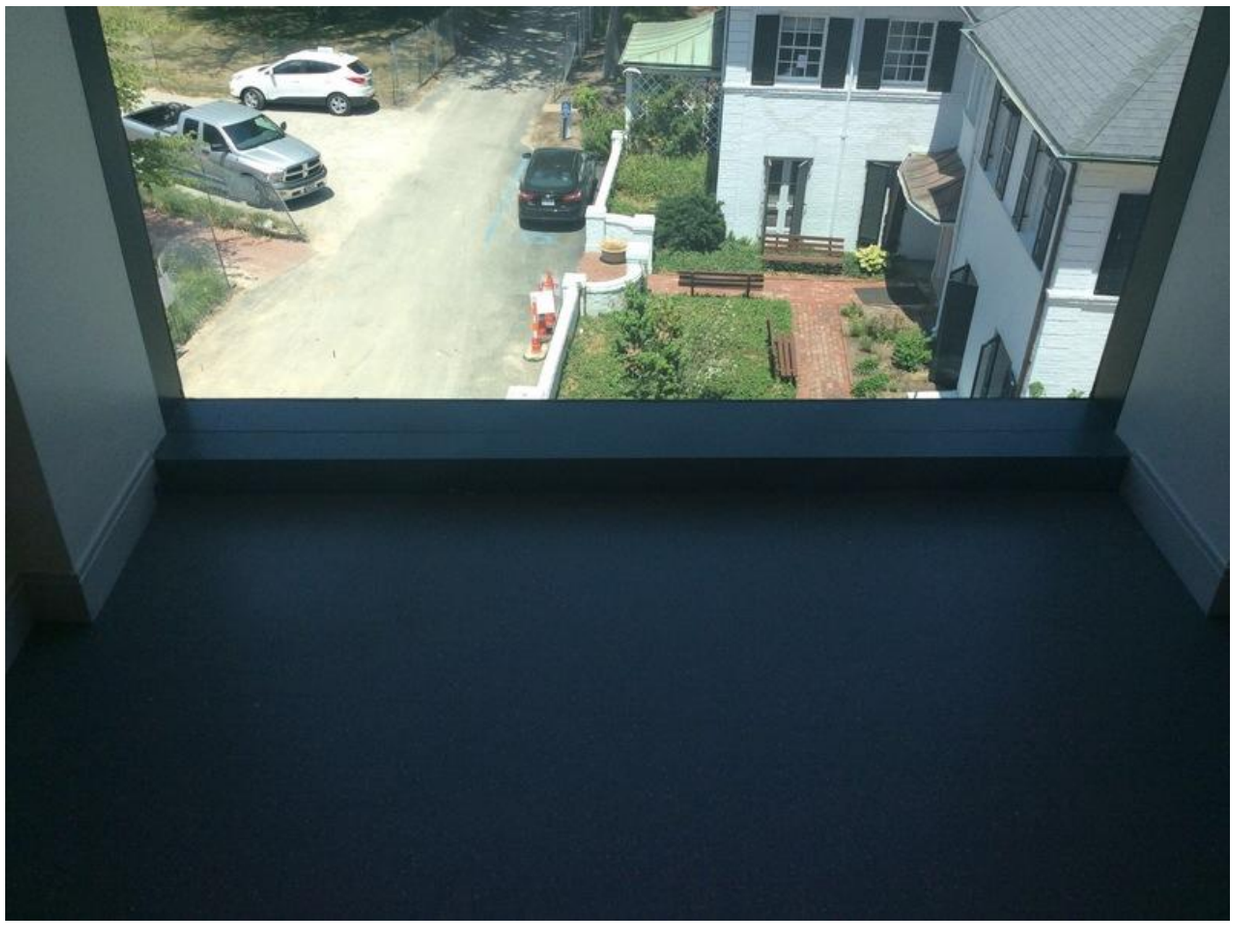
Issue ID	Description	Location Detail	Location	Status	Company	Type	Date Created	Due Date
000894	Seal at flooring to curtainwall at north punch window		Webster > LEVEL_04	Open	Flooring Systems, Inc.	Architect Punch List	12 Jul 2017	17 Jul 2017

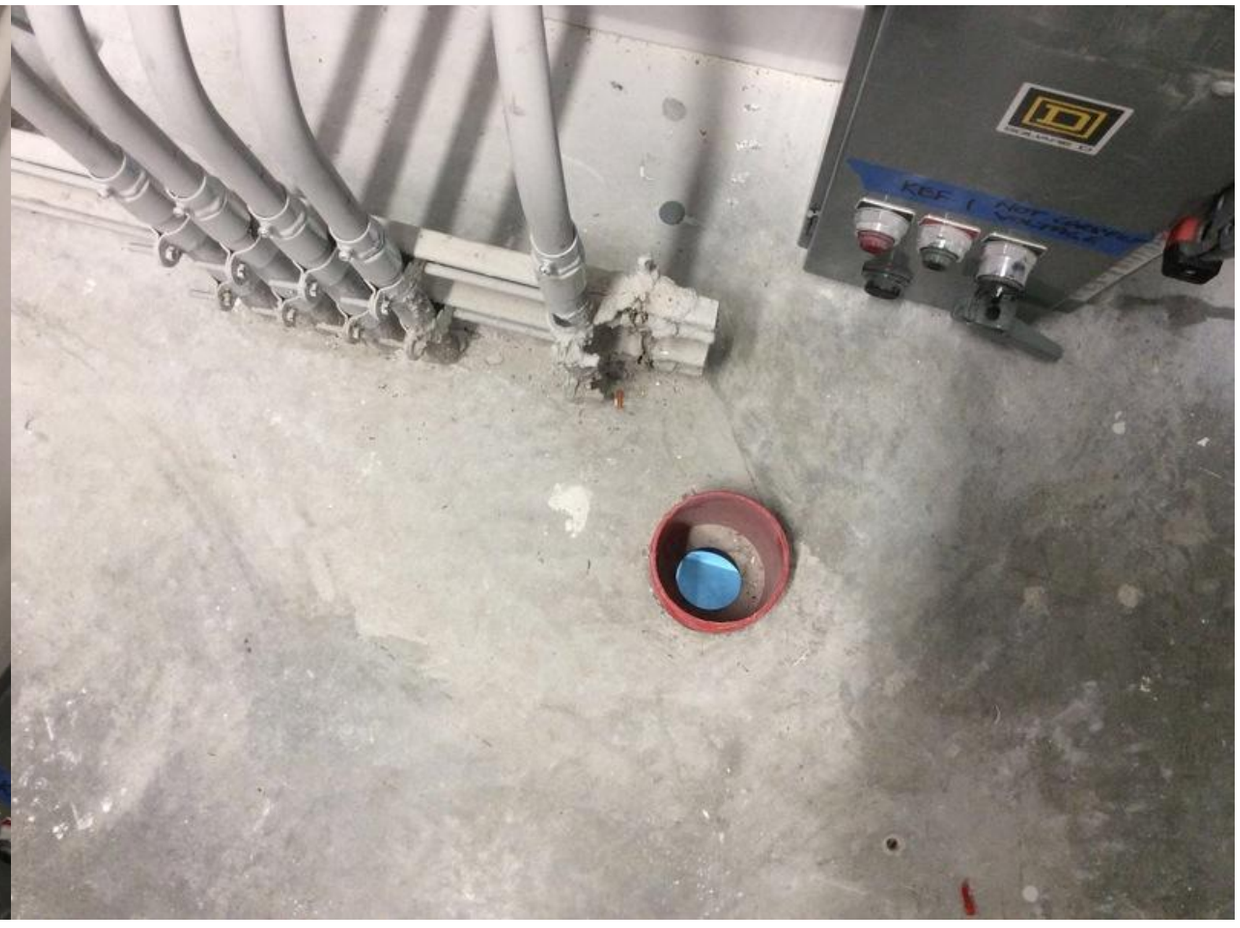
Issue ID	Description	Location Detail	Location	Status	Company	Type	Date Created	Due Date
000710	All penetrations to be fire caulked		Webster > LEVEL_04 > 410_ELEC	Open	Guarantee Electric	Architect Punch List	11 Jul 2017	16 Jul 2017

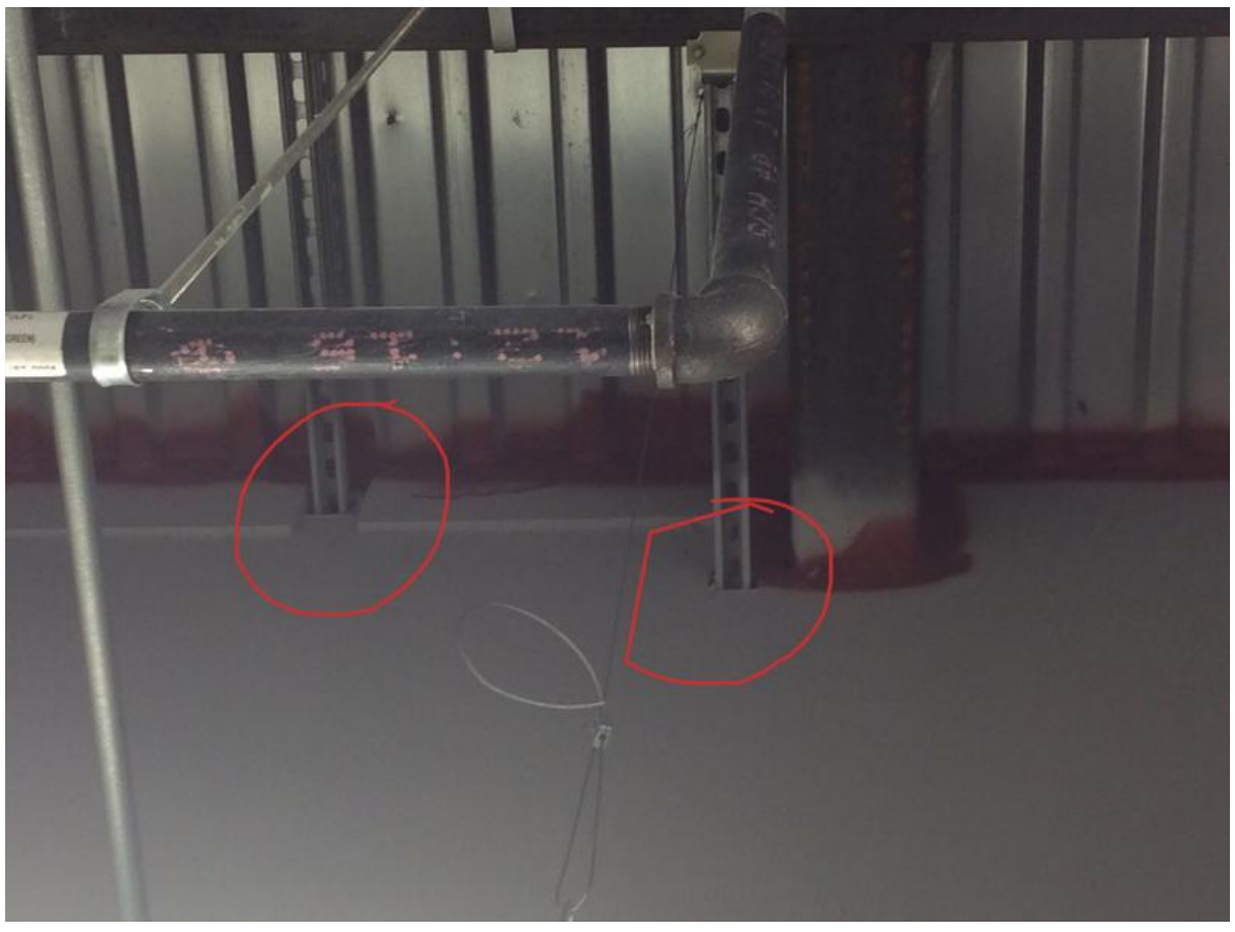
Issue ID	Description	Location Detail	Location	Status	Company	Type	Date Created	Due Date
000711	All penetrations to be fire caulked		Webster > LEVEL_04 > 410_ELEC	Open	ICON Mechanical	Architect Punch List	11 Jul 2017	16 Jul 2017

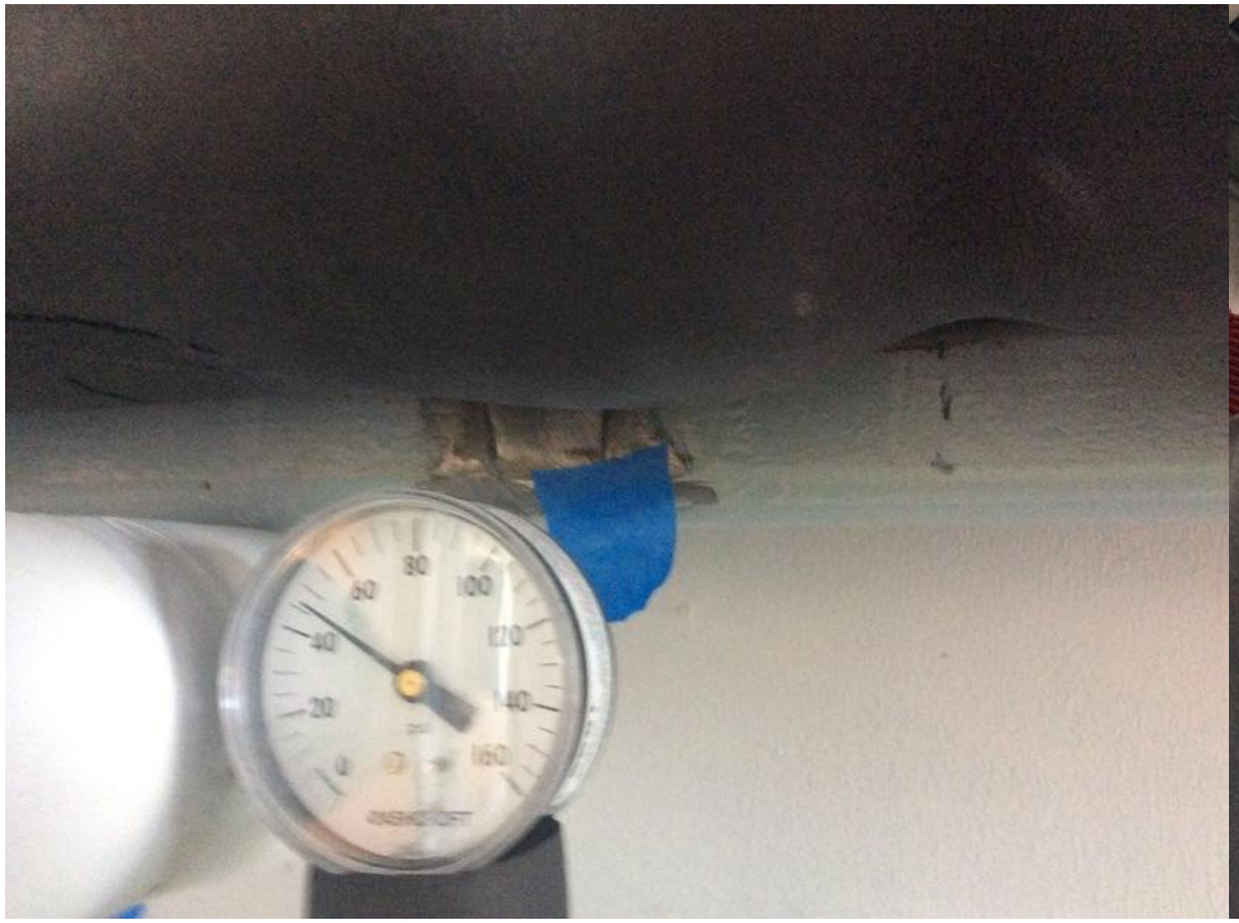
Issue ID	Description	Location Detail	Location	Status	Company	Type	Date Created	Due Date
000854	Mechanical supports need painted, marks should be removed		Webster > LEVEL_04 > 489_CHEM INSTR. LAB	Open	ICON Mechanical	Architect Punch List	12 Jul 2017	17 Jul 2017

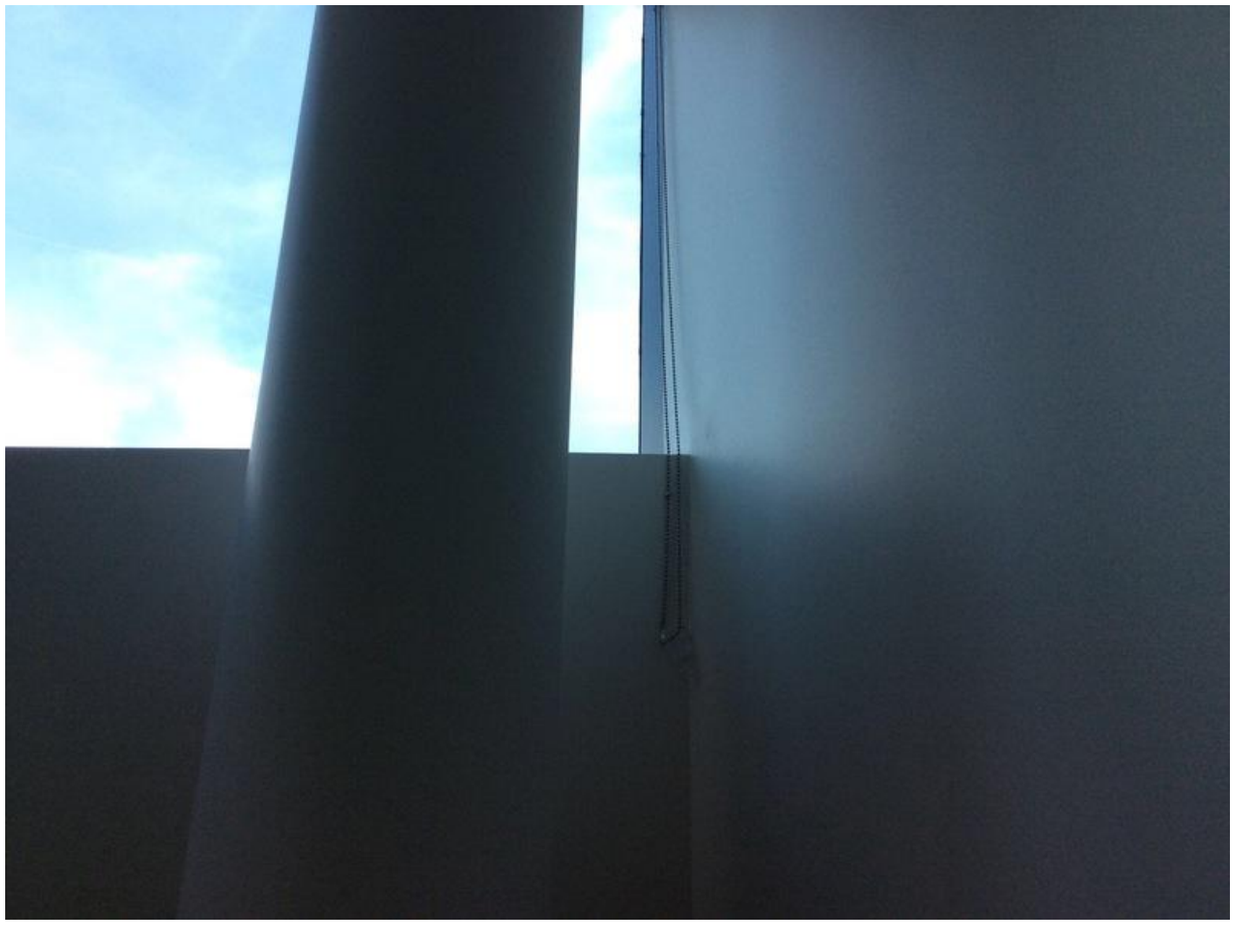
Issue ID	Description	Location Detail	Location	Status	Company	Type	Date Created	Due Date
000737	Chain to be shortened (interior investments)		Webster > LEVEL_04 > 417_OFF. IL	Open	Interior Investments	Architect Punch List	11 Jul 2017	16 Jul 2017

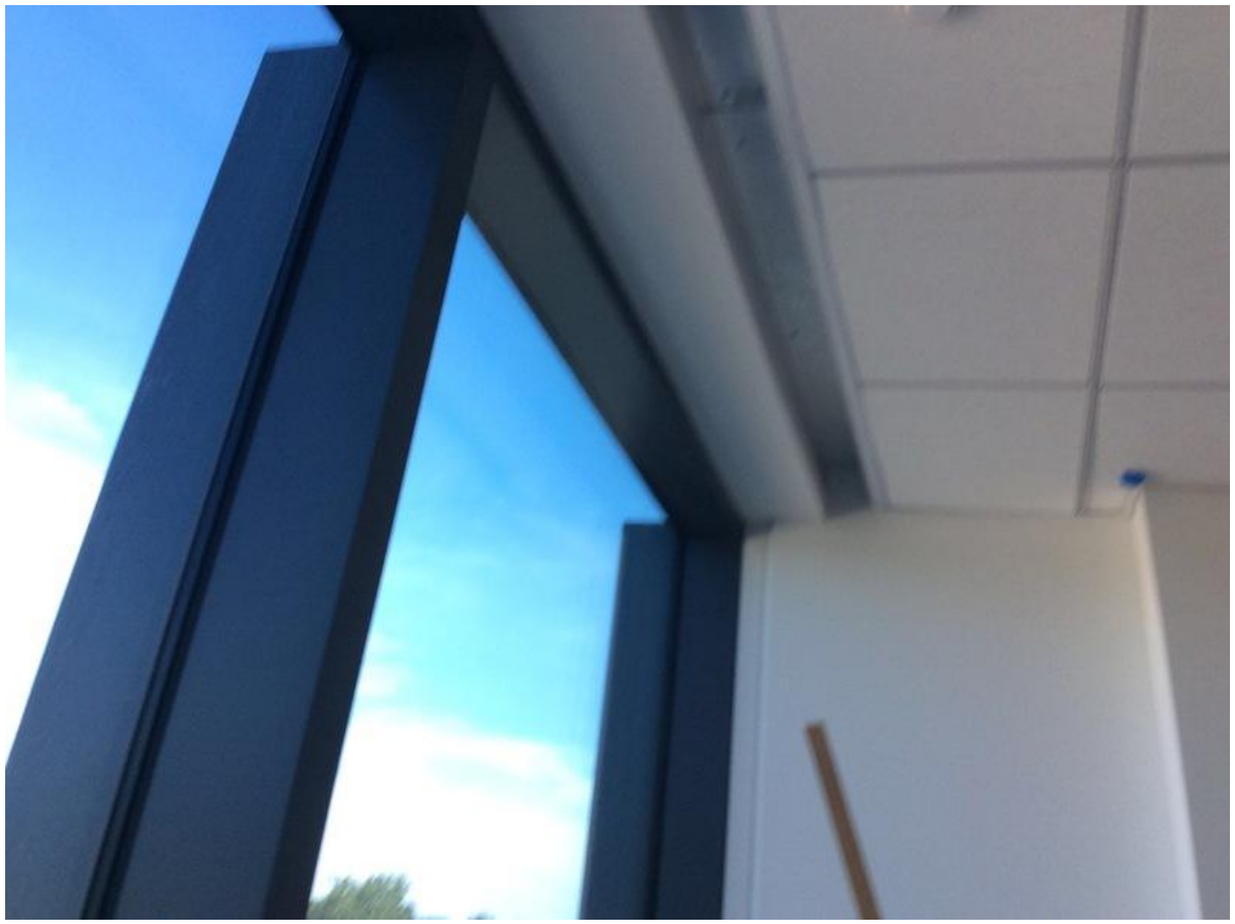
Issue ID	Description	Location Detail	Location	Status	Company	Type	Date Created	Due Date
000804	Shades needed		Webster > LEVEL_04 > 478_CHEM LAB PREP	Open	Interior Investments	Architect Punch List	11 Jul 2017	16 Jul 2017

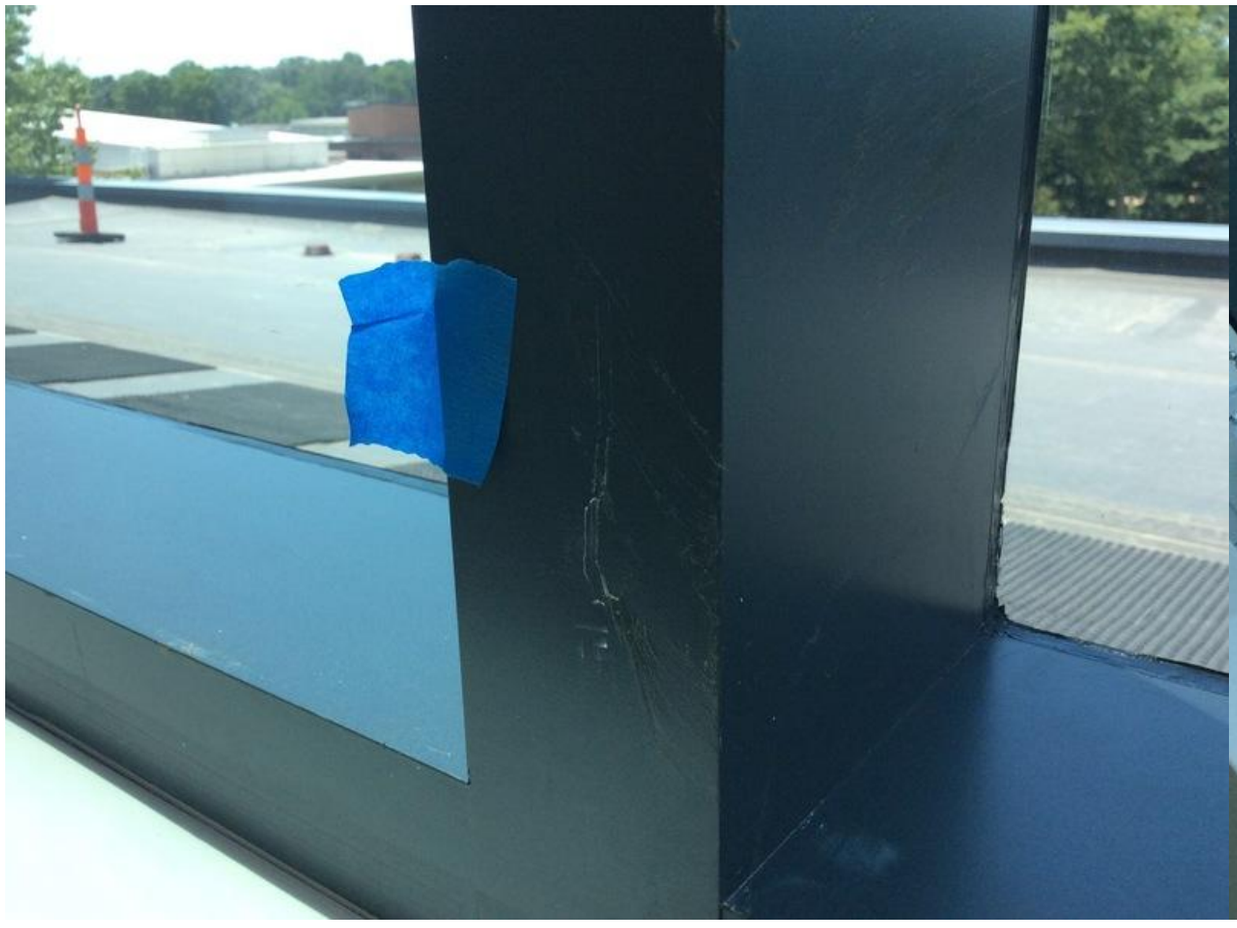
Issue ID	Description	Location Detail	Location	Status	Company	Type	Date Created	Due Date
000755	Remove roofing adhesive from curtainwall		Webster > LEVEL_04 > 435_OFF. IL	Open	Kirberg Company	Architect Punch List	11 Jul 2017	16 Jul 2017

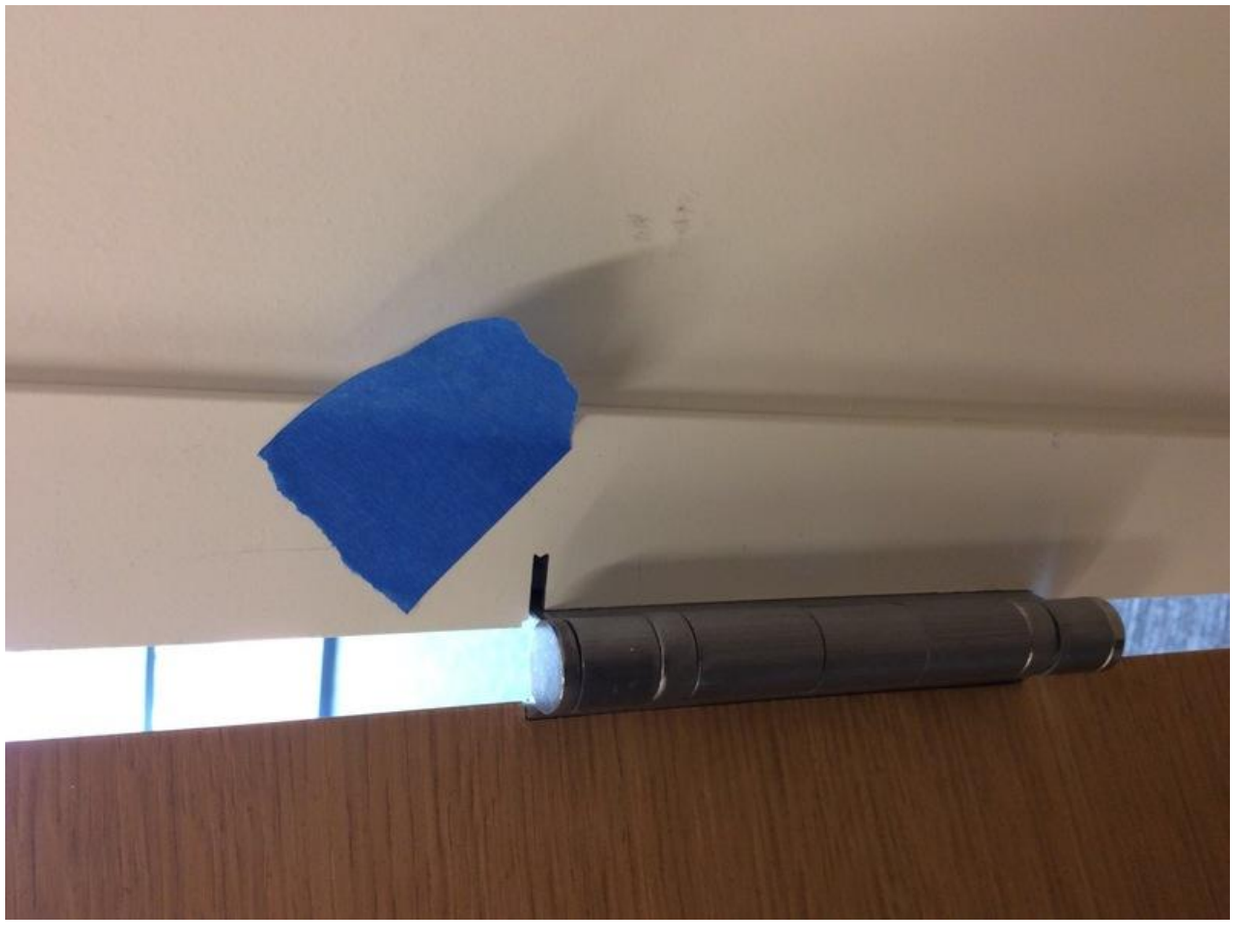
Issue ID	Description	Location Detail	Location	Status	Company	Type	Date Created	Due Date
000680	Aluminum frame over cut at hinge		Webster > LEVEL_04 > 404_OFF. FLX	Open	National Glass & Glazing, Inc.	Architect Punch List	11 Jul 2017	16 Jul 2017

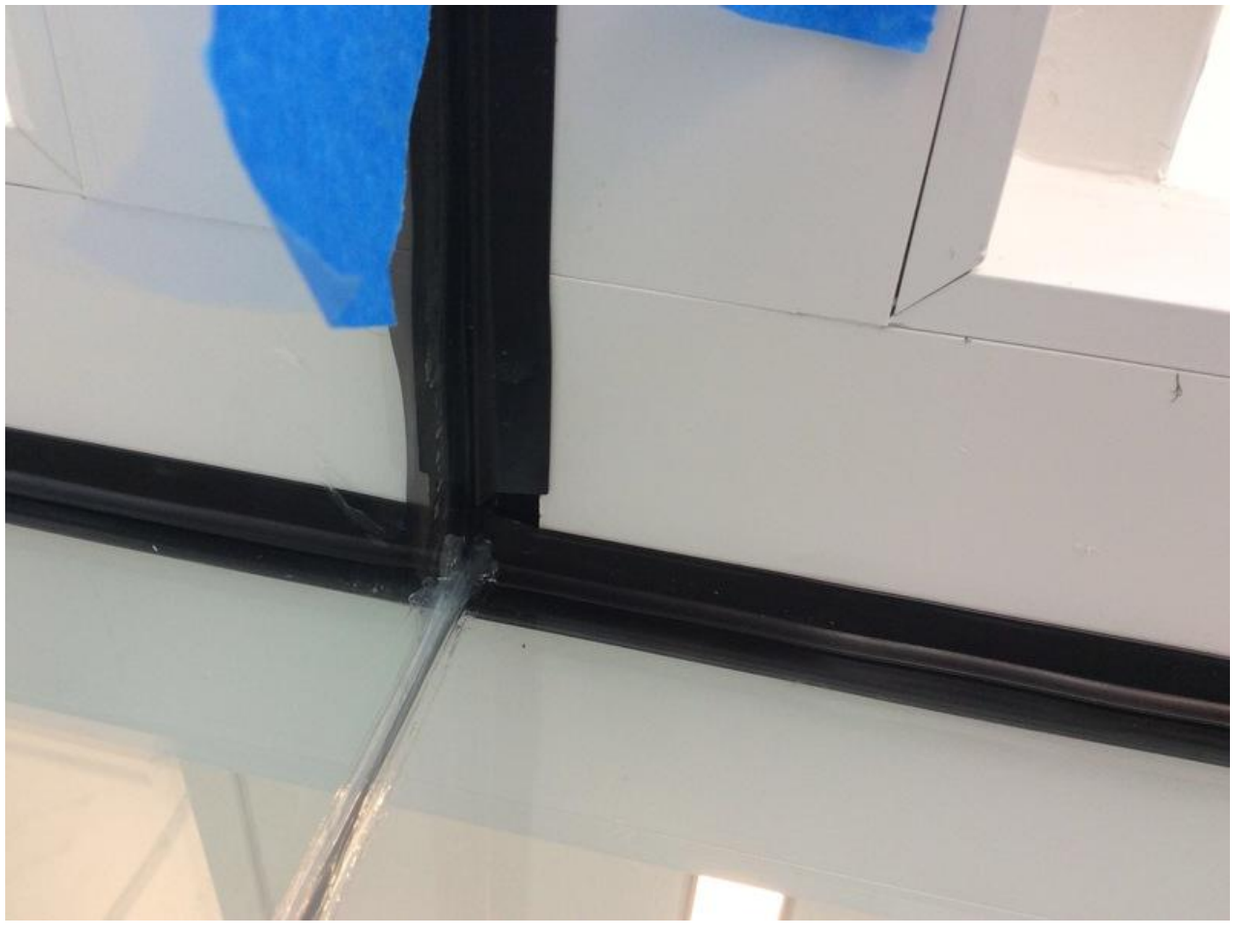
Issue ID	Description	Location Detail	Location	Status	Company	Type	Date Created	Due Date
000698	Gaskets at aluminum framing to be continuous with no holes (NGG to check all locations)		Webster > LEVEL_04 > 405_OFF. FLX	Open	National Glass & Glazing, Inc.	Architect Punch List	11 Jul 2017	16 Jul 2017

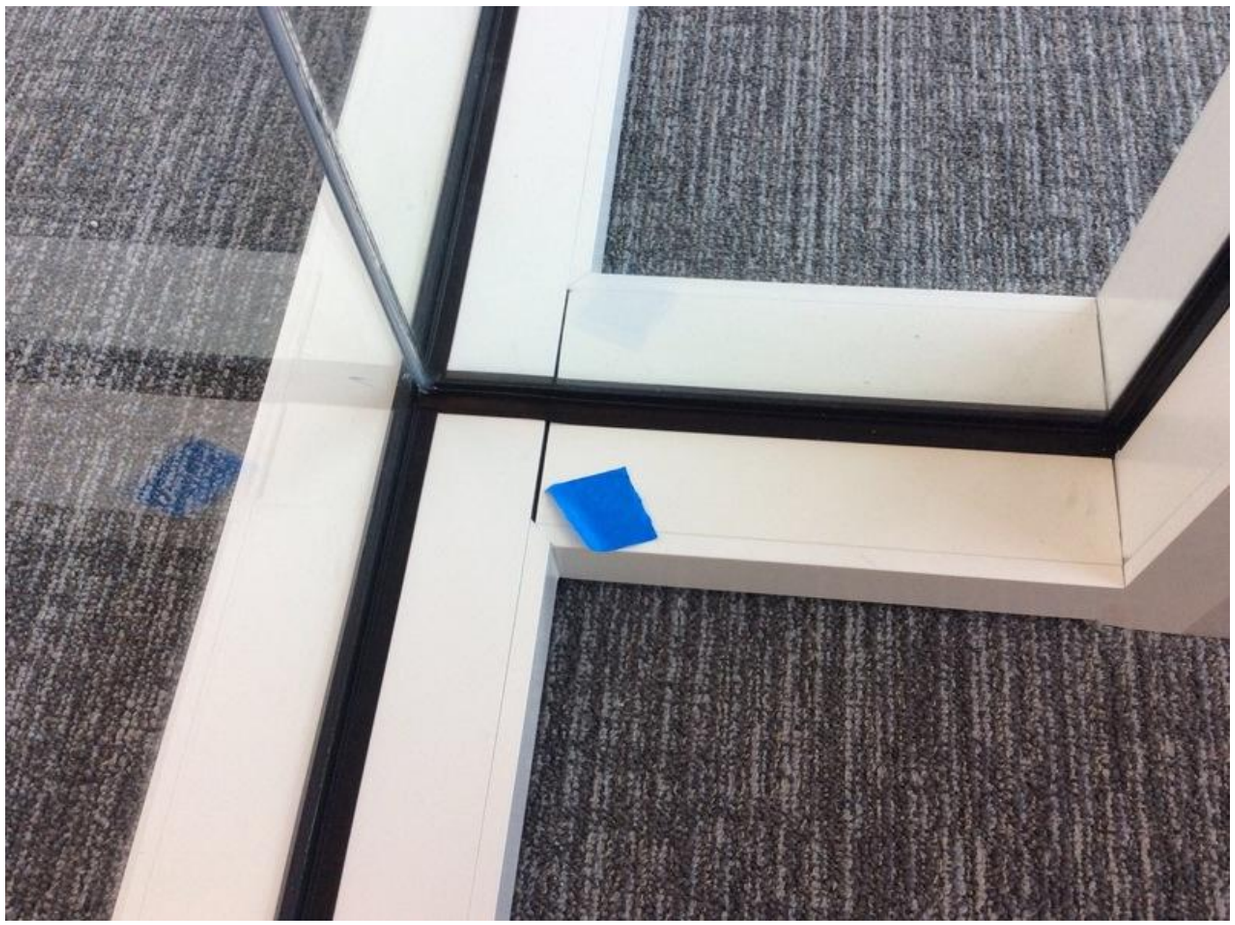
Issue ID	Description	Location Detail	Location	Status	Company	Type	Date Created	Due Date
000739	Adjust aluminum framing to make gaps smaller		Webster > LEVEL_04 > 417_OFF. IL	Open	National Glass & Glazing, Inc.	Architect Punch List	11 Jul 2017	16 Jul 2017

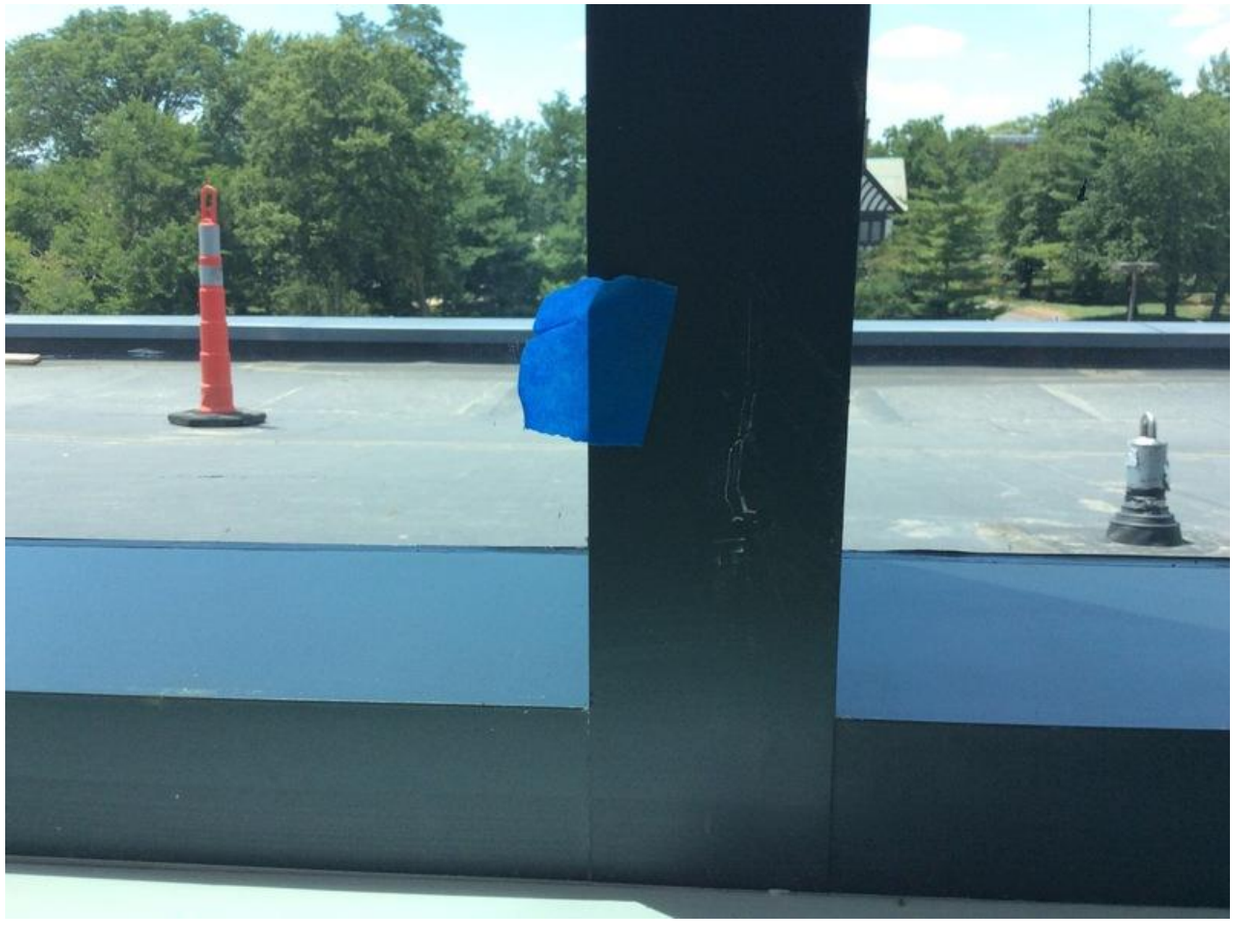
Issue ID	Description	Location Detail	Location	Status	Company	Type	Date Created	Due Date
000759	Touch up scratches at curtainwall		Webster > LEVEL_04 > 435_OFF. IL	Open	National Glass & Glazing, Inc.	Architect Punch List	11 Jul 2017	16 Jul 2017

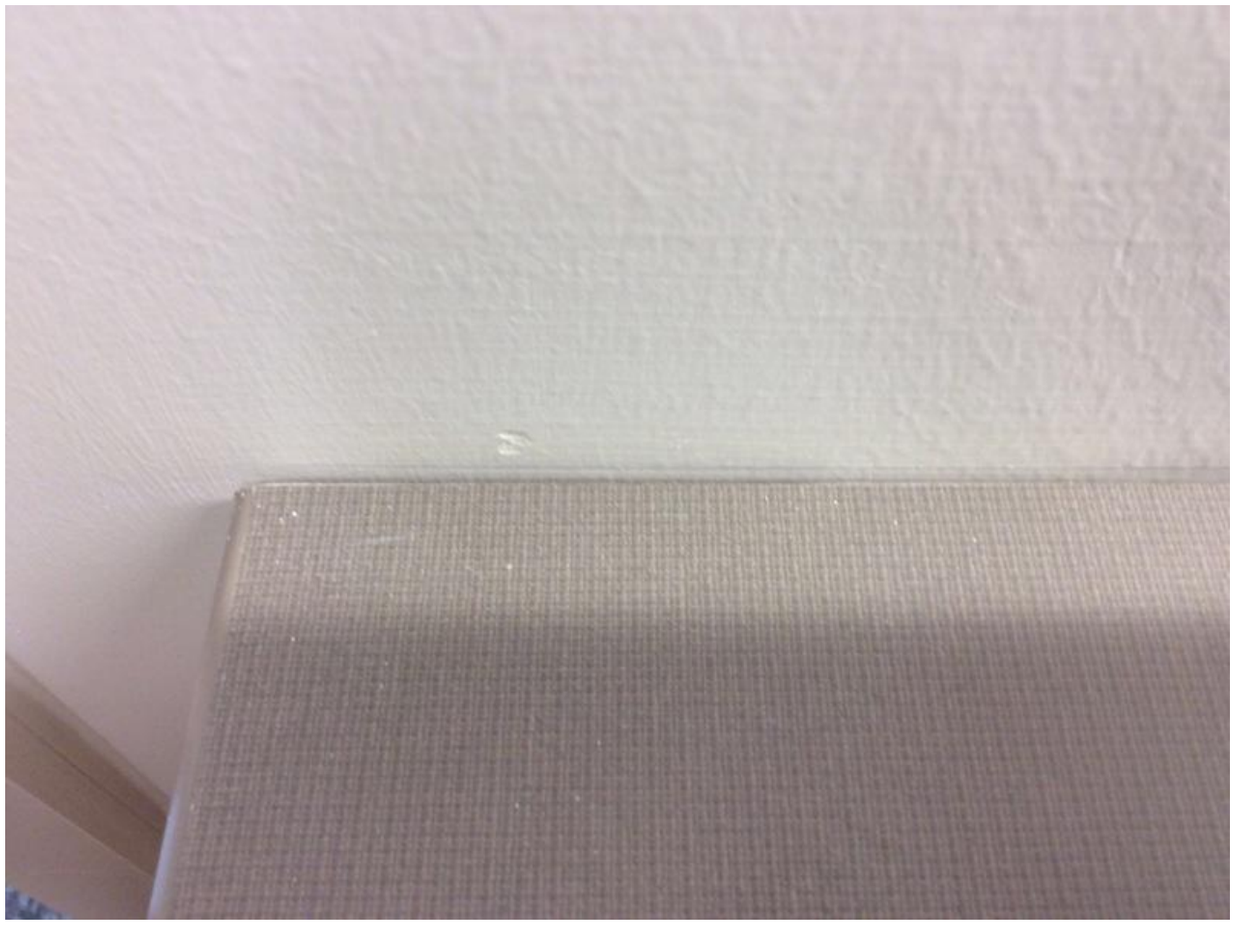
Issue ID	Description	Location Detail	Location	Status	Company	Type	Date Created	Due Date
000662	Install sealant at back of west countertop		Webster > LEVEL_04 > 400A_WORK / COPY	Open	PARIC (Self-Perform)	Architect Punch List	11 Jul 2017	16 Jul 2017

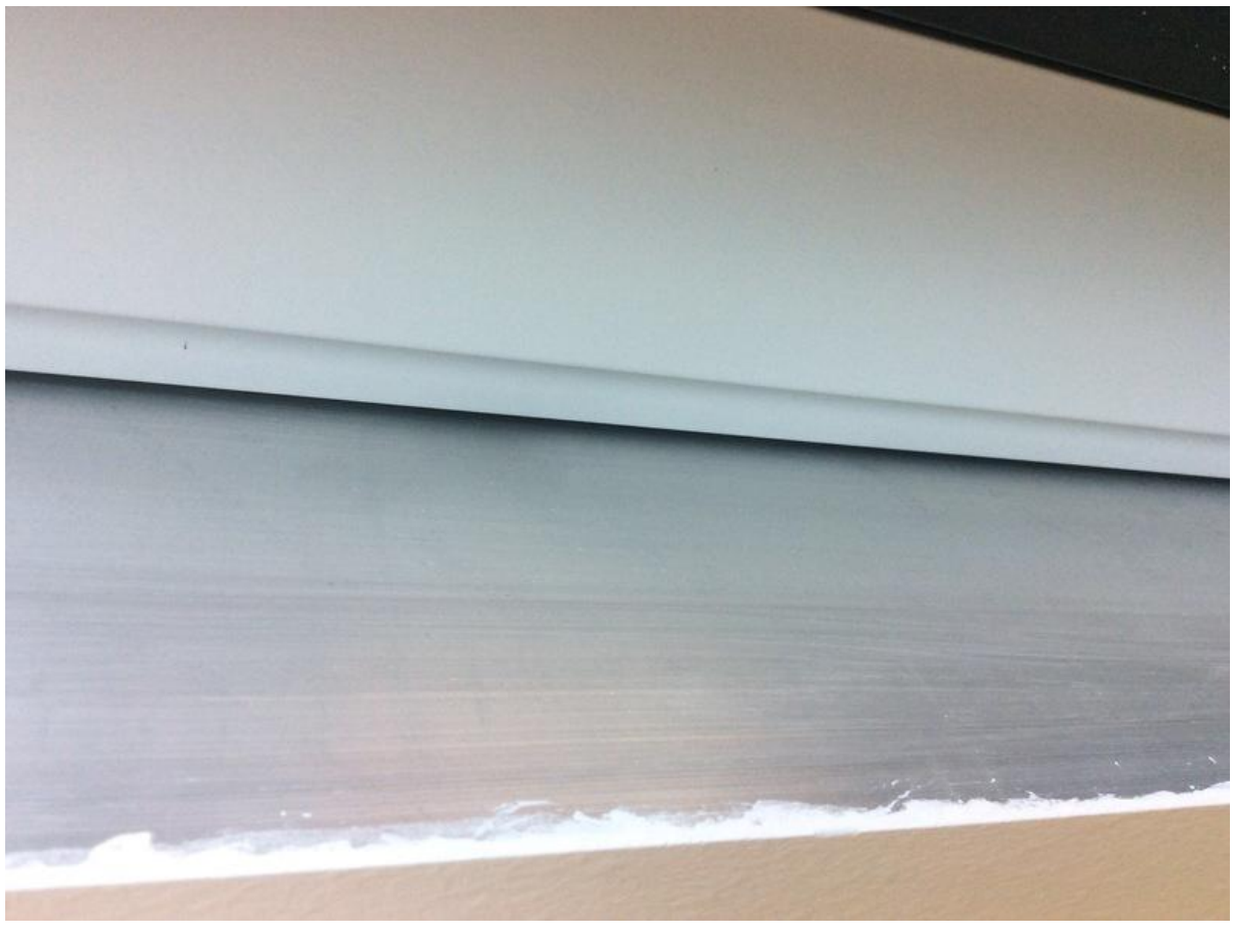
Issue ID	Description	Location Detail	Location	Status	Company	Type	Date Created	Due Date
000674	Seal both sides of mullion mate at end cap. Typical all locations		Webster > LEVEL_04 > 401_OFF. ADJ (4)	Open	PARIC (Self-Perform)	Architect Punch List	11 Jul 2017	16 Jul 2017
