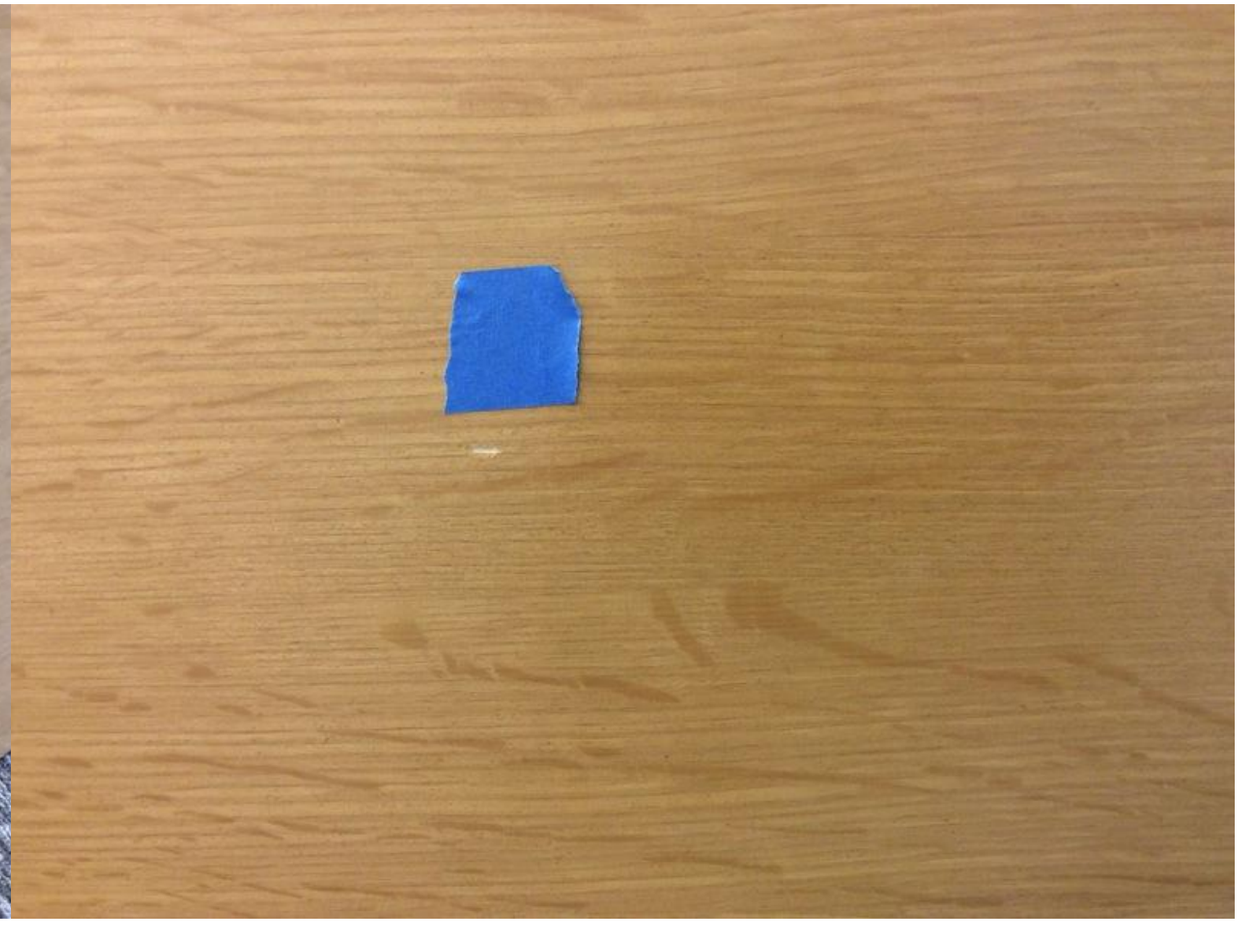
Issue ID	Description	Location Detail	Location	Status	Company	Type	Date Created	Due Date
000724	Chips on door		Webster > LEVEL_04 > 412_TESTING	Open	PARIC (Self-Perform)	Architect Punch List	11 Jul 2017	16 Jul 2017

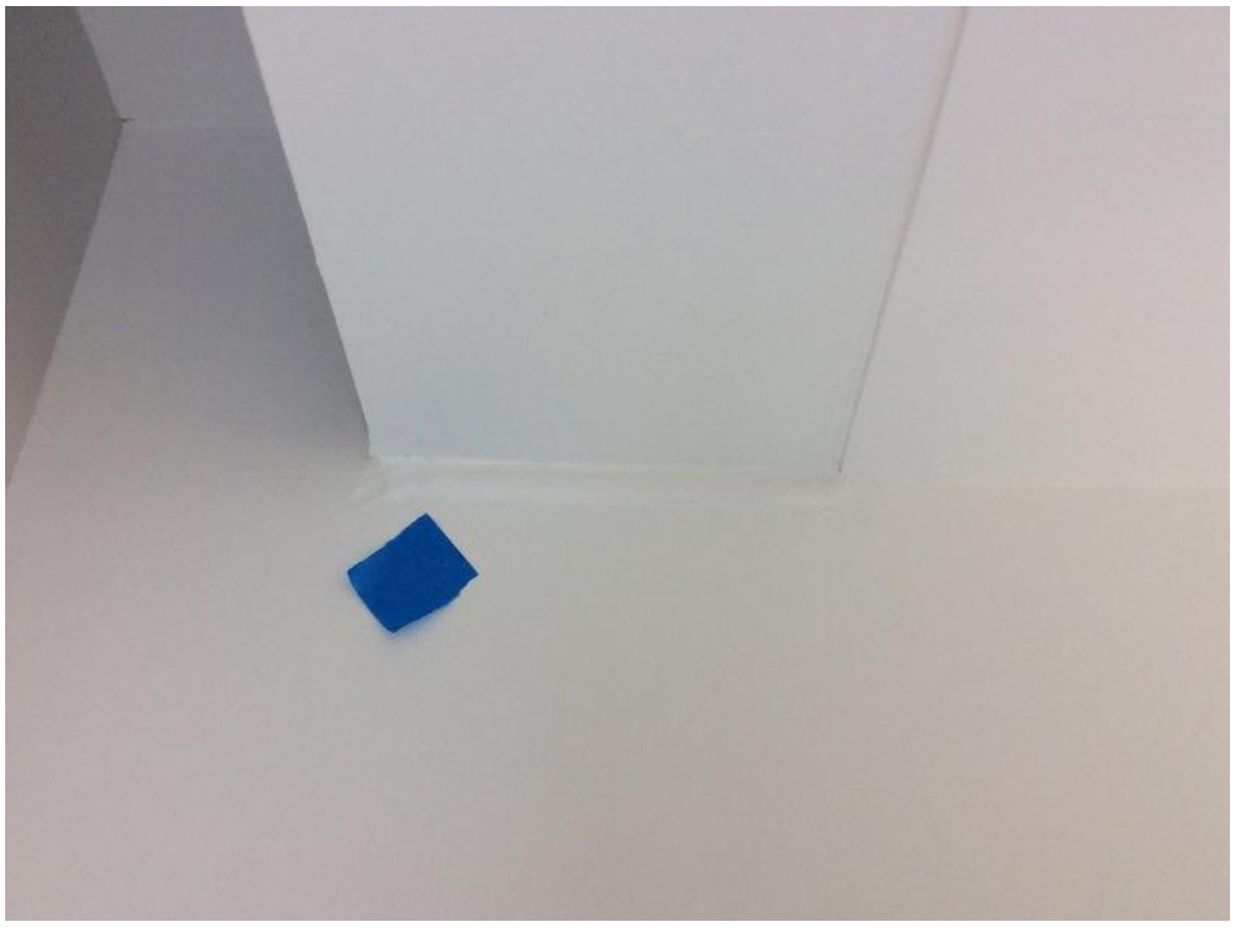
Issue ID	Description	Location Detail	Location	Status	Company	Type	Date Created	Due Date
000765	Fix caulking (backer rod bulging out)		Webster > LEVEL_04 > 452_OFF. TA	Open	PARIC (Self-Perform)	Architect Punch List	11 Jul 2017	16 Jul 2017

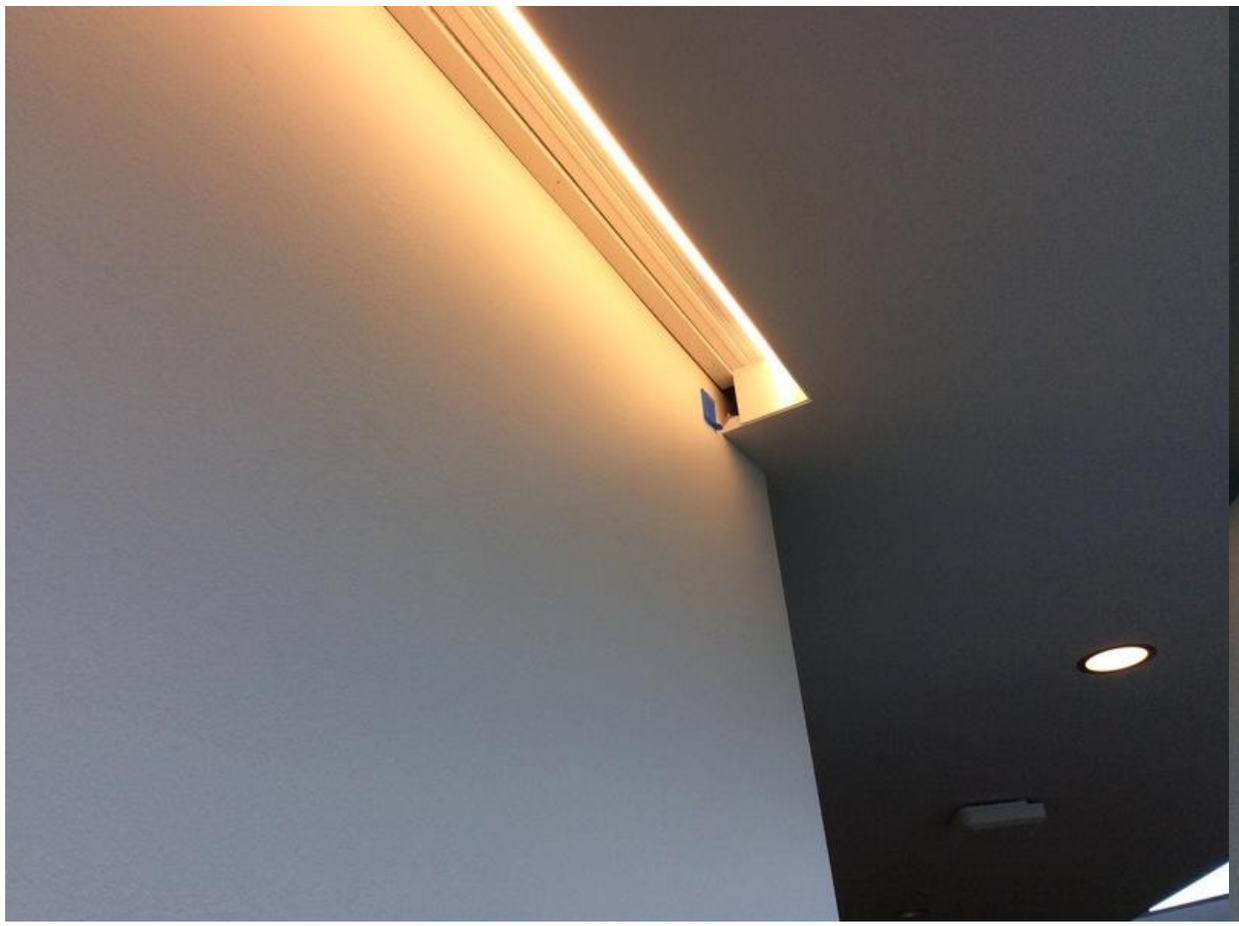
Issue ID	Description	Location Detail	Location	Status	Company	Type	Date Created	Due Date
000775	Fill holes at end of light cove in southwest corridor and finish edges of drywall (possibly use trim)		Webster > LEVEL_04	Open	PARIC (Self-Perform)	Architect Punch List	11 Jul 2017	16 Jul 2017

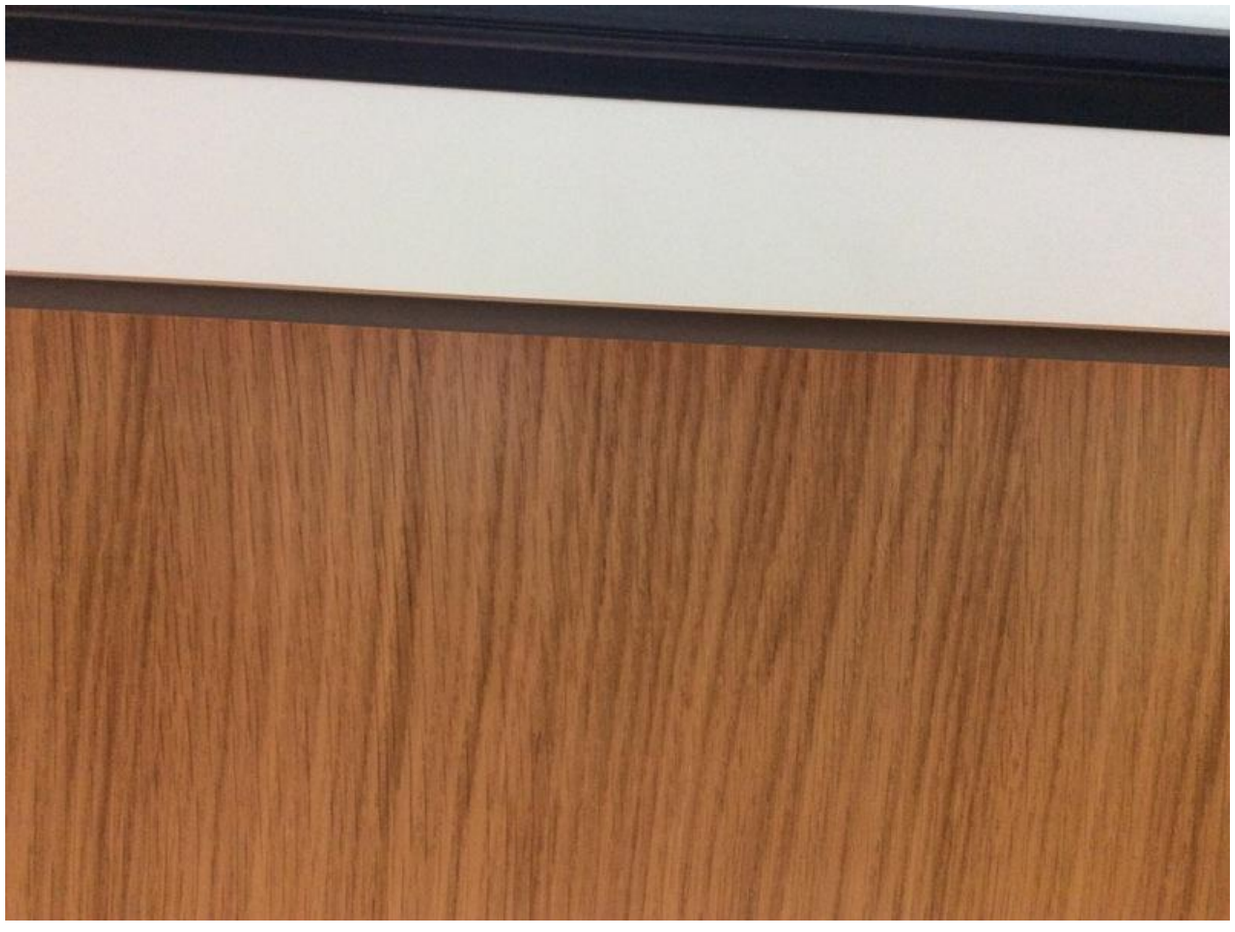
Issue ID	Description	Location Detail	Location	Status	Company	Type	Date Created	Due Date
000784	Seal between wood panels and aluminum frames (typical at all locations)		Webster > LEVEL_04 > 472_CHEM LAB - GENERAL	Open	PARIC (Self-Perform)	Architect Punch List	11 Jul 2017	16 Jul 2017

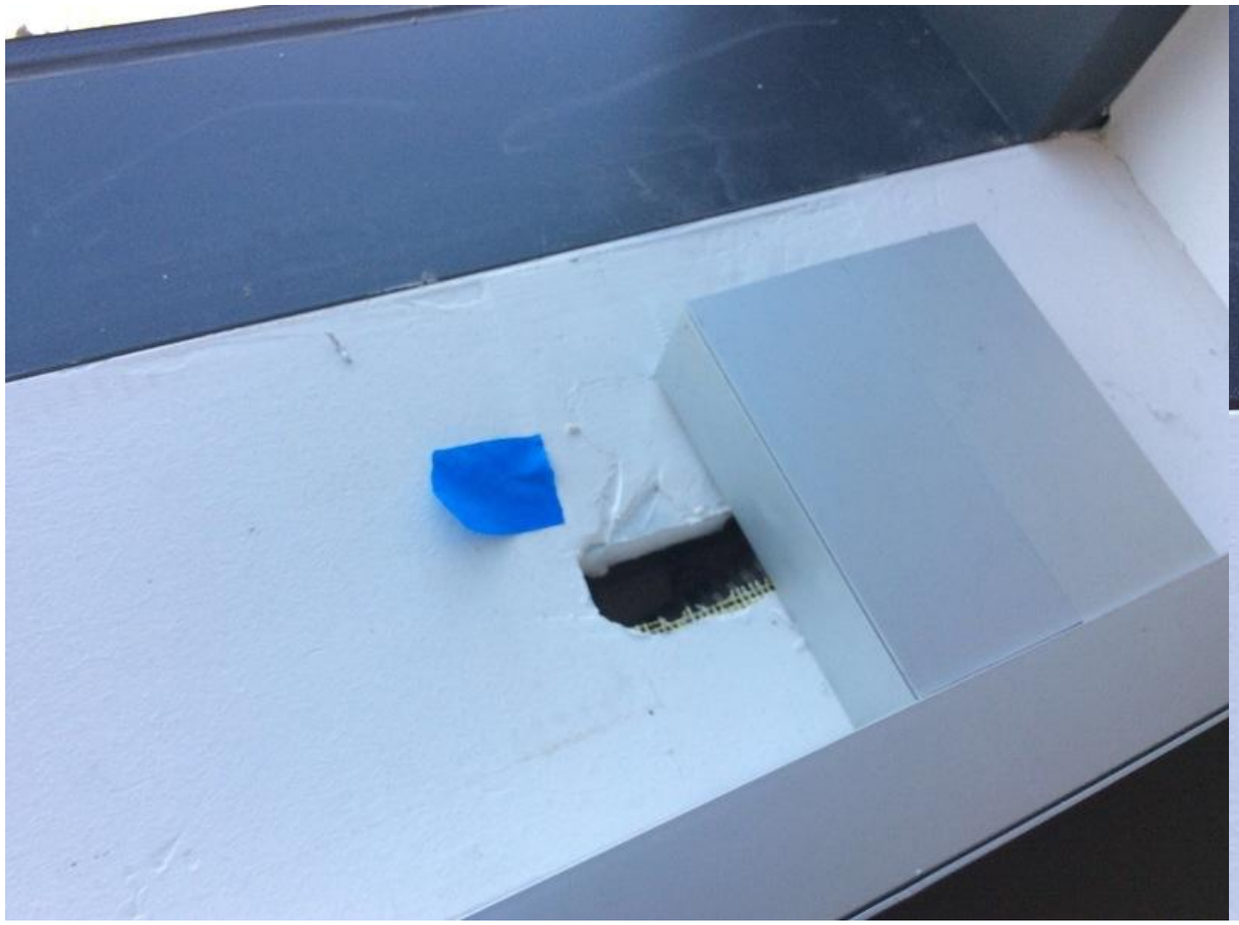
Issue ID	Description	Location Detail	Location	Status	Company	Type	Date Created	Due Date
000791	Drywall repairs needed throughout room		Webster > LEVEL_04 > 472_CHEM LAB - GENERAL	Open	PARIC (Self-Perform)	Architect Punch List	11 Jul 2017	16 Jul 2017

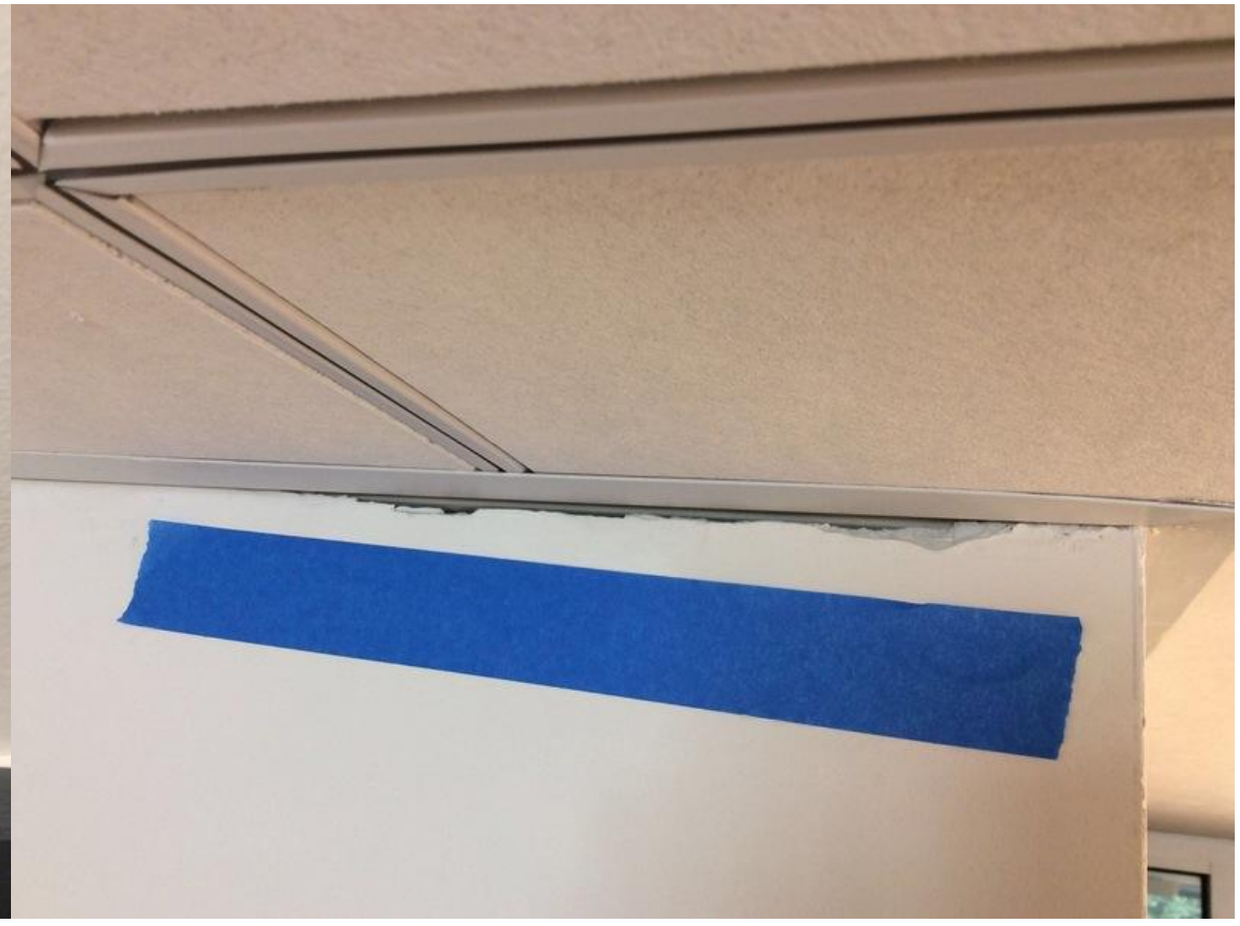
Issue ID	Description	Location Detail	Location	Status	Company	Type	Date Created	Due Date
000801	Drywall needs touched up		Webster > LEVEL_04 > 478_CHEM LAB PREP	Open	PARIC (Self-Perform)	Architect Punch List	11 Jul 2017	16 Jul 2017

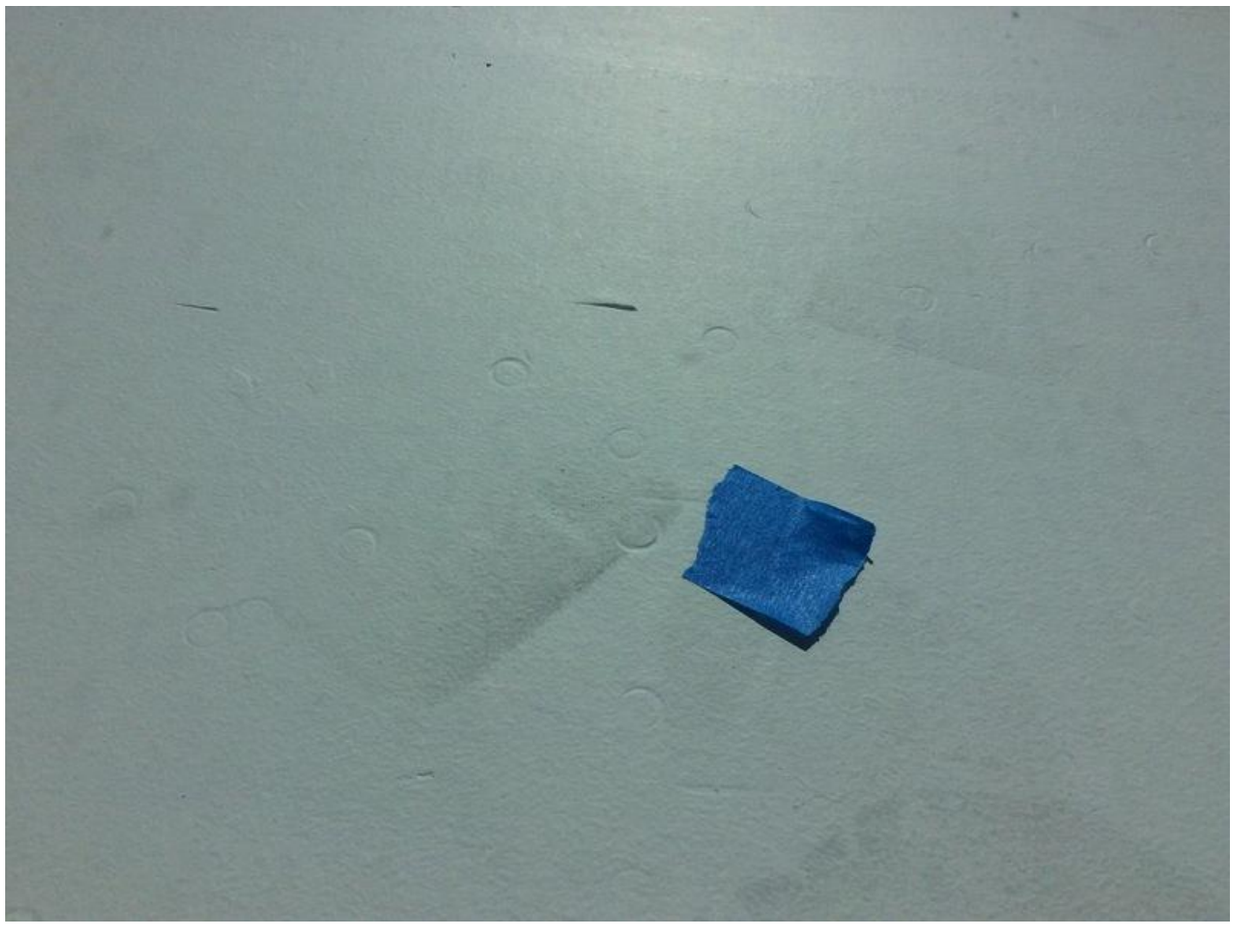
Issue ID	Description	Location Detail	Location	Status	Company	Type	Date Created	Due Date
000828	Touch up drywall on window ledge		Webster > LEVEL_04 > 488_CHEM LAB - ANALYT / INORGANIC	Open	PARIC (Self-Perform)	Architect Punch List	12 Jul 2017	17 Jul 2017

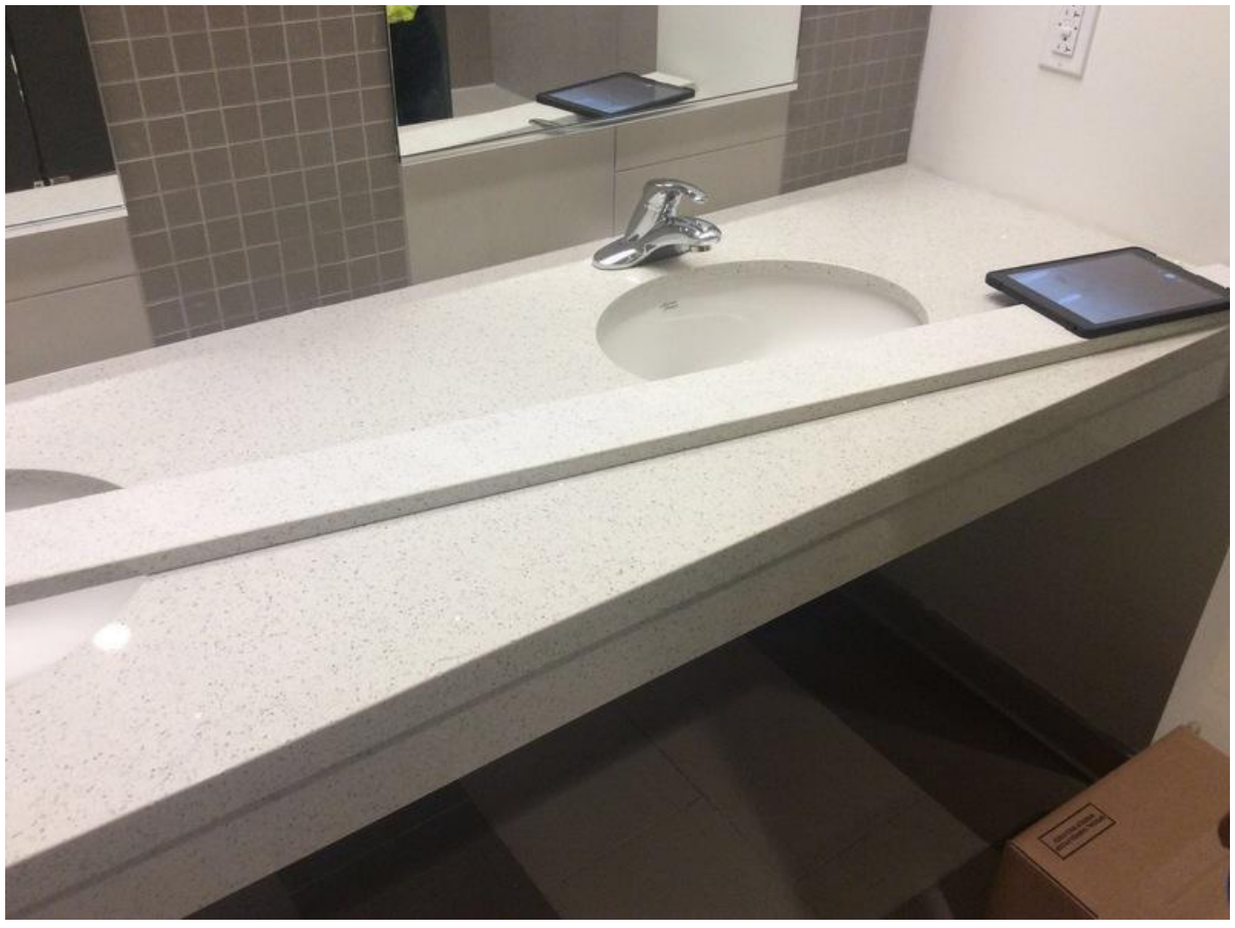
Issue ID	Description	Location Detail	Location	Status	Company	Type	Date Created	Due Date
000878	Install backsplash		Webster > LEVEL_04 > 477_WOMEN	Open	PARIC (Self-Perform)	Architect Punch List	12 Jul 2017	17 Jul 2017

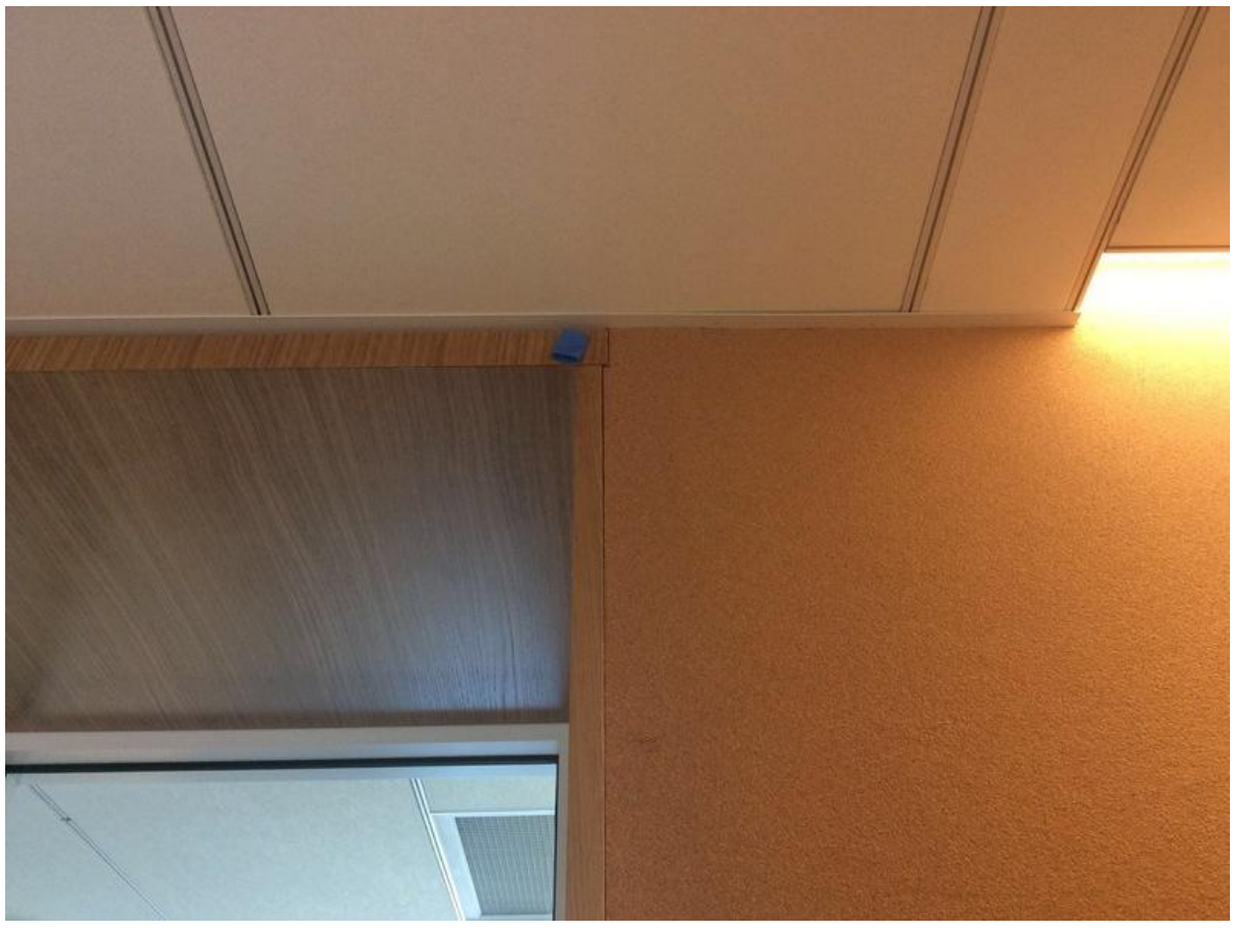
Issue ID	Description	Location Detail	Location	Status	Company	Type	Date Created	Due Date
000889	Vertical edge of paneling should line up with edge of horizontal paneling.		Webster > LEVEL_04	Open	PARIC (Self-Perform)	Architect Punch List	12 Jul 2017	17 Jul 2017

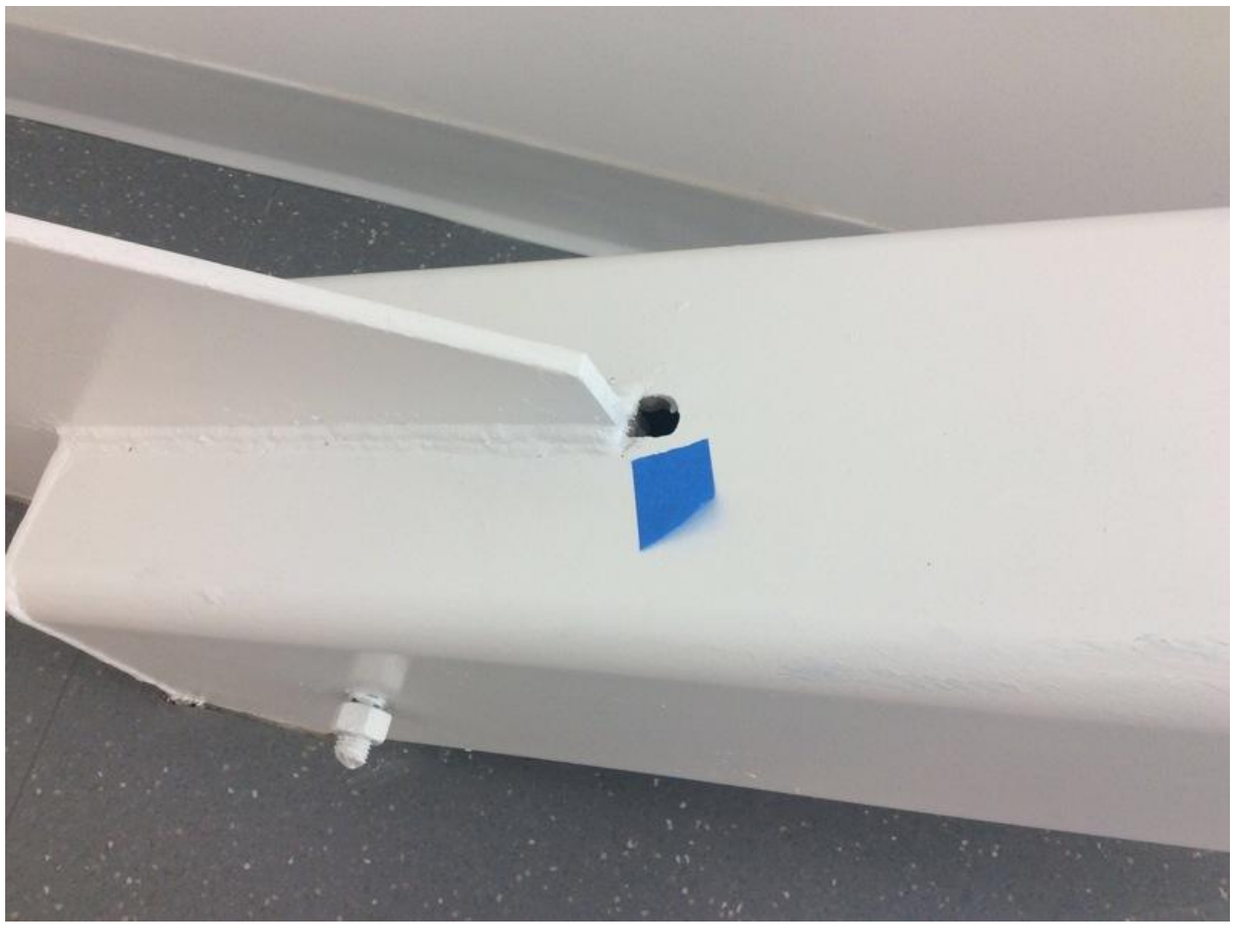
Issue ID	Description	Location Detail	Location	Status	Company	Type	Date Created	Due Date
000821	Fill hole in steel - scope?		Webster > LEVEL_04 > 488_CHEM LAB - ANALYT / INORGANIC	Open	Paric Corp.	Architect Punch List	12 Jul 2017	17 Jul 2017

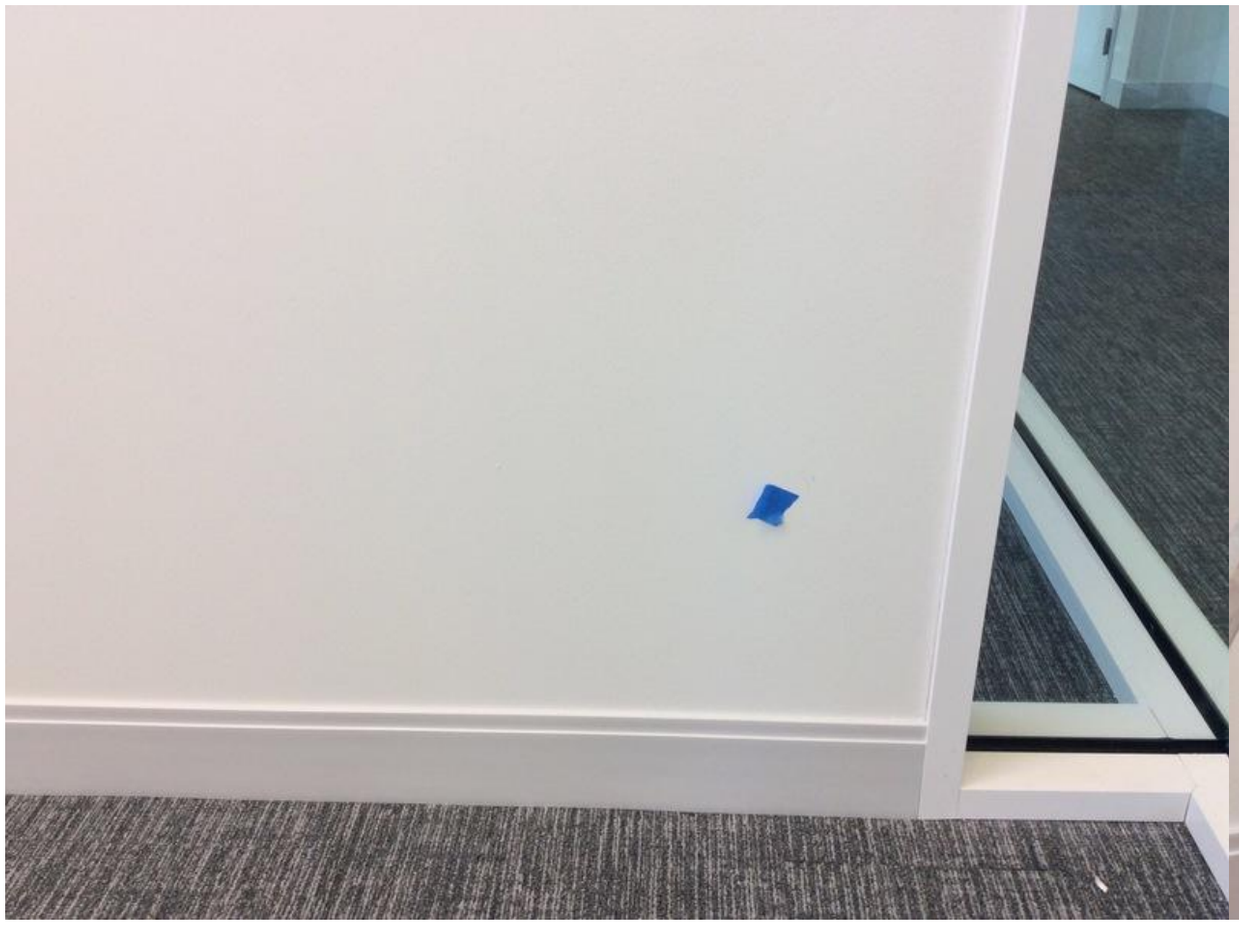
Issue ID	Description	Location Detail	Location	Status	Company	Type	Date Created	Due Date
000733	Paint to be touched up		Webster > LEVEL_04 > 415_OFF. IL	Open	Spectra Painting	Architect Punch List	11 Jul 2017	16 Jul 2017

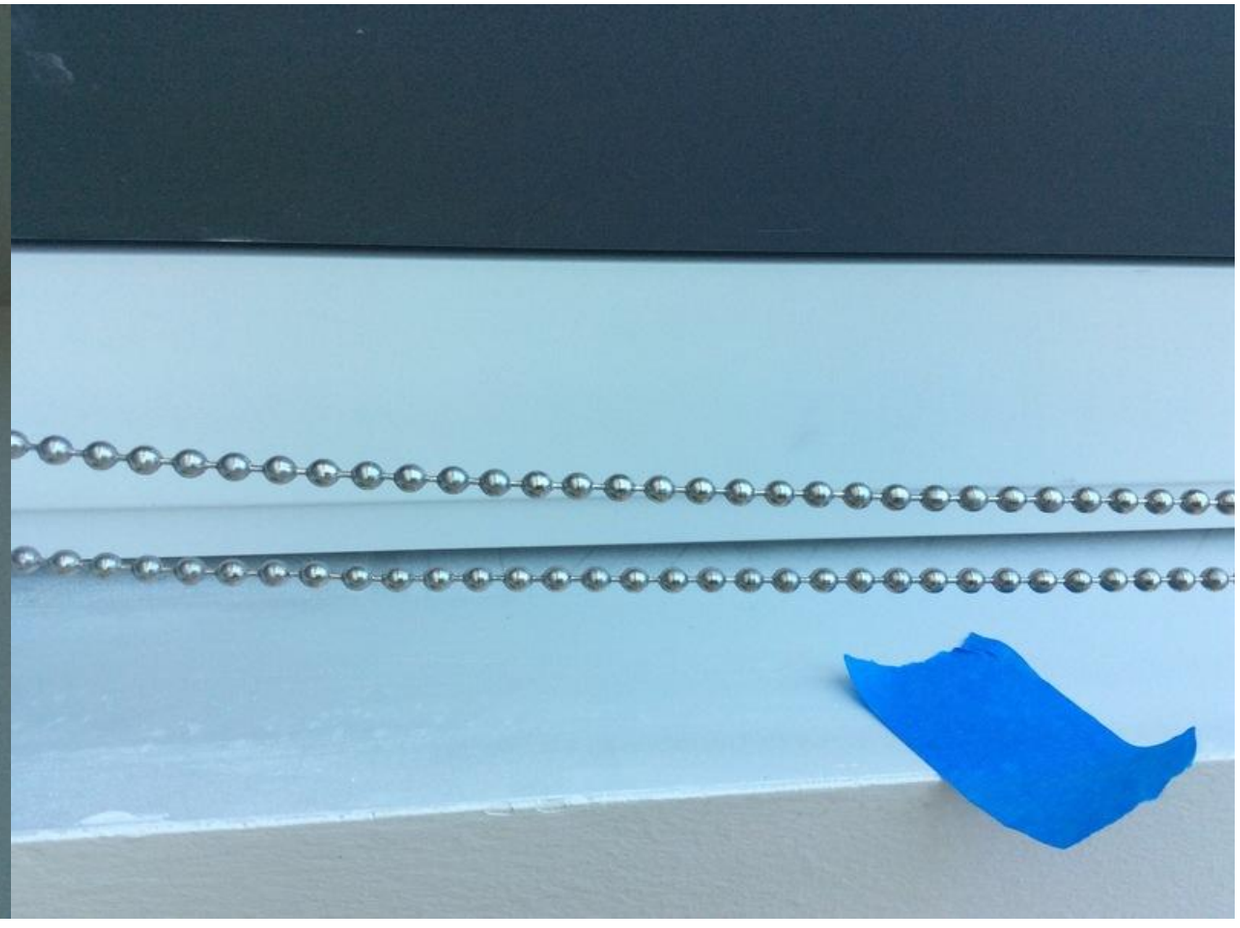
Issue ID	Description	Location Detail	Location	Status	Company	Type	Date Created	Due Date
000744	Touch up paint, paint end caps		Webster > LEVEL_04 > 431_OFF. FUT	Open	Spectra Painting	Architect Punch List	11 Jul 2017	16 Jul 2017

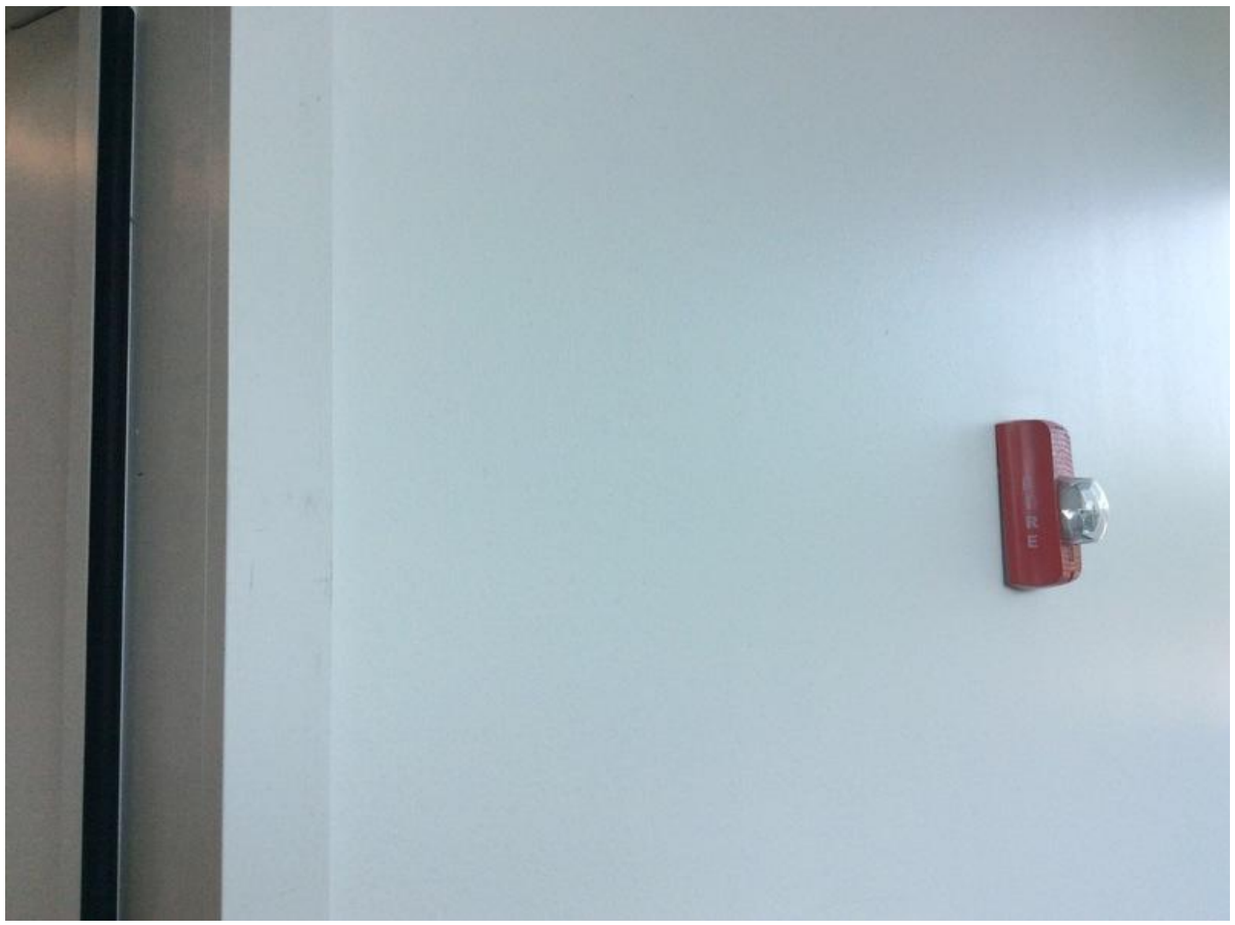
Issue ID	Description	Location Detail	Location	Status	Company	Type	Date Created	Due Date
000745	Touch up "fuzz" in paint		Webster > LEVEL_04 > 419_TRANSLATION	Open	Spectra Painting	Architect Punch List	11 Jul 2017	16 Jul 2017

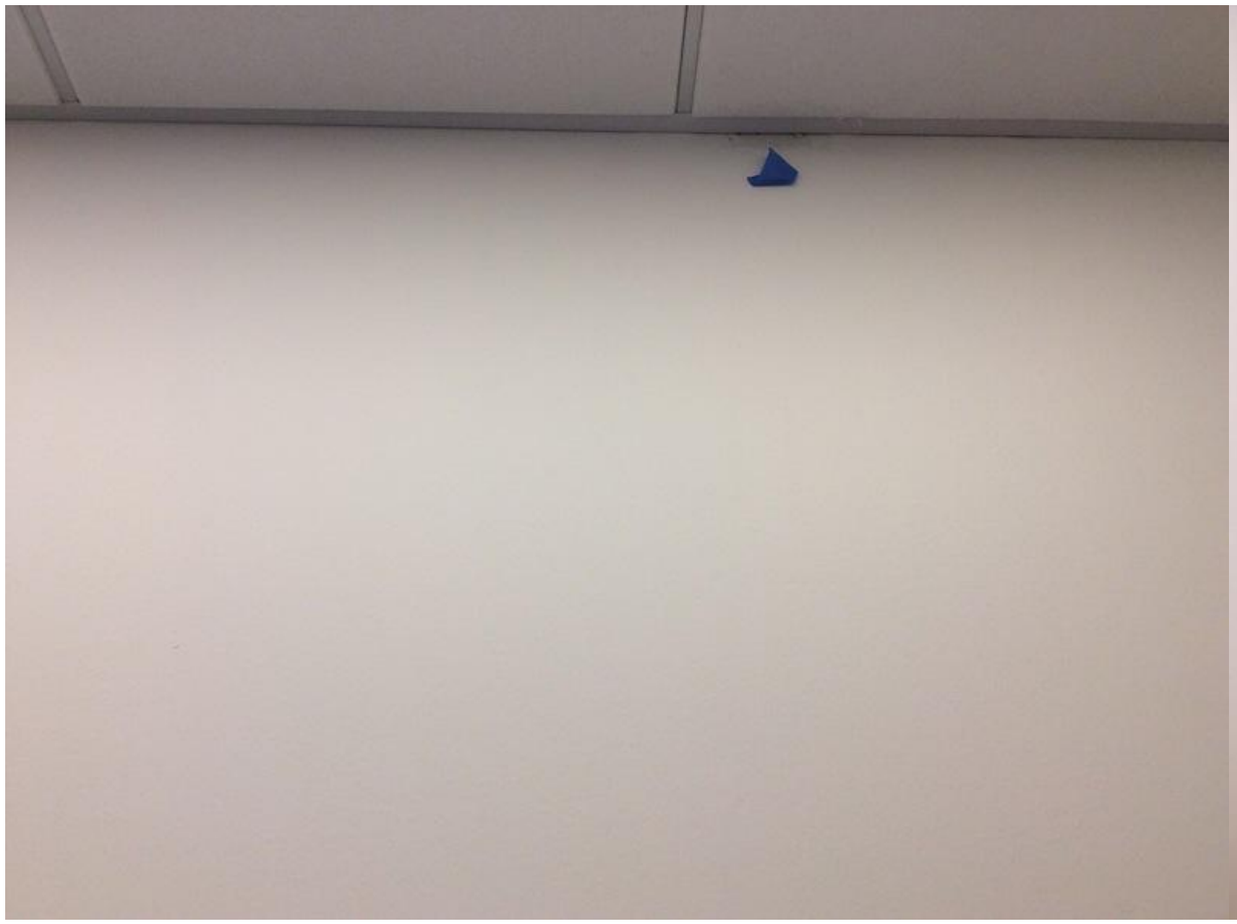
Issue ID	Description	Location Detail	Location	Status	Company	Type	Date Created	Due Date
000747	Touch up paint		Webster > LEVEL_04 > 432_OFF. ADJ. (3)	Open	Spectra Painting	Architect Punch List	11 Jul 2017	16 Jul 2017

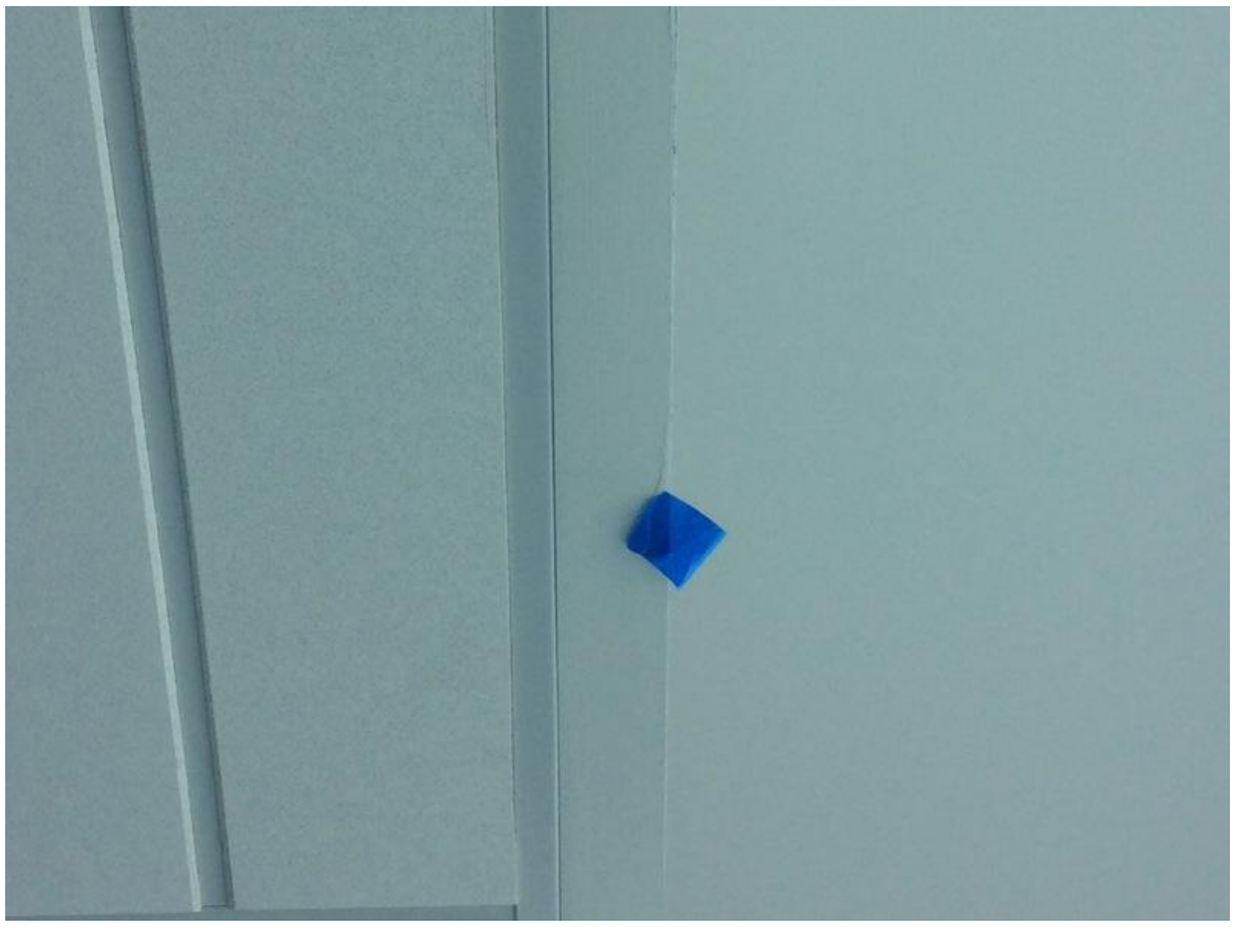
Issue ID	Description	Location Detail	Location	Status	Company	Type	Date Created	Due Date
000752	Touch up paint at soffit trim		Webster > LEVEL_04 > 435_OFF. IL	Open	Spectra Painting	Architect Punch List	11 Jul 2017	16 Jul 2017

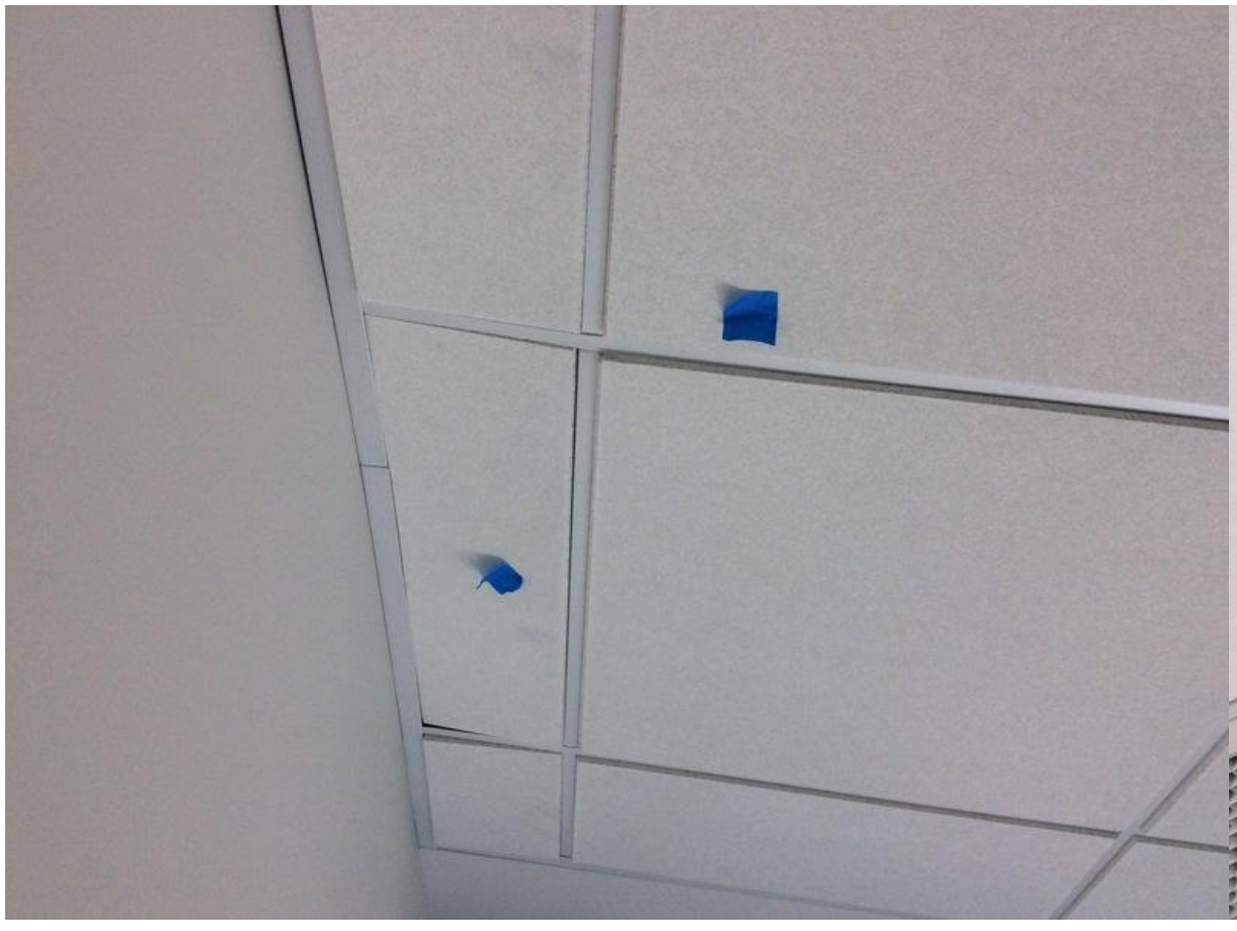
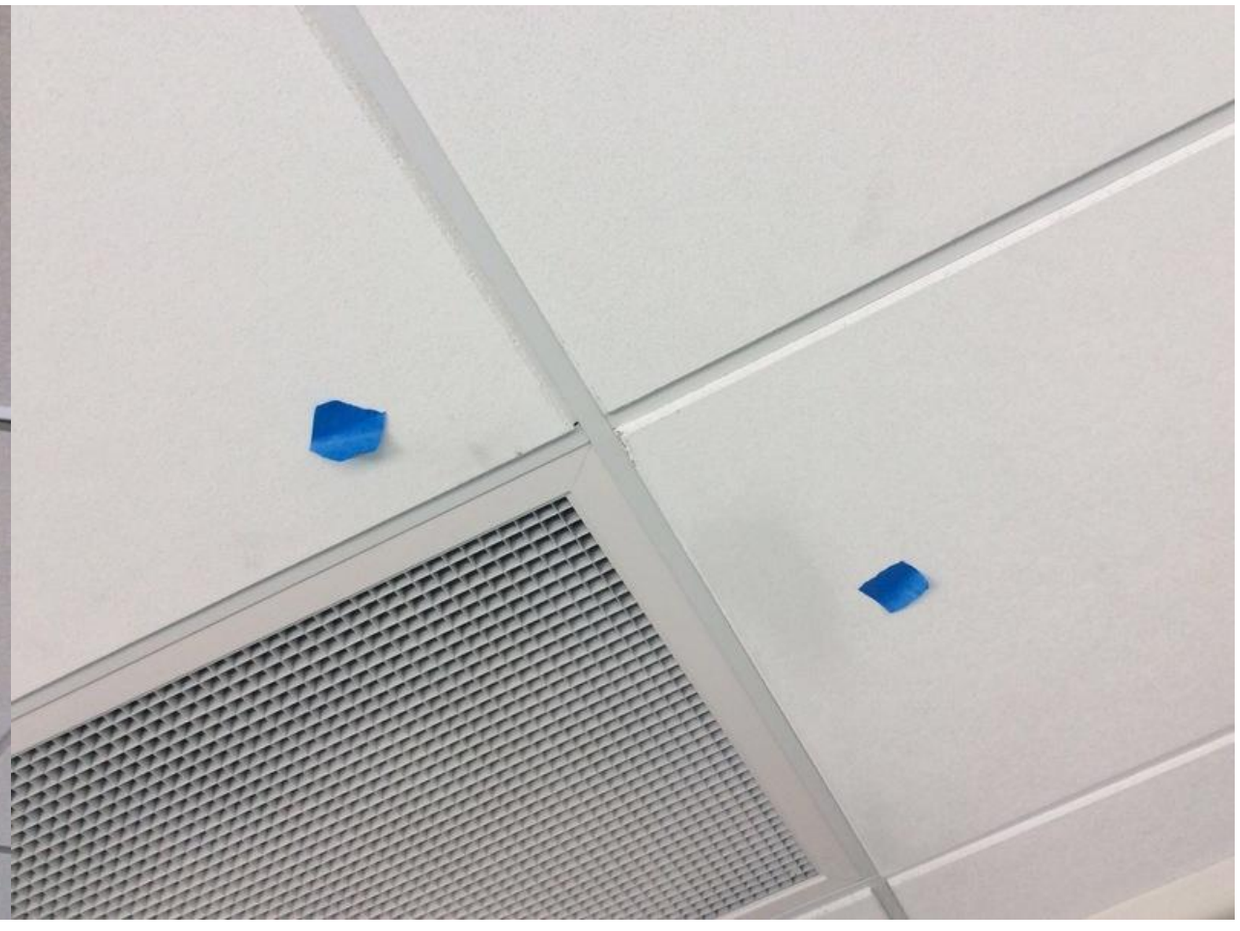
Issue ID	Description	Location Detail	Location	Status	Company	Type	Date Created	Due Date
000764	Damaged ceiling tiles		Webster > LEVEL_04 > 452_OFF. TA	Open	Spectra Painting	Architect Punch List	11 Jul 2017	16 Jul 2017

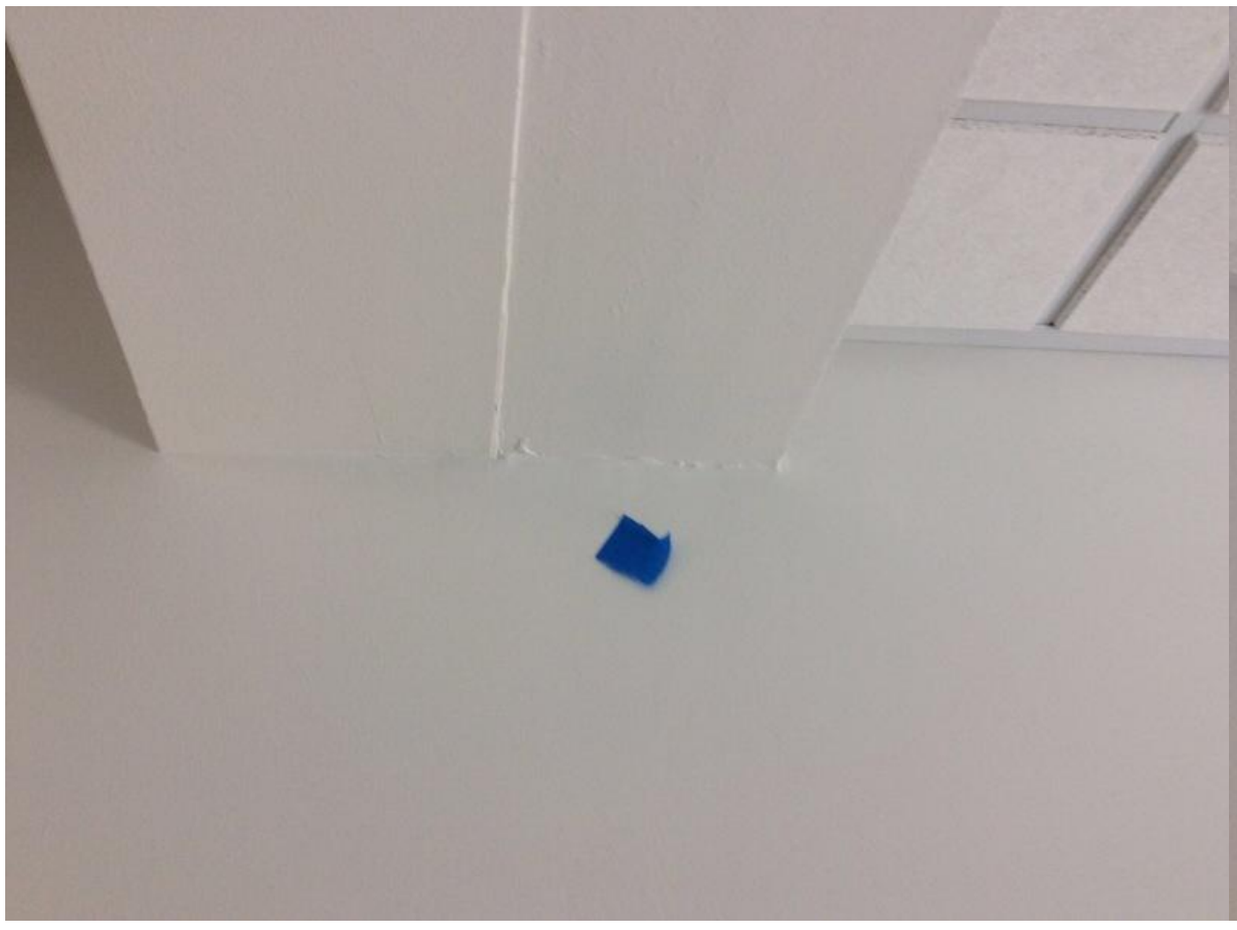
Issue ID	Description	Location Detail	Location	Status	Company	Type	Date Created	Due Date
000766	Touch up paint, fix "runs"		Webster > LEVEL_04 > 452_OFF. TA	Open	Spectra Painting	Architect Punch List	11 Jul 2017	16 Jul 2017

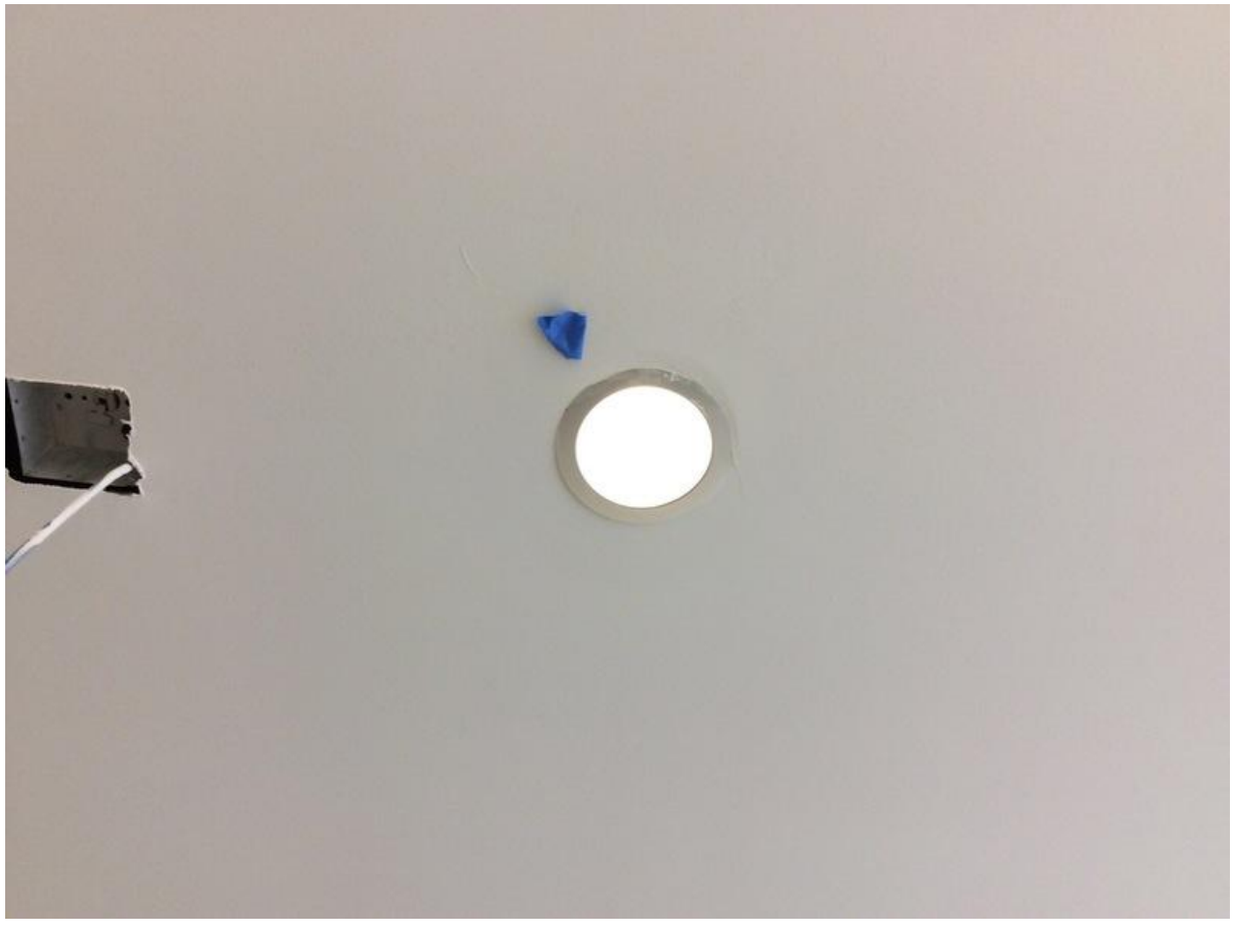
Issue ID	Description	Location Detail	Location	Status	Company	Type	Date Created	Due Date
000779	Clean paint from light fixtures (typical in corridor hard ceilings)		Webster > LEVEL_04	Open	Spectra Painting	Architect Punch List	11 Jul 2017	16 Jul 2017
