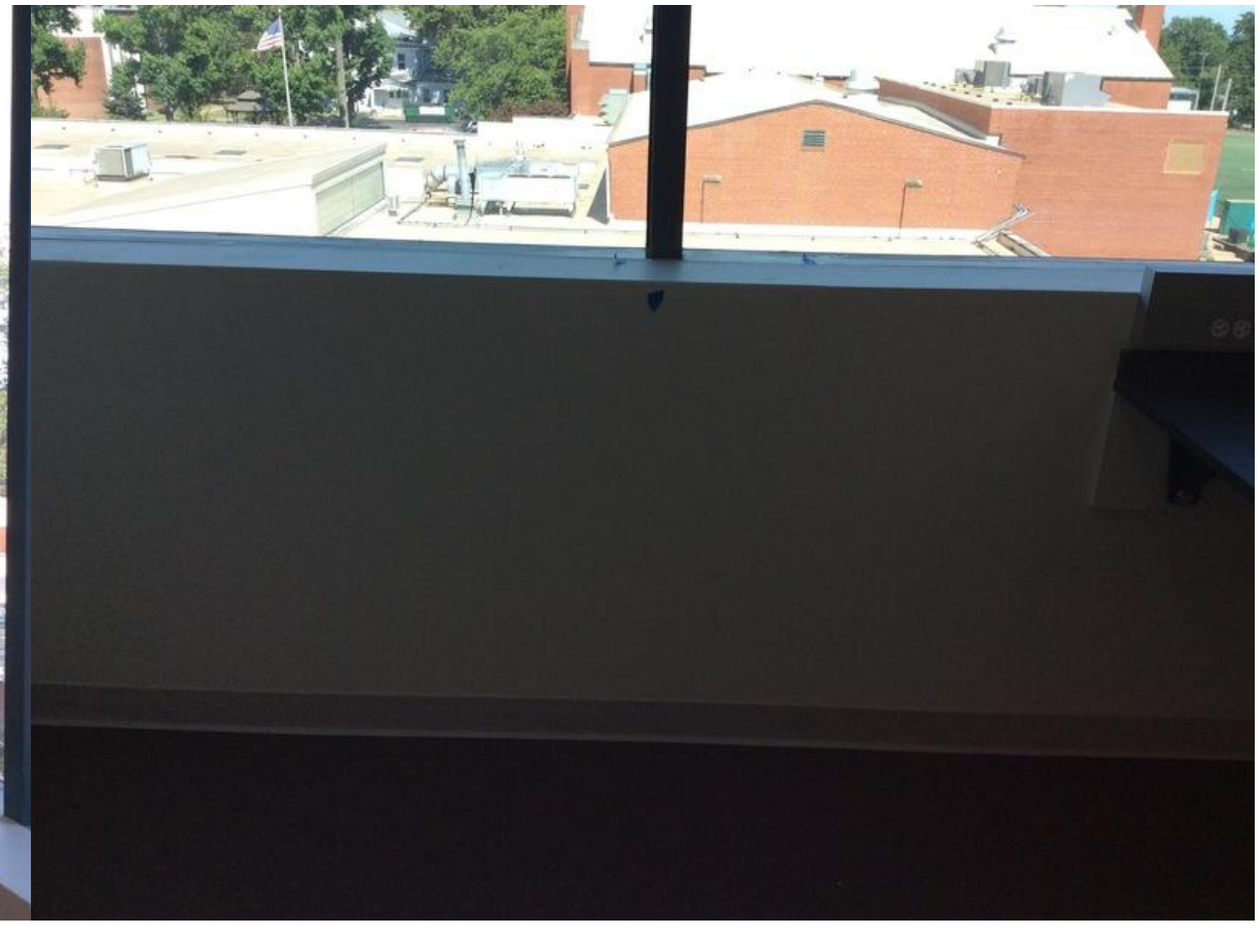
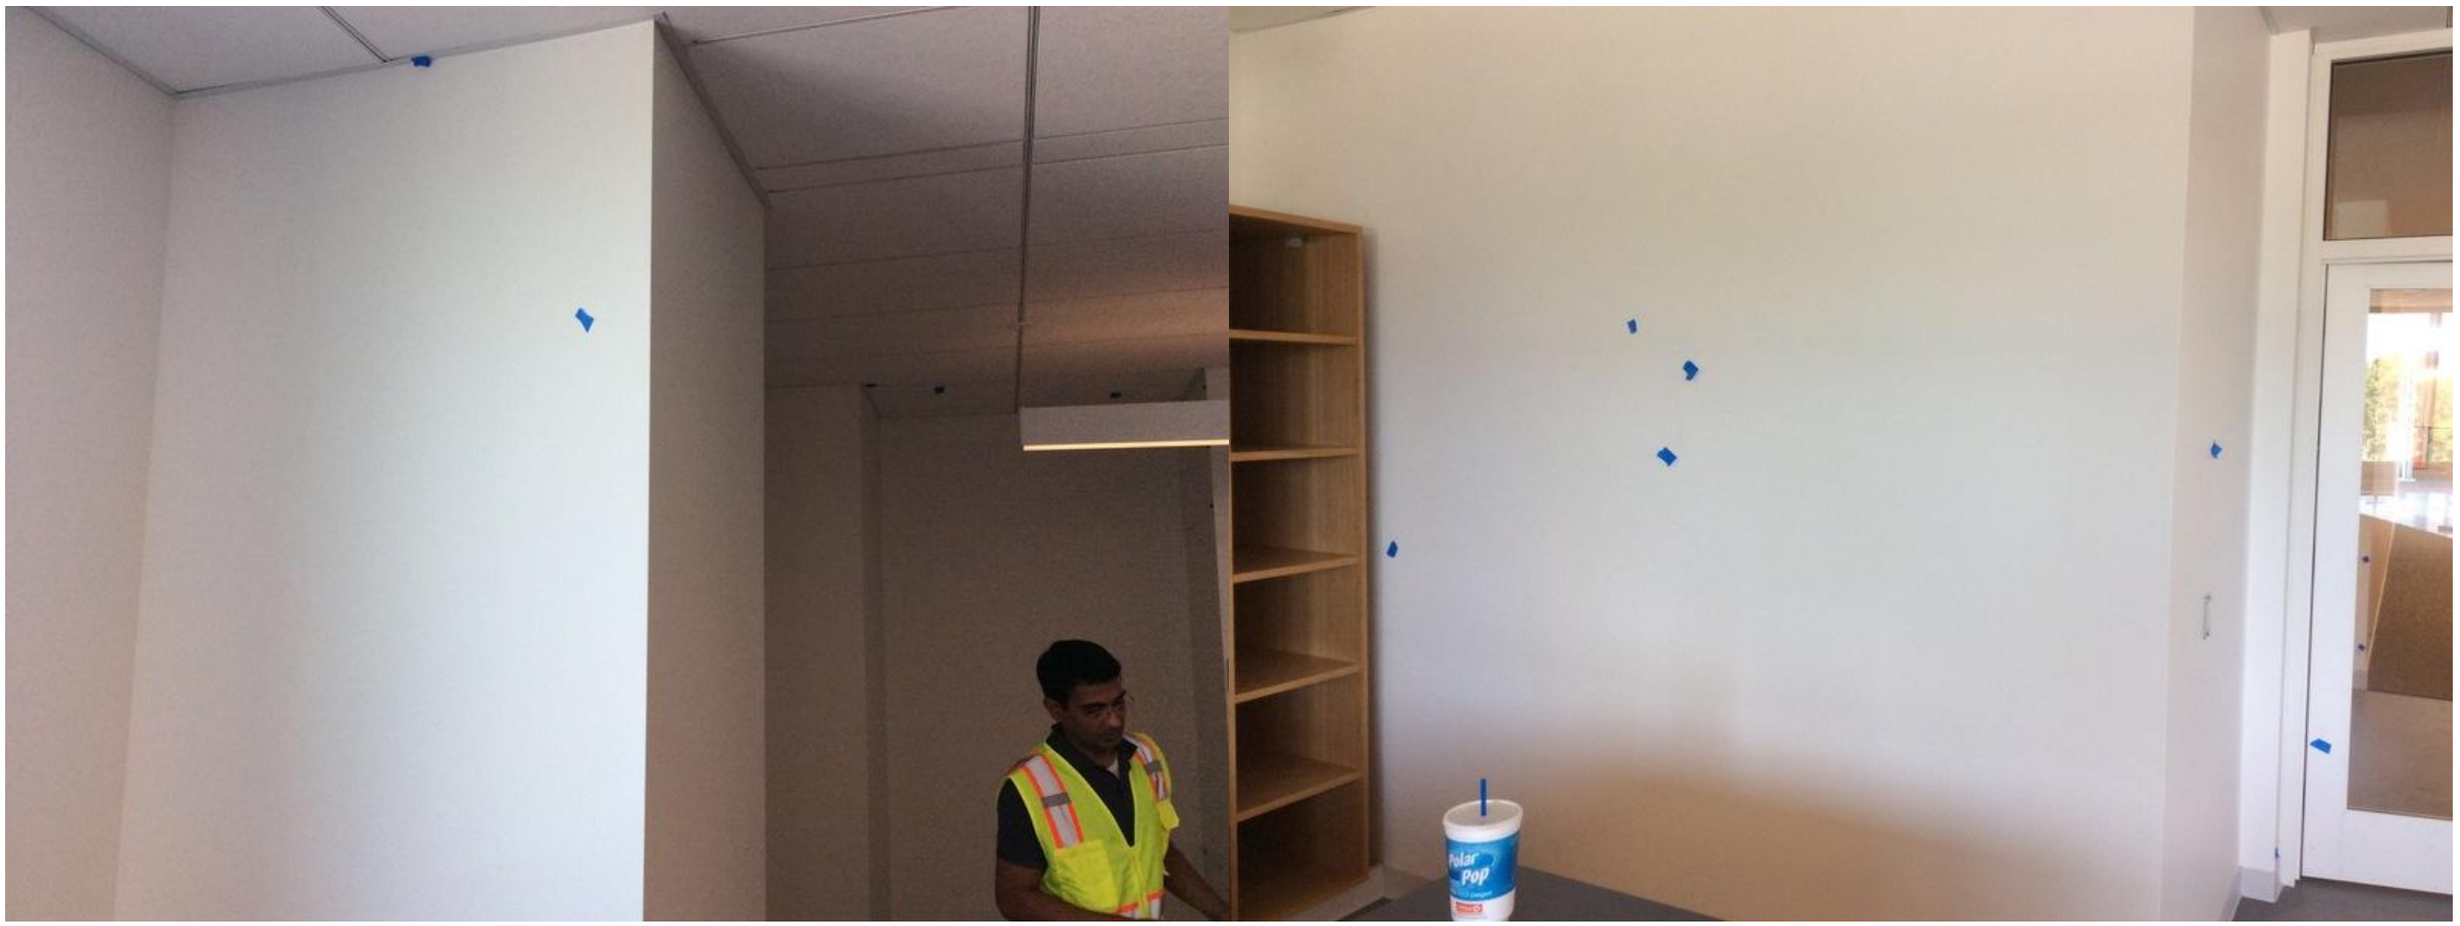
Issue ID	Description	Location Detail	Location	Status	Company	Type	Date Created	Due Date
000790	Touchup paint on walls		Webster > LEVEL_04 > 472_CHEM LAB - GENERAL	Open	Spectra Painting	Architect Punch List	11 Jul 2017	16 Jul 2017

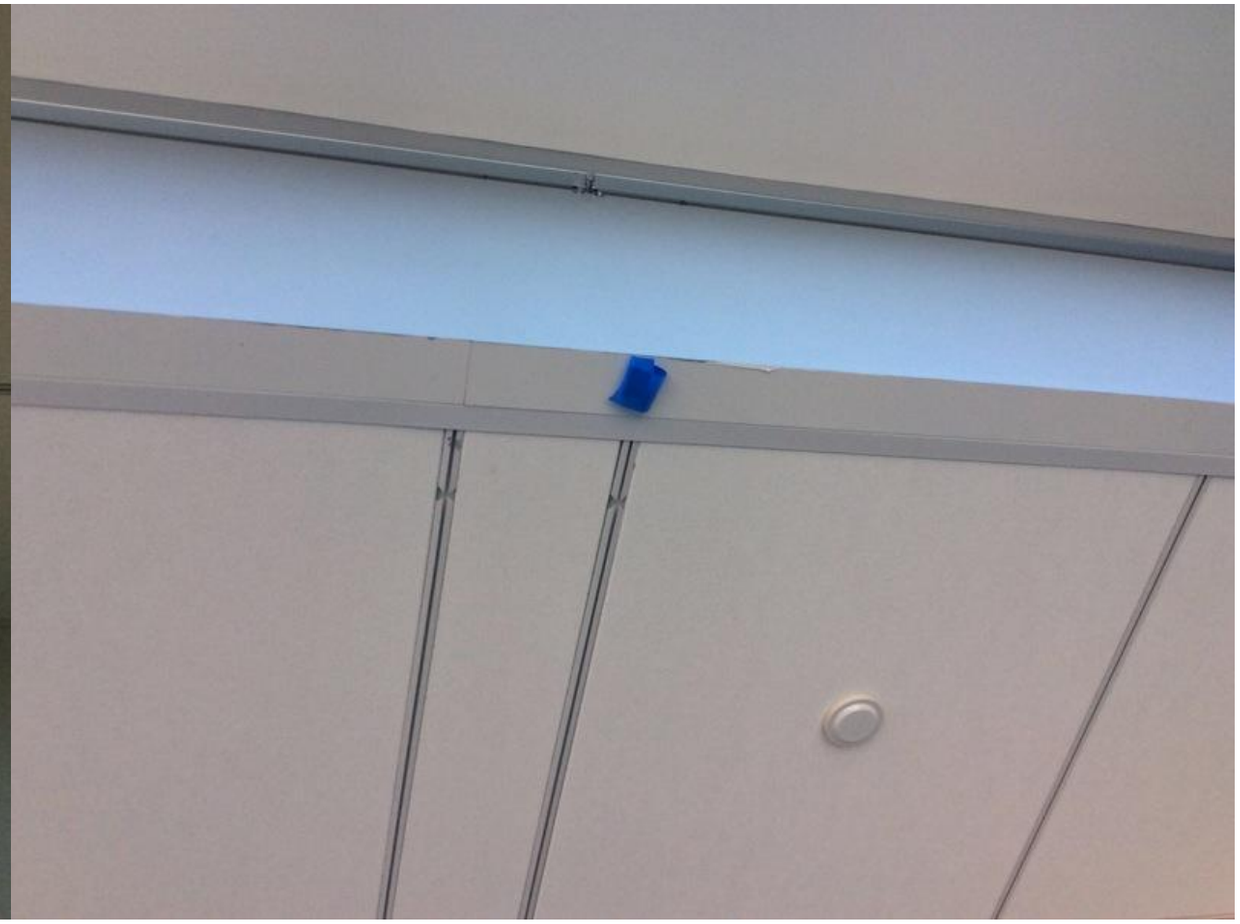
Issue ID	Description	Location Detail	Location	Status	Company	Type	Date Created	Due Date
000866	Touchup walls and soffits		Webster > LEVEL_04 > 483_CHEM LAB - RESEARCH	Open	Spectra Painting	Architect Punch List	12 Jul 2017	17 Jul 2017

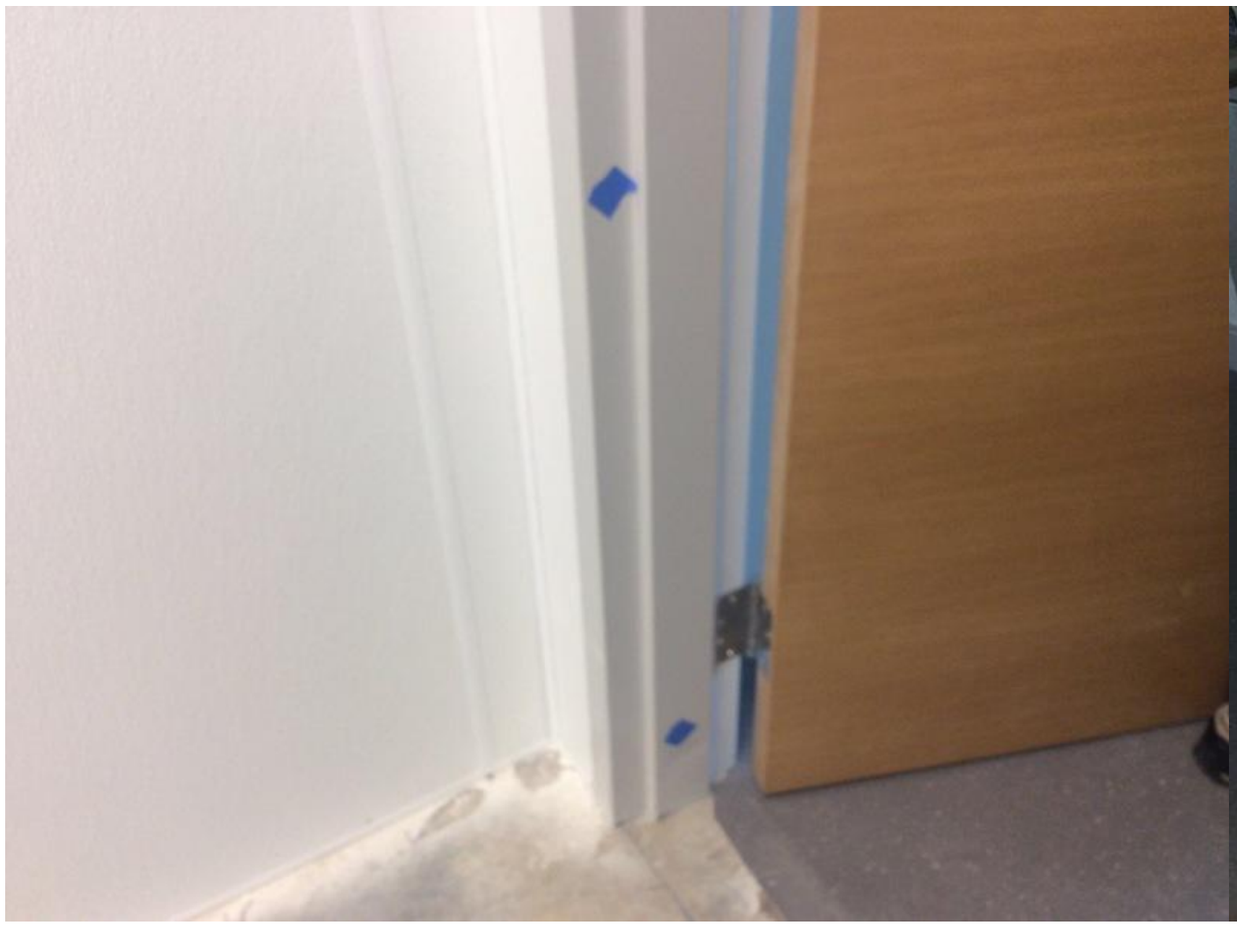
Issue ID	Description	Location Detail	Location	Status	Company	Type	Date Created	Due Date
000884	Touch up paint on door frame		Webster > LEVEL_04 > 480_CHEM LAB - ORGANIC	Open	Spectra Painting	Architect Punch List	12 Jul 2017	17 Jul 2017

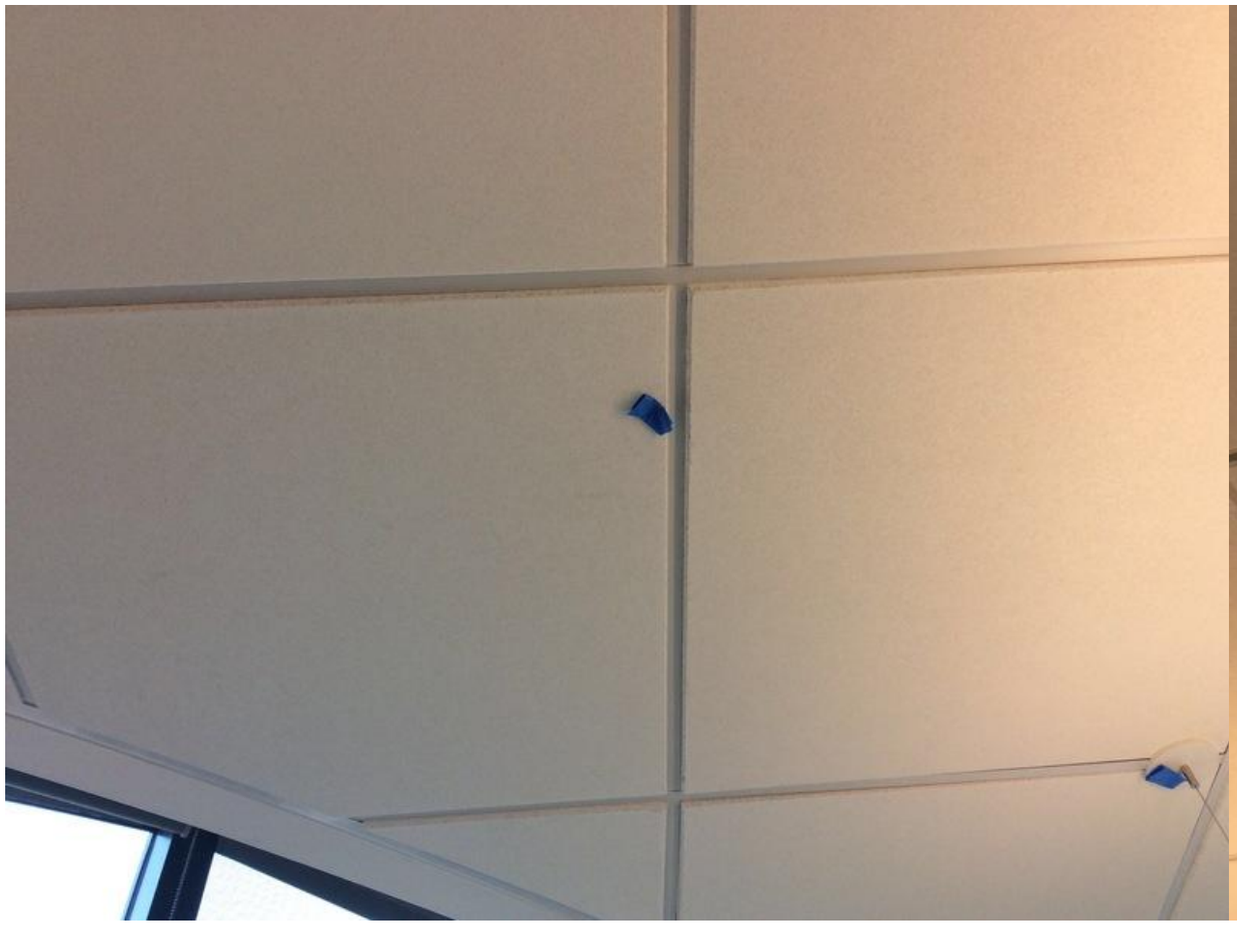
Issue ID	Description	Location Detail	Location	Status	Company	Type	Date Created	Due Date
000668	Scuffed ceiling tiles and damaged grid		Webster > LEVEL_04 > 401_OFF. ADJ (4)	Open	St Charles Acoustics	Architect Punch List	11 Jul 2017	16 Jul 2017

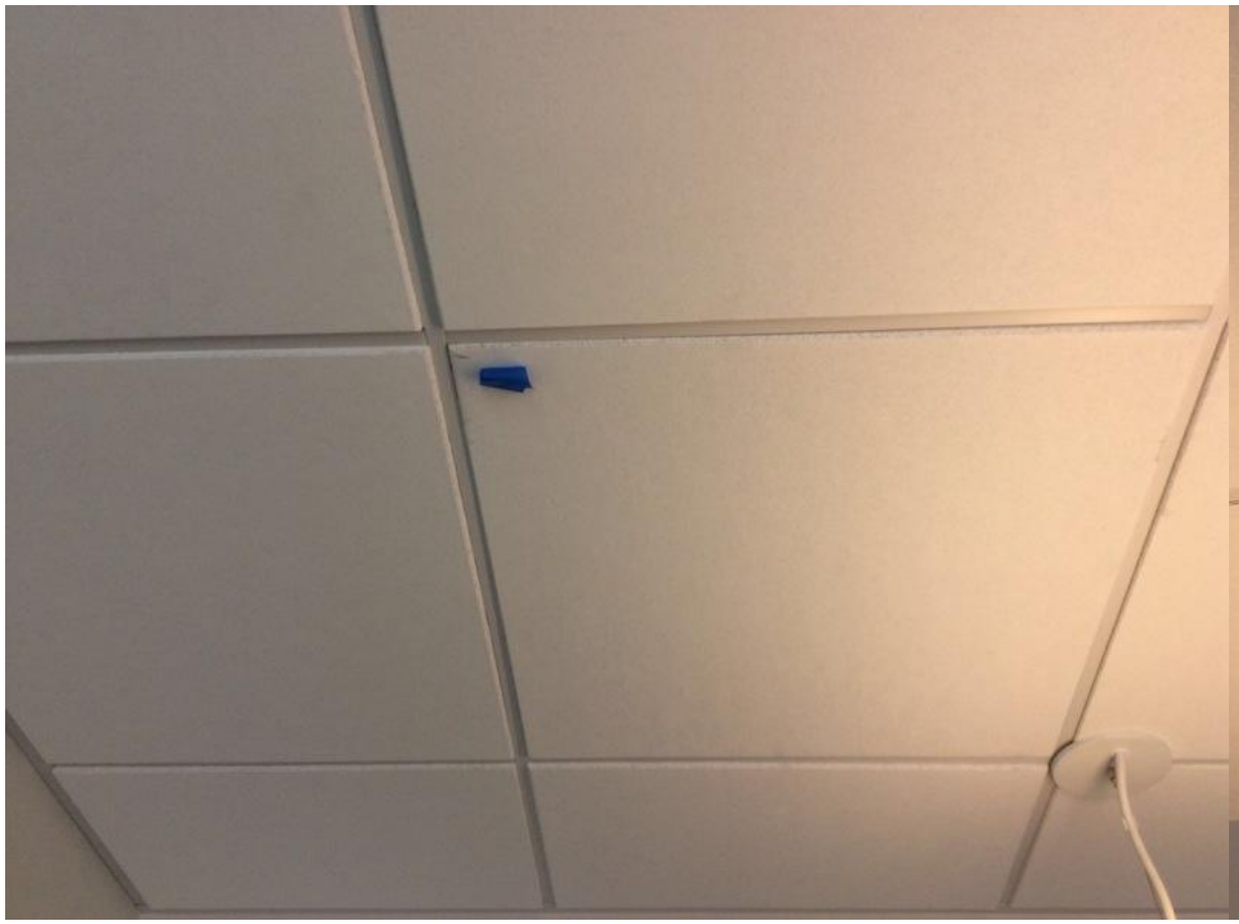
Issue ID	Description	Location Detail	Location	Status	Company	Type	Date Created	Due Date
000706	Ceiling tile scuff marks and corner damage.		Webster > LEVEL_04 > 407_OFF. STAFF	Open	St Charles Acoustics	Architect Punch List	11 Jul 2017	16 Jul 2017

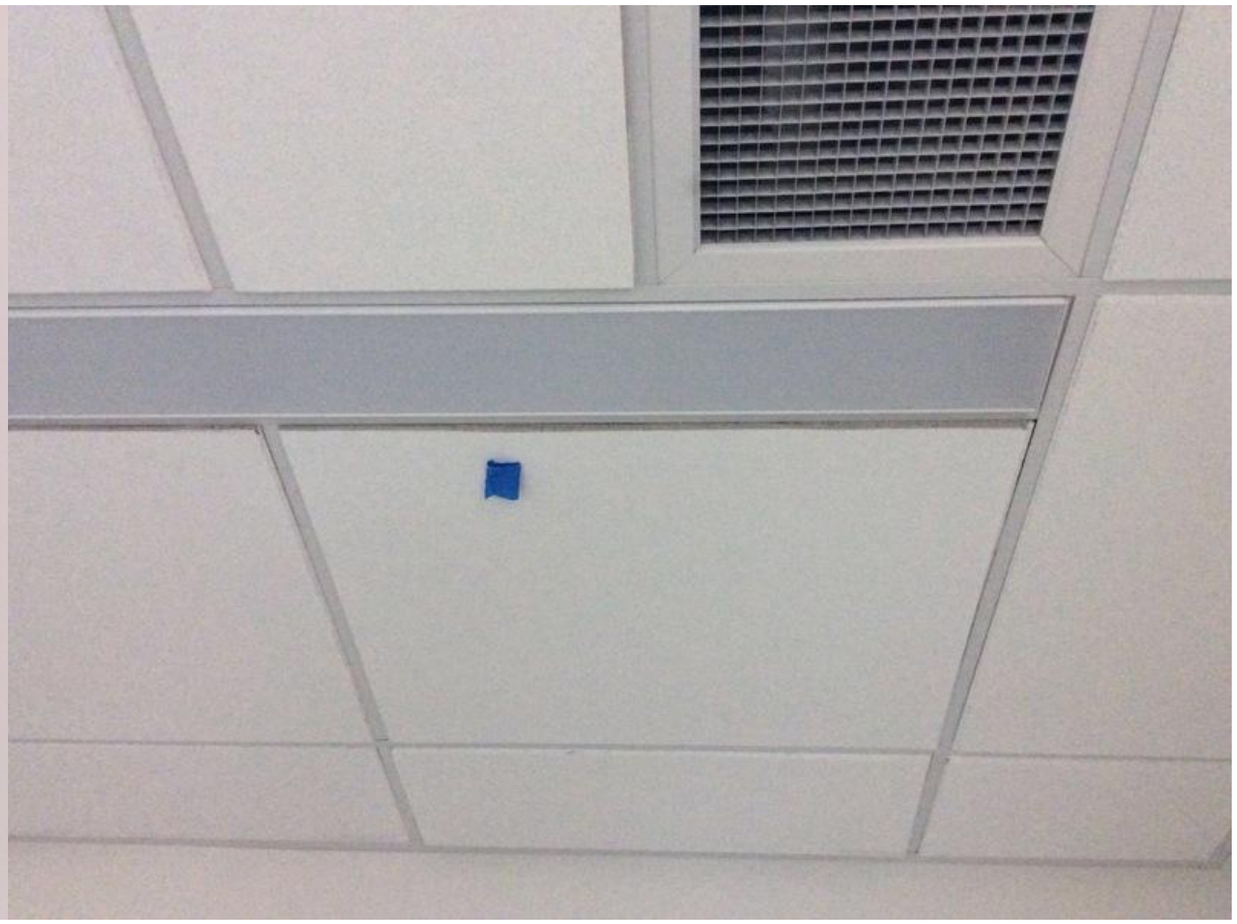
Issue ID	Description	Location Detail	Location	Status	Company	Type	Date Created	Due Date
000730	Ceiling tile cut incorrectly, raw edges to be dressed up		Webster > LEVEL_04 > 414_TESTING	Open	St Charles Acoustics	Architect Punch List	11 Jul 2017	16 Jul 2017

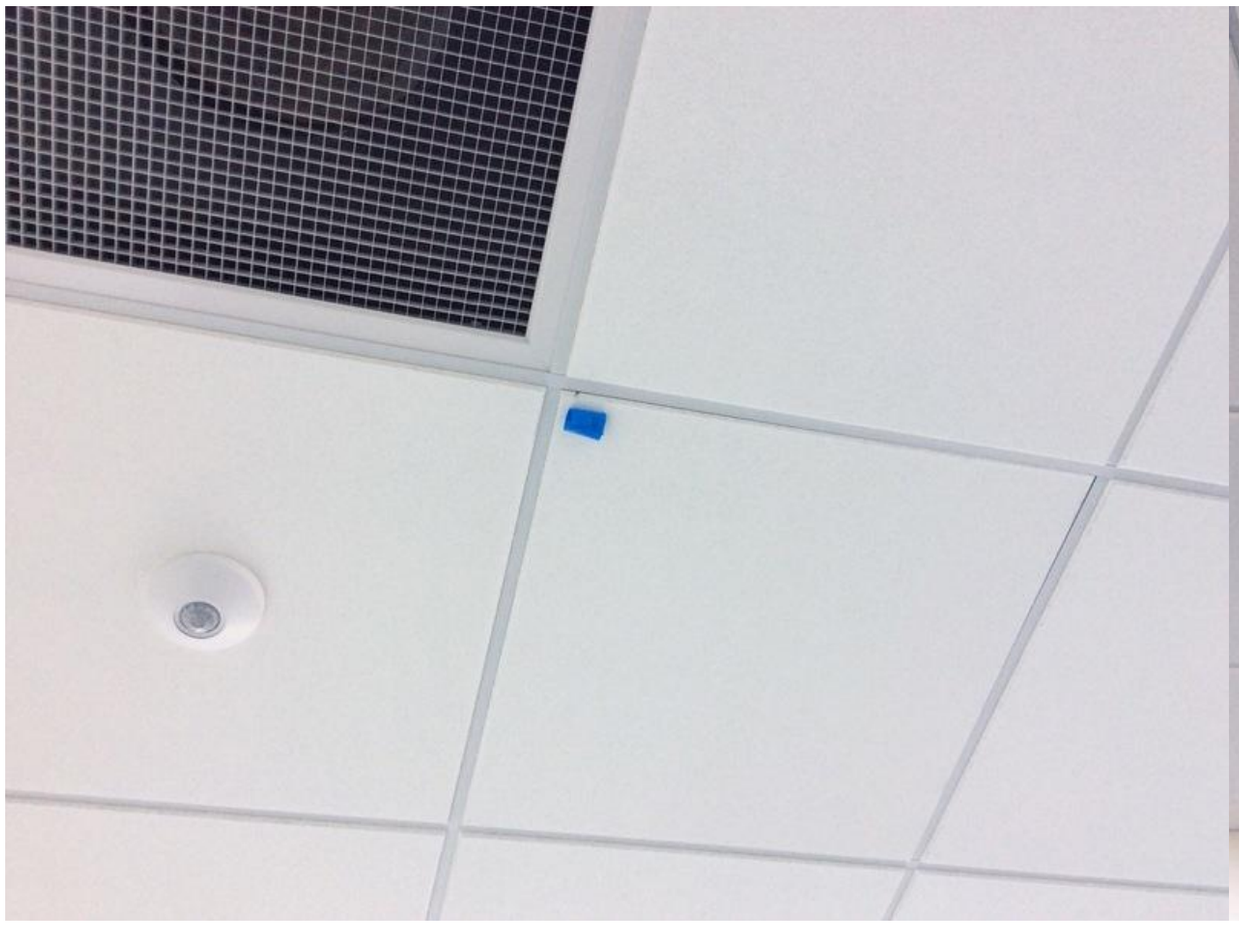
Issue ID	Description	Location Detail	Location	Status	Company	Type	Date Created	Due Date
000741	Scuffed ceiling tiles		Webster > LEVEL_04 > 419_TRANSLATION	Open	St Charles Acoustics	Architect Punch List	11 Jul 2017	16 Jul 2017

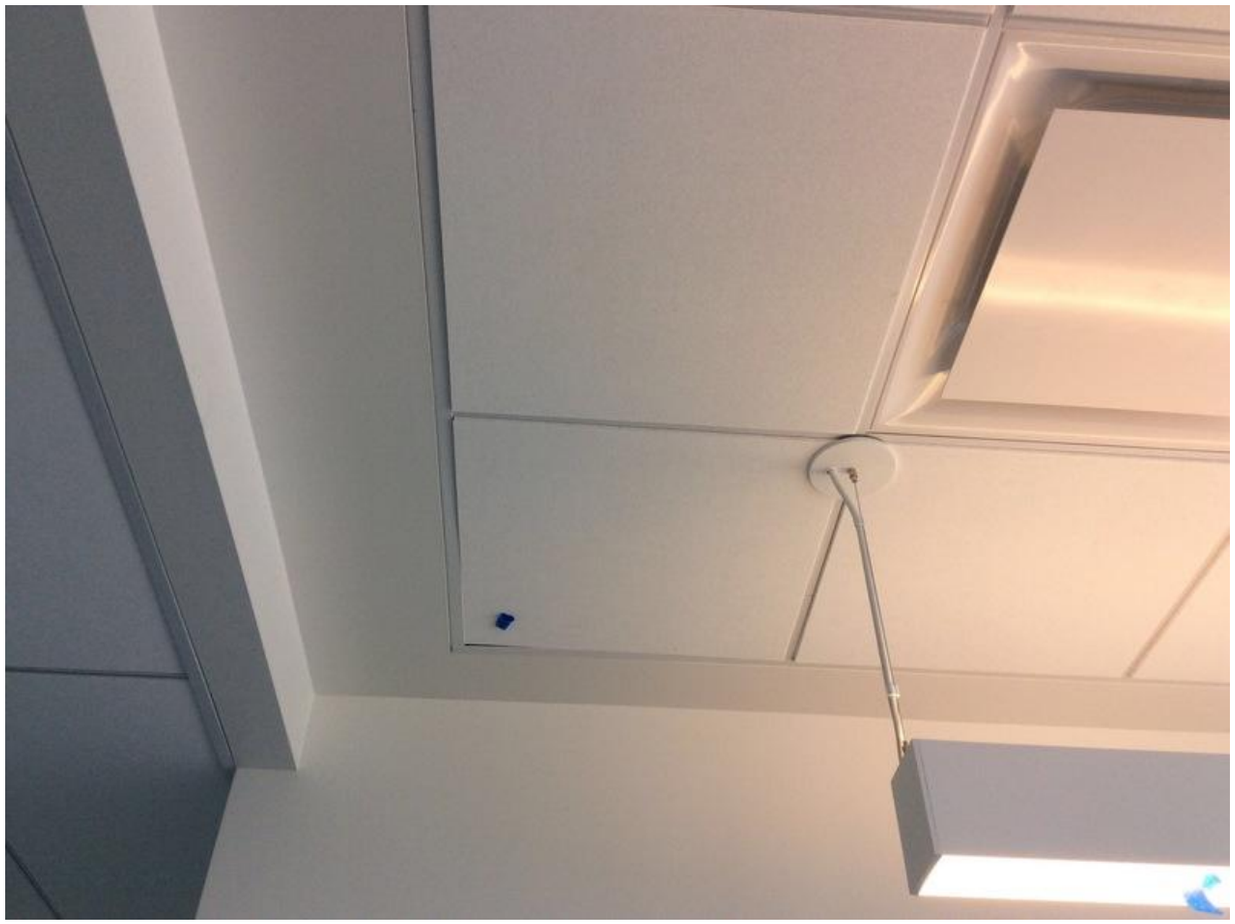
Issue ID	Description	Location Detail	Location	Status	Company	Type	Date Created	Due Date
000742	Adjust ceiling tile		Webster > LEVEL_04 > 431_OFF. FUT	Open	St Charles Acoustics	Architect Punch List	11 Jul 2017	16 Jul 2017

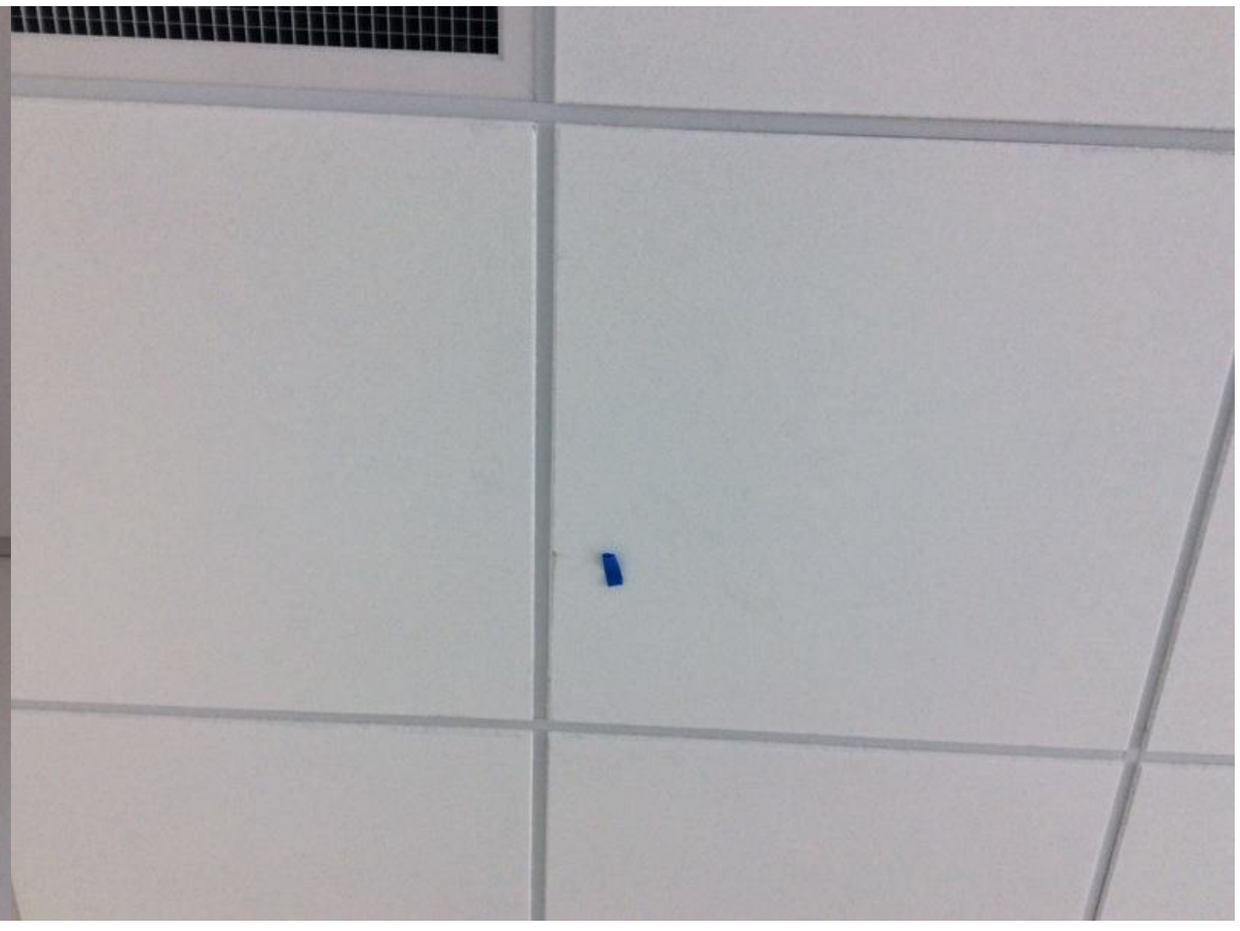
Issue ID	Description	Location Detail	Location	Status	Company	Type	Date Created	Due Date
000760	Scuffs at ceiling tile		Webster > LEVEL_04 > 439_OFF. ESL	Open	St Charles Acoustics	Architect Punch List	11 Jul 2017	16 Jul 2017

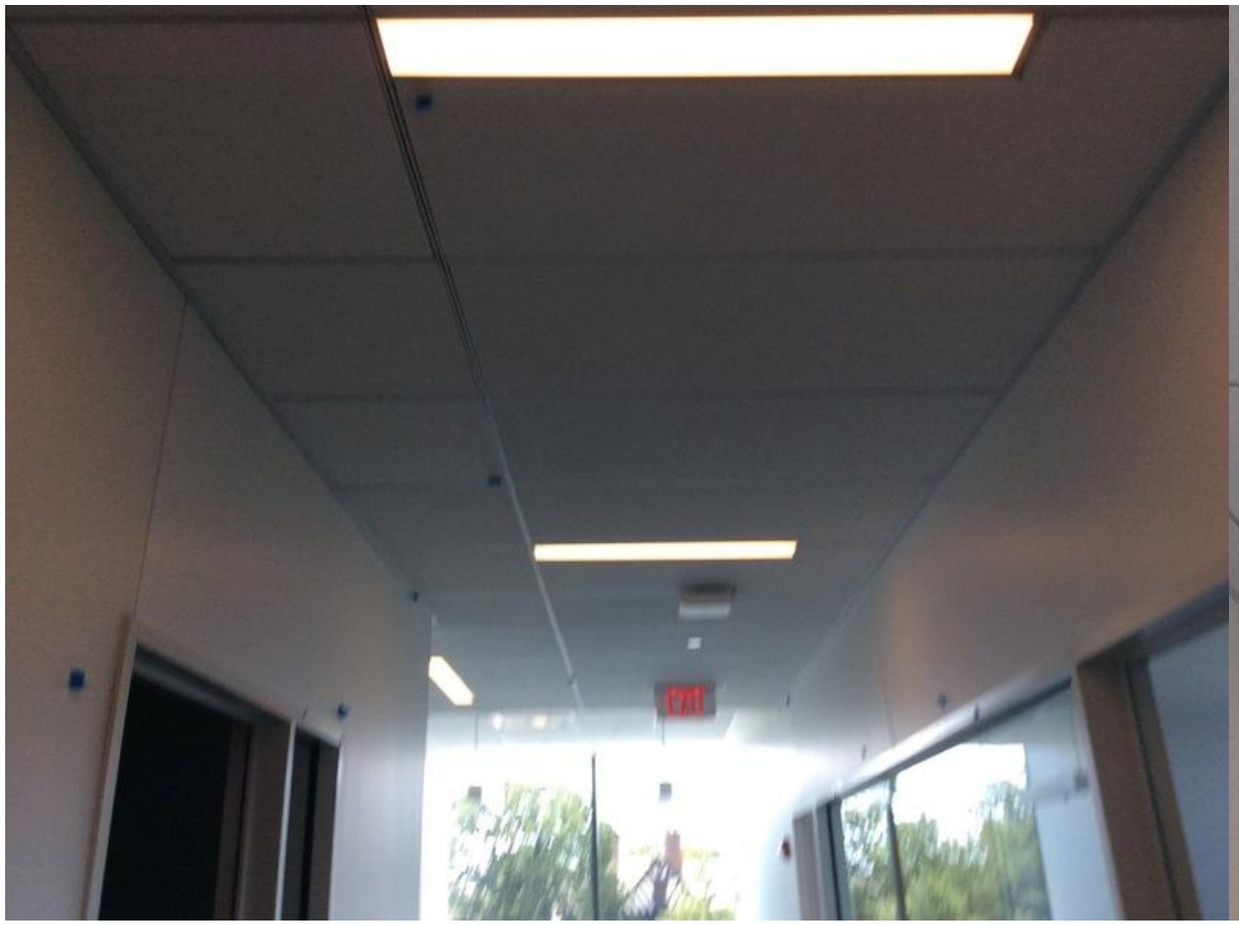
Issue ID	Description	Location Detail	Location	Status	Company	Type	Date Created	Due Date
000777	Scuffs and damaged ceiling tile and grid throughout the corridors marked with blue tape (typ)		Webster > LEVEL_04	Open	St Charles Acoustics	Architect Punch List	11 Jul 2017	16 Jul 2017

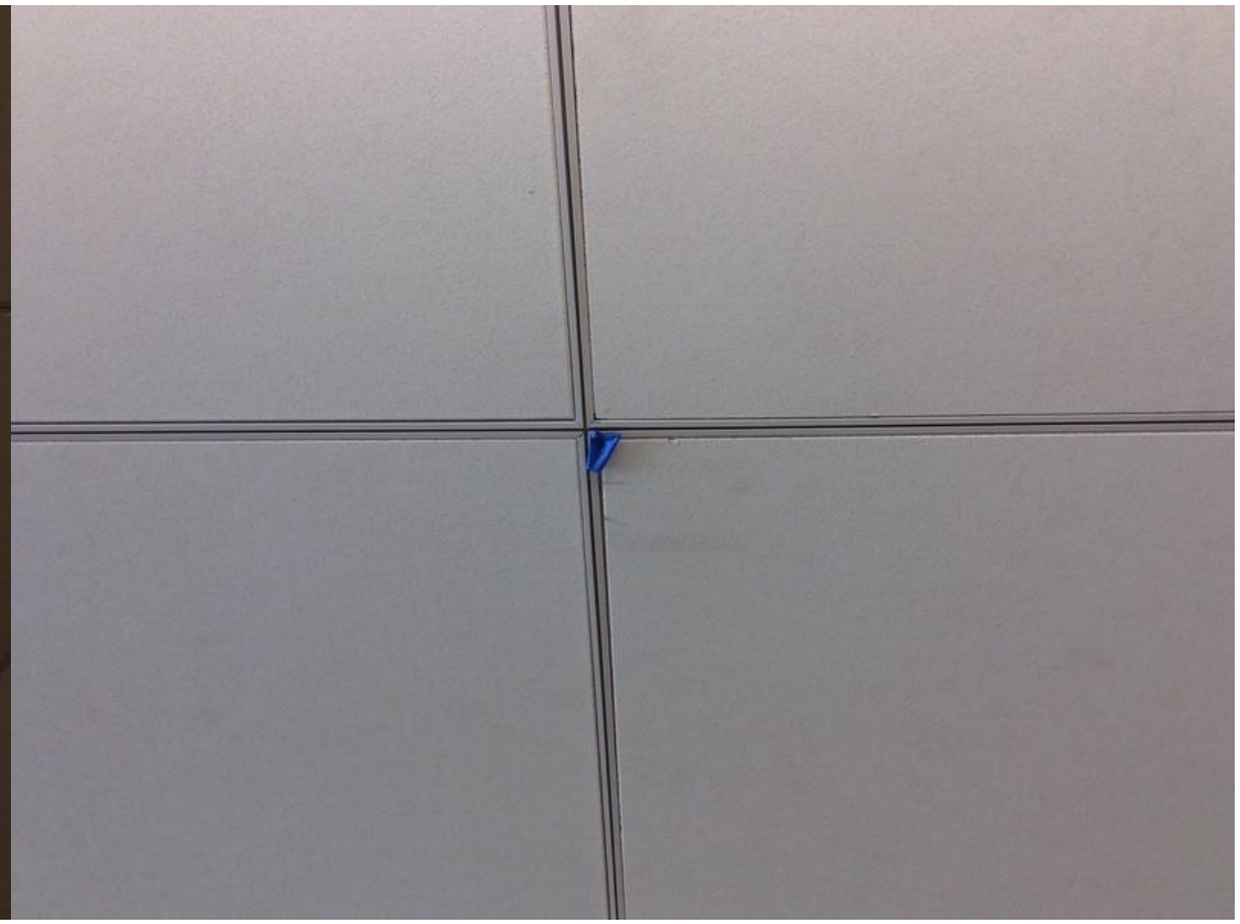
Issue ID	Description	Location Detail	Location	Status	Company	Type	Date Created	Due Date
000800	Damaged/scuffed ceiling tiles, uneven gaps at grid		Webster > LEVEL_04 > 478_CHEM LAB PREP	Open	St Charles Acoustics	Architect Punch List	11 Jul 2017	16 Jul 2017

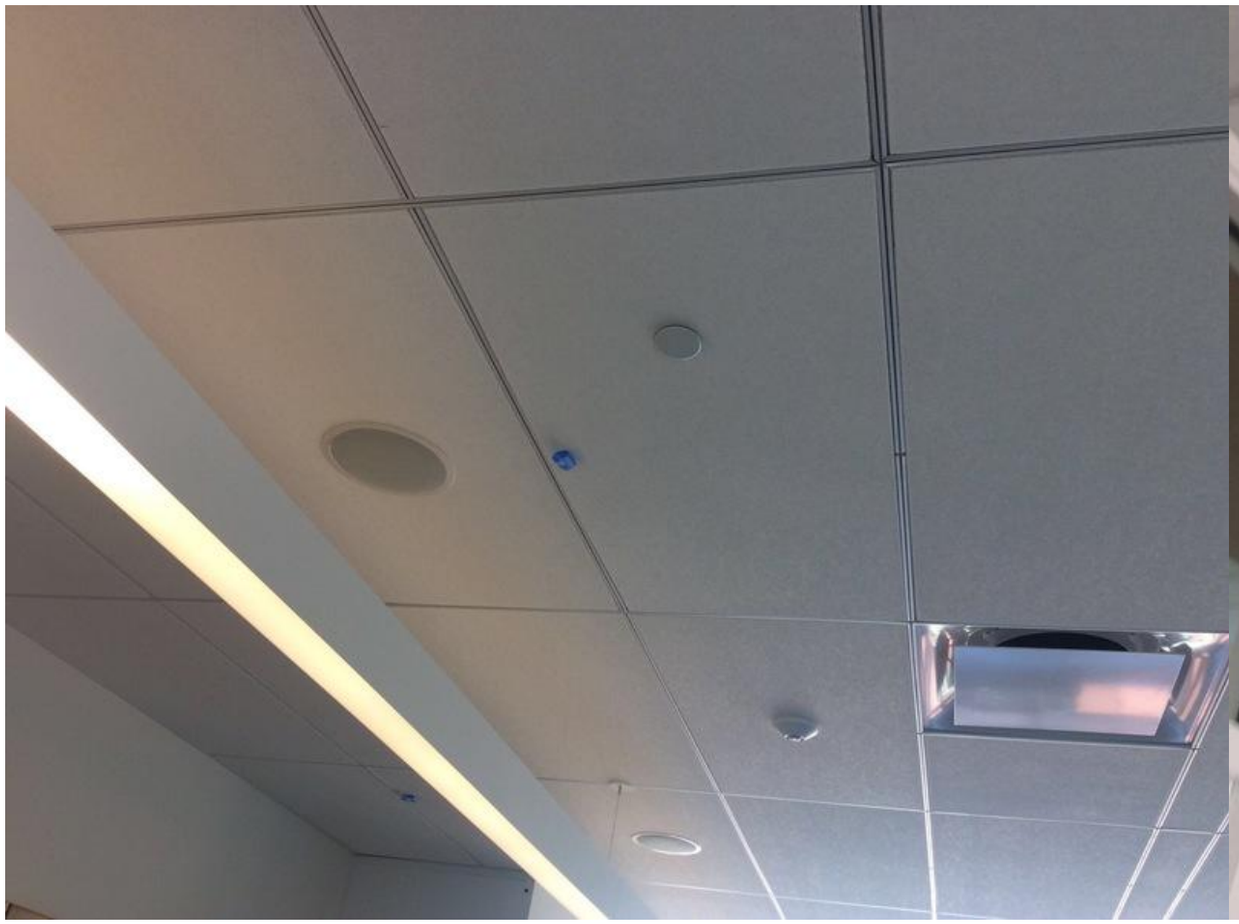
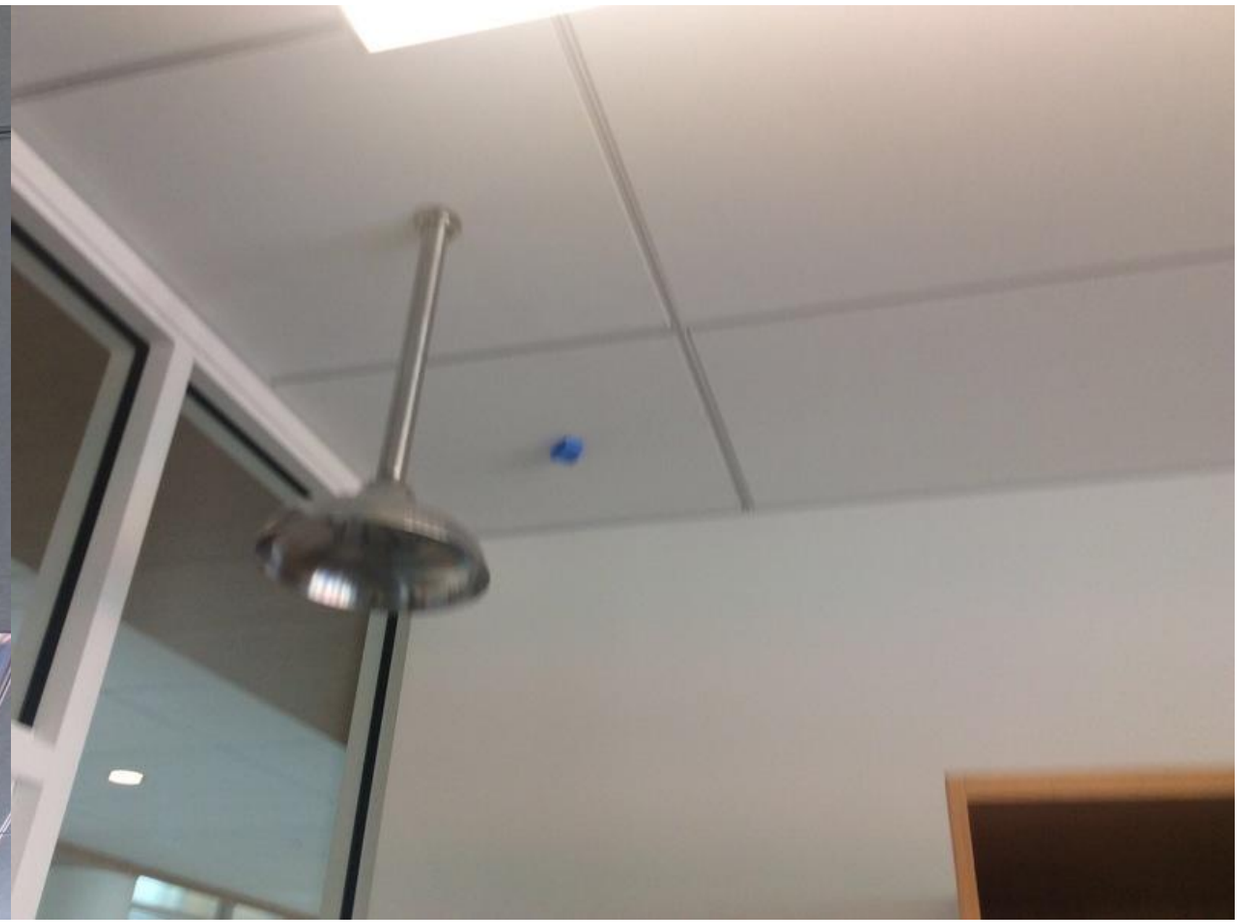
Issue ID	Description	Location Detail	Location	Status	Company	Type	Date Created	Due Date
000845	Adjust ceiling tile and fixed scuffed tile		Webster > LEVEL_04 > 491_CHEM LAB PHYSICAL	Open	St Charles Acoustics	Architect Punch List	12 Jul 2017	17 Jul 2017

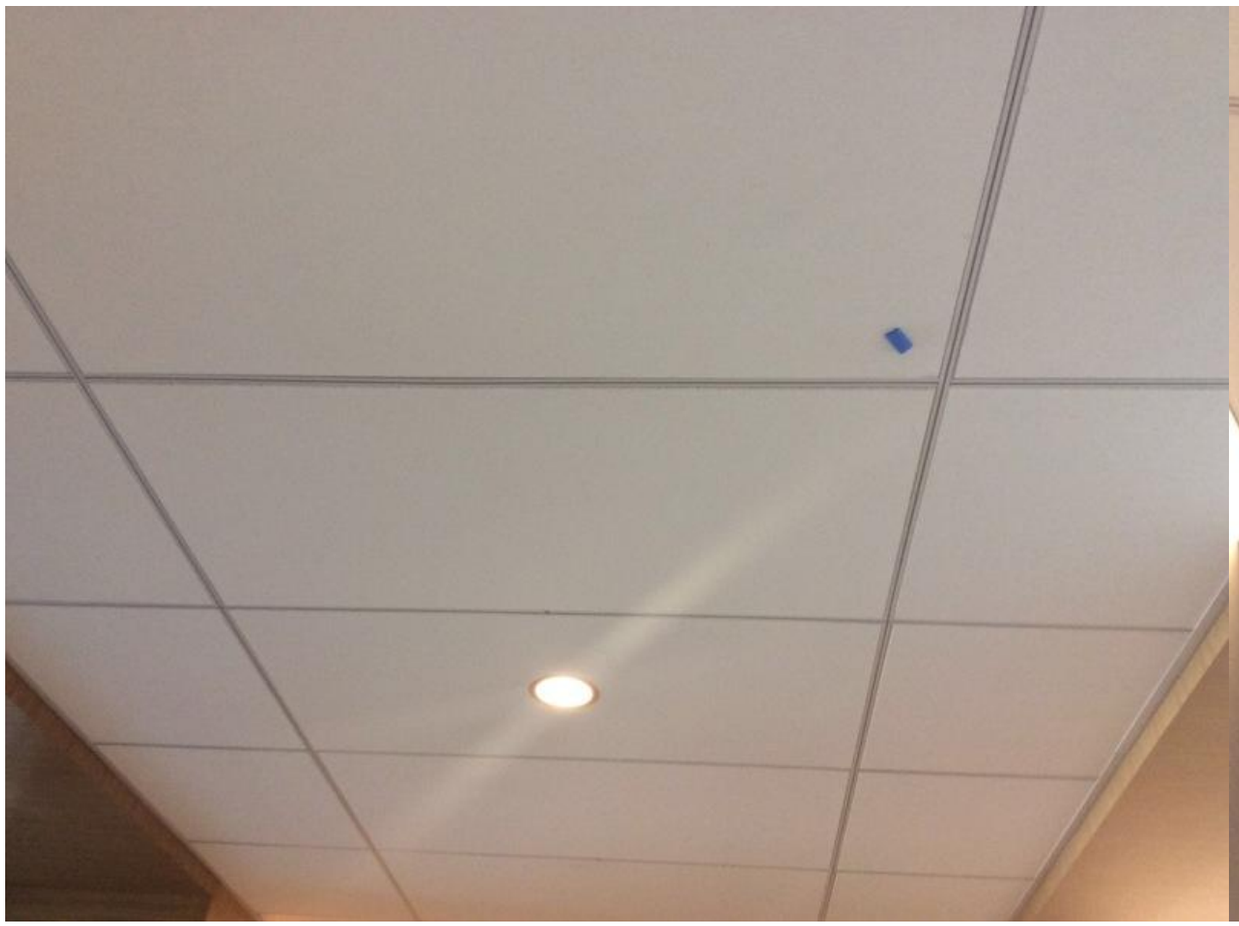
Issue ID	Description	Location Detail	Location	Status	Company	Type	Date Created	Due Date
000896	Replace damaged ceiling tile in corridor		Webster > LEVEL_04	Open	St Charles Acoustics	Architect Punch List	12 Jul 2017	17 Jul 2017

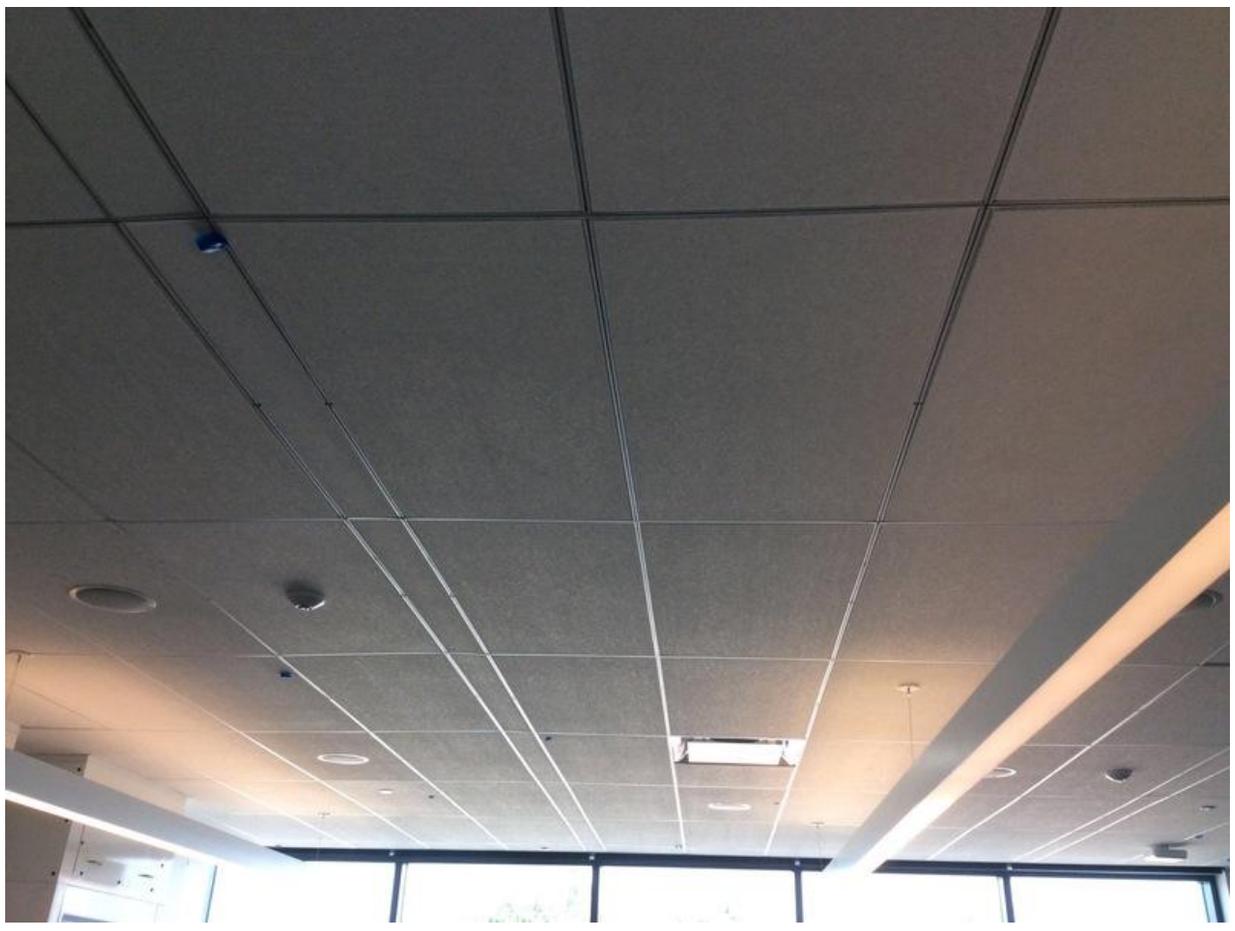
Issue ID	Description	Location Detail	Location	Status	Company	Type	Date Created	Due Date
000789	Damaged and scuffed ceiling tiles		Webster > LEVEL_04 > 472_CHEM LAB - GENERAL	Open	St. Charles Acoustics L.L.C.	Architect Punch List	11 Jul 2017	16 Jul 2017

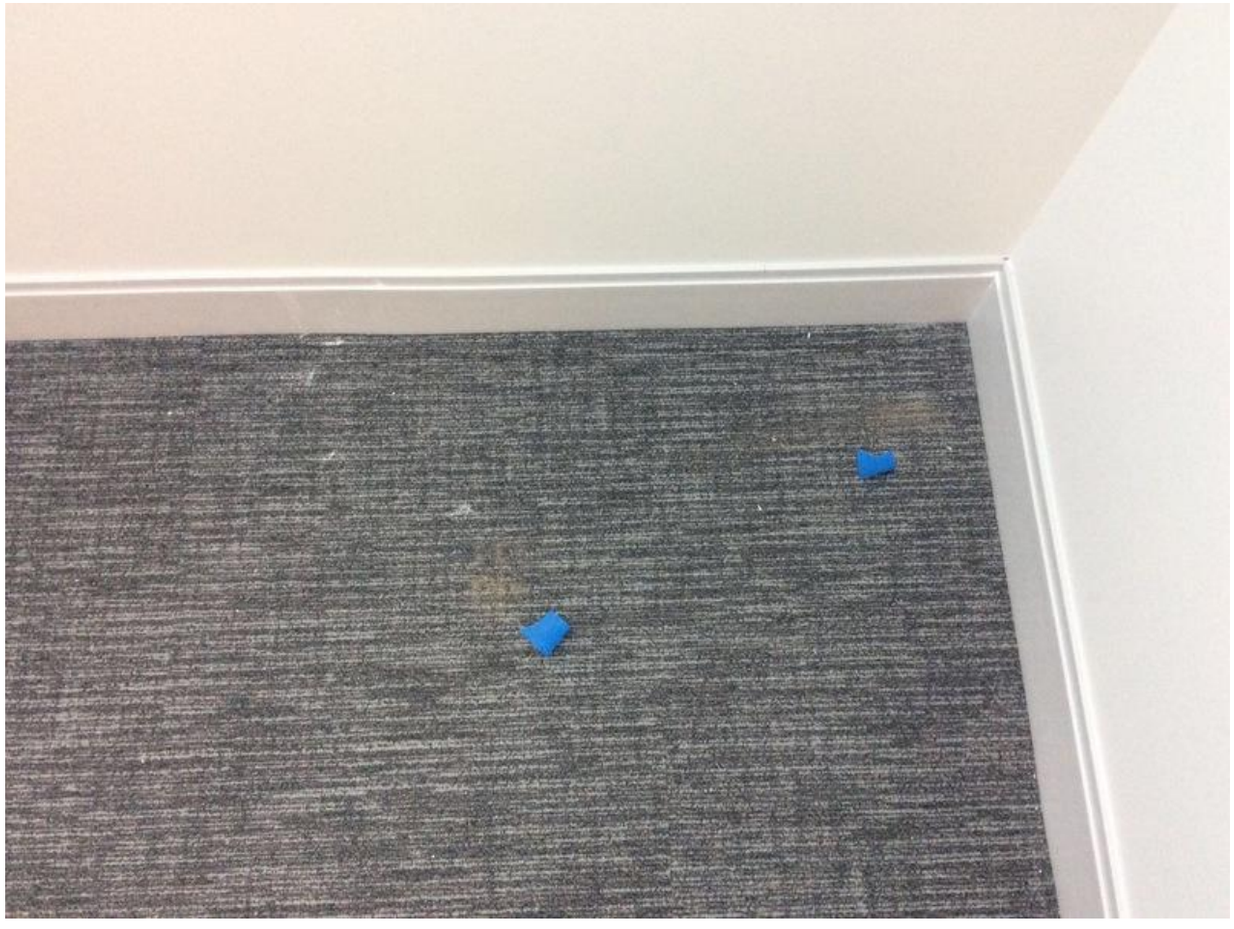
Issue ID	Description	Location Detail	Location	Status	Company	Type	Date Created	Due Date
000725	Clean stains from carpet (Titan please advise if carpet tile must be replaced)		Webster > LEVEL_04 > 413_OFF. IL	Open	Titan Contractor Services	Architect Punch List	11 Jul 2017	16 Jul 2017

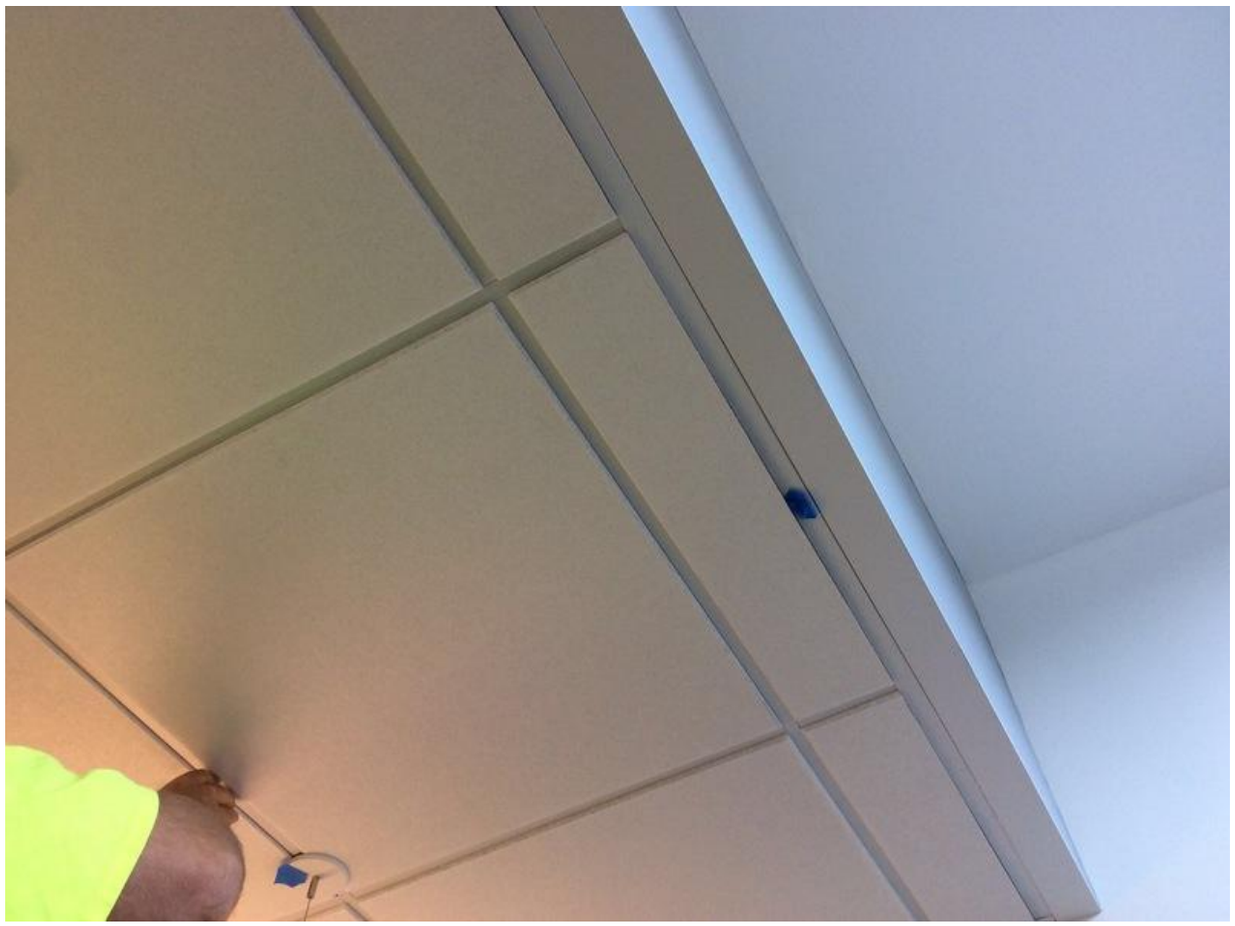
Issue ID	Description	Location Detail	Location	Status	Company	Type	Date Created	Due Date
000732	Ceiling grid to be cleaned off		Webster > LEVEL_04 > 415_OFF. IL	Open	Titan Contractor Services	Architect Punch List	11 Jul 2017	16 Jul 2017
