# Post-Construction Stormwater BMP Incident Report

| Project: <b>Webster University ISB</b> | | License #: <b>MO E-18668</b> |
| Incident Date(s): <b>6/16/2016 - 6/17/2016</b> | | Address: <b>5858 Delor Street 63109</b> |

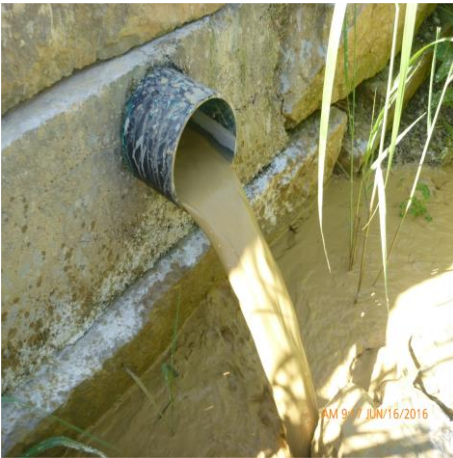
**TURBID WATER FLOWING FROM HDS  
INTO BIODETENTION BASIN**

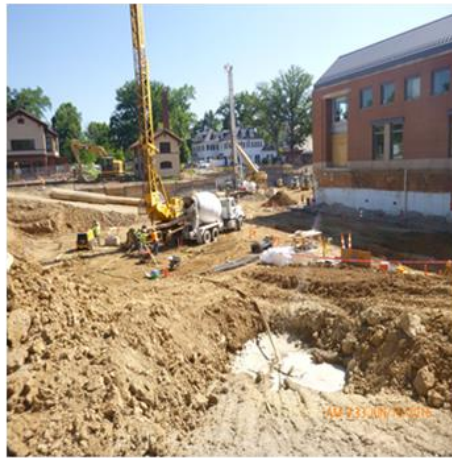
**APPARENT SOURCE OF TURBID WATER  
AND SEDIMENT**

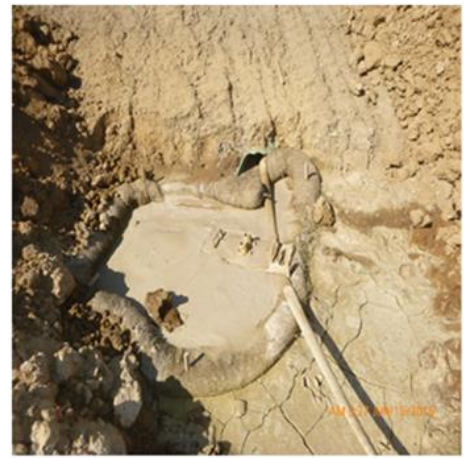
**TURBID WATER BEING PUMPED  
DIRECTLY INTO STORM SEWER**

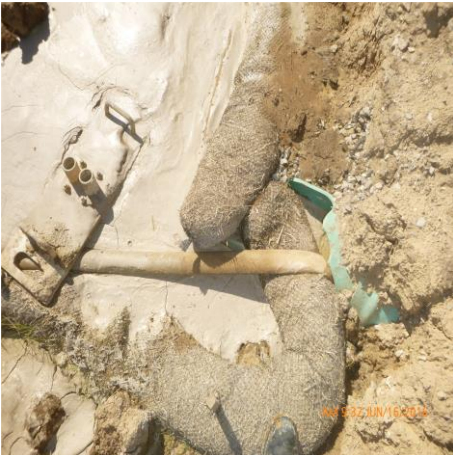
**CLOSE-UP OF TURBID WATER BEING  
PUMPED INTO STORM SEWER**

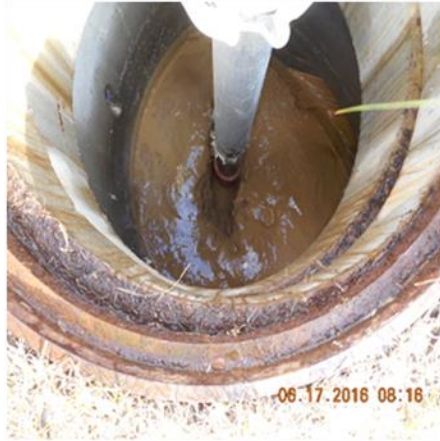
VIEW INTO HDS WITH  
SEDIMENT DEPTH OF 6'-11"

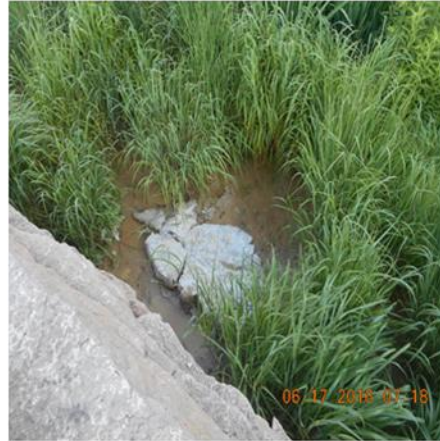
SEDIMENT BUILDUP IN AREA OF  
HDS OUTLET PIPE

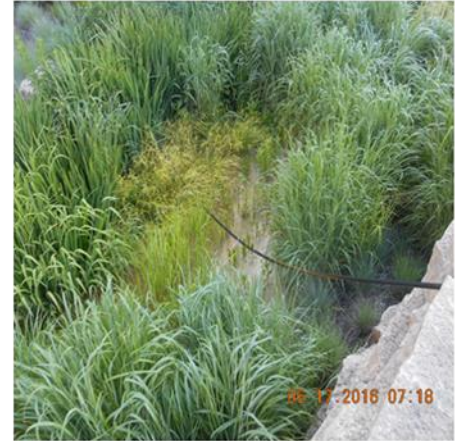
SEDIMENT BUILDUP TO THE EAST OF  
HDS OUTLET PIPE

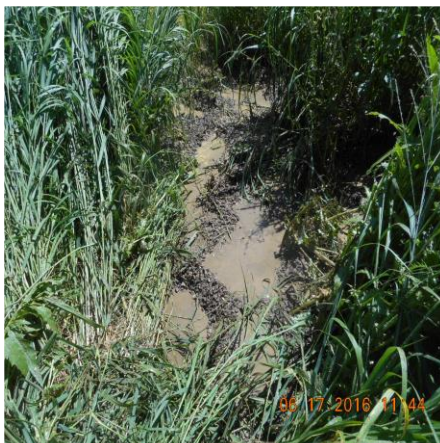
VIEW OF DAMAGED AREA

- \* Remove and legally dispose of soil within the designated repair area to the depth necessary to return the bioretention basin to full functionality.

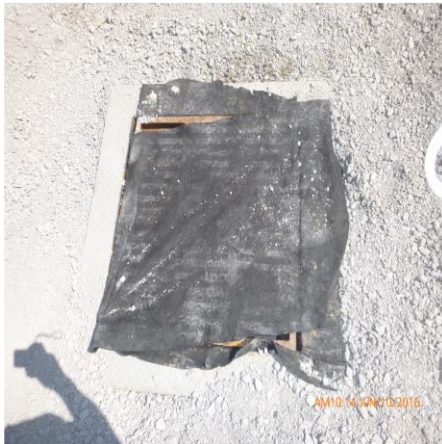
**FILTER FABRIC COVERING INLET # 1**

Inlet #1 has been covered with filter fabric, remove and replace as needed.

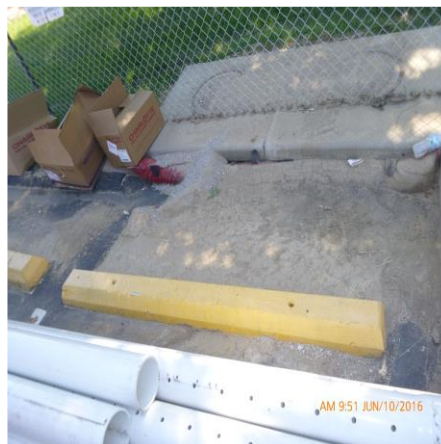
**REMOVE SEDIMENT BUILDUP  
AT DCI 23K2-0374D**

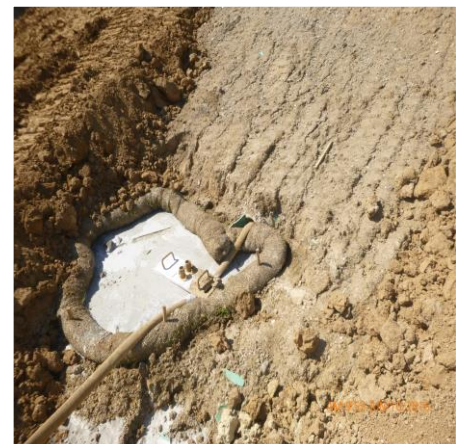
**MONITOR SEDIMENT BUILDUP  
AT END OF PIPE**

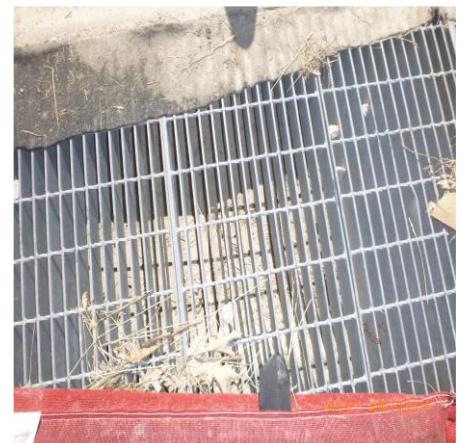
**FILTER FABRIC IN PLACE AT  
GI 23K2-0394D**

| GI 23K2-0394D (SE corner of EAB) | Remove and replace filter fabric under grates---ON GOING |

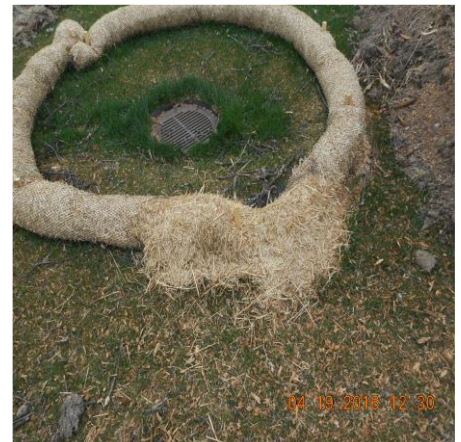
REPLACE TORN SILT SOCK  
AT GI 23K2-0444D

Replace torn silt sock around GI 23K2-0444D

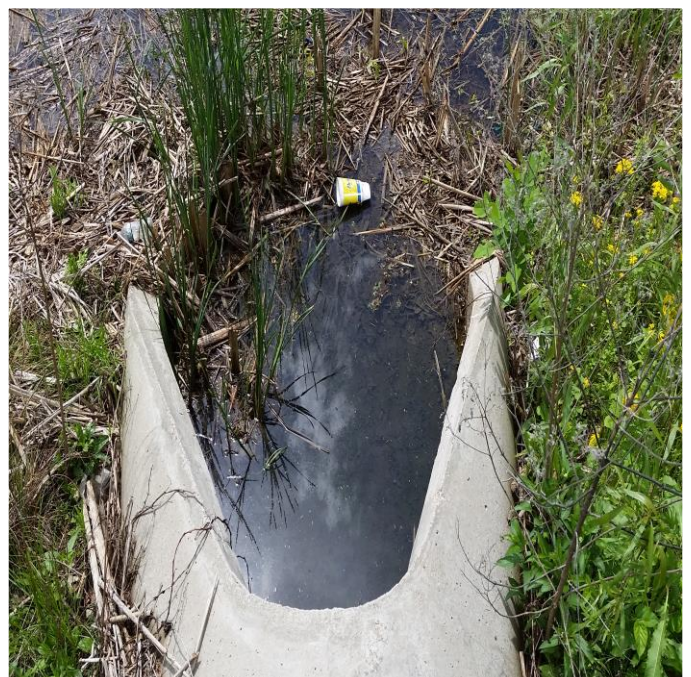
LOOKING AT CLEAR WATER  
STANDING IN INLET PIPE FES

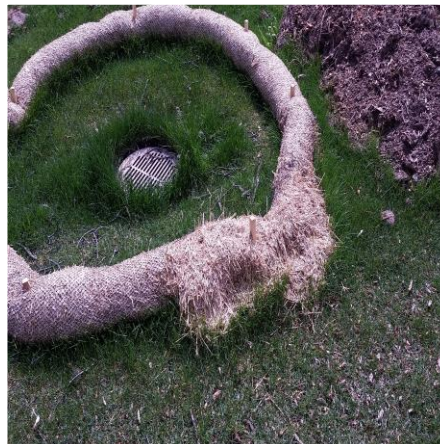
| Silt Sock | Replace torn silt sock around GI 23K2-0444D --- <b>NOT COMPLETED</b> |

REPLACE TORN SILT SOCK  
AT GI 23K2-0444D

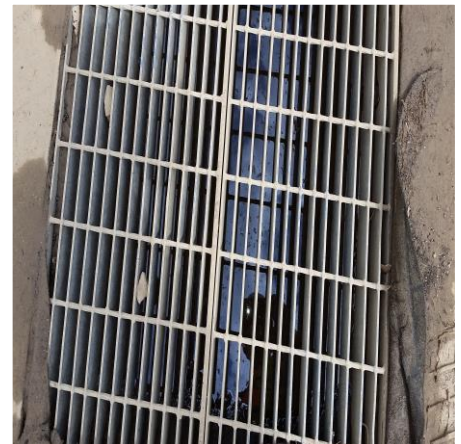
WATER STANDING IN GI 23K2-0392D  
INDICATES FILTER FABRIC IS CLOGGED

| GI 23K2-0392D | Remove and replace filter fabric under grates |

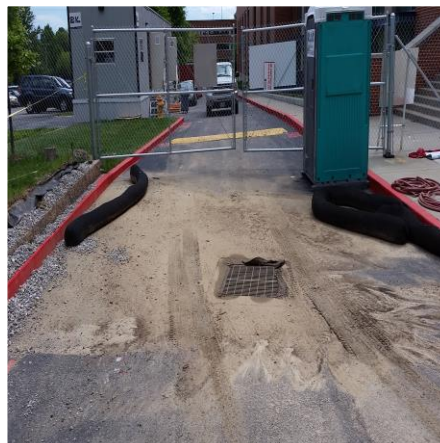
SEDIMENT ON PAVEMENT INDICATES  
PONDING AREA AT GI 23K2-0392D

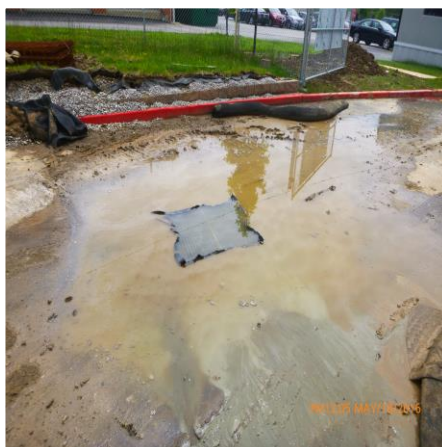
REMOVE AND REPLACE FILTER FABRIC  
IN GI 23K2-0392D

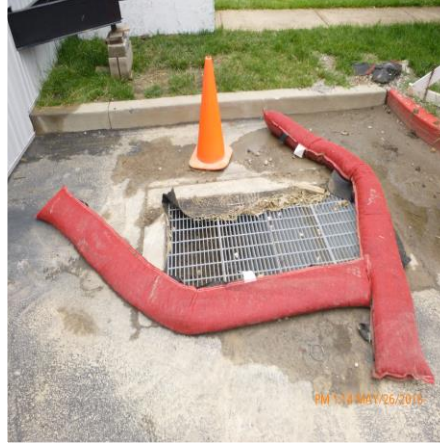
PIN OR WEIGH DOWN SILT SOCK  
AROUND INLET AT SE CORNER OF EAB

The filter sock protecting the four grate inlet at the southeast corner of the East Academic Building should be pinned or weighted to keep it against the curb on one side and the other end next to the trailer, to keep sediment from getting around it and into the grate inlet. The filter fabric inside the inlet needs to be monitored and replaced as needed.

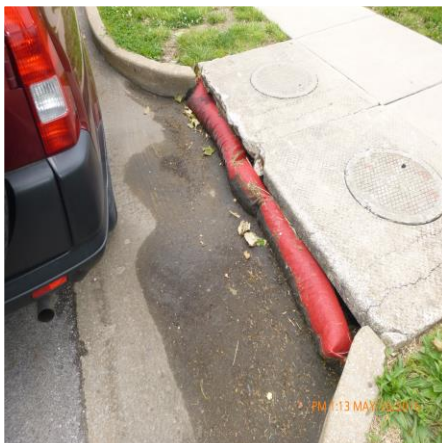
CURB INLET PROTECTION  
ON GARDEN AVENUE

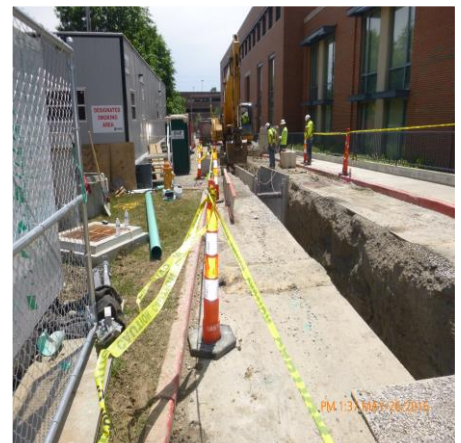
STORM SEWER INSTALLATION  
EAST OF EAB

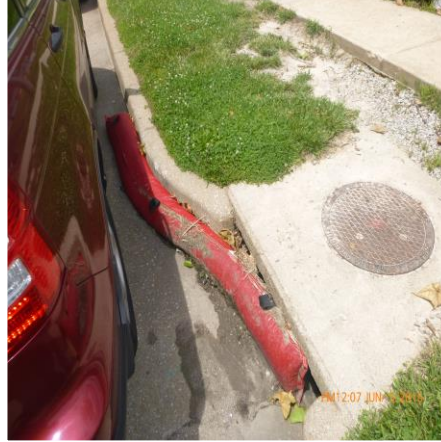
CURB INLET PROTECTION  
ON GARDEN AVENUE

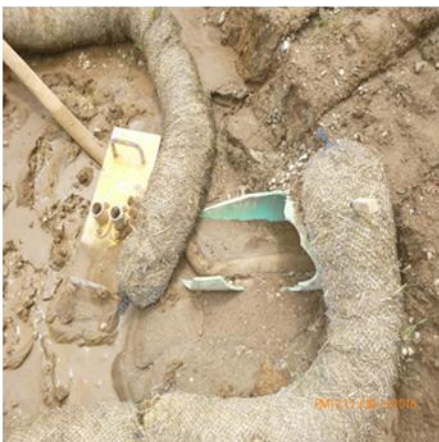
MONITOR SEDIMENT BUILDUP  
AT END OF PIPE

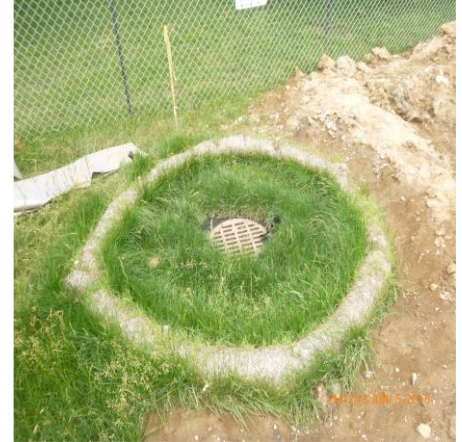
SILT SOCK AND FILTER FABRIC  
PROTECTING GI 23K2-0406D

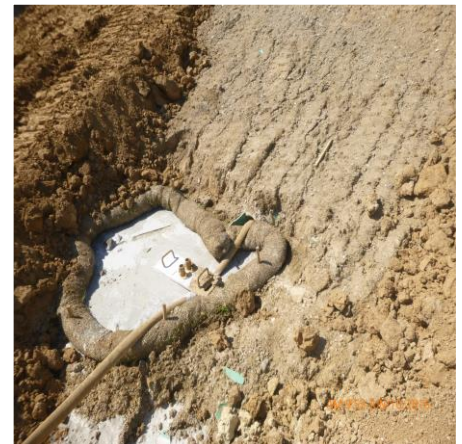
**MONITOR SEDIMENT BUILDUP  
AT END OF PIPE**

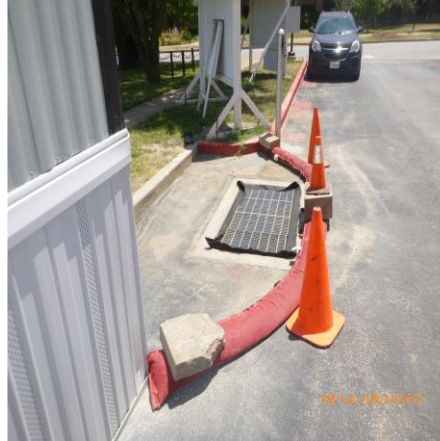
**INLET PROTECTION IN  
GOOD CONDITION**

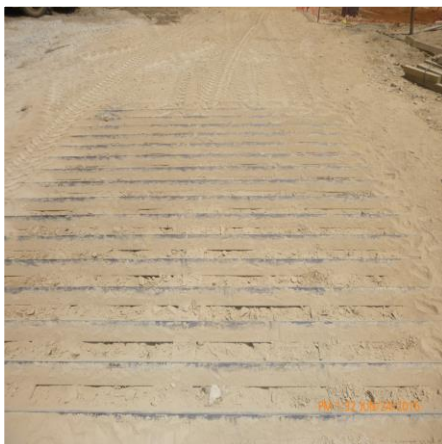
**MONITOR CONDITION OF  
EXIT RAMP RUMBLE STRIP**

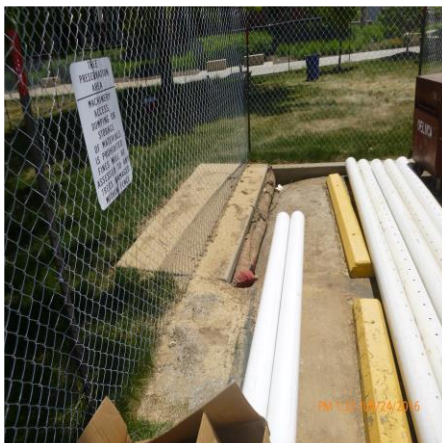
**MONITOR CONDITION OF  
INLET PROTECTION**

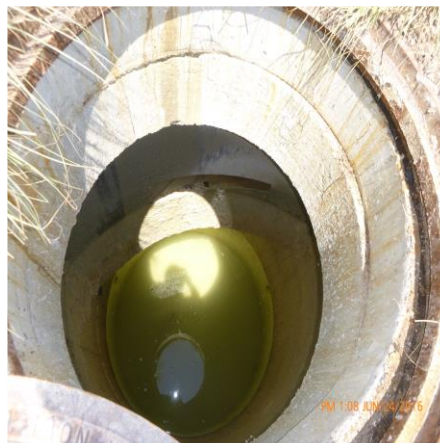
**MONITOR SEDIMENT BUILDUP  
IN HDS – CURRENTLY AT 4"**

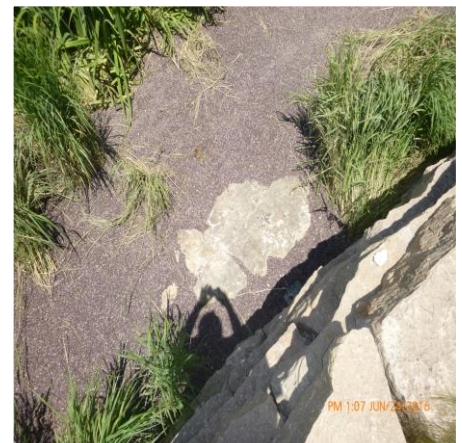
**TEMPORARY REPAIRS TO  
BIODETENTION BASIN ARE COMPLETE**

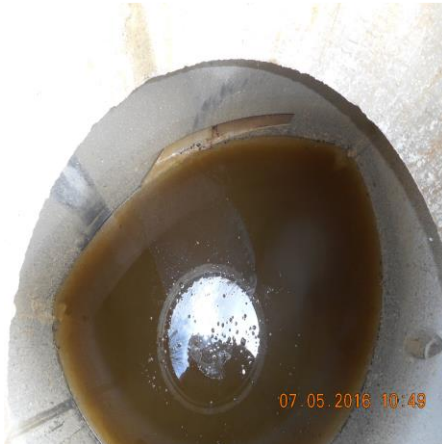
LOOKING AT TURBID WATER IN HDS

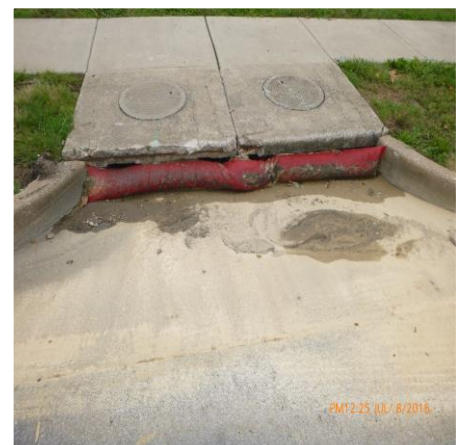
INLET PROTECTION IN PLACE AT GARDEN AVENUE

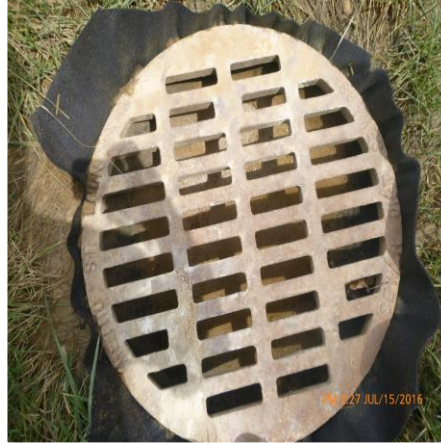
FILTER FABRIC IN PLACE AT INLET

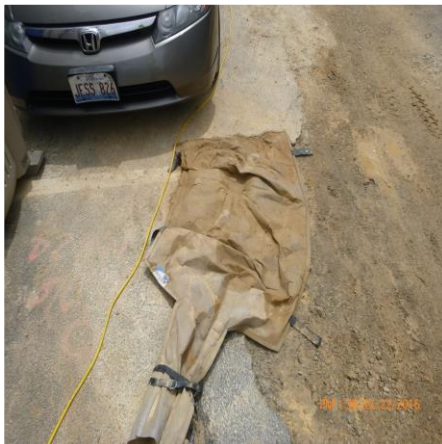
FILTER BAG AFTER COLLECTING  
SEDIMENT BEFORE DISCHARGING

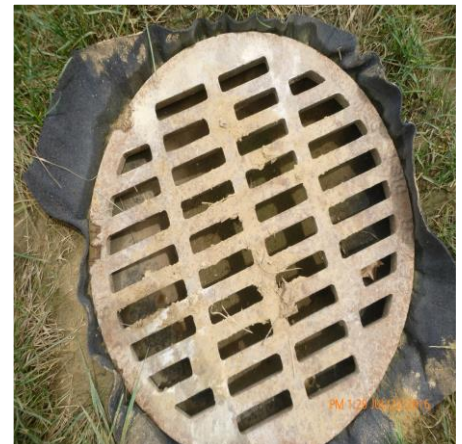
FILTER FABRIC IN PLACE AT INLET

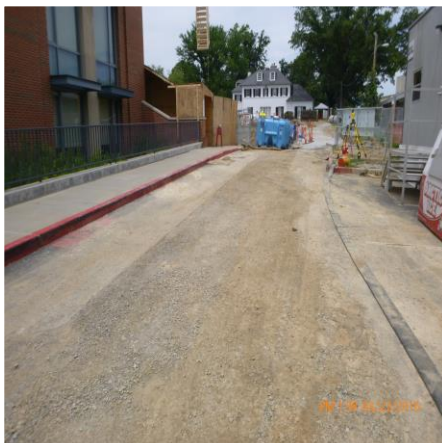
MONITOR SEDIMENT AT  
CONSTRUCTION DRIVEWAY ENTRANCE

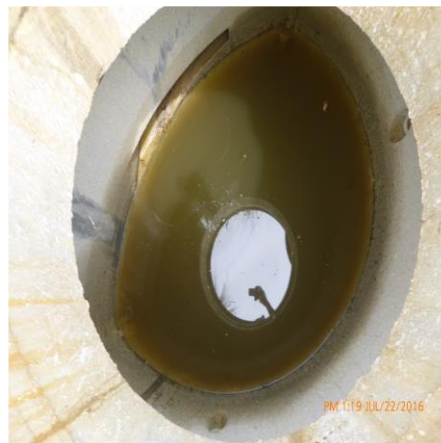
LOOKING AT TURBID WATER IN HDS

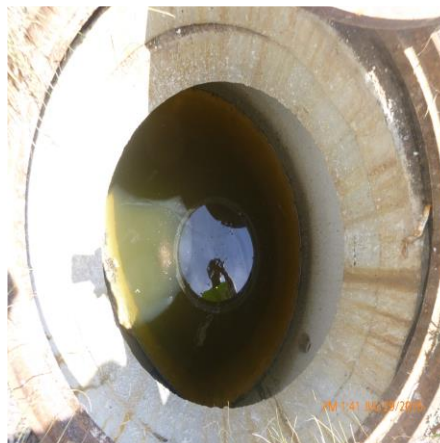
LOOKING AT TURBID WATER IN HDS

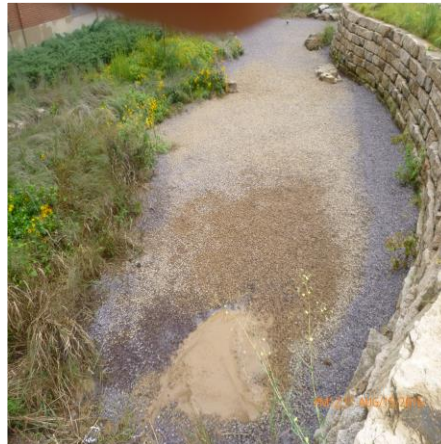
SEDIMENT ENCROACHMENT INTO RAIN  
GARDEN A

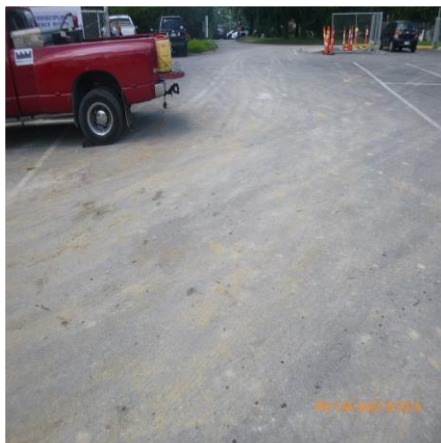
MONITOR SEDIMENT ON PARKING LOT  
LEAVING CONSTRUCTION SITE

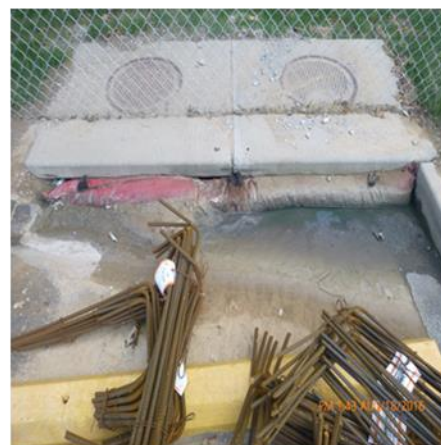
REMOVE SEDIMENT IN FROM OF INLET

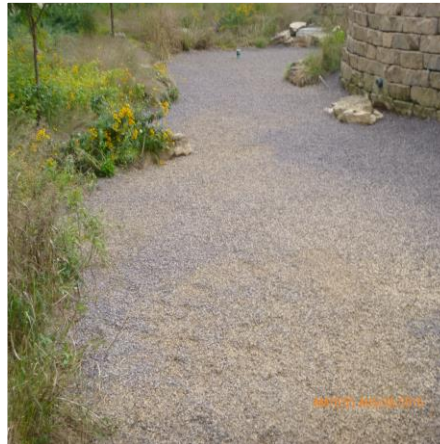
LOOKING AT MINOR SEDIMENT ON TOP OF  
ROCK IN RAIN GARDEN

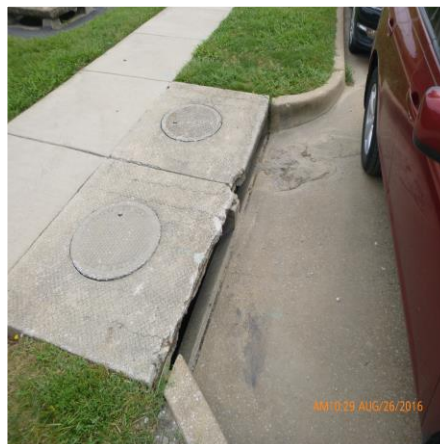
REPLACE MISSING INLET PROTECTION  
(GARDEN AVENUE)

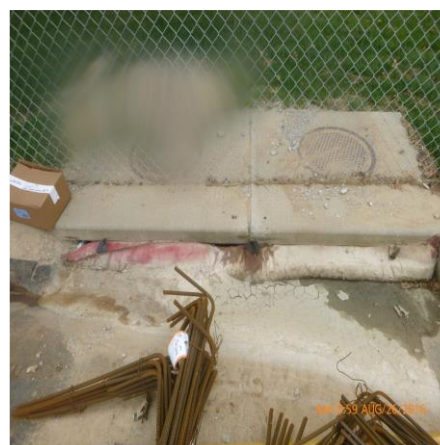
REMOVE SEDIMENT IN FROM OF INLET

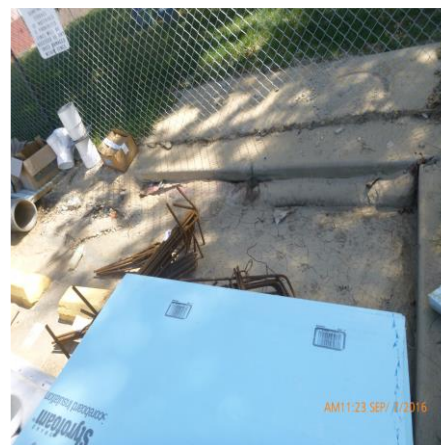
REMOVE SEDIMENT IN FROM OF INLET

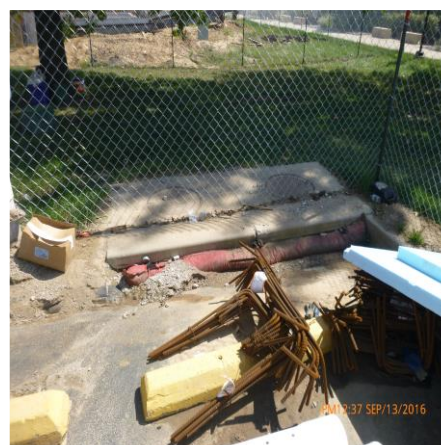
REMOVE SEDIMENT IN FROM OF INLET

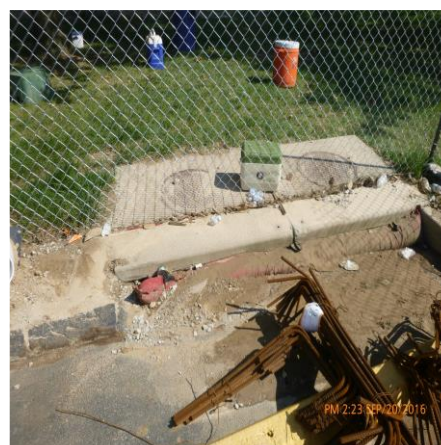
REMOVE SEDIMENT IN FROM OF INLET

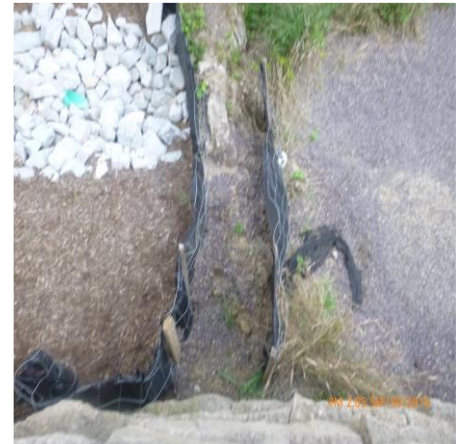
REINSTALL LOWER PORTION OF SILT FENCE

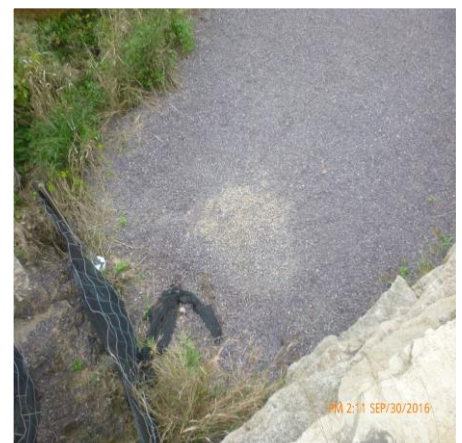
MONITOR SEDIMENT ENCROACHMENT IN  
RAIN GARDEN

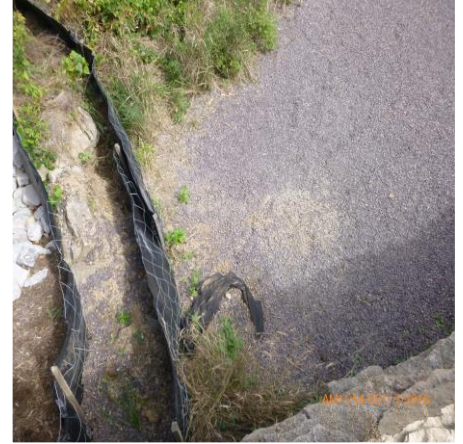
SILT FENCE REPAIRED AT RAIN GARDEN

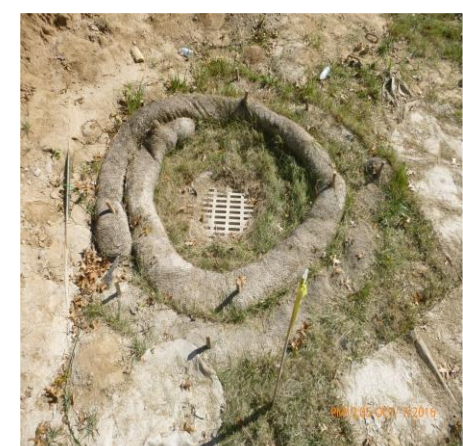
INLET PROTECTION IN PLACE

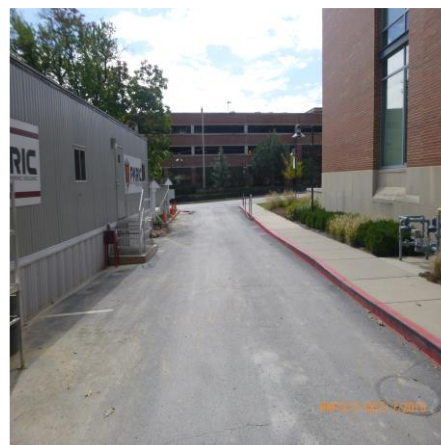
LOOKING SOUTH AT CONSTRUCTION  
DRIVEWAY ENTRANCE

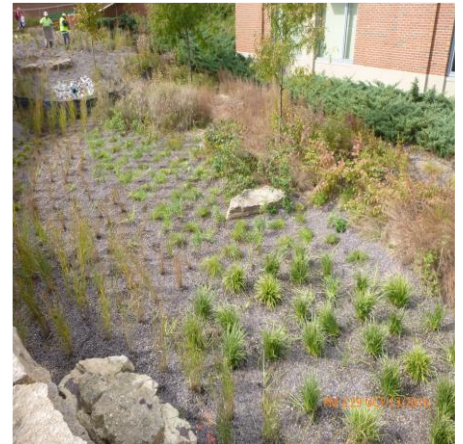
REPLANTING OF THE RAIN GARDEN

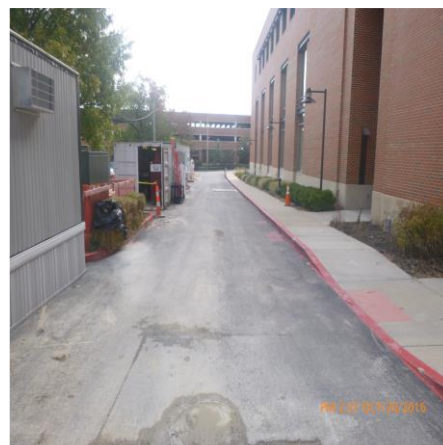
LOOKING SOUTH AT CONSTRUCTION  
DRIVEWAY ENTRANCE

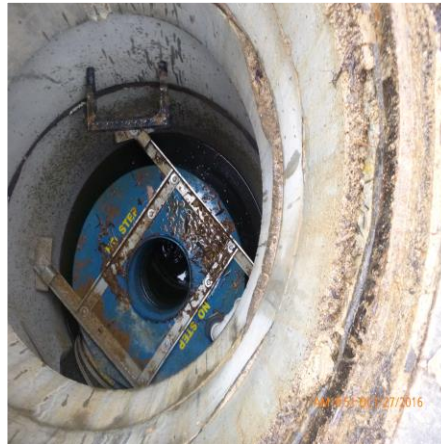
LOOKING AT TURBID WATER IN HDS

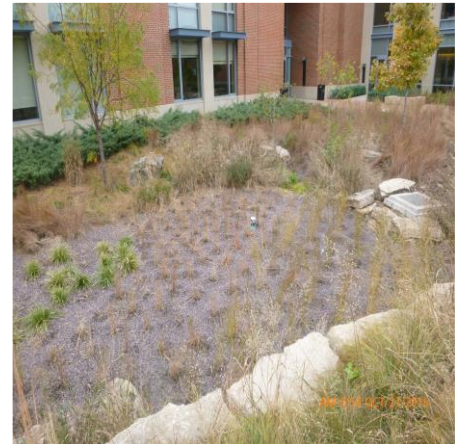
VIEW OF NEW PLANTS IN RAIN GARDEN A

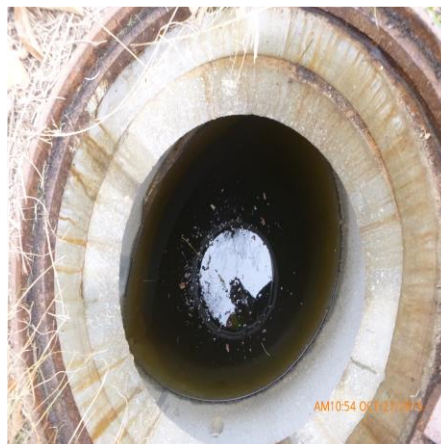
VIEW OF TURBID WATER IN HDS

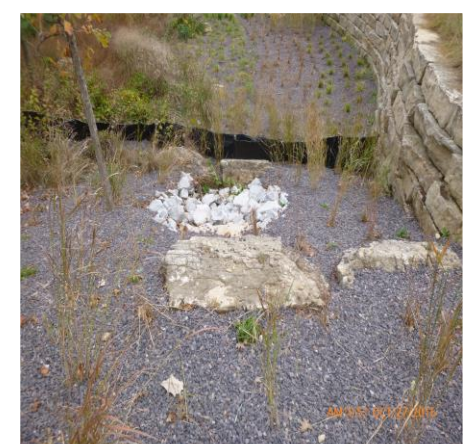
SILT FENCE IN PLACE IN RAIN GARDEN

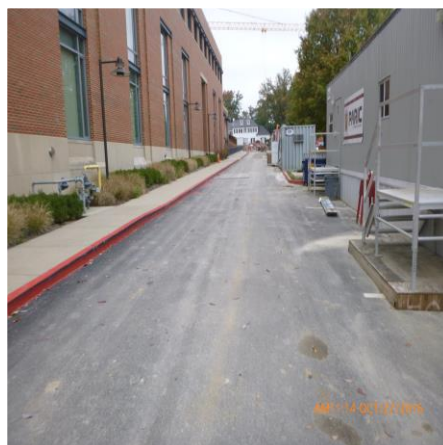
LOOKING NORTH AT CONSTRUCTION SITE  
ENTRANCE

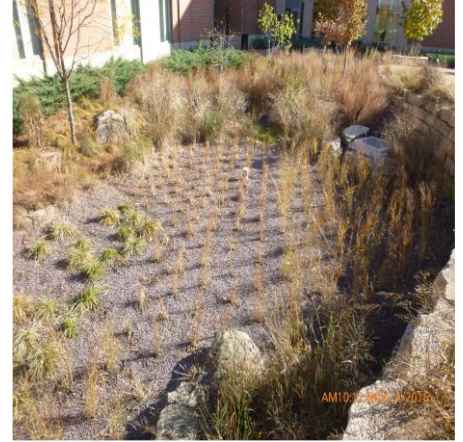
VIEW OF RAIN GARDEN A

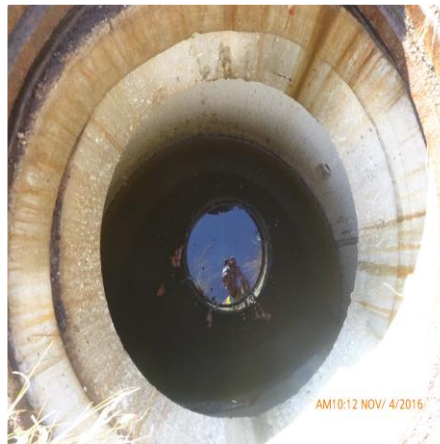
VIEW OF TURBID WATER IN HDS

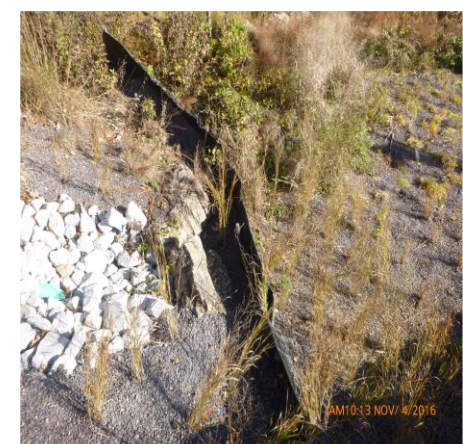
SILT FENCE IN PLACE IN RAIN GARDEN

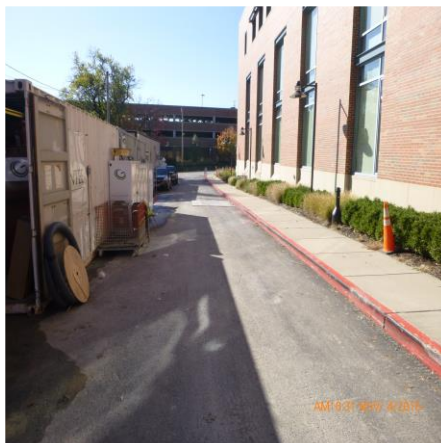
LOOKING SOUTH AT CONSTRUCTION SITE  
ENTRANCE

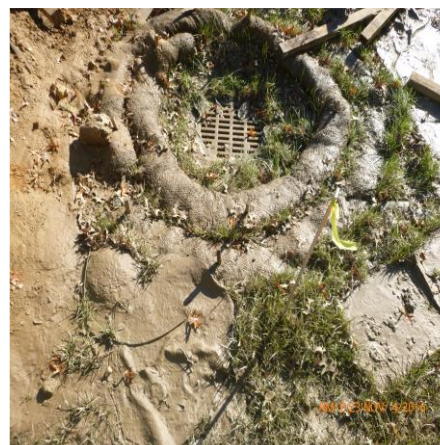
INLET PROTECTION IN PLACE

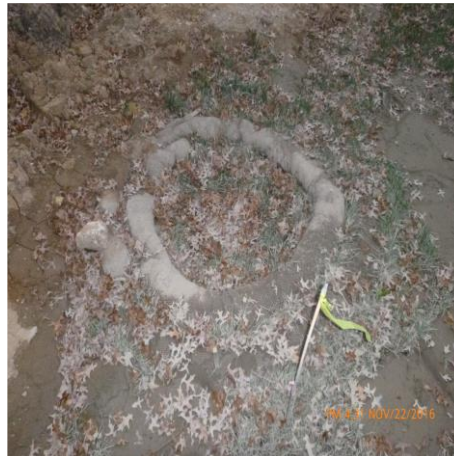
INLET PROTECTION IN PLACE

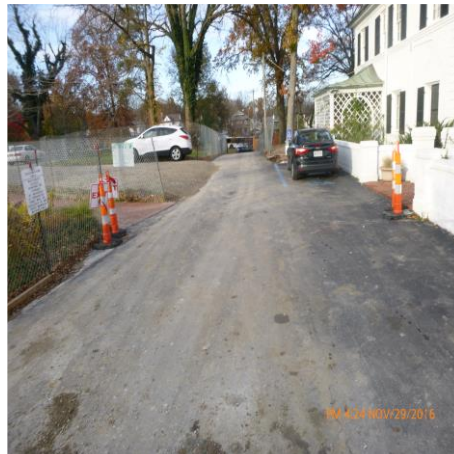
MONITOR SEDIMENT AT SITE ENTRANCE

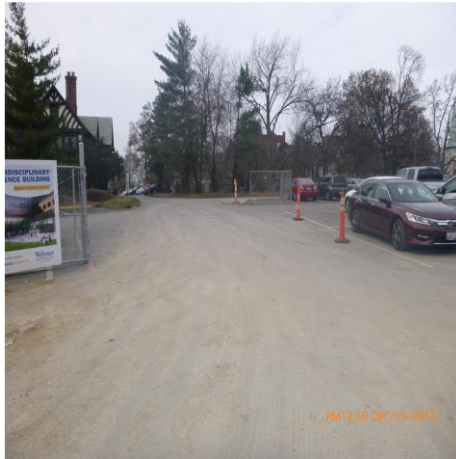
MONITOR SEDIMENT AT PARKING LOT  
ENTRANCE

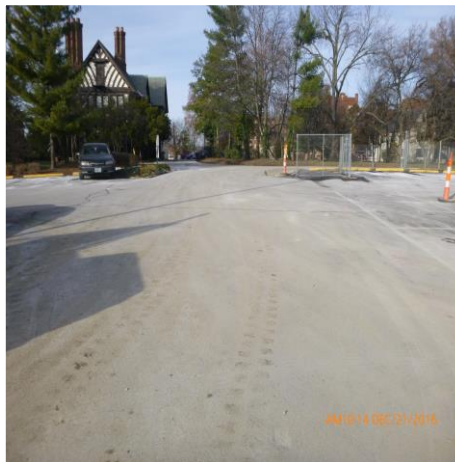
MONITOR SEDIMENT AT PARKING LOT  
ENTRANCE

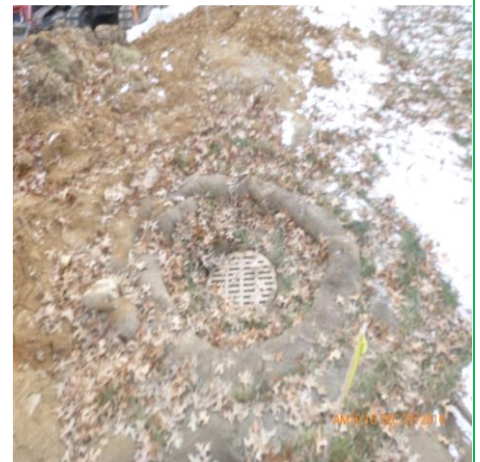
INLET PROTECTION IN PLACE

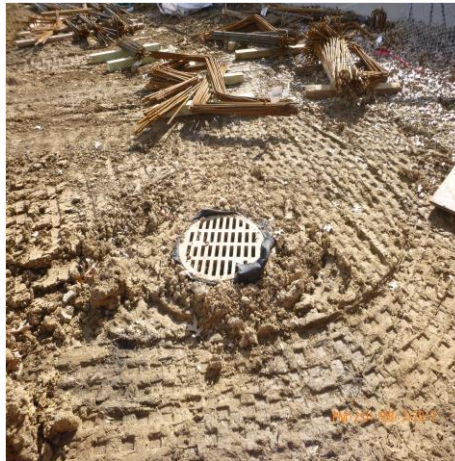
FILTER FABRIC IN PLACE INLET  
# 23K2-040D

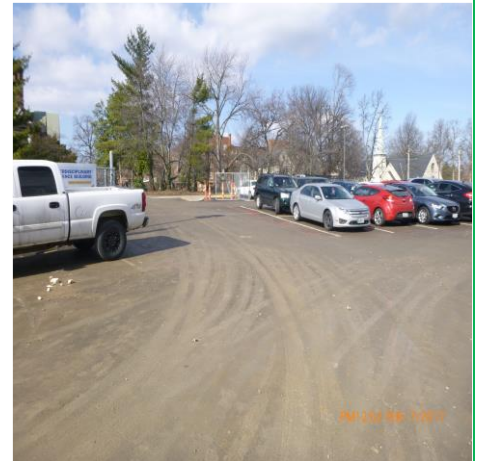
MONITOR SEDIMENT LEAVING SITE  
(PARKING LOT)

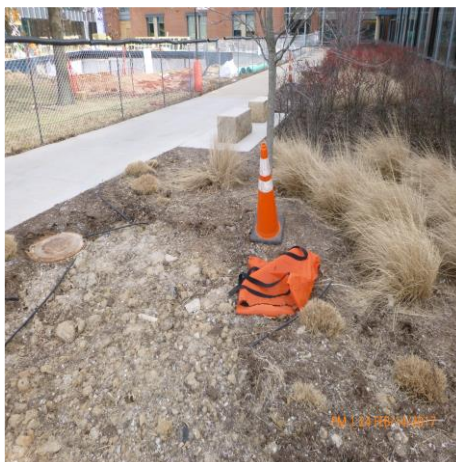
INLET PROTECTION IN PLACE

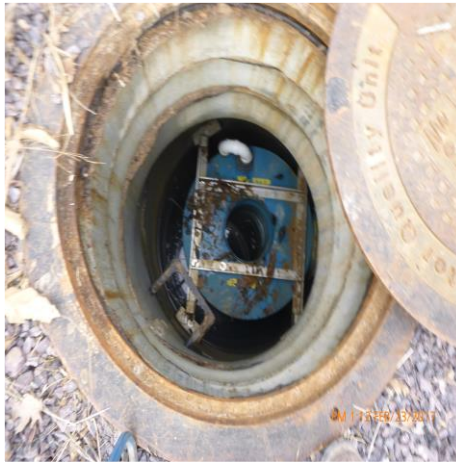
INSIDE VIEW OF DOWNSTREAM  
DEFENDER

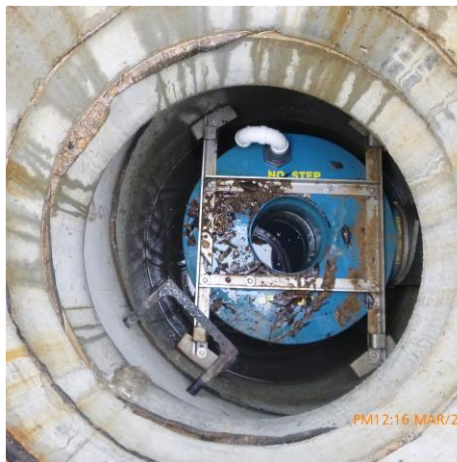
LOOKING AT INSIDE OF DOWNSTREAM  
DEFENDER

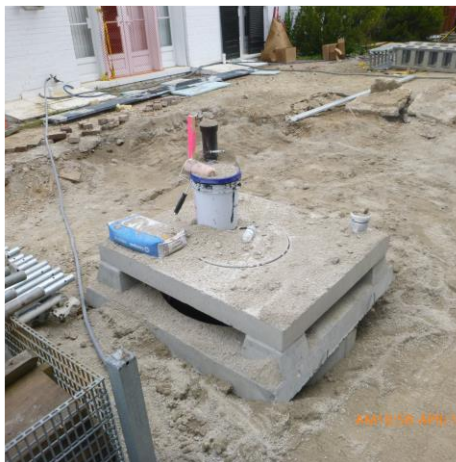
ADD PROTECTION TO AREA INLET # 4

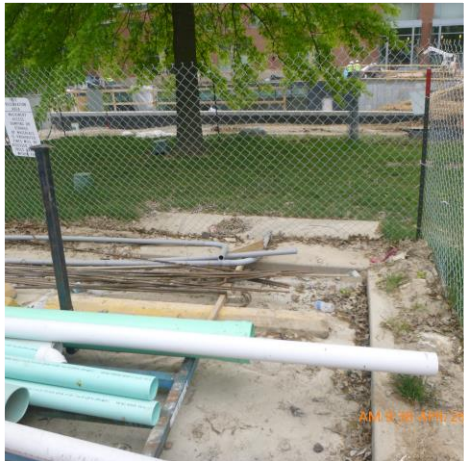
REMOVE SEDIMENT FROM IN FRONT OF CURB INLET (PARKING LOT)

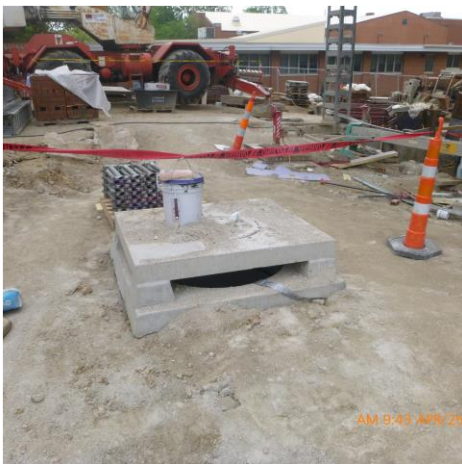
ADD PROTECTION TO AREA INLET # 4

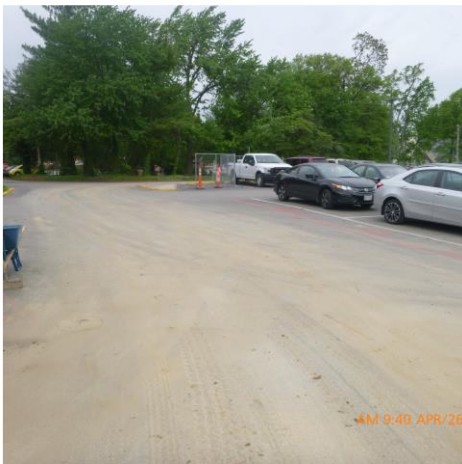
MONITOR SEDIMENT AT SITE ENTRANCE (PARKING LOT)

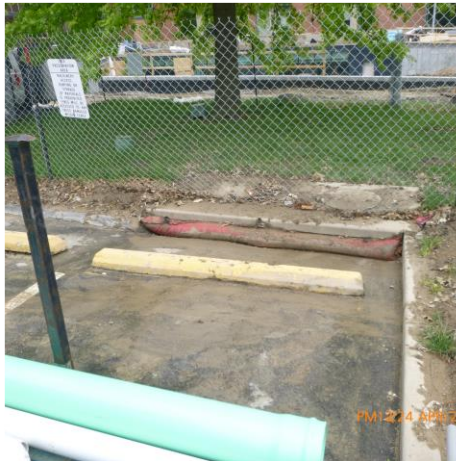
MONITOR SEDIMENT IN FRONT OF CURB  
INLET (PARKING LOT)

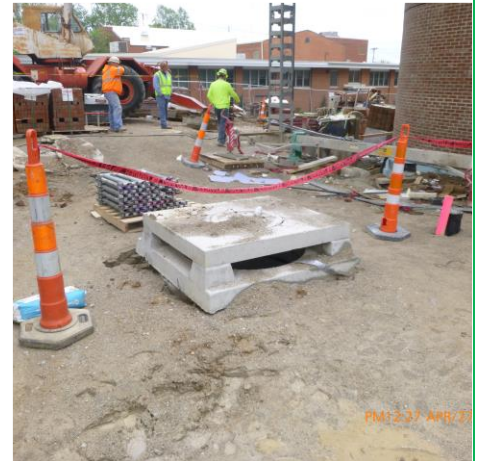
ADD PROTECTION TO AREA INLET # 4

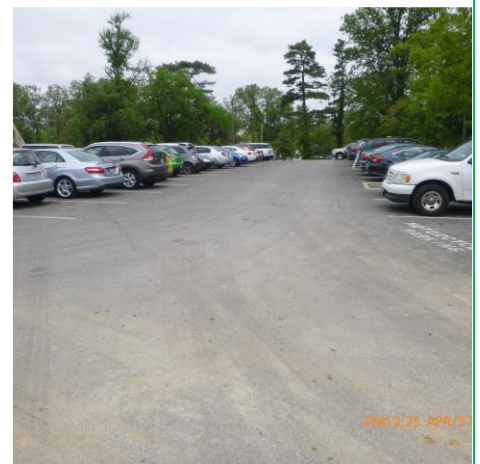
MONITOR SEDIMENT AT SITE  
ENTRANCE (PARKING LOT)

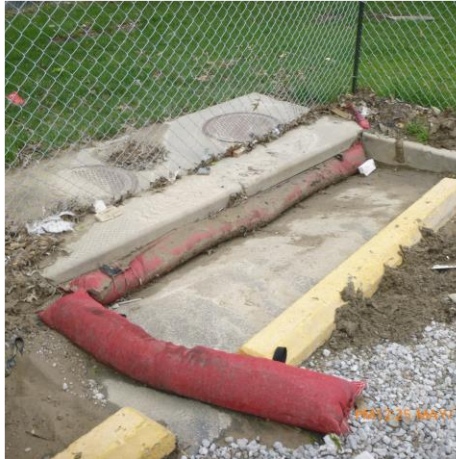
ADDITIONAL SILT SOCK ADDED TO CURB  
INLET (PARKING LOT)

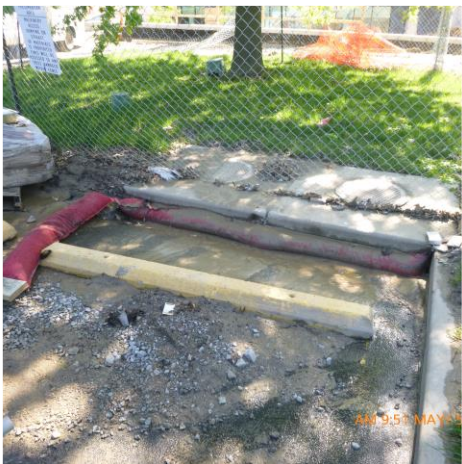
MONITOR SEDIMENT AT CURB INLET  
(PARKING LOT)

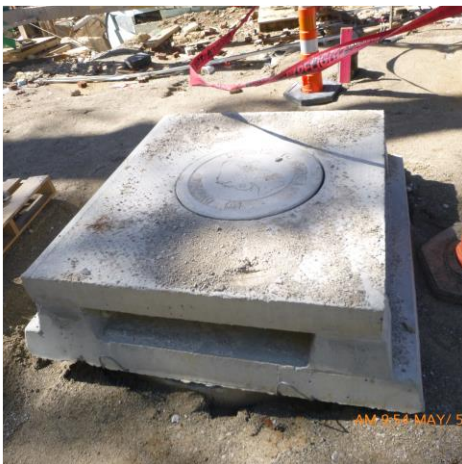
ADD PROTECTION TO AREA INLET # 4

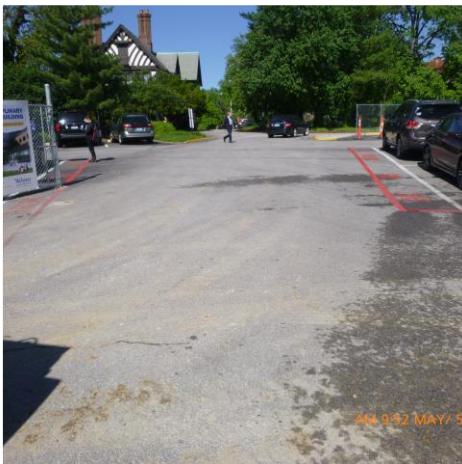
MONITOR SEDIMENT AT SITE  
ENTRANCE (PARKING LOT)

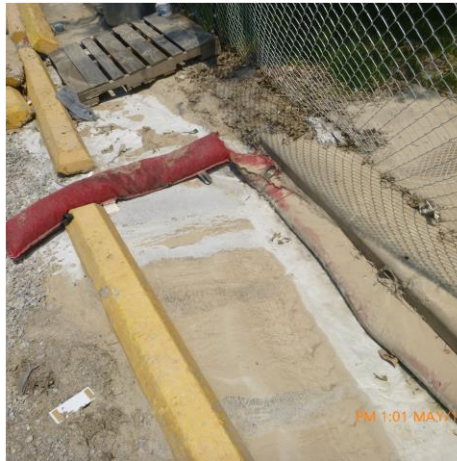
MONITOR SEDIMENT AT CURB INLET  
(PARKING LOT)

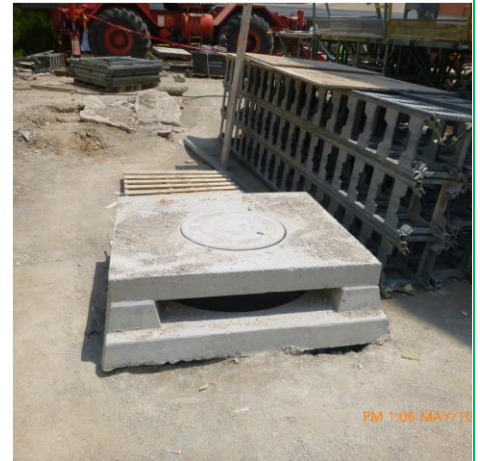
ADD PROTECTION TO AREA INLET # 4

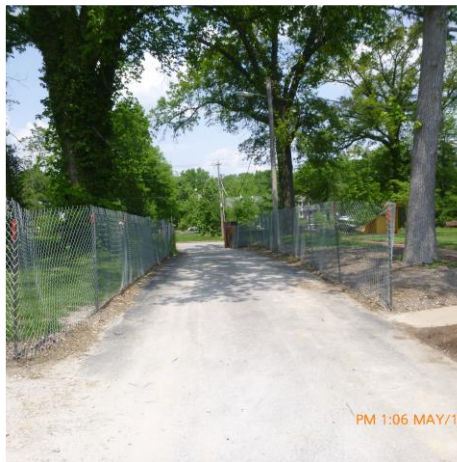
MONITOR SEDIMENT AT SITE ENTRANCE  
(BIG BEND ROAD)

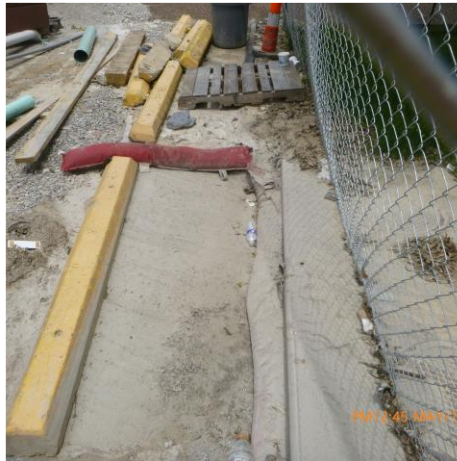
MONITOR SEDIMENT AT CURB INLET  
(PARKING LOT)

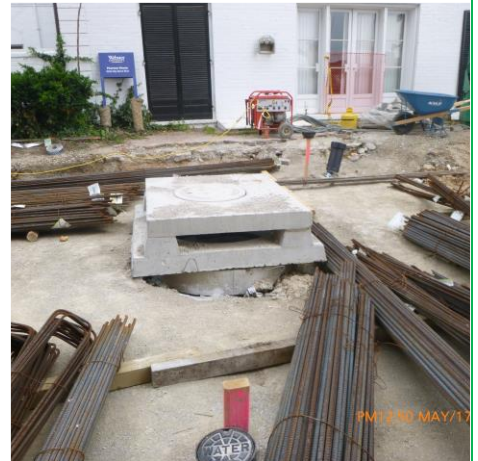
ADD PROTECTION TO AREA INLET # 4

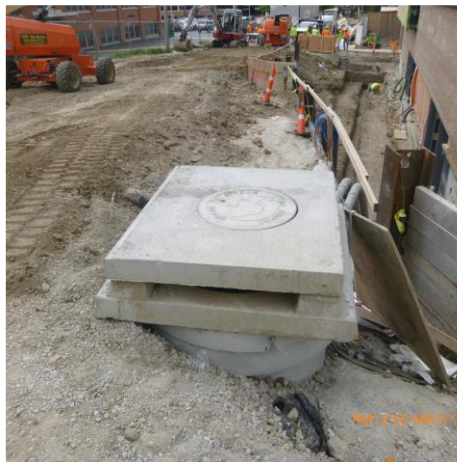
ADD PROTECTION TO AREA INLET # 3

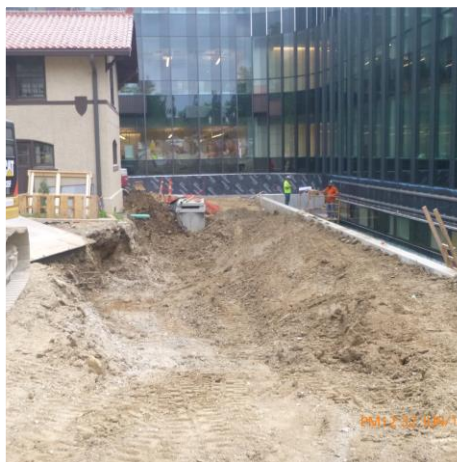
EXCAVATION OF RAIN GARDEN STARTING

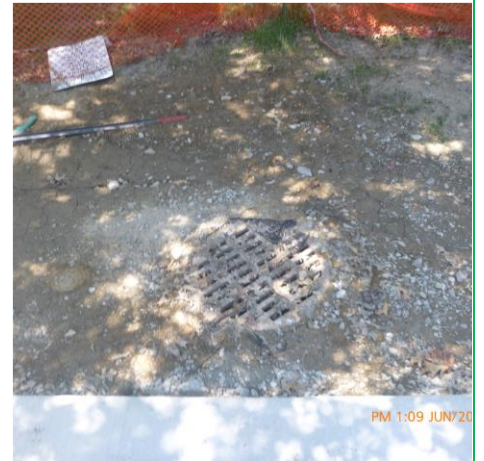
INLET PROTECTION IN PLACE

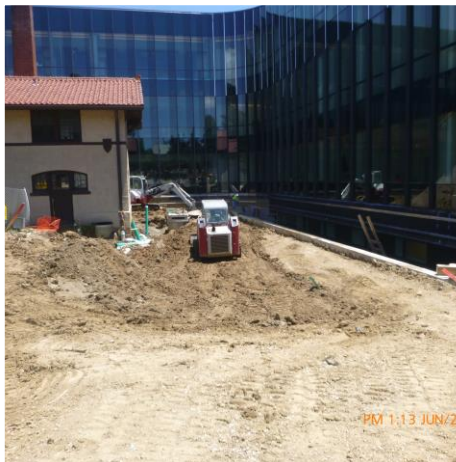
EXCAVATION OF RAIN GARDEN STARTING

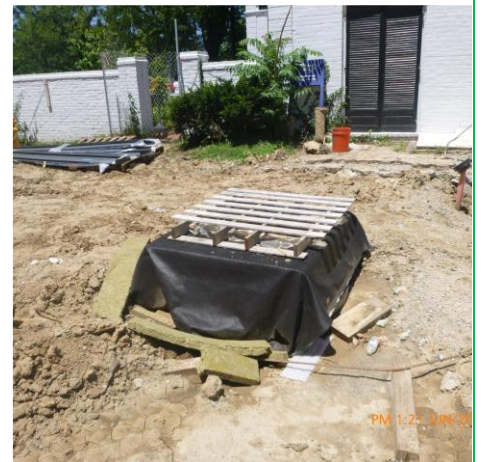
INLET PROTECTION IN PLACE

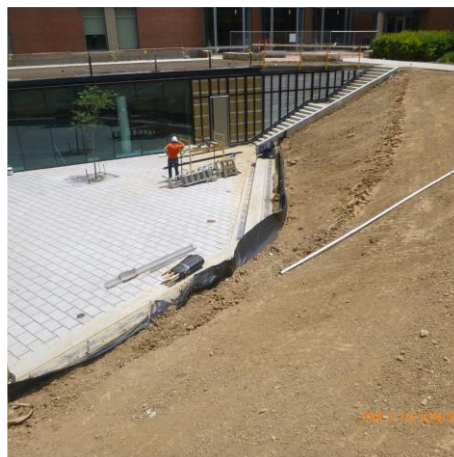
SILT FENCE INSTALLED ABOVE PATIO  
AREA

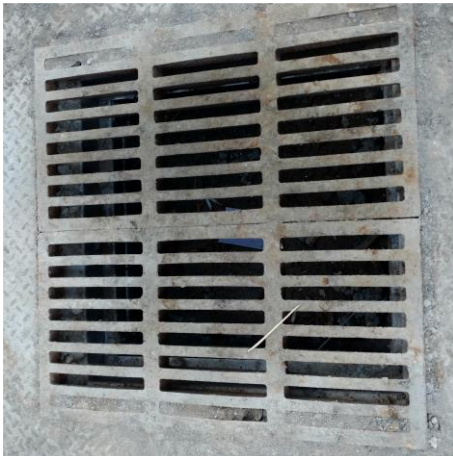
VIEW OF DBL GRATE INLET # 1

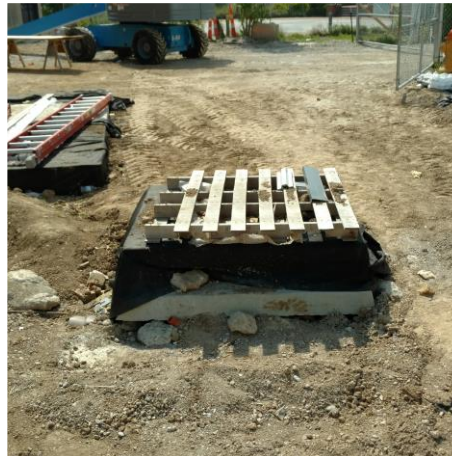
INLET PROTECTION IN PLACE

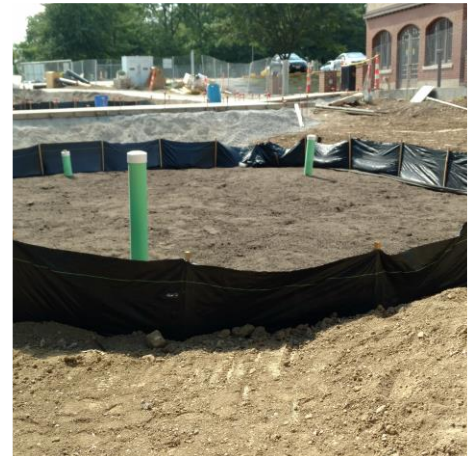
SILT FENCE IN PLACE AROUND RAIN  
GARDEN # 2

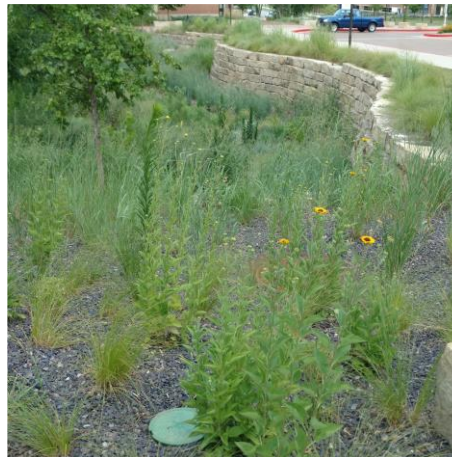
VIEW OF RAIN GARDEN A

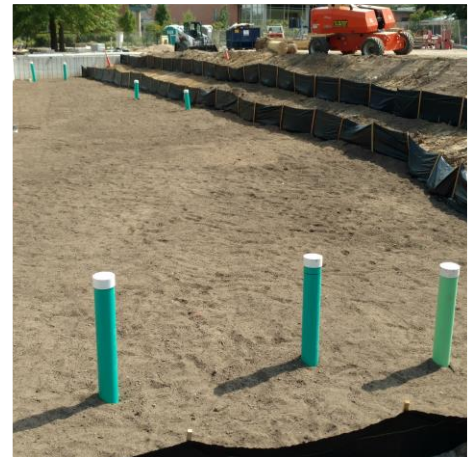
SILT FENCE IN PLACE AROUND RAIN  
GARDEN # 1

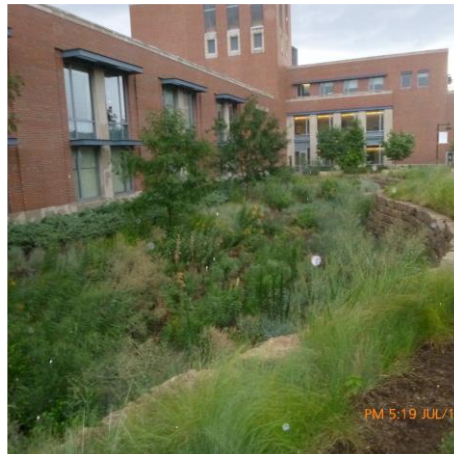
VIEW OF RAIN GARDEN A

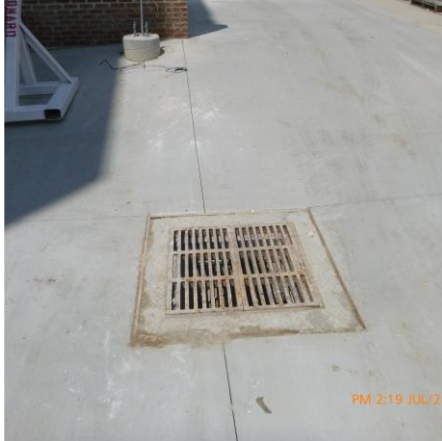
VIEW OF DBL GRATE INLET # 1  
PROTECTED BY FILTER INSERT

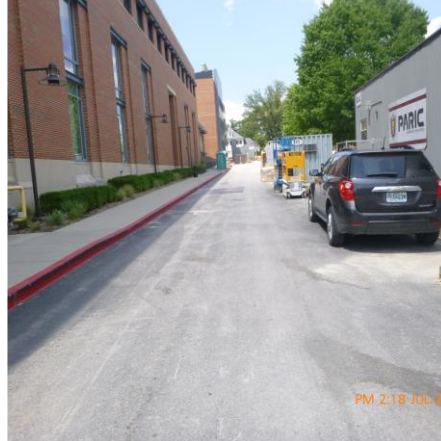
LOOKING NORTH AT SITE ENTRANCE  
DRIVEWAY

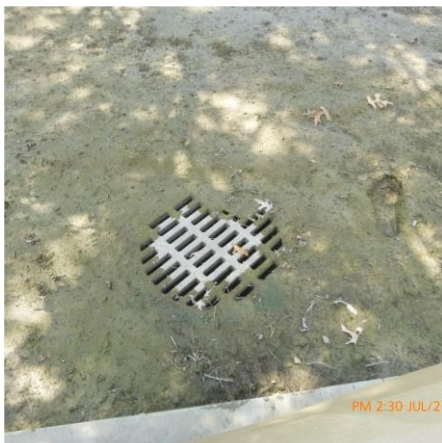
INLET PROTECTION IN PLACE
