# Post-Construction Stormwater BMP Incident Report

| Project: <b>Webster University ISB</b> | | License #: <b>MO E-18668</b> |
| Incident Date(s): <b>6/16/2016 - 6/17/2016</b> | | Address: <b>5858 Delor Street 63109</b> |

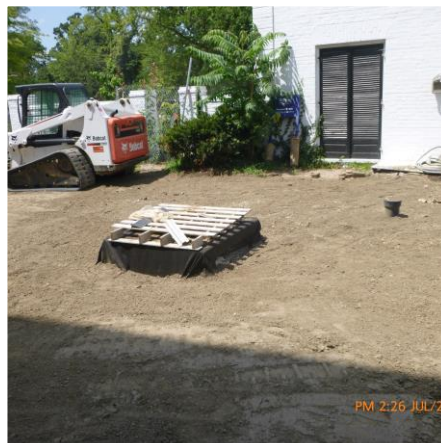
INLET PROTECTION IN PLACE

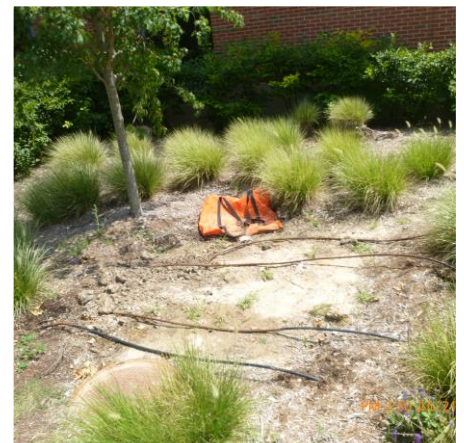
INLET PROTECTION IN PLACE

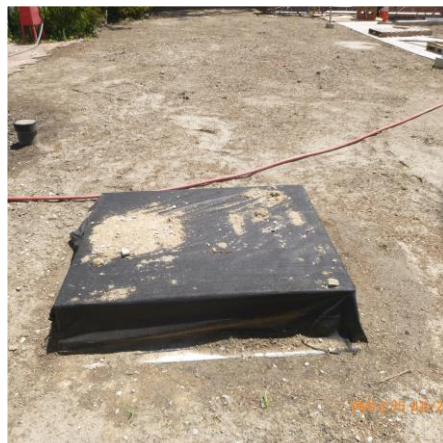
INLET PROTECTION IN PLACE

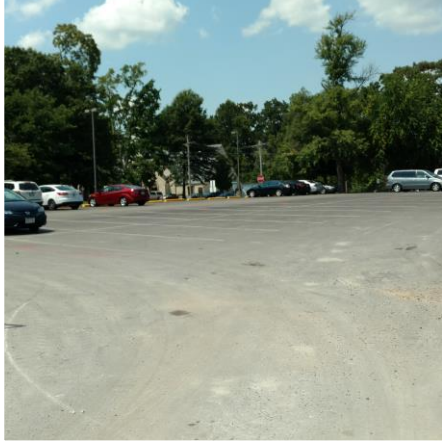
MONITOR SEDIMENT AT SITE  
ENTRANCE (PARKING LOT)

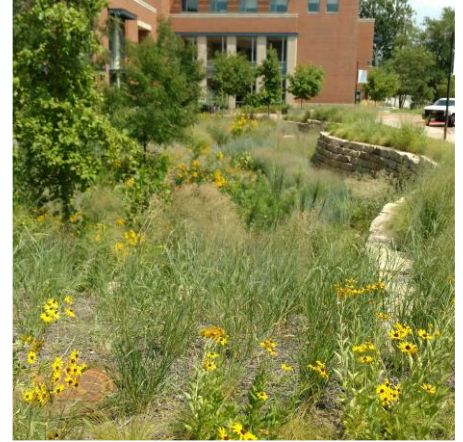
VIEW OF RAIN GARDEN # 1
