## **ARCHITECTURAL PUNCH LIST (EXTERIOR FAÇADE & ROOF)**

**Project:** Webster University Interdisciplinary Science Building

**Project No:** CannonDesign #004561.01

**Date of Observation:** August 7, 2017

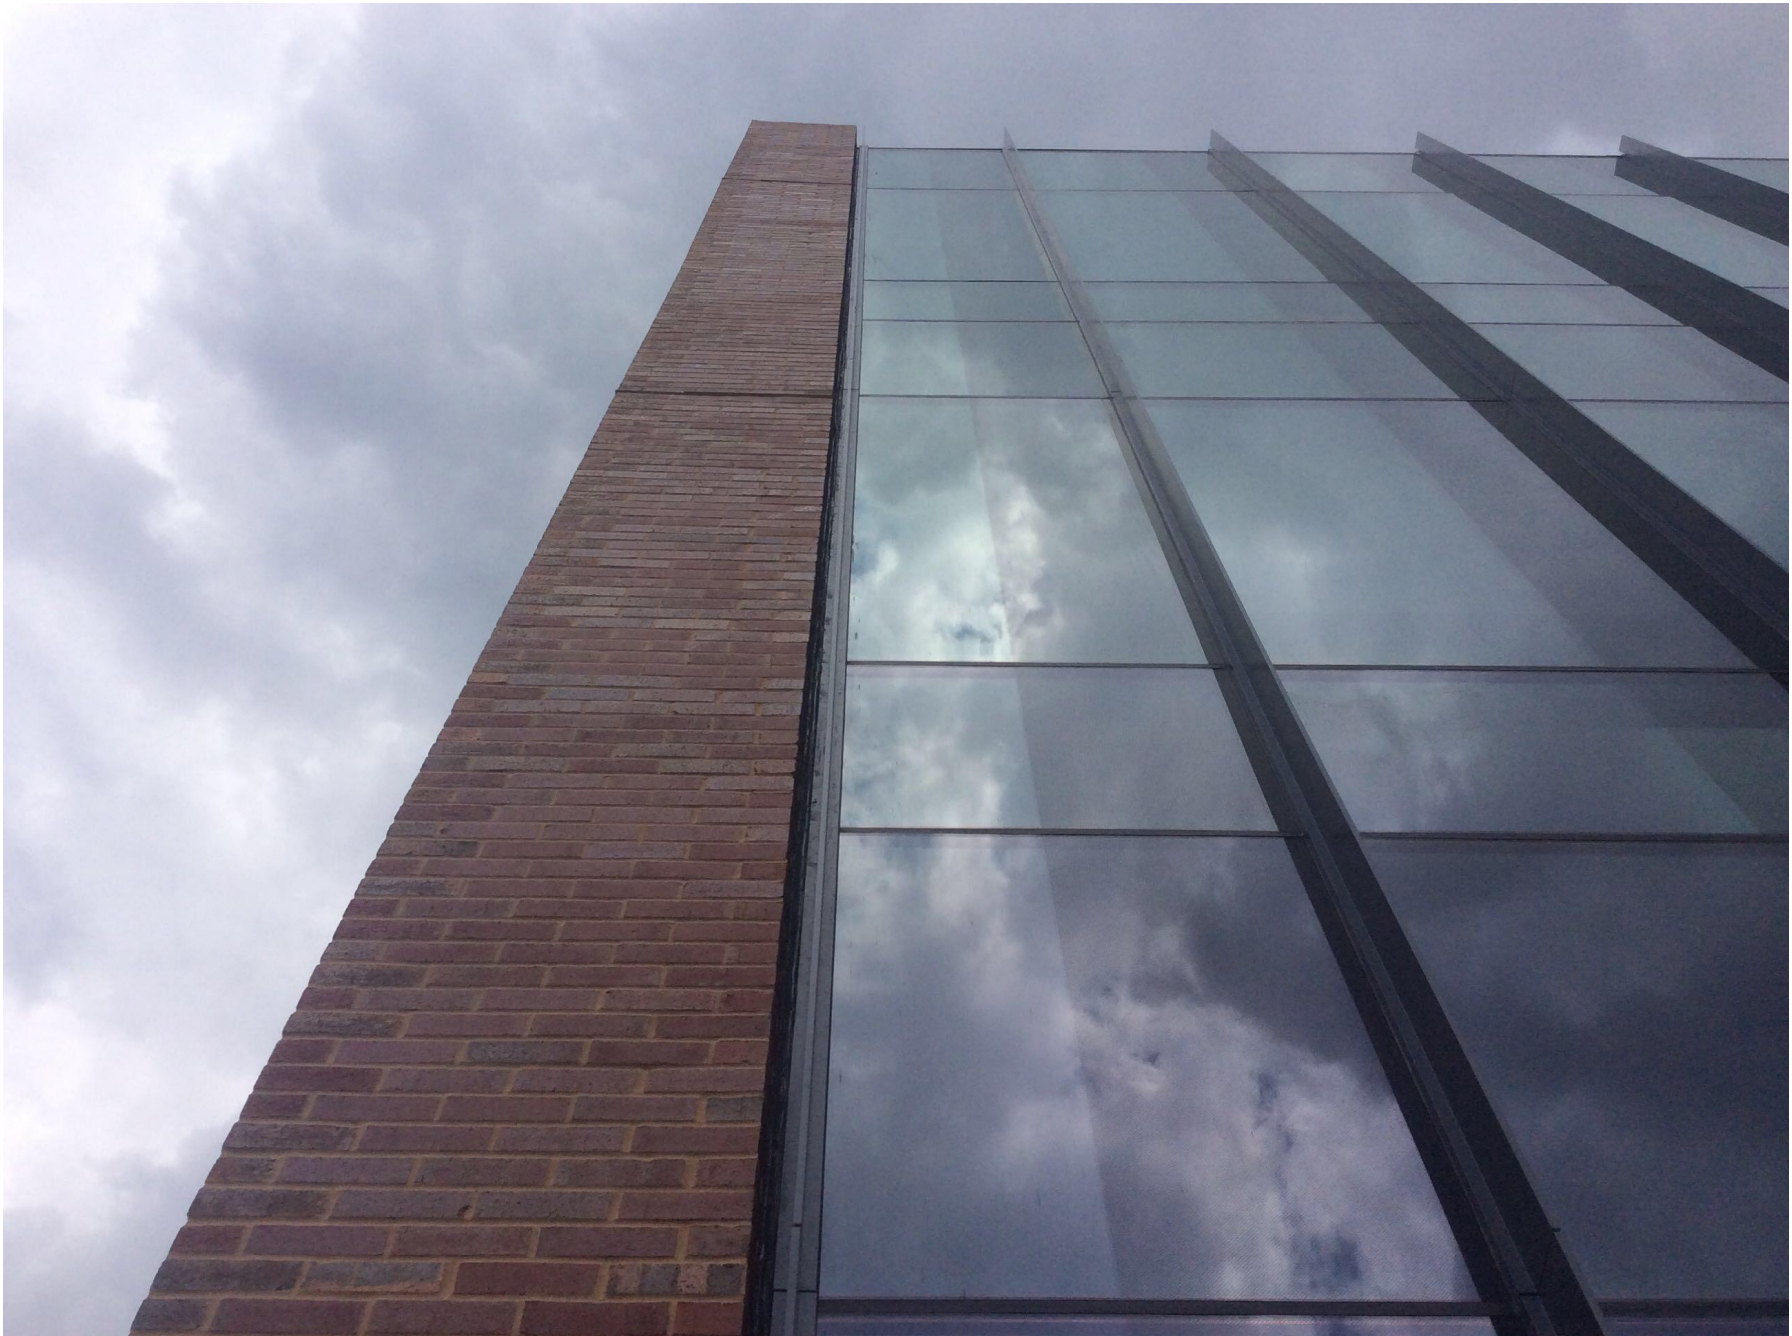
| Issue ID | Description | Location Detail | Location | Status | Company | Type | Date Created | Due Date |
|---|---|---|---|---|---|---|---|---|
| 002134 | Cleanup sealant joint curtainwall to masonry | | Site | Open | National Glass & Glazing, Inc. | Architect Punch List | 07 Aug 2017 | 12 Aug 2017 |

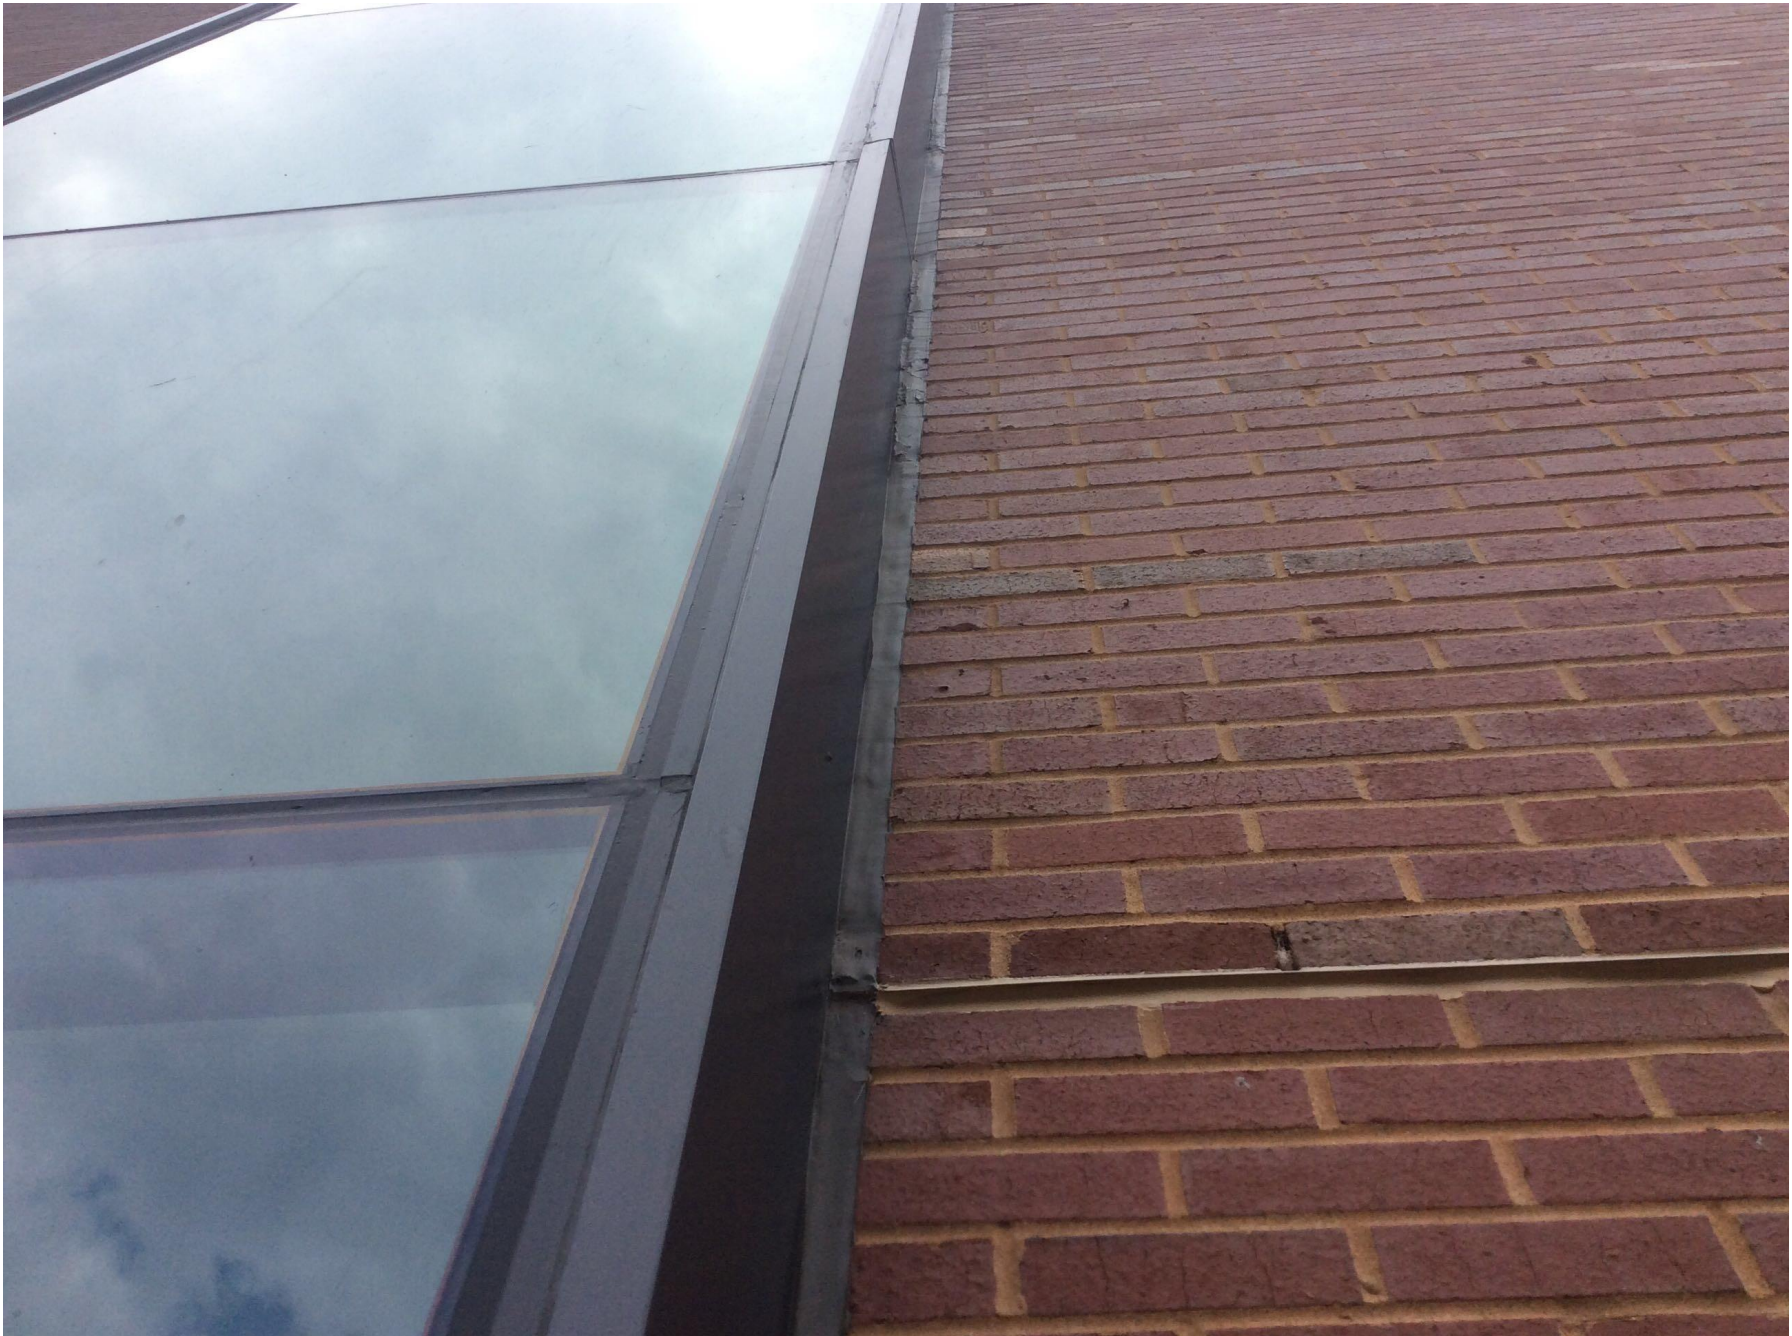
| Issue ID | Description | Location Detail | Location | Status | Company | Type | Date Created | Due Date |
|---|---|---|---|---|---|---|---|---|
| 002136 | Repair substandard sealant at north window | | Site | Open | National Glass & Glazing, Inc. | Architect Punch List | 07 Aug 2017 | 12 Aug 2017 |

At north vertical window, the vertical sealant joints along the jambs are wider and does not conform to documents. The sealant has to be tooled to have smooth consistent finish.

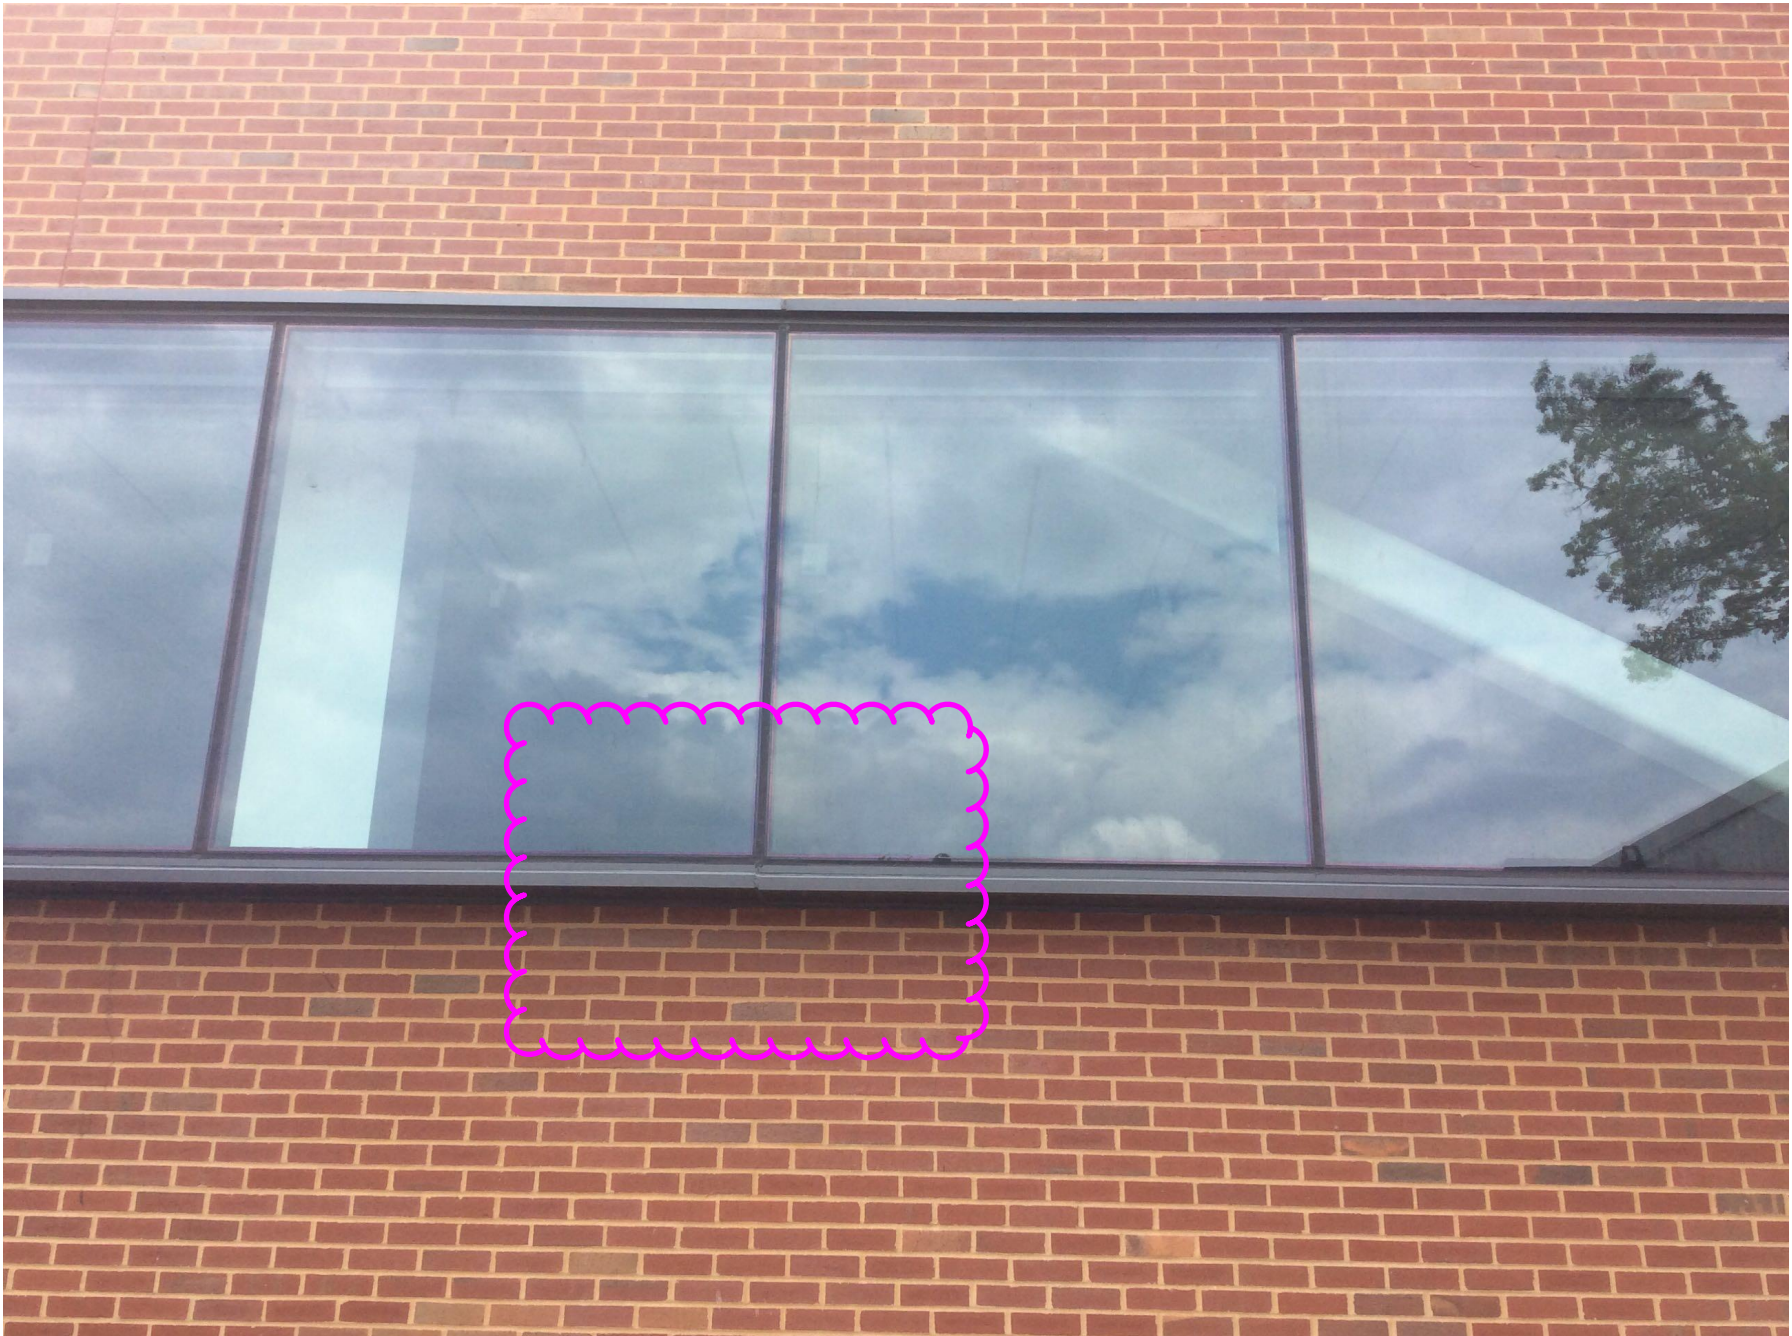
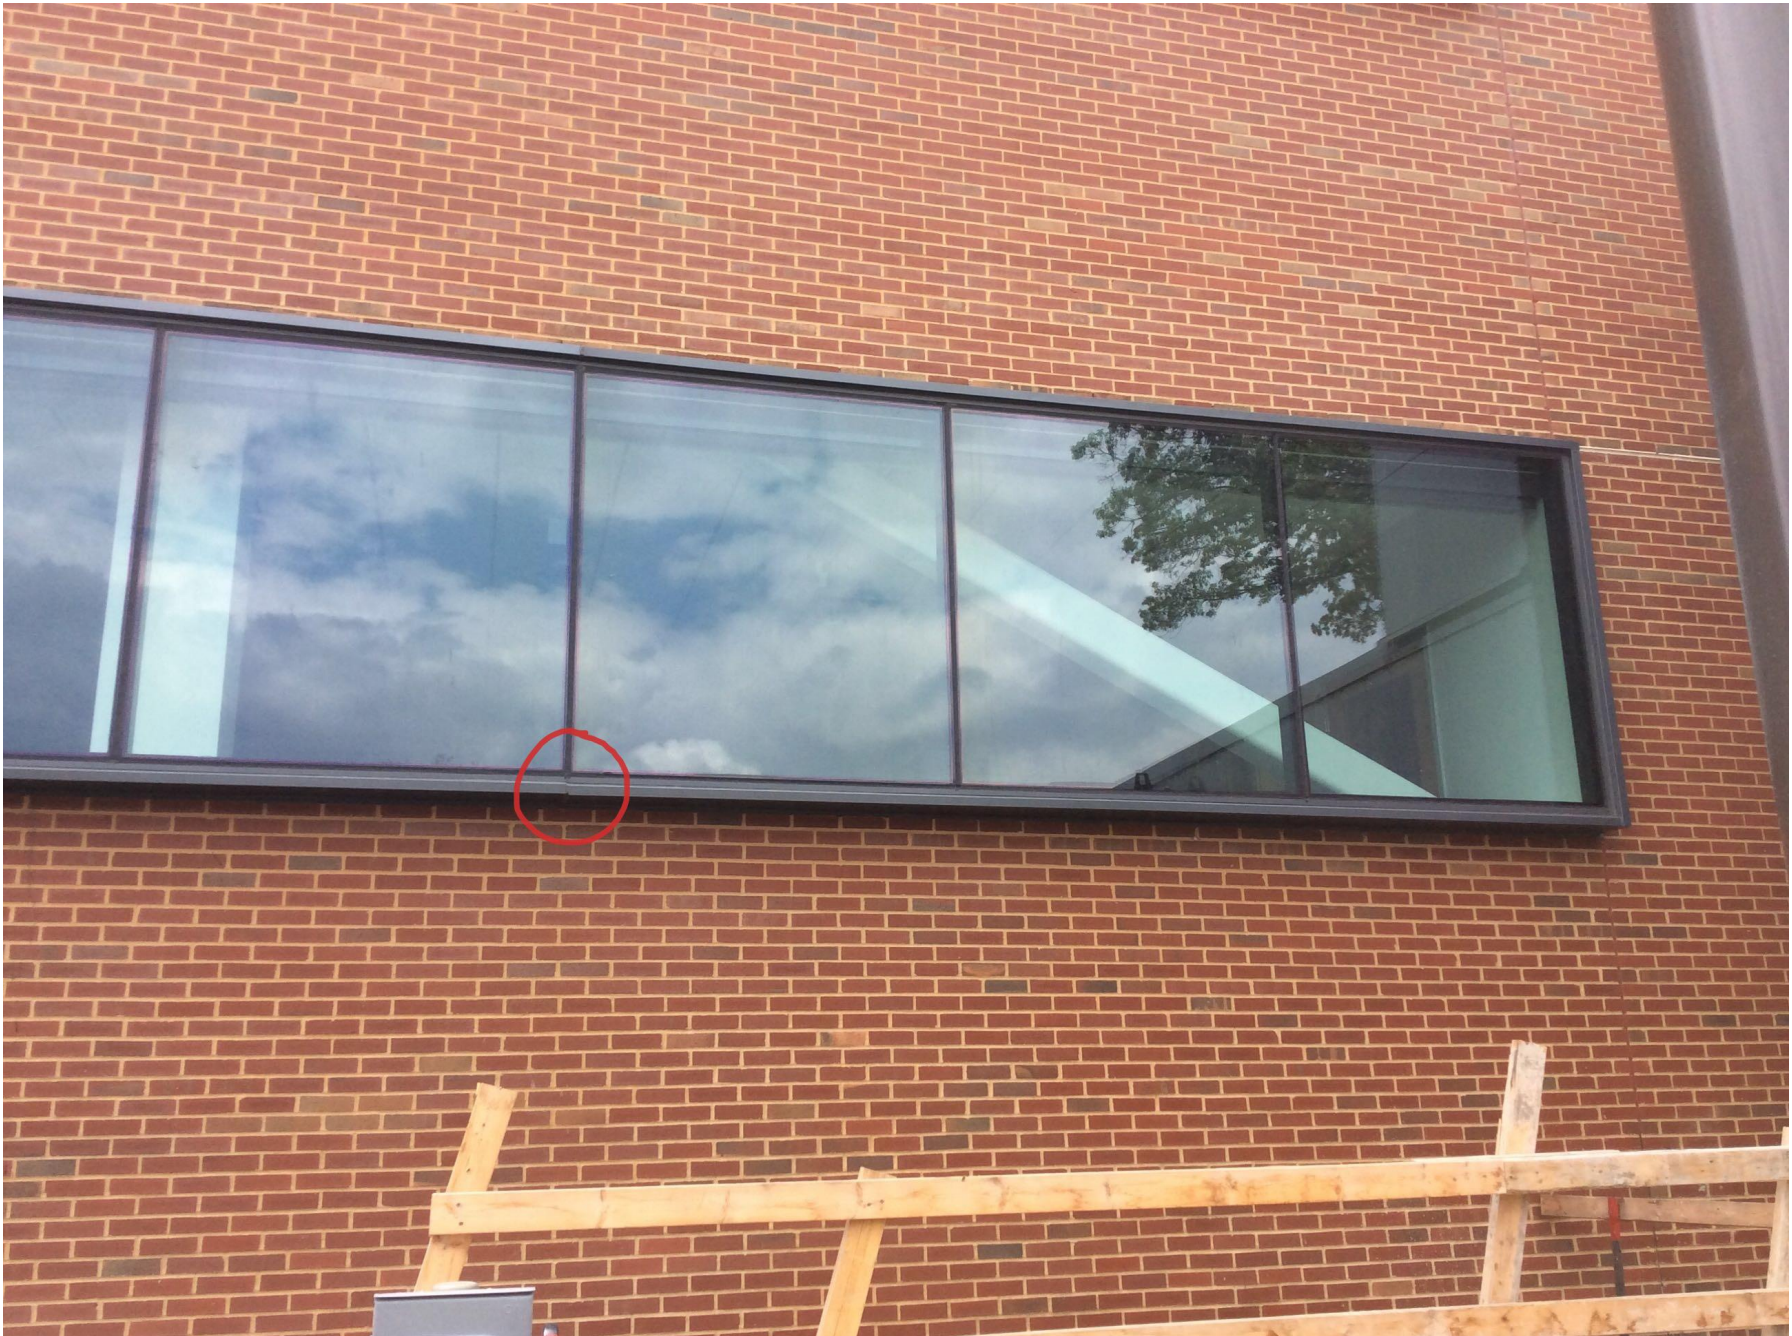
| Issue ID | Description | Location Detail | Location | Status | Company | Type | Date Created | Due Date |
|---|---|---|---|---|---|---|---|---|
| 002140 | Misalignment at window sill - east projection window | | Site | Open | National Glass & Glazing, Inc. | Architect Punch List | 07 Aug 2017 | 12 Aug 2017 |

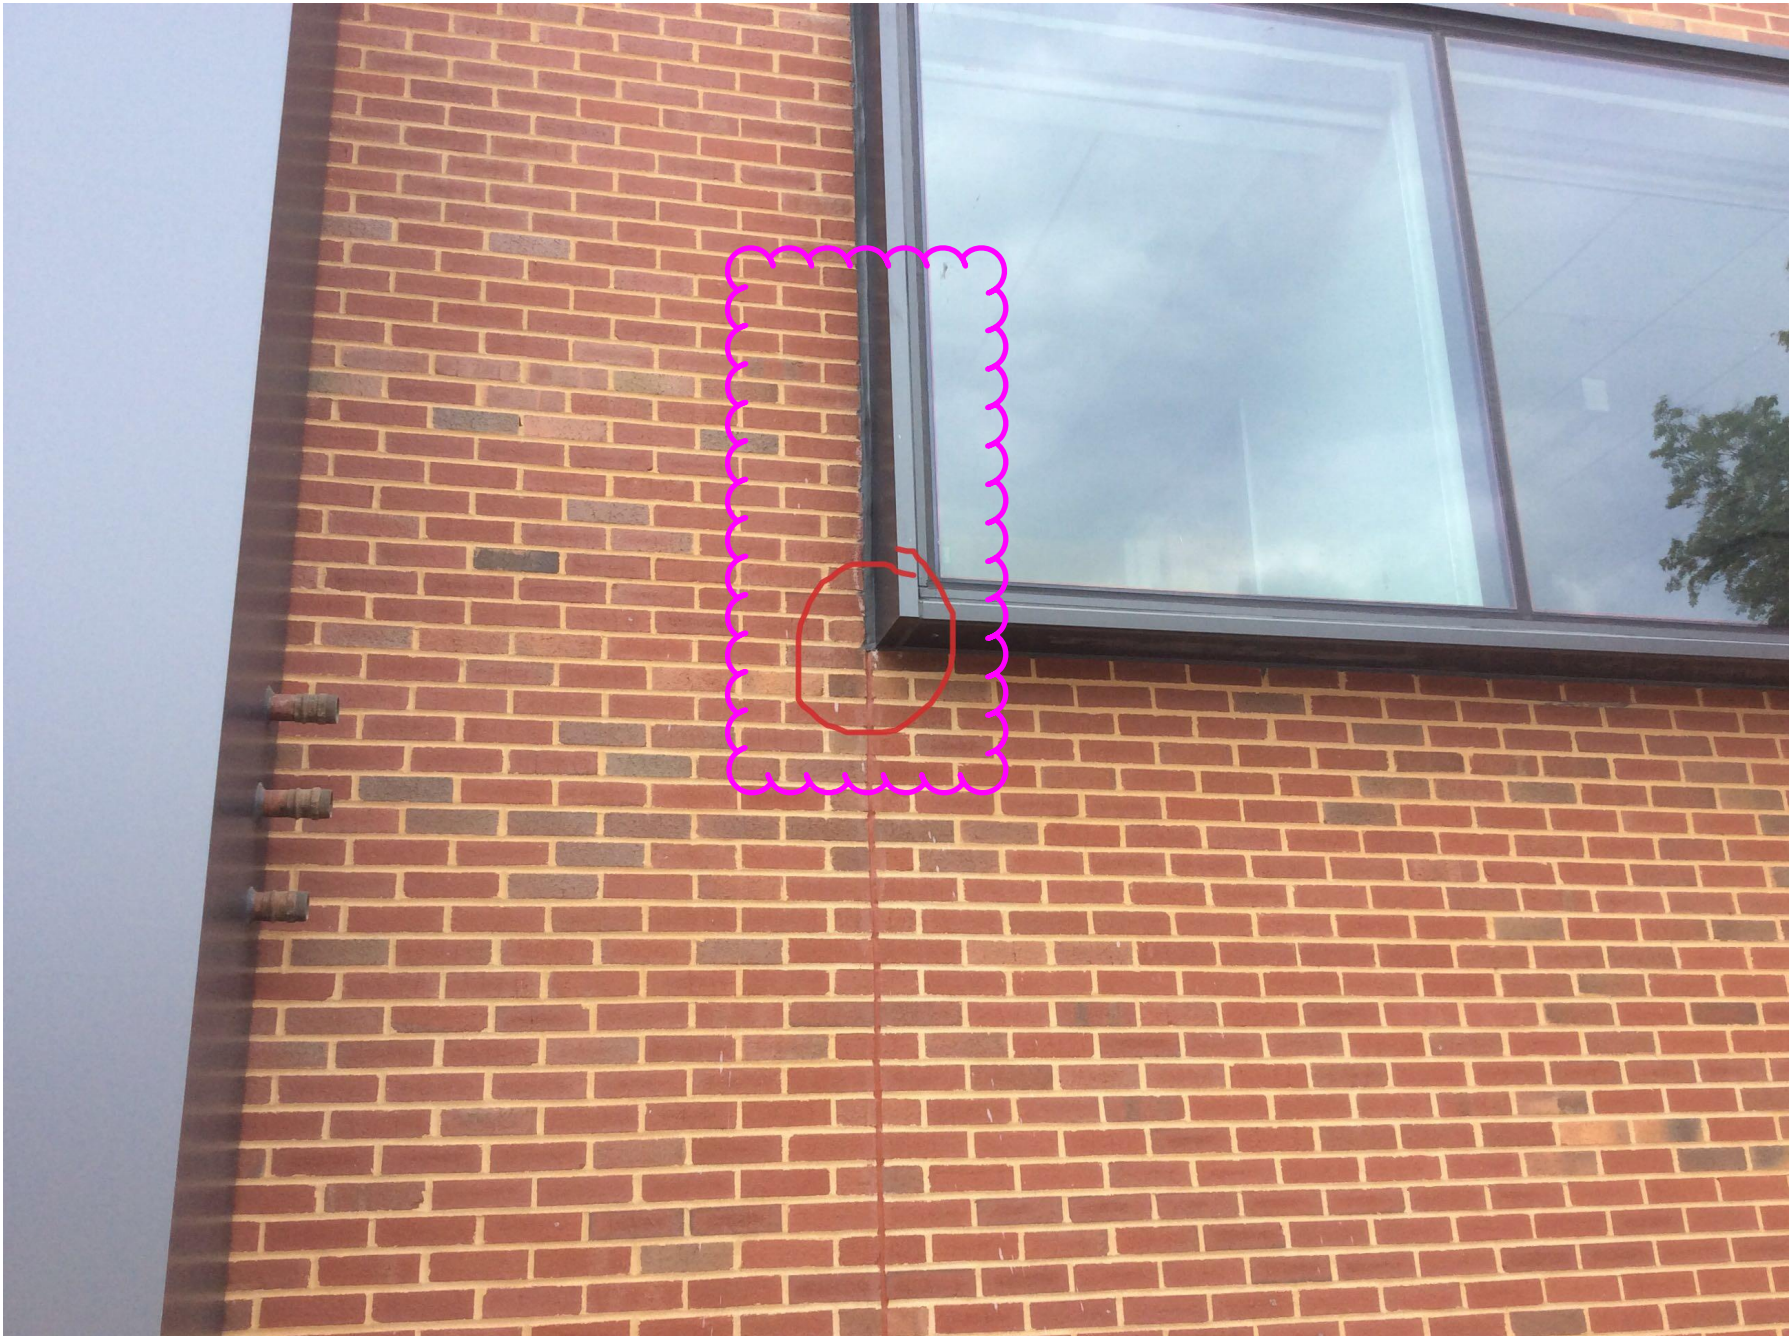
| Issue ID | Description | Location Detail | Location | Status | Company | Type | Date Created | Due Date |
|---|---|---|---|---|---|---|---|---|
| 002142 | Cleanup excess sealant on masonry, tool joint correctly - east projection window | | Site | Open | National Glass & Glazing, Inc. | Architect Punch List | 07 Aug 2017 | 12 Aug 2017 |

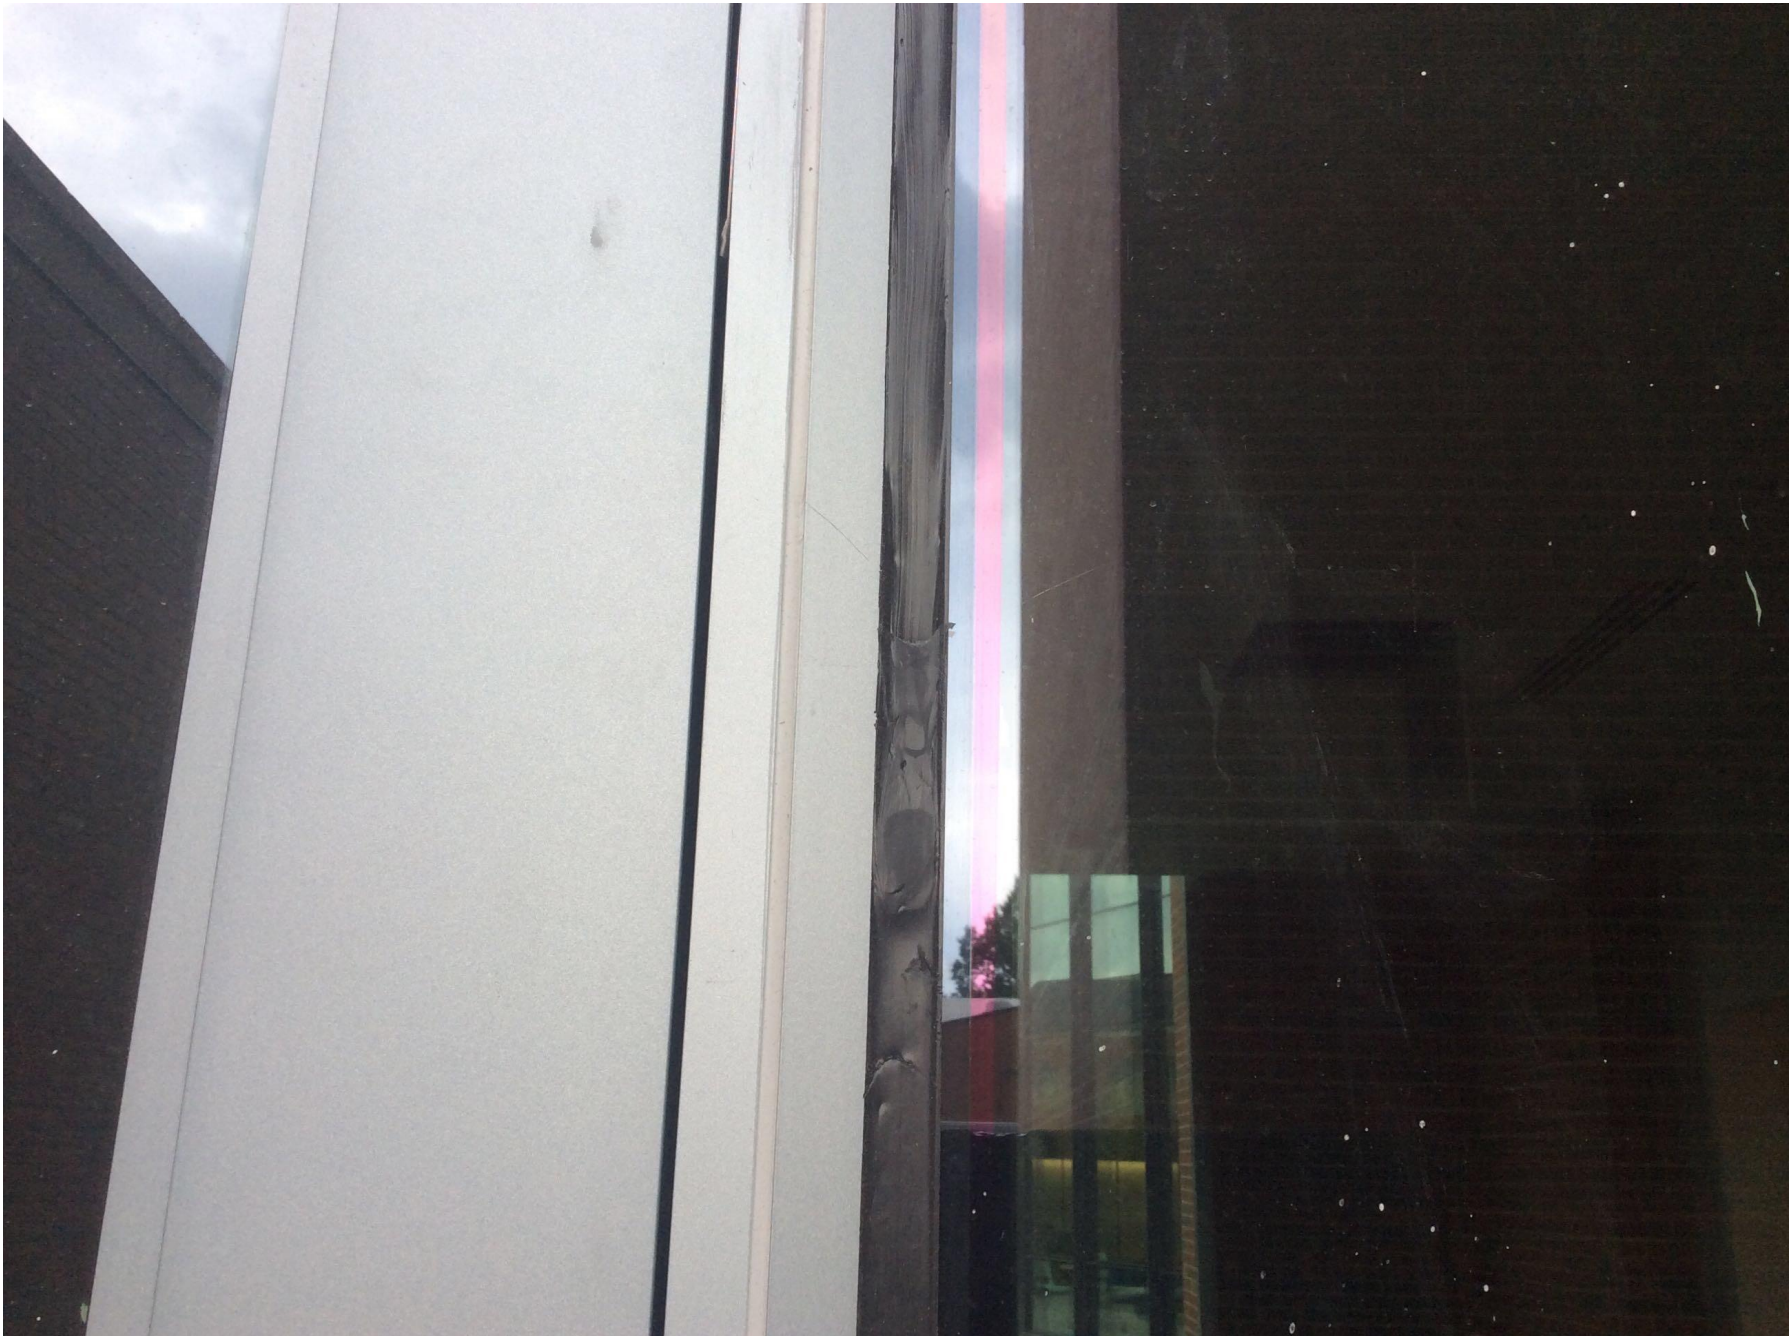
| Issue ID | Description | Location Detail | Location | Status | Company | Type | Date Created | Due Date |
|---|---|---|---|---|---|---|---|---|
| 002150 | Touchup sealant at curtainwall - eab connector - east | | Site | Open | National Glass & Glazing, Inc. | Architect Punch List | 07 Aug 2017 | 12 Aug 2017 |

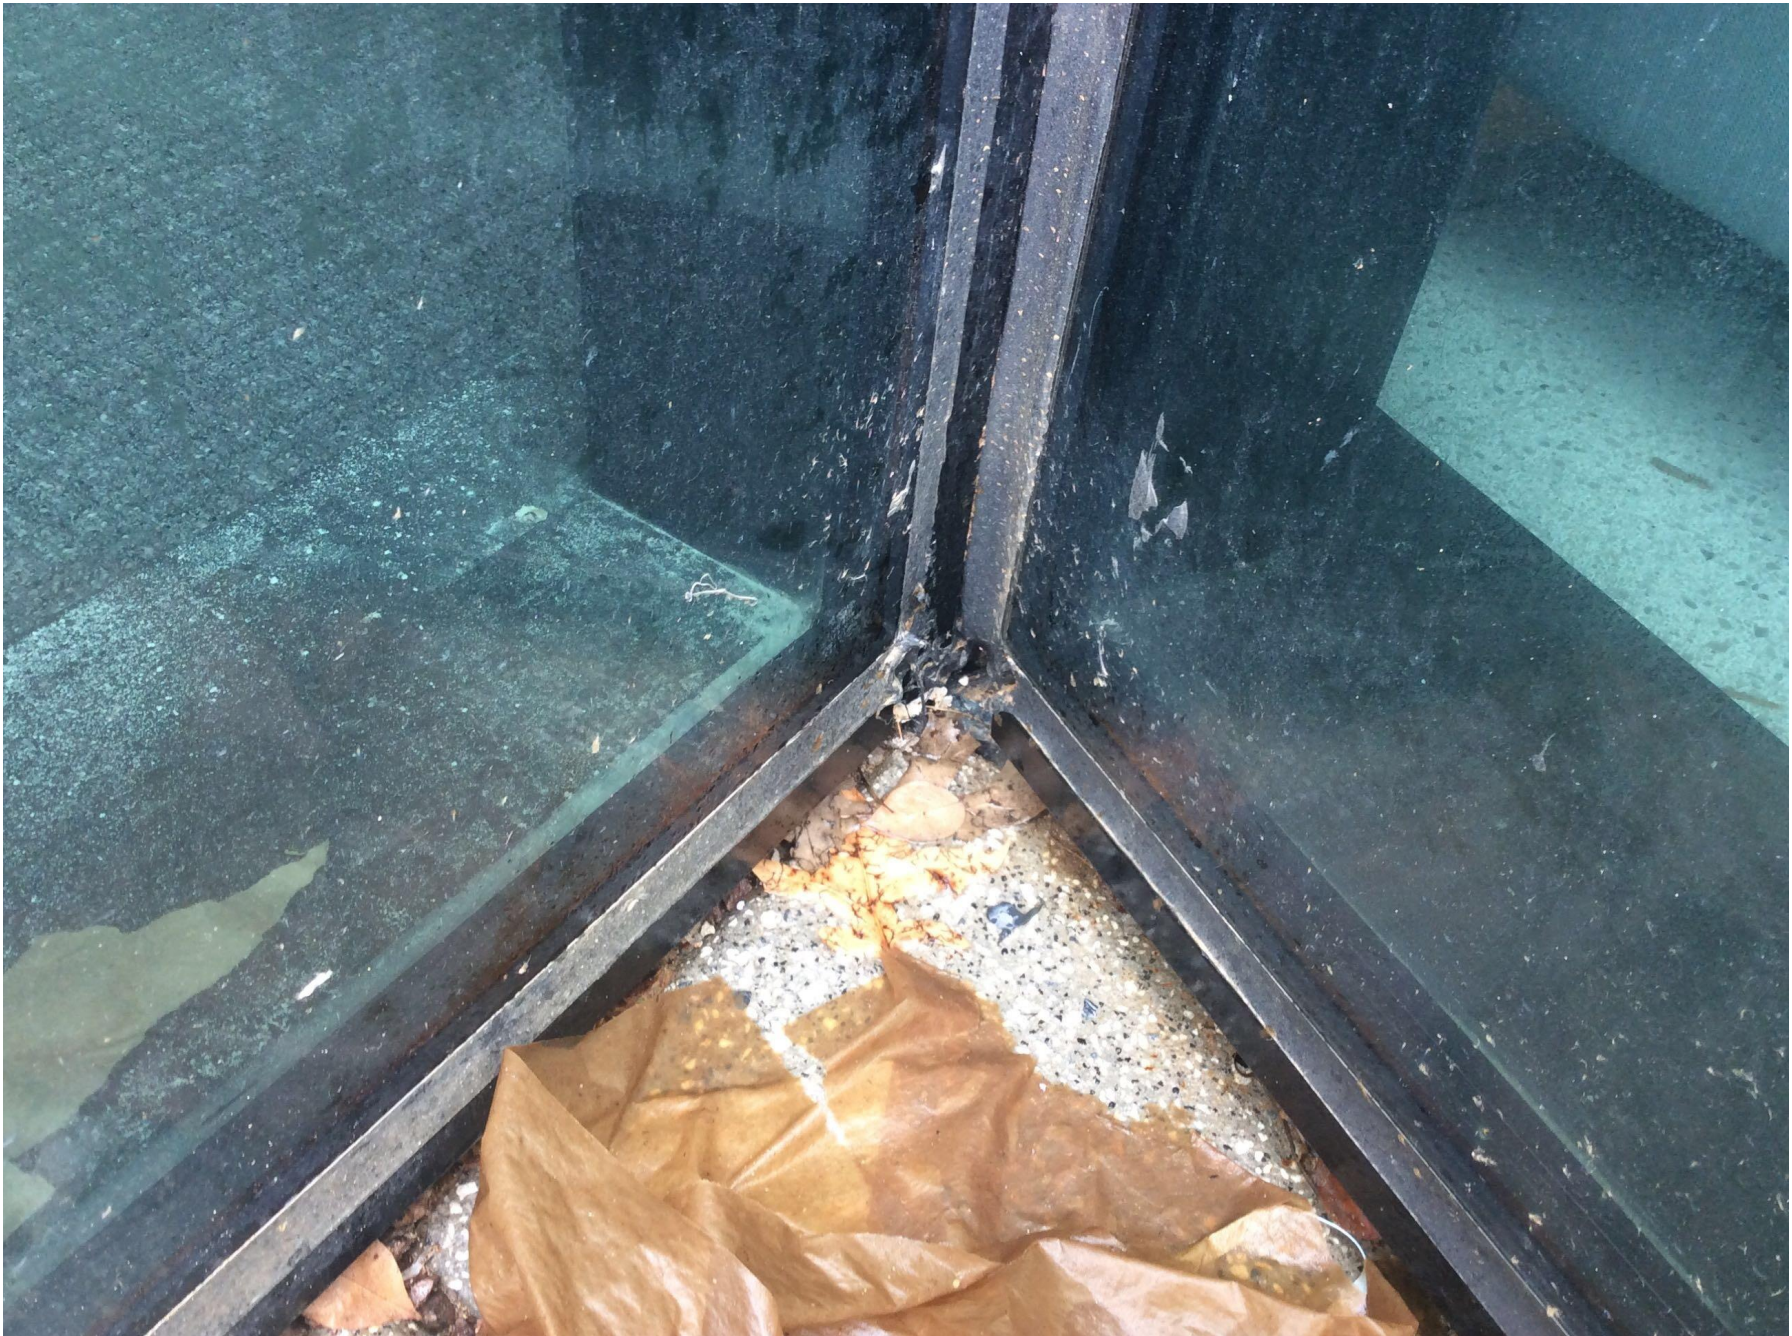
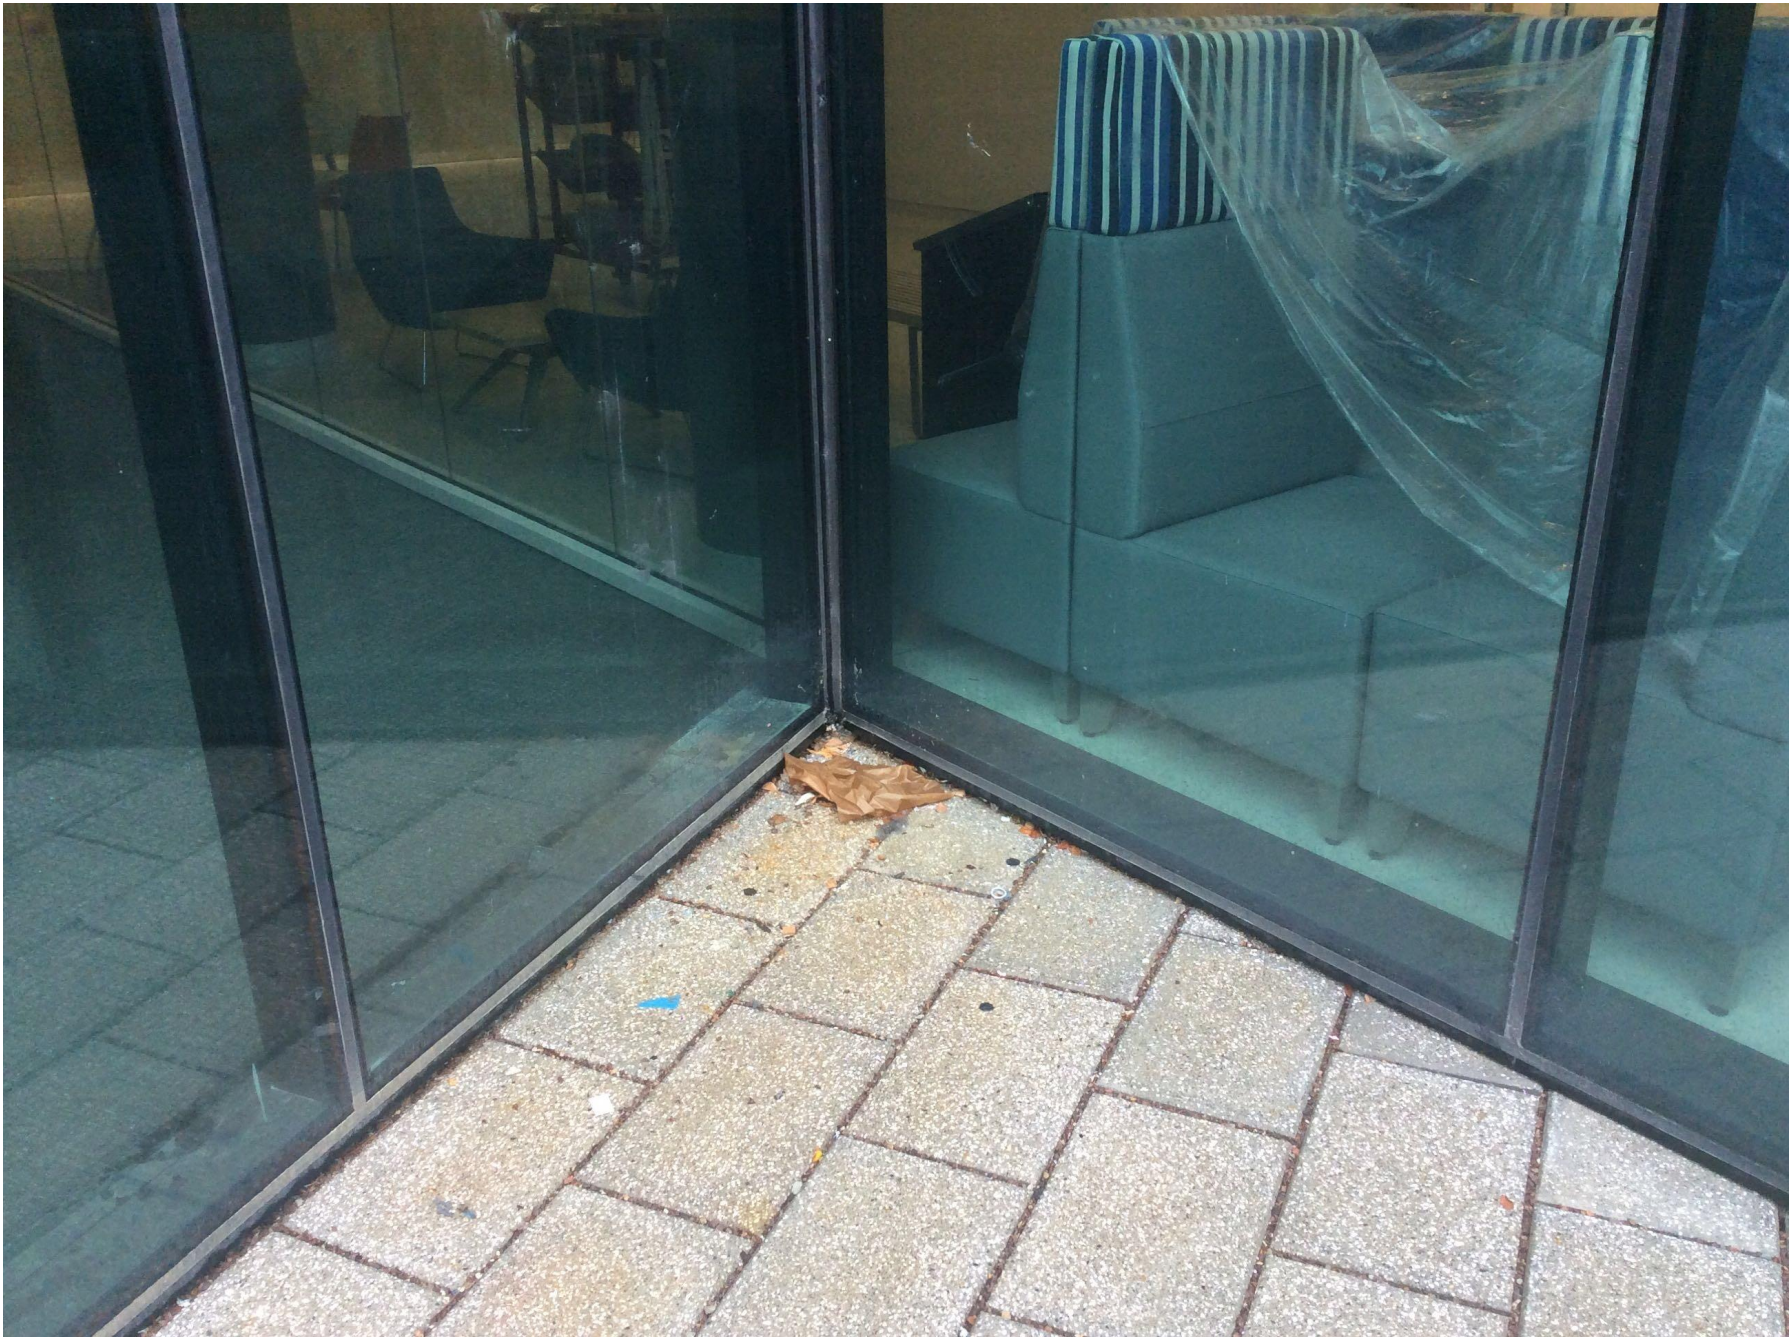
| Issue ID | Description | Location Detail | Location | Status | Company | Type | Date Created | Due Date |
|---|---|---|---|---|---|---|---|---|
| 002156 | Corner sealant needs to be cleaned up - possible break metal solution? | | Site | Open | National Glass & Glazing, Inc. | Architect Punch List | 07 Aug 2017 | 12 Aug 2017 |

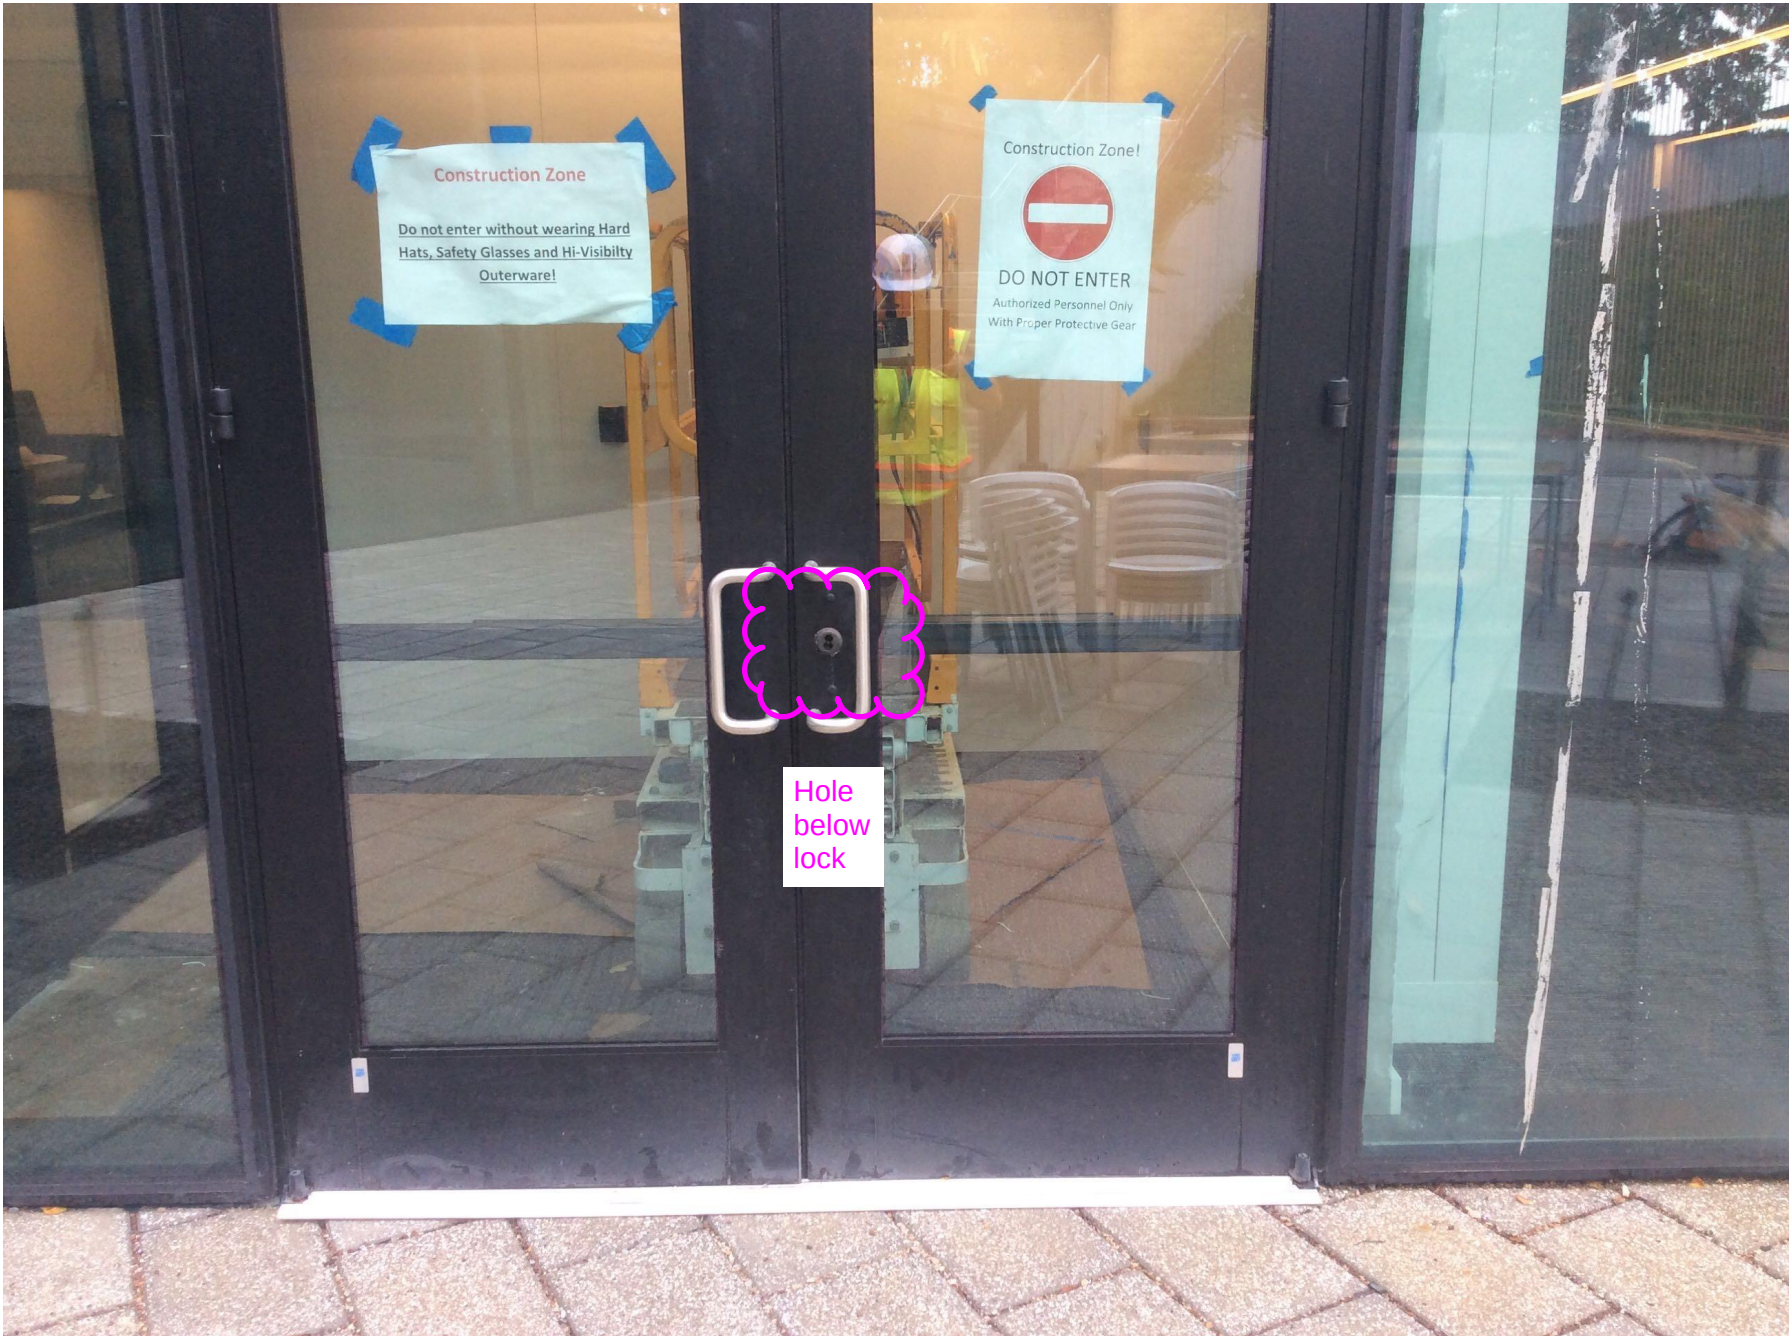
| Issue ID | Description | Location Detail | Location | Status | Company | Type | Date Created | Due Date |
|---|---|---|---|---|---|---|---|---|
| 002157 | Hole in door at lock - courtyard | | Site | Open | National Glass & Glazing, Inc. | Architect Punch List | 07 Aug 2017 | 12 Aug 2017 |
