## **ARCHITECTURAL PUNCH LIST (EXTERIOR FAÇADE & ROOF)**

**Project:** Webster University Interdisciplinary Science Building

**Project No:** CannonDesign #004561.01

**Date of Observation:** August 7, 2017

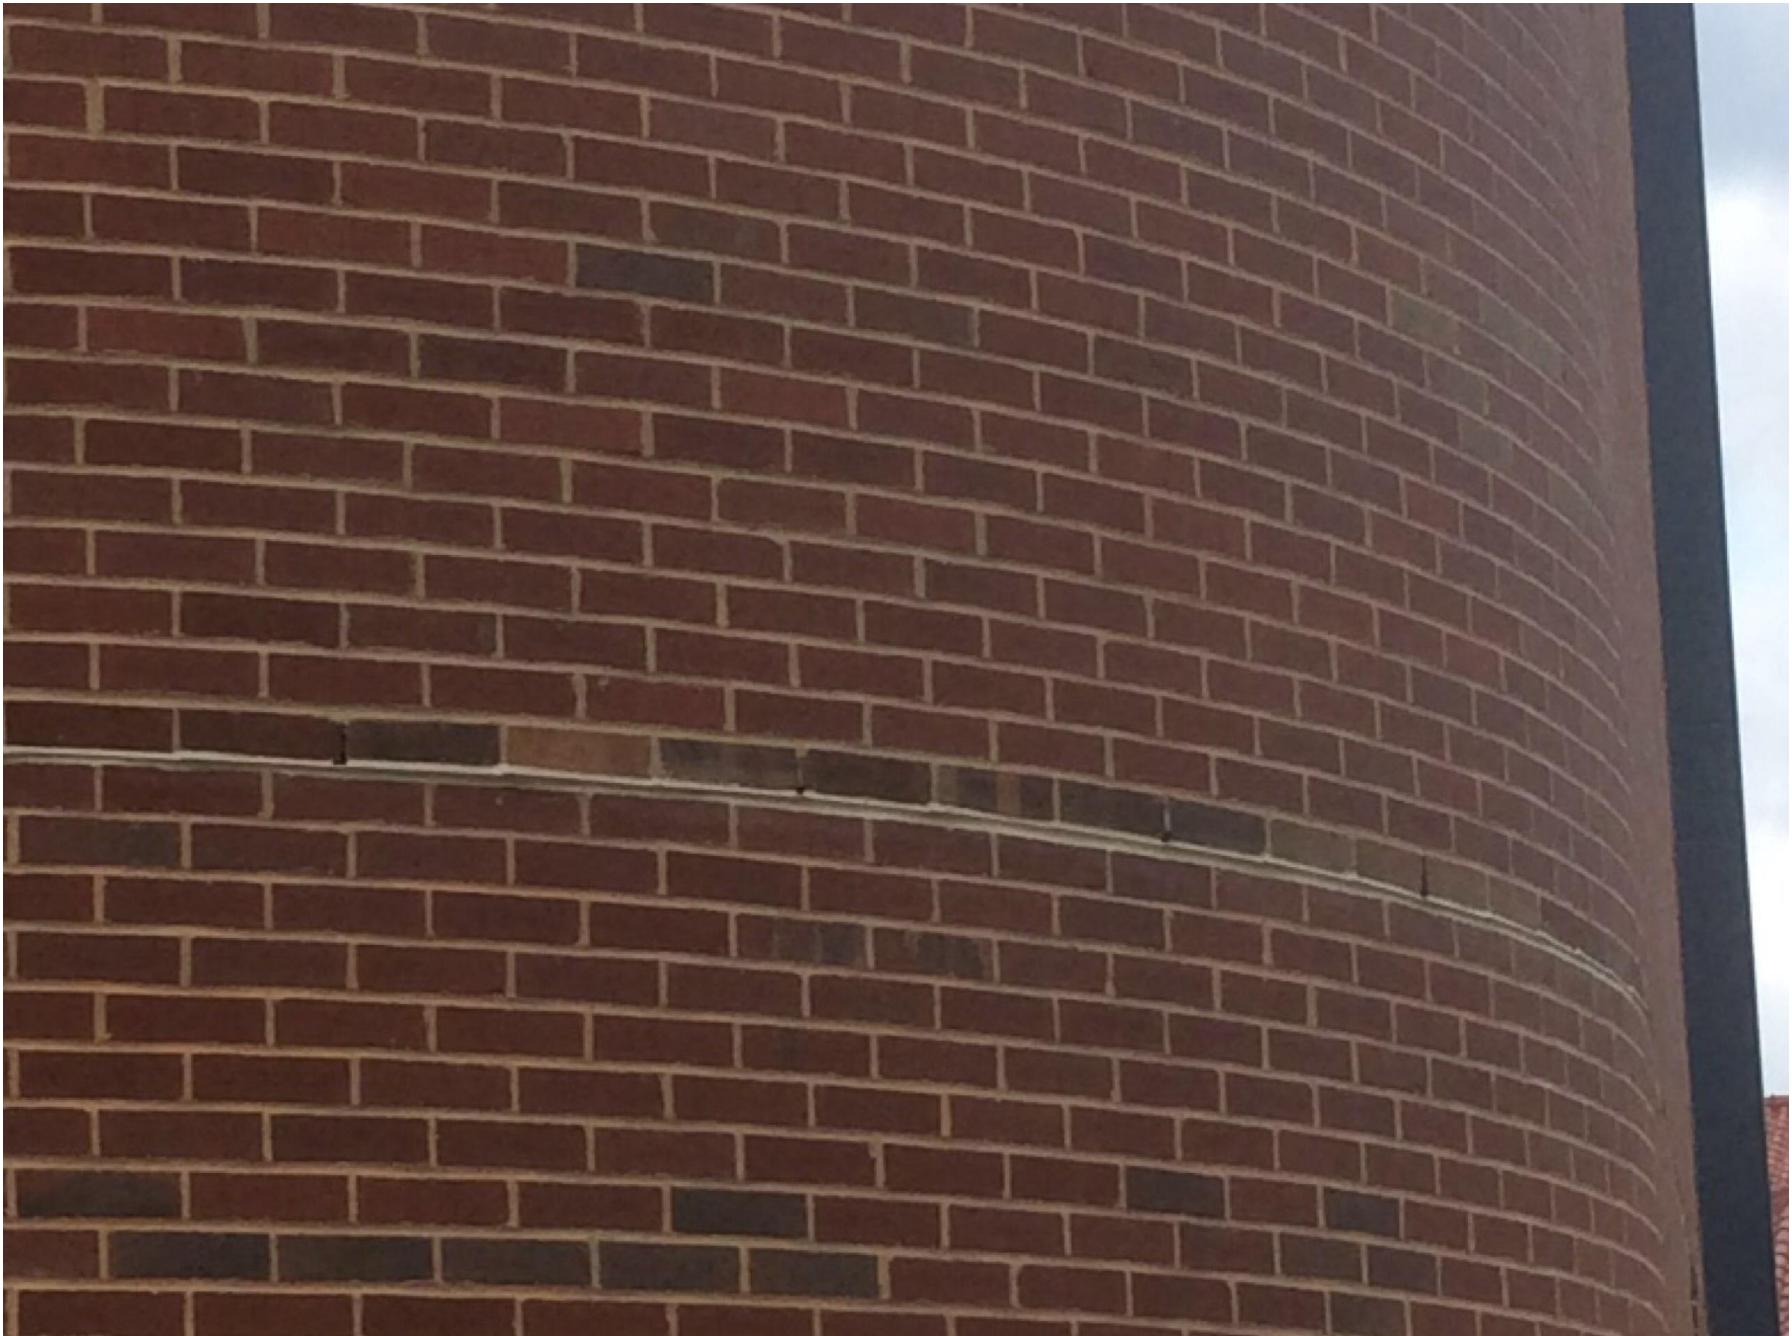
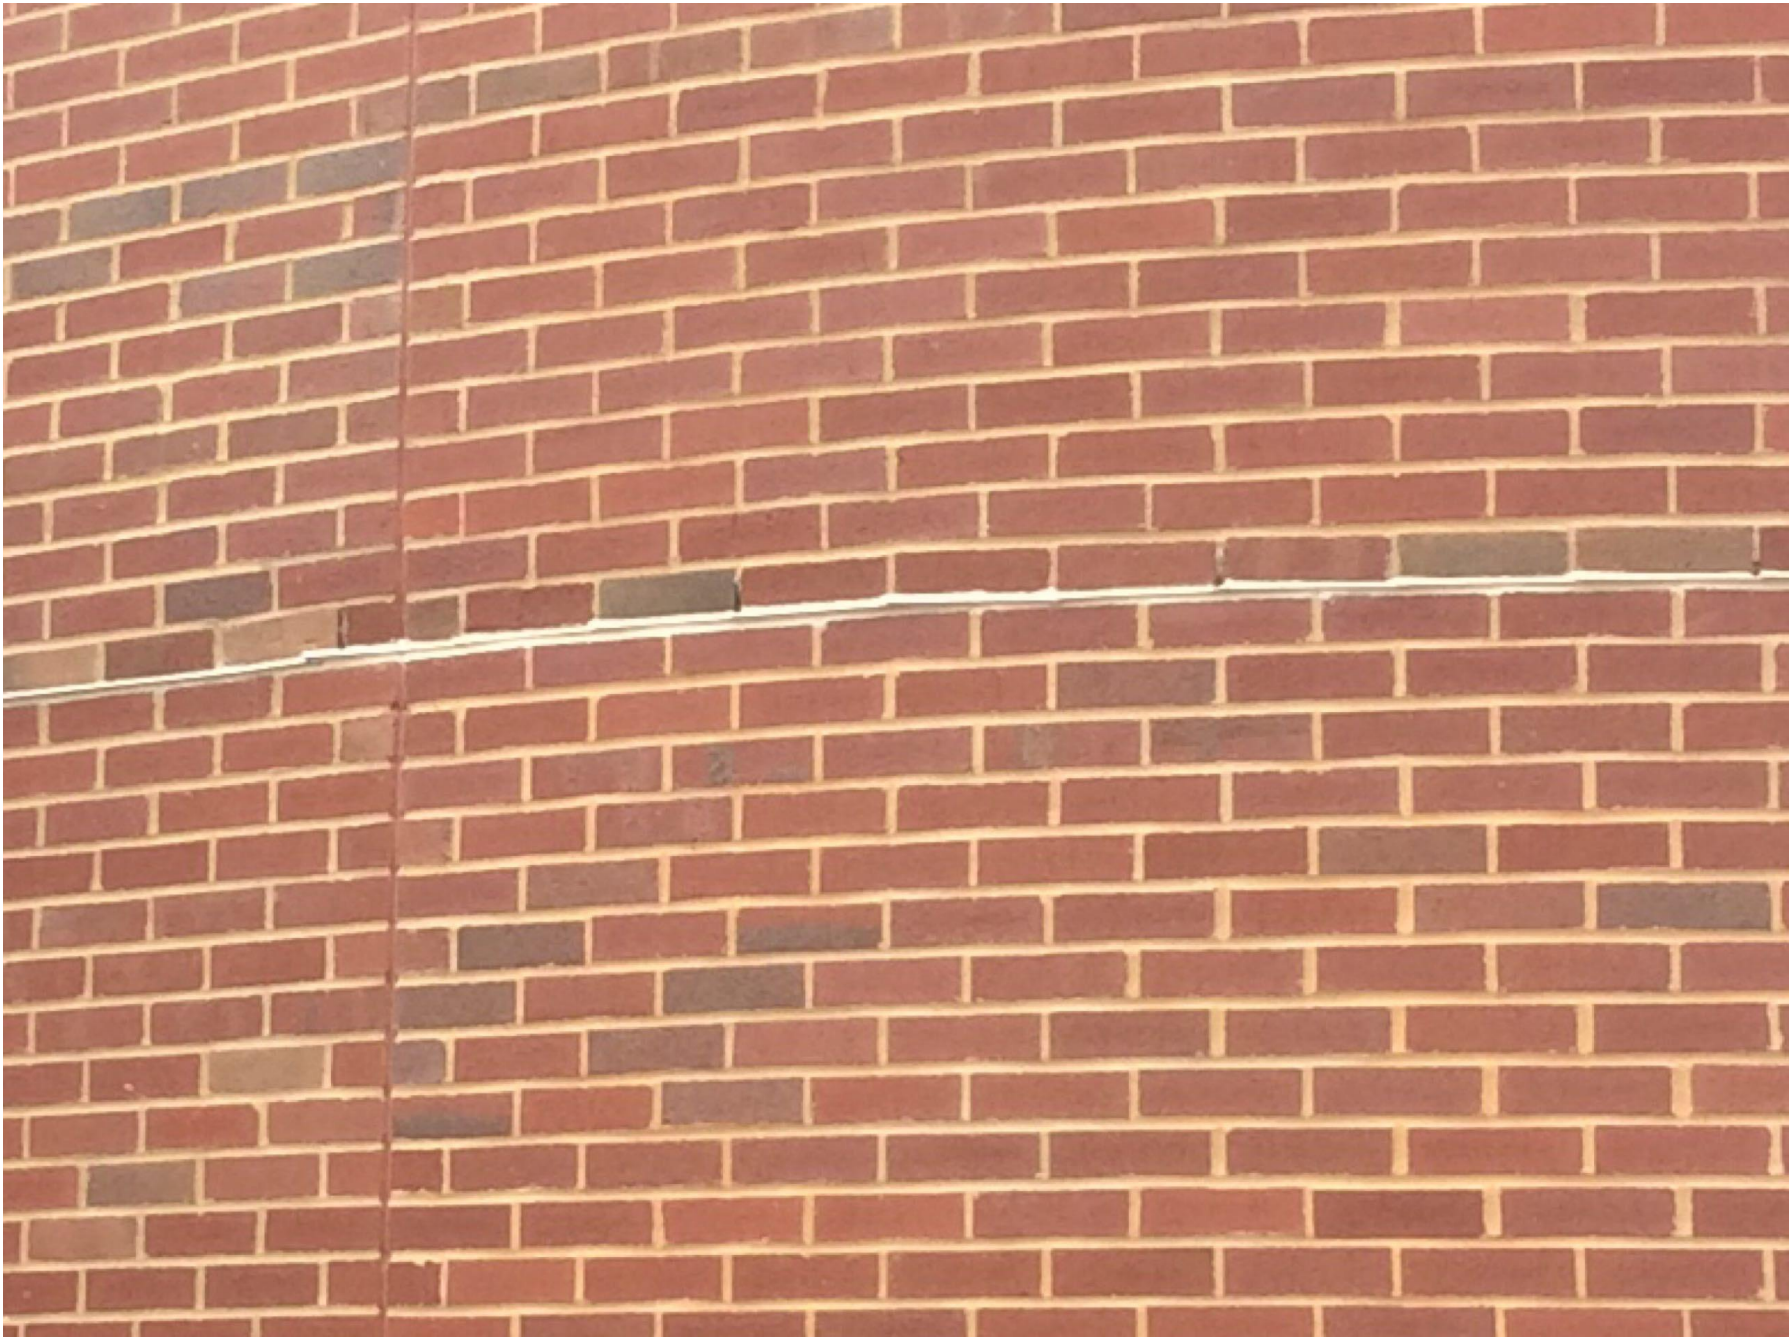
| Issue ID | Description | Location Detail | Location | Status | Company | Type | Date Created | Due Date |
|---|---|---|---|---|---|---|---|---|
| 002138 | Remove excess sealant from face of brick | | Site | Open | Staat Tuckpointing | Architect Punch List | 07 Aug 2017 | 12 Aug 2017 |

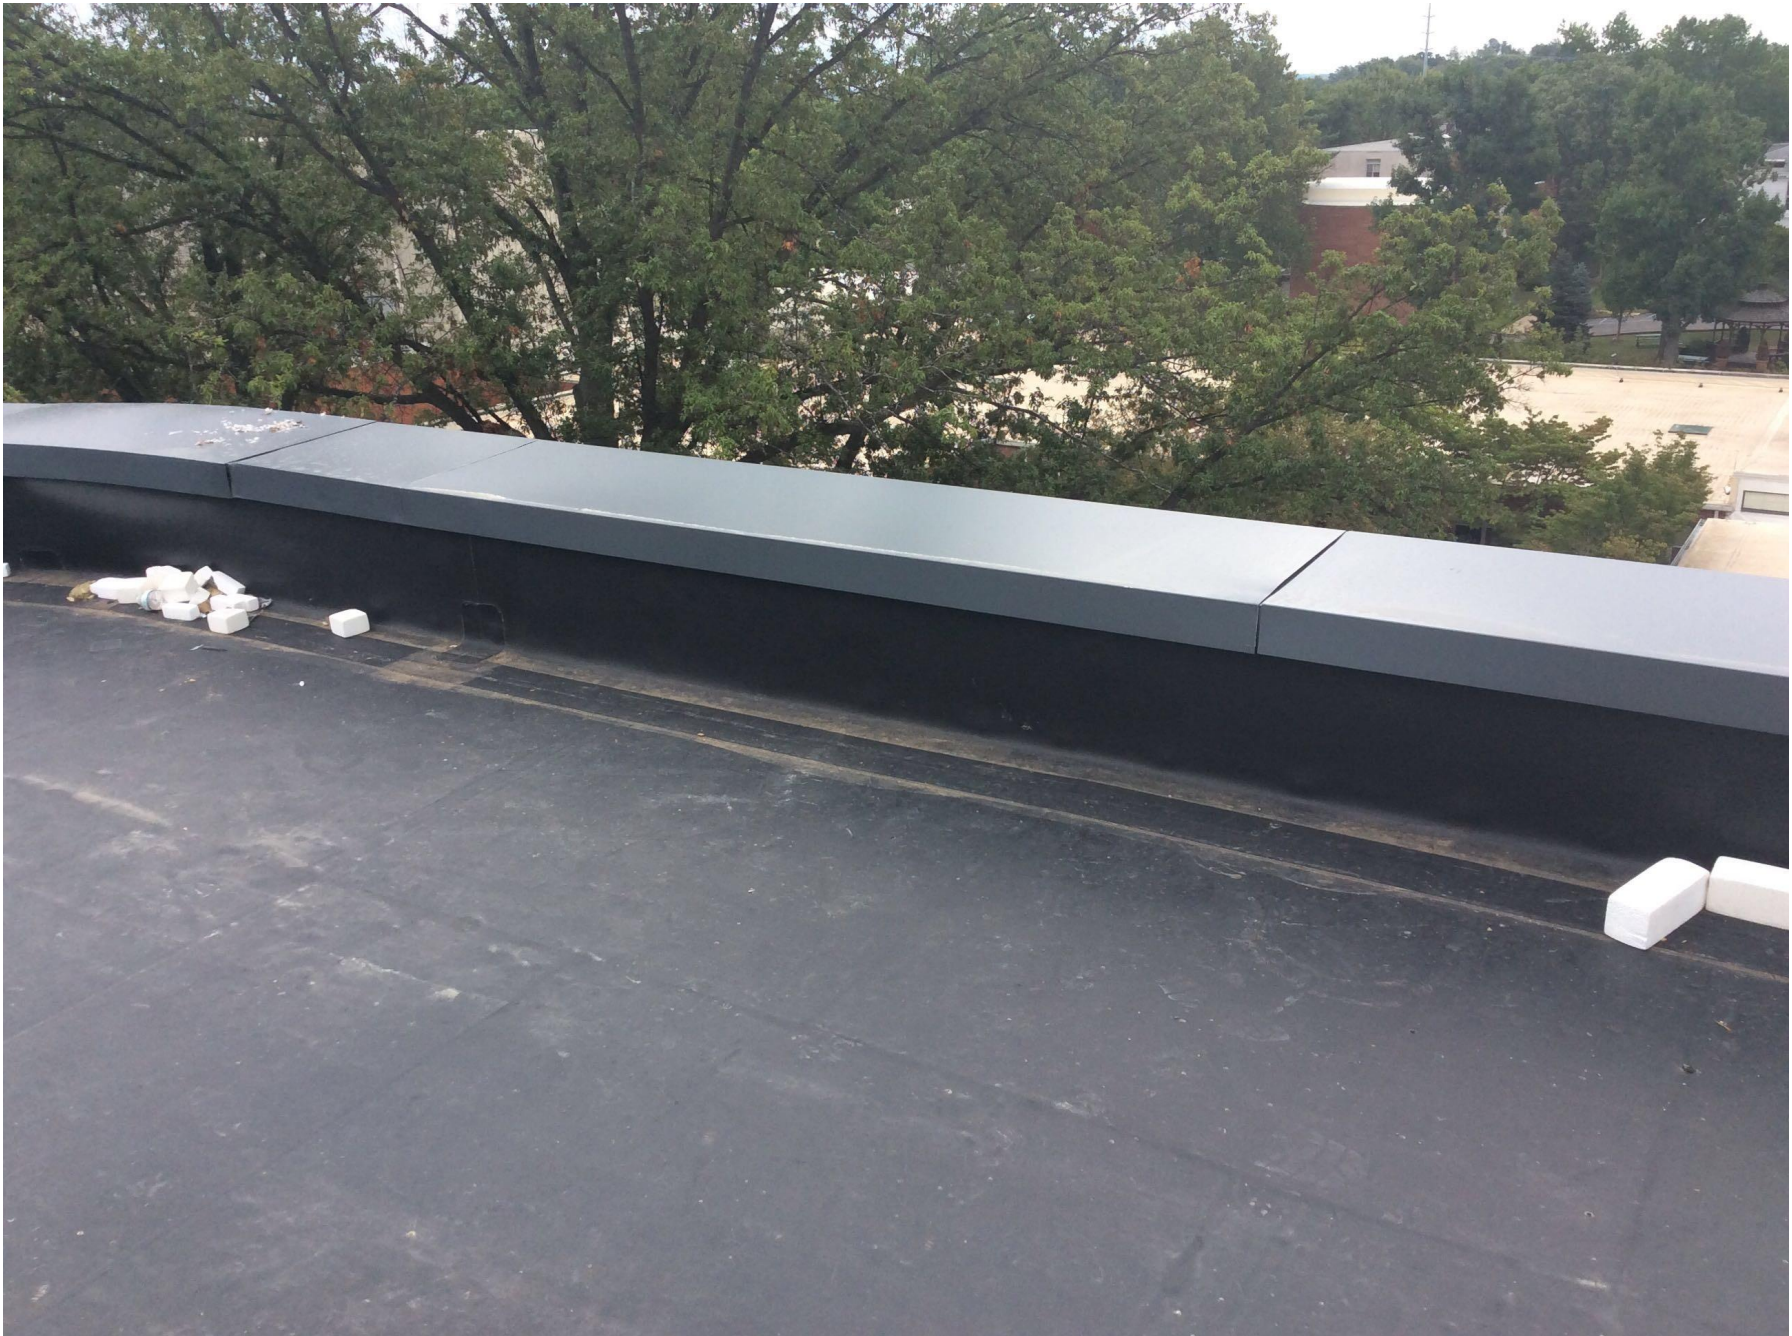
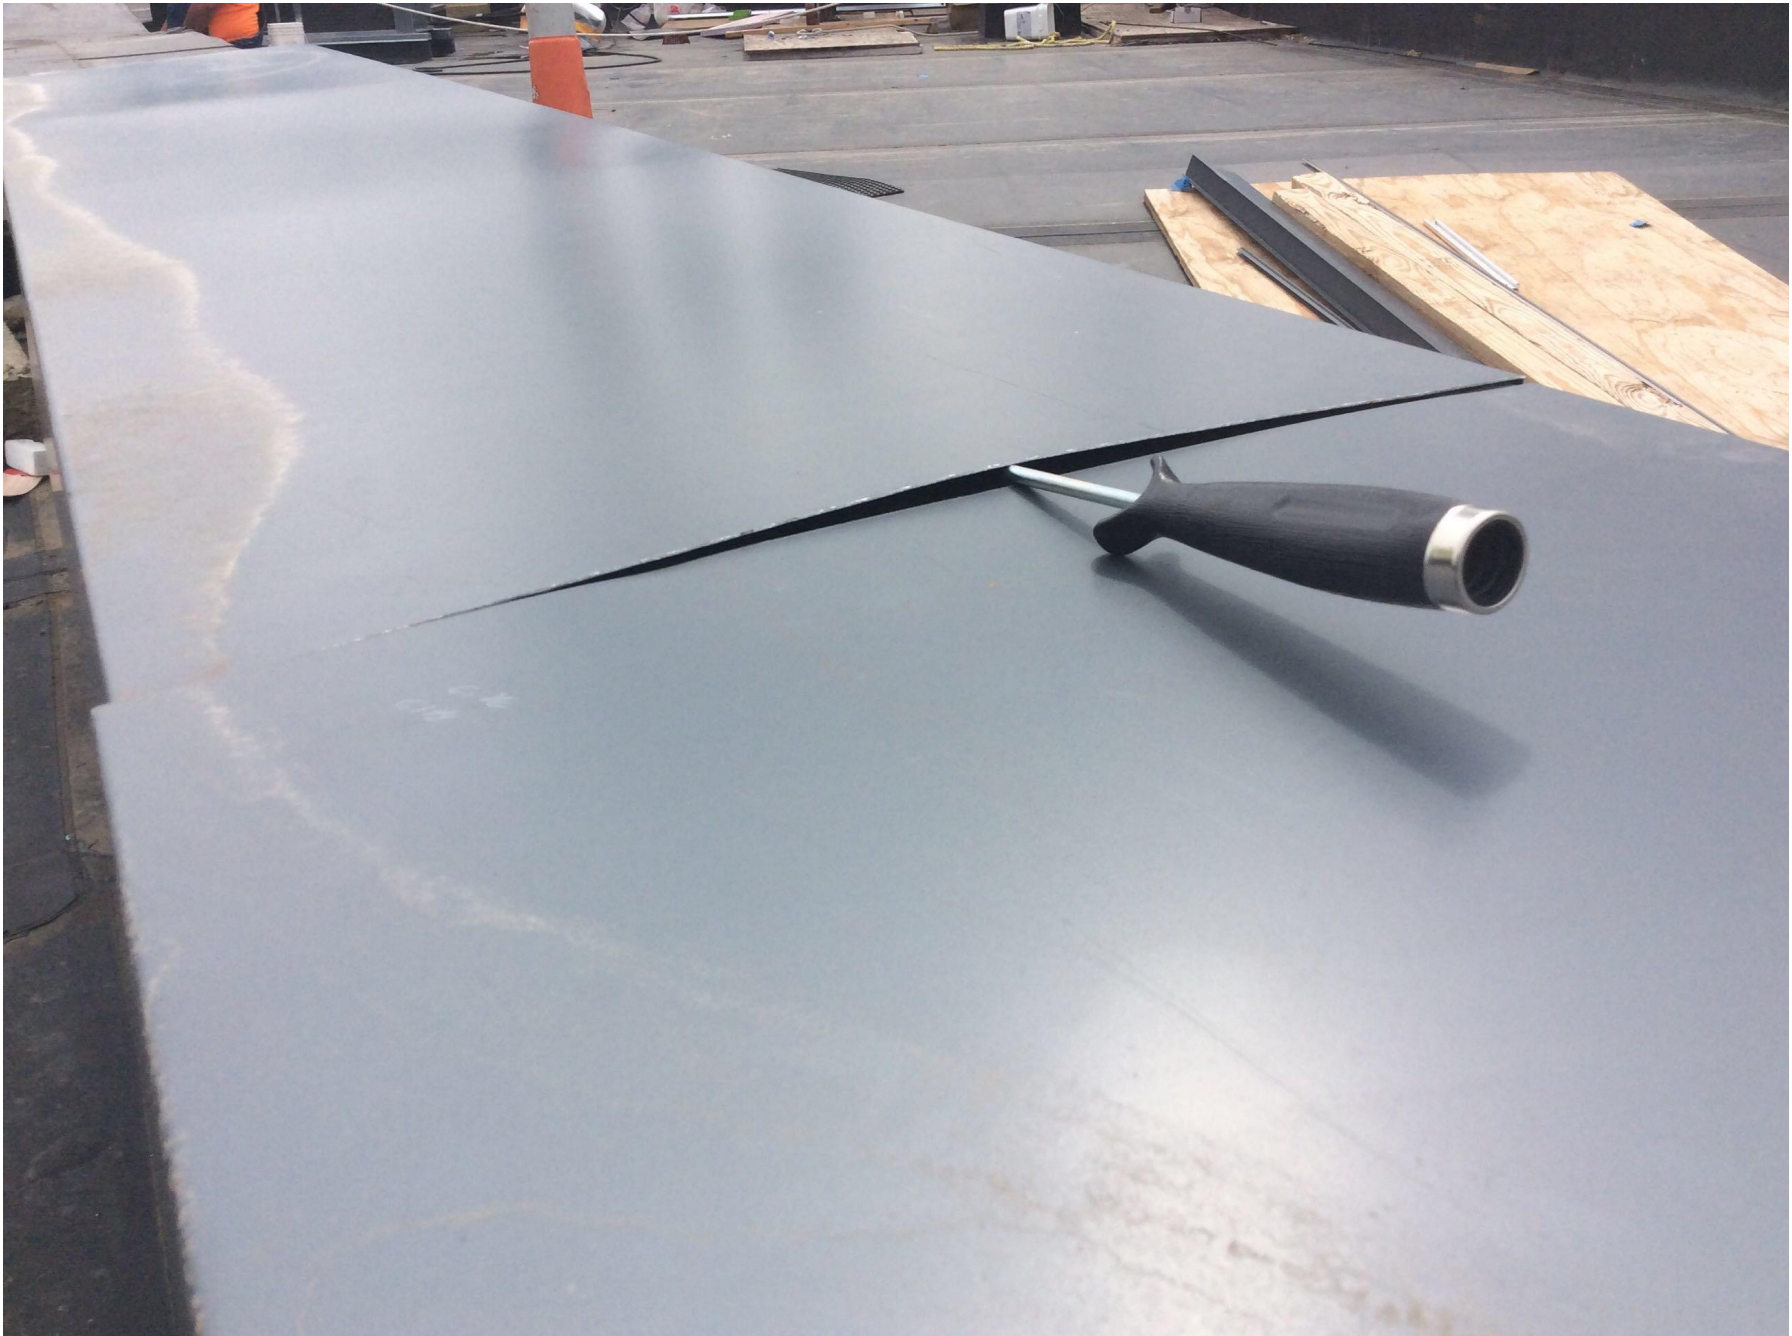
| Issue ID | Description | Location Detail | Location | Status | Company | Type | Date Created | Due Date |
|---|---|---|---|---|---|---|---|---|
| 002098 | Seal gaps at coping (typical all location) | | Webster > Roof | Open | VOGEL HEATING & COOLING | Architect Punch List | 07 Aug 2017 | 12 Aug 2017 |

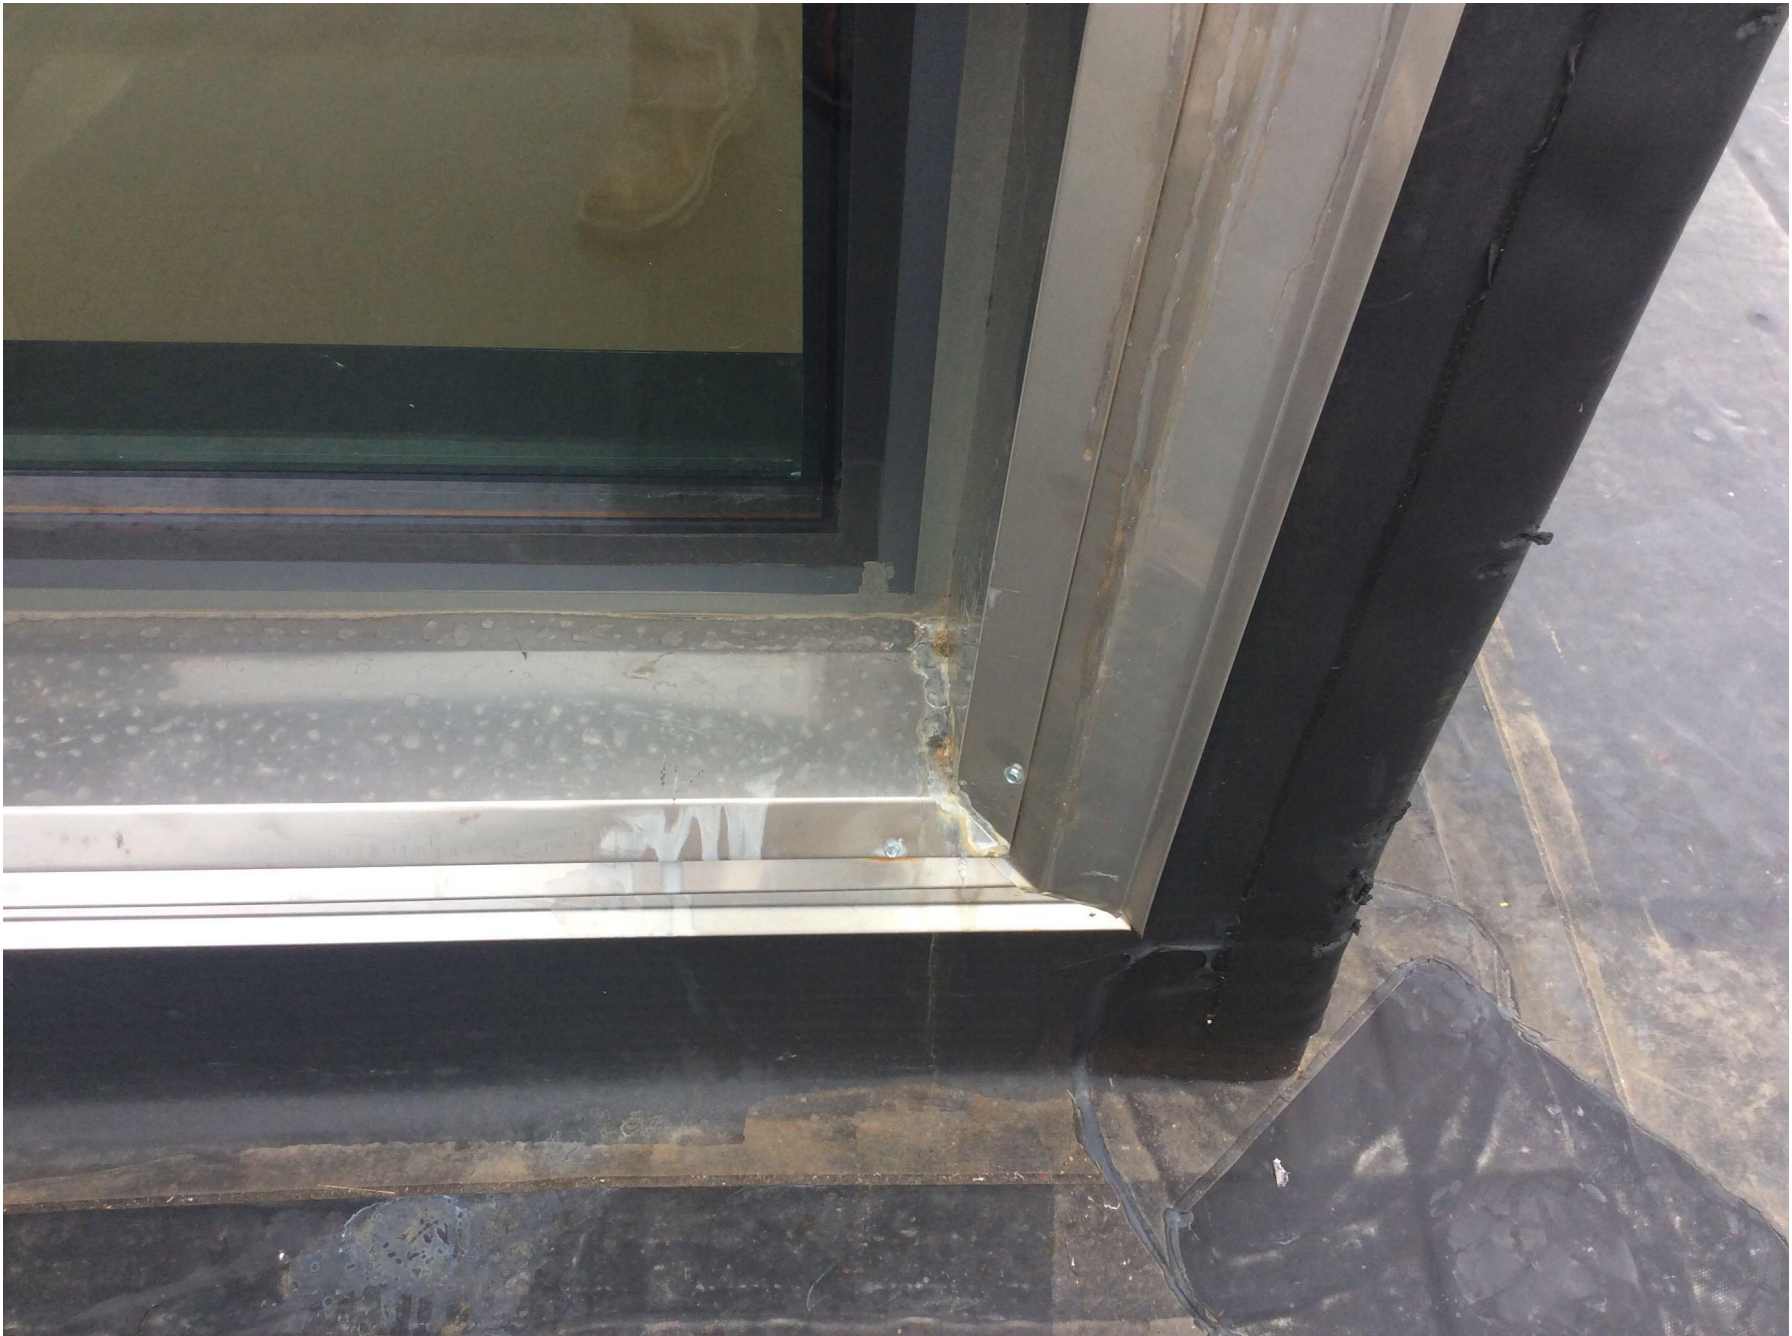
| Issue ID | Description | Location Detail | Location | Status | Company | Type | Date Created | Due Date |
|---|---|---|---|---|---|---|---|---|
| 002103 | Screws should be stainless at flashing | | Webster > Roof | Open | VOGEL<br>HEATING &<br>COOLING | Architect<br>Punch List | 07 Aug<br>2017 | 12 Aug<br>2017 |

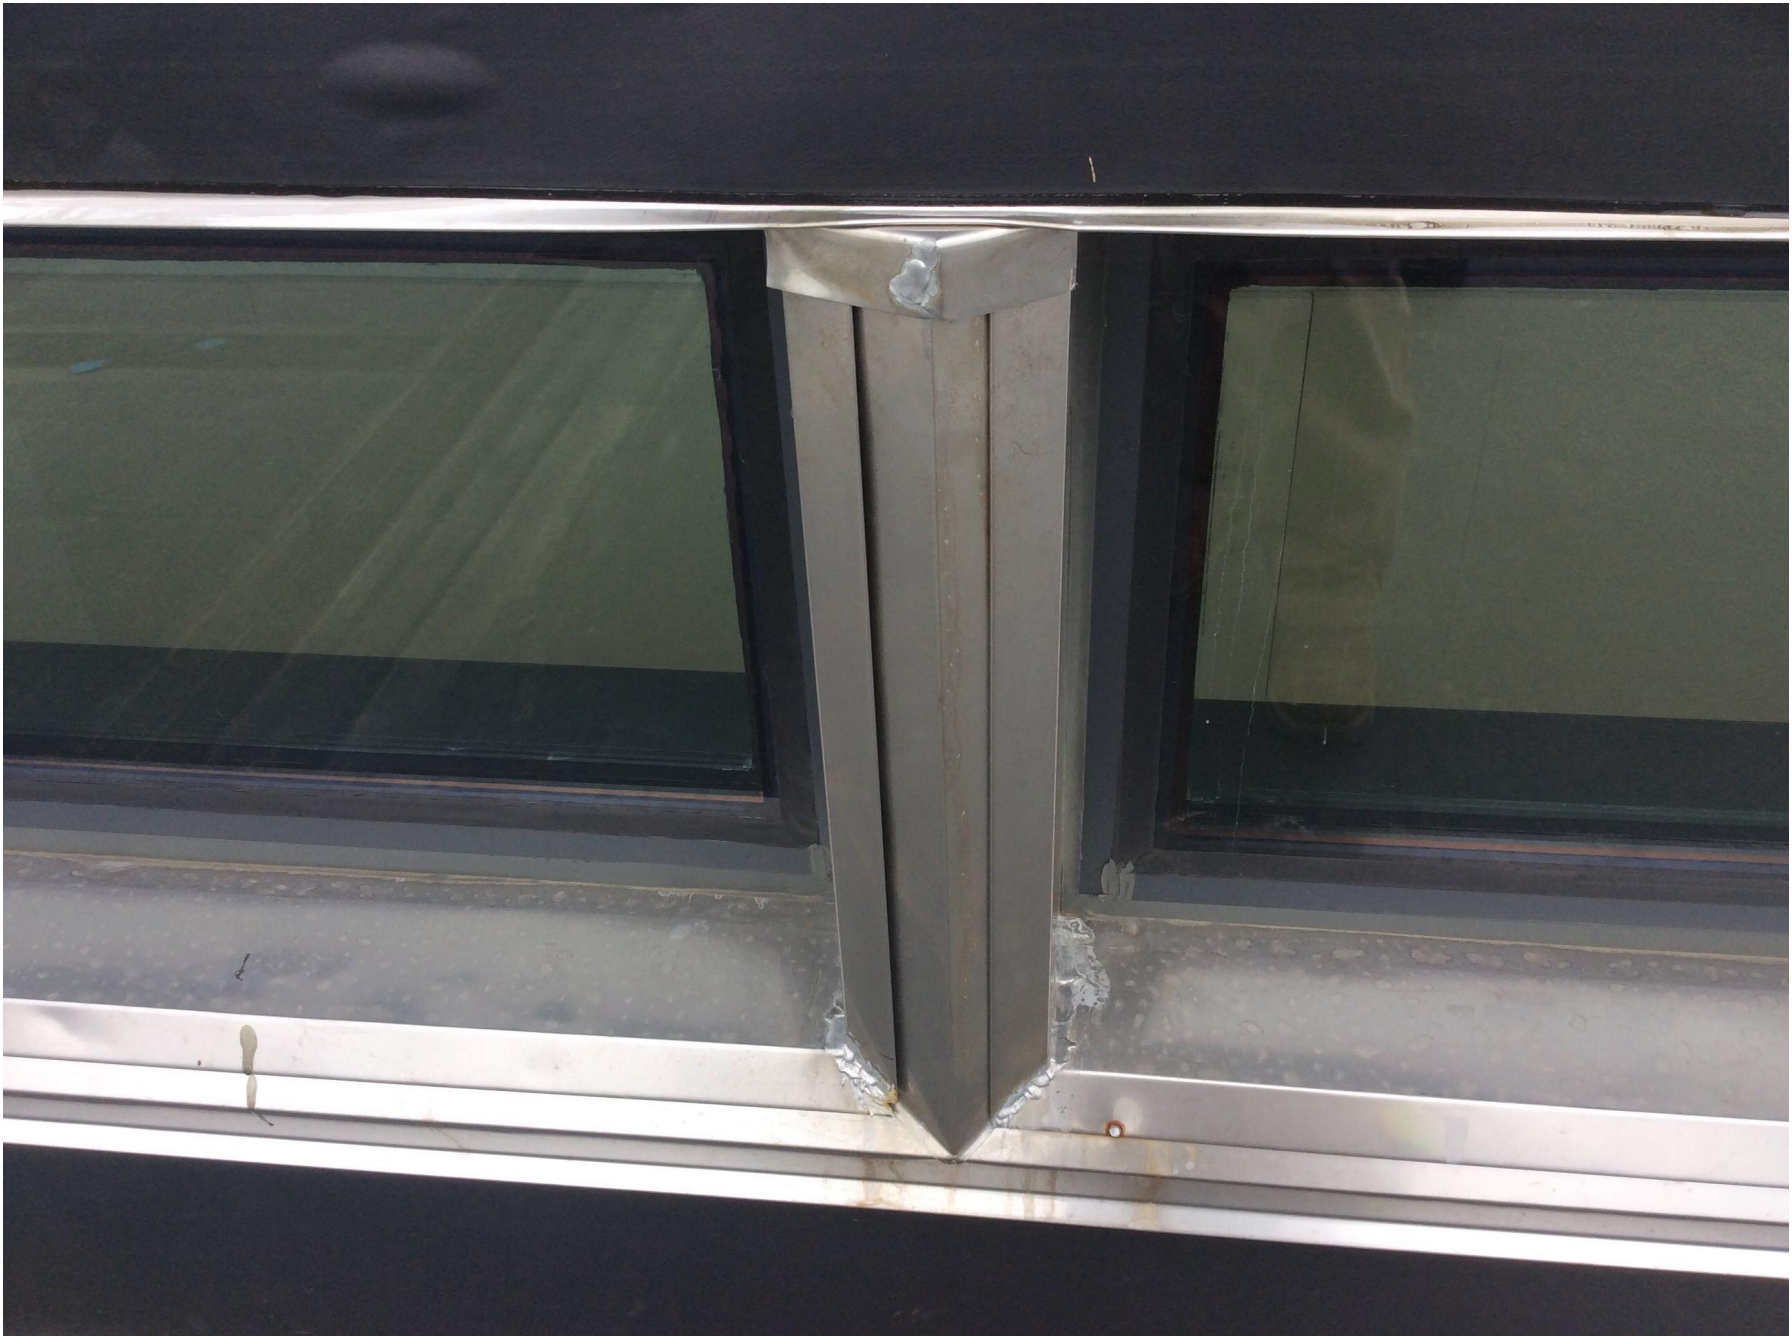
| Issue ID | Description | Location Detail | Location | Status | Company | Type | Date Created | Due Date |
|---|---|---|---|---|---|---|---|---|
| 002104 | Seal flashing to metal at clerestory roof | | Webster > Roof | Open | VOGEL HEATING & COOLING | Architect Punch List | 07 Aug 2017 | 12 Aug 2017 |

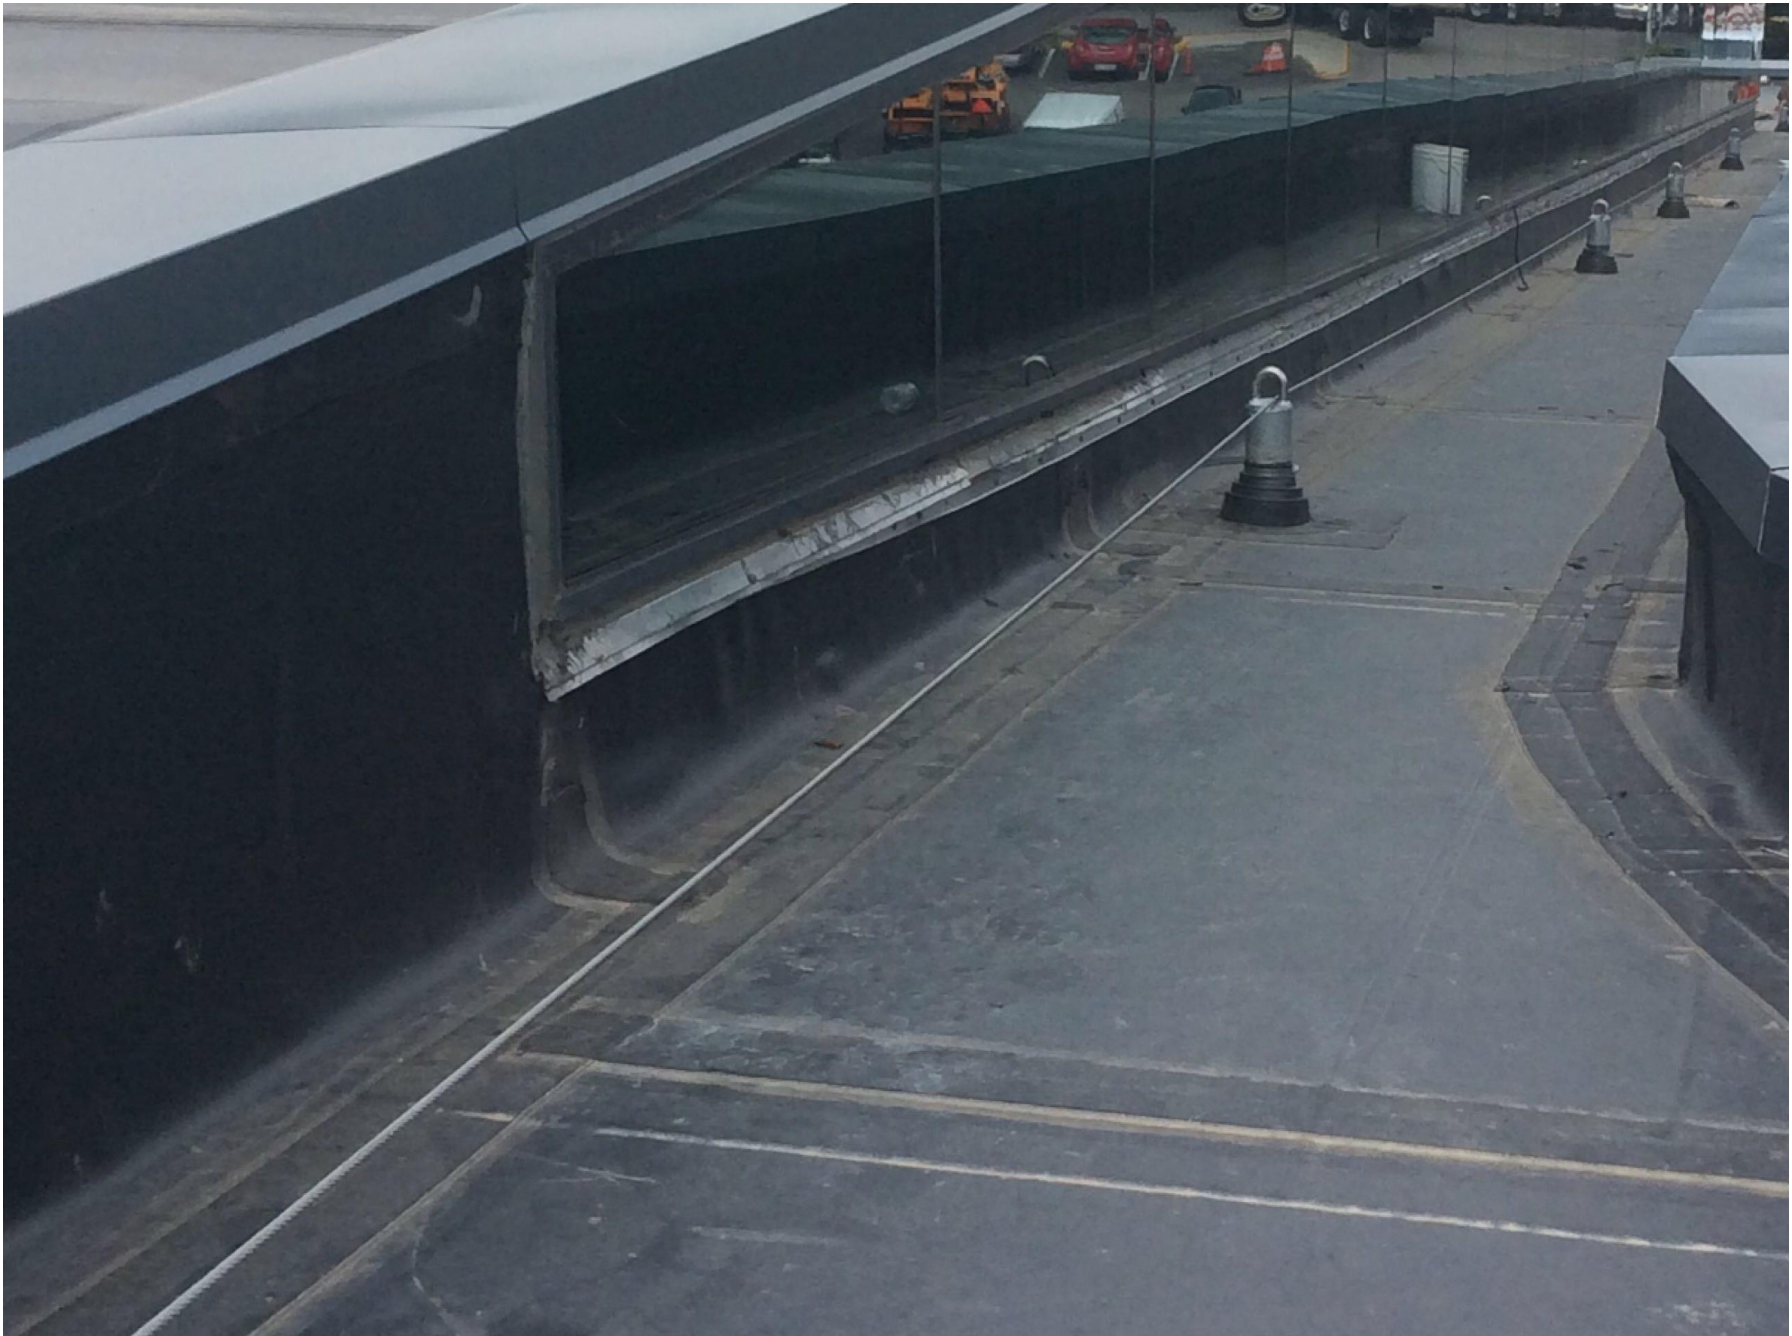
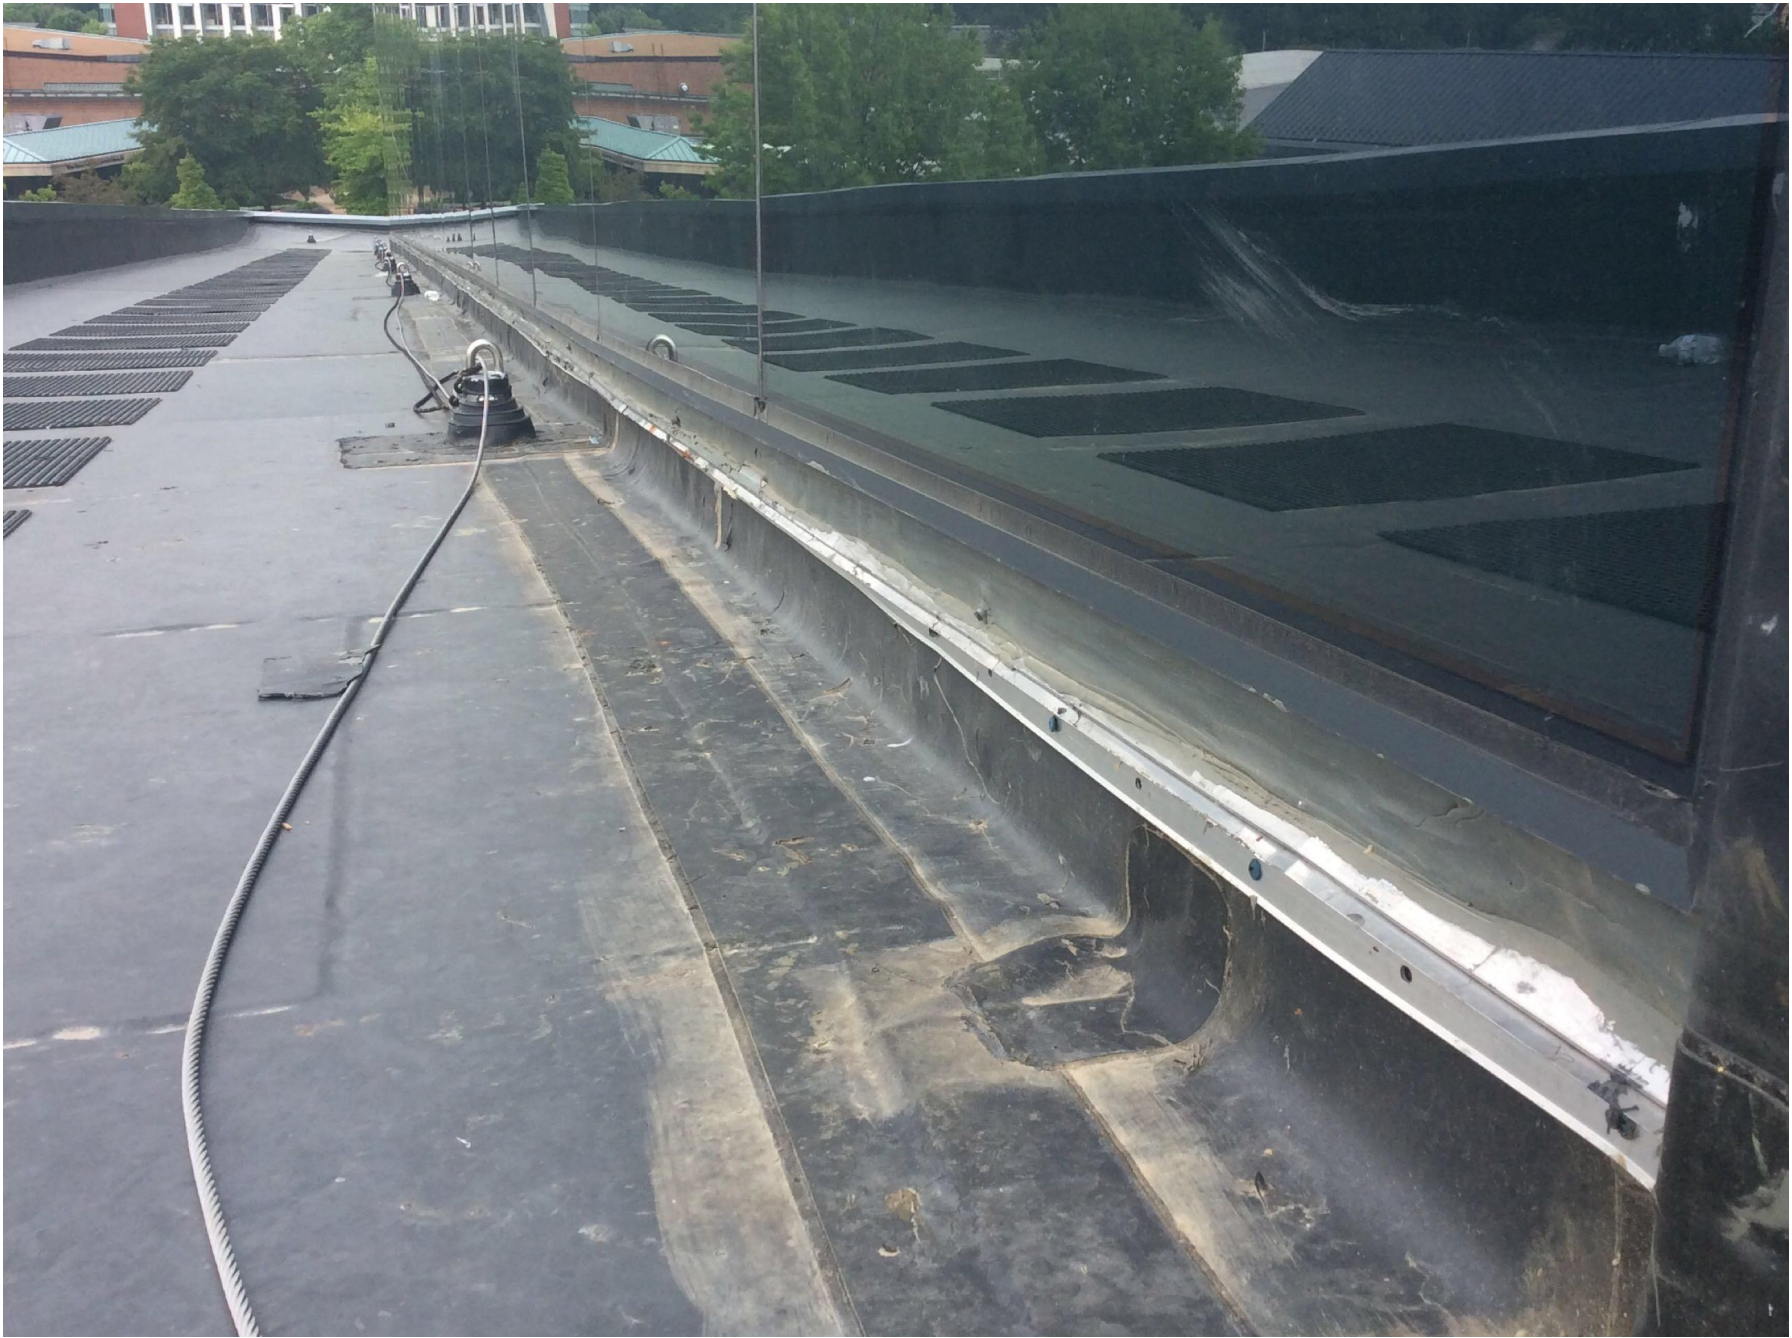
| Issue ID | Description | Location Detail | Location | Status | Company | Type | Date Created | Due Date |
|---|---|---|---|---|---|---|---|---|
| 002108 | Two piece flashing to cover turn bar under glazing still needed | | Webster > Roof | Open | VOGEL HEATING & COOLING | Architect Punch List | 07 Aug 2017 | 12 Aug 2017 |
