## **ARCHITECTURAL PUNCH LIST (EXTERIOR FAÇADE & ROOF)**

**Project:** Webster University Interdisciplinary Science Building

**Project No:** CannonDesign #004561.01

**Date of Observation:** August 7, 2017

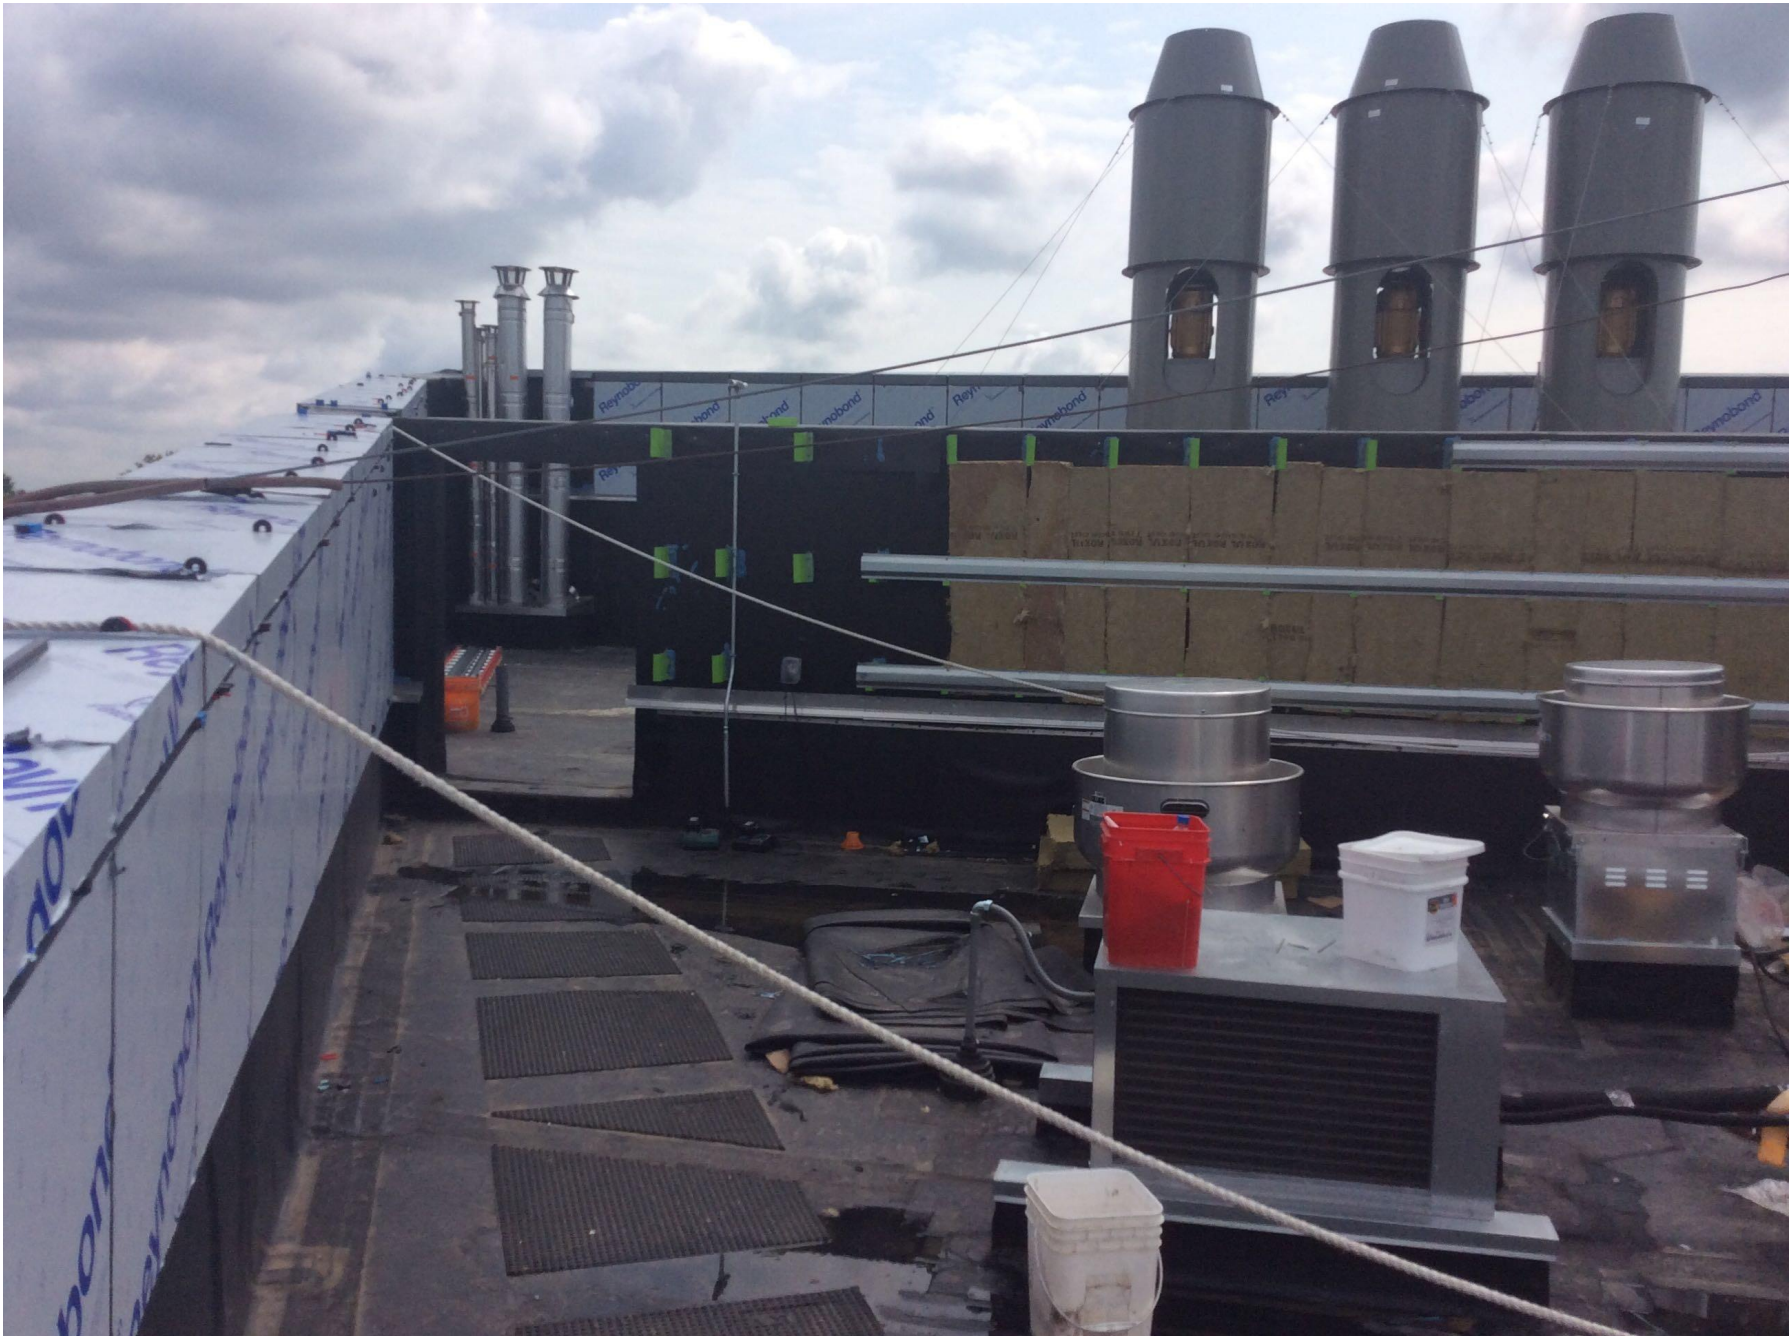
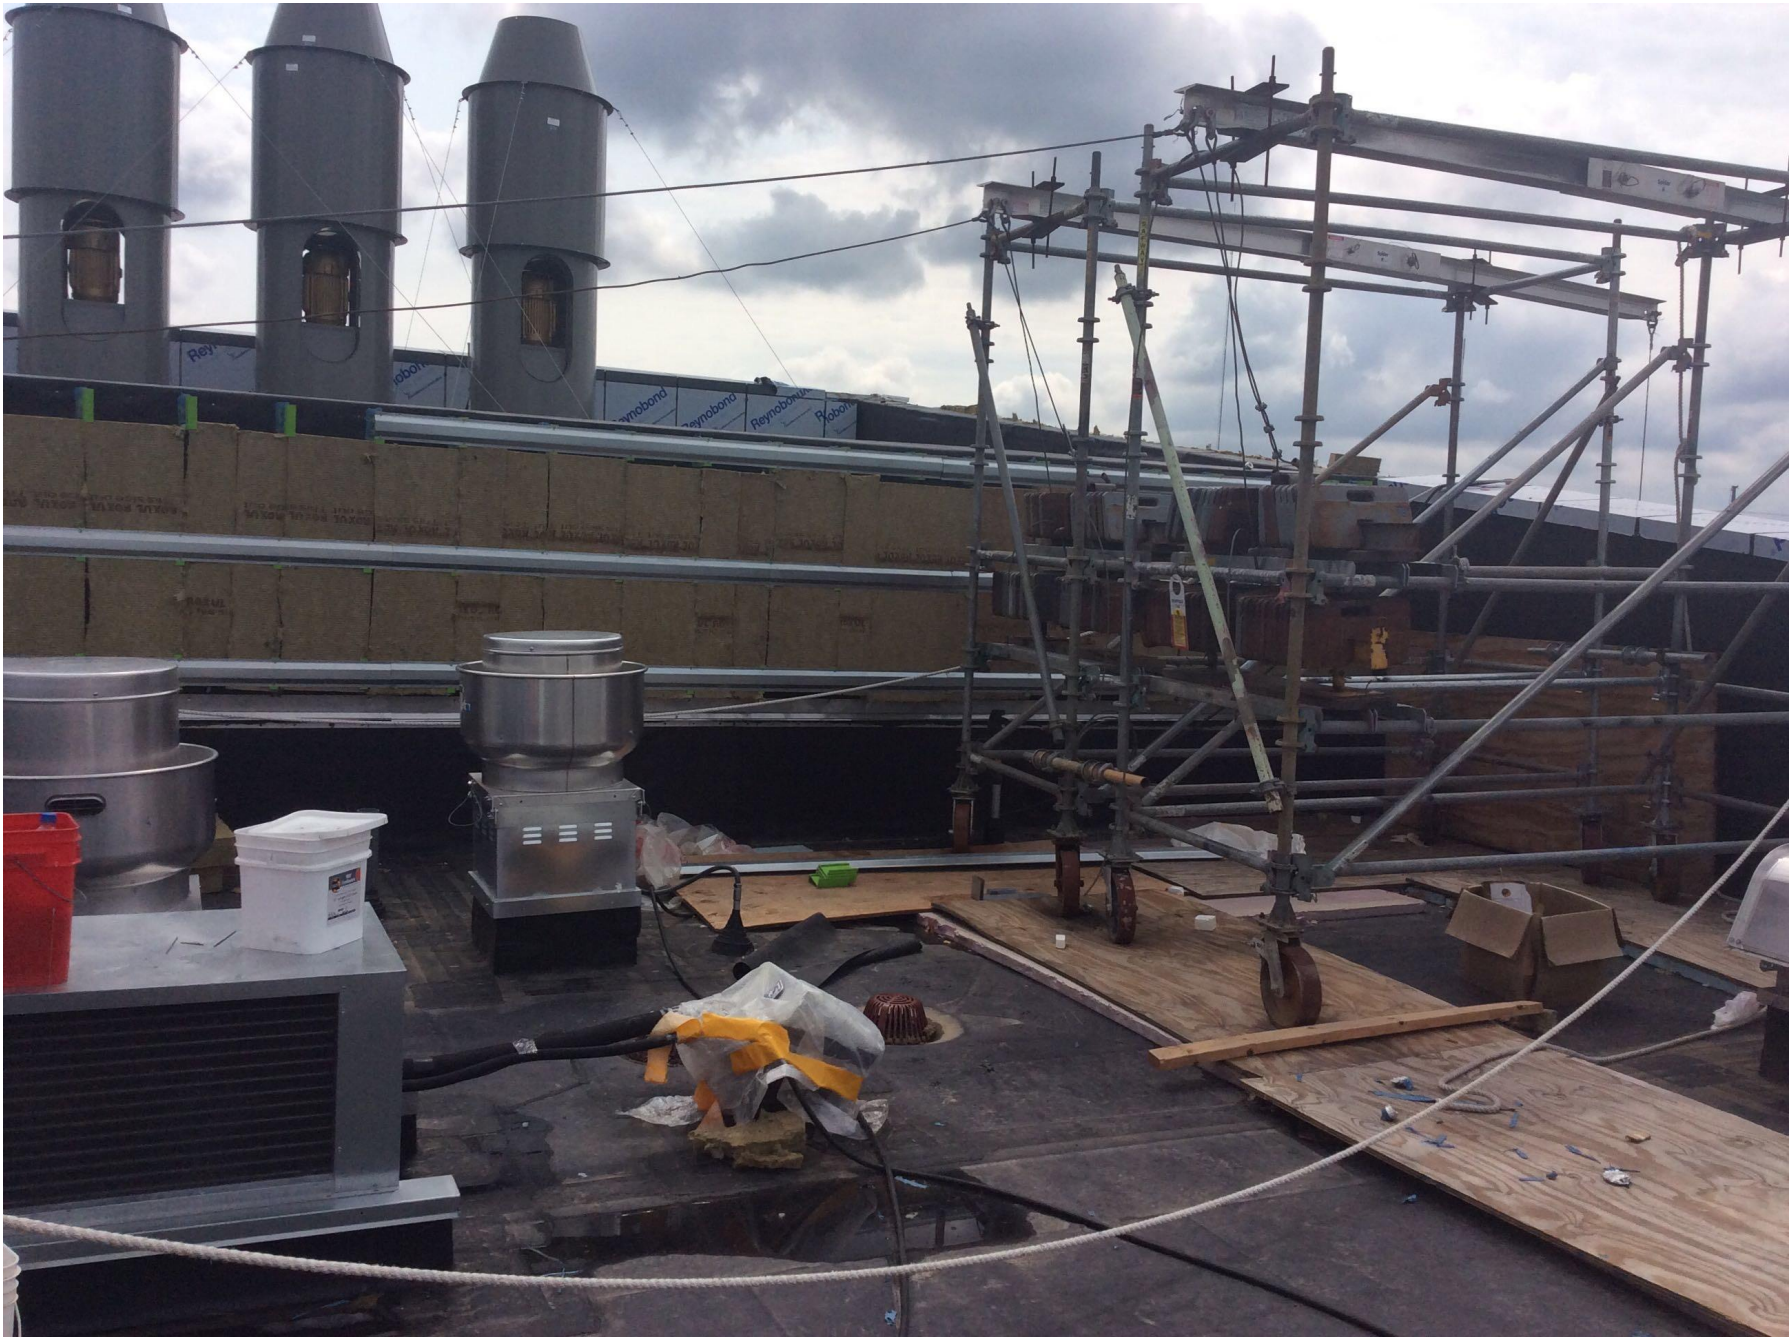
| Issue ID | Description | Location Detail | Location | Status | Company | Type | Date Created | Due Date |
|---|---|---|---|---|---|---|---|---|
| 002113 | Finish metal panel installation and doors | | Webster > Roof | Open | VOGEL HEATING & COOLING | Architect Punch List | 07 Aug 2017 | 12 Aug 2017 |

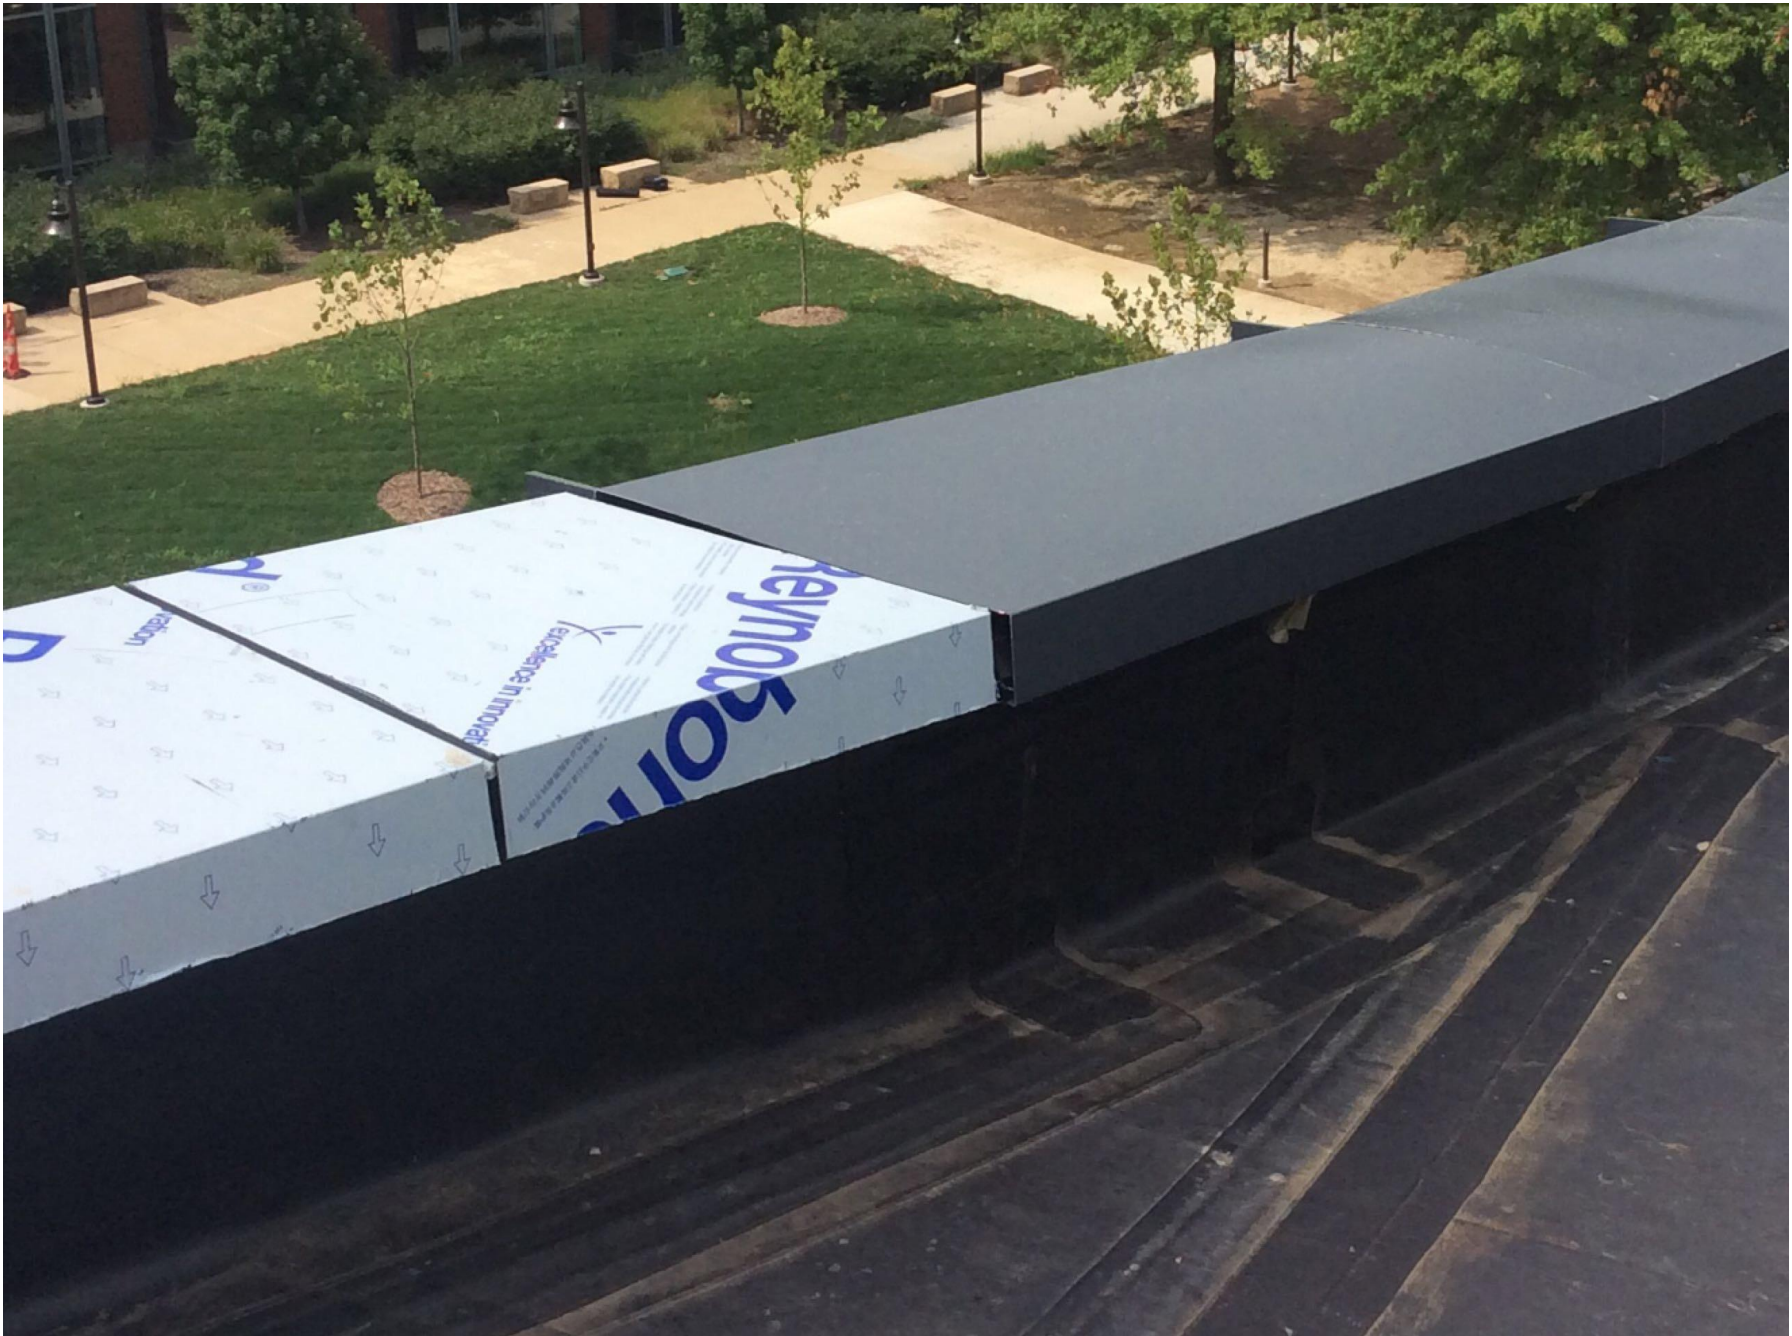
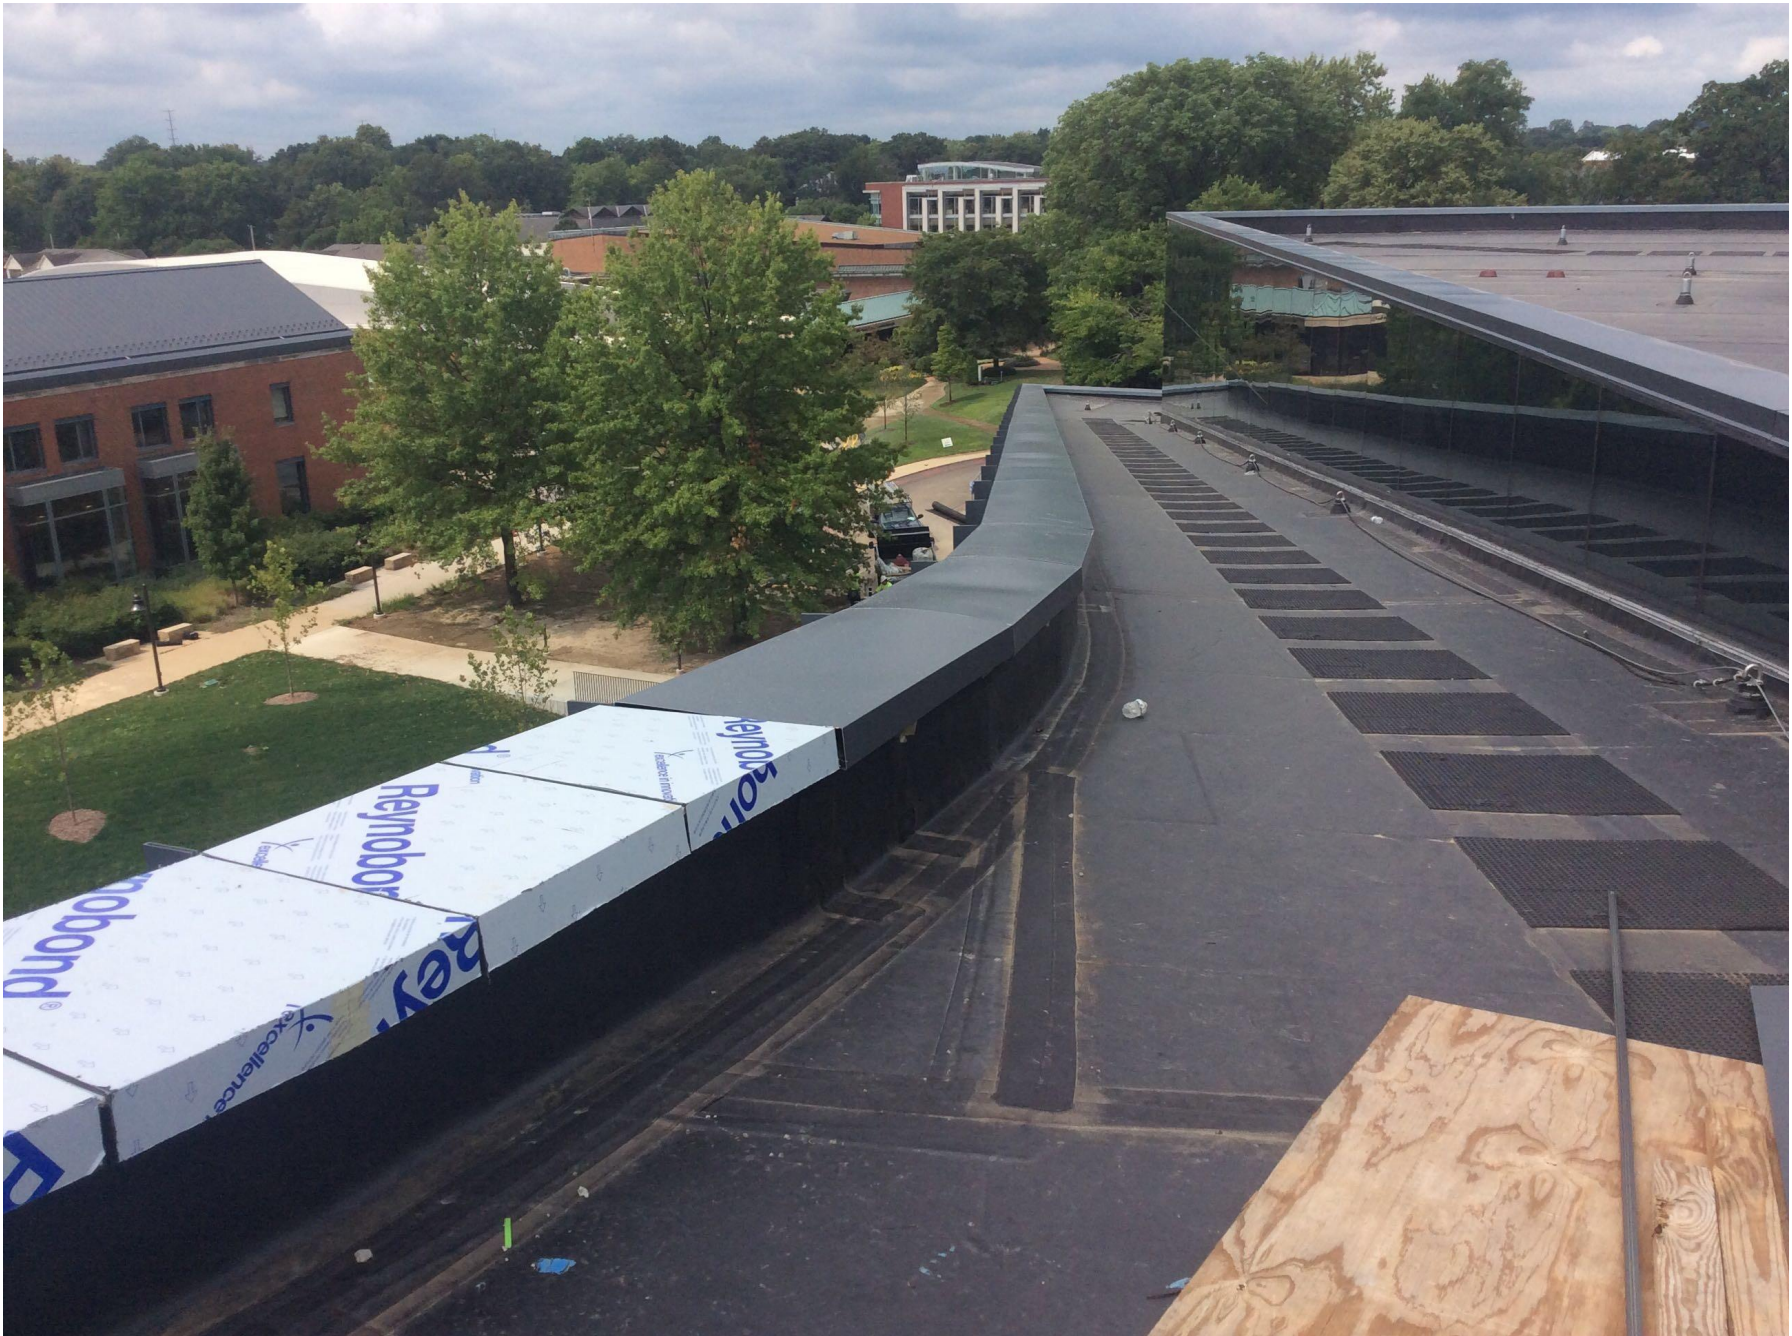
| Issue ID | Description | Location Detail | Location | Status | Company | Type | Date Created | Due Date |
|---|---|---|---|---|---|---|---|---|
| 002115 | Seal gaps where two types of coping meet | | Webster > Roof | Open | VOGEL HEATING & COOLING | Architect Punch List | 07 Aug 2017 | 12 Aug 2017 |

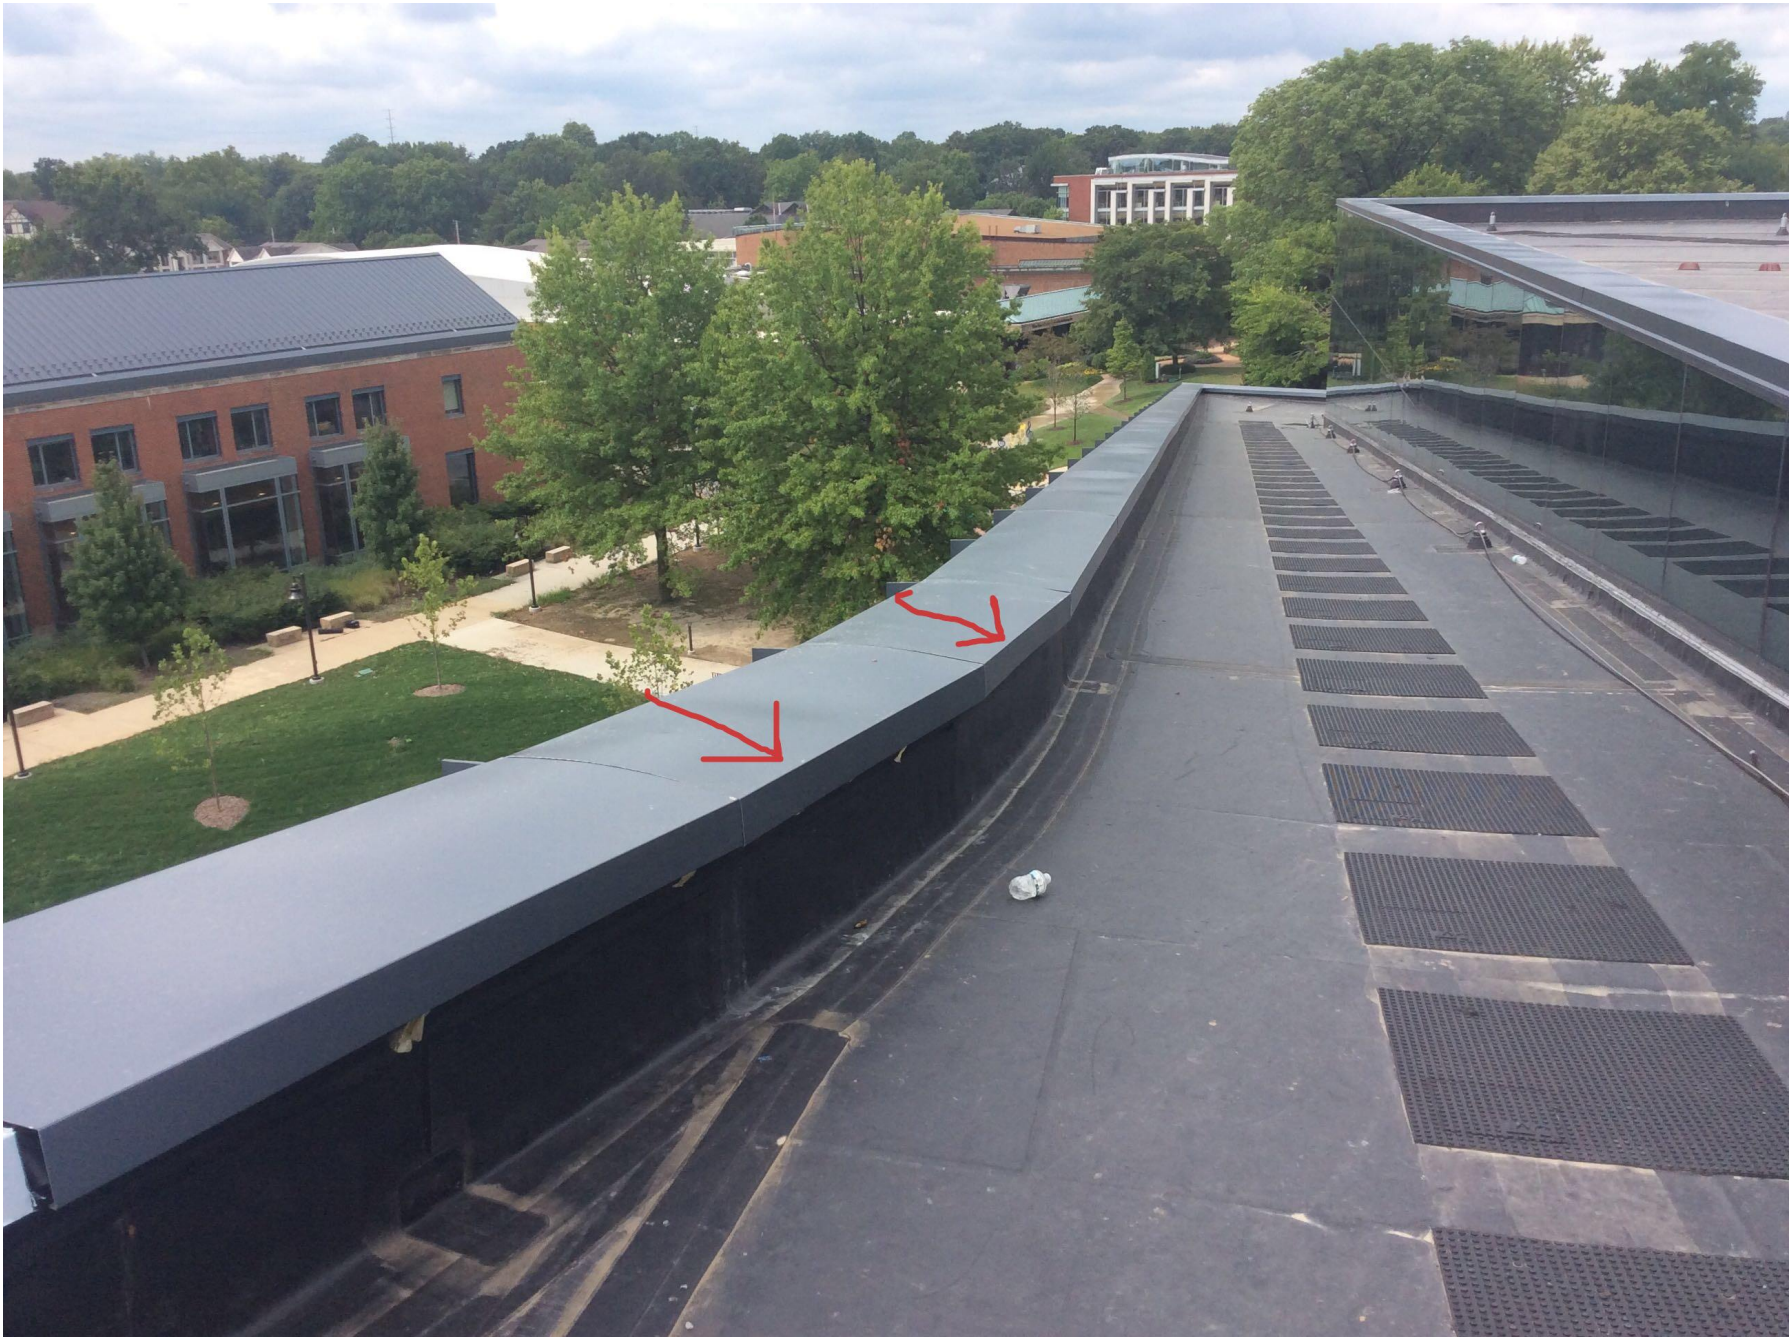
| Issue ID | Description | Location Detail | Location | Status | Company | Type | Date Created | Due Date |
|---|---|---|---|---|---|---|---|---|
| 002116 | Coping should slope onto roof, no "hump" | | Webster > Roof | Open | VOGEL HEATING & COOLING | Architect Punch List | 07 Aug 2017 | 12 Aug 2017 |

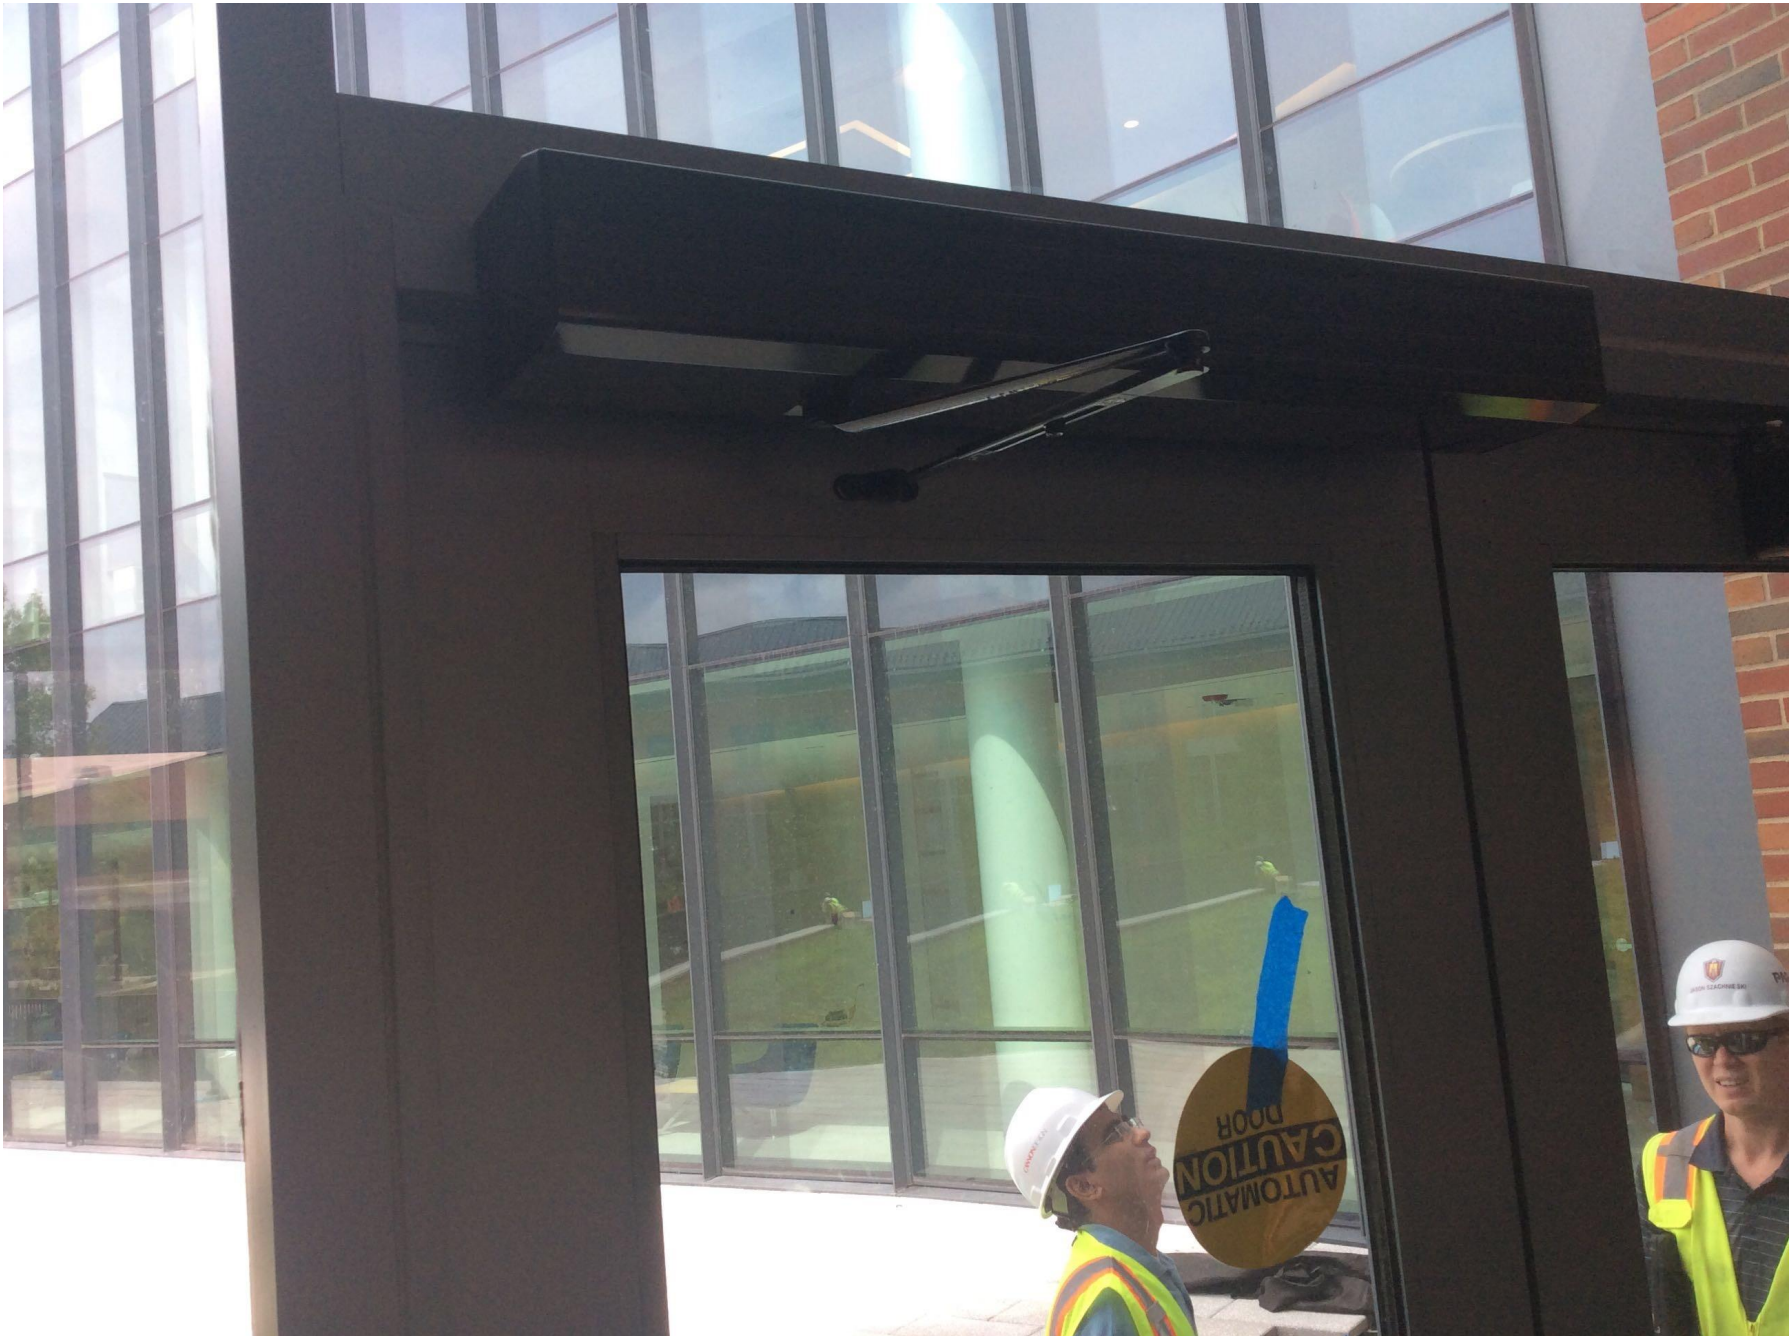
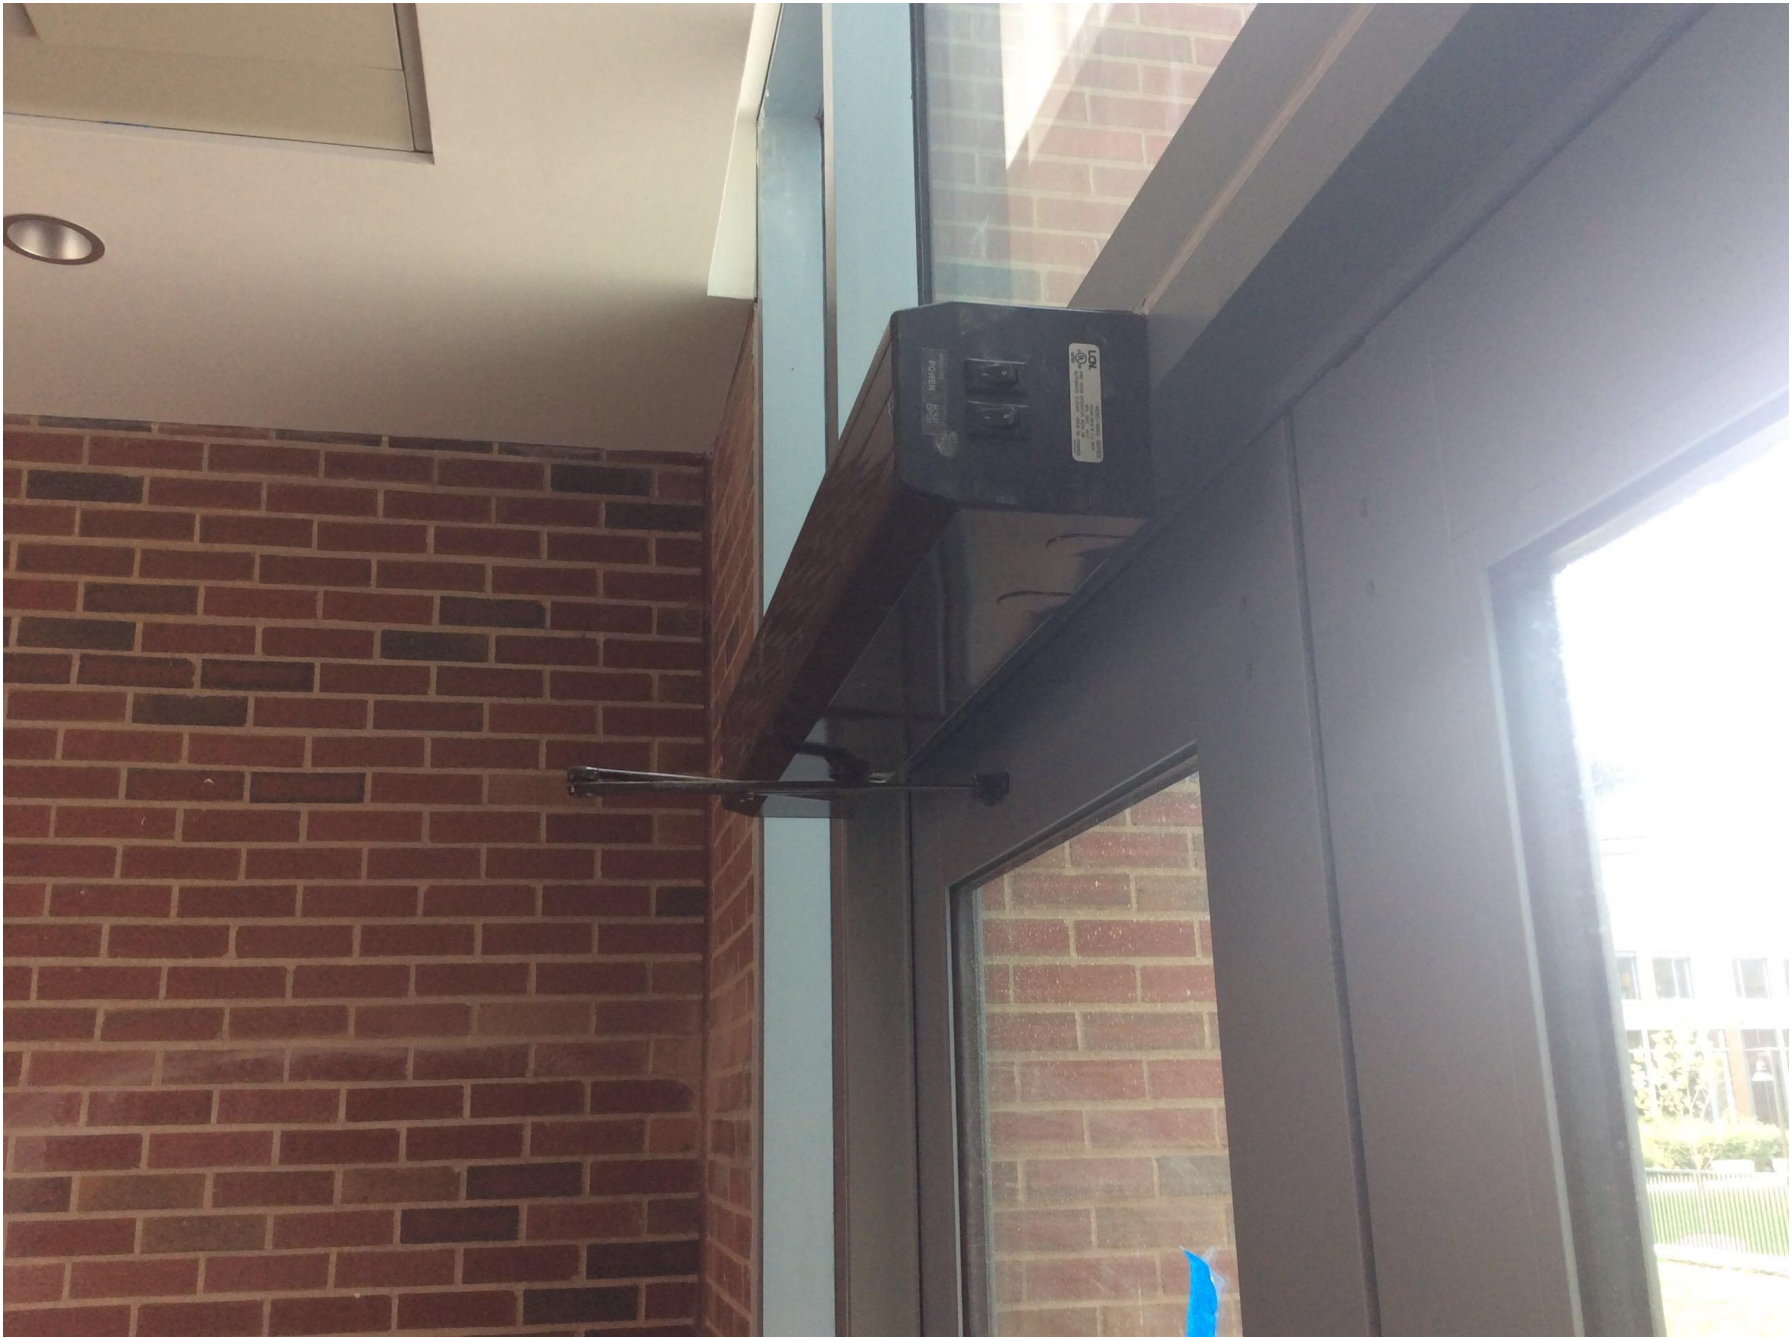
| Issue ID | Description | Location Detail | Location | Status | Company | Type | Date Created | Due Date |
|---|---|---|---|---|---|---|---|---|
| 002119 | Automatic door closer to be raised - eab connector | | Site | Open | VOGEL HEATING & COOLING | Architect Punch List | 07 Aug 2017 | 12 Aug 2017 |

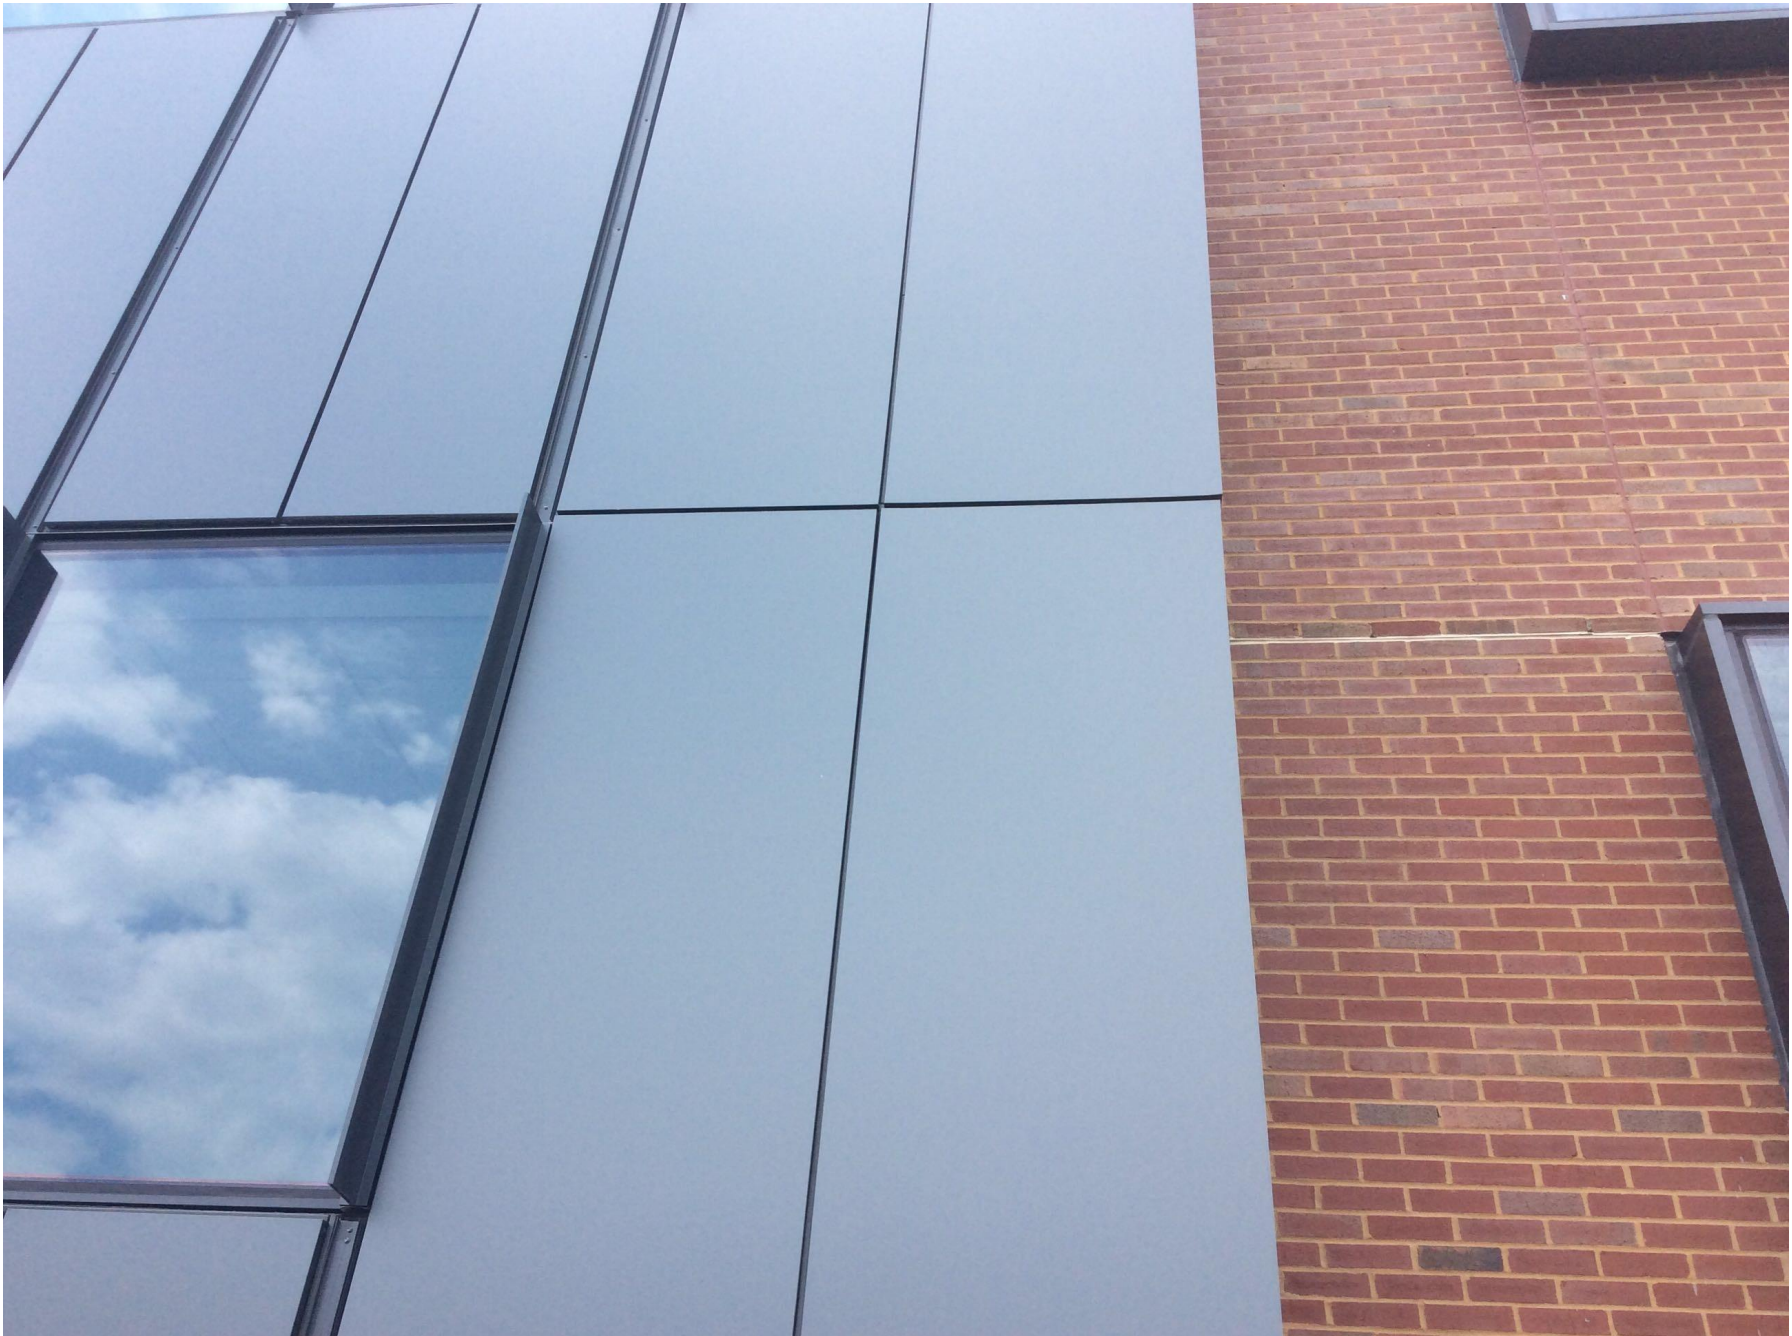
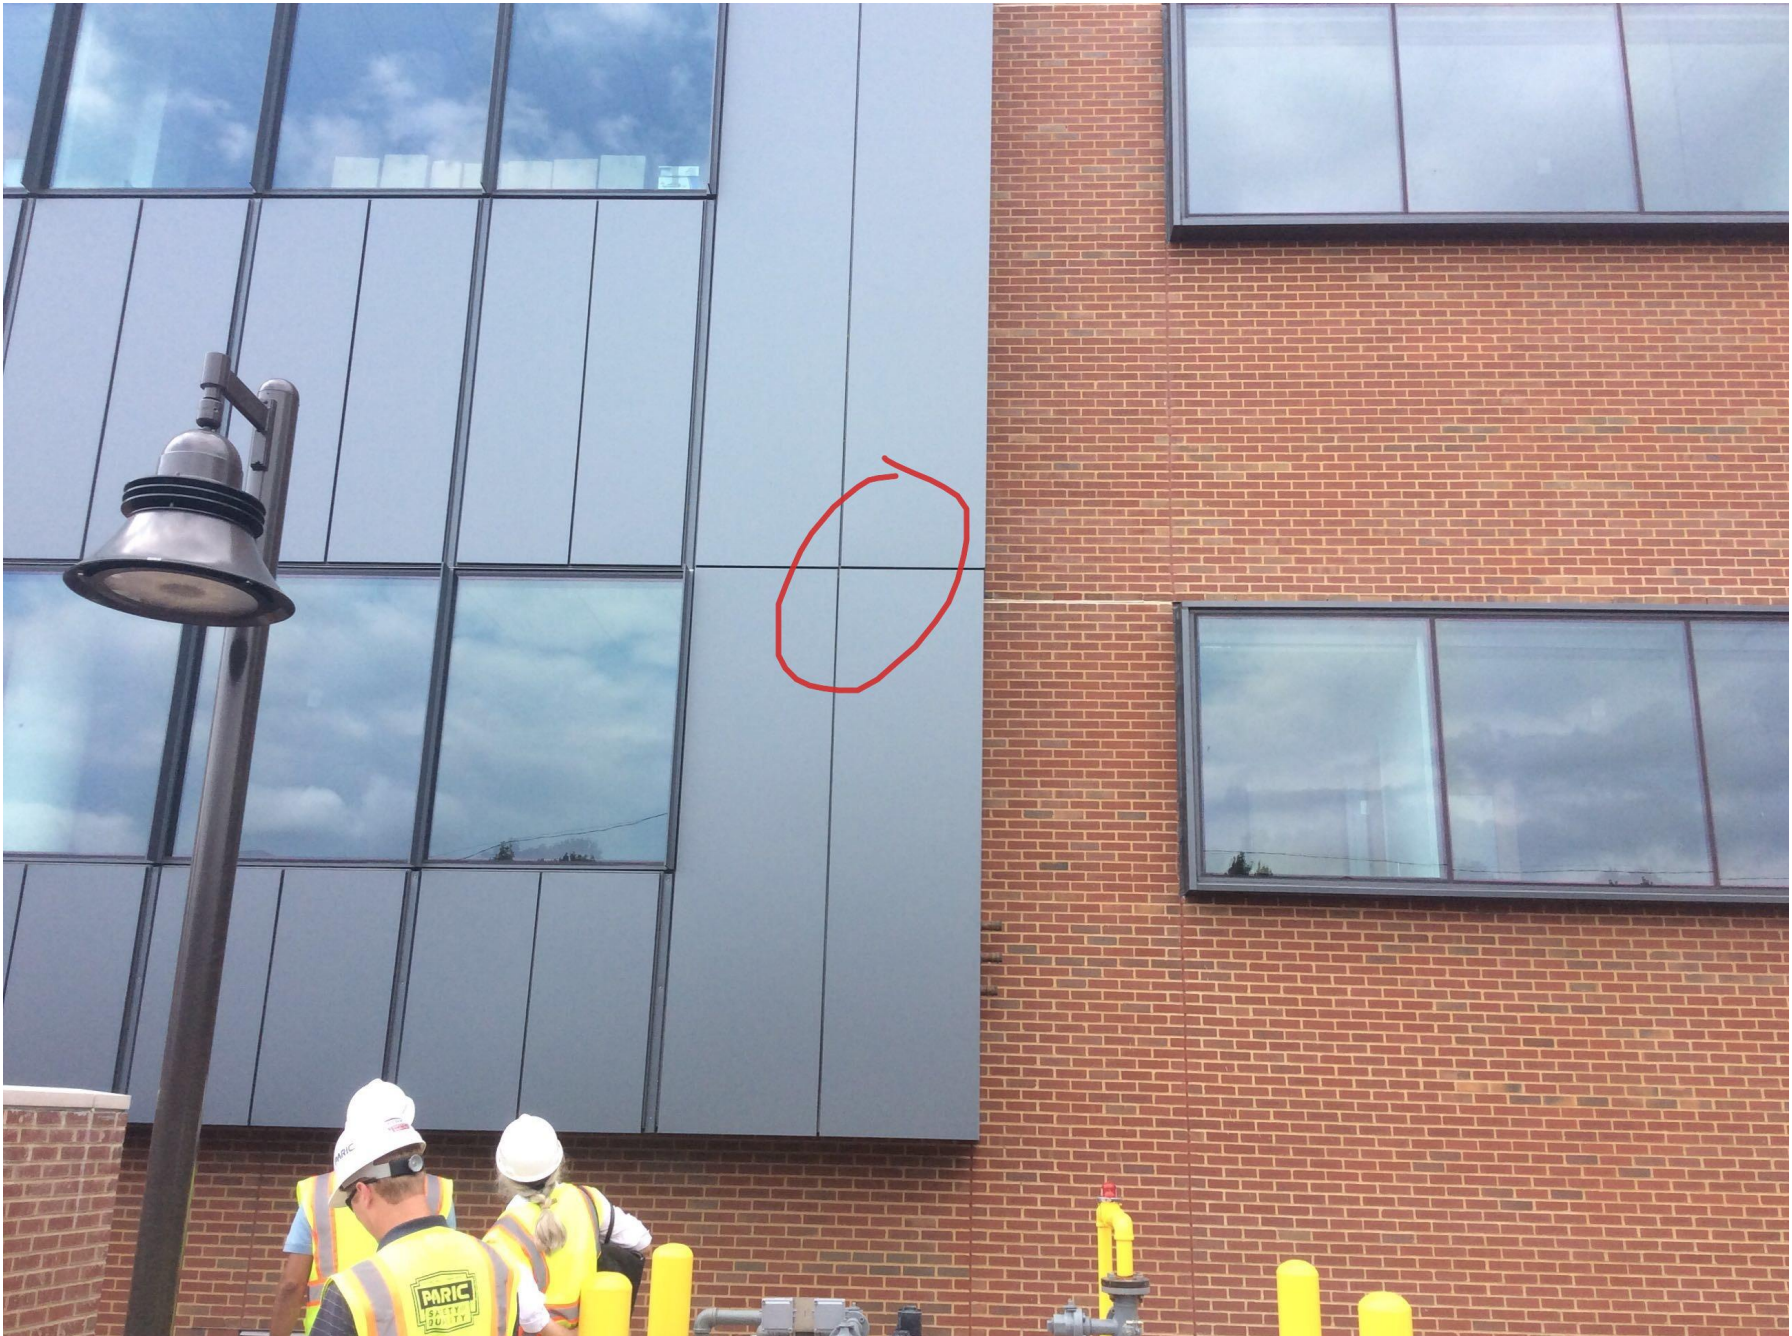
| Issue ID | Description | Location Detail | Location | Status | Company | Type | Date Created | Due Date |
|---|---|---|---|---|---|---|---|---|
| 002144 | Joints out of alignment at metal panel intersection - east | | Site | Open | VOGEL HEATING & COOLING | Architect Punch List | 07 Aug 2017 | 12 Aug 2017 |
