## **ARCHITECTURAL PUNCH LIST (EXTERIOR FAÇADE & ROOF)**

**Project:** Webster University Interdisciplinary Science Building

**Project No:** CannonDesign #004561.01

**Date of Observation:** August 7, 2017

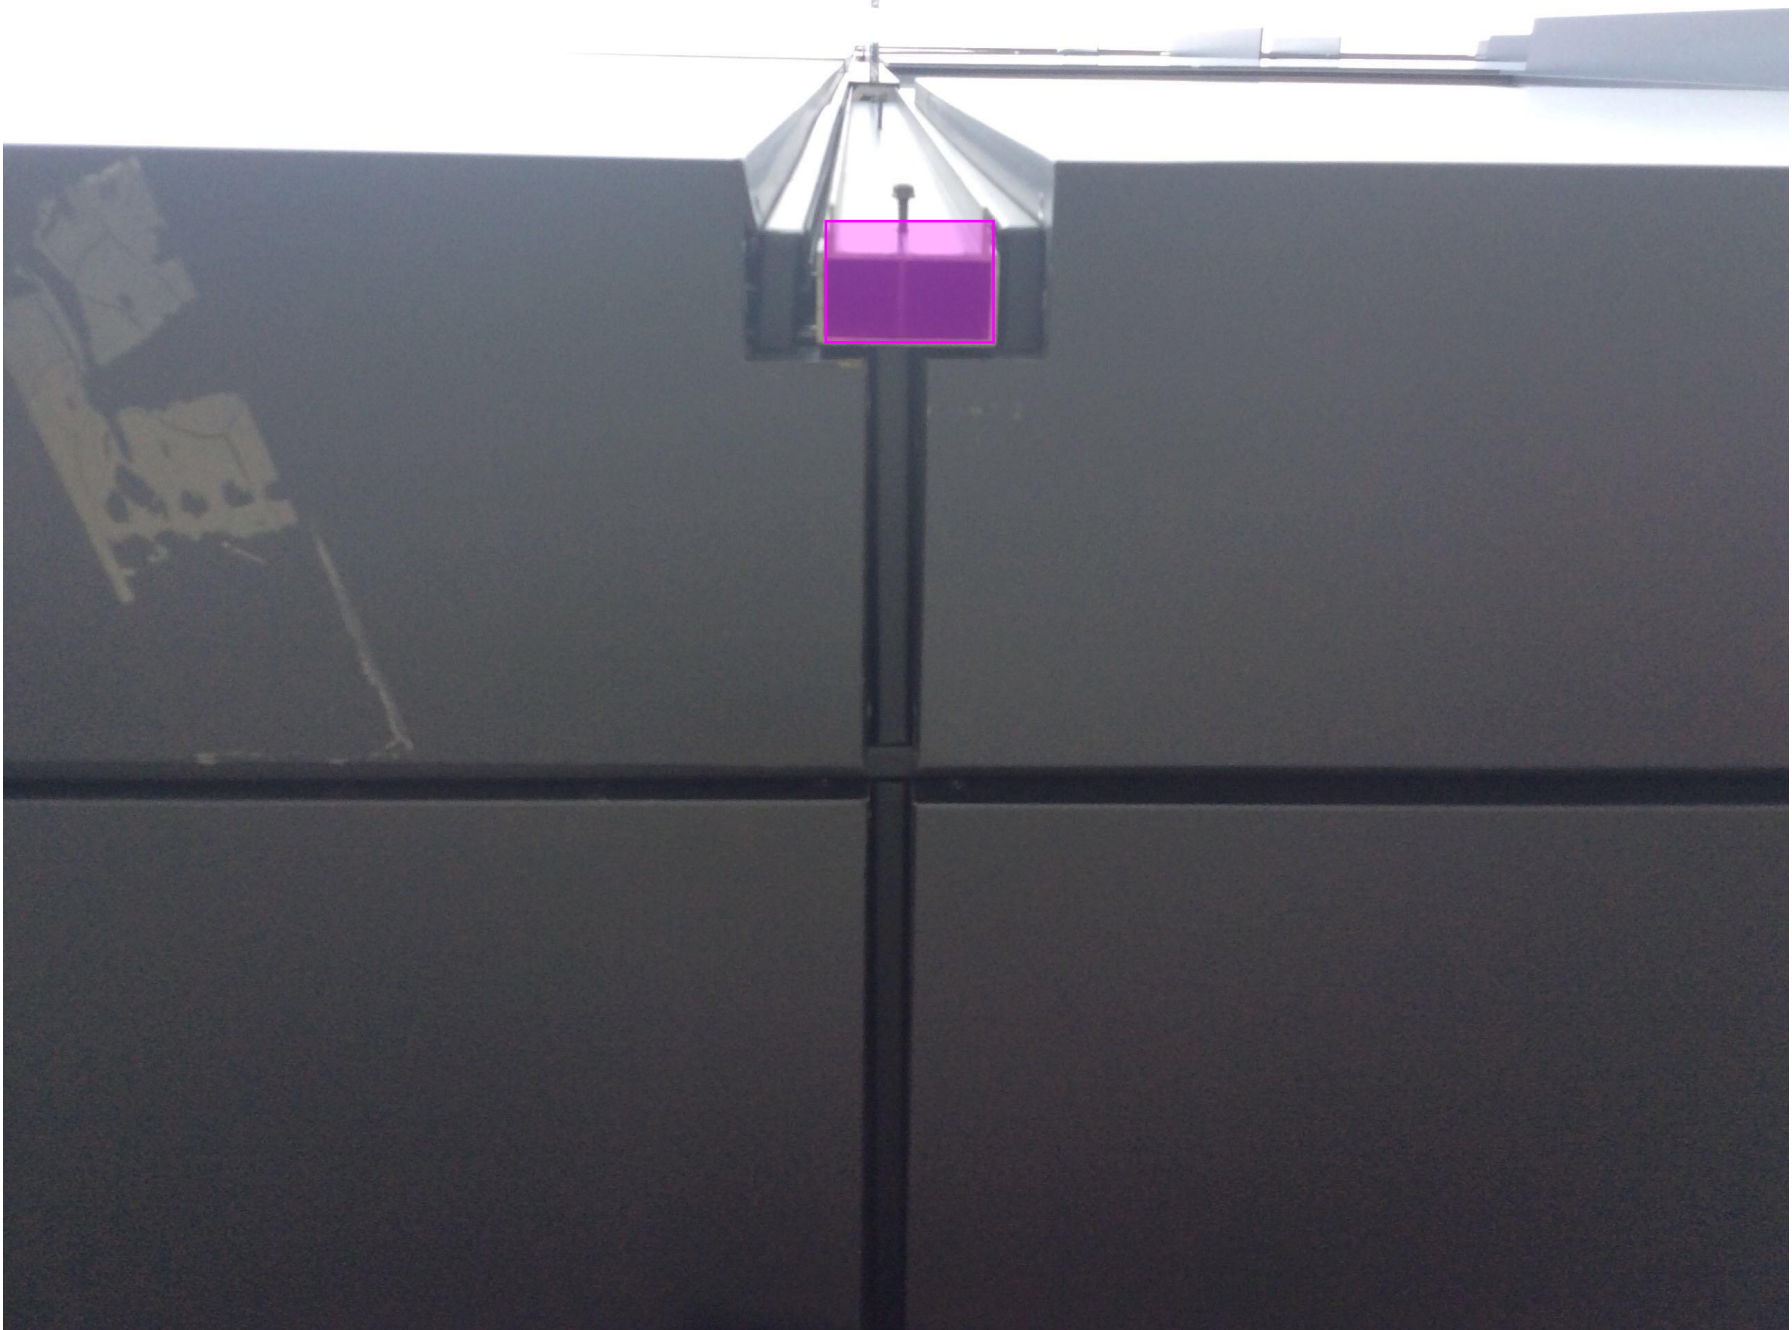
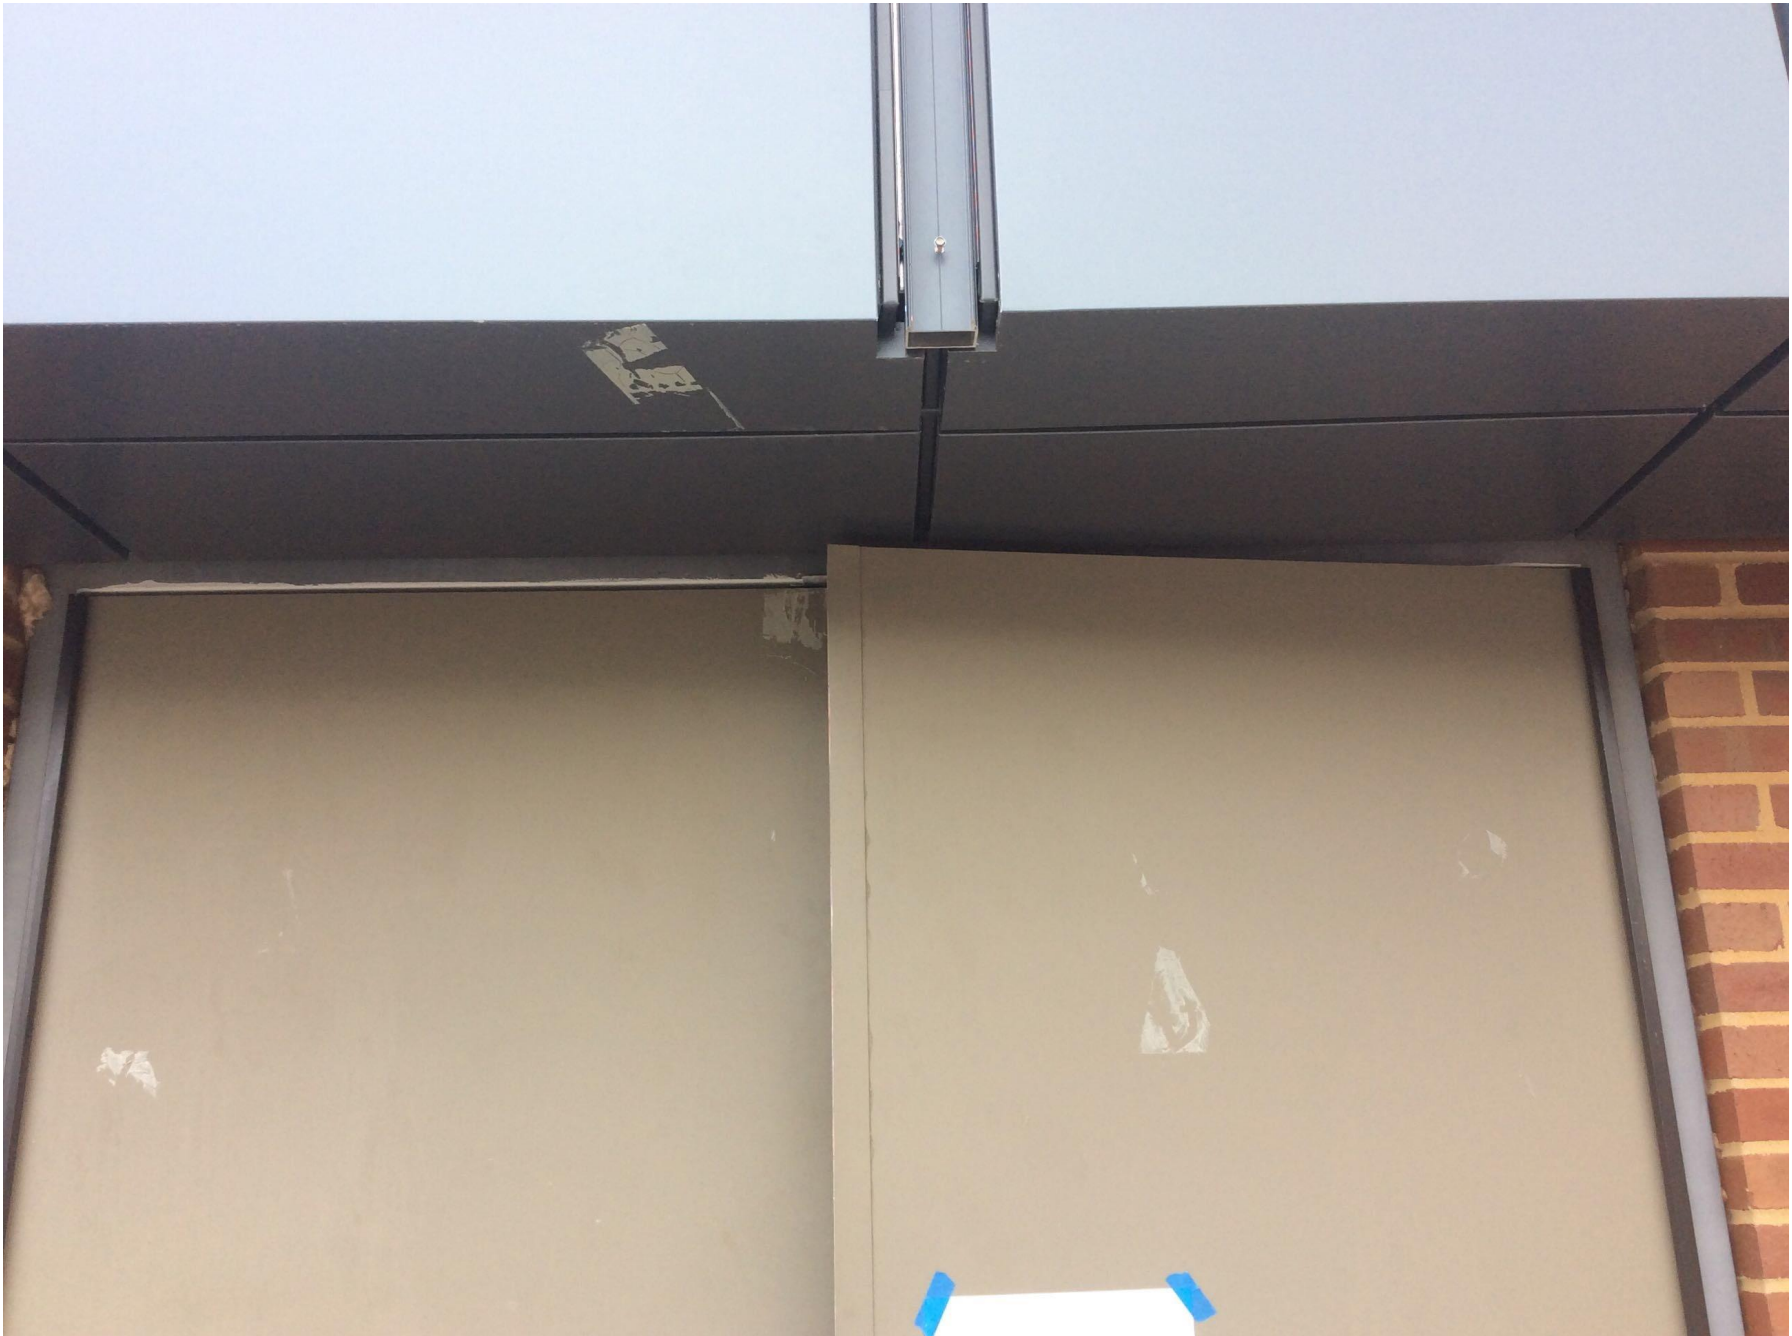
| Issue ID | Description | Location Detail | Location | Status | Company | Type | Date Created | Due Date |
|---|---|---|---|---|---|---|---|---|
| 002146 | Cover plate needed at opening above east loading dock door | | Site | Open | VOGEL HEATING & COOLING | Architect Punch List | 07 Aug 2017 | 12 Aug 2017 |

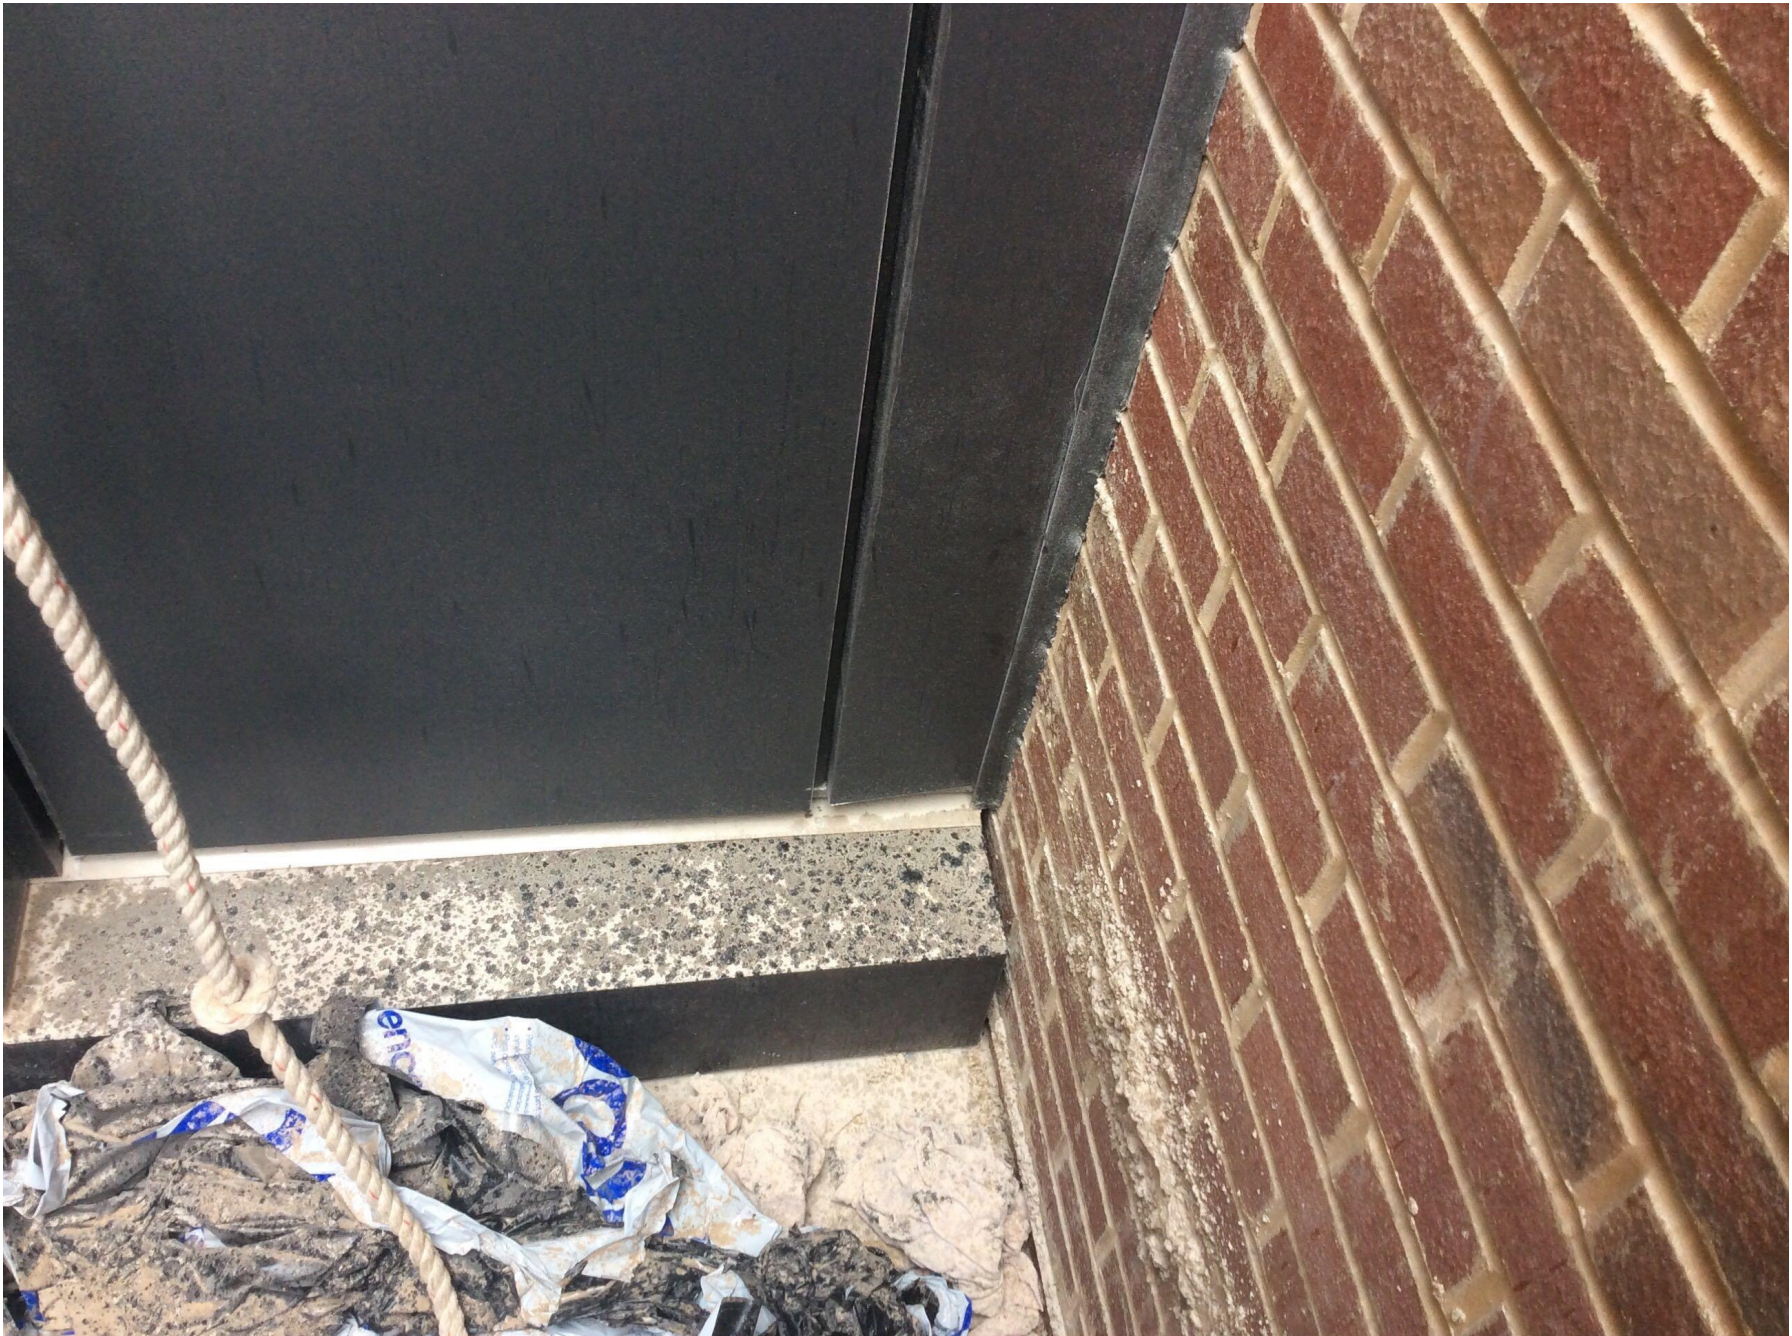
| Issue ID | Description | Location Detail | Location | Status | Company | Type | Date Created | Due Date |
|---|---|---|---|---|---|---|---|---|
| 002151 | Metal panel to masonry detail not per approved shops<br>At south elevation. | | Site | Open | VOGEL HEATING & COOLING | Architect Punch List | 07 Aug 2017 | 12 Aug 2017 |
