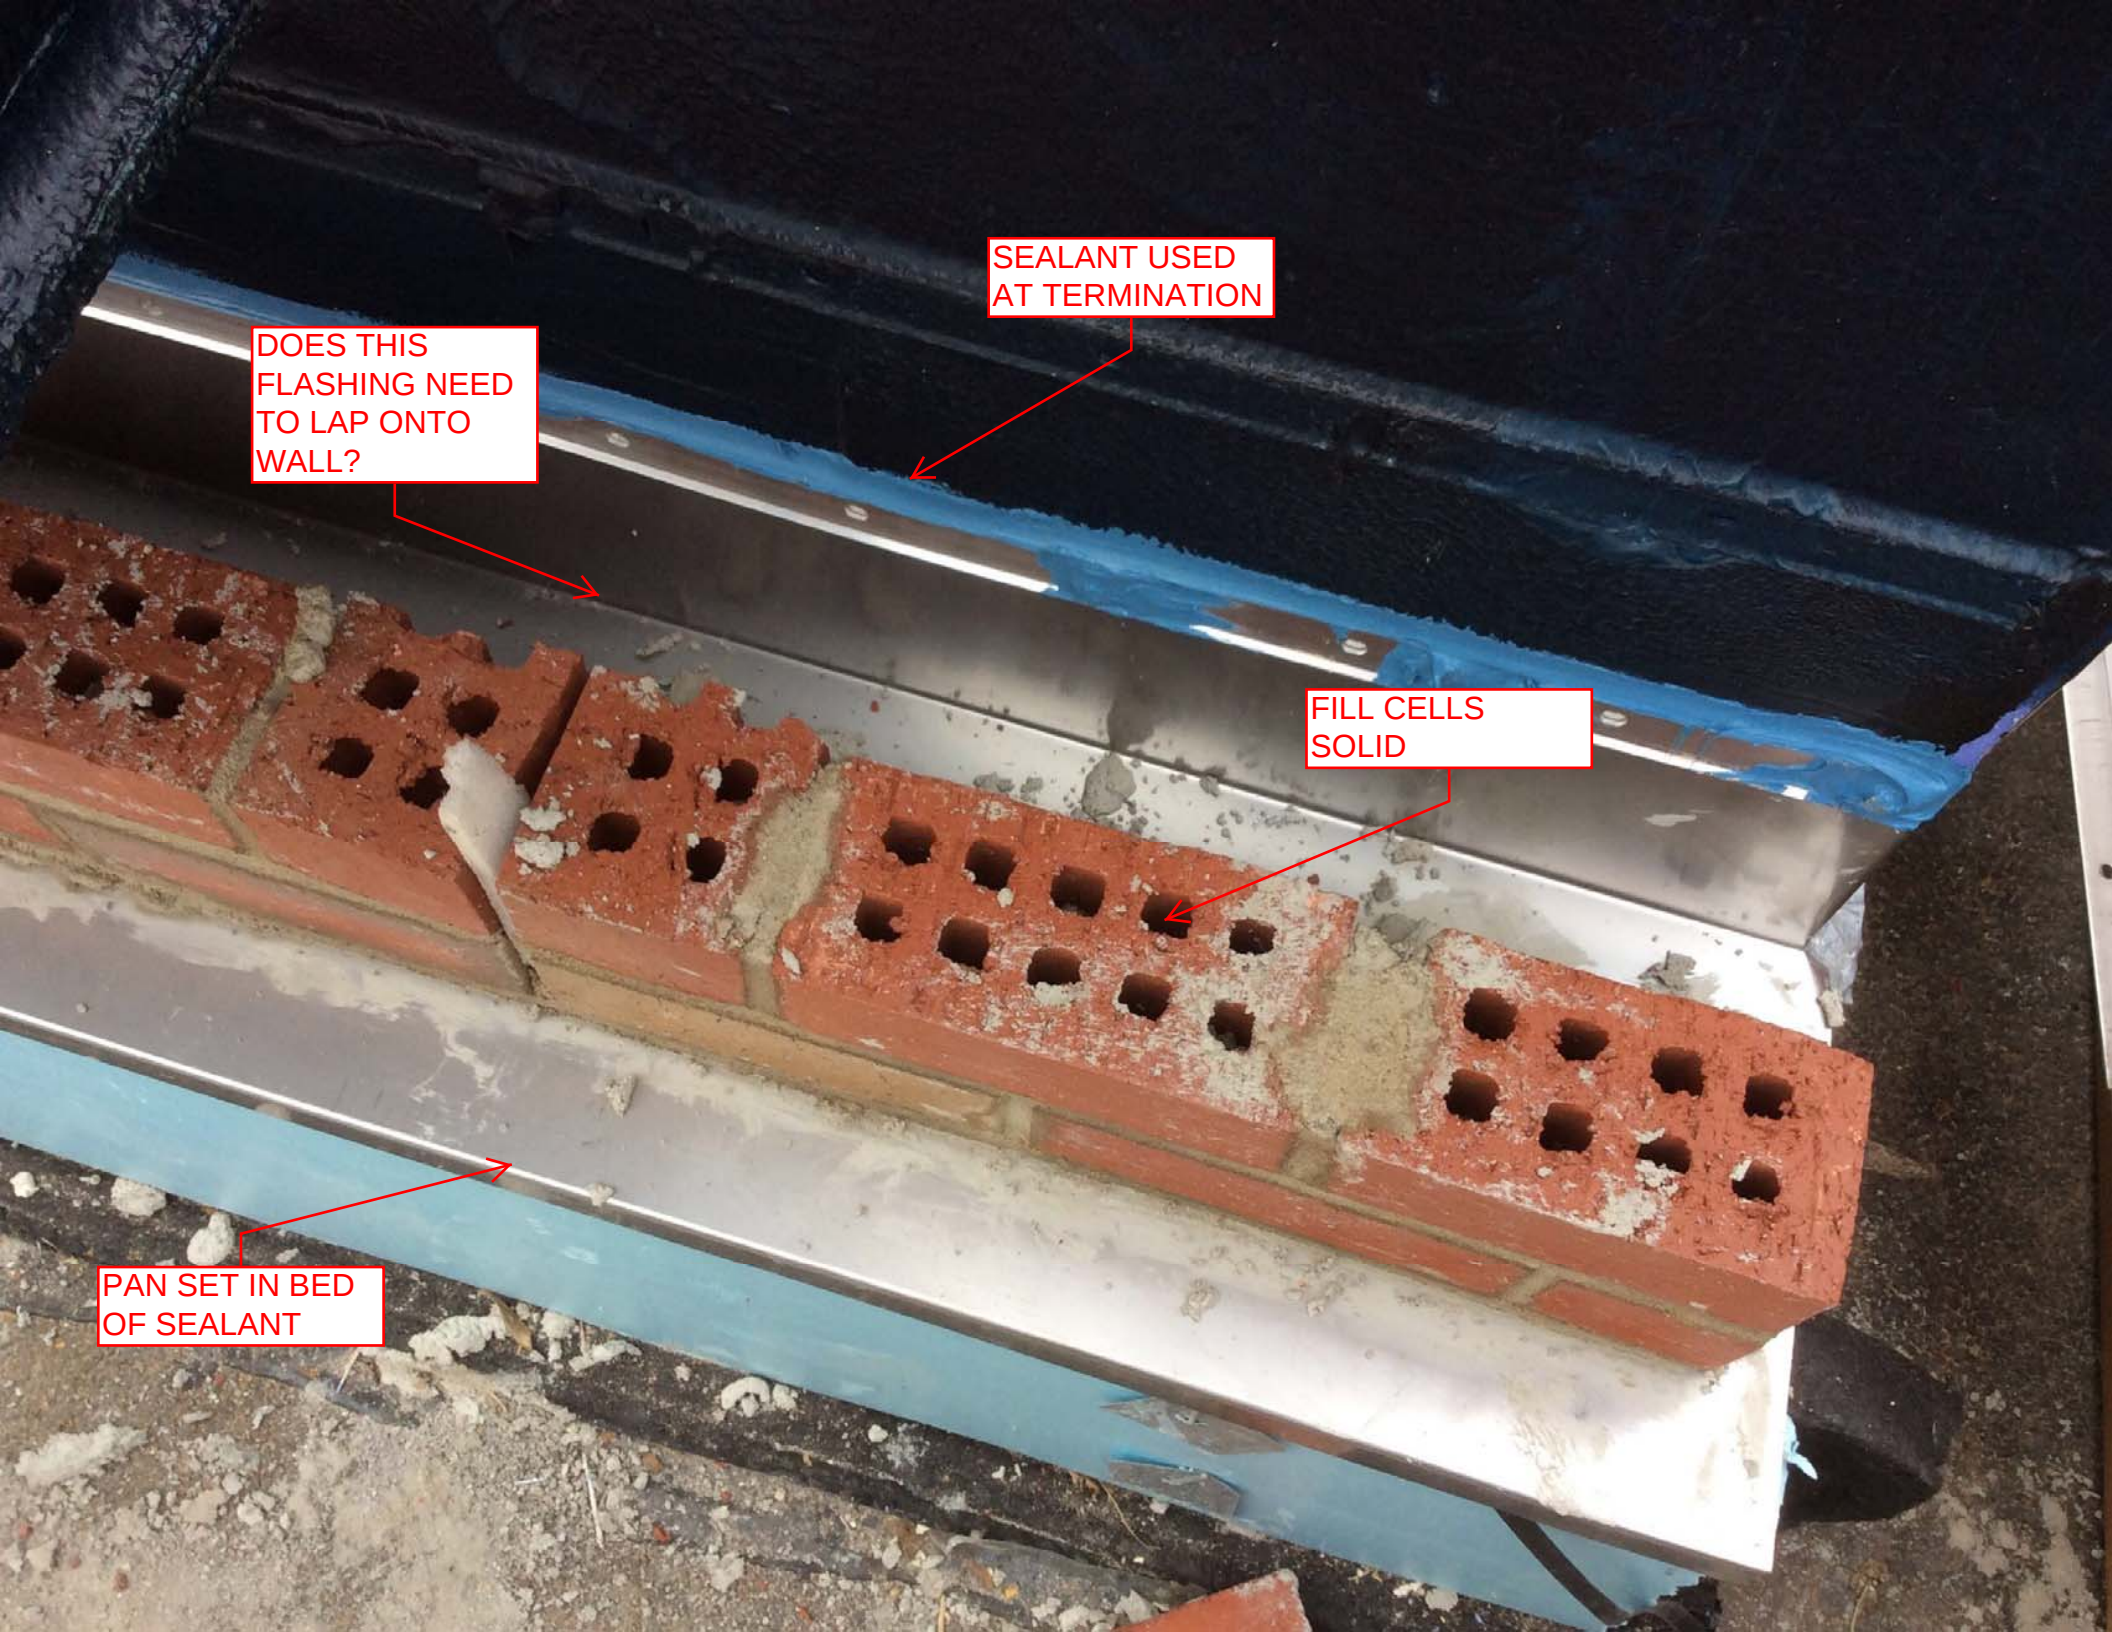
SEALANT USED  
AT TERMINATION

DOES THIS  
FLASHING NEED  
TO LAP ONTO  
WALL?

FILL CELLS  
SOLID

PAN SET IN BED  
OF SEALANT

GROUTED SOLID  
BENEATH  
FLASHING

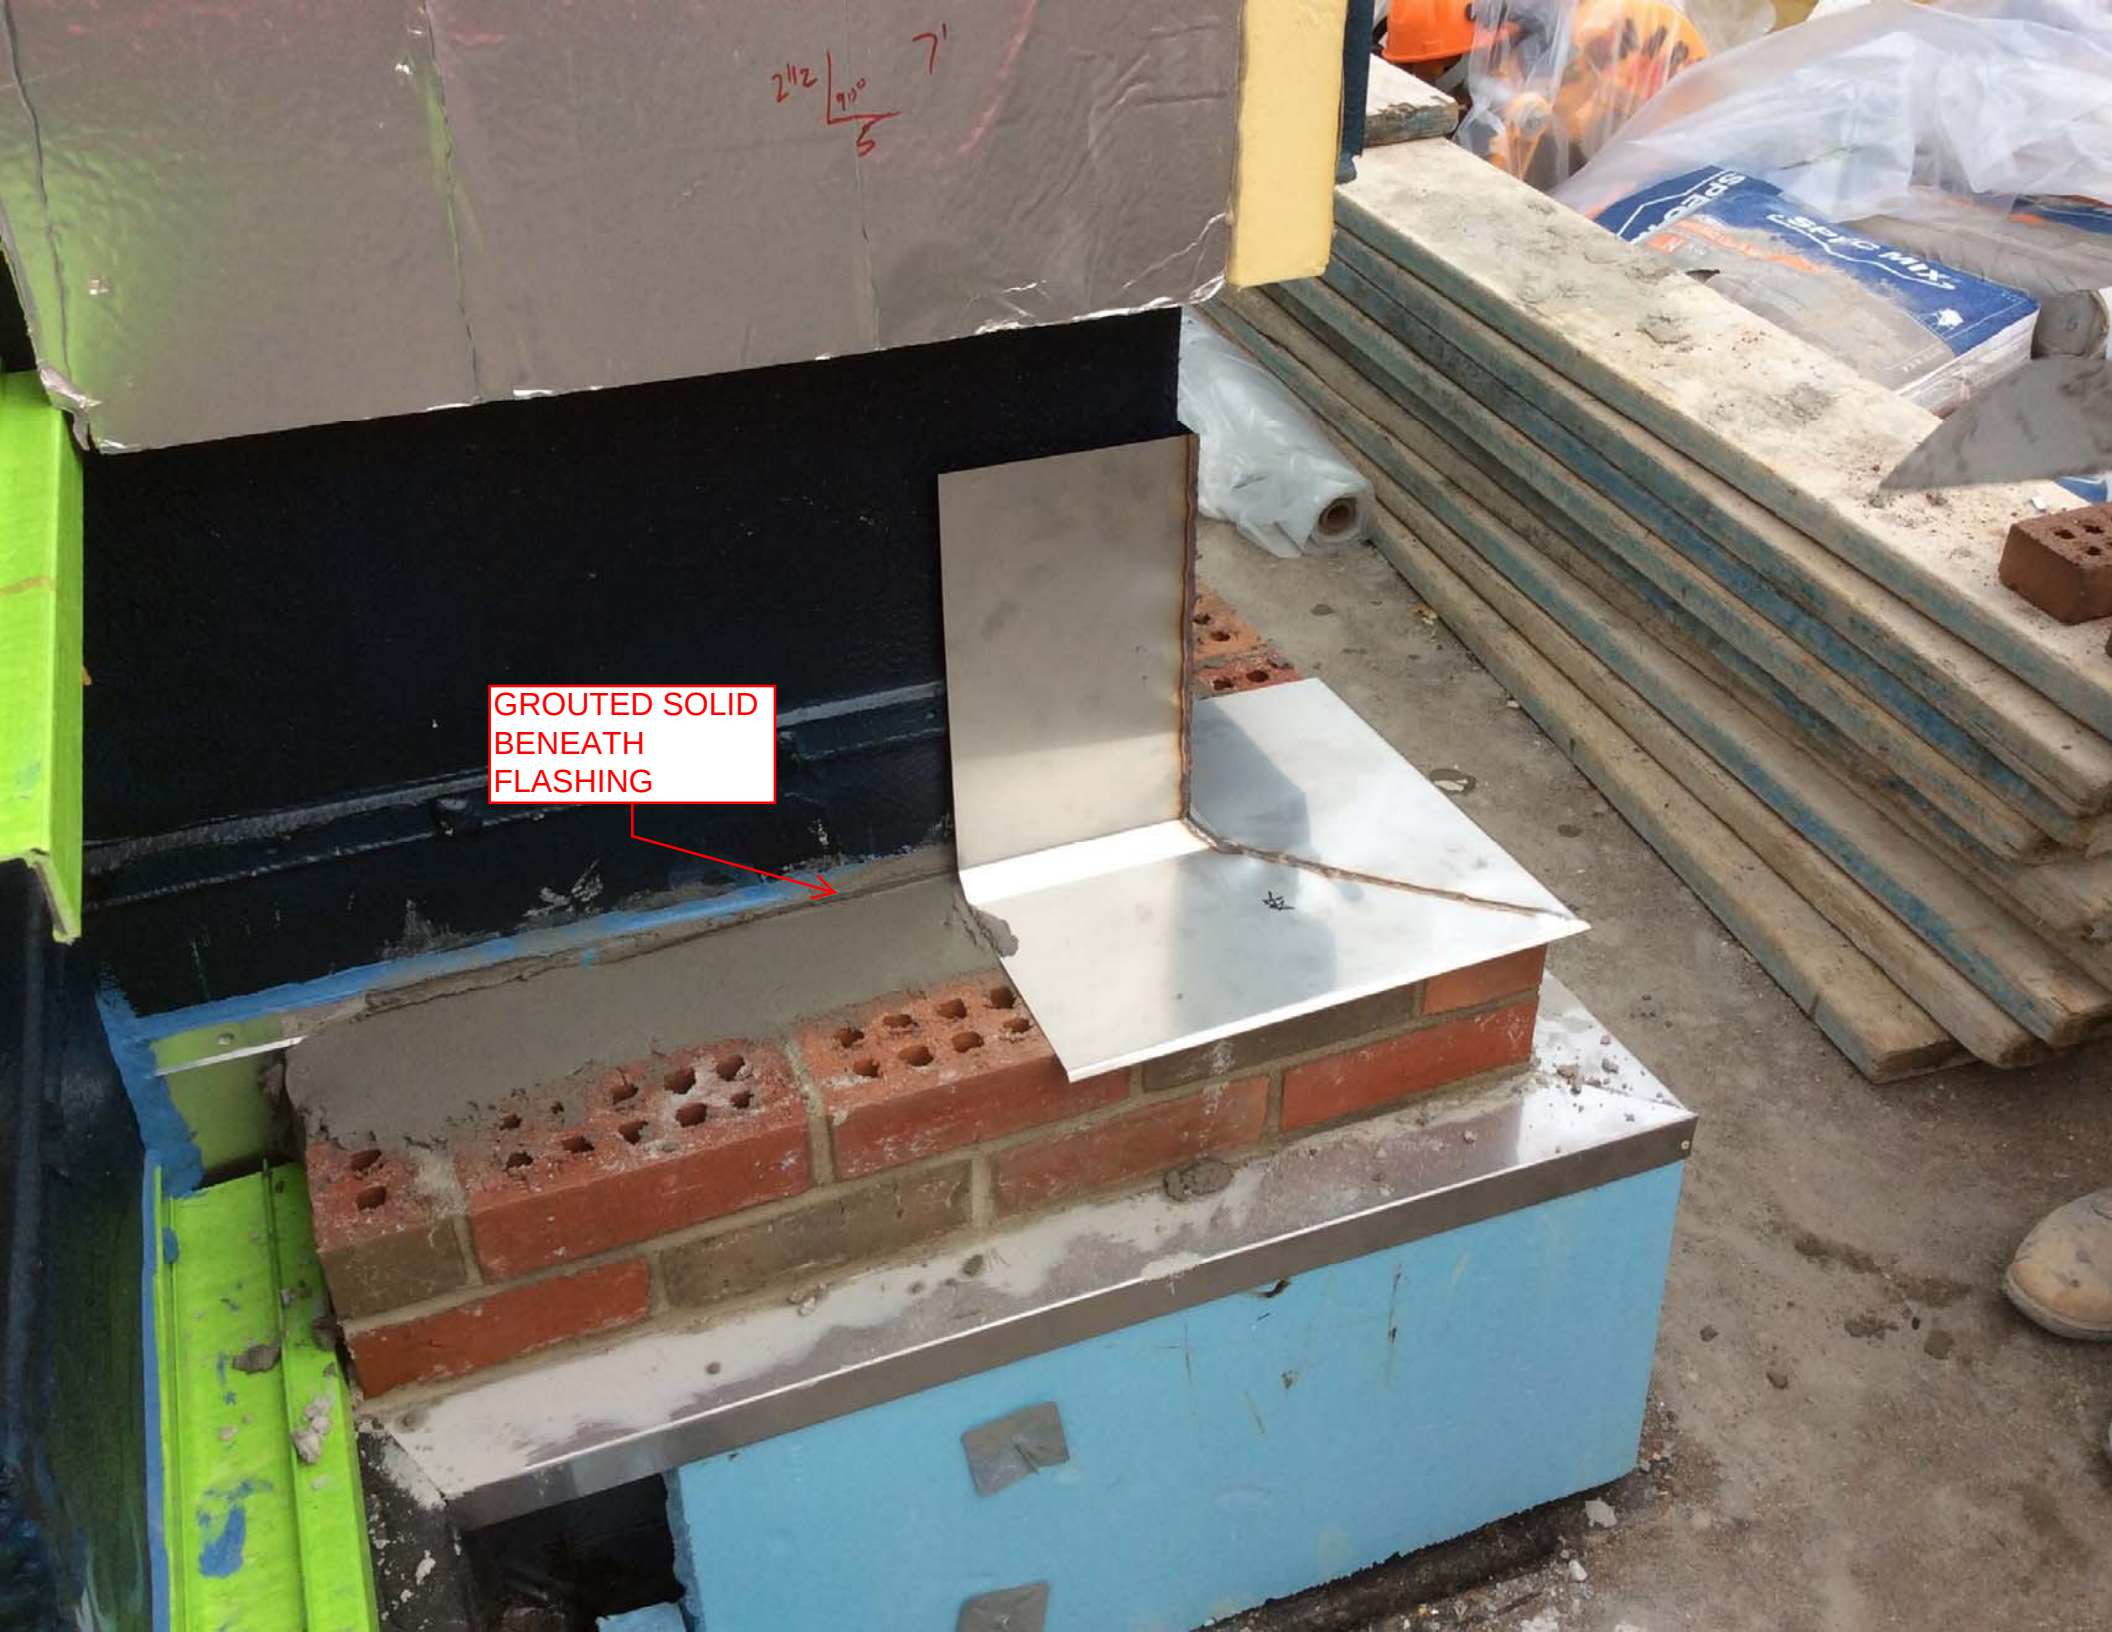
GRACE  
situr

JOINTS WELDED

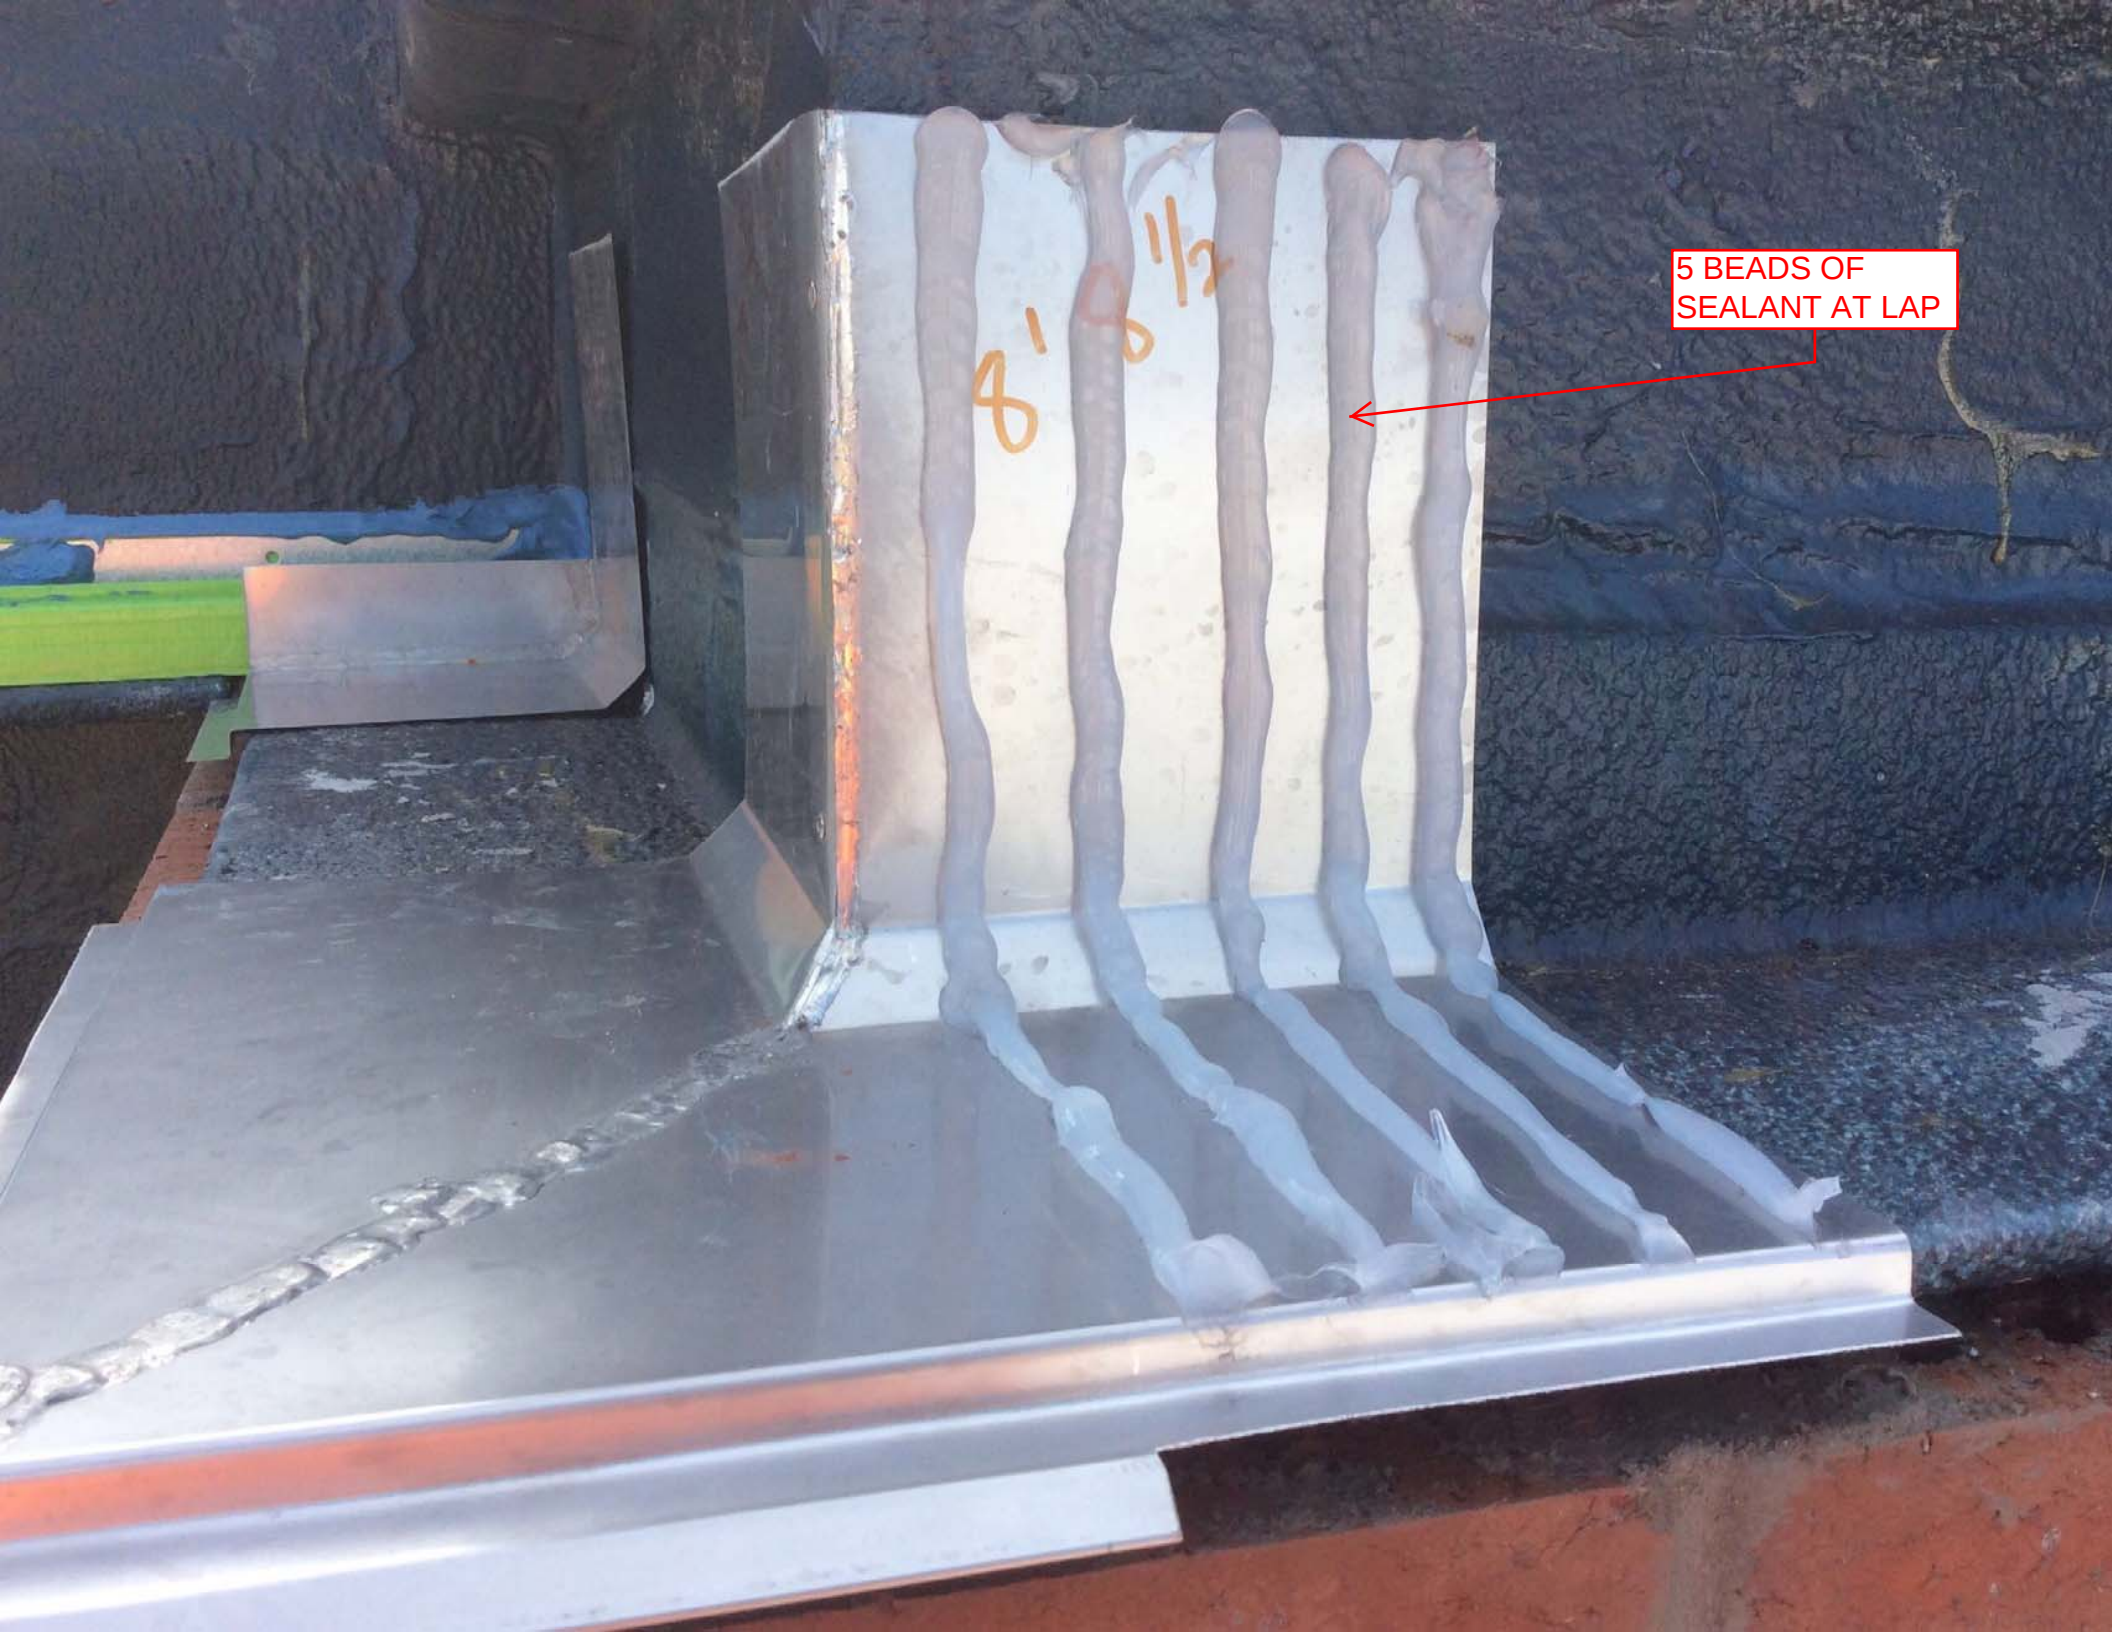
5 BEADS OF  
SEALANT AT LAP

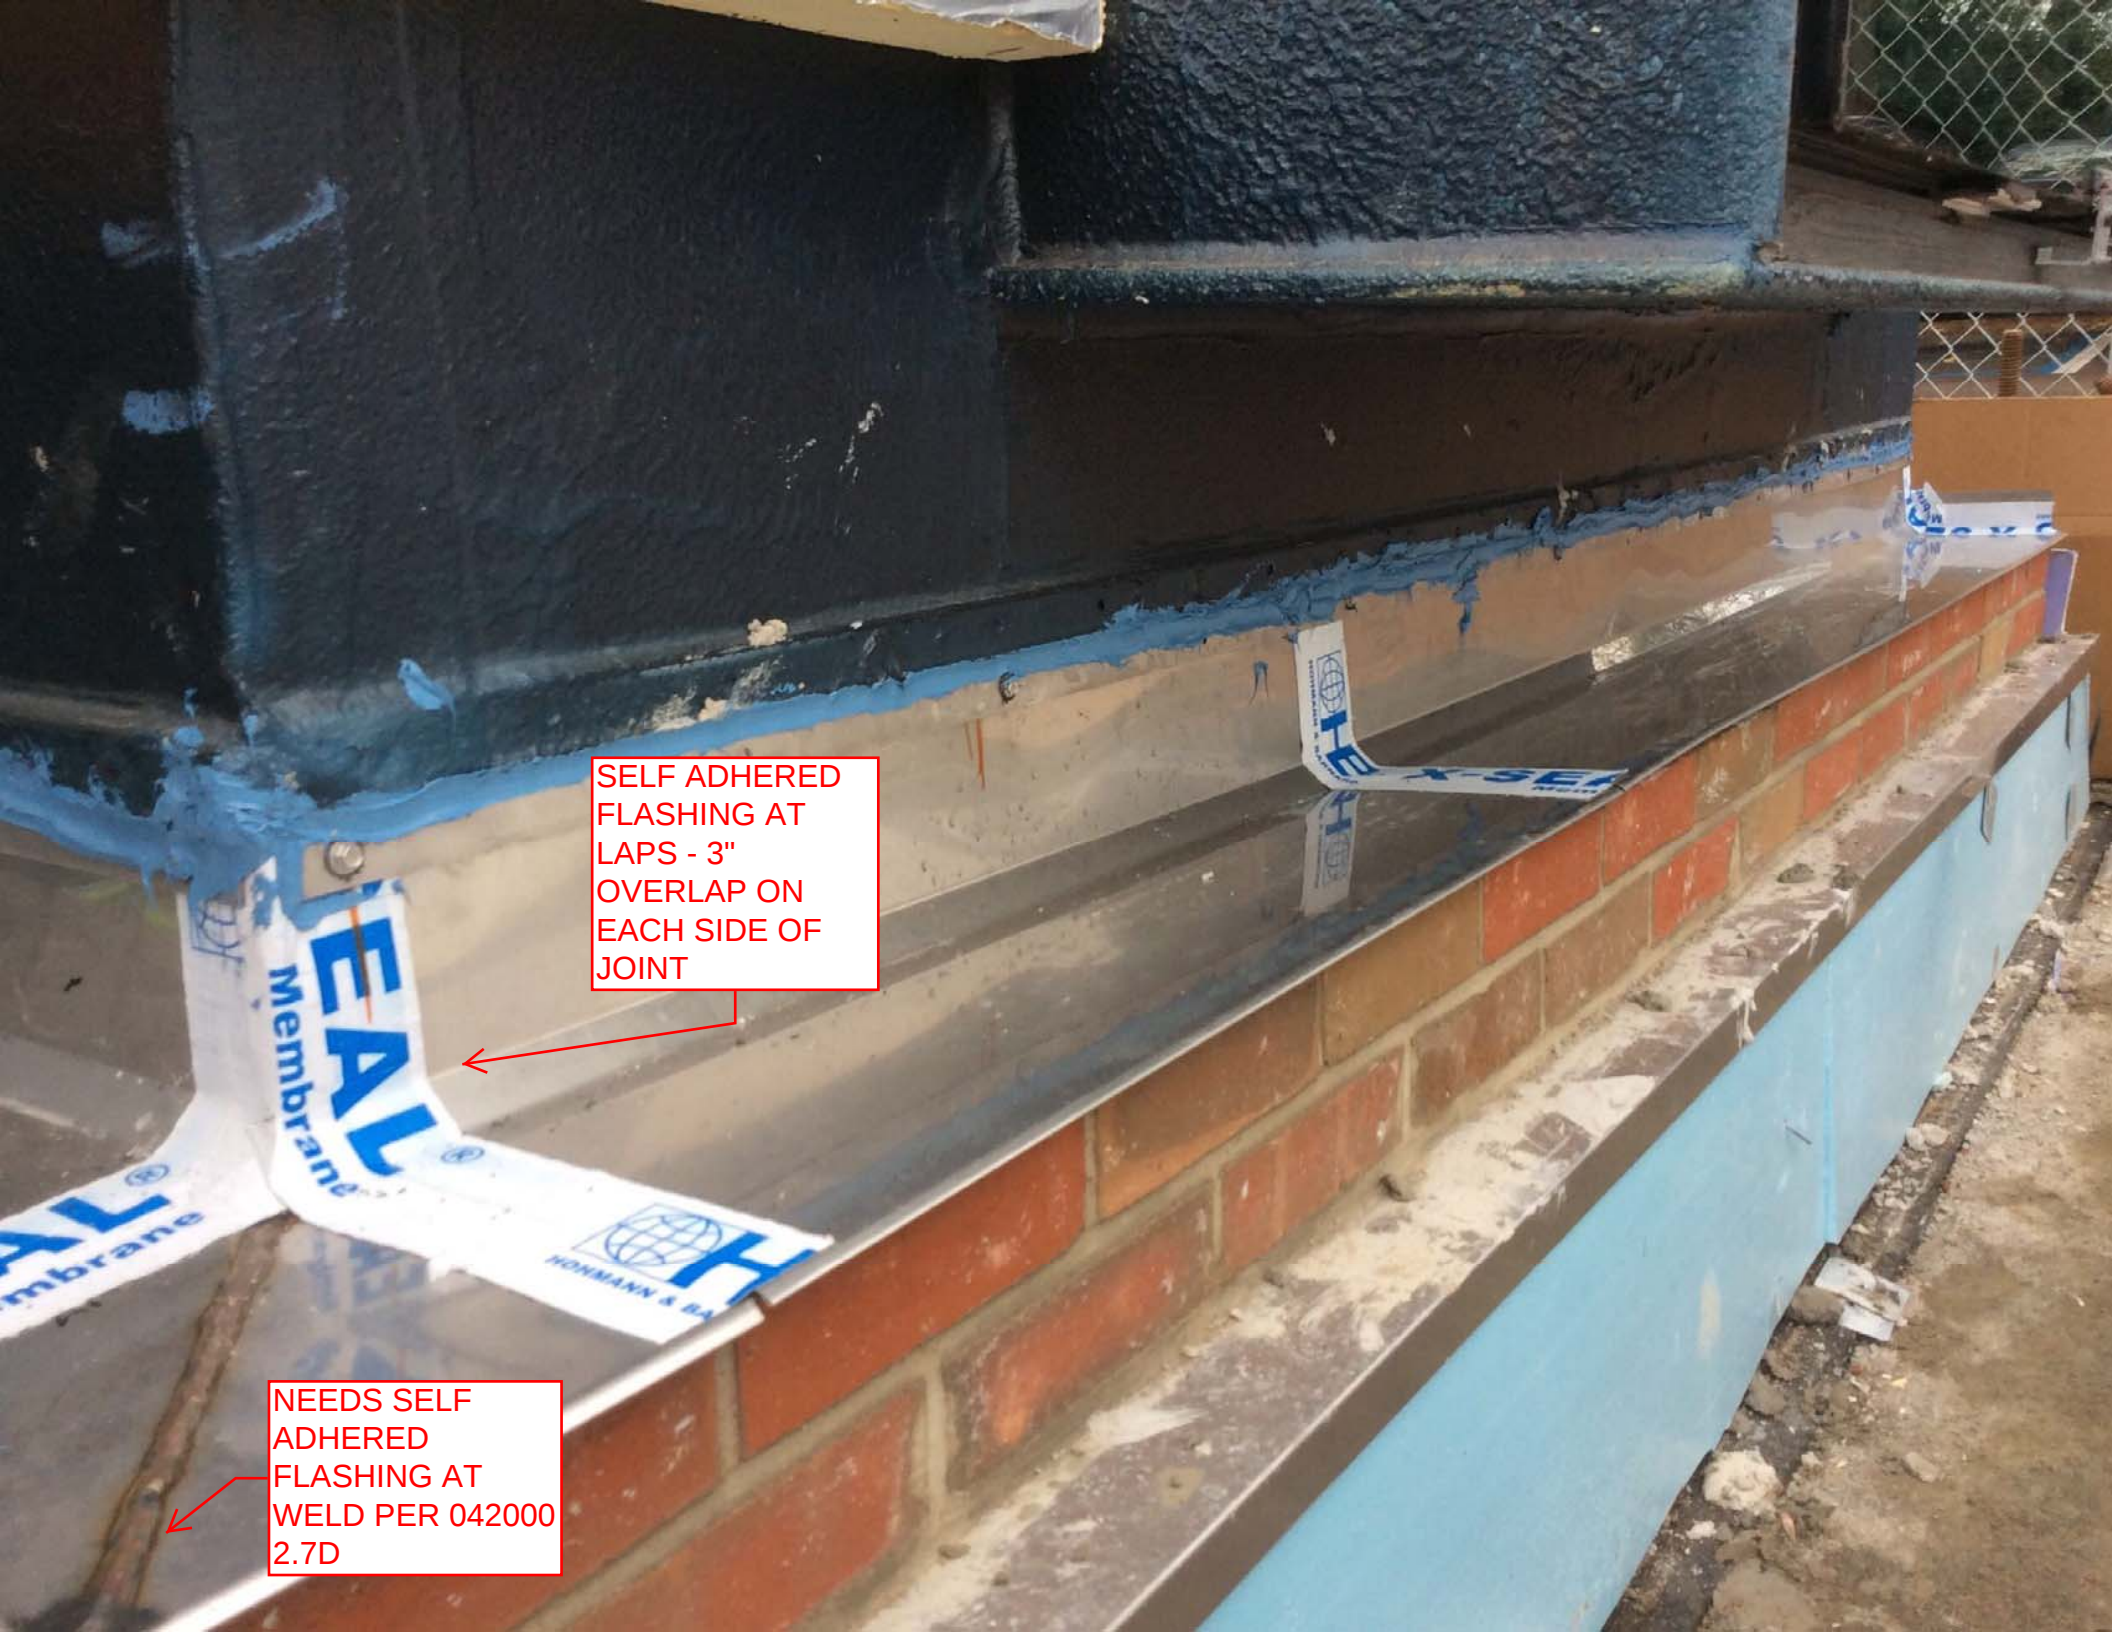
SELF ADHERED  
FLASHING AT  
LAPS - 3"  
OVERLAP ON  
EACH SIDE OF  
JOINT

NEEDS SELF  
ADHERED  
FLASHING AT  
WELD PER 042000  
2.7D

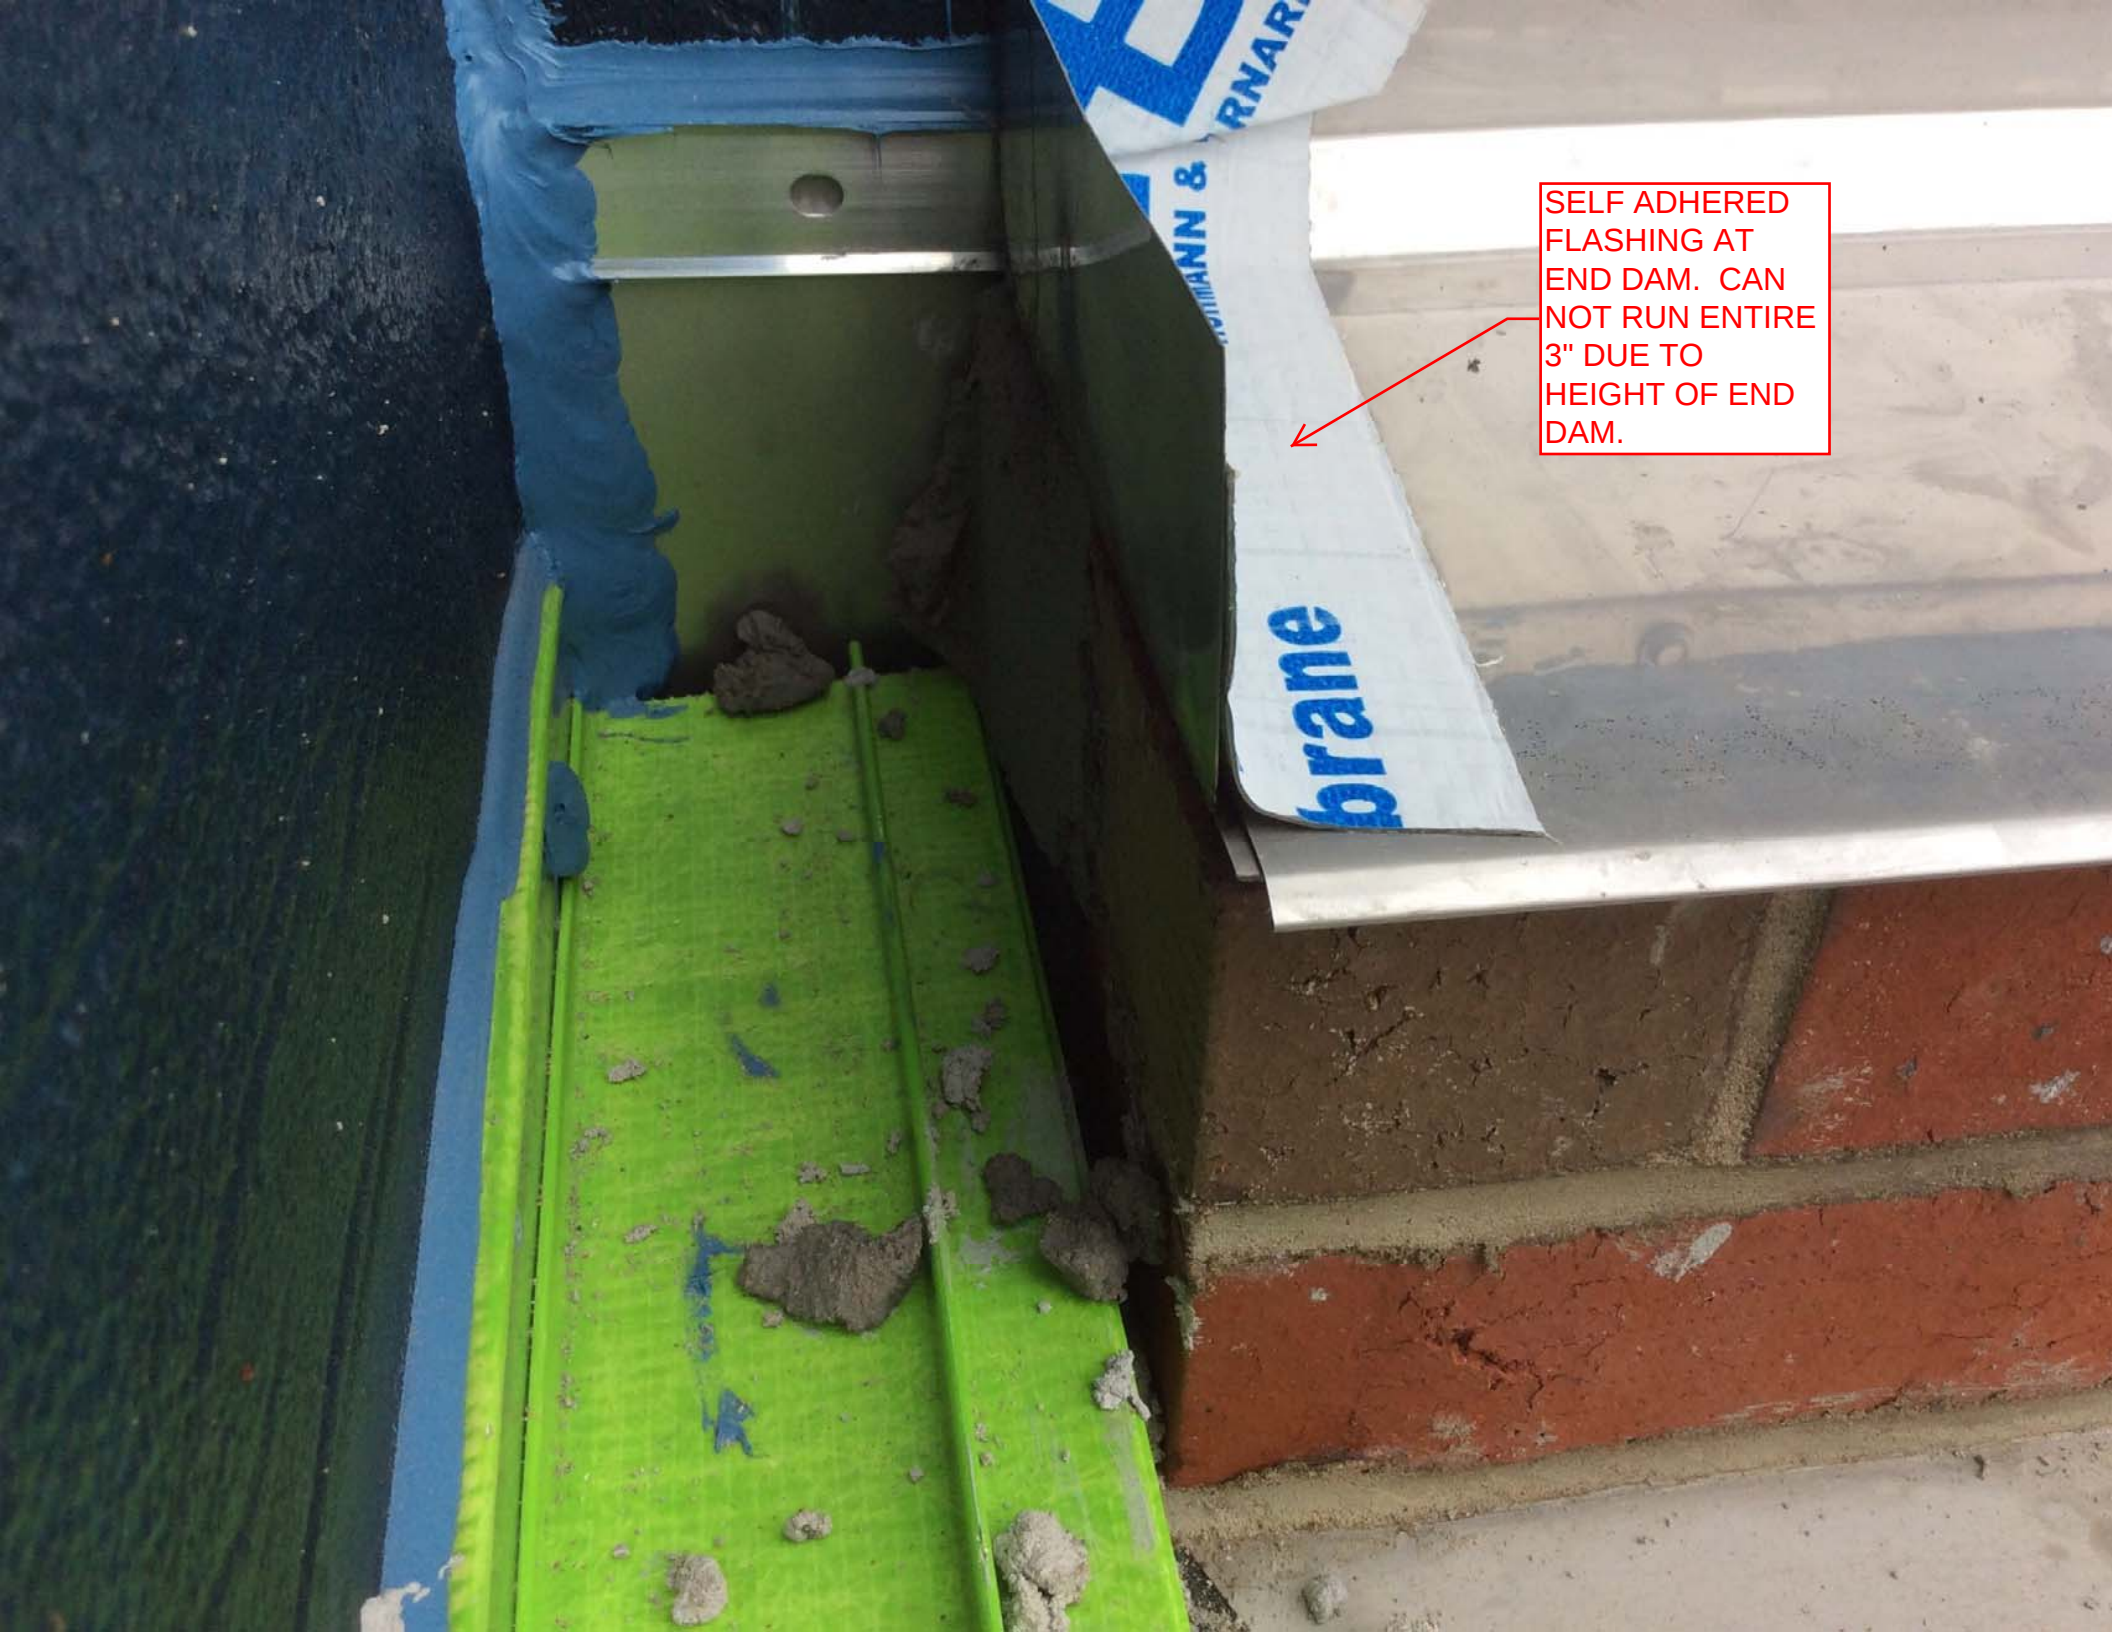
SELF ADHERED  
FLASHING AT  
END DAM. CAN  
NOT RUN ENTIRE  
3" DUE TO  
HEIGHT OF END  
DAM.

INSTALL  
TERMINATION  
BAR AND USE  
BERRIBOND AT  
TOP OF  
FLASHING

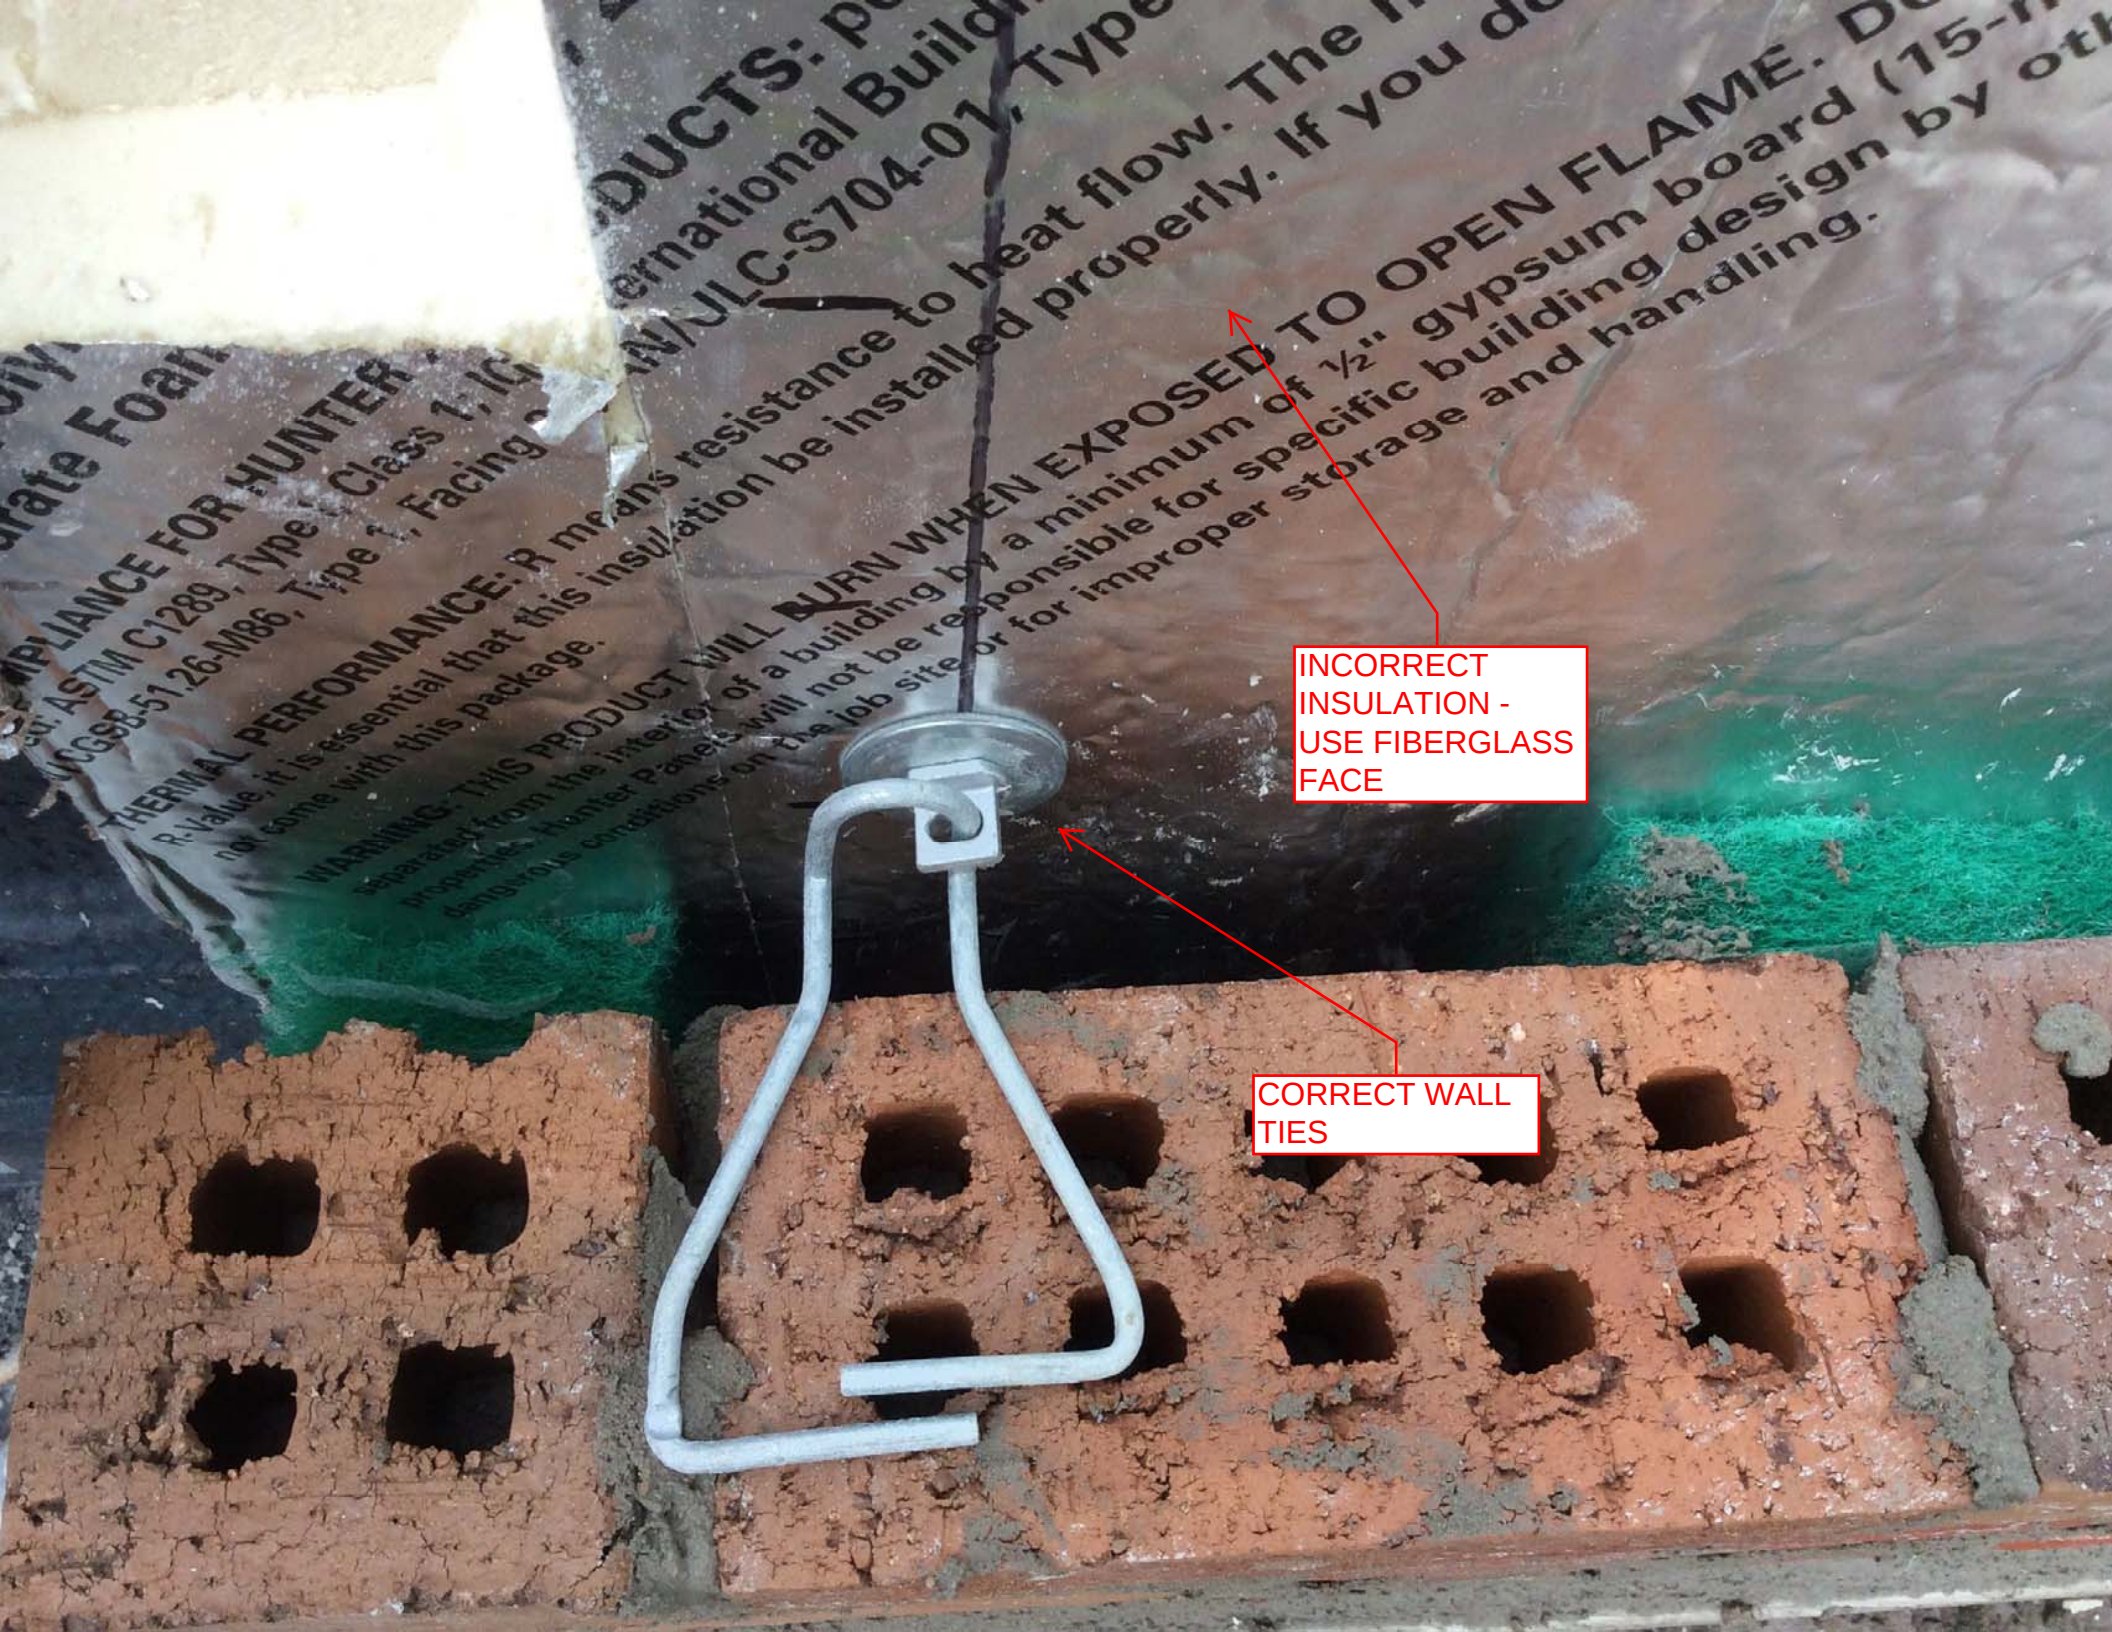
INCORRECT  
INSULATION -  
USE FIBERGLASS  
FACE

CORRECT WALL  
TIES

WEEPS  
INSTALLED

1/4" MAX

CURRENT  
FLASHING  
OVERHANG - DO  
NOT EXCEED 1/4"

OVERLAP  
FLASHING  
PIECES - DO NOT  
TRIM DRIP EDGE
