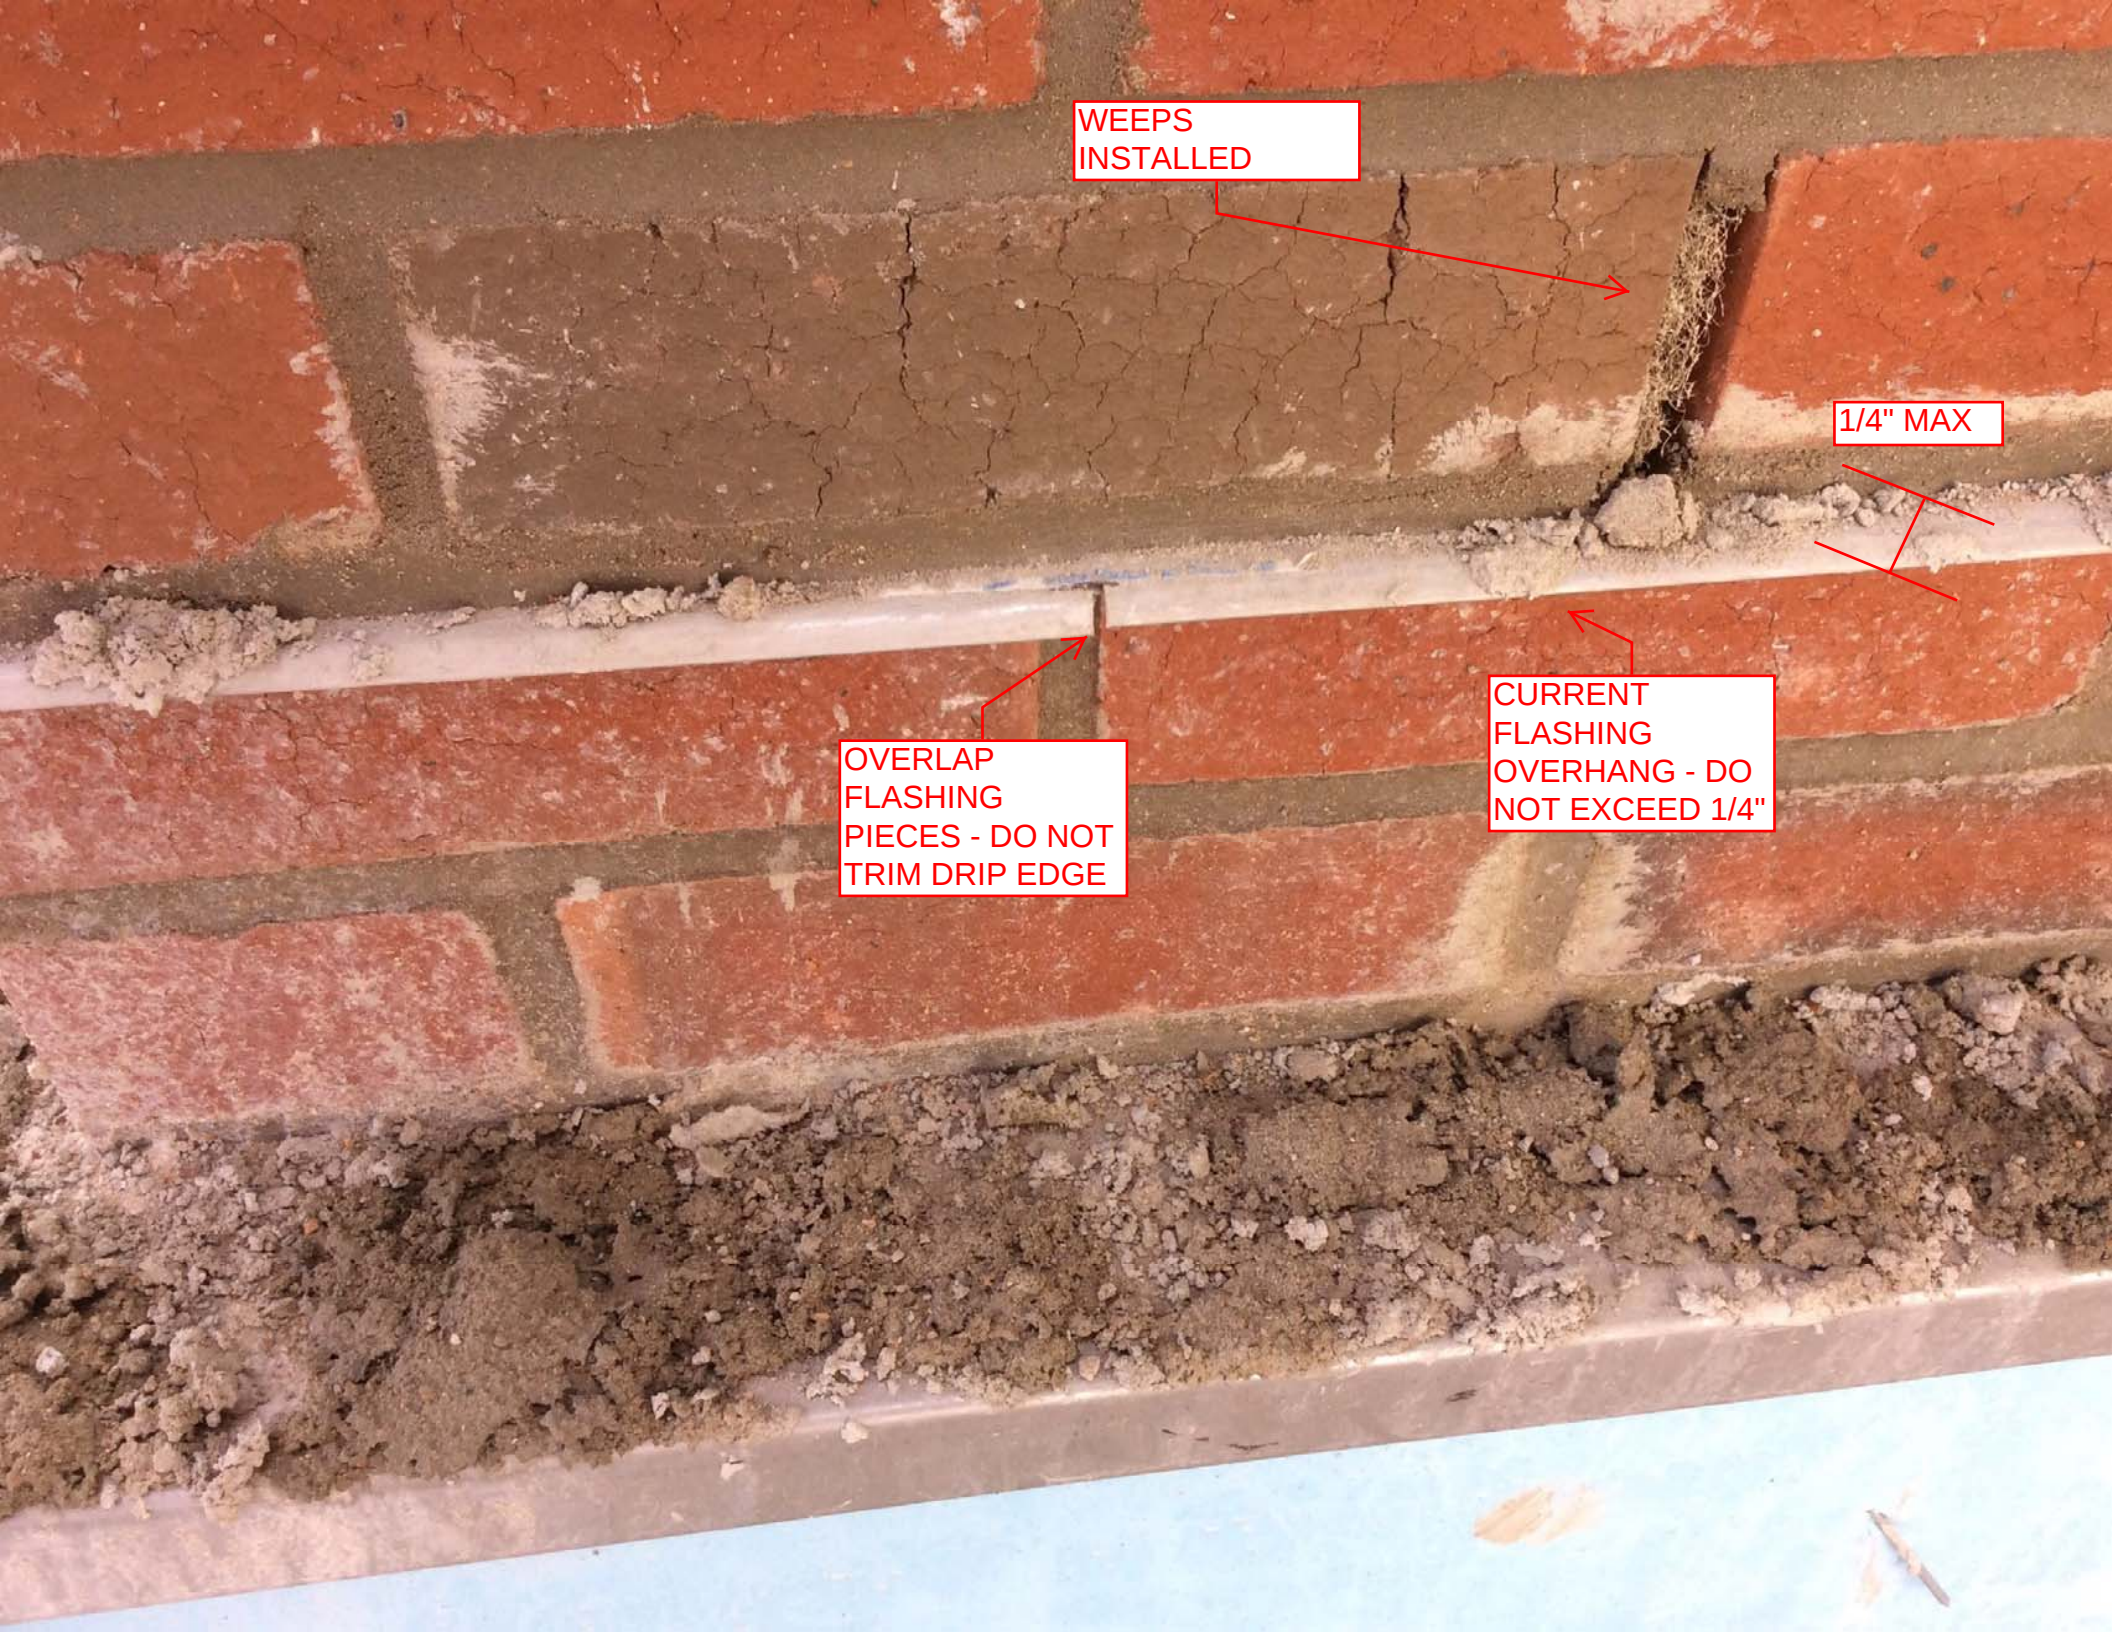
IS THIS  
FLASHING  
OVERHANG  
ACCEPTABLE?
