## Observation Report

| File: | Webster University Interdisciplinary Science Bldg.<br>WT 14127.01 (7) | c: | |

### **Observations**

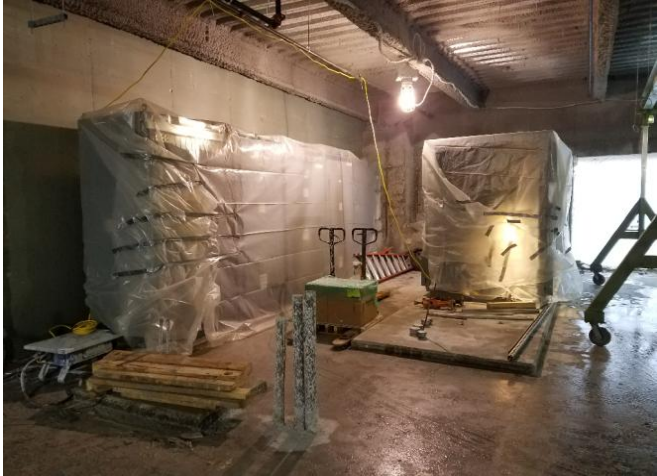
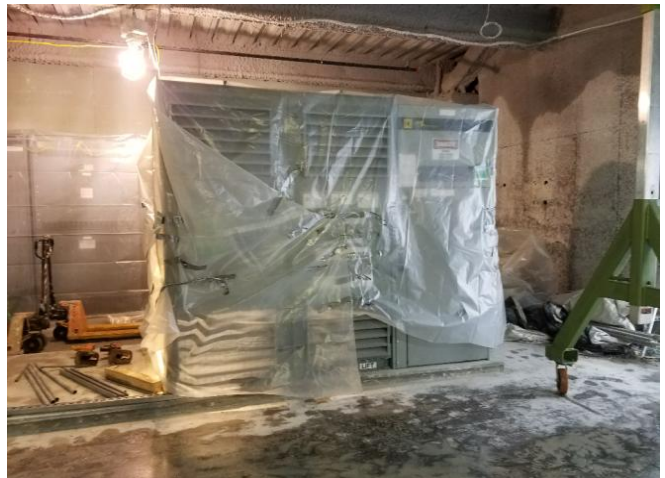
- Main electrical gear is currently being installed.

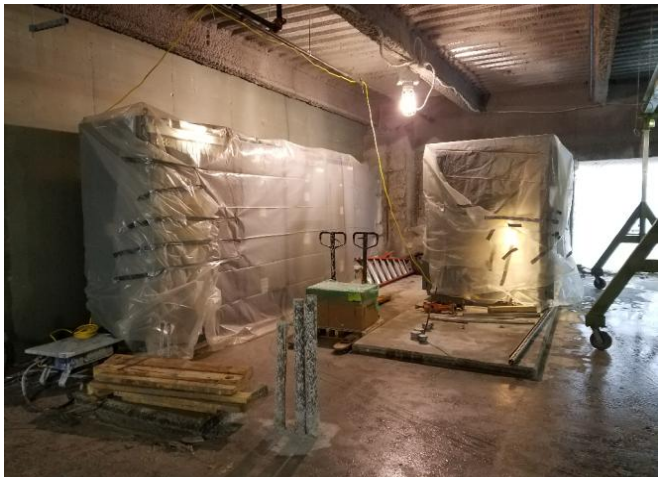
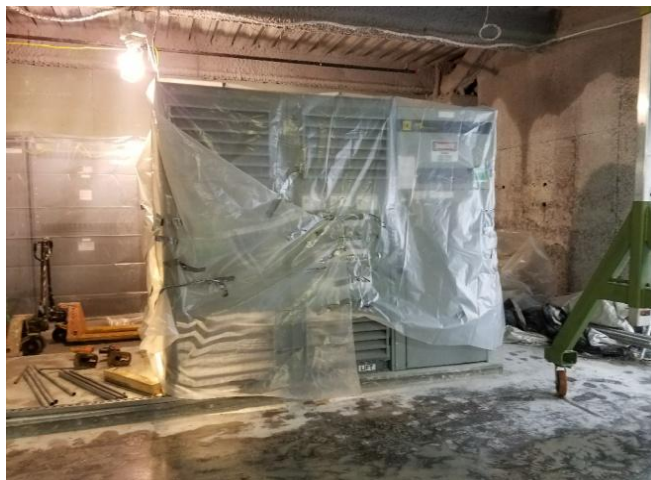
- Main electrical gear is currently being installed.

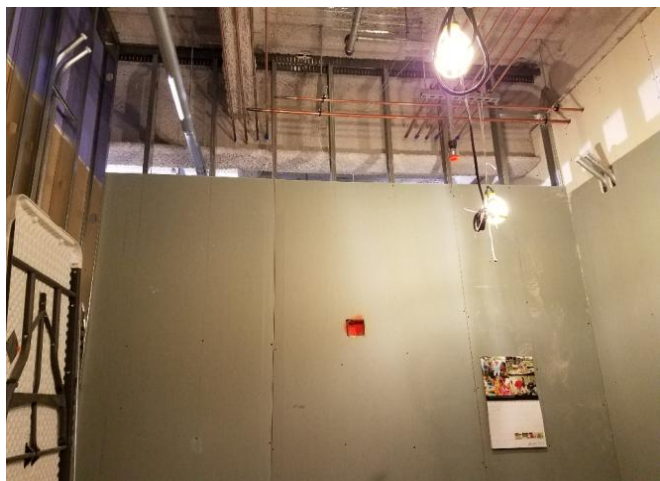
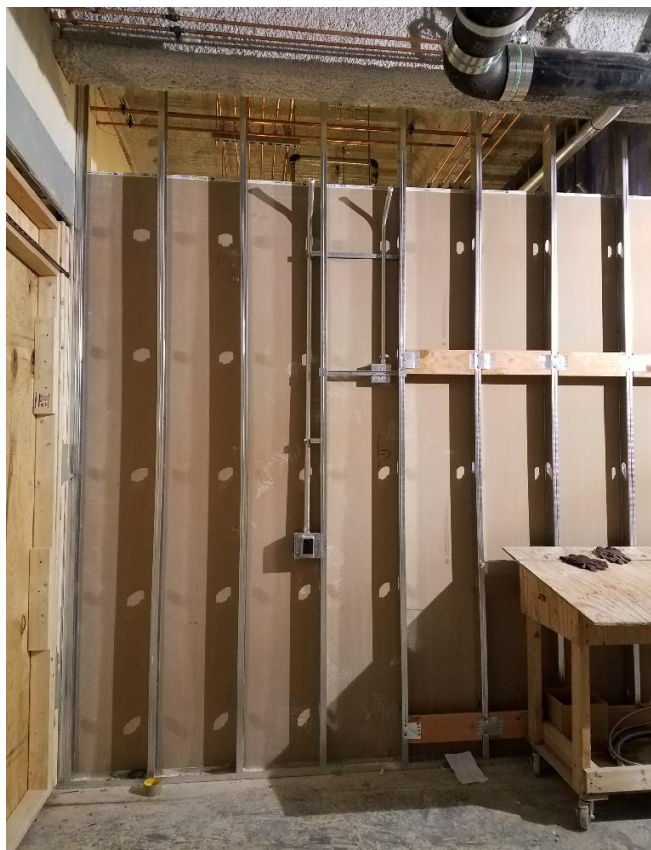
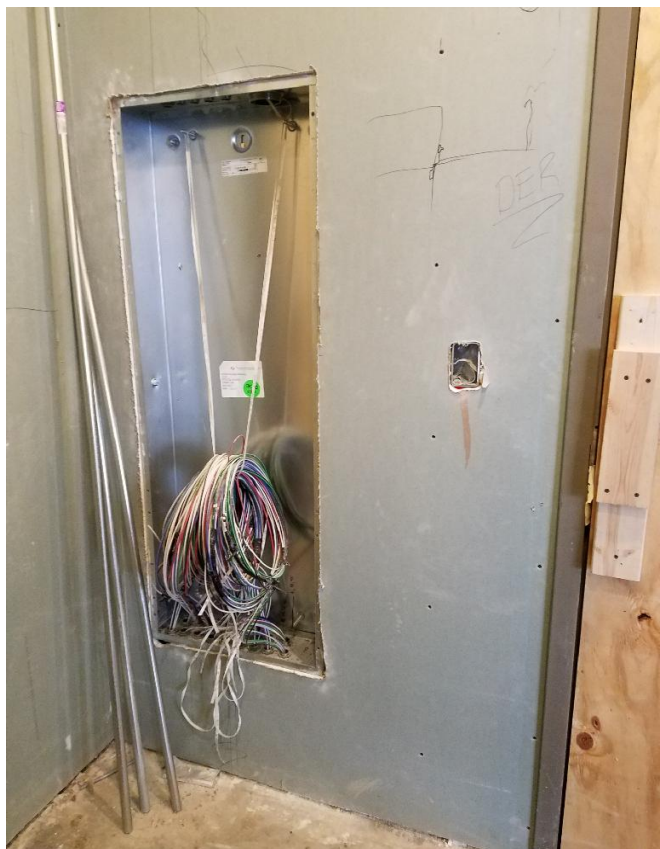
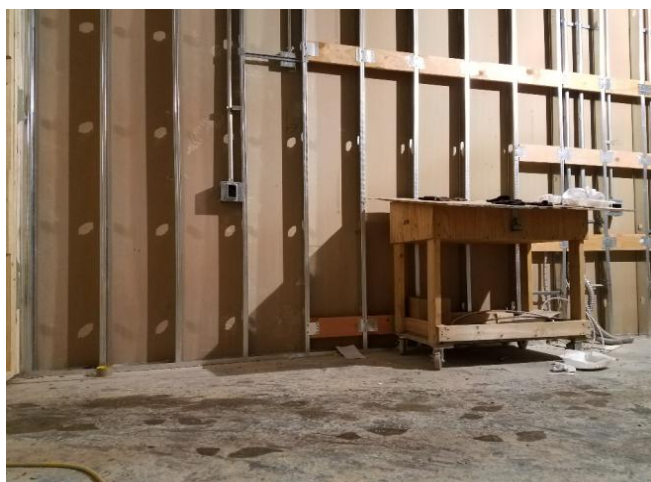
- Sim Lab Control Room and Health Assessment Lab 131 current electrical rough-in.

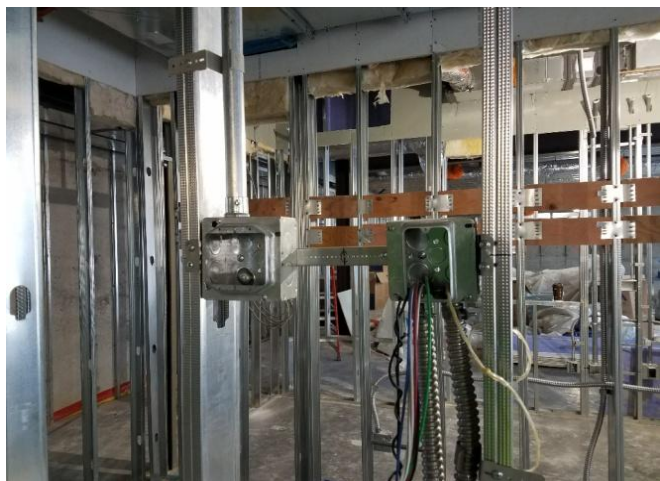
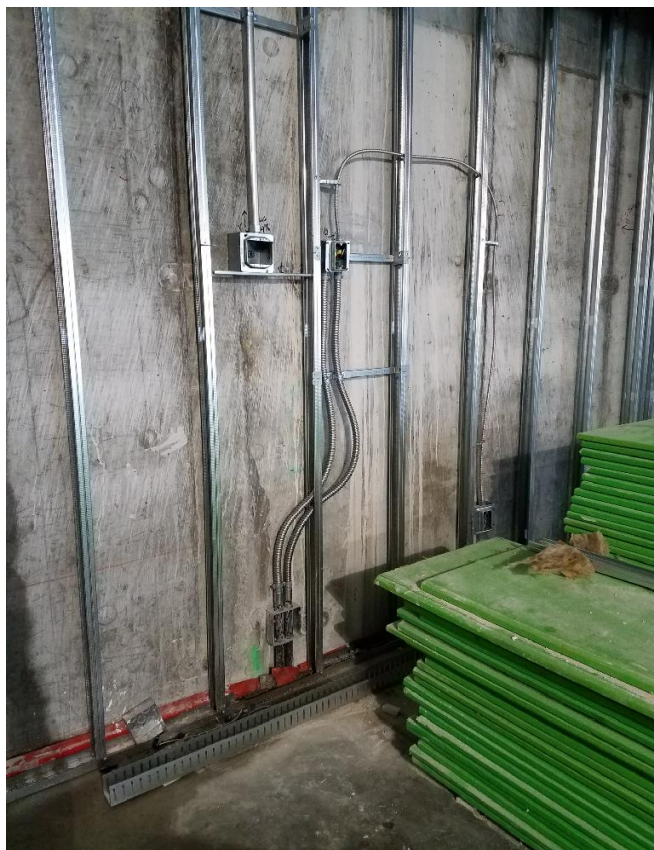
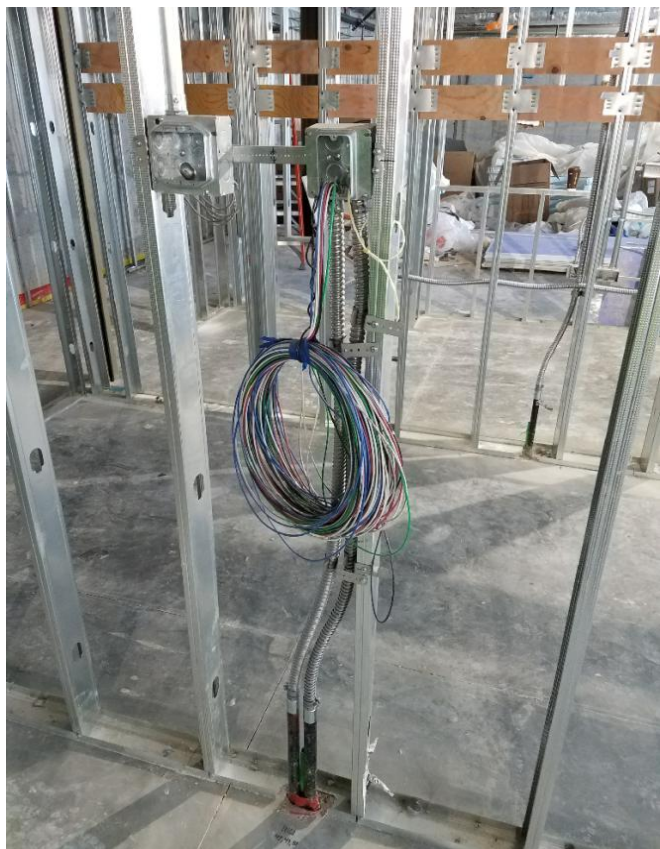
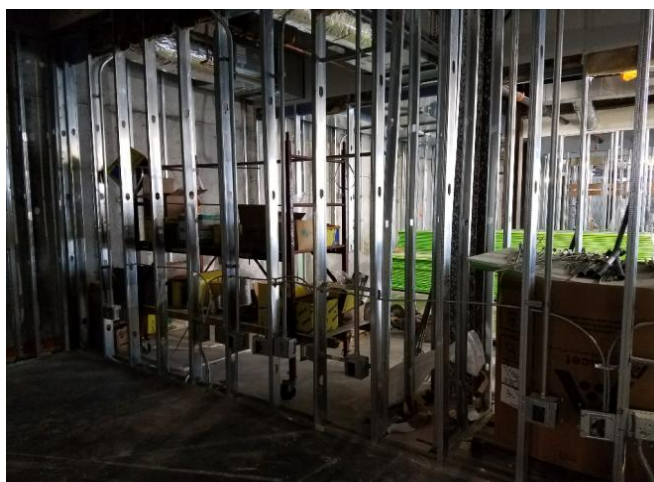
- Vending, Green Room, and Conference Room 154 electrical rough-in.

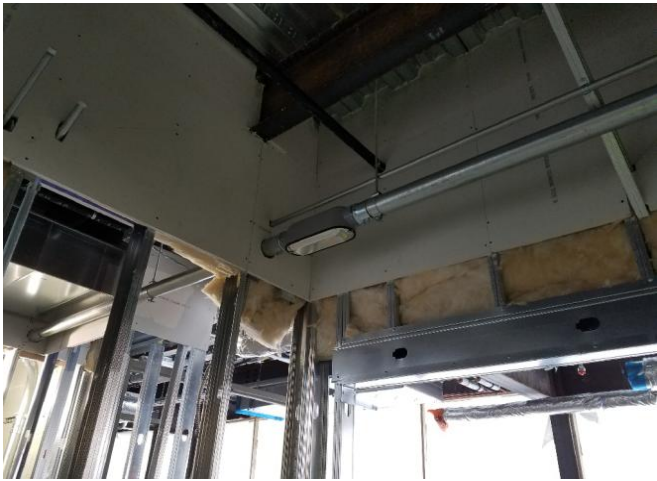
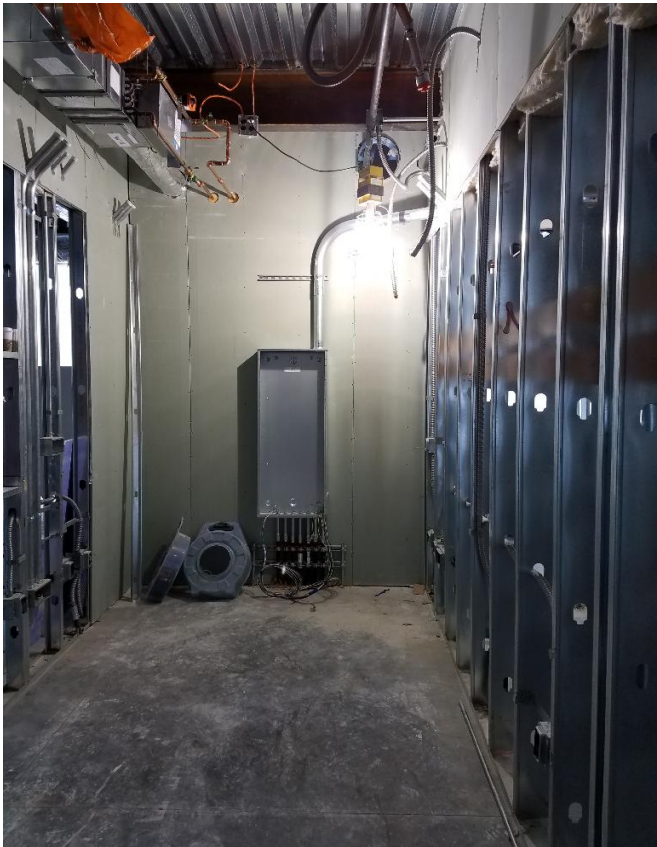
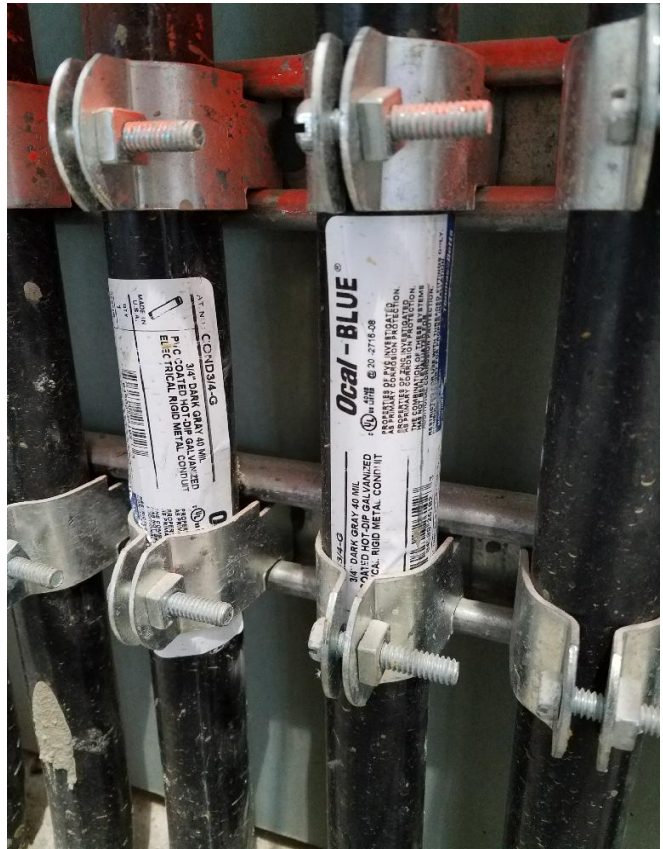
- Auditorium Control room electrical rough-in.
- PVC coated Rigid Metal Conduit stub-ups were confirmed.

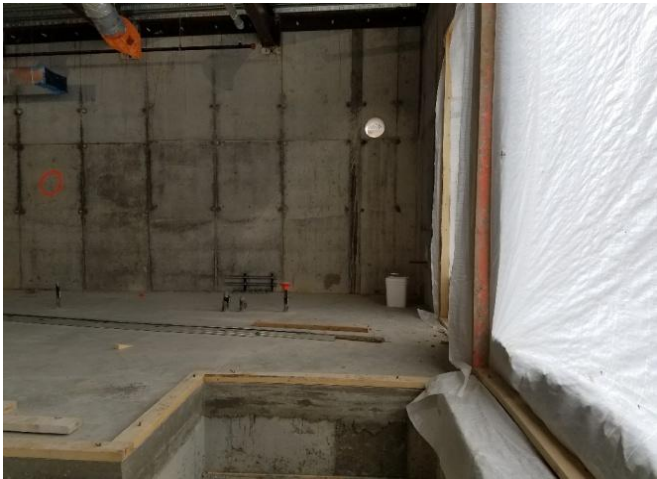
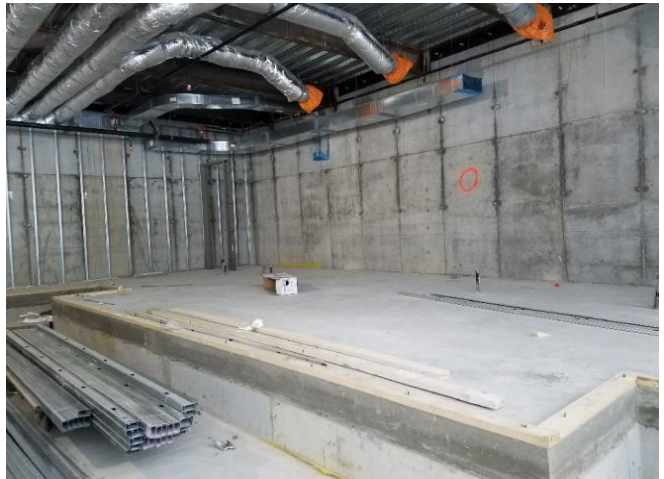
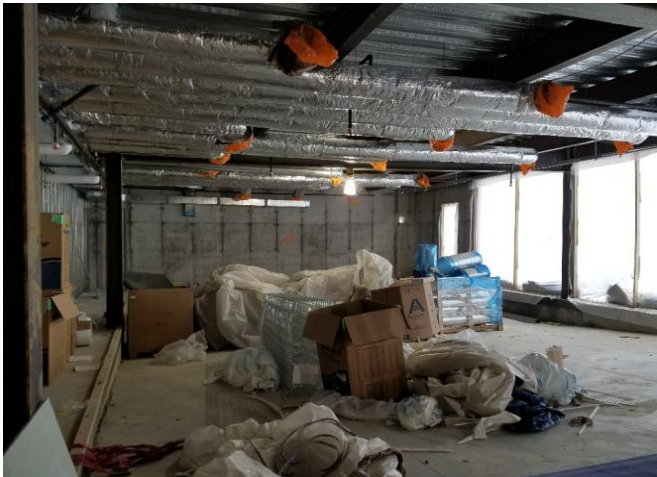
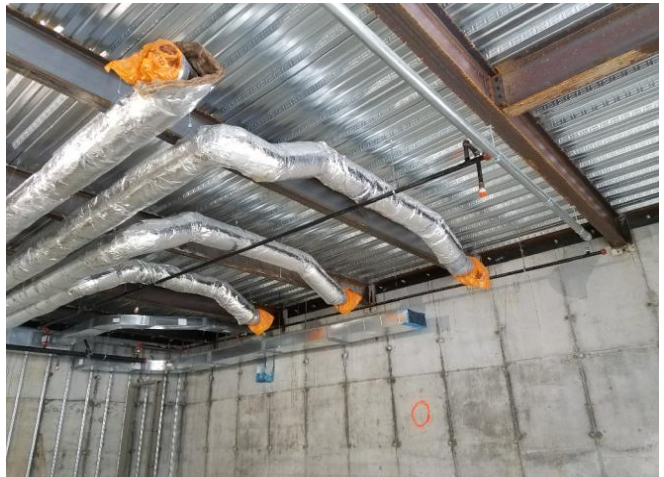
- Auditorium electrical rough-in.

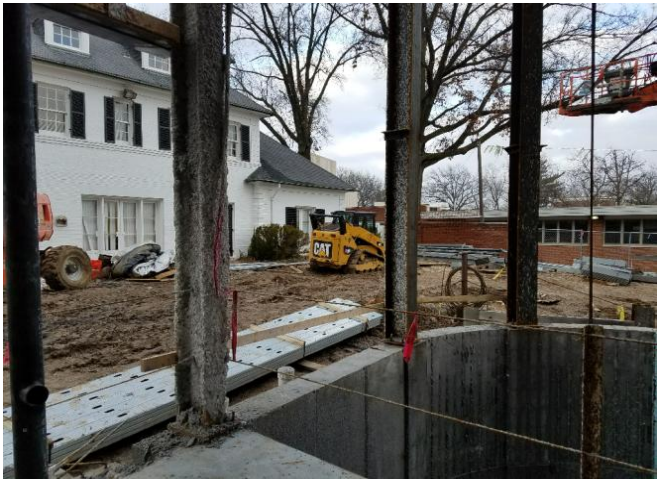
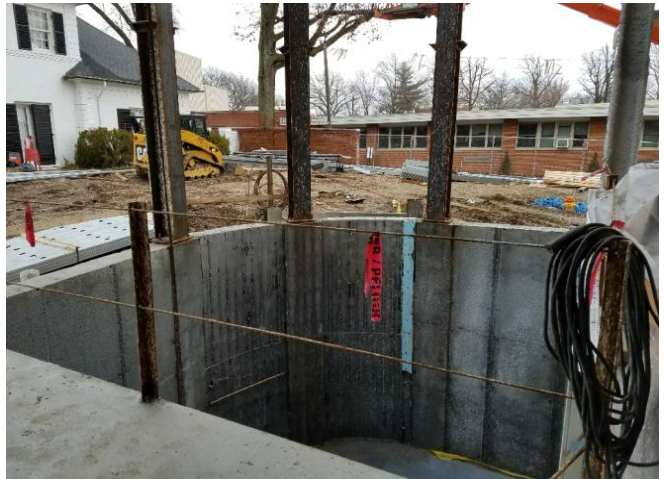
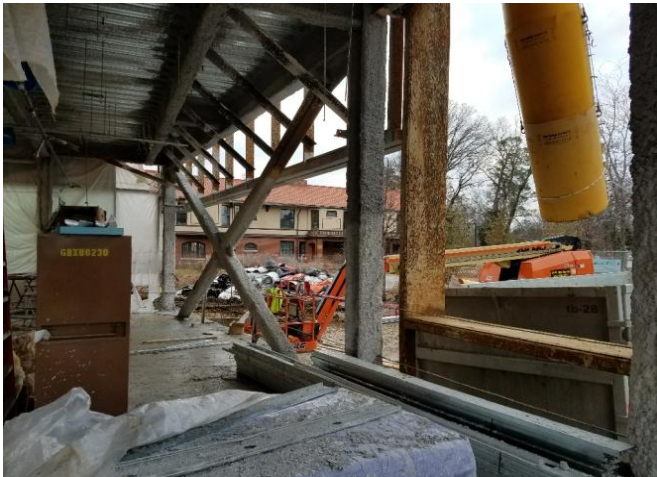
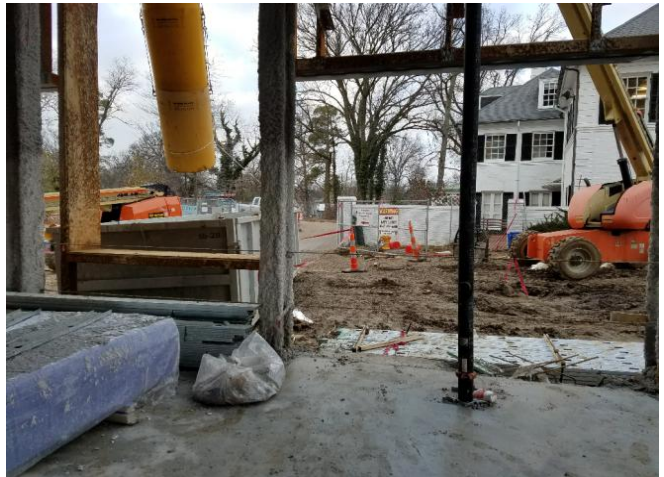
- Commons C280A and Stair 2-2.

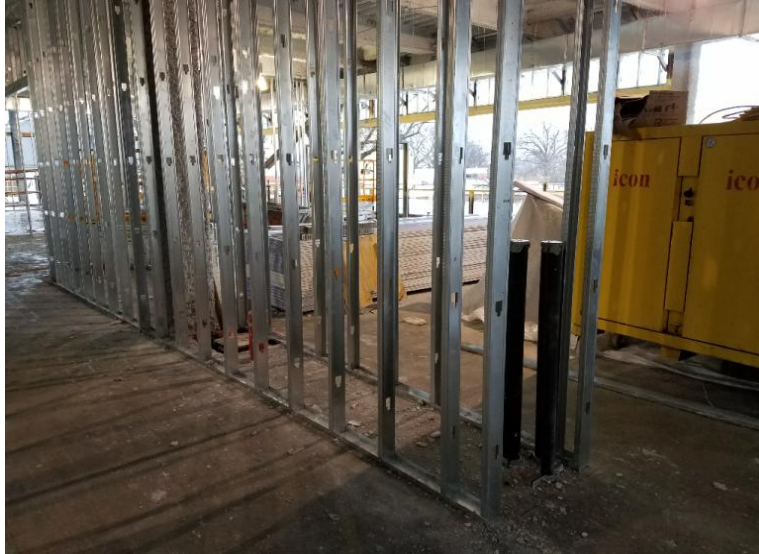
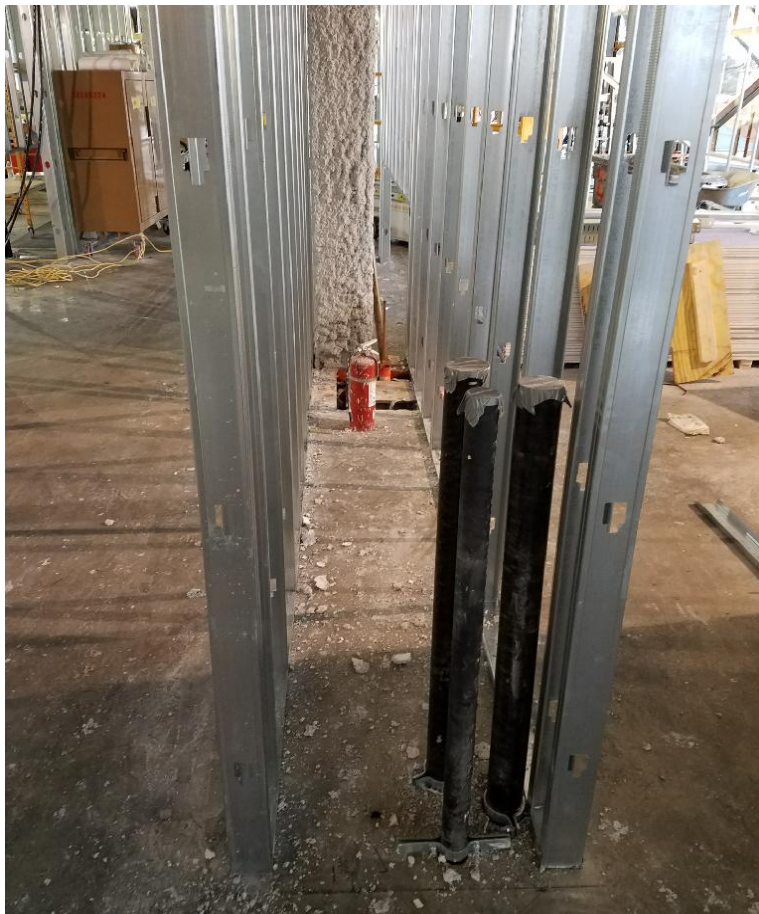
- Current aquarium area electrical rough-in.

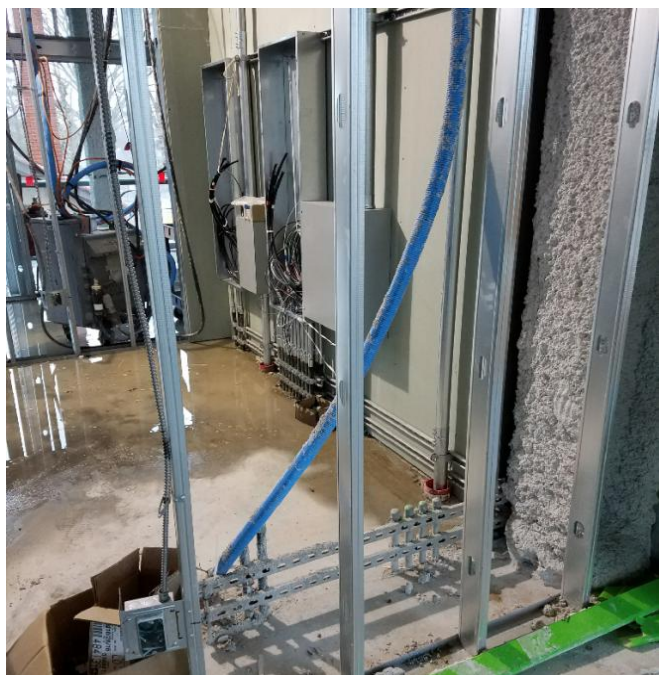
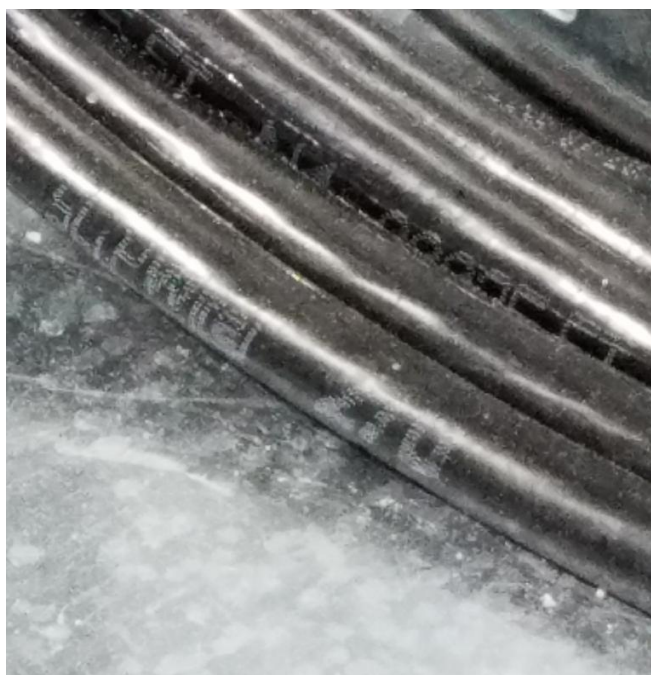
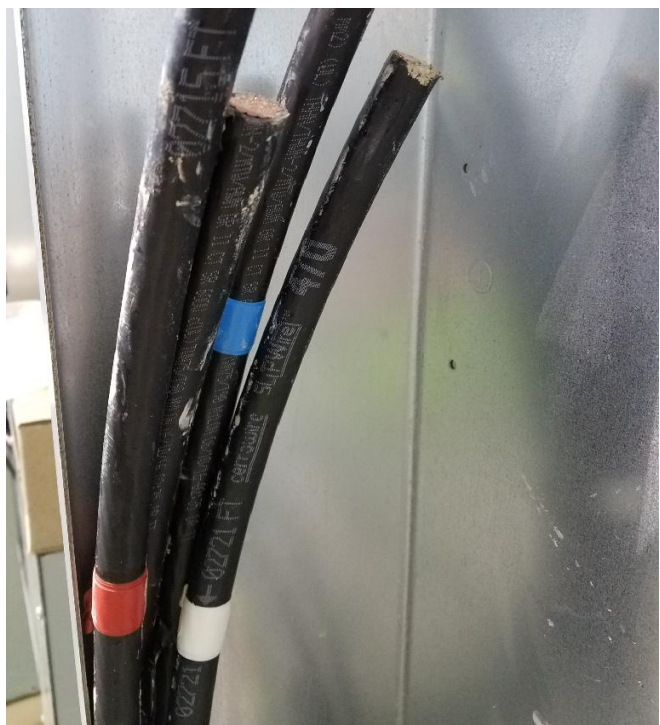
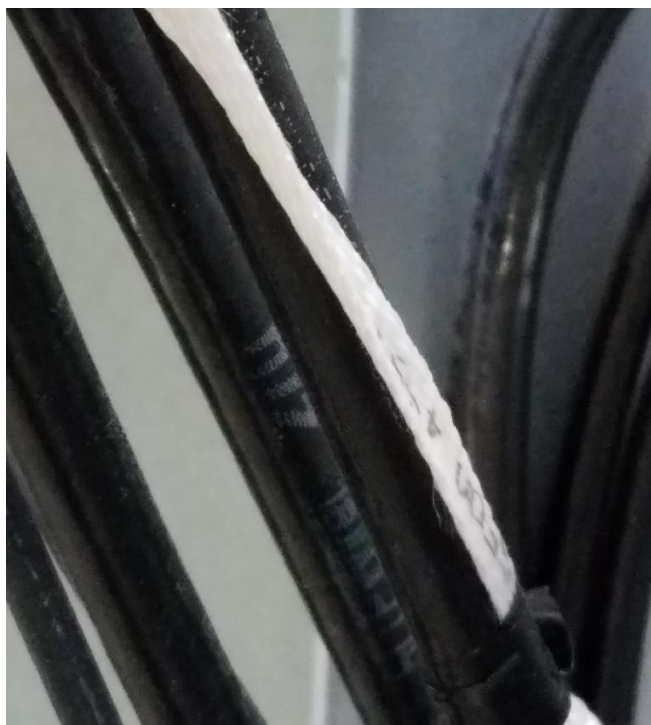
- Phase conductors to panels 3NL1 and 3NH1 appear to be as specified.

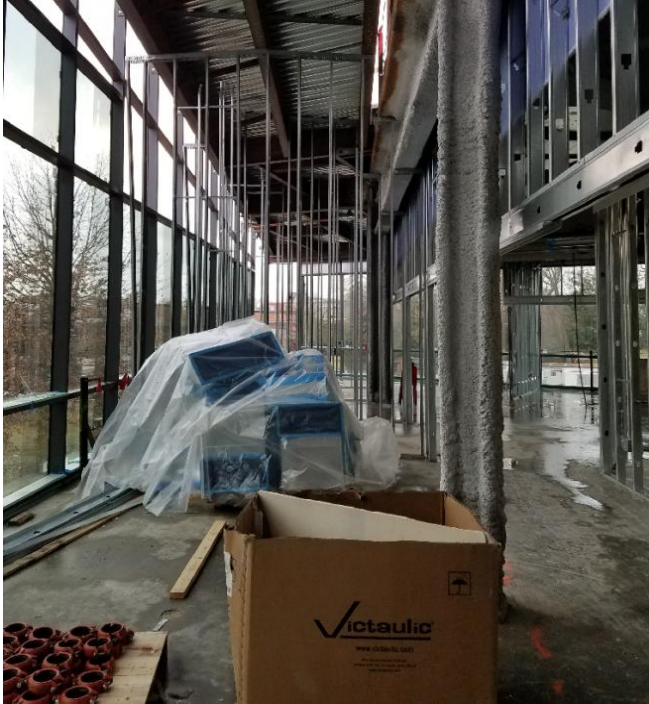
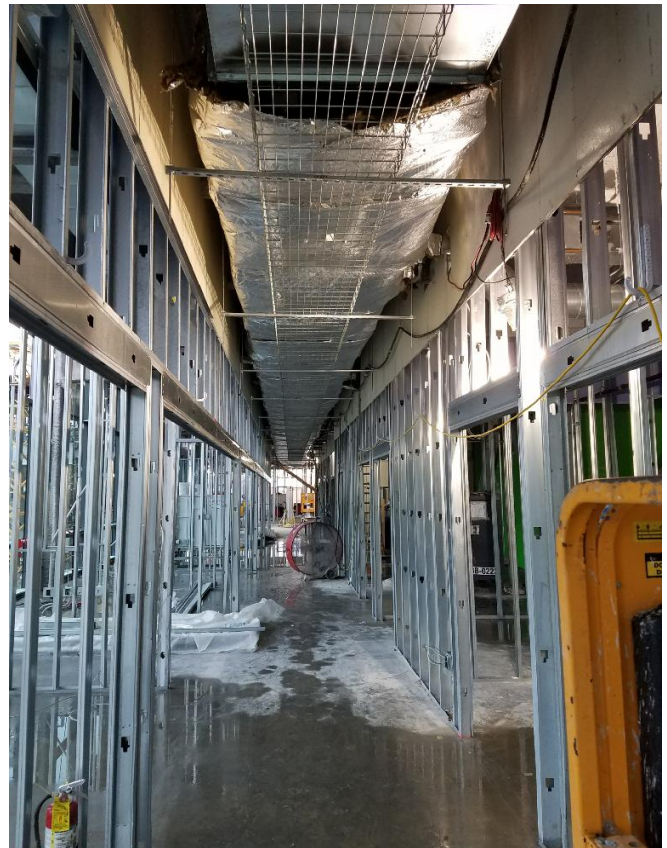
- Conference Room 352 electrical rough-in and cable tray in Corridor C310.

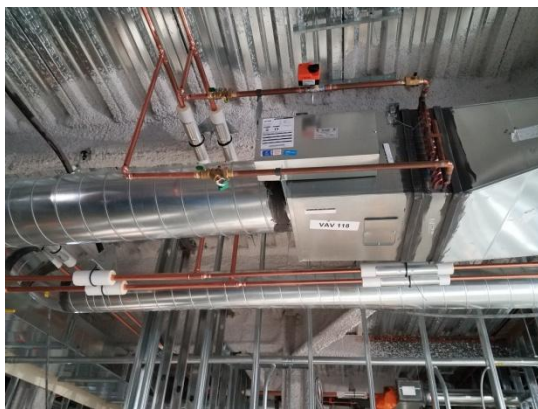
1. Mechanical piping, ductwork, and equipment installations are in progress. Area "B" levels 1 through 3 are farther along than same levels in Area "A".
2. Due to windy onsite conditions, several duct openings have had protective film covers blown off. Duct, terminal box, and lab air valve openings need to be protected from the elements, dust, debris, birds, etc.
3. Service Clearance for air terminal units appears to be tight. This has been noted previously and responded to.
4. Insulation at hangars appears to be continuous and per specification.

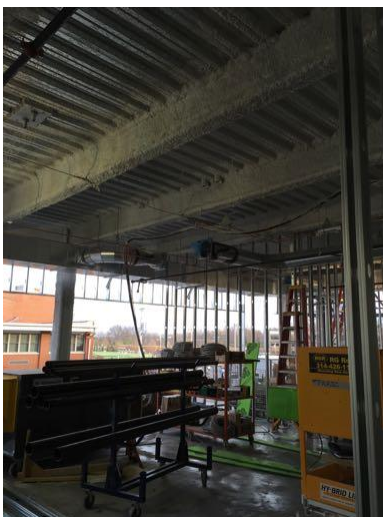
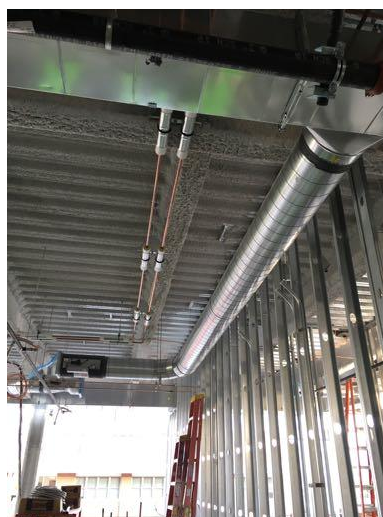
- 14. SAV-208 Needs To Be Capped Securely To Prevent From Blowing Off
- 15. SAV-208 was installed in a different location than shown on M0102.A, and has an extremely long and restrictive inlet coming off the main in a different location. Contractor to confirm pressure drops of installed fittings and duct sizes for comparison, and increase size of inlet ductwork to reduce pressure drop as required.

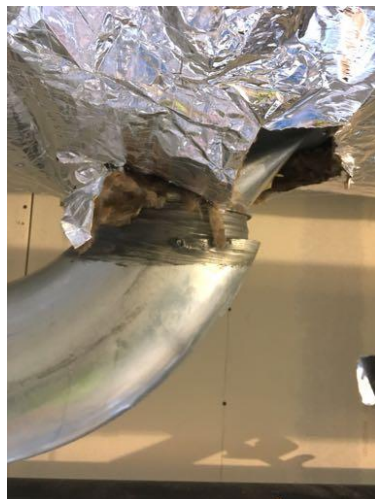
17. Abrupt Fitting Connection At VAV207 looks restrictive. (below, left)  
18. SAV-212 discharge branch duct protective film cover blown off by wind. (below, right)

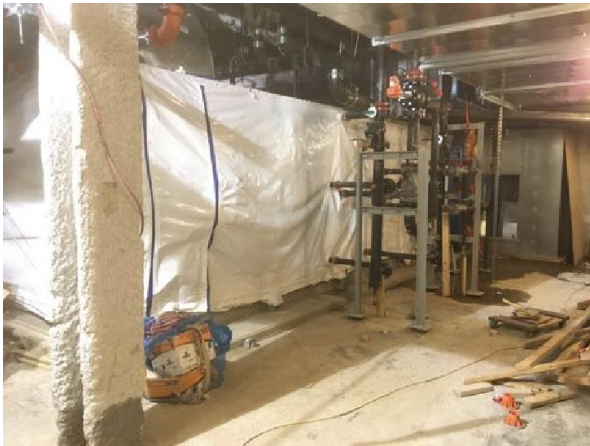
## #24 Mechanical

**Description**  
Mechanical room work in progress

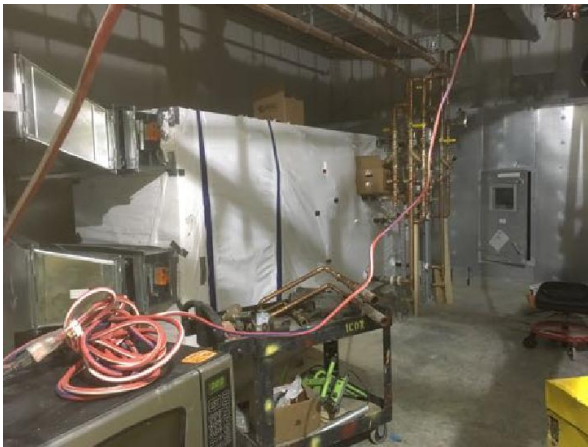
## #25 Mechanical

AHU-3 & 4 piping work in progress.

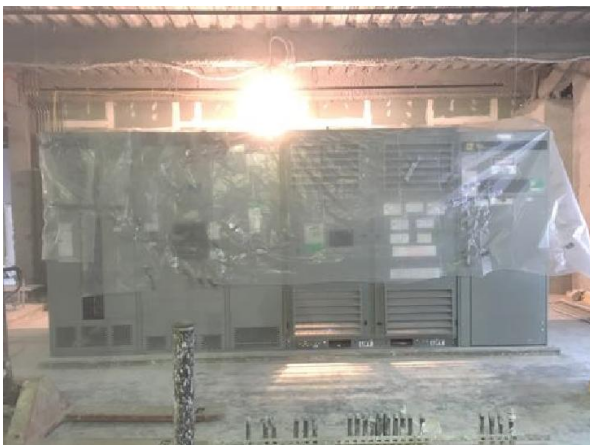
## #23 Mechanical

Keep equipment properly protected until start-up.

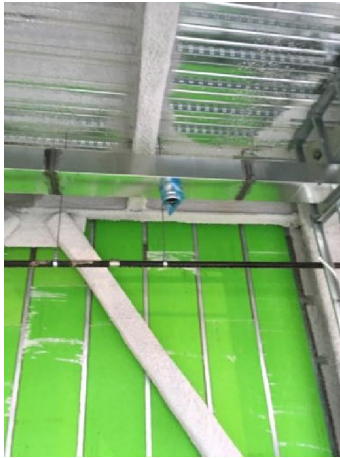
## #17 Mechanical

Duct cover blown off

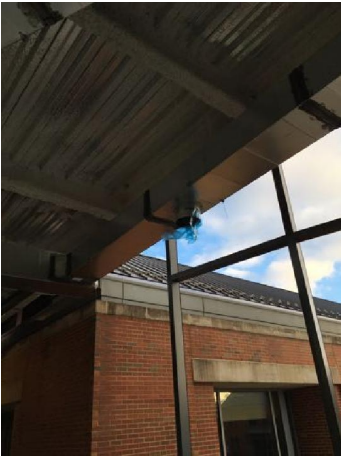
#19 Mechanical

Description  
Duct cover missing / blown off

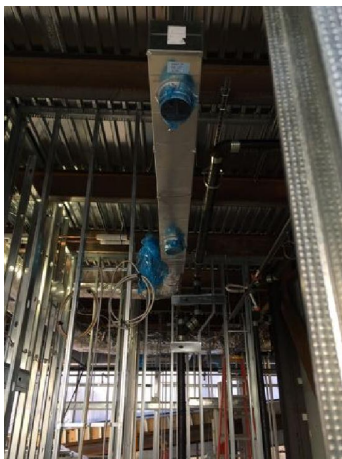
## #9 Mechanical

Where installing bottom taps, ensure that offsets are installed between tap and diffuser.

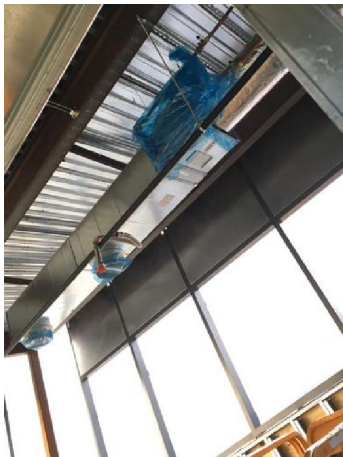
#10 Mechanical

Description  
Where installing bottom taps, ensure that offsets are used between tap and diffuser.

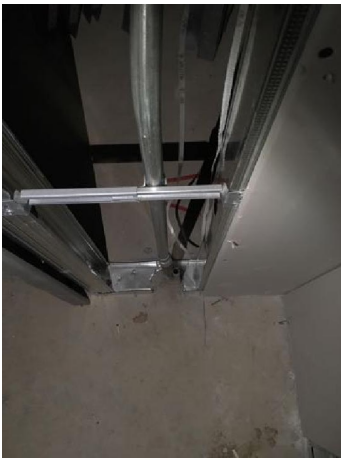
#32 Electrical

**Description**  
Conduit end not protected.

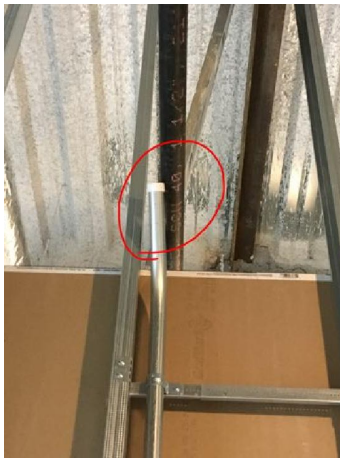
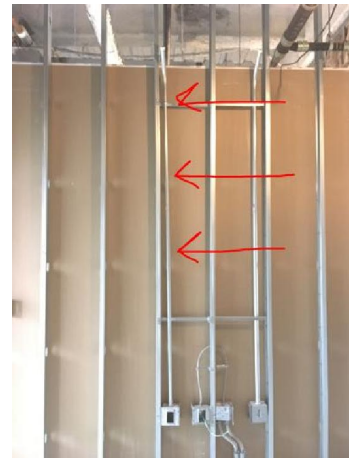
## #48 Electrical

Conduit in conflict with FP piping.

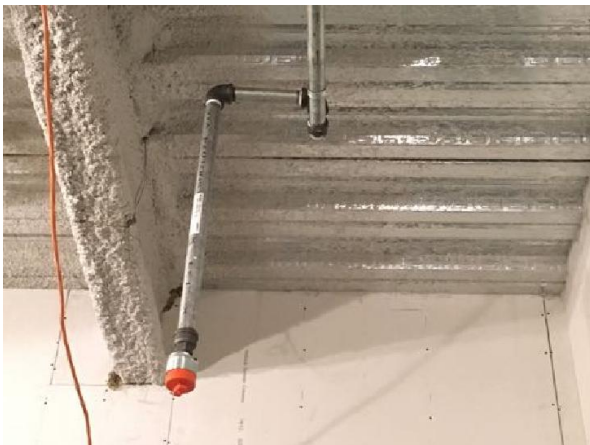
## #28 FP Sprinkler

**Description**  
Non galvanized fittings used for pre-action system.

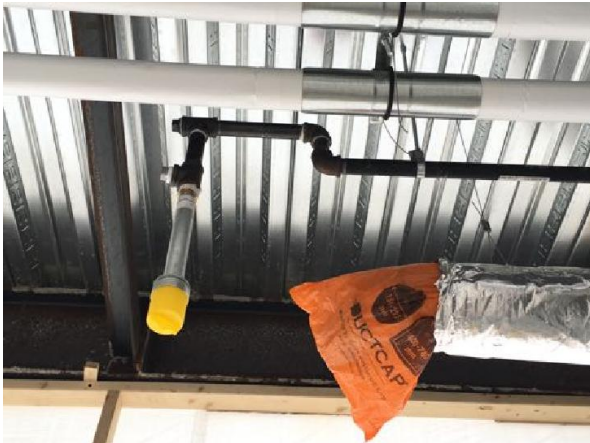
## #38 FP Sprinkler

End of line support too far from end of line.

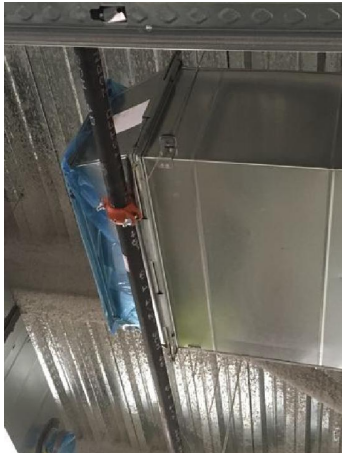
## #39 FP Sprinkler

Spkr coupling appears to conflict with duct.

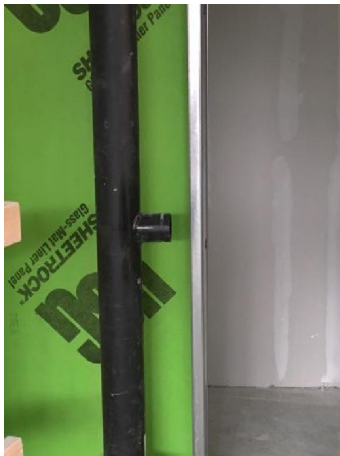
## #42 FP Sprinkler

Standpipe connection is open. Should be capped when not being worked on. This is typical throughout the project.

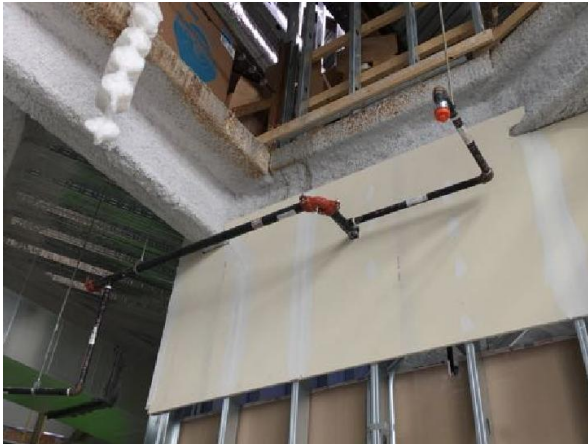
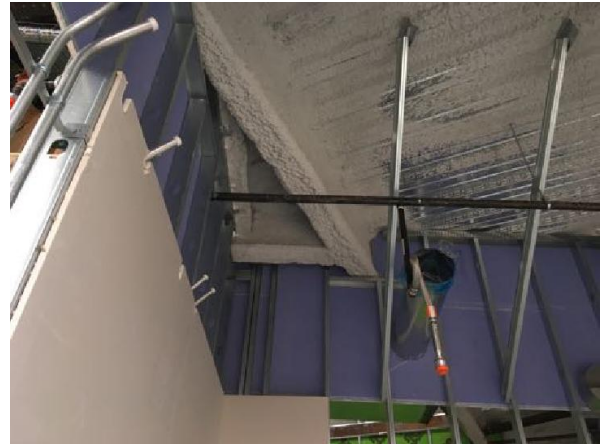
## #43 FP Sprinkler

Concerned with long distance of unsupported piping. End up branch-line appears unsupported with arm-movers at end being supported.

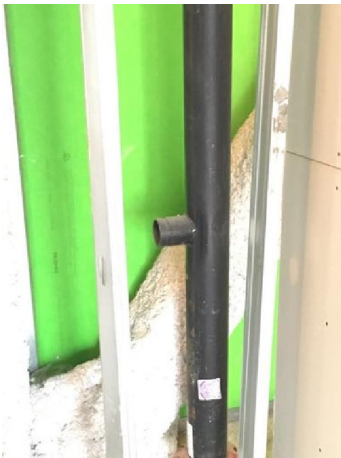
#49 FP Sprinkler

Description  
Standpipe hose connection open.

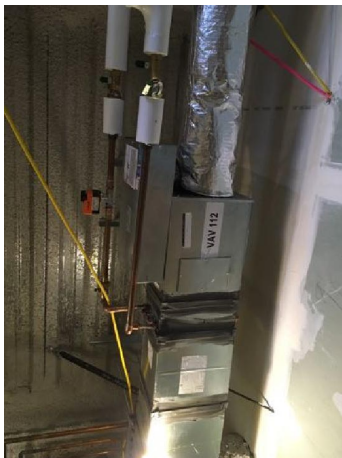
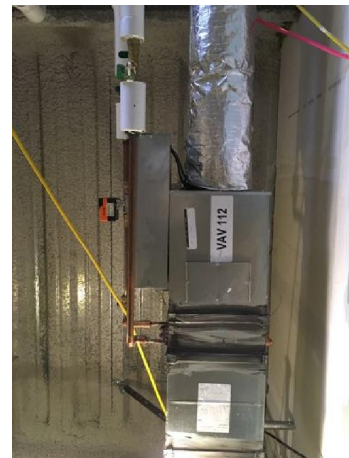
## #27 Mechanical

Insulation looks difficult to install on piping at box.

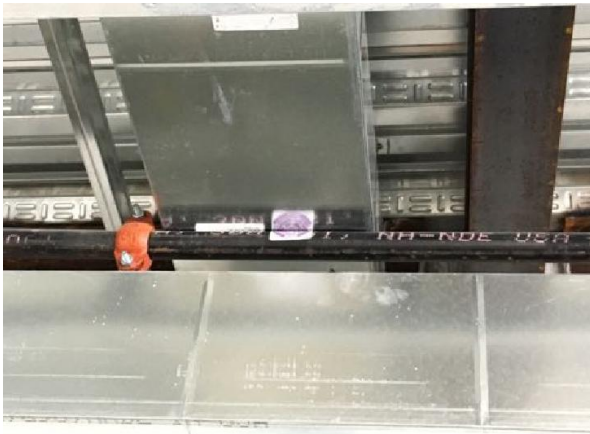
## #35 Mechanical

It appears that FP piping and duct are touching. Noise is a concern in the auditorium.

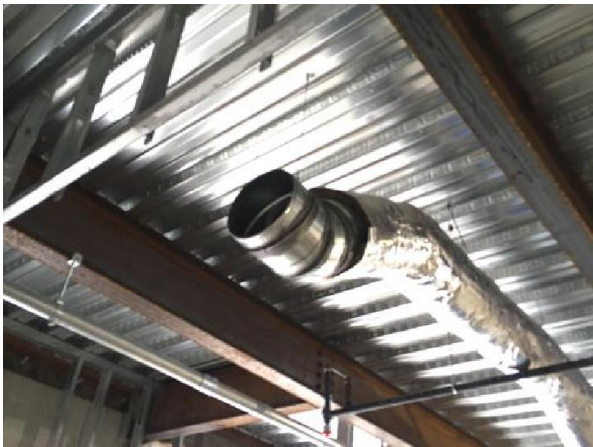
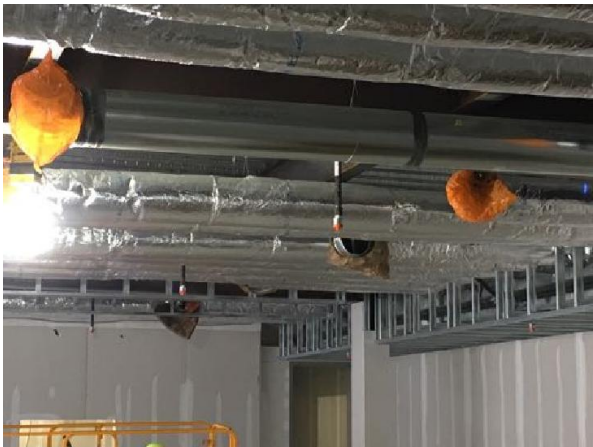
#36 Mechanical

**Description**  
Few open ducts this room.

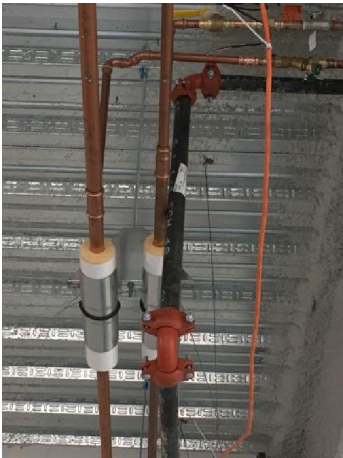
#40 Mechanical

Description  
Steel FP piping in conflict with copper hw piping.

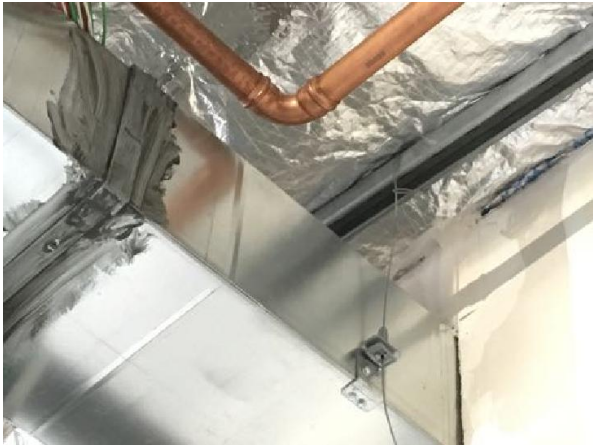
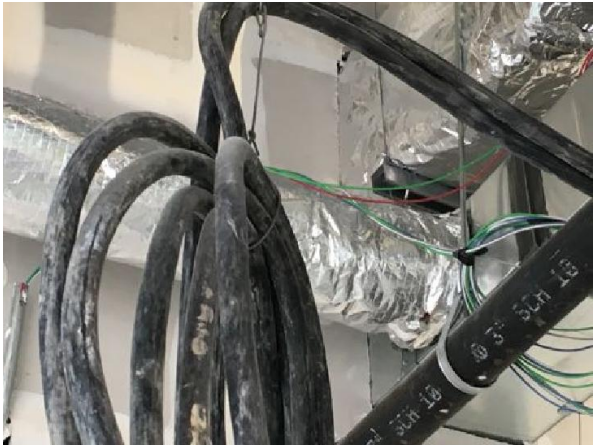
#41 Mechanical

Description  
Duct hanger appears to be non traditional.

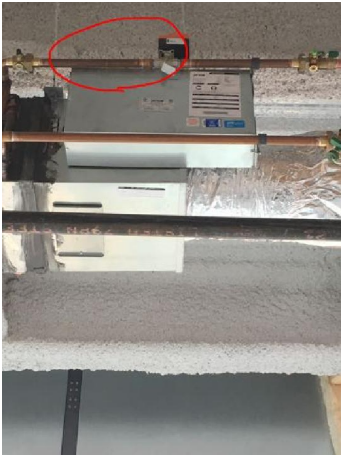
#50 Mechanical

Description  
Vav 305 access panel appears to be inaccessible.

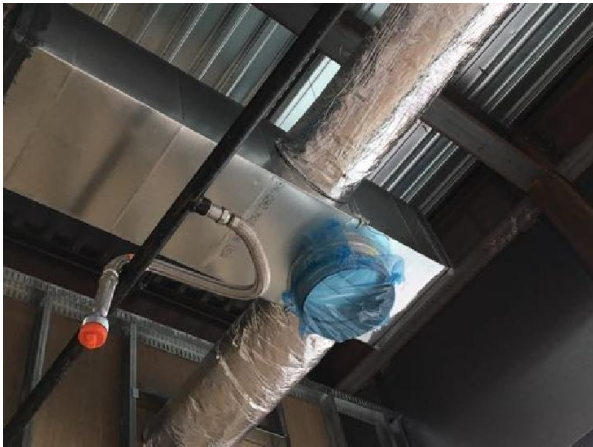
#51 Mechanical

**Description**  
Confusing tap arrangement. Noise is concerning.

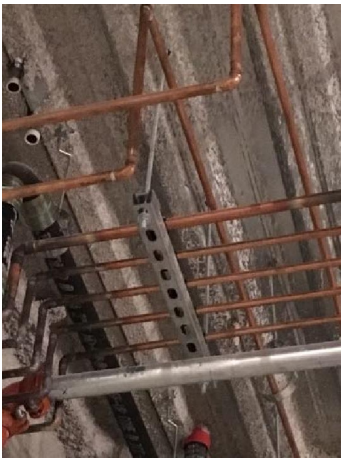
#29 Plumbing

Description  
Bent hanger rod.

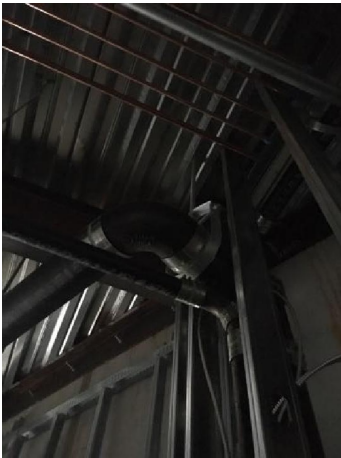
#31 Plumbing

**Description**  
Hanger placed on no hub band.  
Should be supported by piping.

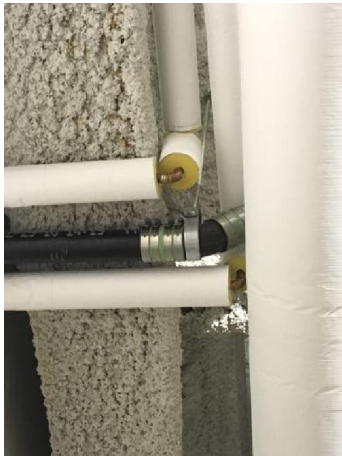
## #33 Plumbing

Hanger supporting fitting instead of the piping.

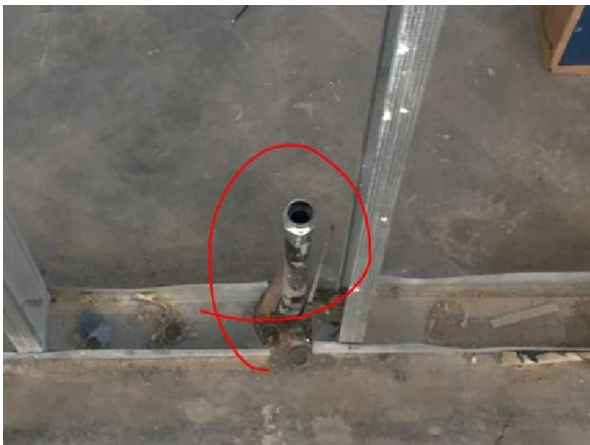
## #60 Electrical

Keep conduit ends covered when not working on them.

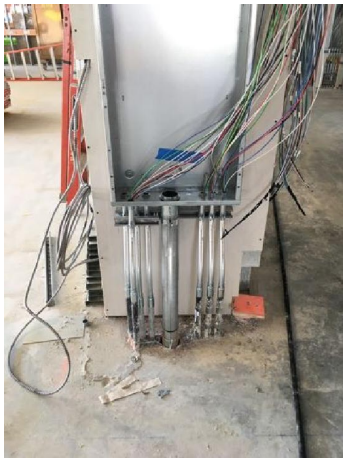
#73 Electrical

Description  
Wire is being pulled to panels. WIP.

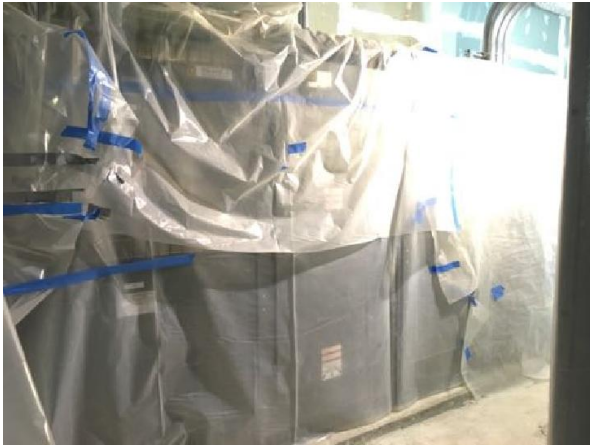
## #75 Electrical

Electrical gear set in place and covered.

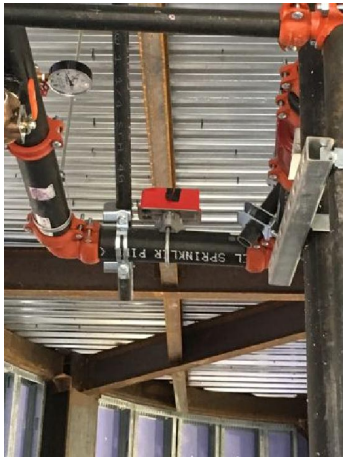
#56 FP Sprinkler

Description  
Verify distance before and after flow switch is per manufacturer requirements.

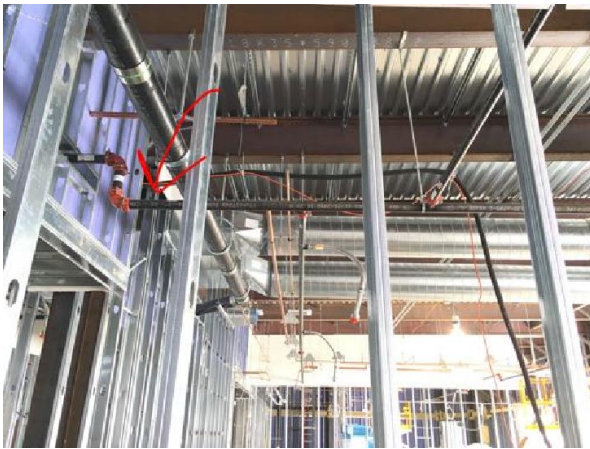
## #58 FP Sprinkler

Sprinkler system appears to be trapped without approved means of draining.

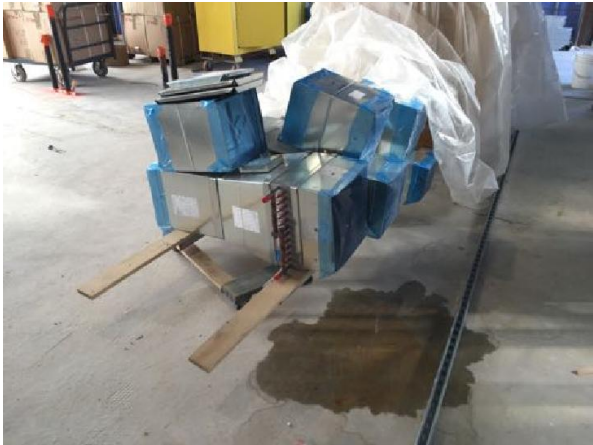
#59 Mechanical

Description  
Good job keeping material off of wet floor.

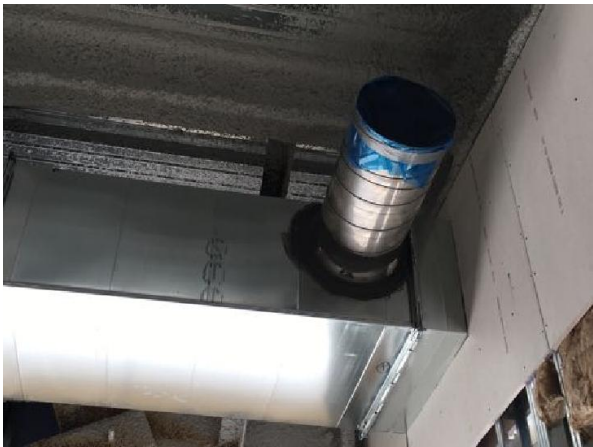
#68 Mechanical

**Description**  
Boot tap not used.

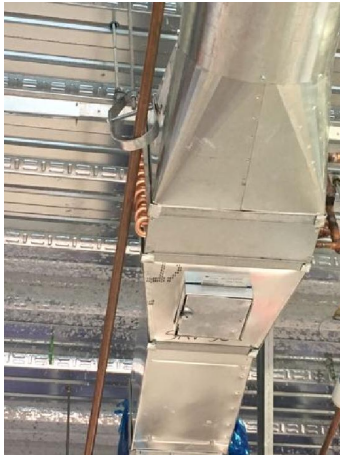
## #70 Mechanical

VAV and piping will be very difficult to insulate.

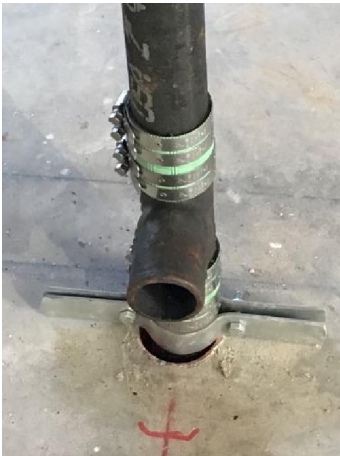
## #55 Plumbing

**Description**  
Cover/plug piping during construction. Typ.

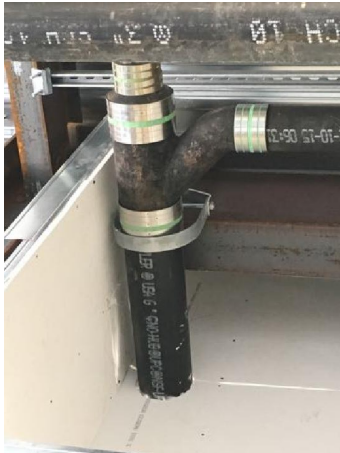
## #57 Plumbing

Do not place hangers on no hub bands.
