## Observation Report

| File: | Webster University Interdisciplinary Science Bldg.<br>WT 14127.01 (7) | c: | |

### **Observations**

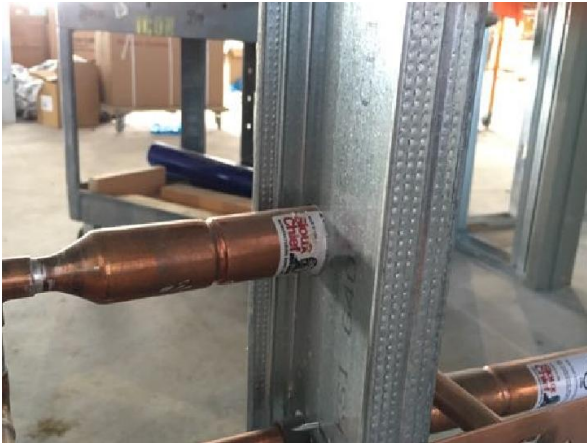
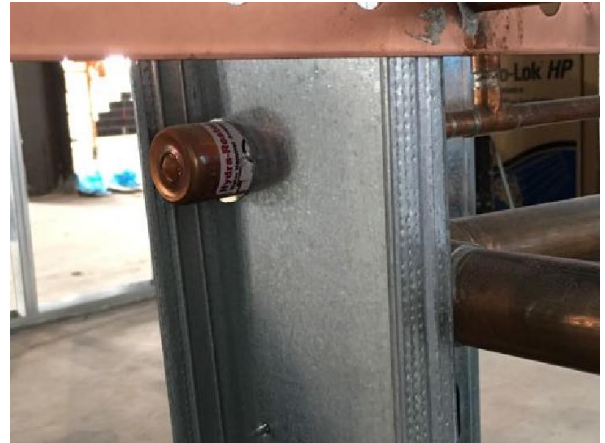
## #61 Plumbing

Maintain clearance between piping and metal wall studs.

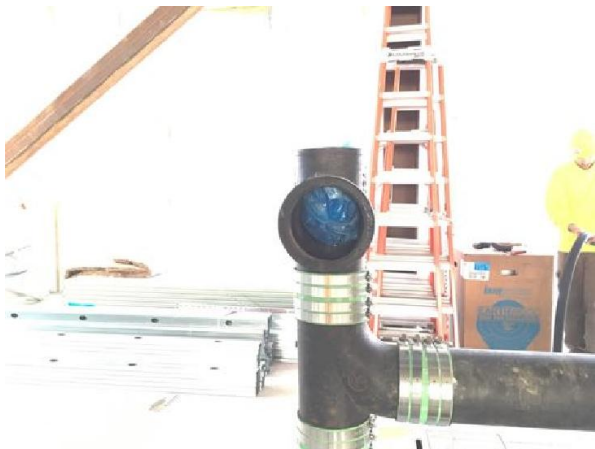
#62 Plumbing

Description  
Trash in piping.

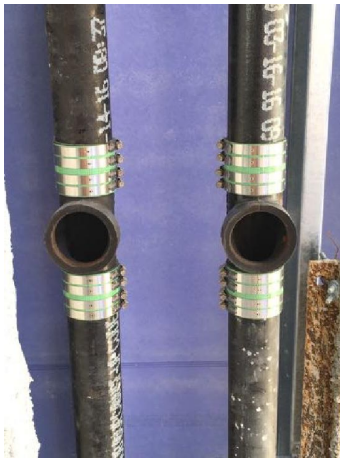
## #63 Plumbing

**Description**  
Cap piping.

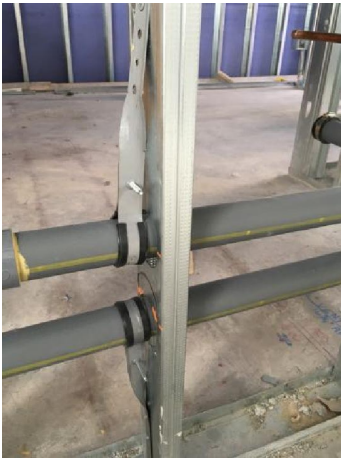
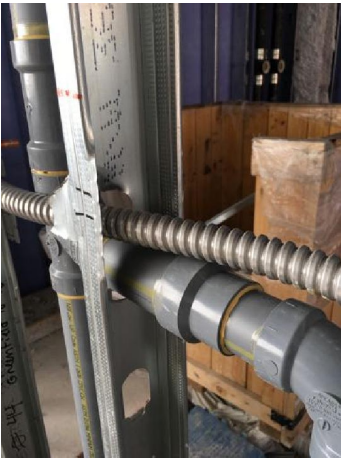
#65 Plumbing

Description  
Make sure nail guards are used at necessary locations.

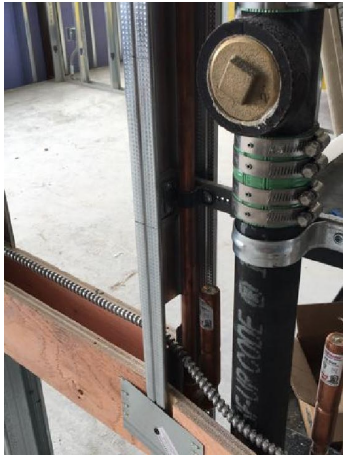
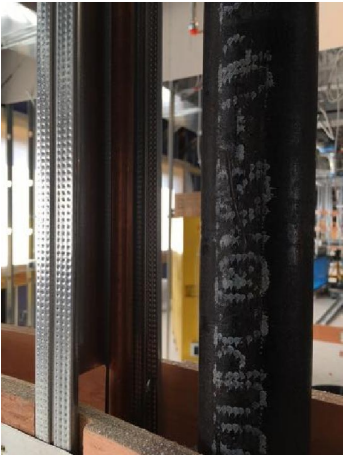
#67 Plumbing

Description  
Concerned about copper piping within the stud.

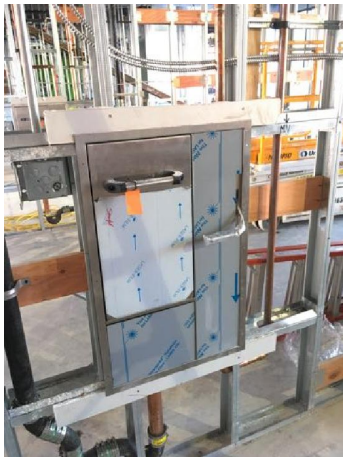
Description  
Emergency showers are being installed.

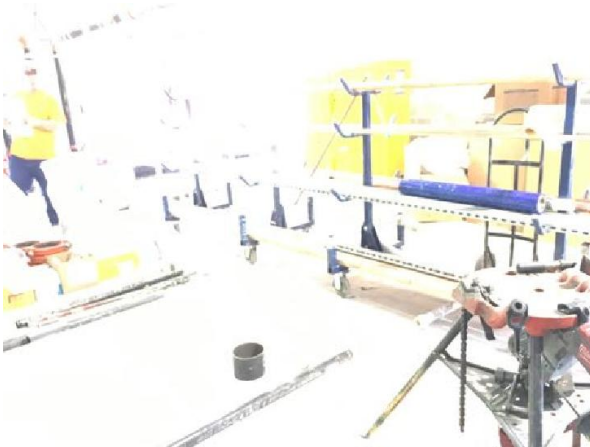
## #76 Plumbing

Plumbing and FP major equipment not in place yet.
