# Post-Construction Stormwater BMP Incident Report

| Project: <b>Webster University ISB</b> | | License #: <b>MO E-18668</b> |
| Incident Date(s): <b>6/16/2016 - 6/17/2016</b> | | Address: <b>5858 Delor Street 63109</b> |

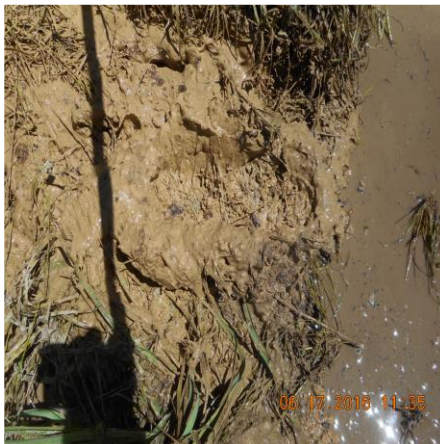
CLOSE-UP VIEW OF  
FOOTPRINT IN SEDIMENT

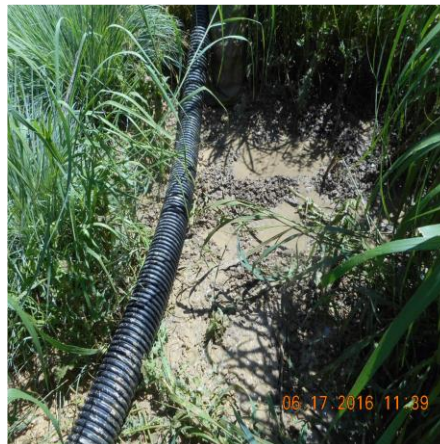
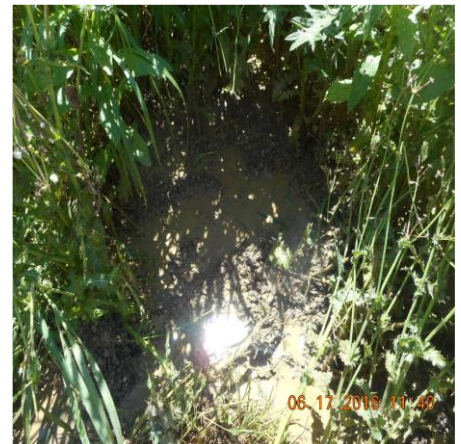
VIEW OF DAMAGED AREA

- \* Remove and legally dispose of soil within the designated repair area to the depth necessary to return the bioretention basin to full functionality.

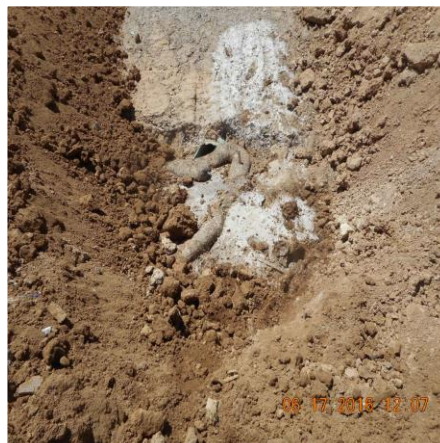
VIEW OF STORM SEWER AFTER DIRECT  
PUMPING WAS DISCONTINUED

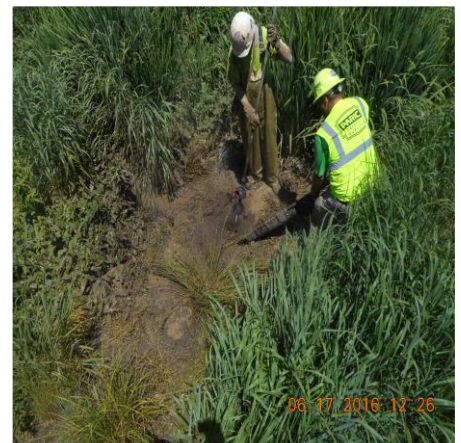
VIEW OF PRESSURIZED WATER AND  
VACUUMING OPERATION IN PROGRESS

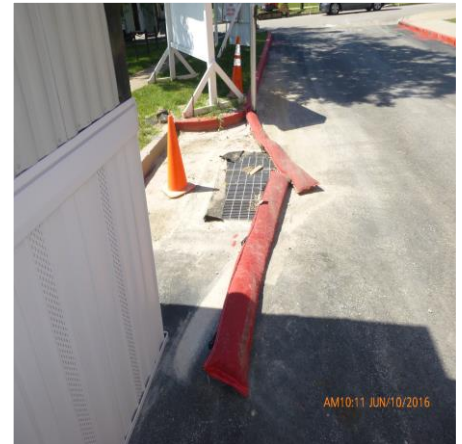
**PIN OR WEIGH DOWN INLET  
PROTECTION 23K2-0394D**

The filter sock protecting the four grate inlet at the southeast corner of the East Academic Building should be pinned or weighted to keep it against the curb on one side and the other end next to the trailer, to keep sediment from getting around it and into the grate inlet. The filter fabric inside the inlet needs to be monitored and replaced as needed.

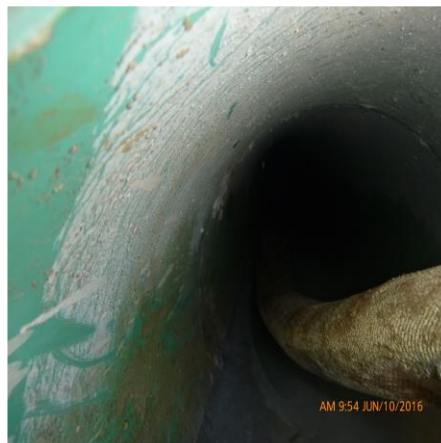
**WATER PUMPED THROUGH HOSE  
INTO END OF PIPE**

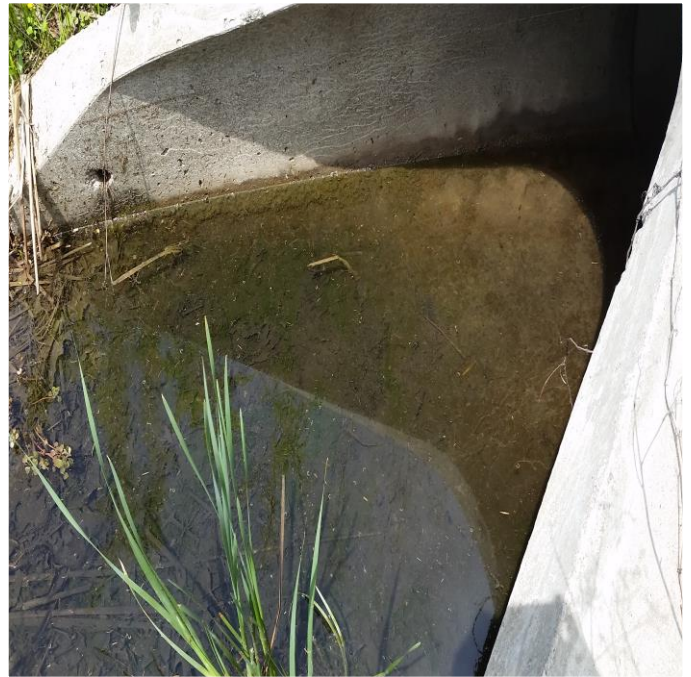
LOOKING AT CLEAR WATER  
STANDING IN INLET PIPE FES

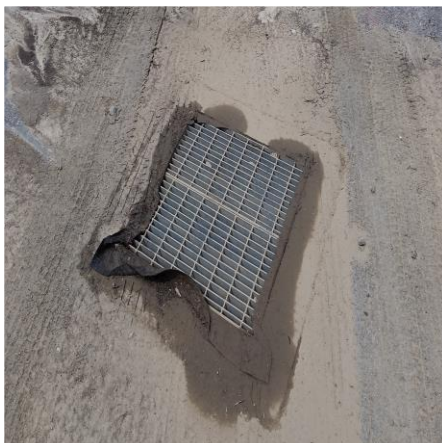
REMOVE AND REPLACE FILTER FABRIC  
IN GI 23K2-0392D

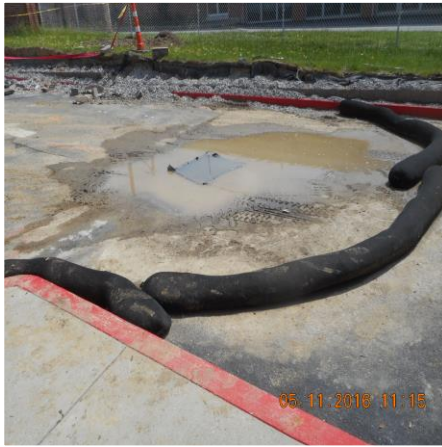
| GI 23K2-0392D | Remove and replace filter fabric under grates. | <b>On-Going</b> |

REMOVE AND REPLACE FILTER FABRIC  
IN GI 23K2-0392D

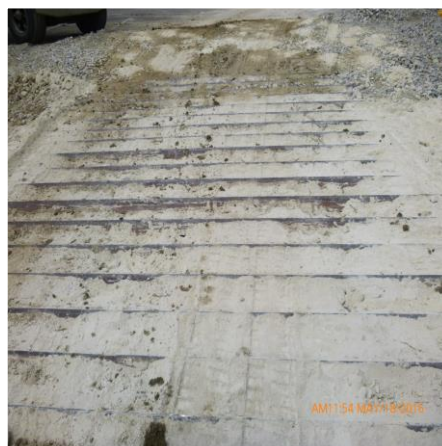
MONITOR FUNCTIONALITY OF  
TRUCK WASH DOWN AREA

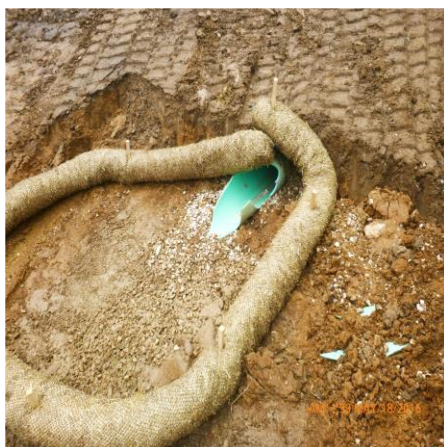
MONITOR SILT SOCK CONDITION AT  
EXISTING PVC PIPE AFTER EACH RAIN

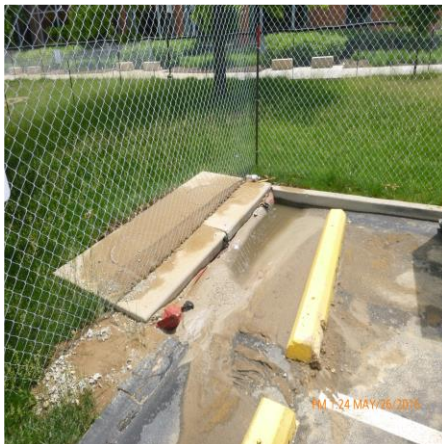
REMOVE SEDIMENT BUILDUP  
AT DCI 23K2-0374D

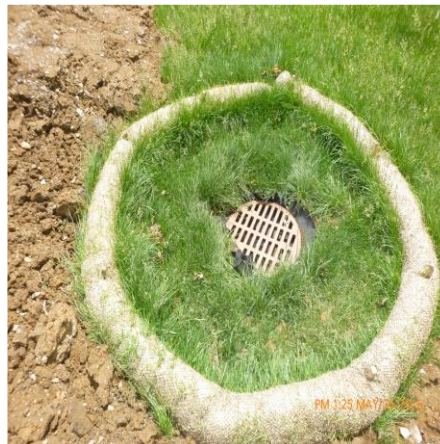
SILT SOCK AND FILTER FABRIC  
PROTECTING GI 23K2-0406D

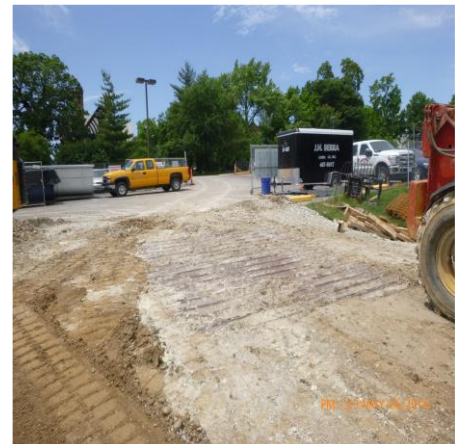
MONITOR FUNCTIONALITY OF  
TRUCK WASH DOWN AREA

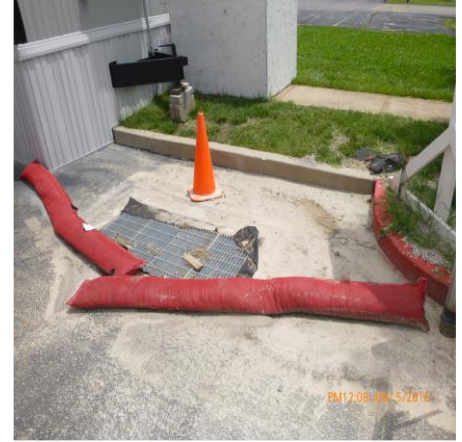
PIN OR WEIGH DOWN INLET  
PROTECTION 23K2-0394D

The filter sock protecting the four grate inlet at the southeast corner of the East Academic Building should be pinned or weighted to keep it against the curb on one side and the other end next to the trailer, to keep sediment from getting around it and into the grate inlet. The filter fabric inside the inlet needs to be monitored and replaced as needed.

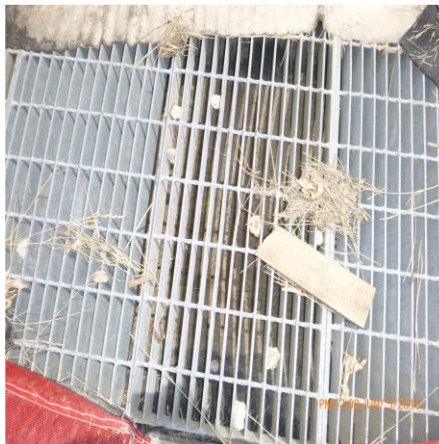
FILTER FABRIC IN PLACE AT  
GI 23K2-0394D

| GI 23K2-0394D (SE corner of EAB) | Remove and replace filter fabric under grates---ON GOING |

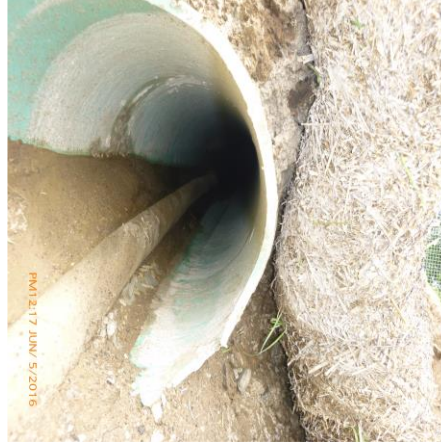
WATER PUMPED THROUGH HOSE  
INTO END OF PIPE

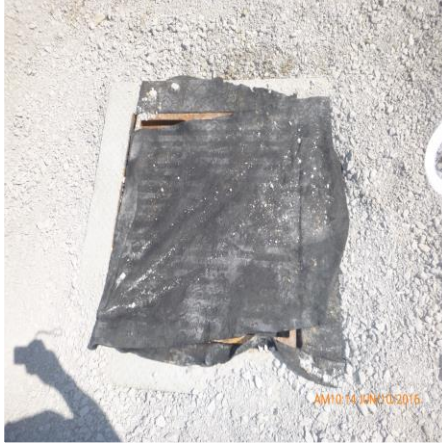
**FILTER FABRIC COVERING INLET # 1**

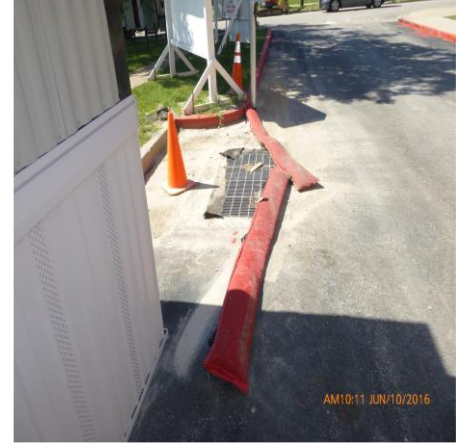
**PIN OR WEIGH DOWN INLET  
PROTECTION 23K2-0394D**

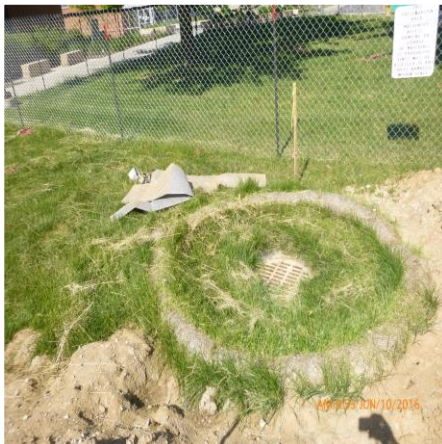
**SILT SOCK AND FILTER FABRIC  
PROTECTING GI 23K2-0406D**

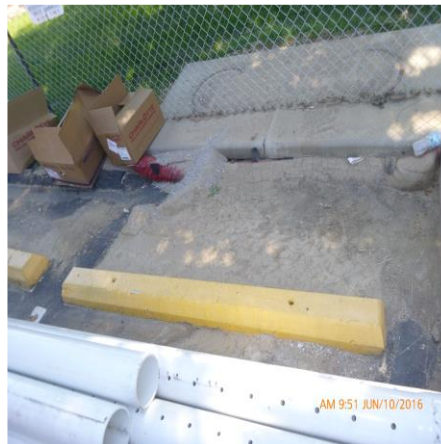
**REMOVE SEDIMENT BUILDUP  
AT DCI 23K2-0374D**

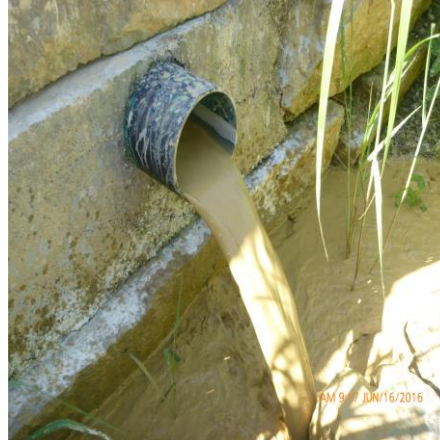
**TURBID WATER AND SEDIMENT  
DISCHARGING FROM HDS**

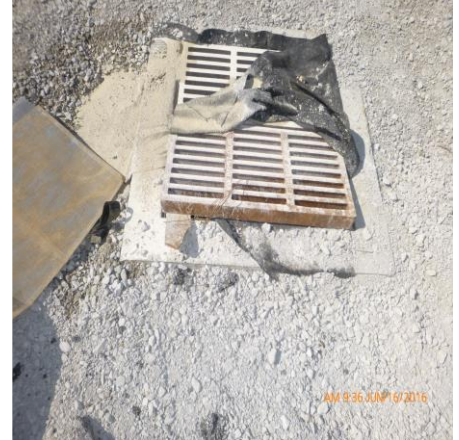
**REMOVE AND REPLACE FILTER FABRIC  
AND RESEAT GRATES ON INLET #1**

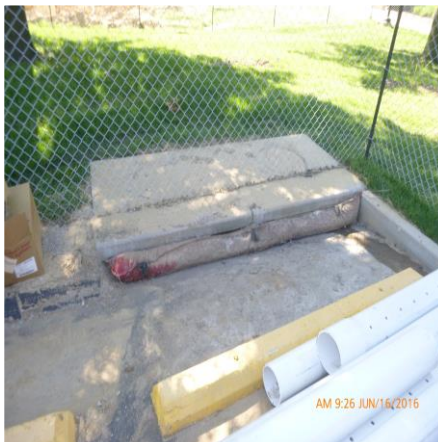
**SEDIMENT REMOVED IN FRONT OF  
INLET 23K2-0374D**

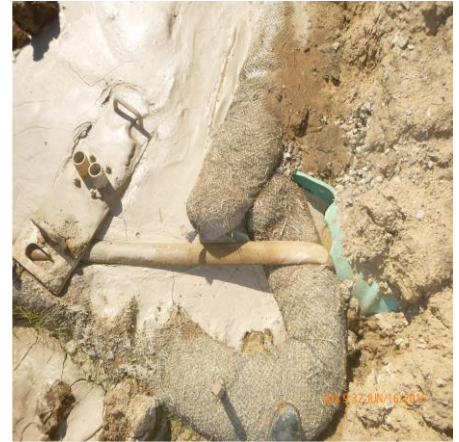
**STOP PUMPING TURBID WATER AND  
SEDIMENT INTO PIPE W/O FILTRATION**

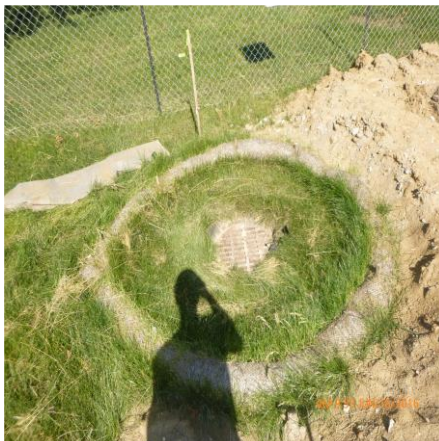
**SILT SOCK AND FILTER FABRIC PROTECTING  
GI 23K2-0406D**

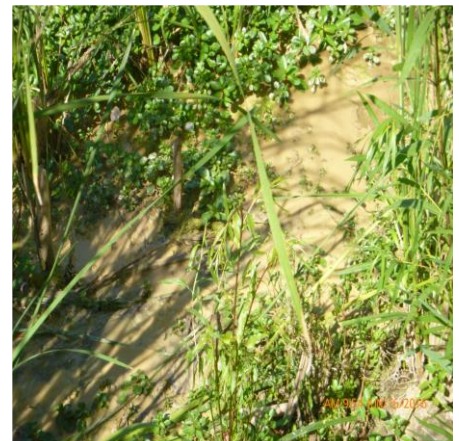
**REPAIR SEDIMENT ENCROACHMENT  
AT NE CORNER OF THE LAKE**

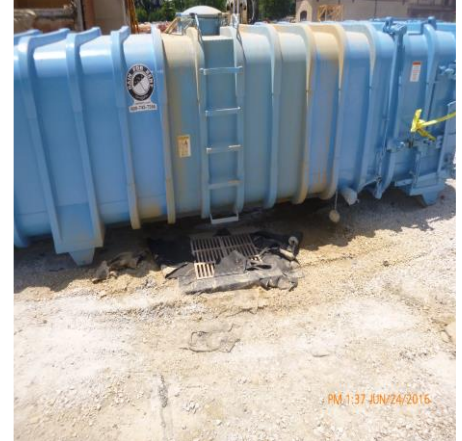
**DEWATERING TANK AND INLET  
PROTECTION IN GOOD CONDITION**

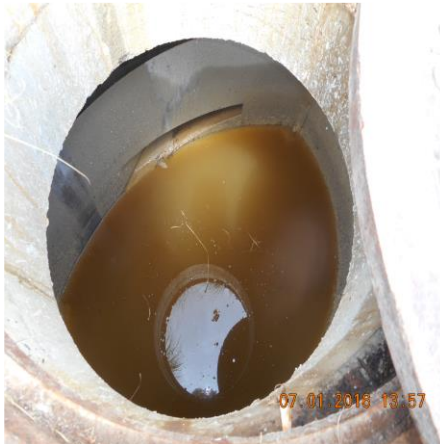
LOOKING AT TURBID WATER IN HDS

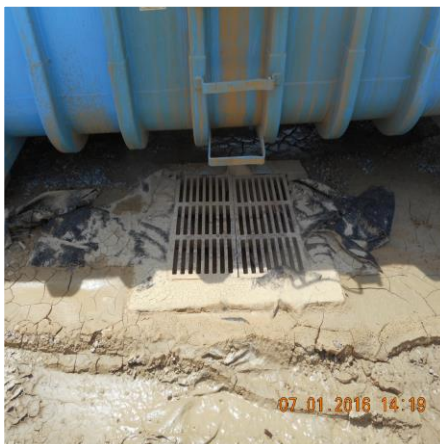
LOOKING AT DEWATERING TANK  
AND INLET PROTECTION

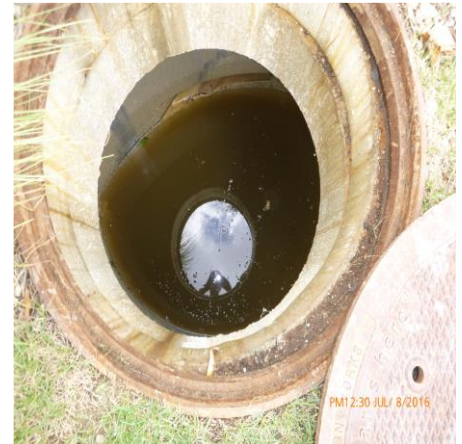
LOOKING AT TURBID WATER IN HDS

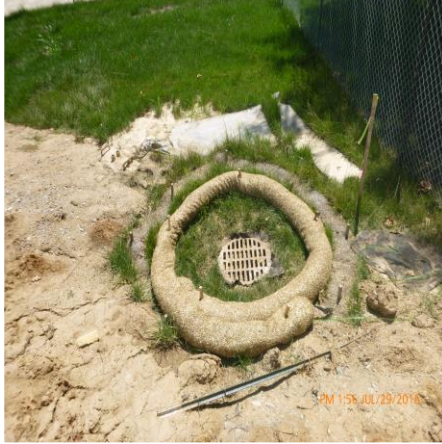
NEW INLET PROTECTION IN PLACE

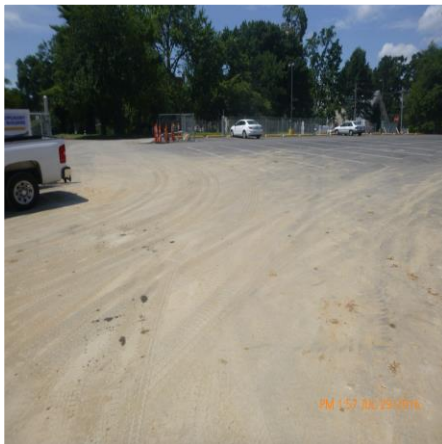
MONITOR SEDIMENT LEAVING  
CONSTRUCTION SITE

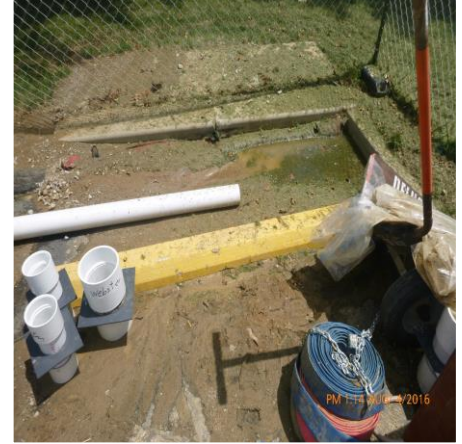
REMOVE SEDIMENT AROUND CURB  
INLET

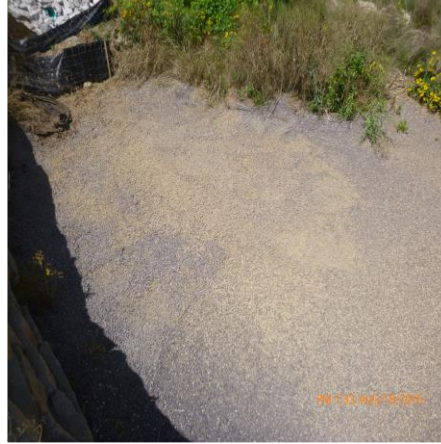
FINISH CLEANING RAIN GARDEN

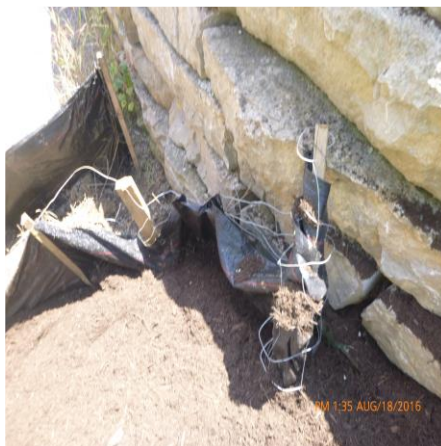
REINSTALL SILT FENCE

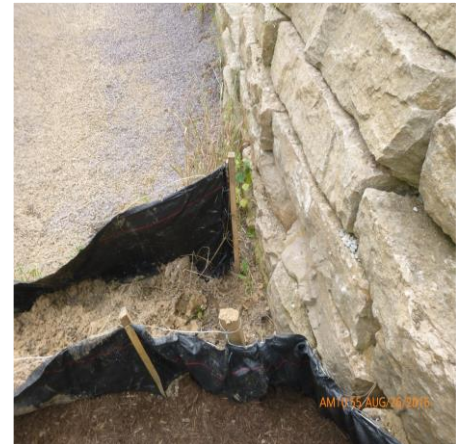
REINSTALL SILT FENCING BELOW  
DOWNSTREAM DEFENDER

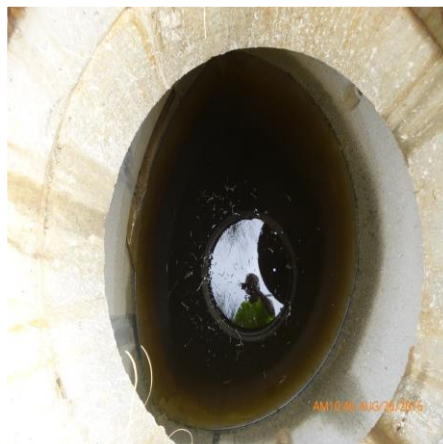
PICTURE OF TURBID WATER IN HDS

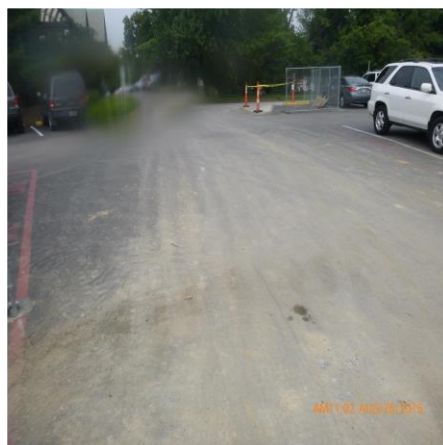
MONITOR SEDIMENT ON PARKING LOT  
LEAVING CONSTRUCTION SITE

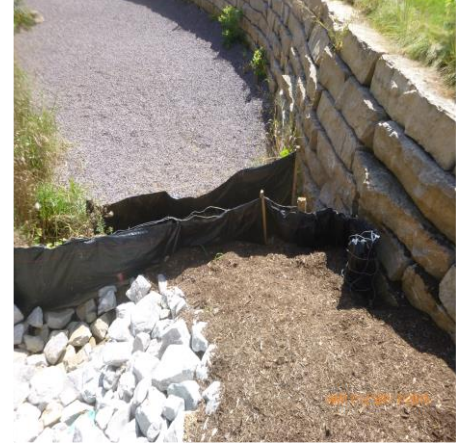
The silt fencing installed below the downstream defender needs to be removed and replaced. There is a gap between the wall and the fence that will allow sediment and mulch into the garden. Other parts of the fence were not repaired properly, they were just backfilled with mulch instead of being buried according to the City of Webster Groves SWPPP regulations.

REINSTALL SILT FENCING BELOW  
DOWNSTREAM DEFENDER

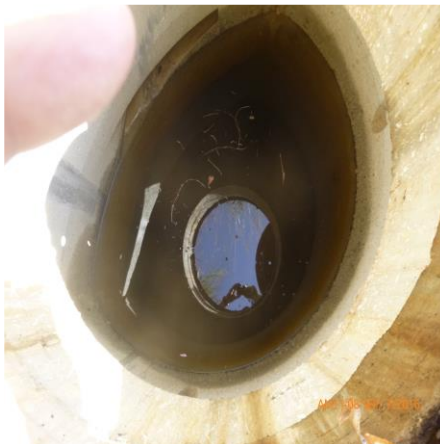
PICTURE OF TURBID WATER IN HDS

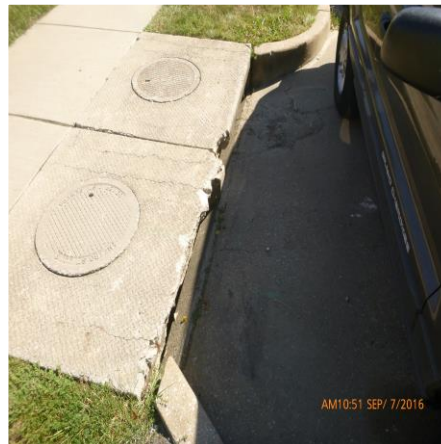
REPLACE MISSING INLET PROTECTION  
(GARDEN AVENUE)

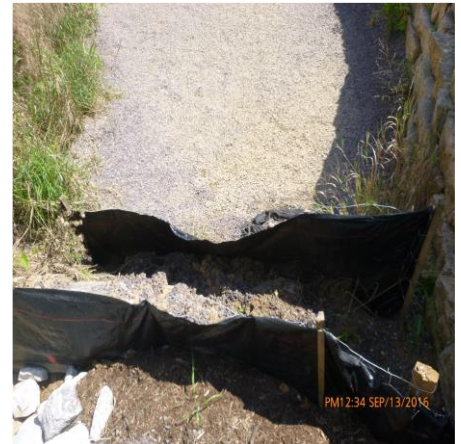
Part of the silt fencing installed below the downstream defender was repaired, however the lower fence that is installed is not installed properly, it has gaps at each end that will allow rain water and sediment to flow around it. The fence needs to be tight against the retaining wall and the other end needs to be tight up against the rock in the rain garden. A small amount of sediment from the last few days of rain has once again encroached into the rain garden.

REINSTALL LOWER PORTION OF FENCE

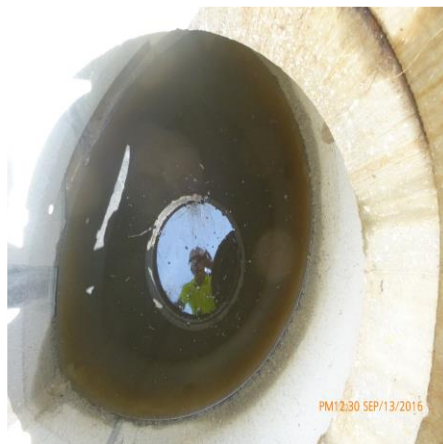
PICTURE OF TURBID WATER IN HDS

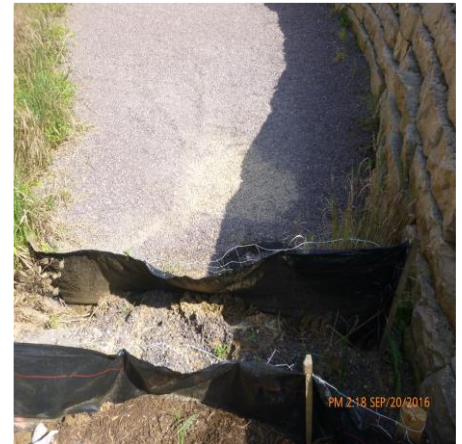
REINSTALL LOWER PORTION OF SILT FENCE

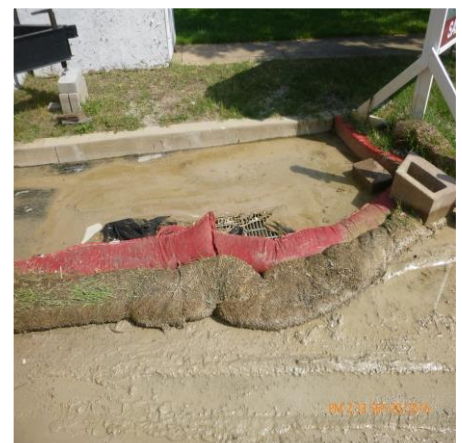
REPLACE FILTER FABRIC AS NEEDED

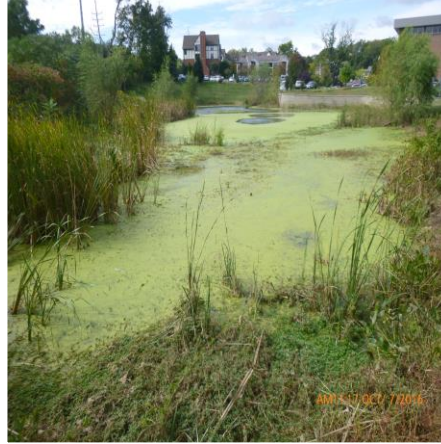
LOOKING SOUTH AT LAKE

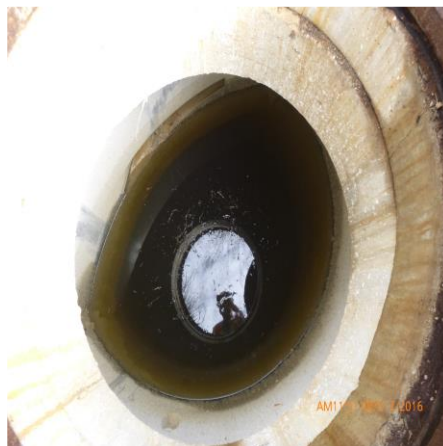
LOOKING AT TURBID WATER INSIDE HDS

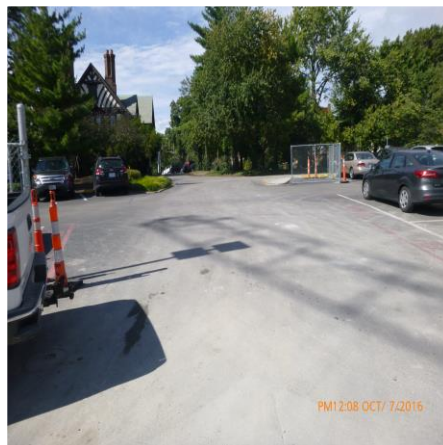
MONITOR SEDIMENT ON PARKING LOT  
LEAVING CONSTRUCTION SITE

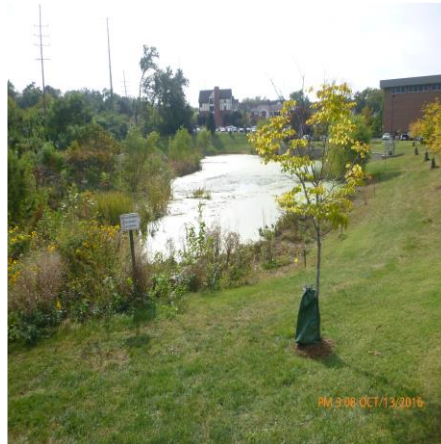
LOOKING SOUTH AT LAKE

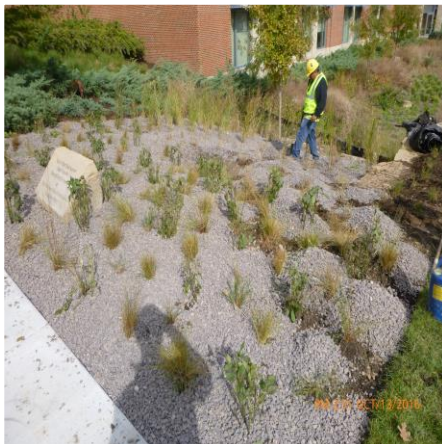
PLANTS AND ROCK BEING ADDED ON HILL  
ABOVE RAIN GARDEN

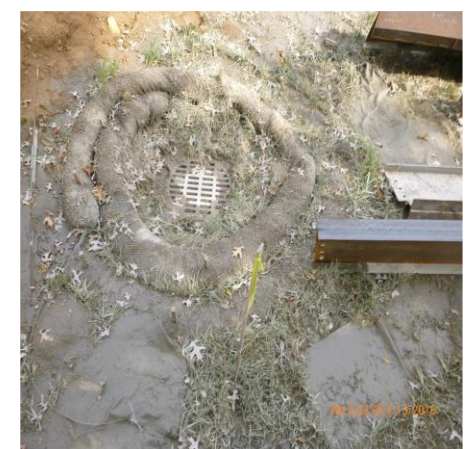
INLET PROTECTION IN PLACE

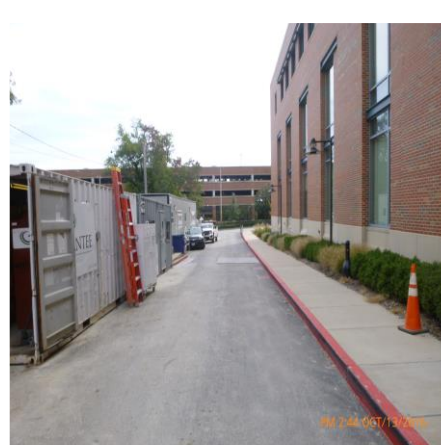
LOOKING SOUTH AT CONSTRUCTION  
DRIVEWAY ENTRANCE

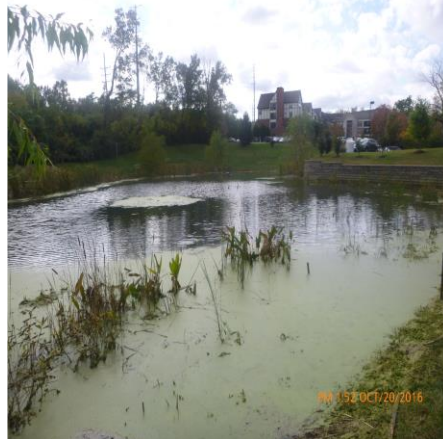
LOOKING SOUTH AT LAKE

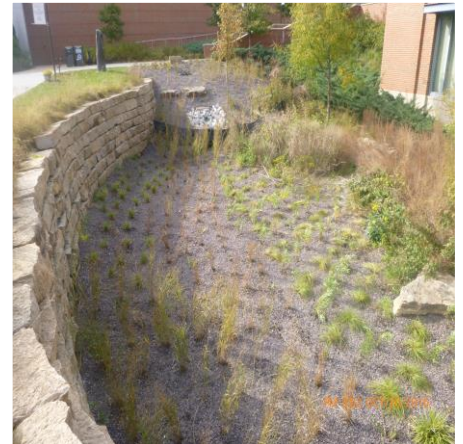
NEW PLANTS IN RAIN GARDEN A

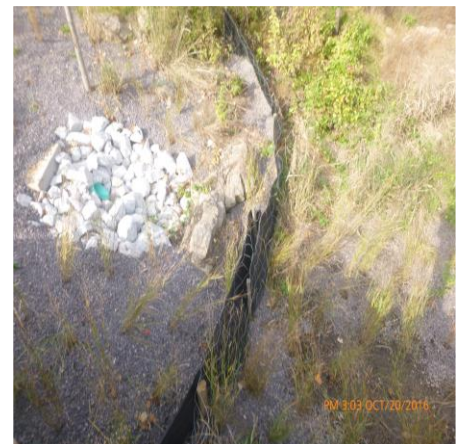
SILT FENCE IN PLACE IN RAIN GARDEN

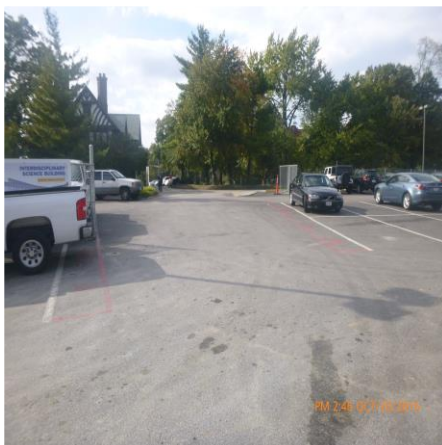
MONITOR SEDIMENT ON PARKING LOT  
LEAVING CONSTRUCTION SITE

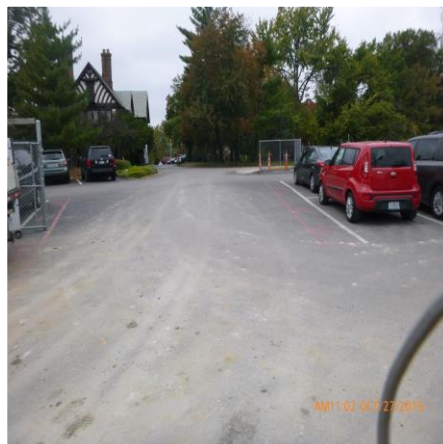
MONITOR SEDIMENT ON PARKING LOT  
LEAVING CONSTRUCTION SITE

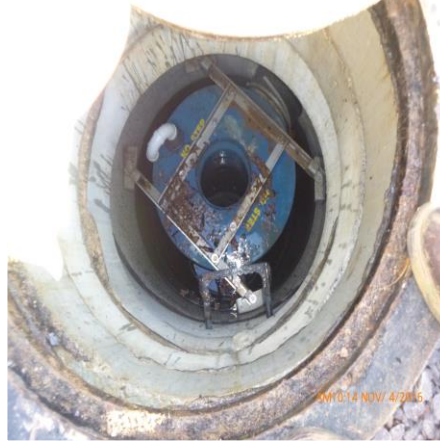
VIEW OF DOWNSTREAM DEFENDER

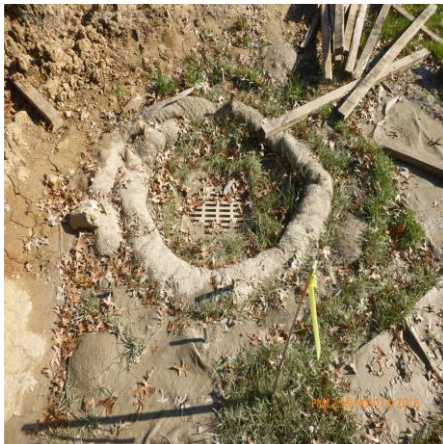
INLET PROTECTION IN PLACE

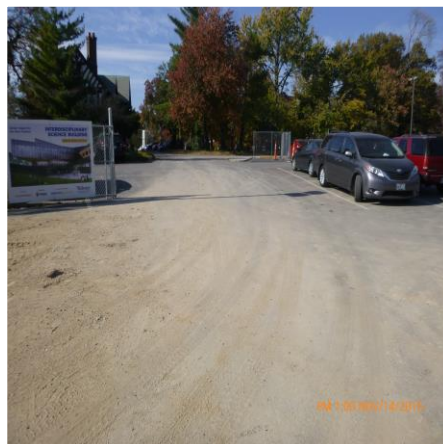
MONITOR SEDIMENT AT PARKING LOT  
LEAVING CONSTRUCTION SITE

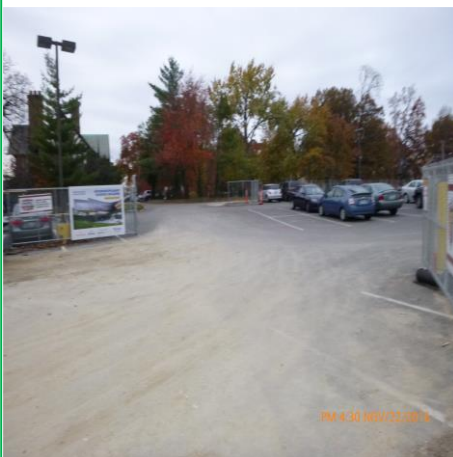
MONITOR SEDIMENT ON PARKING LOT  
LEAVING CONSTRUCTION SITE

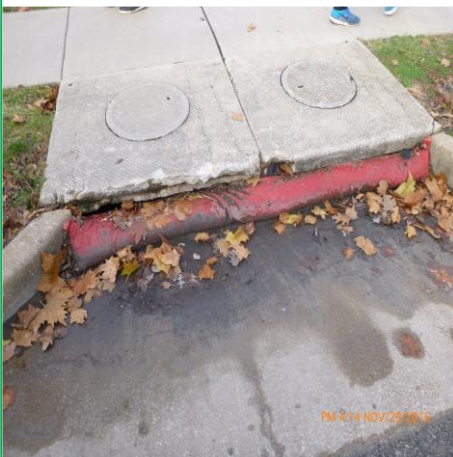
CURB INLET PROTECTION IN PLACE

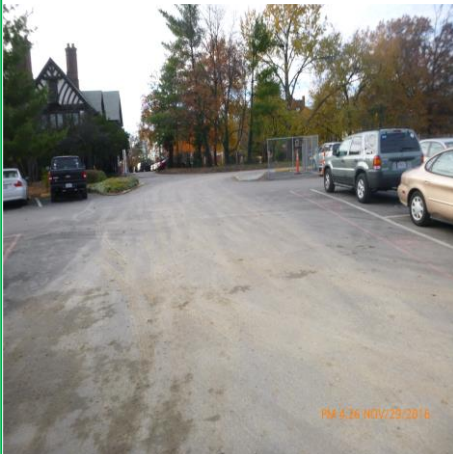
MONITOR SEDIMENT ON PARKING LOT  
LEAVING CONSTRUCTION SITE

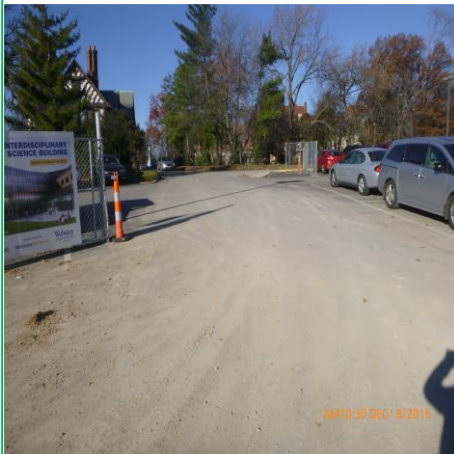
MONITOR SEDIMENT ON PARKING LOT  
LEAVING CONSTRUCTION SITE

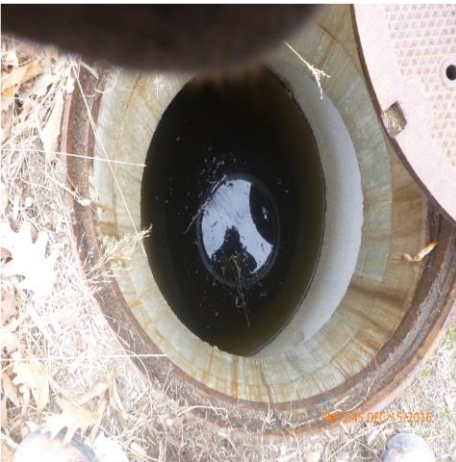
LOOKING AT TURBID WATER IN THE HDS

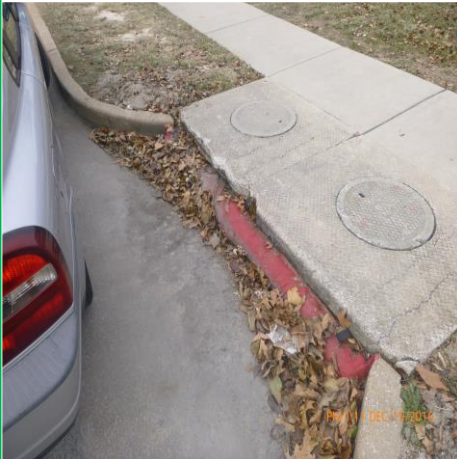
MONITOR SEDIMENT AT CURB INLET  
(GARDEN AVENUE)

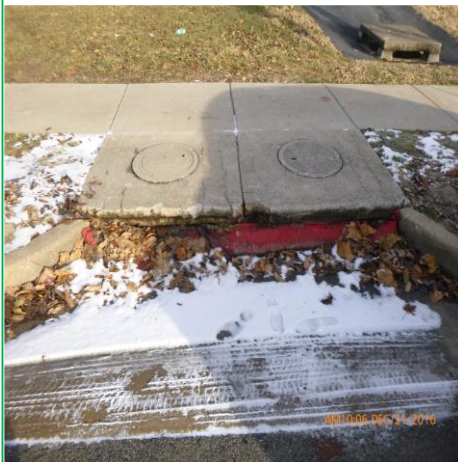
MONITOR SEDIMENT AT CURB INLET  
(GARDEN AVENUE)

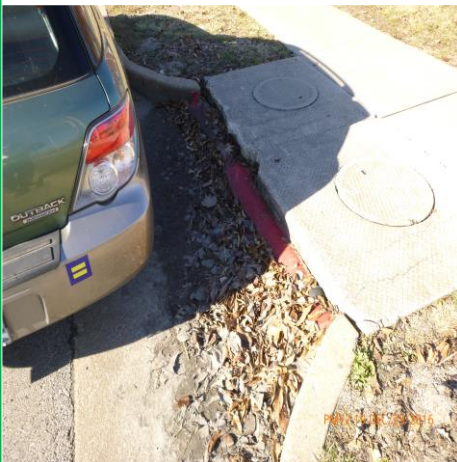
MONITOR SEDIMENT AT PARKING LOT  
ENTRANCE

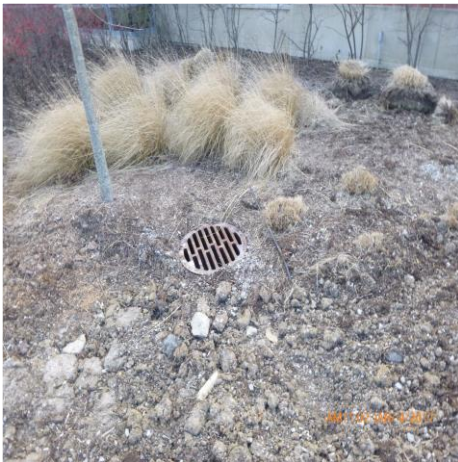
ADD PROTECTION TO INLET # 23K2-  
0407D SOUTH OF SIDEWALK

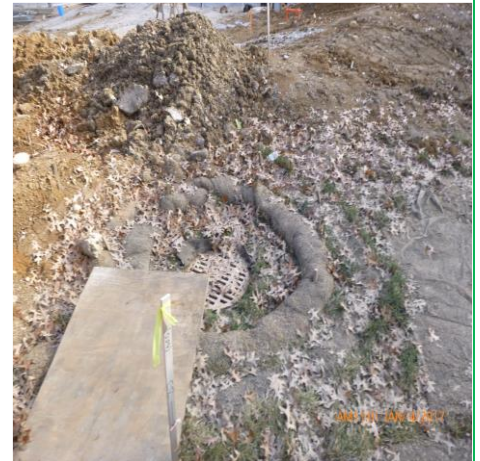
INLET PROTECTION IN PLACE

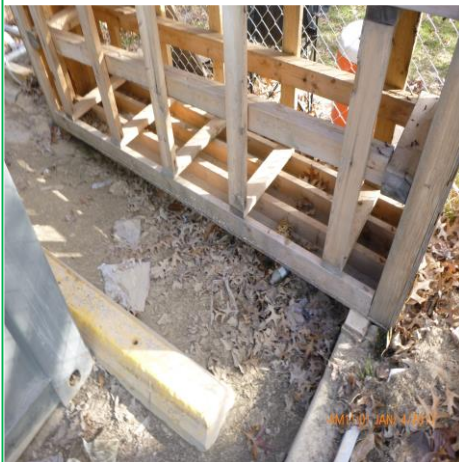
MONITOR SEDIMENT AT CURB INLET  
(PARKING LOT)

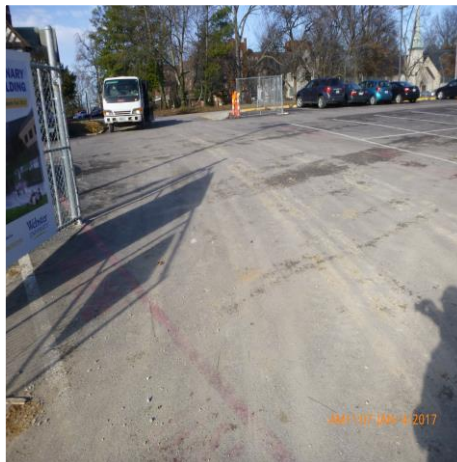
MONITOR SEDIMENT AT PARKING LOT  
ENTRANCE

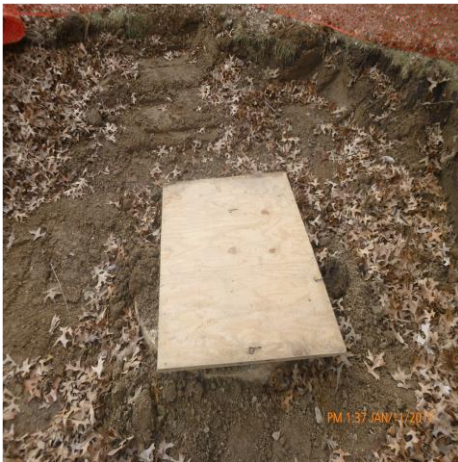
ADD INLET PROTECTION TO 23K2-0406D  
WHEN PROJECT IS FINISHED

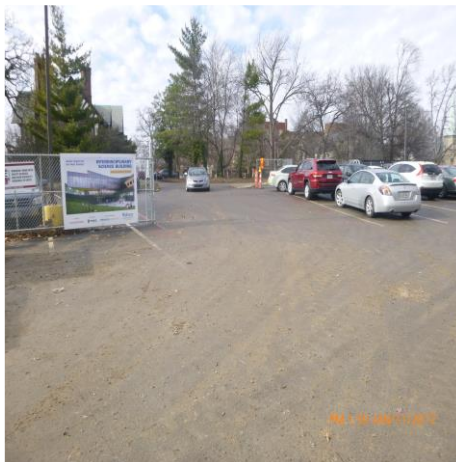
MONITOR SEDIMENT AT PARKING LOT  
ENTRANCE

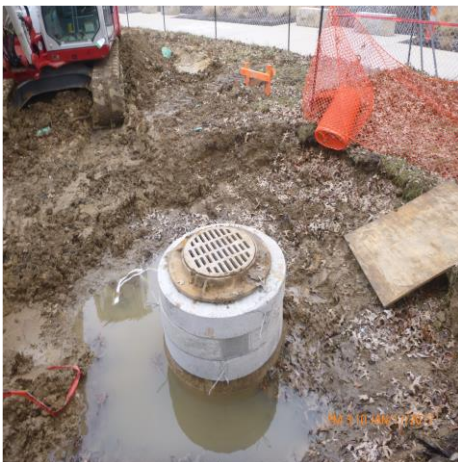
ADD INLET PROTECTION TO 23K2-0406D  
WHEN PROJECT IS FINISHED

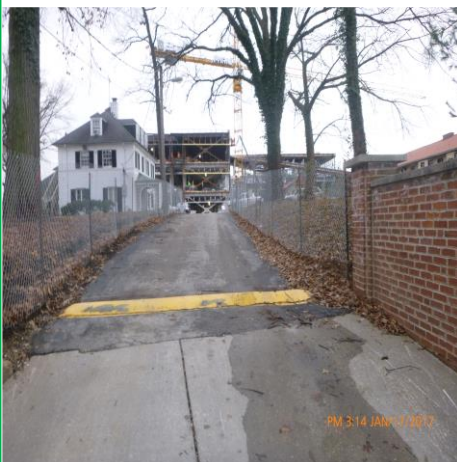
MONITOR SEDIMENT IN DRIVEWAY (BIG  
BEND)

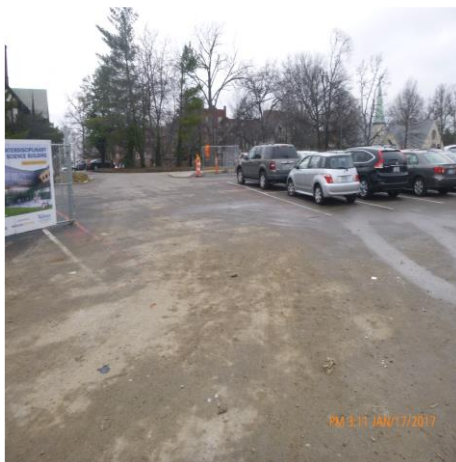
MONITOR SEDIMENT AT PARKING LOT  
ENTRANCE

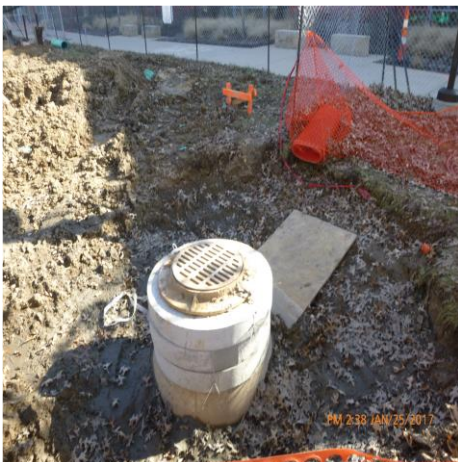
ADD INLET PROTECTION TO 23K2-0406D  
WHEN PROJECT IS FINISHED

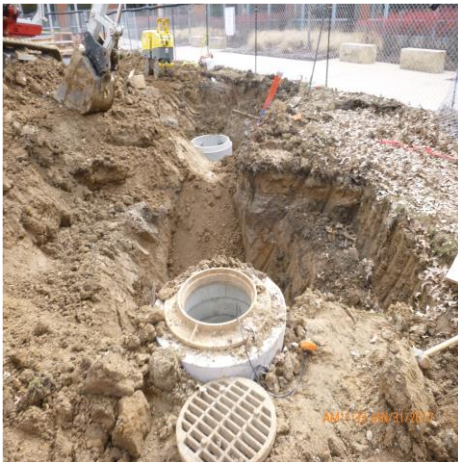
ADD INLET PROTECTION TO 23K2-0406D  
WHEN PROJECT IS FINISHED

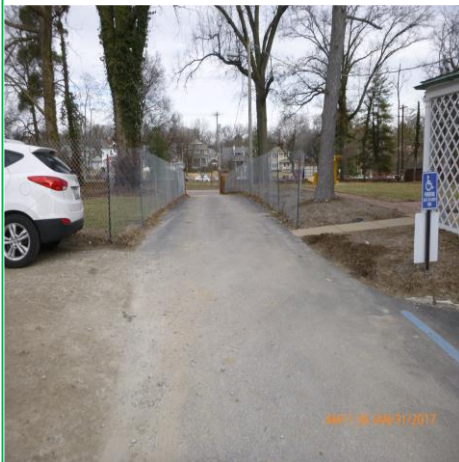
MONITOR ROCK AND SEDIMENT ON  
DRIVEWAY ENTRANCE

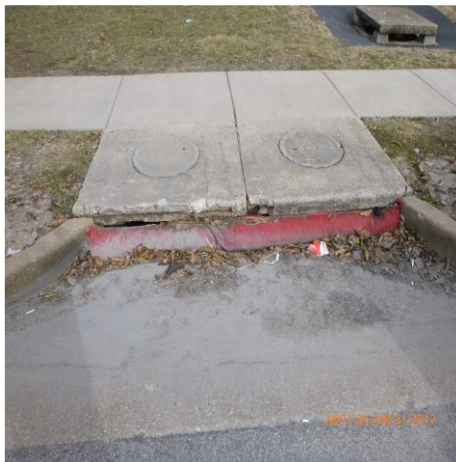
REMOVE SEDIMENT AT INLET (GARDEN AVE)  
AND AREA OF GRASS

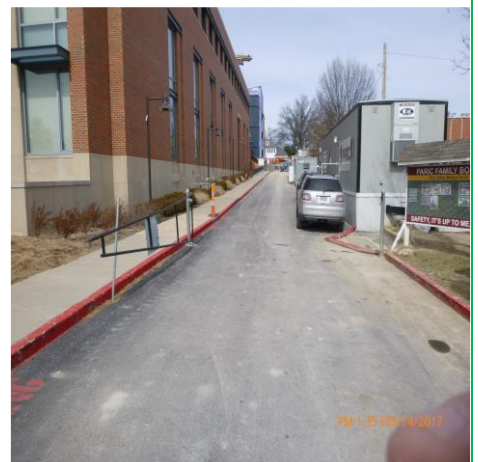
LOOKING NORTH AT SITE ENTRANCE

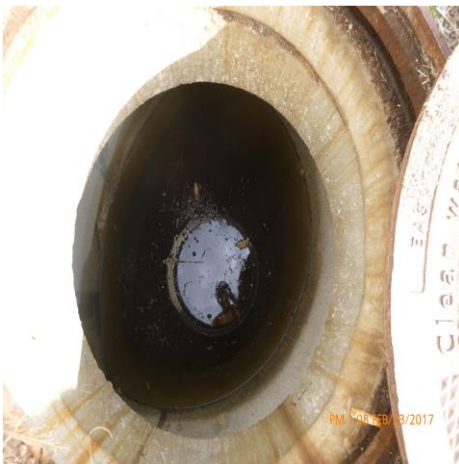
VIEW OF TURBID WATER IN HDS

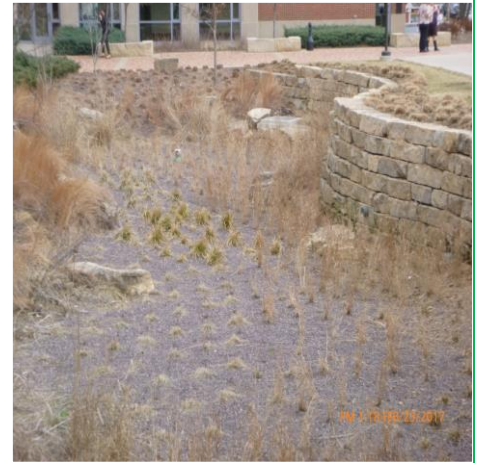
PICTURE OF RAIN GARDEN

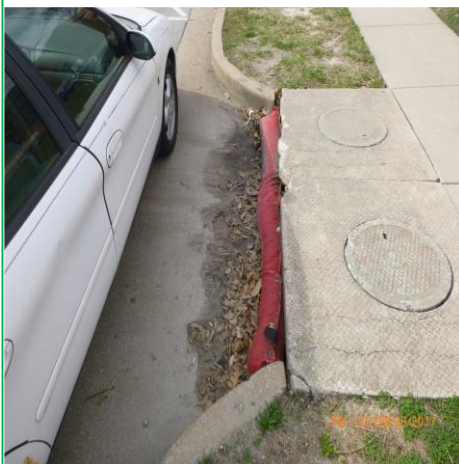
INLET PROTECTION IN PLACE  
(GARDEN AVENUE)

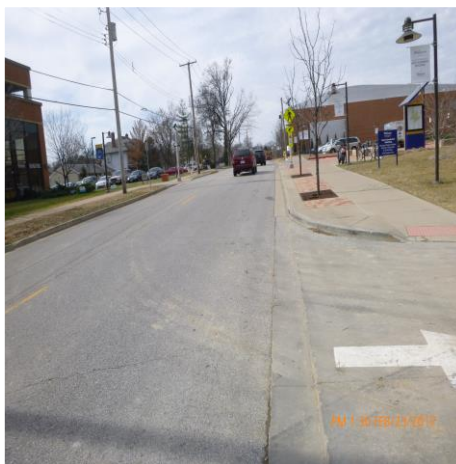
VIEW OF SITE ENTRANCE  
(GARDEN AVENUE)

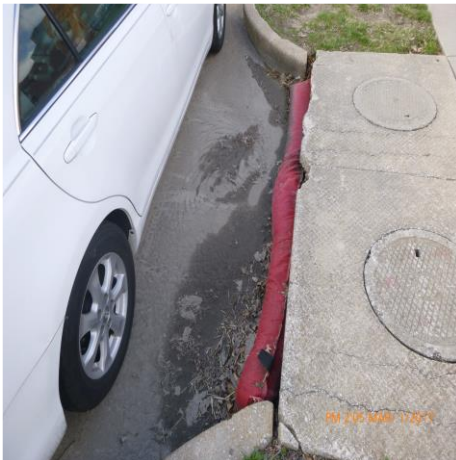
INLET PROTECTION IN PLACE  
GARDEN AVENUE

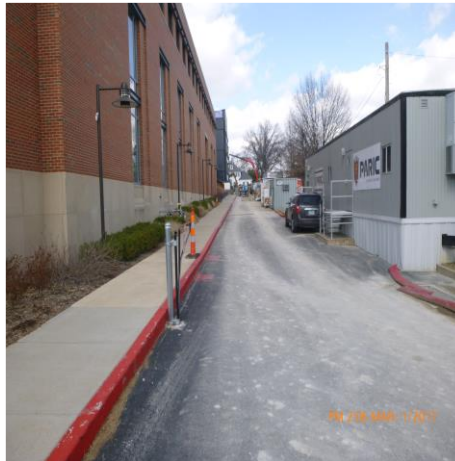
LOOKING NORTH AT SITE ENTRANCE

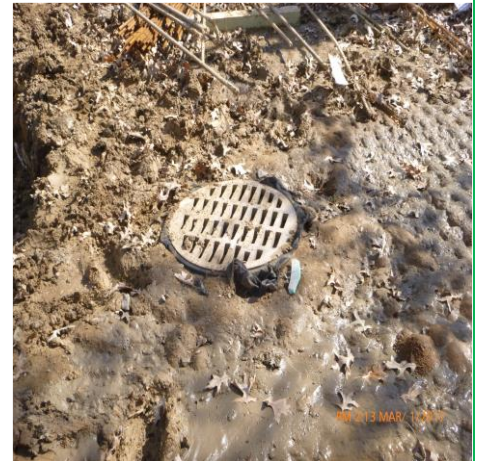
INLET PROTECTION IN PLACE

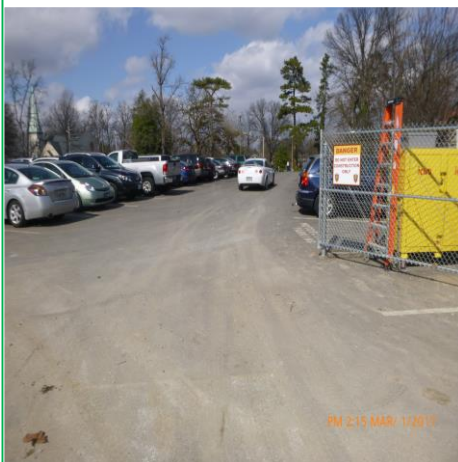
MONITOR SEDIMENT LEAVING SITE  
(PARKING LOT)

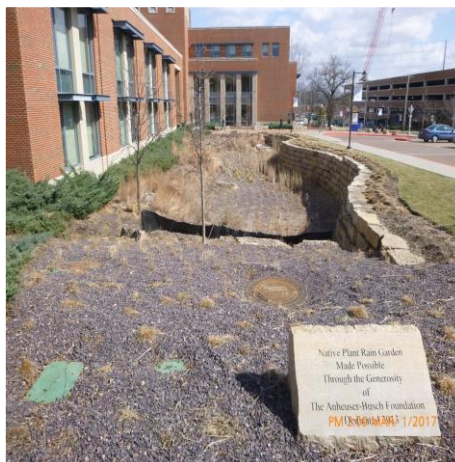
VIEW OF RAIN GARDEN

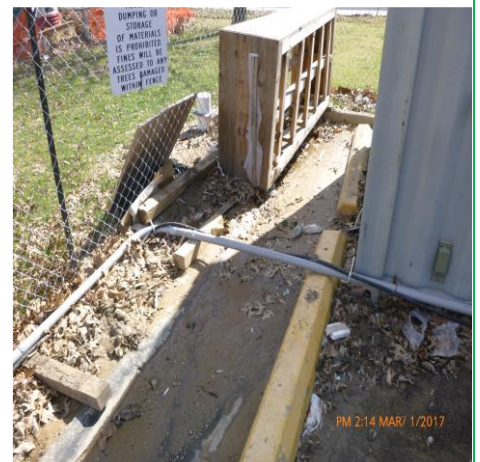
MONITOR SEDIMENT AT CURB INLET  
(PARKING LOT)

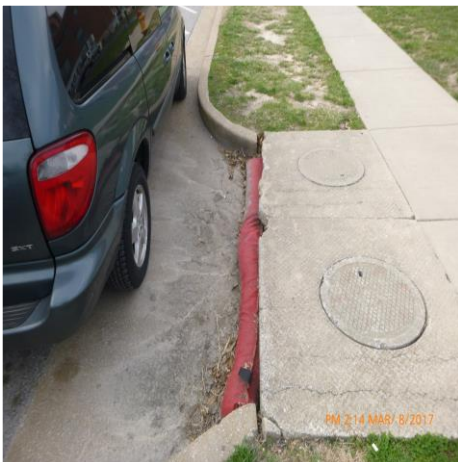
INLET PROTECTION IN PLACE  
GARDEN AVENUE

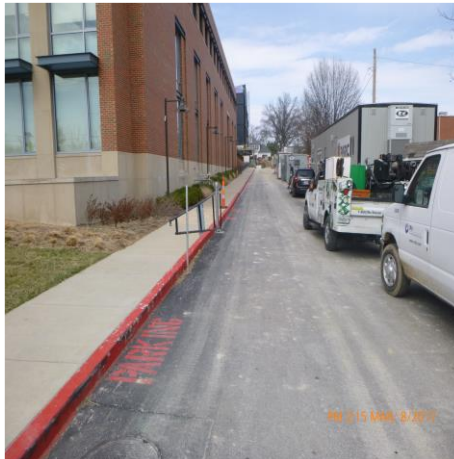
LOOKING NORTH AT SITE ENTRANCE

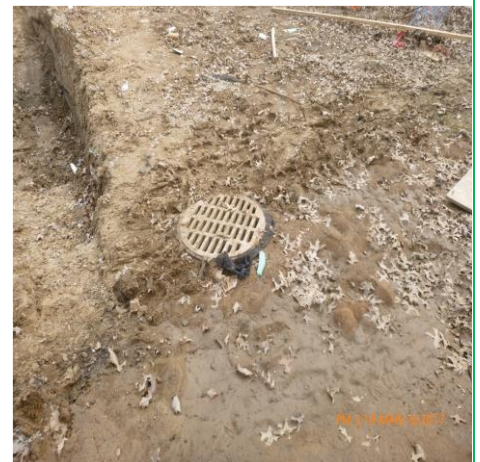
INLET PROTECTION IN PLACE

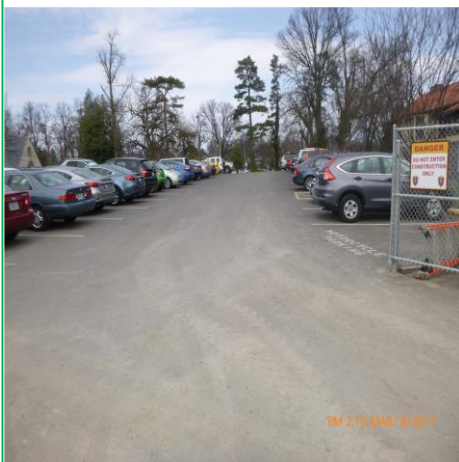
MONITOR SEDIMENT LEAVING SITE  
(PARKING LOT)

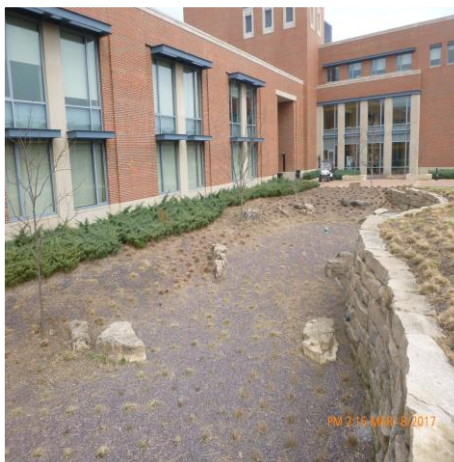
VIEW OF RAIN GARDEN

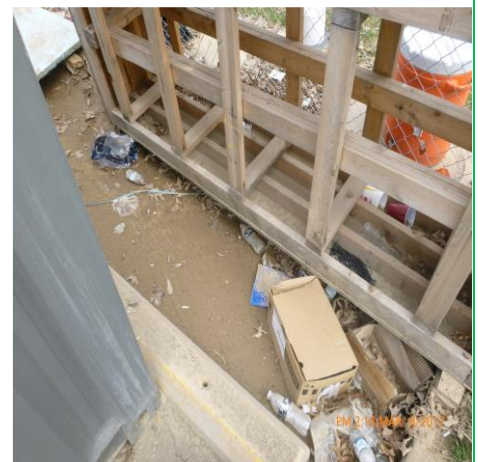
MONITOR SEDIMENT AT CURB INLET  
(PARKING LOT)

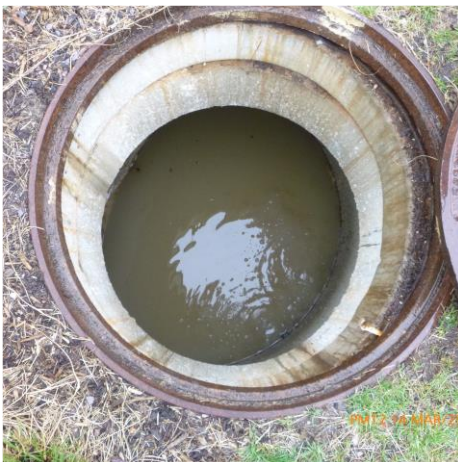
LOOKING AT TURBID WATER IN HDS

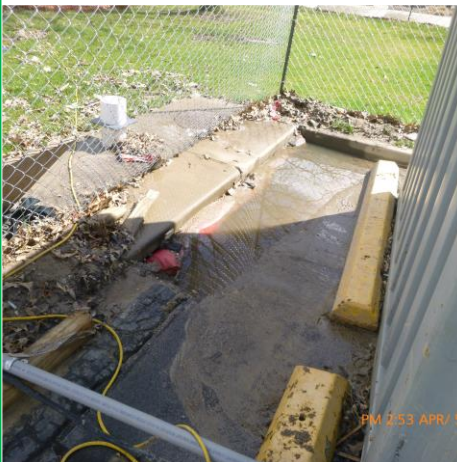
MONITOR SEDIMENT AT CURB INLET  
(PARKING LOT)

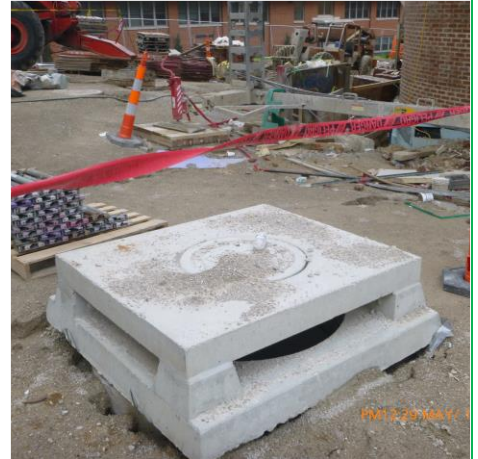
ADD PROTECTION TO AREA INLET # 4
