# Post-Construction Stormwater BMP Incident Report

| Project: <b>Webster University ISB</b> | | License #: <b>MO E-18668</b> |
| Incident Date(s): <b>6/16/2016 - 6/17/2016</b> | | Address: <b>5858 Delor Street 63109</b> |

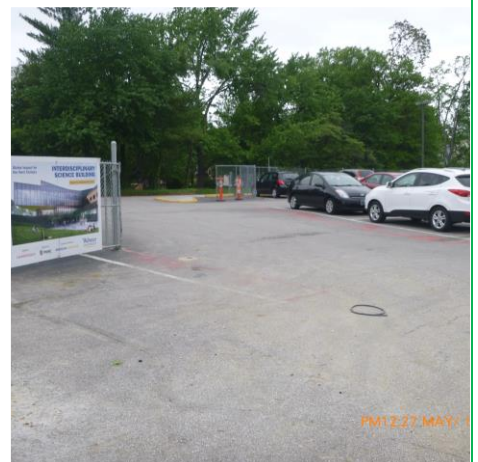
MONITOR SEDIMENT AT SITE  
ENTRANCE (PARKING LOT)

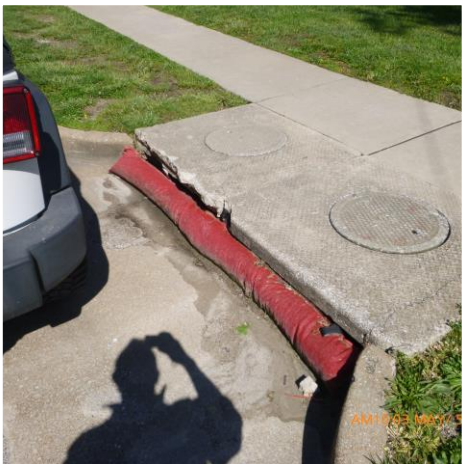
MONITOR SEDIMENT AT CURB INLET  
(GARDEN AVENUE)

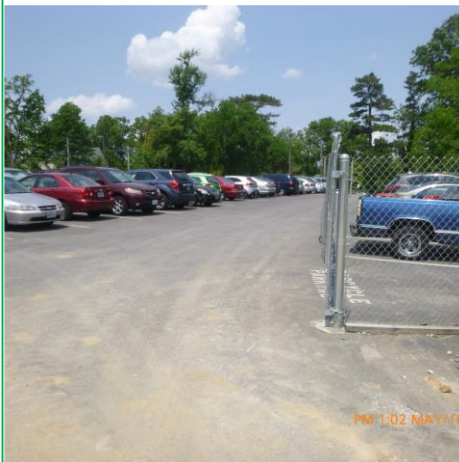
MONITOR SEDIMENT AT SITE ENTRANCE  
(PARKING LOT)

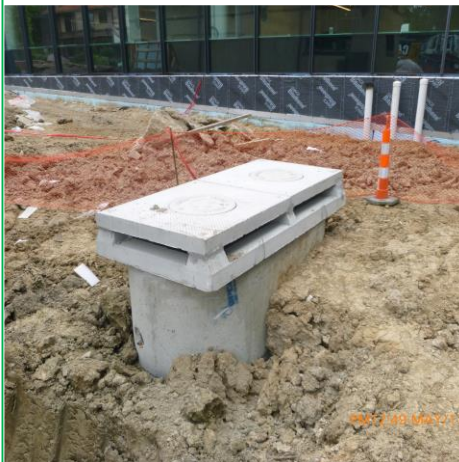
ADD PROTECTION TO AREA INLET # 6

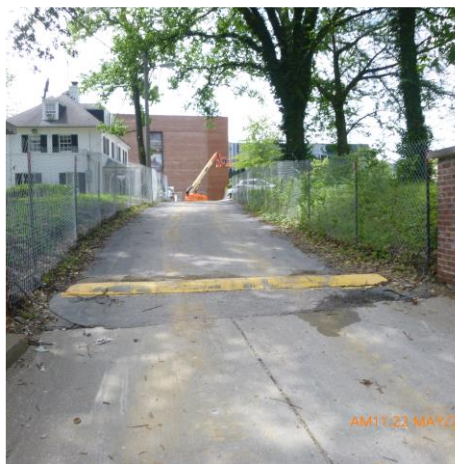
MONITOR SEDIMENT LEAVING SITE  
ENTRANCE (BIG BEND BLVD)

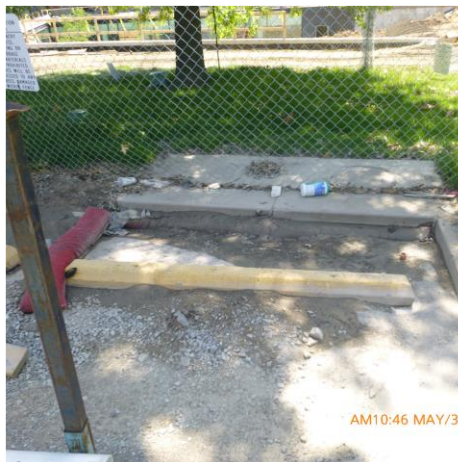
REMOVE SEDIMENT AROUND CURB  
INLET

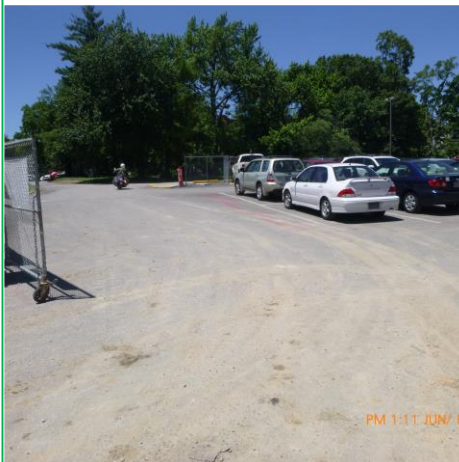
MONITOR SEDIMENT AT PARKING LOT  
ENTRANCE

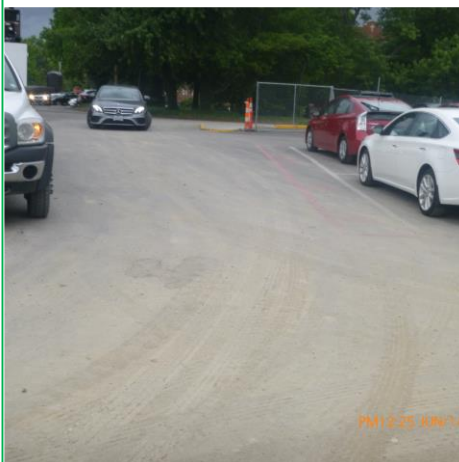
MONITOR SEDIMENT AT PARKING LOT  
ENTRANCE

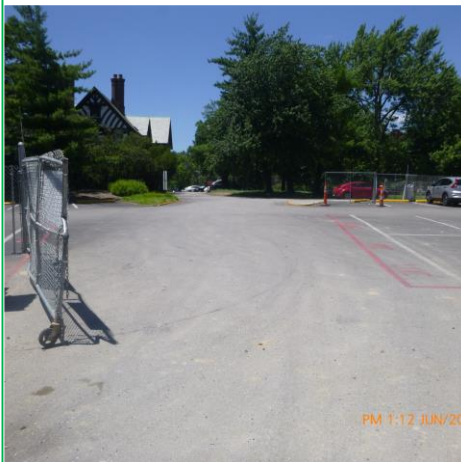
MONITOR SEDIMENT AT PARKING LOT  
ENTRANCE

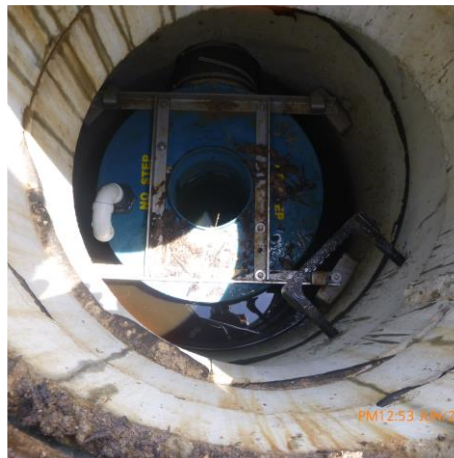
VIEW OF DOWNSTREAM DEFENDER

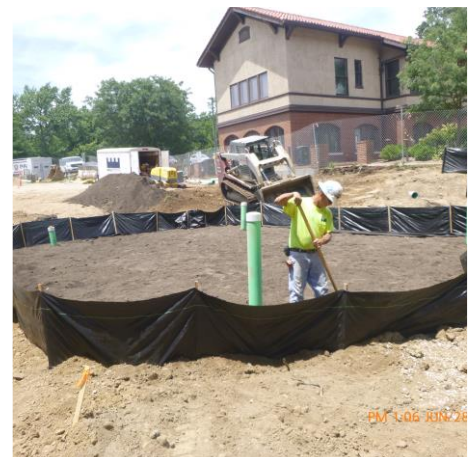
VIEW OF RAIN GARDEN # 2

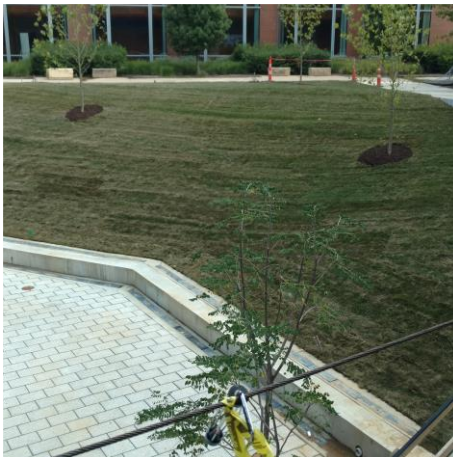
SOD ADDED ALONG PATIO HILL

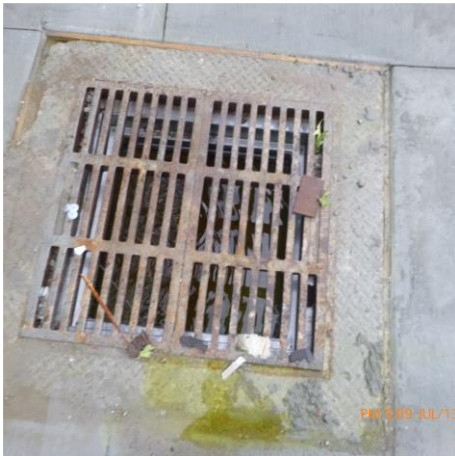
VIEW OF DBL GRATE INLET # 1  
PROTECTED BY FILTER INSERT

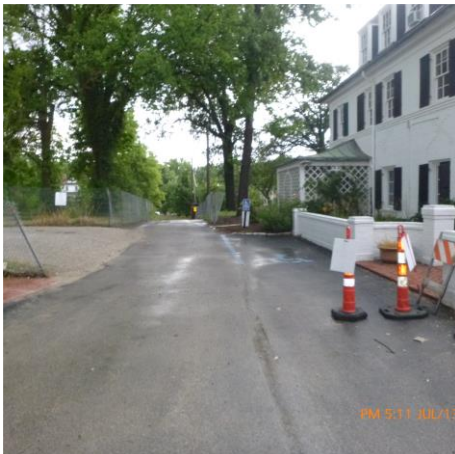
LOOKING NORTH AT SITE ENTRANCE  
(BIG BEND BLVD)

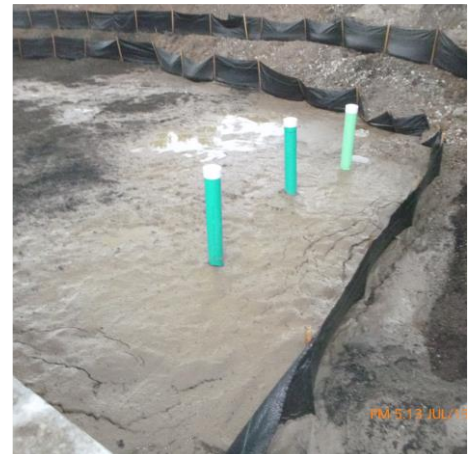
VIEW OF RAIN GARDEN # 1

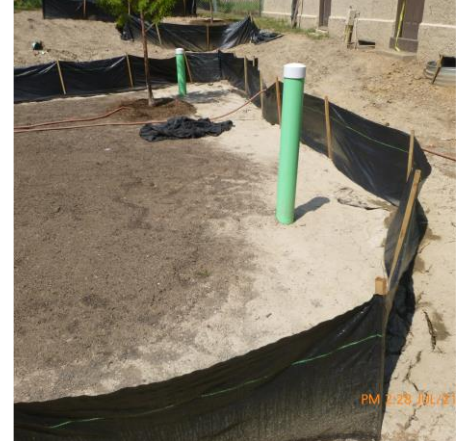
VIEW OF RAIN GARDEN # 2

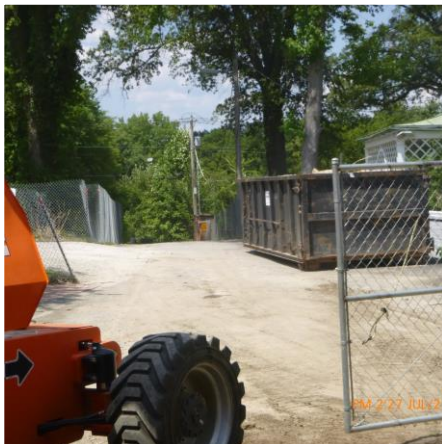
LOOKING NORTH AT SITE ENTRANCE  
(BIG BEND BLVD)

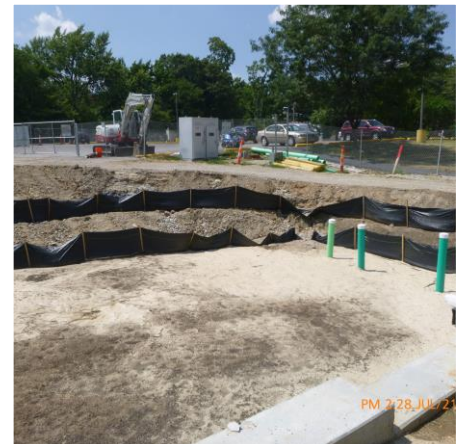
VIEW OF RAIN GARDEN # 1

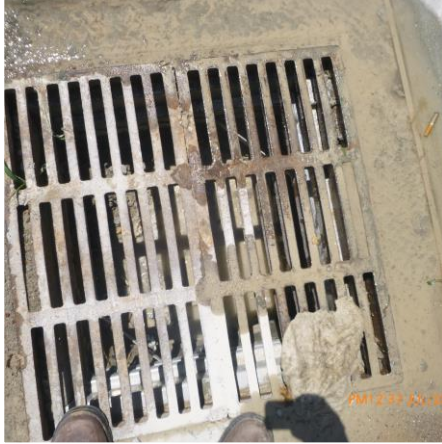
VIEW OF DBL GRATE INLET # 1  
PROTECTED BY FILTER INSERT

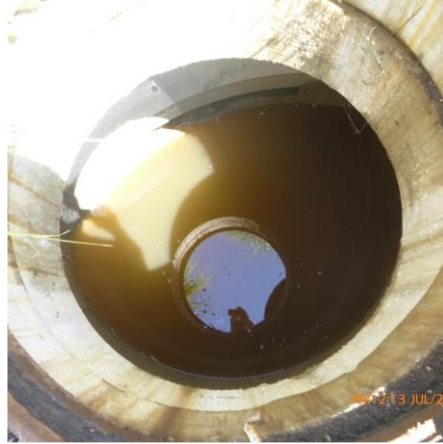
VIEW OF TURBID WATER IN HDS UNIT

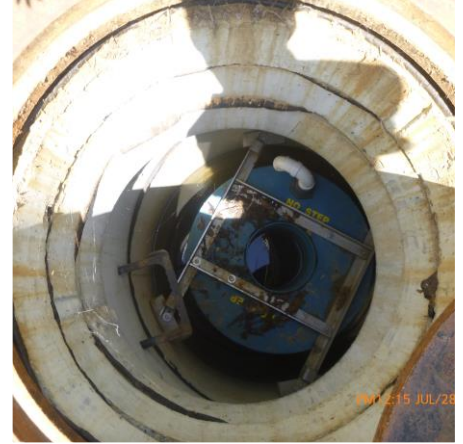
VIEW OF DOWNSTREAM DEFENDER

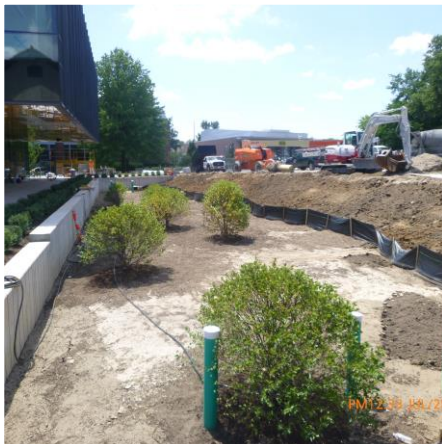
VIEW OF RAIN GARDEN # 1

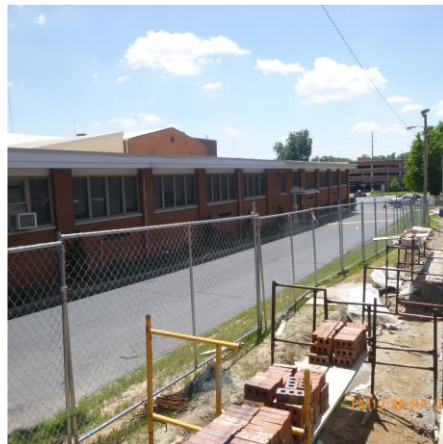
LOOKING SOUTH AT EAST PROERTY  
LINE

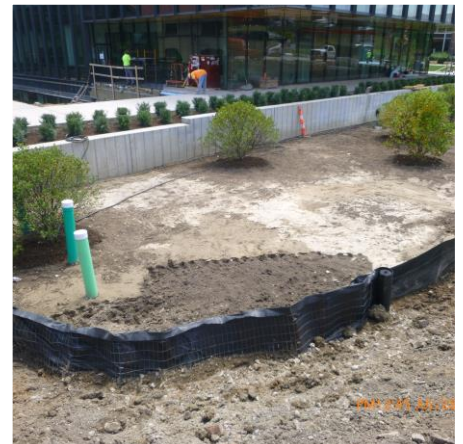
VIEW OF RAIN GARDEN # 1

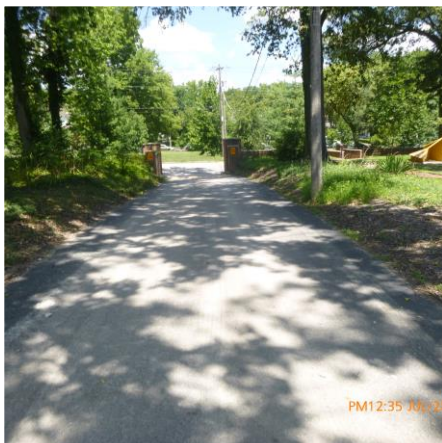
LOOKING NORTH AT SITE ENTRANCE  
(BIG BEND)

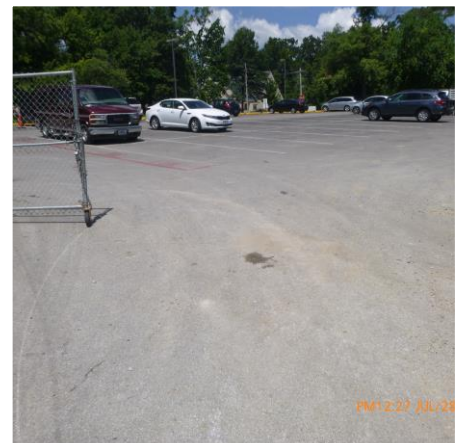
LOOKING WEST AT SITE ENTRANCE  
(PARKING LOT)

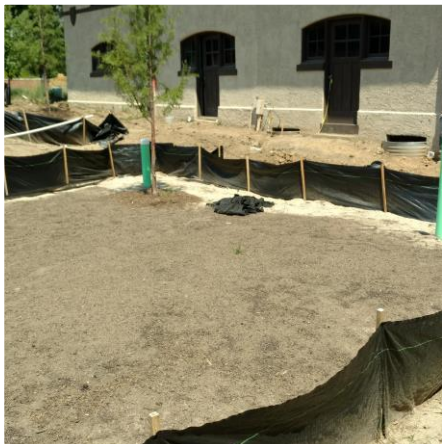
LOOKING SOUTH AT EAST PROERTY  
LINE
